# The Sizewell C Project

## 6.10 Volume 9 Rail Chapter 1 Introduction Appendix 1A Sizewell Branch Track Condition Report

**Sizewell Power Station Branch Line**

**Permanent Way Condition Report**

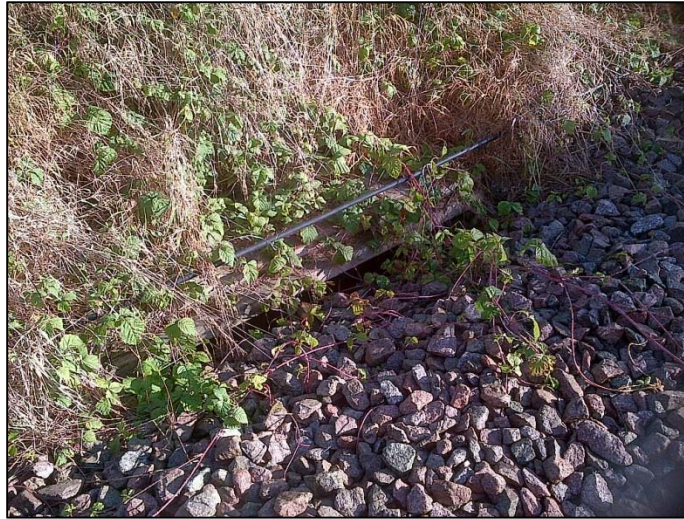
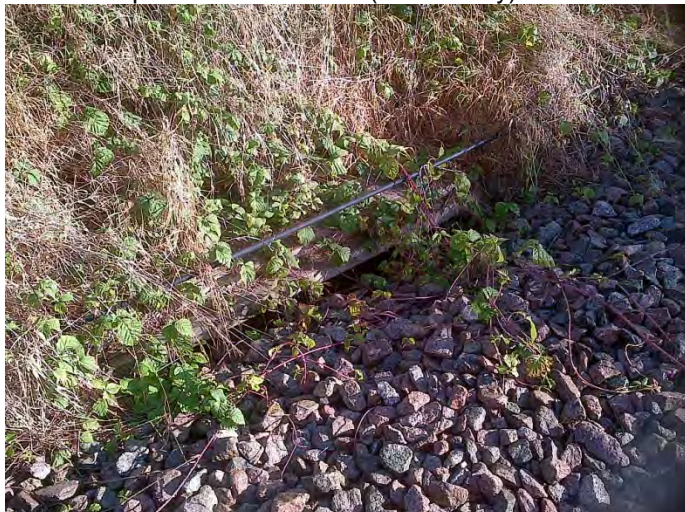
D5 - Catchpit found at 693.2m (91M 1705y)

Only one catchpit was found during this survey at 91M 1705y (see photo D5).

The catchpit is located in the left hand cess (with back to low mileage) with water freely flowing through it. No other catchpits were found during the survey. The route and outfall of the track drainage could not be determined and further investigation is required.

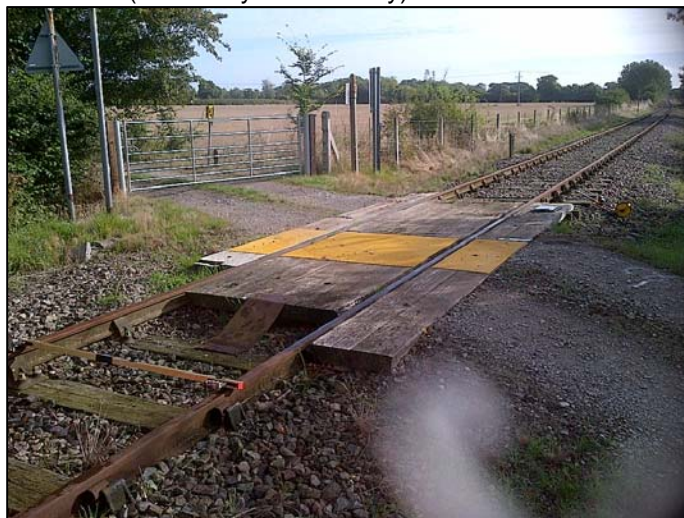
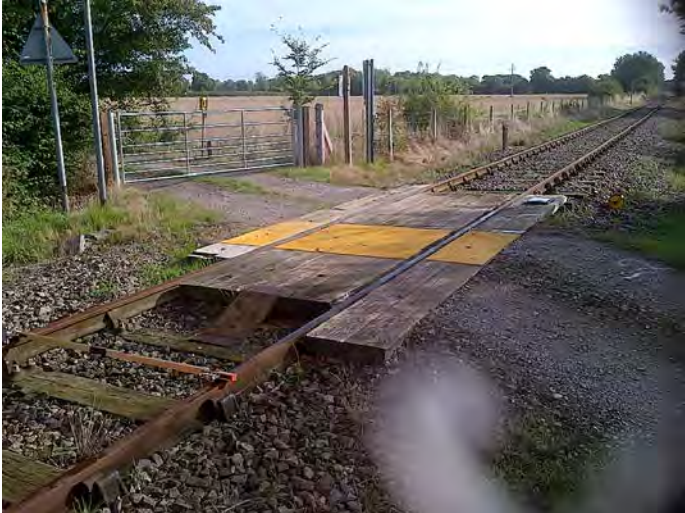
D7 - Bratts Black No1 UWC (92M 420y – 92M 427y)

This is a UWC comprising of wooden decking fixed to the sleepers. Visible areas of rail foot appeared to be satisfactory. Flangeways were found to be clear. The gates of this crossing were found to be in satisfactory/poor condition, showing signs of rot and peeling paint.

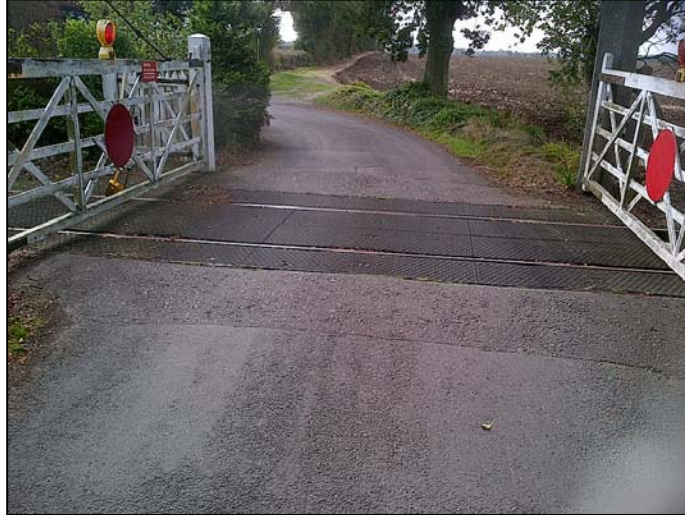
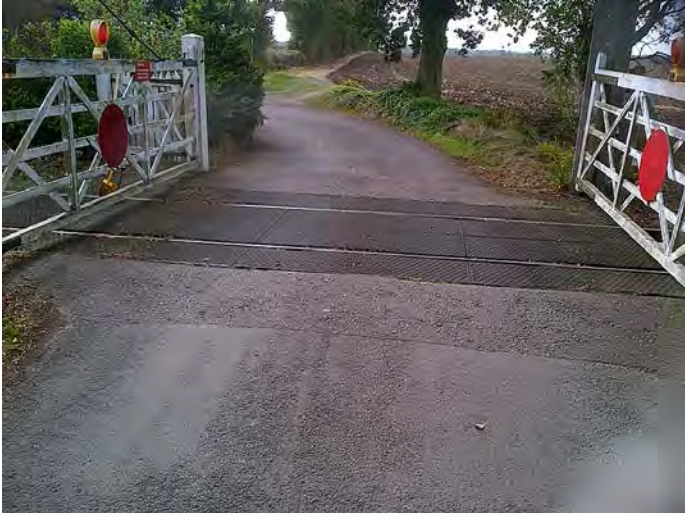
4.6.2 Knodishall Crossing 92M 49ch  
D8 - Knodishall Crossing (92M 1075y – 92M 1083y)

This is a UWC comprising of Hardfast rubber decking. The rail foot was not visible, so could not be inspected. Some debris was found in the flangeways. The gates of this crossing were found to be in satisfactory/poor condition, showing signs of rot and peeling paint.

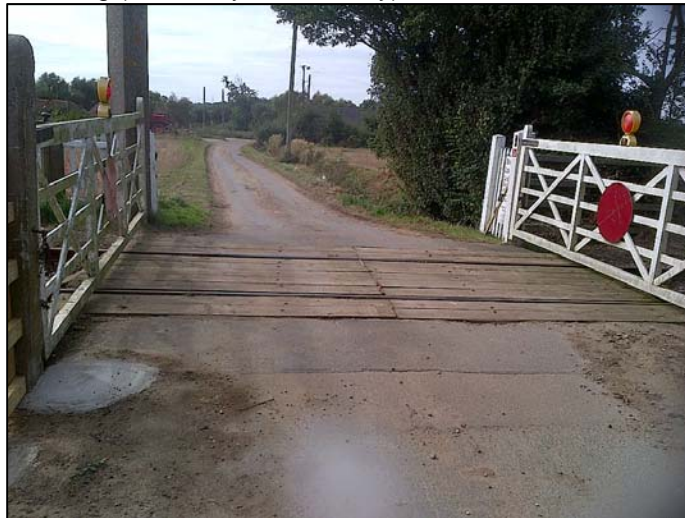
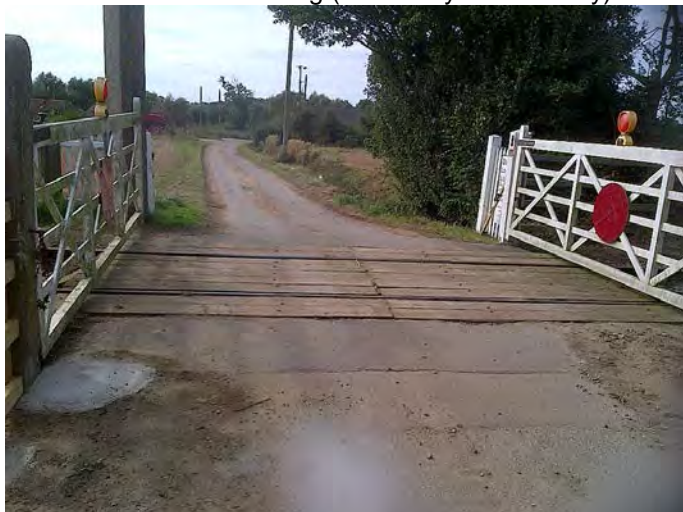
4.6.3 Westhouse Crossing 93M 32ch  
D14 - Westhouse Crossing (93M 687y – 93M 693y)

This is a UWC comprising of wooden decking fixed to the sleepers. The rail foot was not visible to inspect due to mud. Flangeways were found to be clear. The gates of this crossing were found to be in satisfactory/poor condition, showing signs of rot and peeling paint.

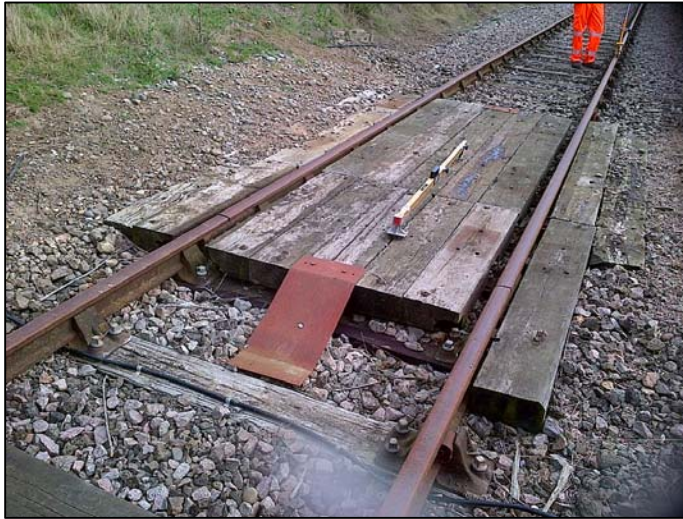
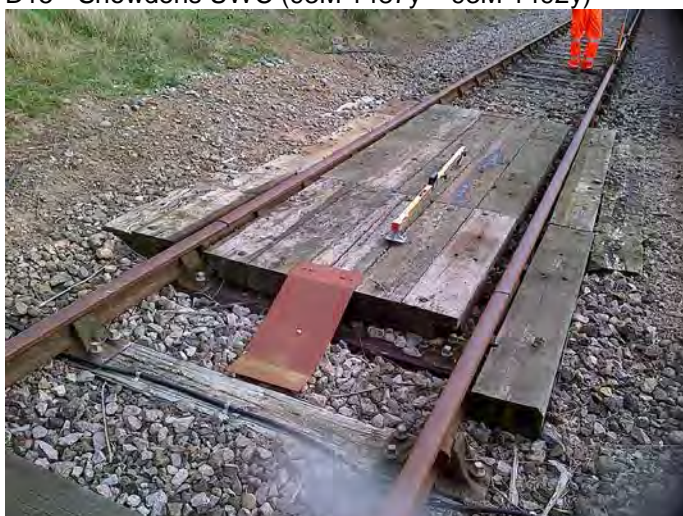
4.6.4 Snowdens Crossing 93M 68ch  
D15 - Snowdens UWC (93M 1487y – 93M 1492y)

This is a UWC comprising of wooden decking fixed to the sleepers. The rail foot was visible and appeared to be satisfactory. Flangeways were found to be clear. The gates of this crossing were found to be in satisfactory/poor condition, showing signs of rot and peeling paint.

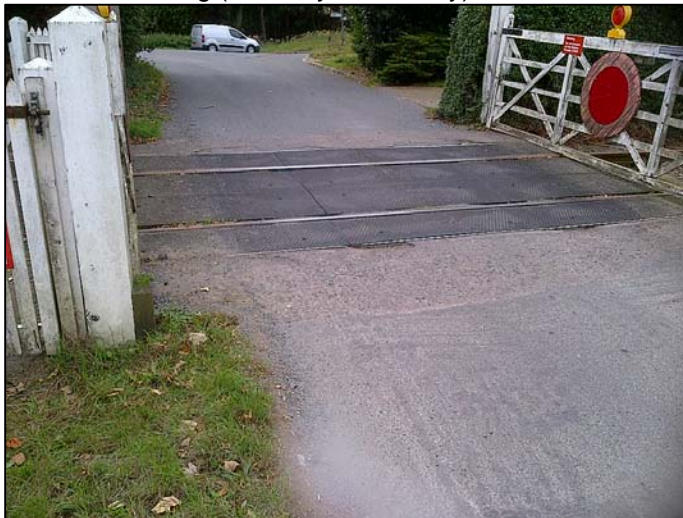
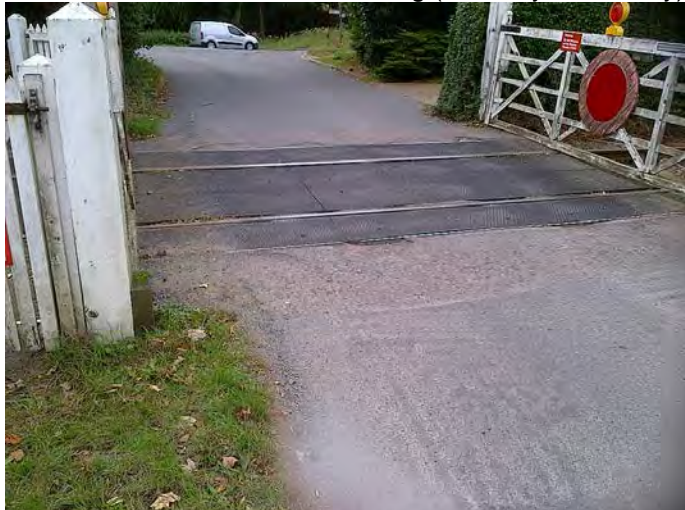
4.6.5 Saxmundham Road LC 94M 02ch  
D16 - Saxmundham Road Crossing (94M 39y – 94M 46y)

This is a level crossing comprising of Hardfast rubber decking. The rail foot was not visible, so could not be inspected. All decking appeared to be secure, no issues found. The gates of this crossing were found to be in satisfactory/poor condition, showing signs of rot and peeling paint.

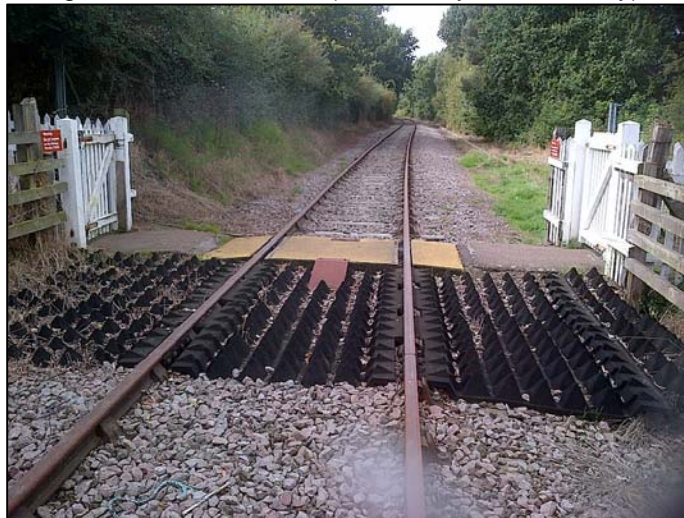
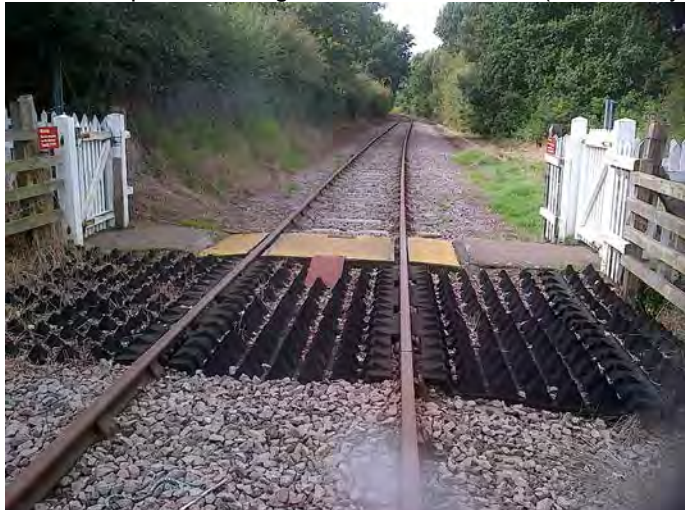
- 4.6.6 Leiston Footpath Crossing 94M 66ch  
D17 - Footpath crossing 5272.7m – 5273.9m (94M 1445y – 94M 1447y)

This is a footpath crossing comprising of wooden decking fixed to the sleepers. Visible area of the rail foot appeared to be satisfactory. Flangeways were found to be clear.

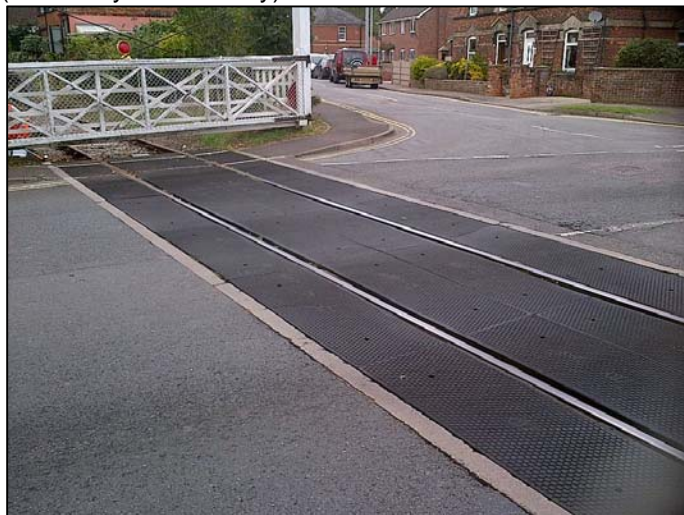
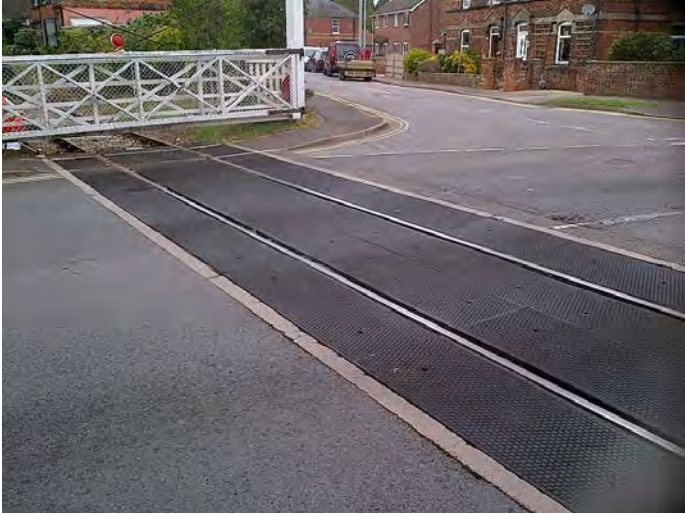
- 4.6.7 Leiston Station LC (station disused) 95M 15ch  
D27 - Leiston LC (95M 111y – 95M 127y)

This is a UWC comprising of Hardfast rubber decking. The rail foot was not visible, so could not be inspected. However, the rail through the crossing is much newer (2007) than the rail either side of the crossing (1939). The gates of this crossing were found to be in satisfactory/poor condition, showing signs of rot and peeling paint.

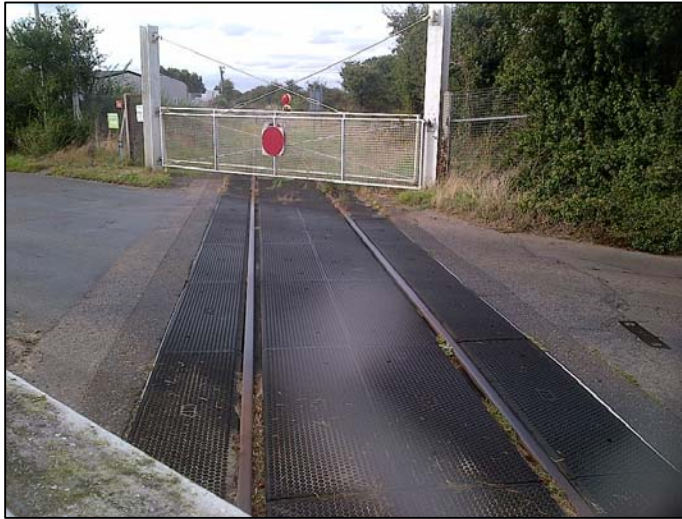
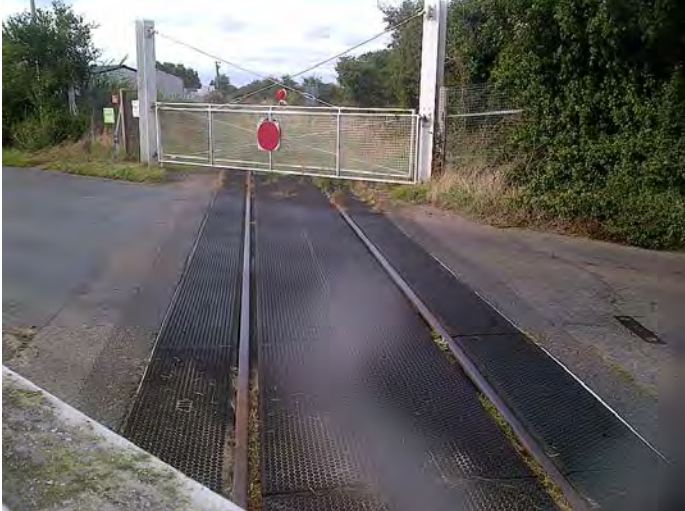
4.6.8 Sizewell Road LC 95M 79ch  
D31 – Sizewell Road Crossing (95M 1560y – 95M 1577y)

This is a UWC comprising of Hardfast rubber decking, which appeared to be secure. The rail foot was not visible, so could not be inspected. Flangeways were found to be clear. The gates of this crossing were found to be in satisfactory/poor condition, showing signs of rot and peeling paint.

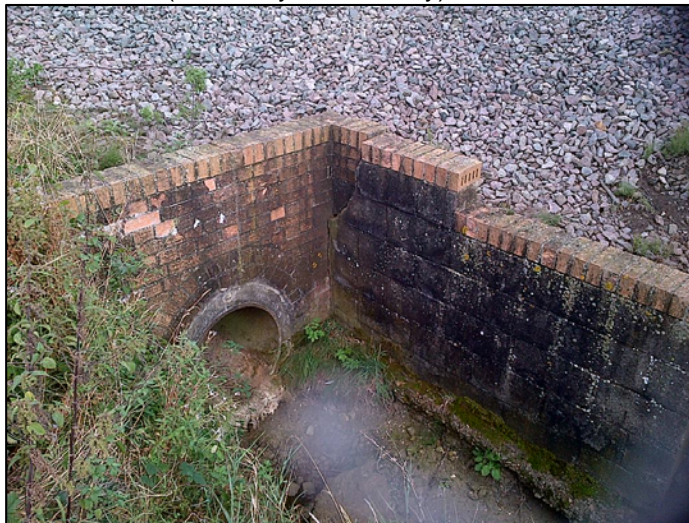
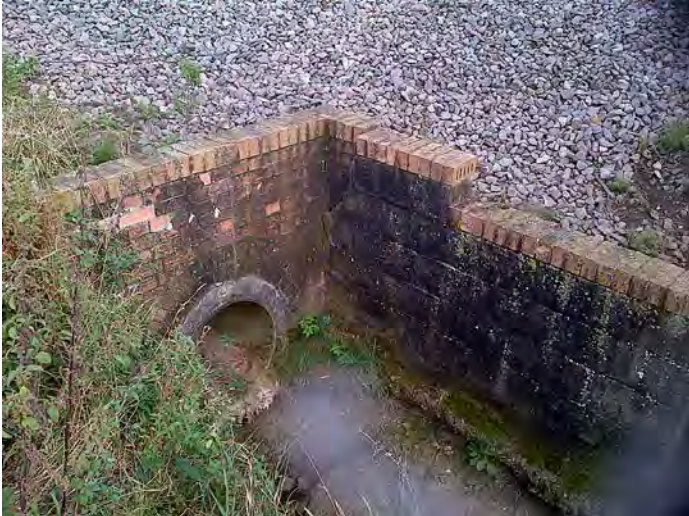
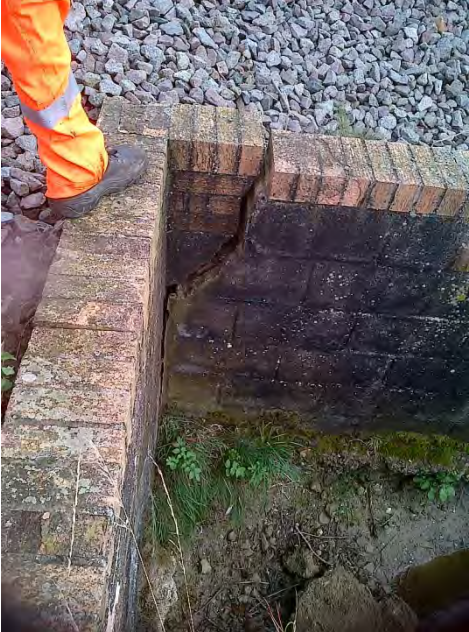
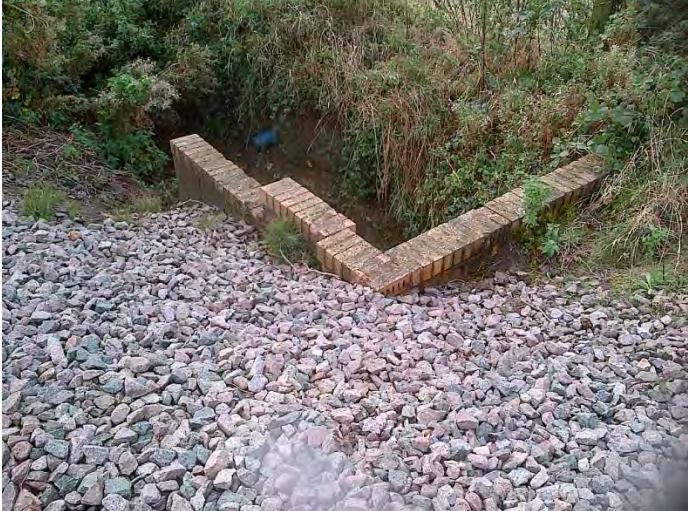
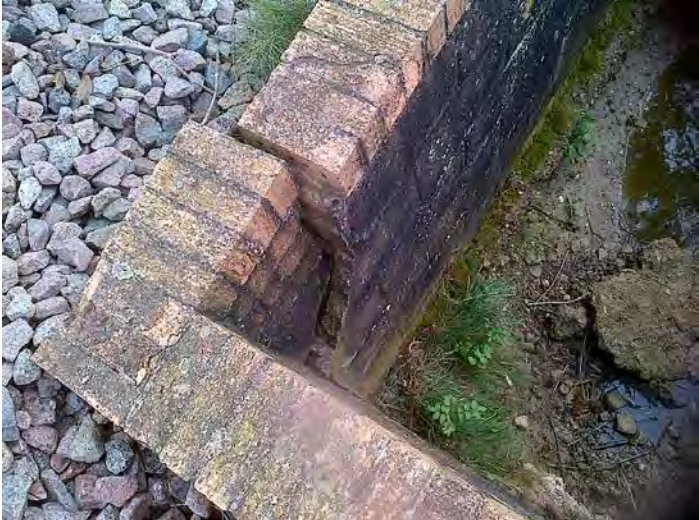
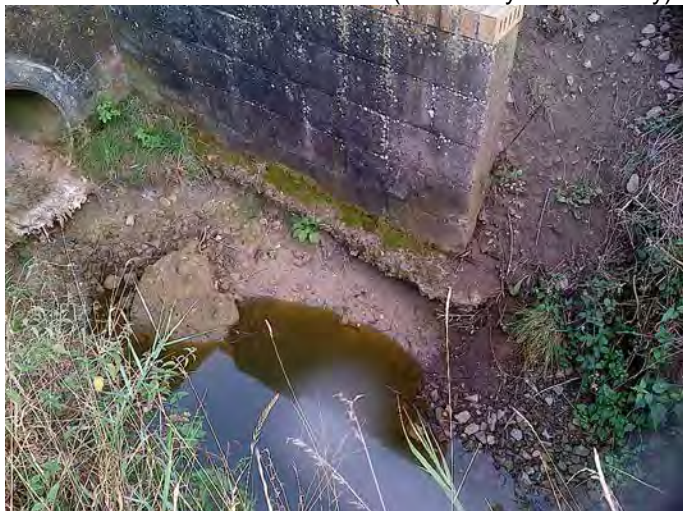
D9 - Culvert 2479.6m – 2500m (93M 142y – 93M 164y)

There is a culvert between 93M 0141y and 93M 0164y, which was found to be in need of a structural assessment. The wing wall appears to be coming away from the main structure of the culvert (see Appendix D - Photos D9-13) due to the foundations being washed away by water.

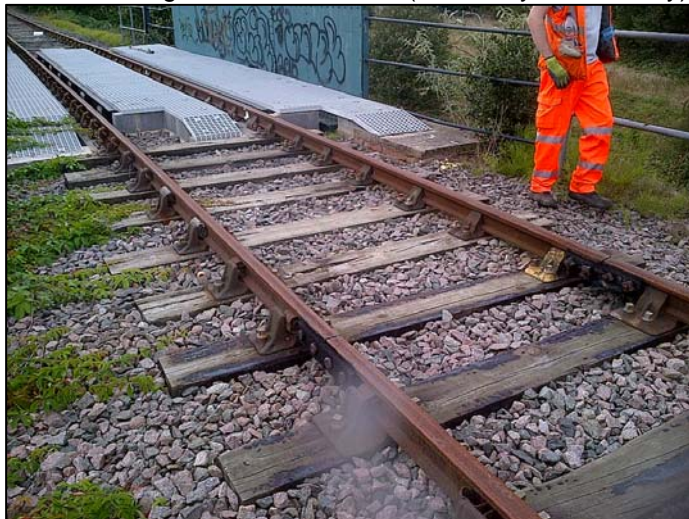
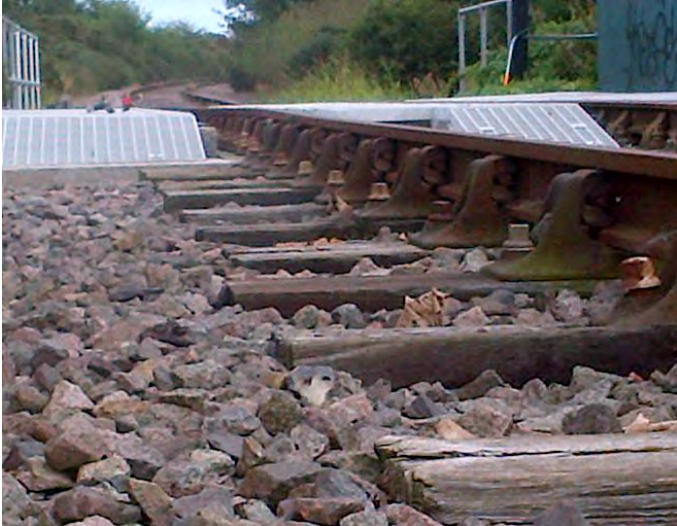
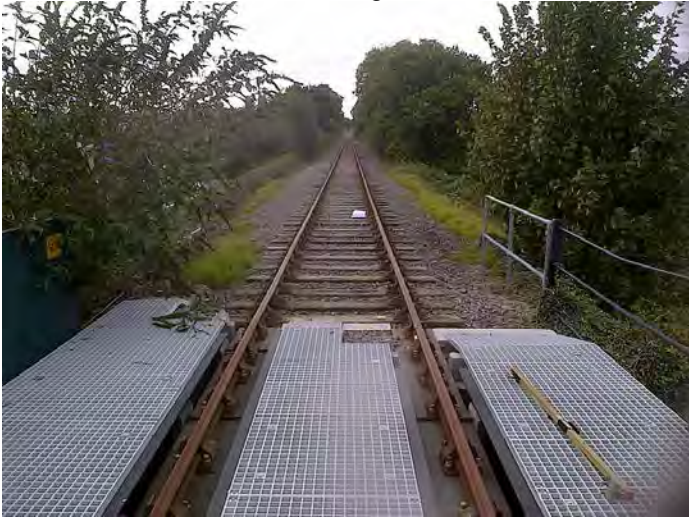
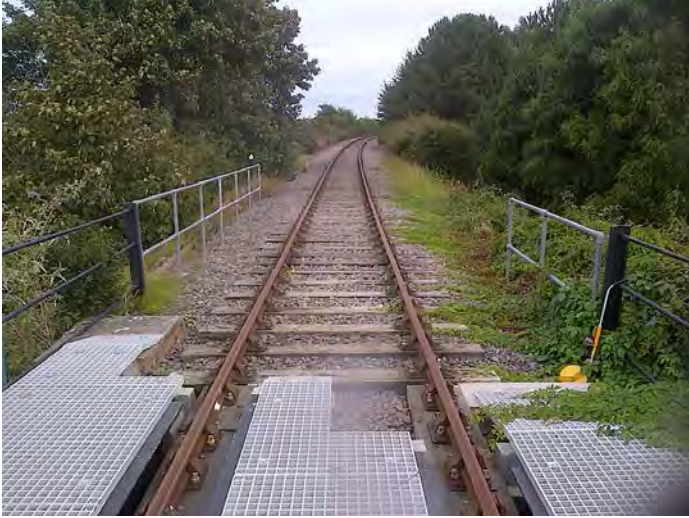
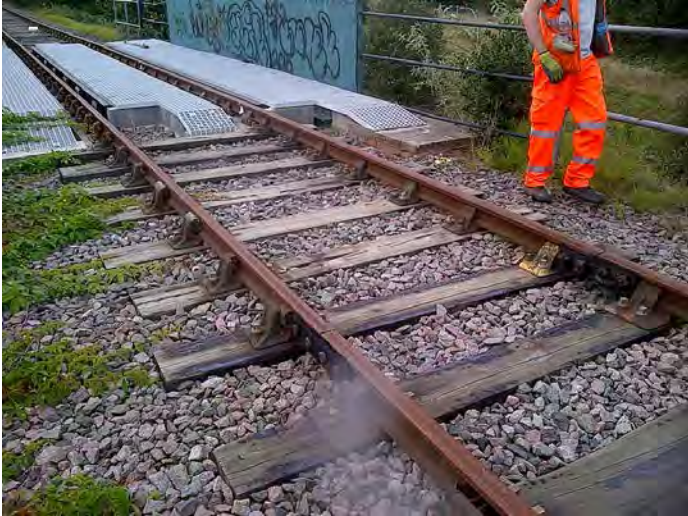
D28D - Longitudinal timber bridge 6249m 6260.2m (95M 748y – 95M 761y)

At 95M 766y there is underbridge (U/B) 1110 at Valley Road, Leiston (Appendix D – Photos D28A-28D.)

This structure appears to be in good condition. The track over this bridge is on longitudinal timbers. Track level each side is low in relation to the bridge resulting in a poor run-on and run-off, with visible voids under the sleepers next to the bridge deck. There are fishplate joints approx. 1m from the end of the longitudinal timber, which is below the minimum distance

stated in NR/L2/TRK/2102, which states the minimum distance from the end of longitudinal timber to a joint is 4.5m.

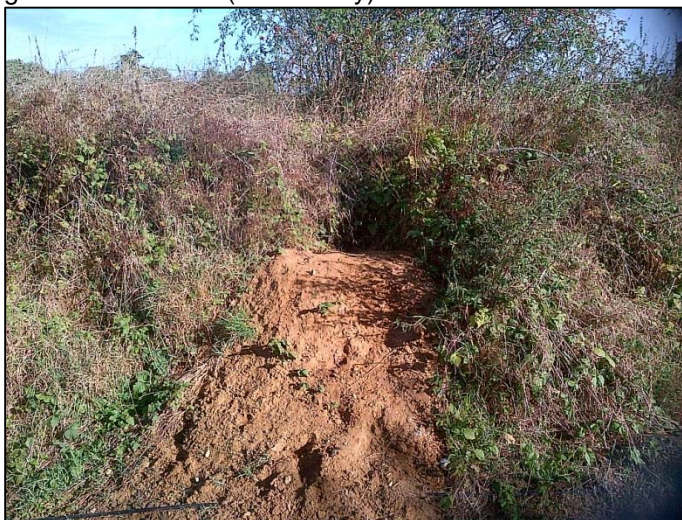
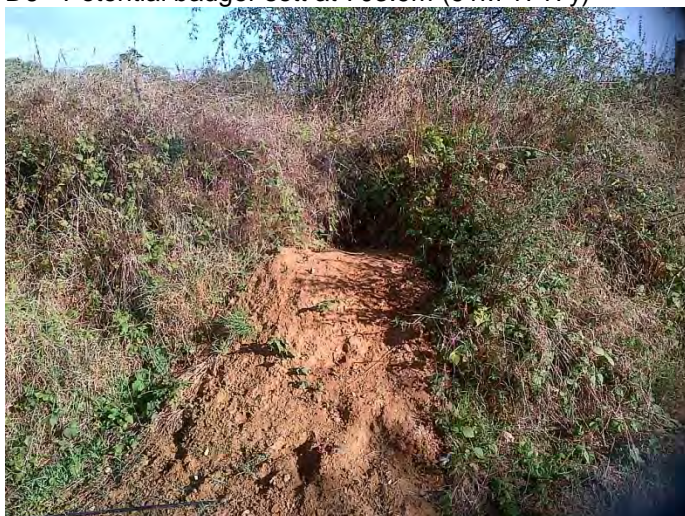
D6 - Potential badger sett at 703.9m (91M 1717y)

In addition to the animal burrow mentioned above, a potential badger sett was also identified along this route at 91M 1717y. (Appendix D – Photo D6).

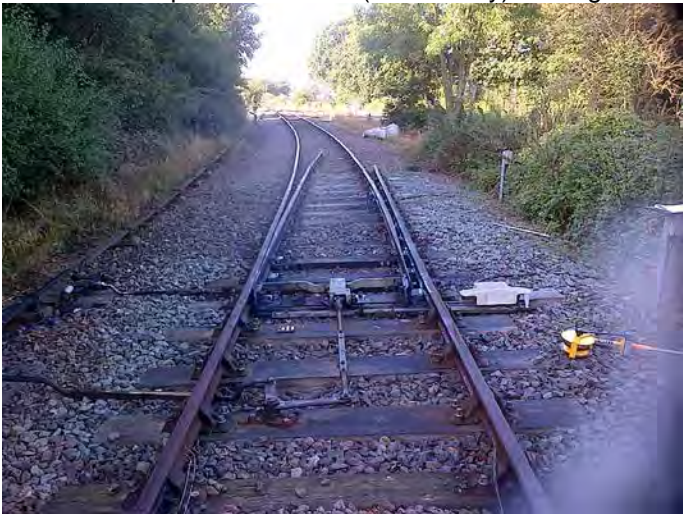
3B catch points on the Sizewell single line are located at 91M 1030y; these switches were found to be in good condition. The rail year of these switches is 2011, indicating that they have been installed within the last 5 years.

D3 - 3B catch points at 75.8m (91M 1028y) looking towards low mileage

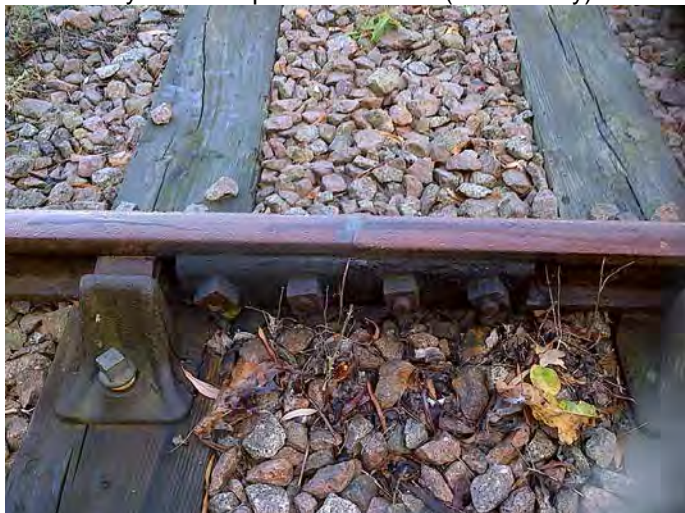
The physical condition of the joints on this line were found to be in a satisfactory condition, with one pair of fishplates found to be improperly fitted at 91M 1160y.

D4 - Poorly fitted fishplate at 195.1m (91M 1158y)

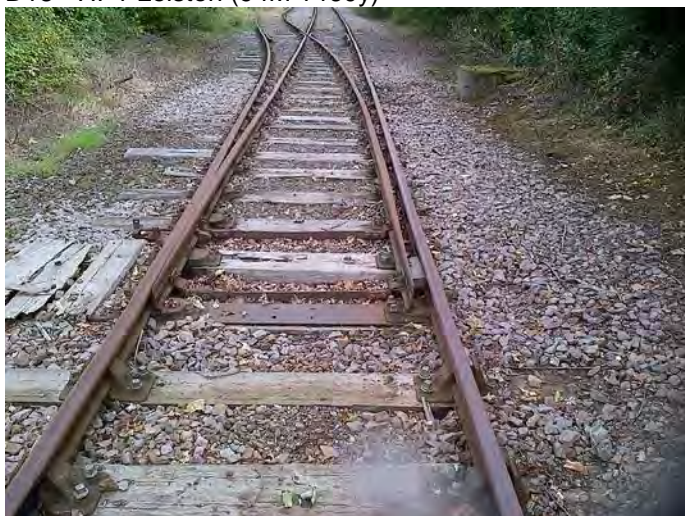
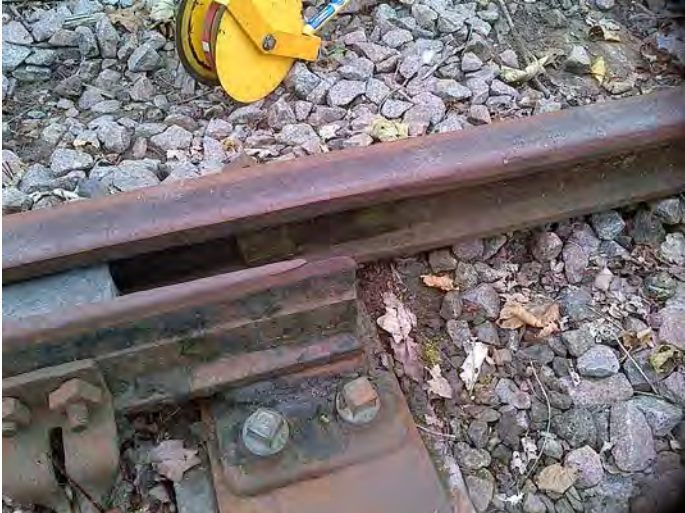
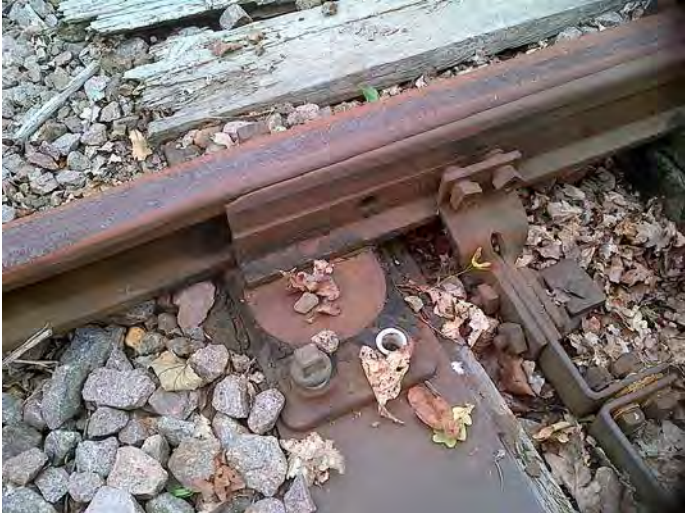
D18 - HP1 Leiston (94M 1460y)

HP1 points at Leiston are located at 94M 1461y and mark the low mileage entrance/exit of the passing loop. These switches were found to be in a reasonable condition.

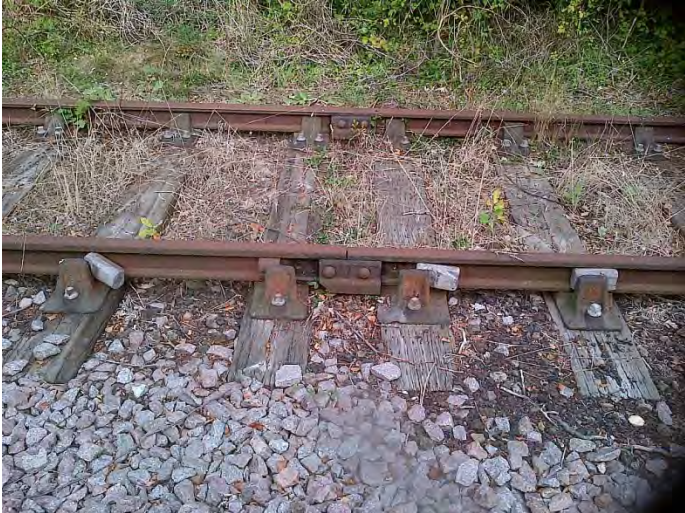
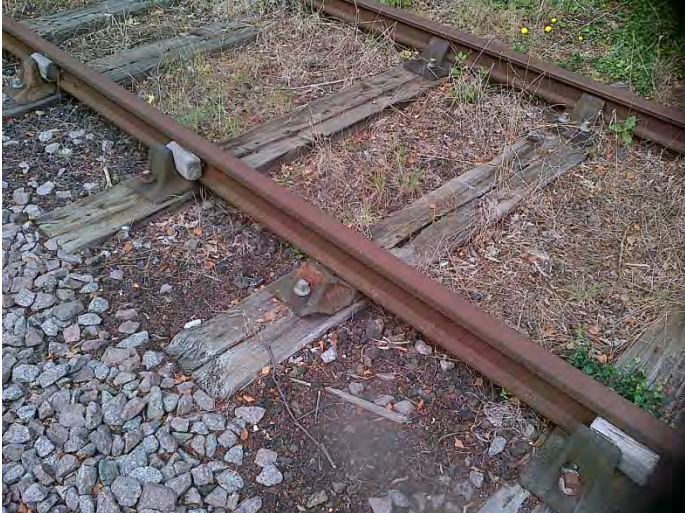
The passing loop at Leiston (94M 66ch to 94M 79ch) was found to be in poor condition. The loop comprises of poor heavily contaminated ballast, rotten timber sleepers throughout, 2-hole fishplates throughout, and some of the baseplates were found to be broken. The passing loop is also overgrown with vegetation and will require significant work to facilitate its reopening.

D21 - Passing Loop – Leiston (94M 1460y – 94M 1745y)

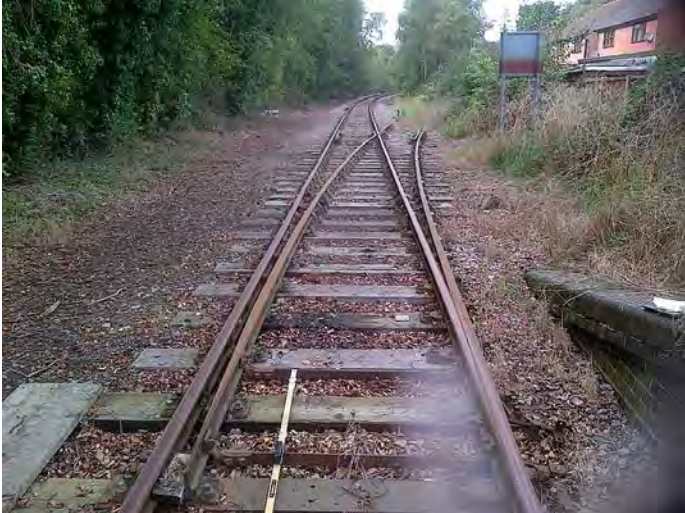
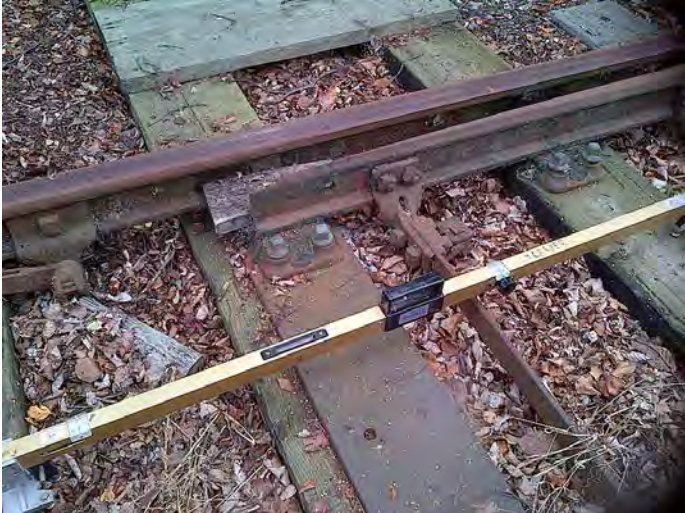
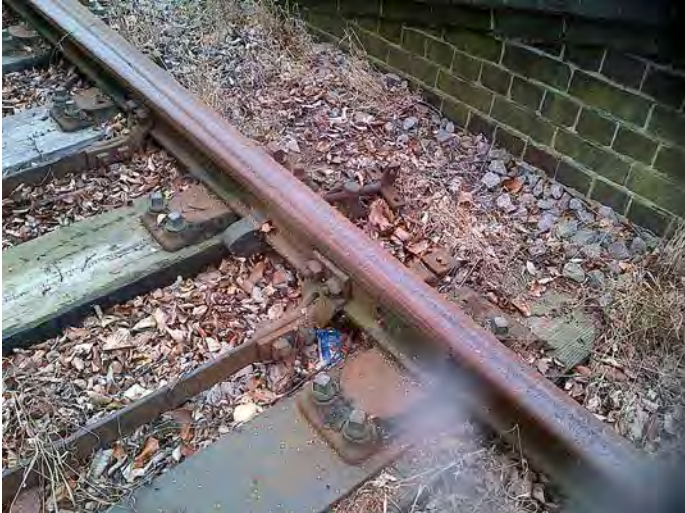
D23 - HP2 Leiston (94M 1745y)

HP2 points at Leiston are located at 94M 1741y and mark the high mileage entrance/exit of the passing loop. These switches were also found to be in a reasonable condition.

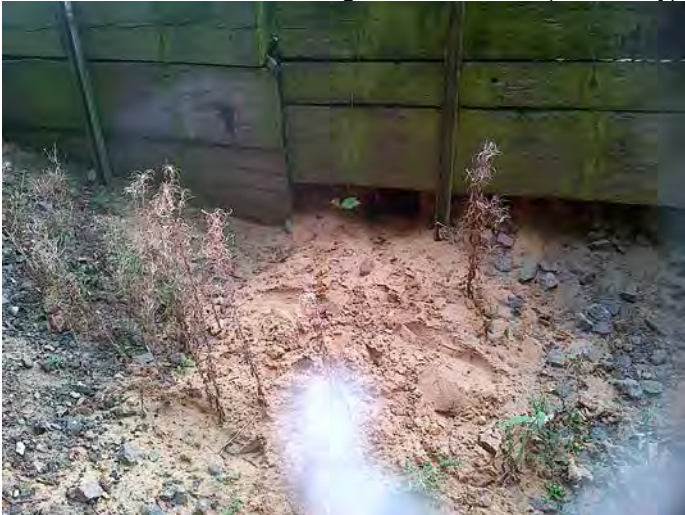
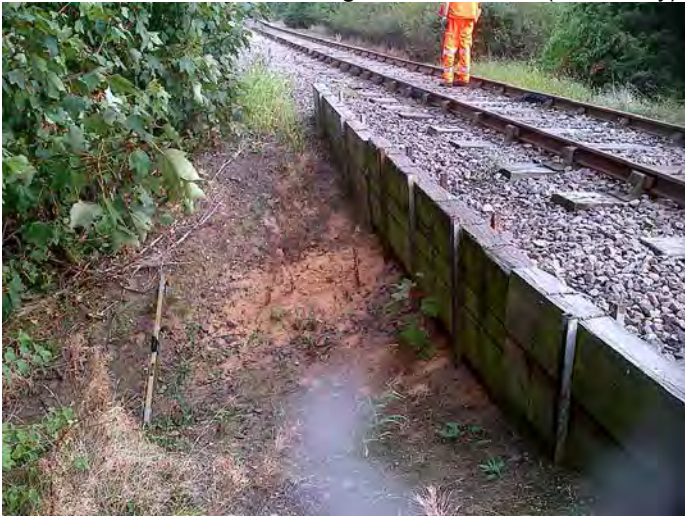
D29 - Embankment burrowing issue 6286.1m (95M 789y)

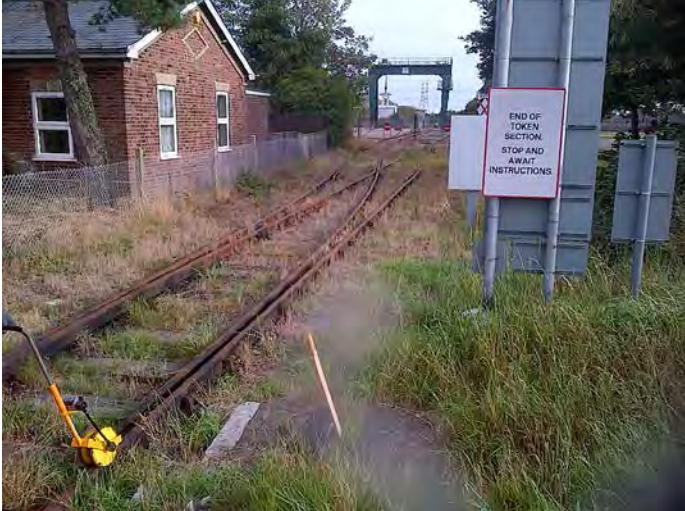
D32 - HP3 Leiston (95M 1578y)

HP3 points at Leiston are located at 95M 1574y, just before the NR boundary gates. These switches were found to be in a satisfactory condition.
