From: [REDACTED]
To: [East Anglia ONE North](#); [East Anglia Two](#)
Subject: Friston House ASI1 Flooding report and photographs EAO 10077 ref: 20023661 EAO10078 ref: 20023663
Date: 03 February 2021 15:55:32
Attachments: [Friston House Grade 11 ASI1 EAO10077 +EAO10078.pdf](#)

Re Flooding and Infiltration estimates by the applicant.

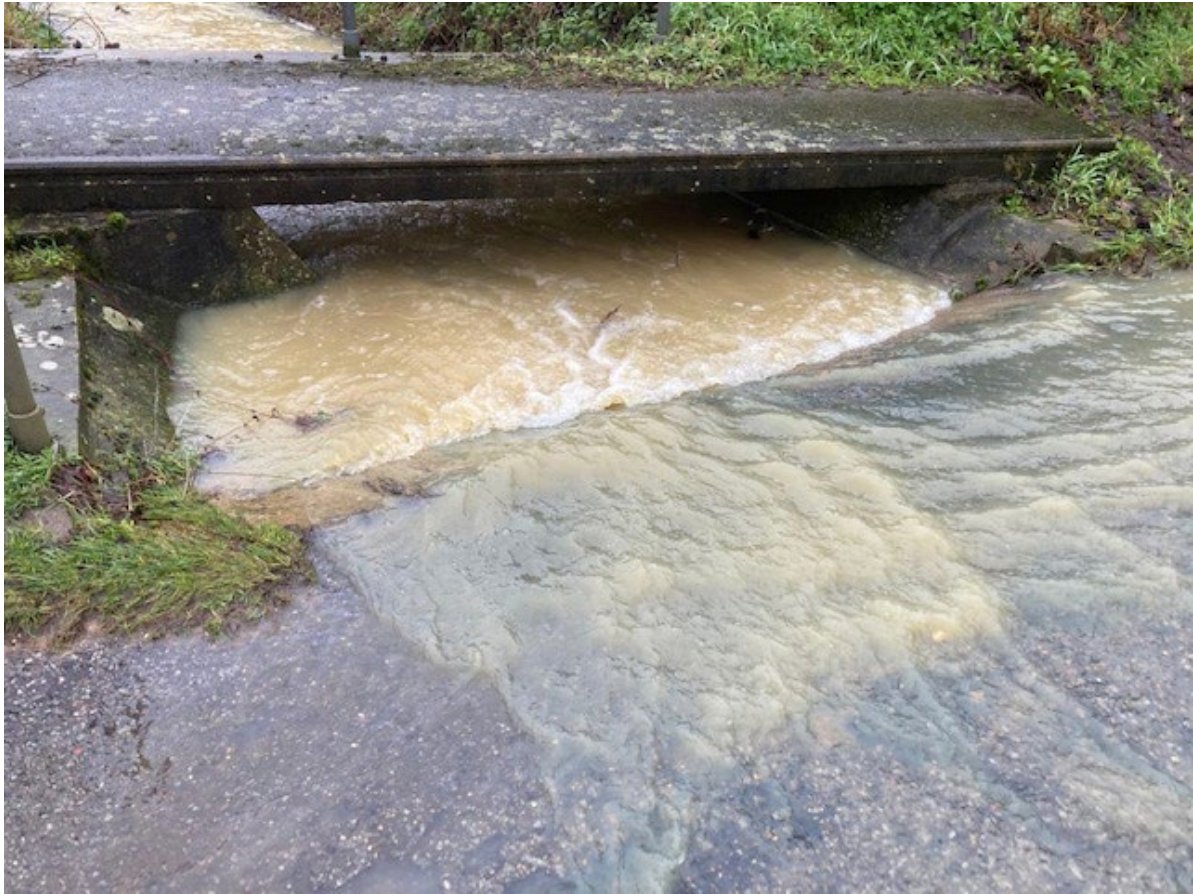
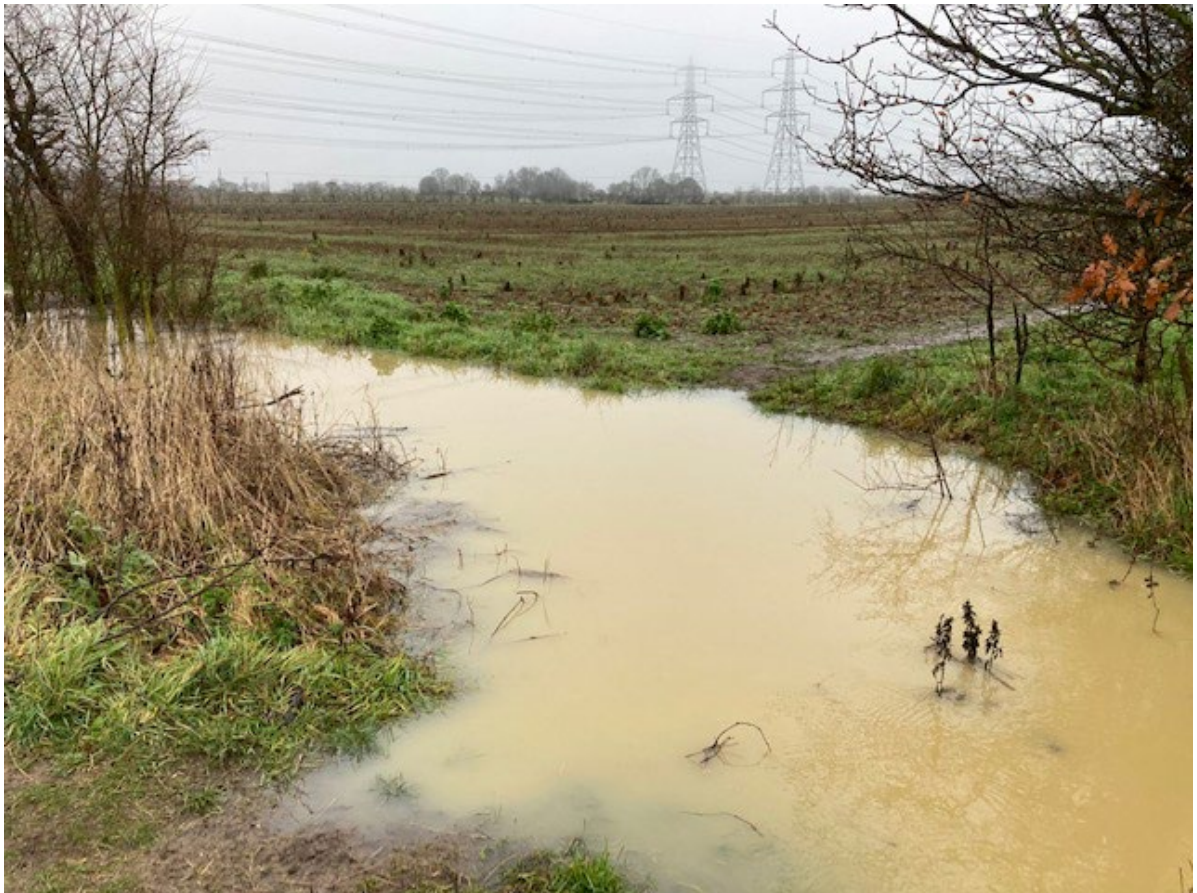
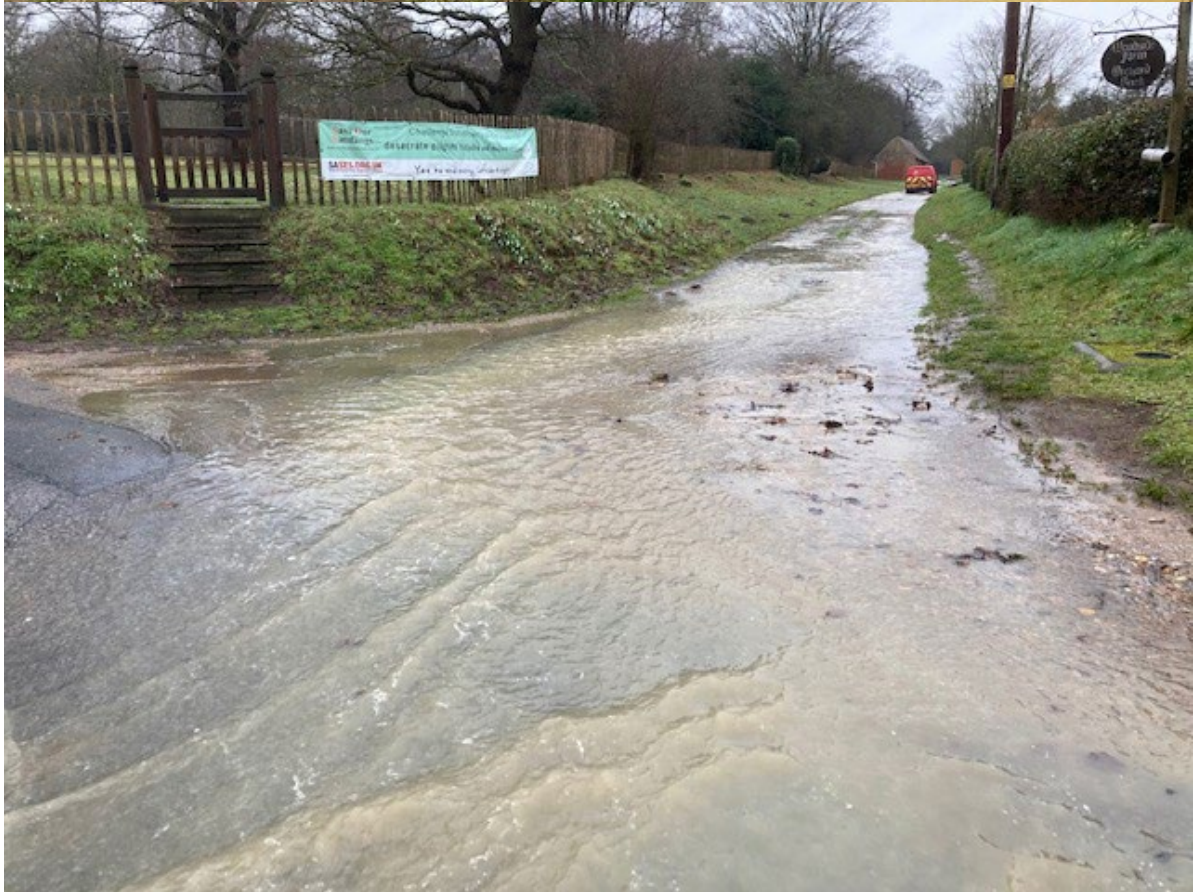
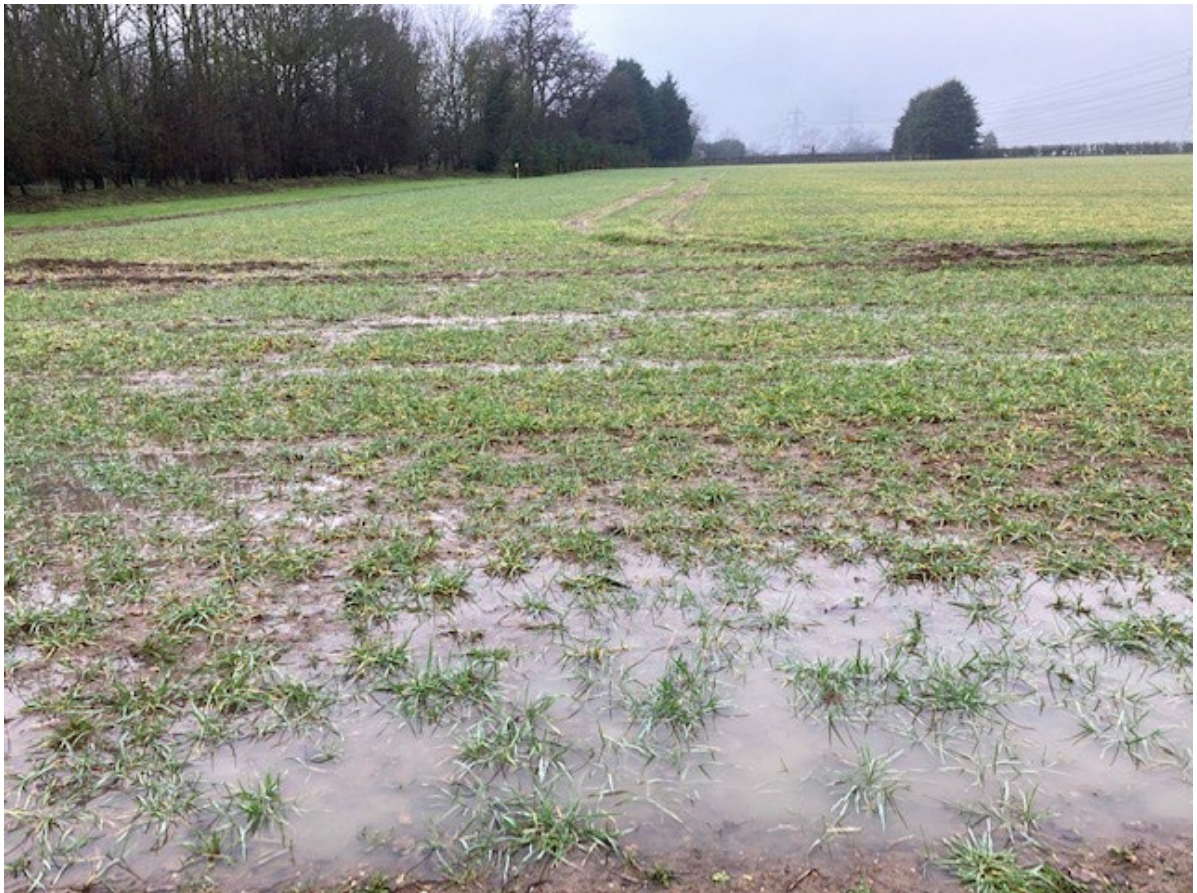
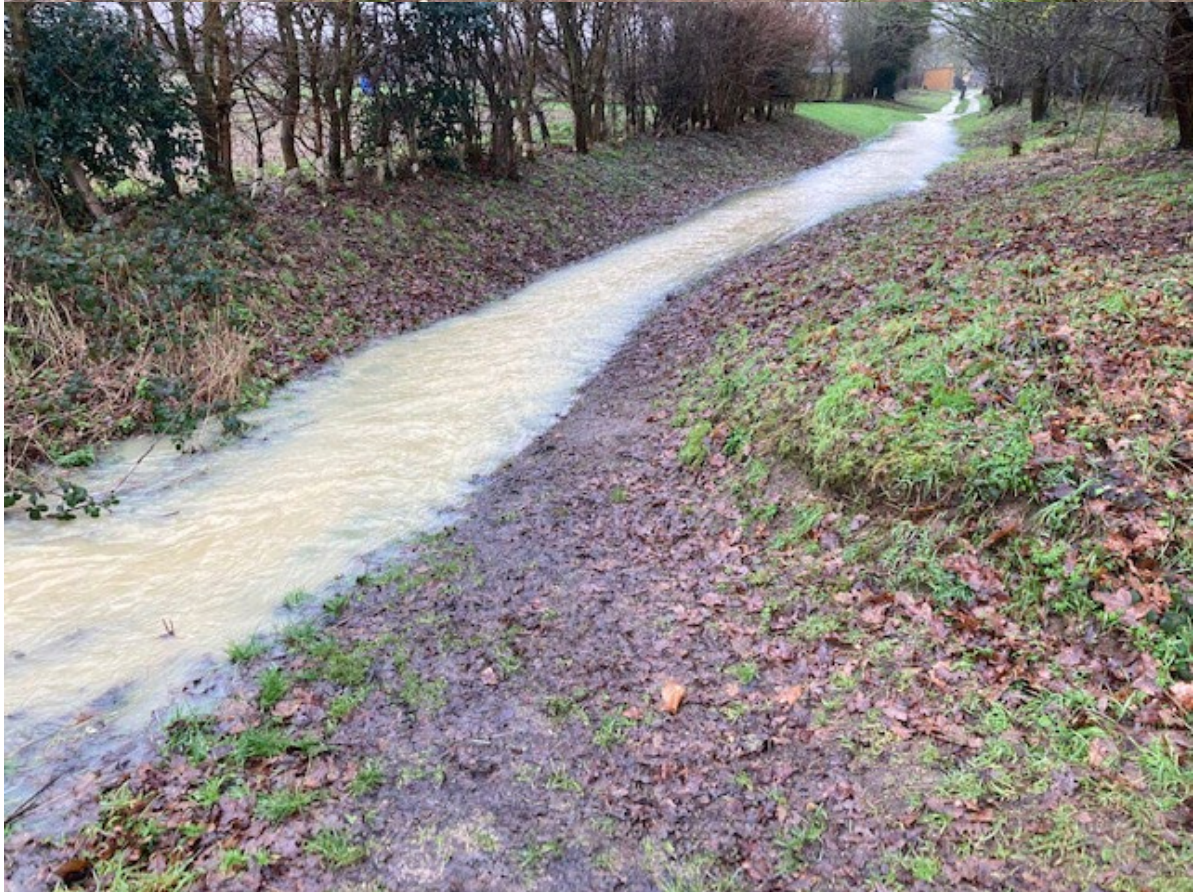
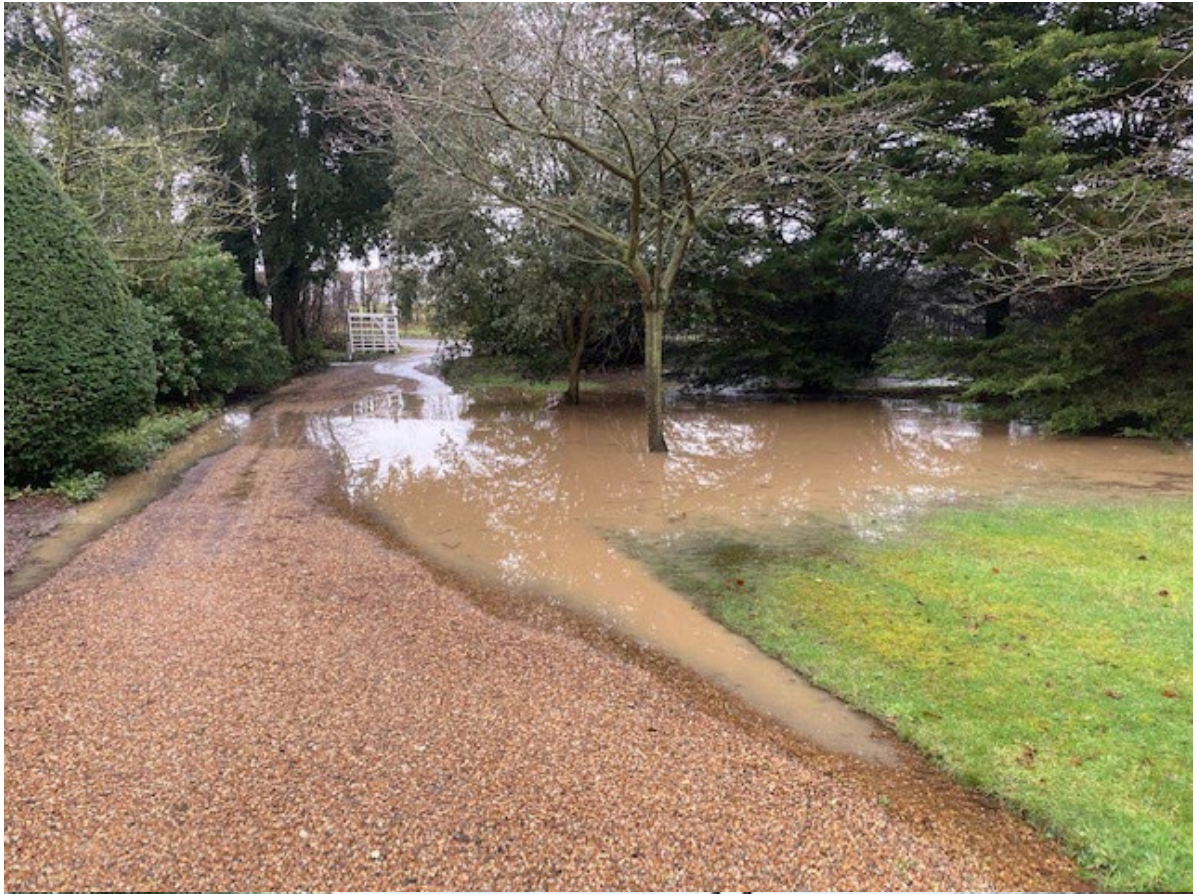
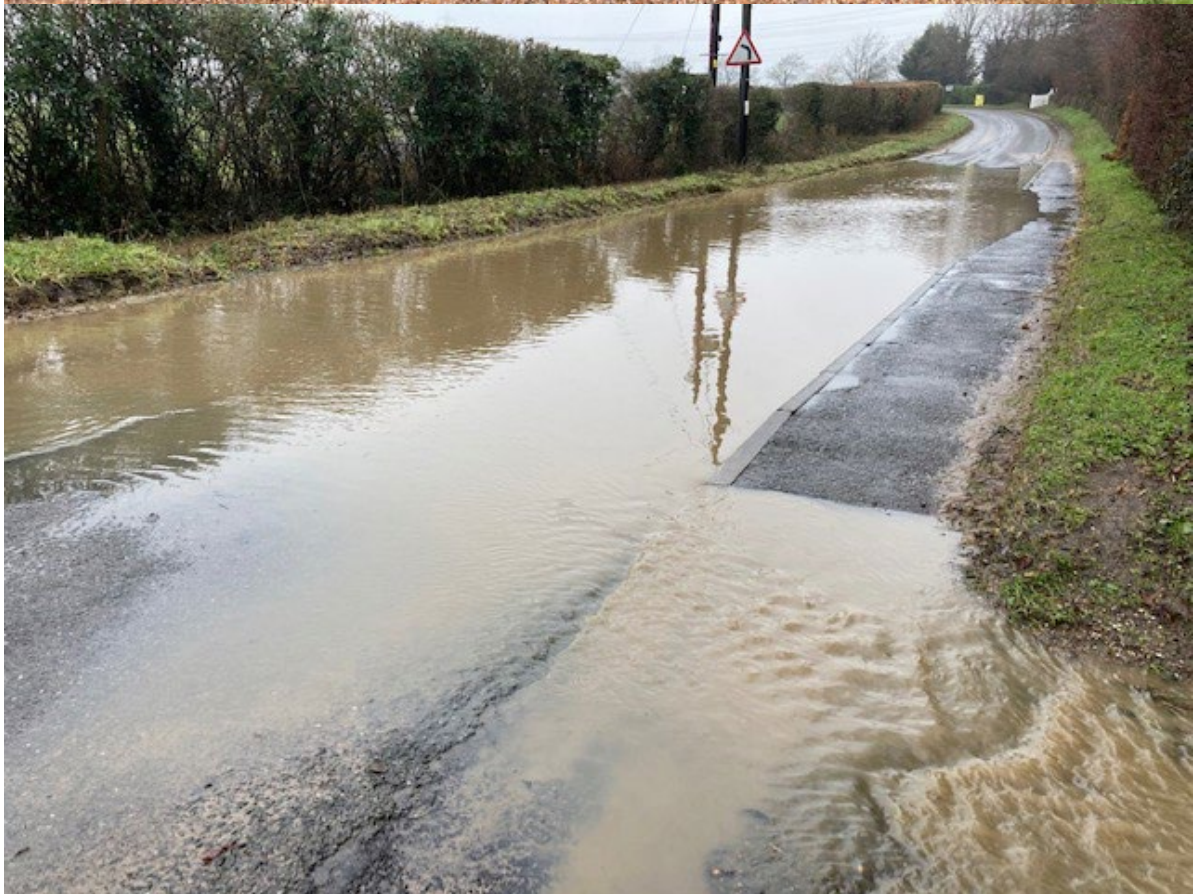
I attach photographs taken the morning after one night of rain immediately after site inspection ASI1 when no surface water was present. The photographs are from site 6 (waterlogged field) and site 1 + 2 from the ASI1 on the 26/01/2021

This illustrates the lack of or low level of infiltration in contradiction of the applicants desk top models of infiltration with reference to the site of Friston.

which again illustrate the flooding aspects of Friston after one night of rain during the winter months. This has become a frequent feature over the last few years.
