Report on the investigation of
the collision between
the offshore supply vessel
Highland Pioneer
and the *DA* jack-up rig
of the *Douglas* offshore installation
in Liverpool Bay
on 27 January 2000

Marine Accident Investigation Branch
First Floor, Carlton House
Carlton Place
Southampton
United Kingdom
SO15 2DZ

Report No 15/2001

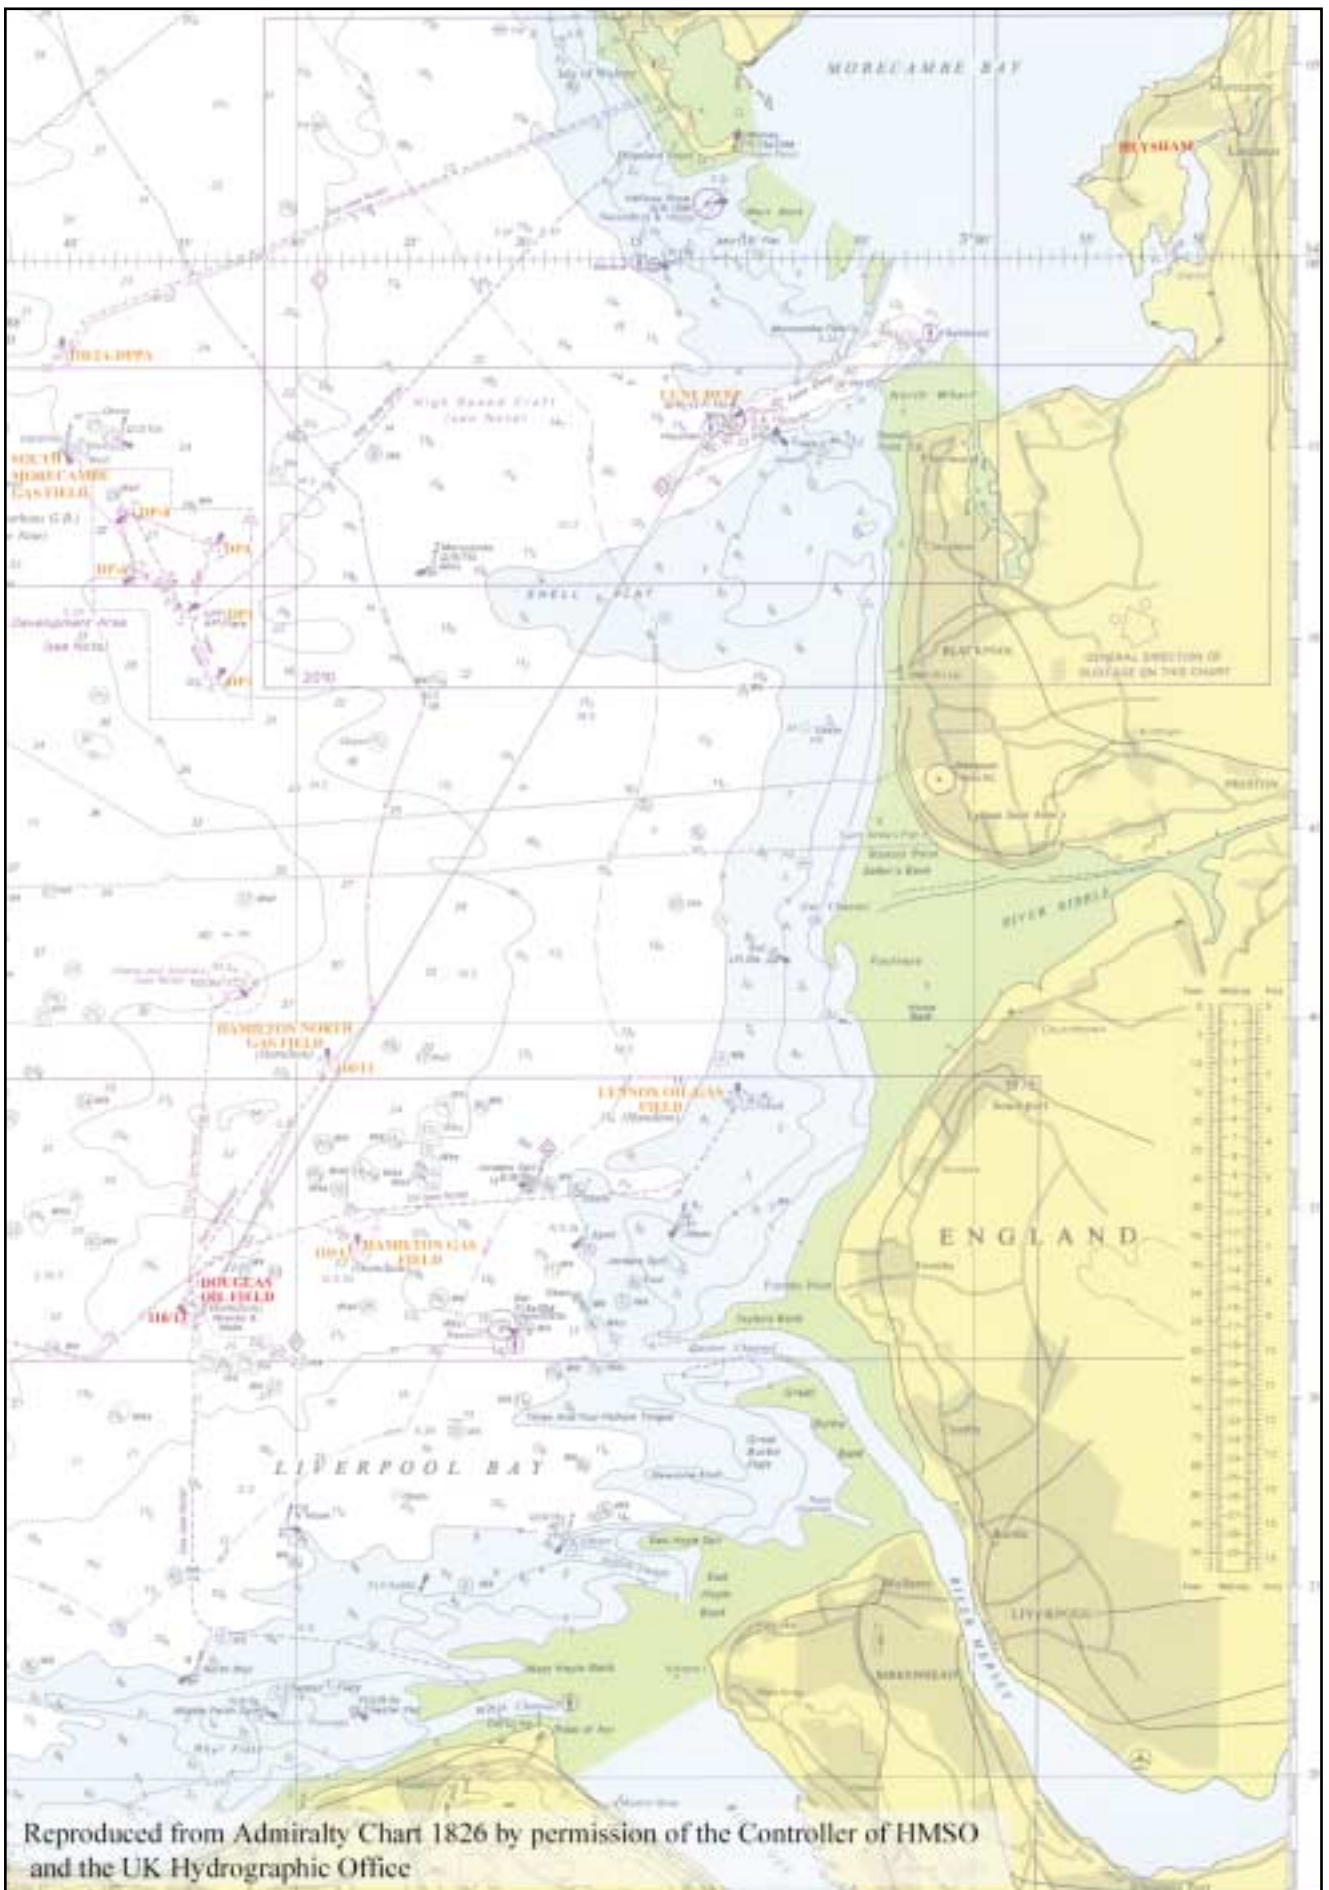
Gas and oil installations in the North and South Morecambe oil fields

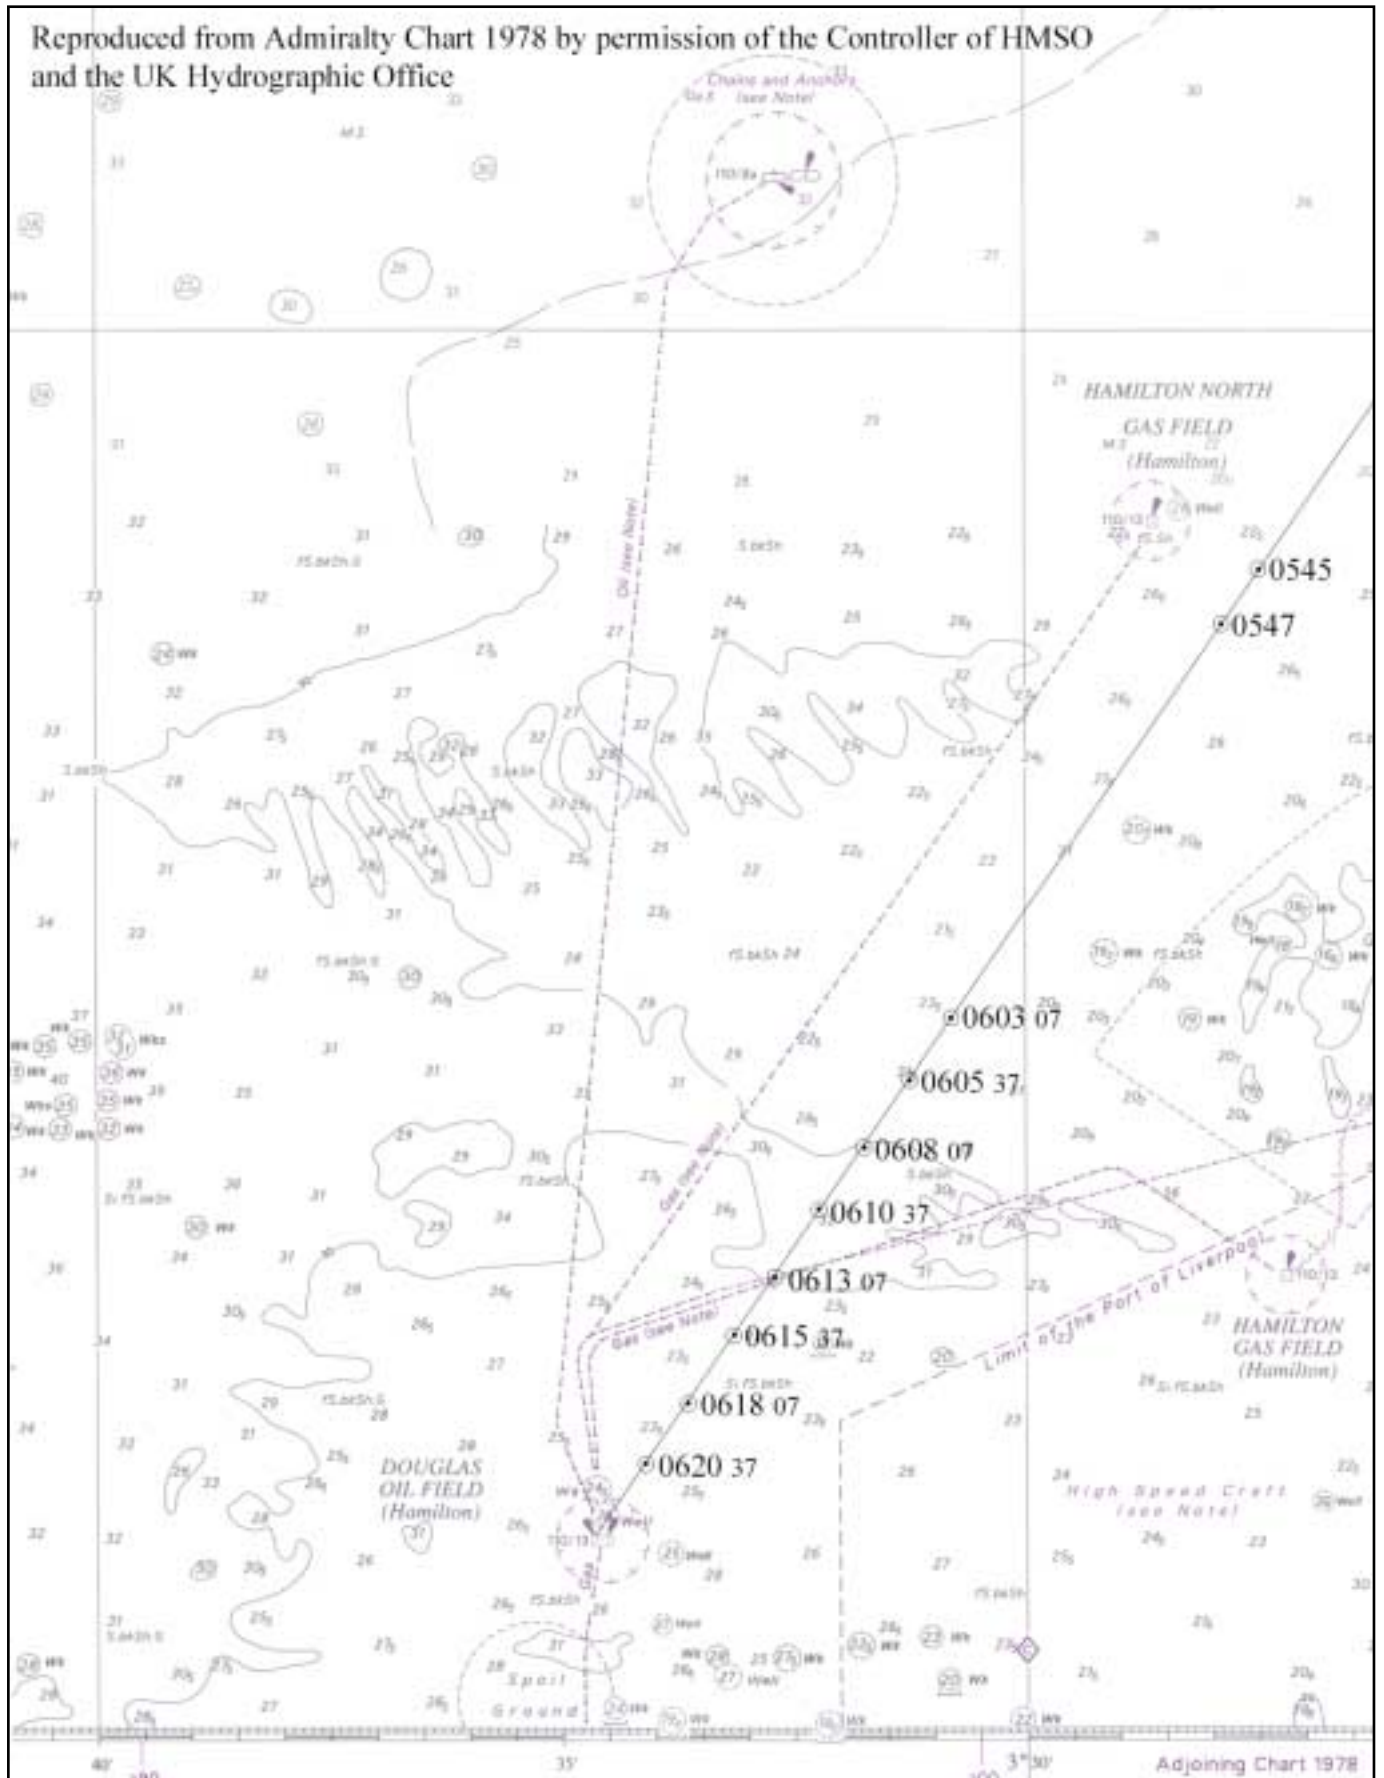
After the accident the REWS database was downloaded, the plot from which is shown in **diagram 2 opposite**. The positions and times are from DGPS, and have a high degree of accuracy.

- 0545 the vessel was abeam of the *Hamilton* platform and was **7.53** miles away from the *Douglas* installation;
- 0603, she was **4.05** miles away from the installation, (confirming the master's estimation);
- 0621 she was **5.8** cables away from the installation; and
- collision occurred at 0623.

The distances between 0545 and 0603 and between 0603 and 0621 (18-minute intervals) were the same at **3.48** miles, giving a speed of 11.8 knots.

From 0603 to the impact, the vessel covered the distance in 20 minutes, which gave a speed of 12.15 knots.

Plot derived from REWS database

Therefore, from the above, it is concluded that the speed before and after 0603 did not change until just before the impact, when the master took action to prevent the collision.
