Report on the investigation of the
collision between

Saga Sky

Stema Barge II

on 20 November 2016

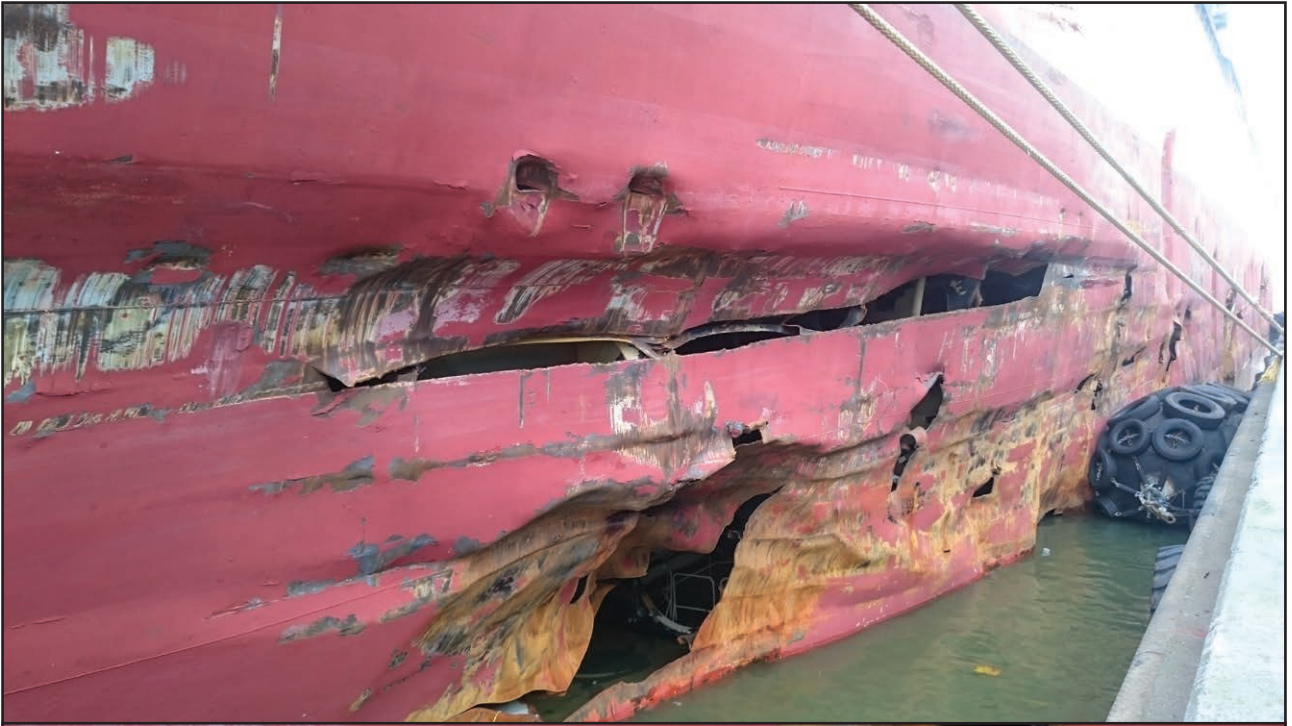
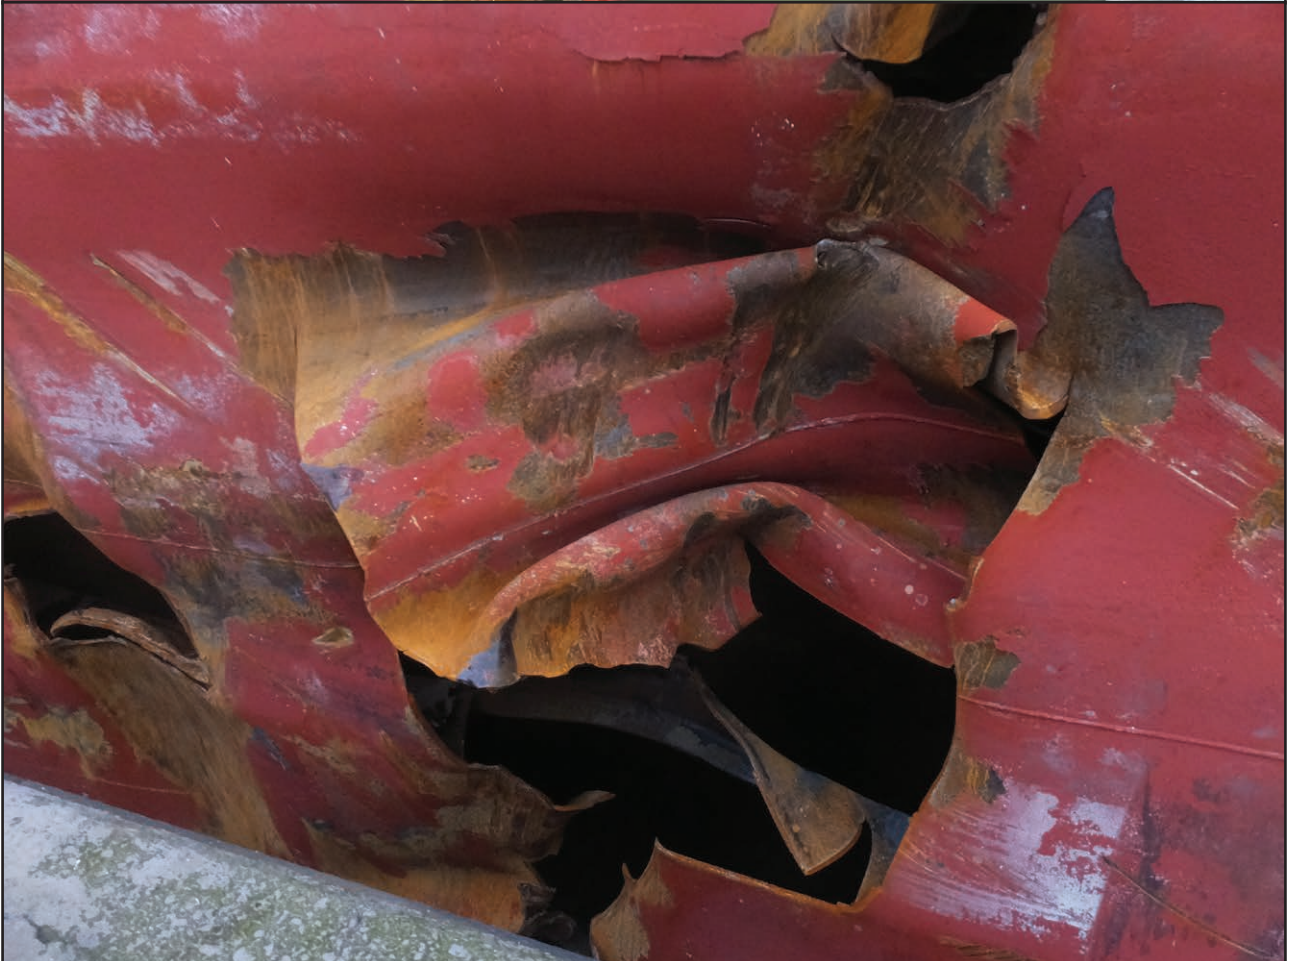
Figure 3a and 3b: Damage to Saga Sky's starboard side

Saga Sky suffered damage to ballast tanks along its starboard side (**Figures 3a and 3b**), and the crew were able to compensate for the resulting port list by pumping out ballast from the port ballast tanks. The vessel was assessed by French surveyors as remaining seaworthy and it subsequently crossed the English Channel with the French tug *Abeille Languedoc* in attendance. It then berthed alongside in Dunkirk until a dry dock became available in which to complete permanent repairs.

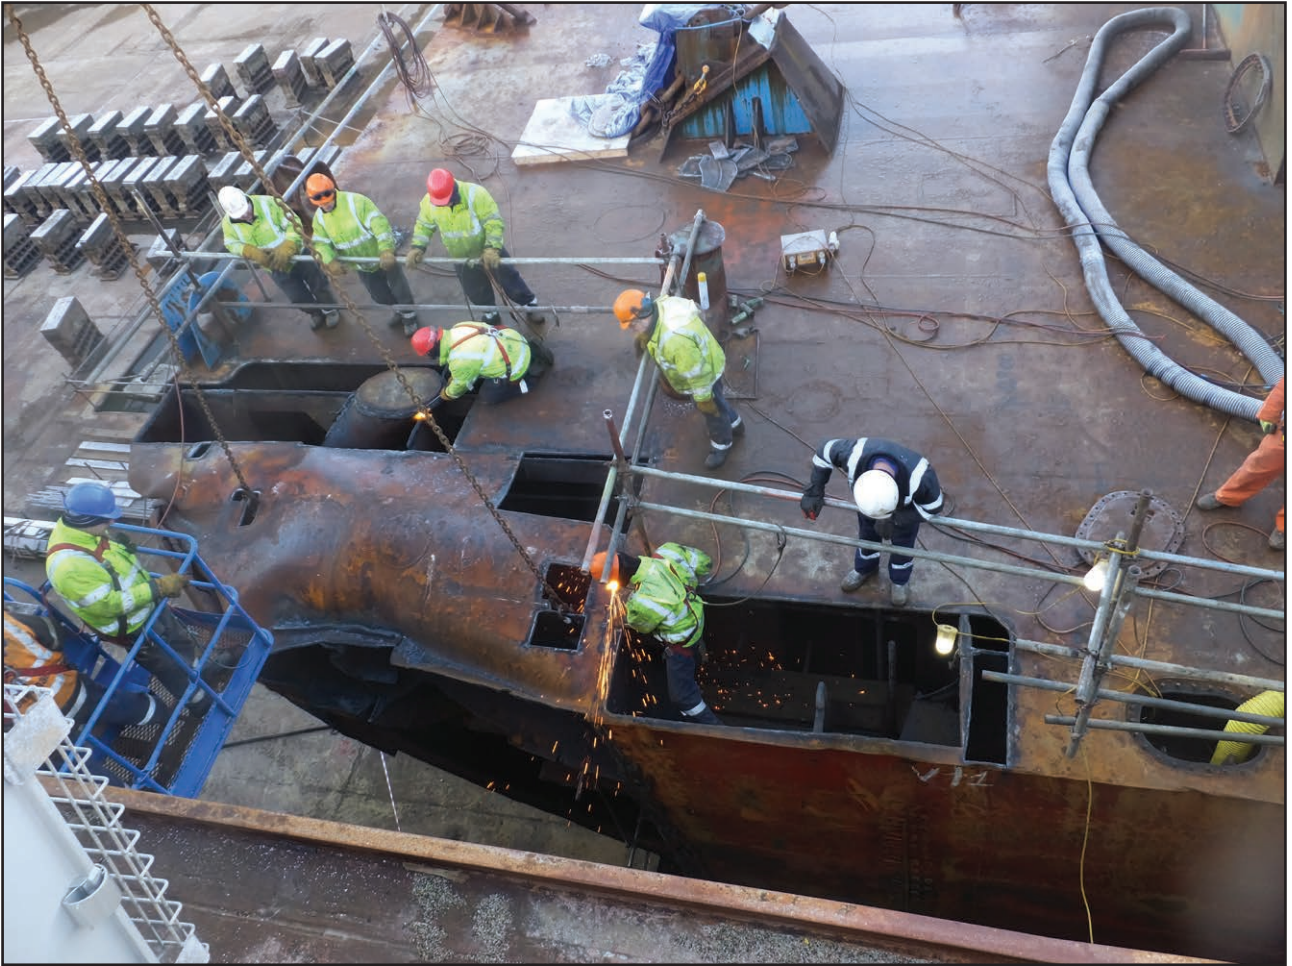
Figure 4: *Stema Barge II* undergoing repairs

Stema Barge II suffered extensive damage to its port ballast tanks. The barge remained at anchor off Dover for several days until arrangements were made to tow it to a facility on the River Tyne to carry out repairs (**Figure 4**).

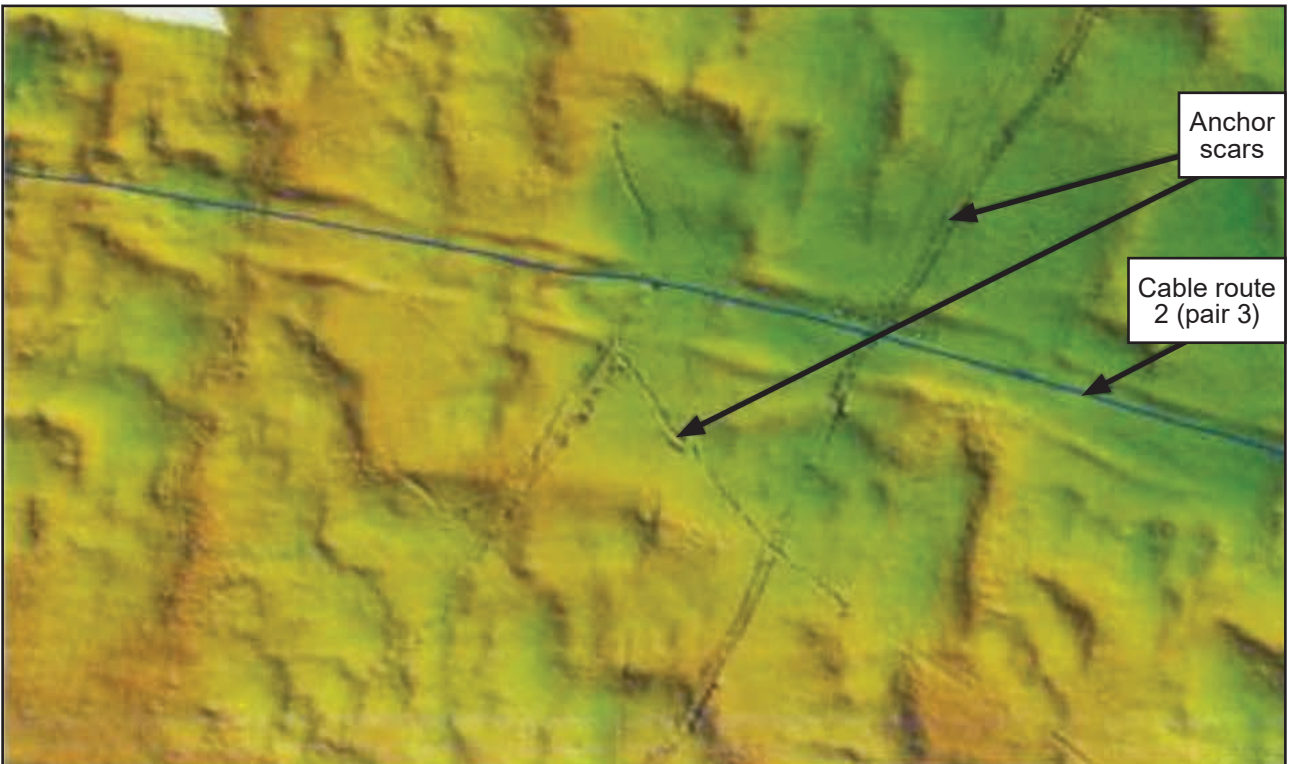
Figure 5: Seabed scan image of cable route 2

The subsea cables of IFA 1 were damaged in way of cable routes 2 and 4 (see section 1.4.1). Subsequent seabed surveys indicated that the cable pairs at both routes were severed and that seabed scars consistent with anchor dragging crossed cable routes 2 (**Figure 5**), 3 and 4. Despite a clear scar crossing cable route 3, no damage was recorded on these cables.

In view of the reconstructed tracks of *Saga Sky* and *Stema Barge II* during the period leading up to and during the accident, and supporting images from seabed scans, it is concluded that their anchors probably impacted with the cables of IFA 1 at the points where damage occurred.

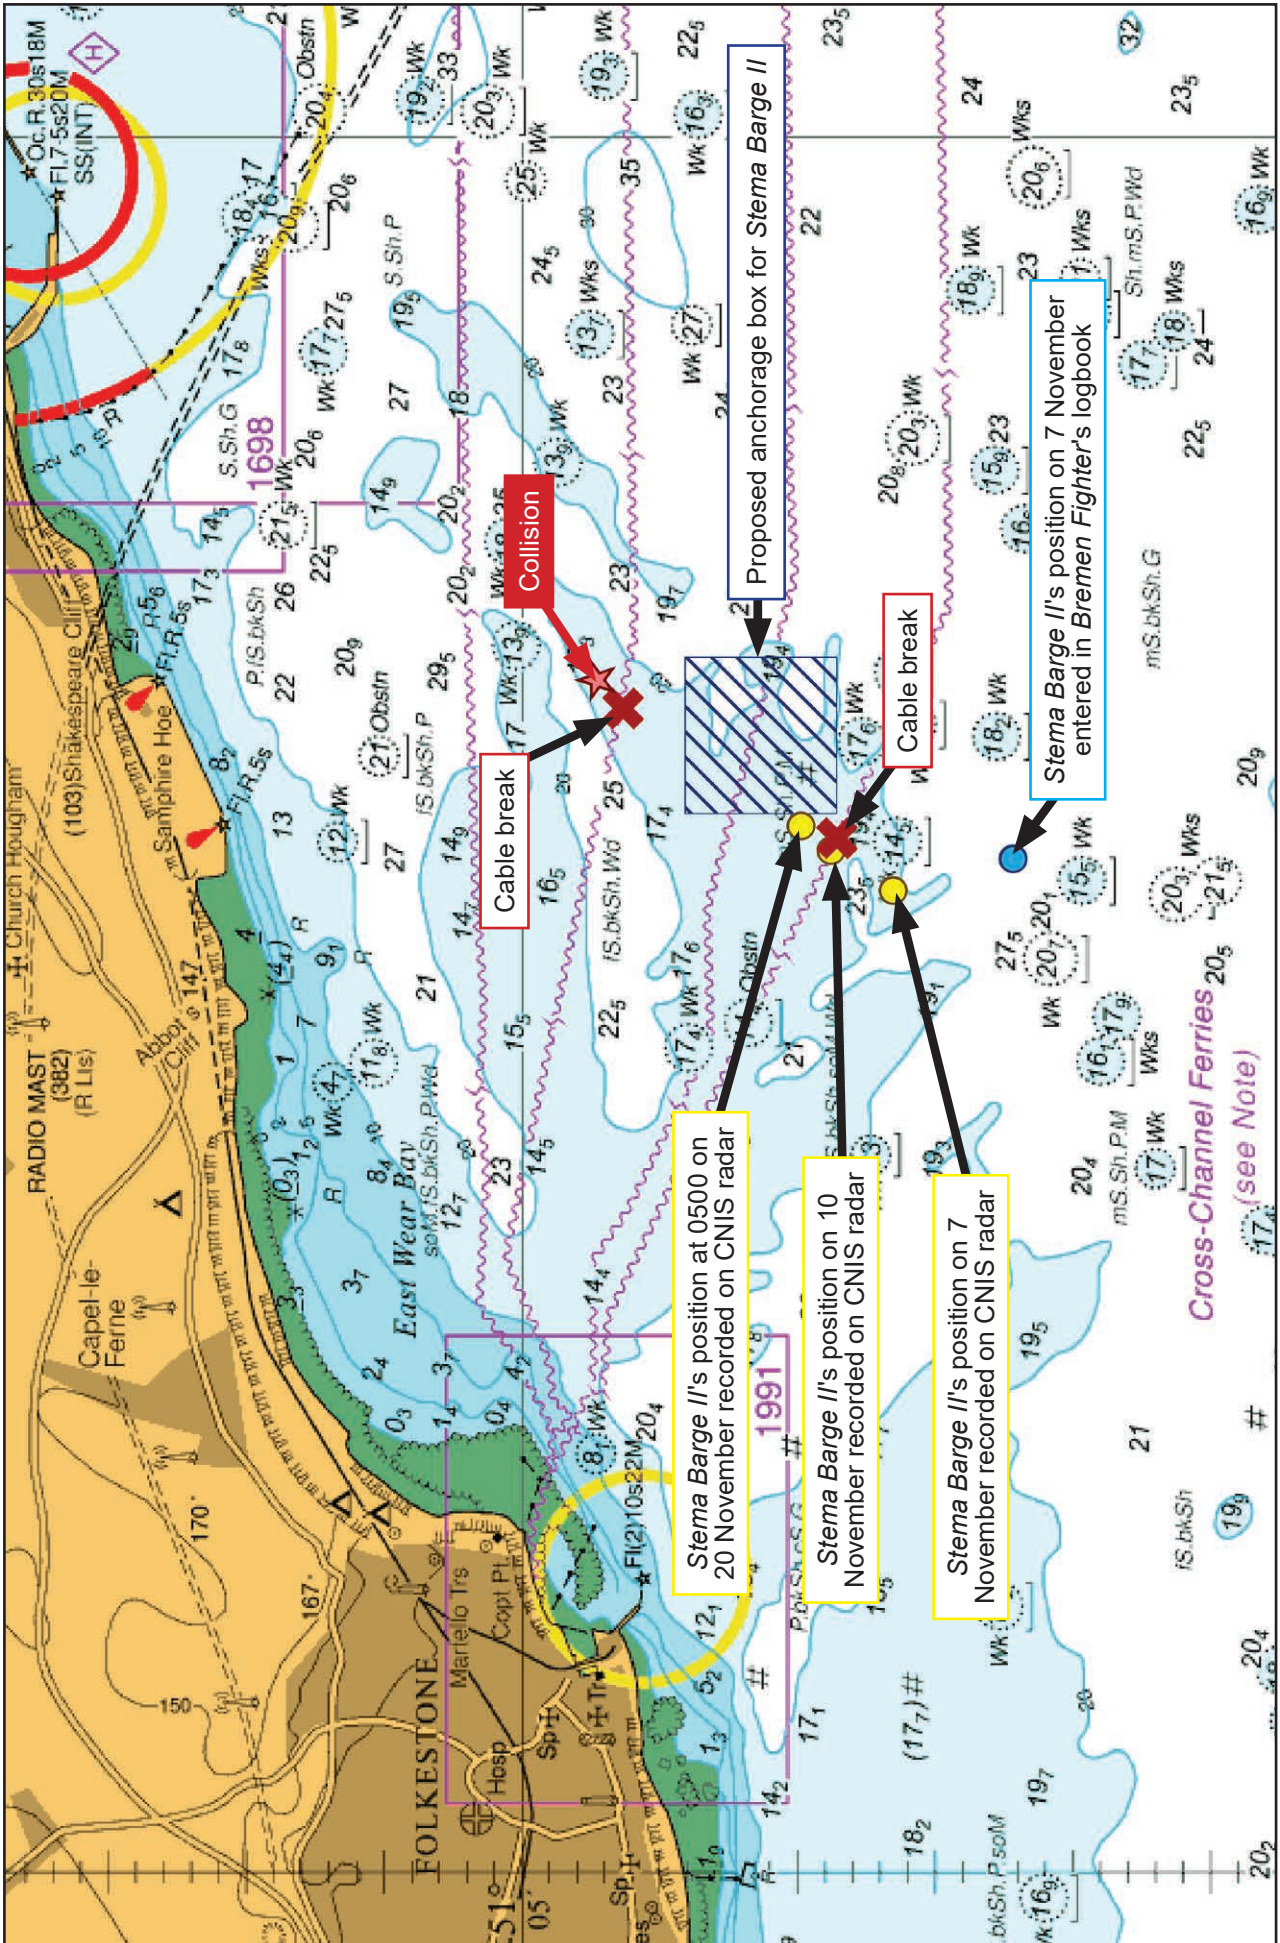
Figure 9: Admiralty Chart 1892 extract showing anchorage locations

recording of radar imagery from the Channel Navigation Information Service (CNIS) at Dover showed the barge's actual position as 51° 03.6444'N 001° 15.6583'E. Neither of these positions was within the proposed anchorage box. The CNIS radar recordings show that the barge was anchored approximately 0.28nm south-west of IFA 1, cable route 4 (**Figure 9**).

The navigational chart used to determine the anchorage was out of date and did not show the subsea cables of IFA 1. The chart used was owned by Stema Shipping UK Ltd and was part of a chart folio that had been used to support similar method statements on other UK projects. The charts were not regularly replaced and were not subject to chart updates.
