**MERSEYSIDE  
FIRE & RESCUE  
SERVICE**

## **Fire Investigation Report 132-20**

**Ørsted BESS,**

TYPE OF PROPERTY: Battery energy storage site BESS

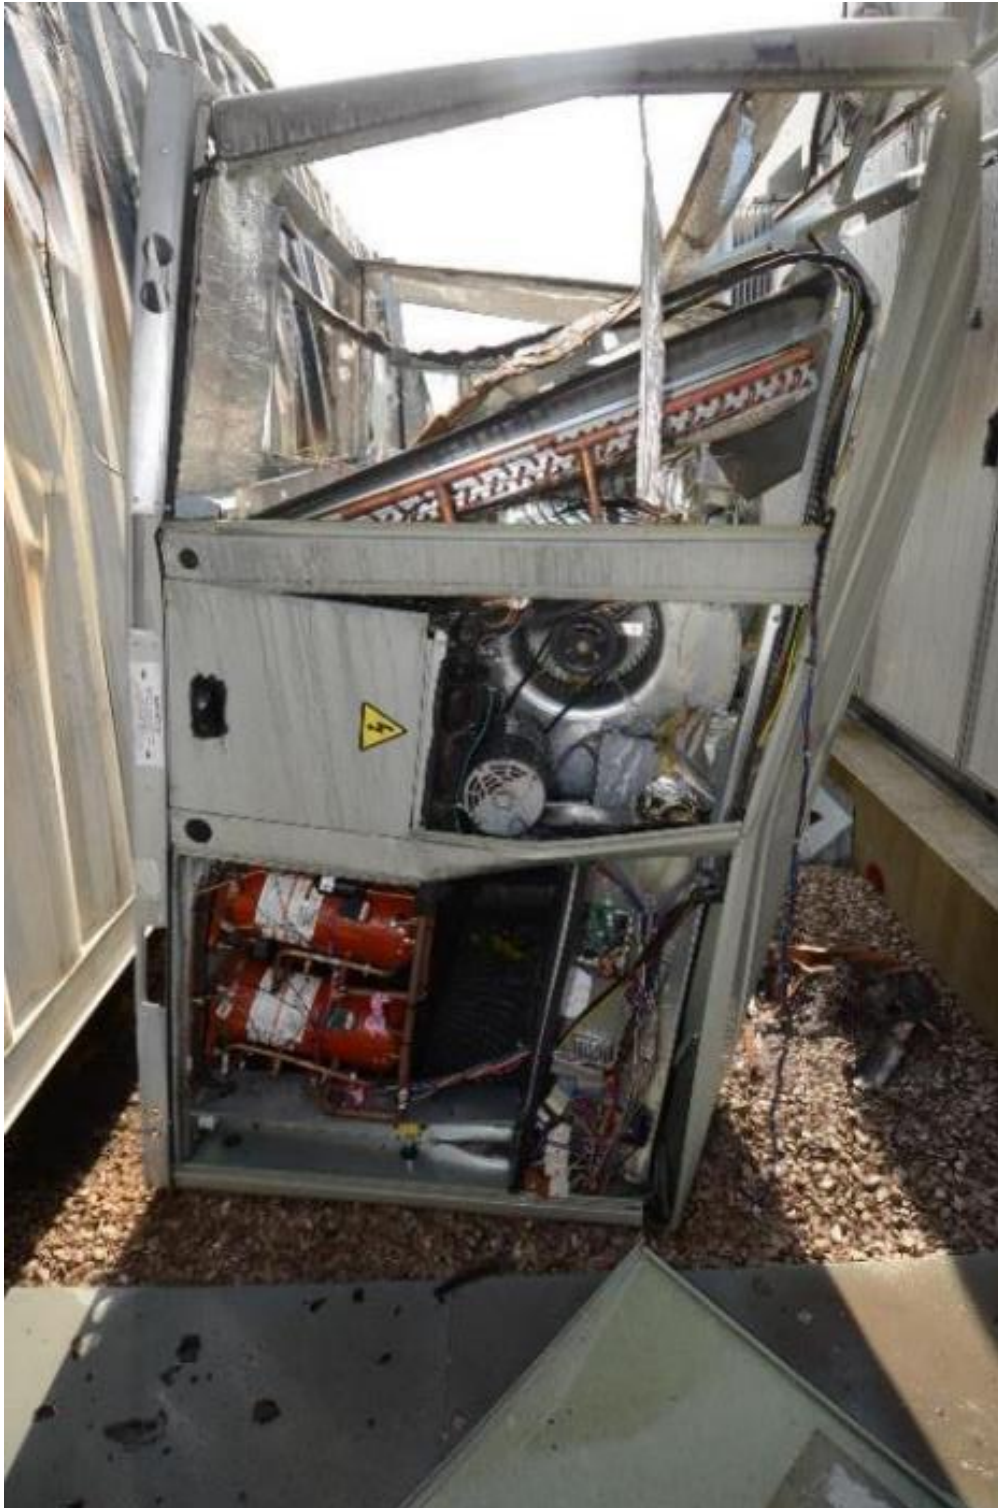
- All four HVACs had come detached from their fittings and landed in a row alongside the container and did not display much fire damage (see photo 4 & 5 in section 13).

HVACS after coming dismounted from the container roof

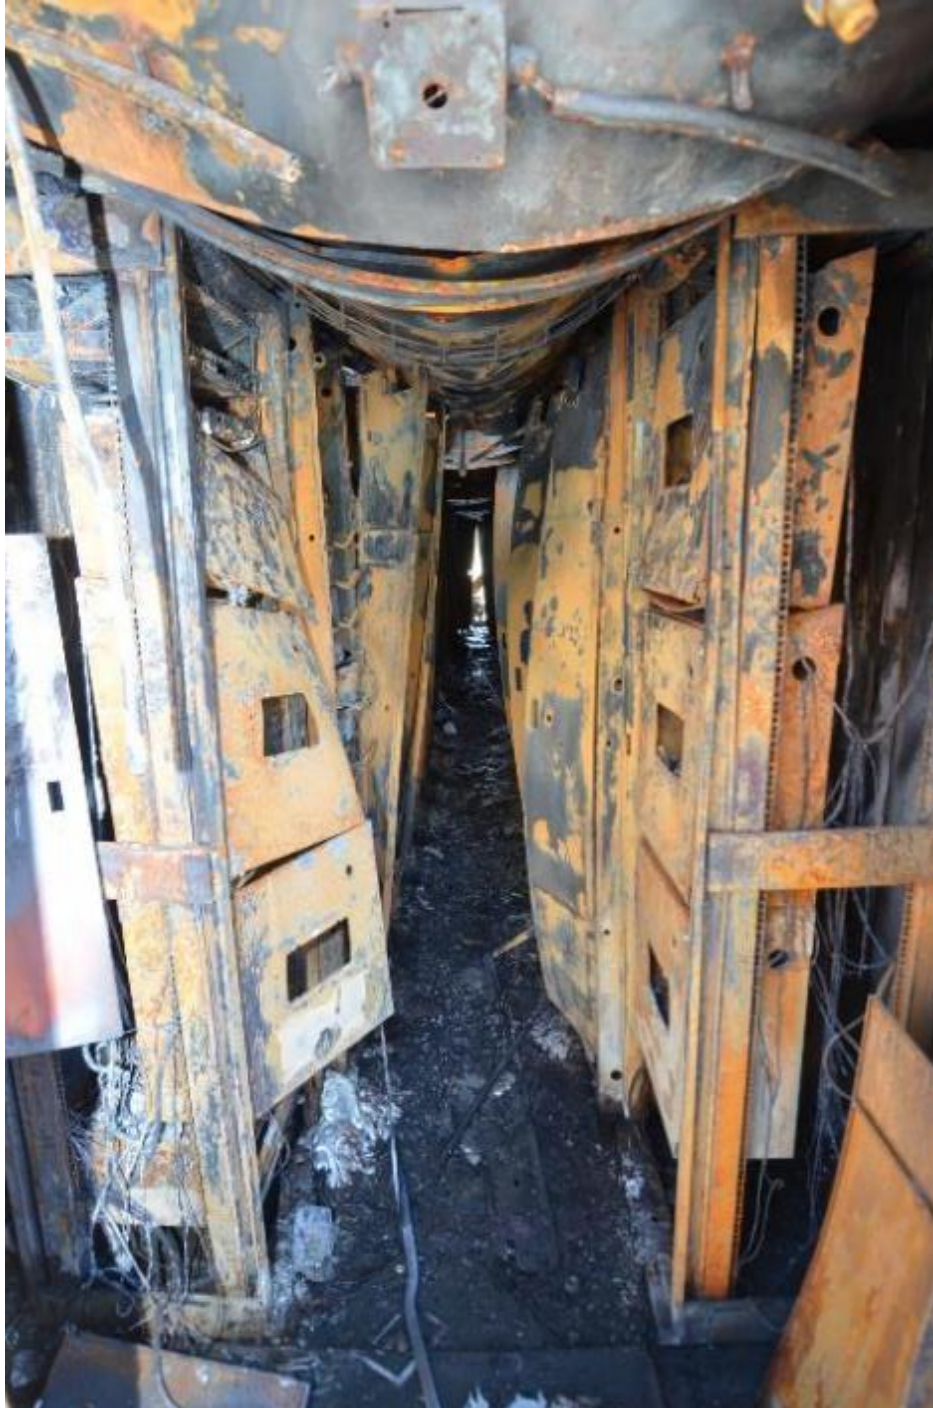
- The internal racking and contents had been extensively damaged and there was significant evidence that the internal container suffered weakening from the heat and the blast (see photo 6 section 13).

Internal view of container one from the Fisheries side

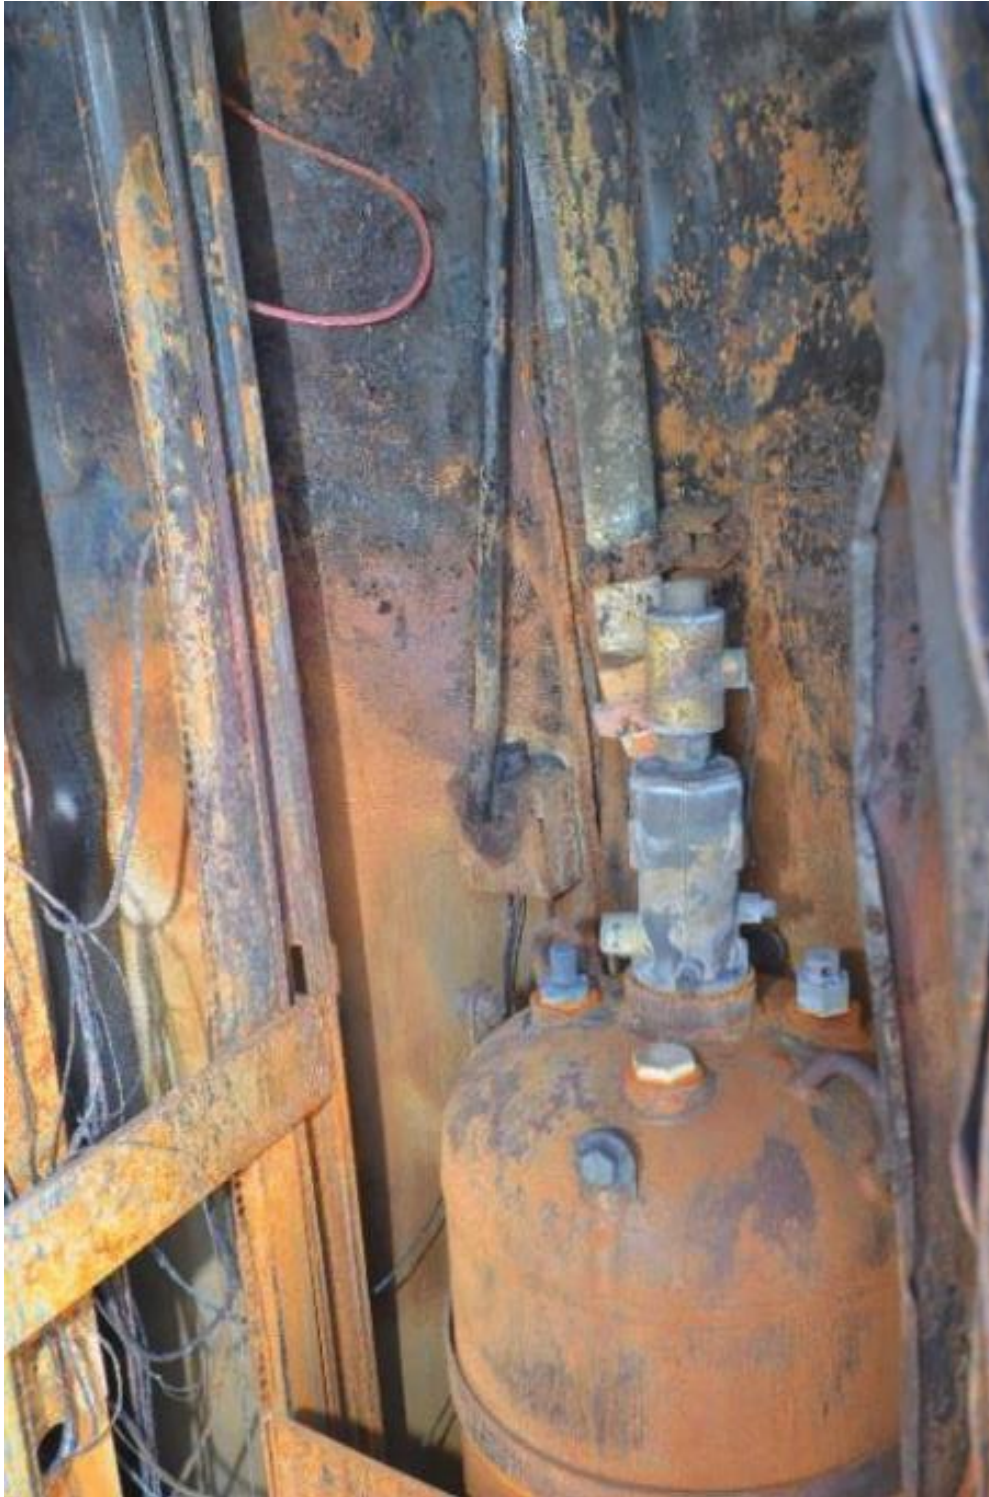
- On inspecting the suppression pipework, I noted that the discharge heads were missing and only appeared to have been attached by three threads. The responsible person informed me that PTFE tape and lock tight sealant was used to keep the heads in place.

NOVEC system in container one with damaged pipe work

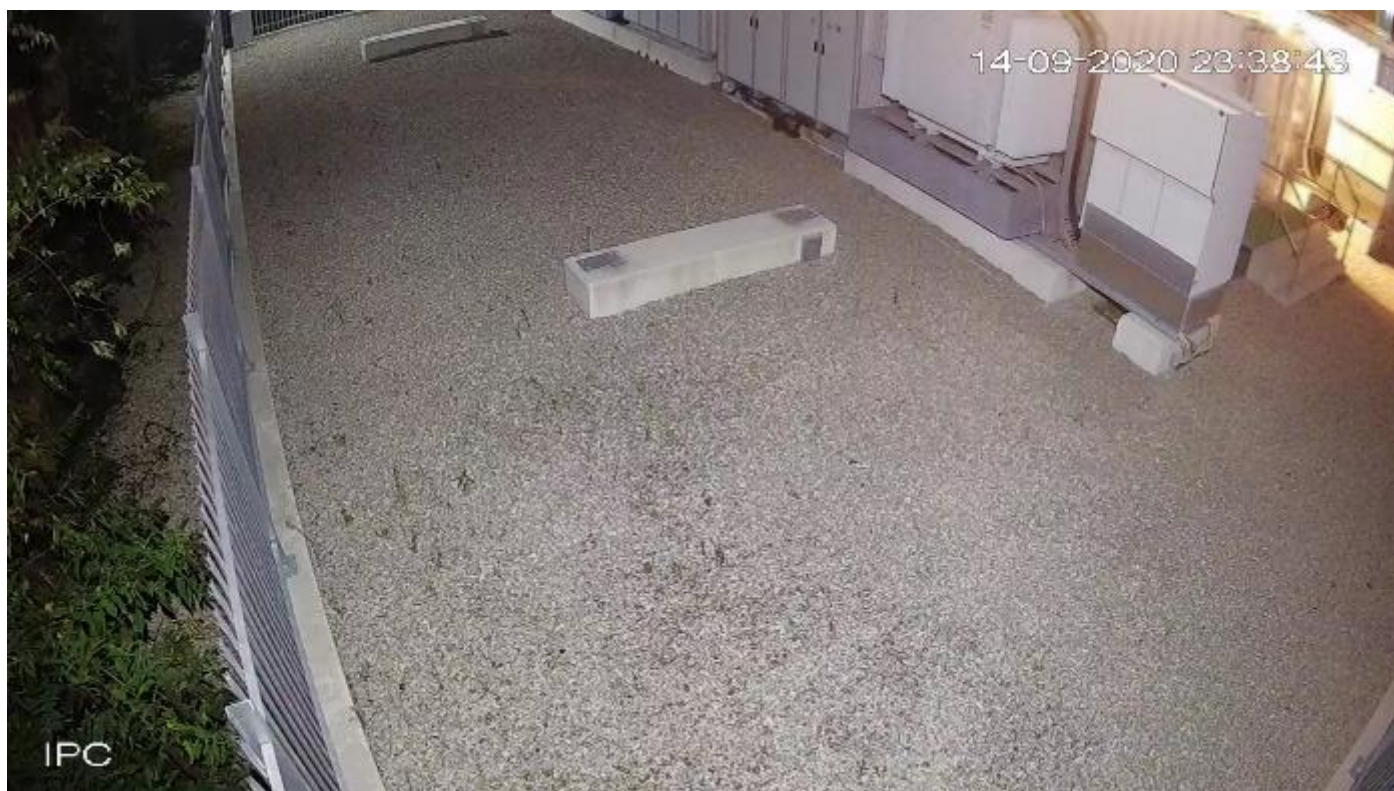
12

External CCTV at point of blast for the door fails

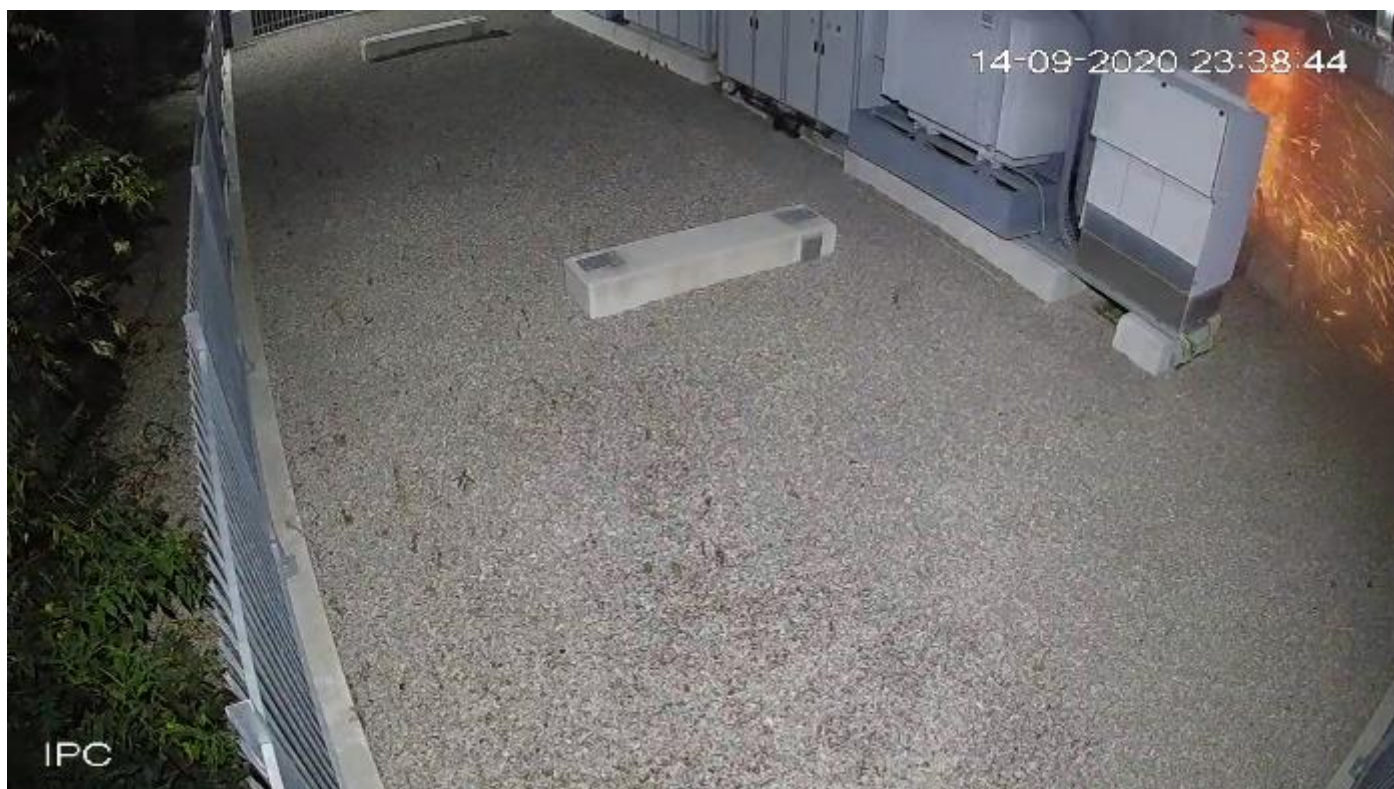
13

External CCTV showing flaming discharge consistent with a failing Lithium cell

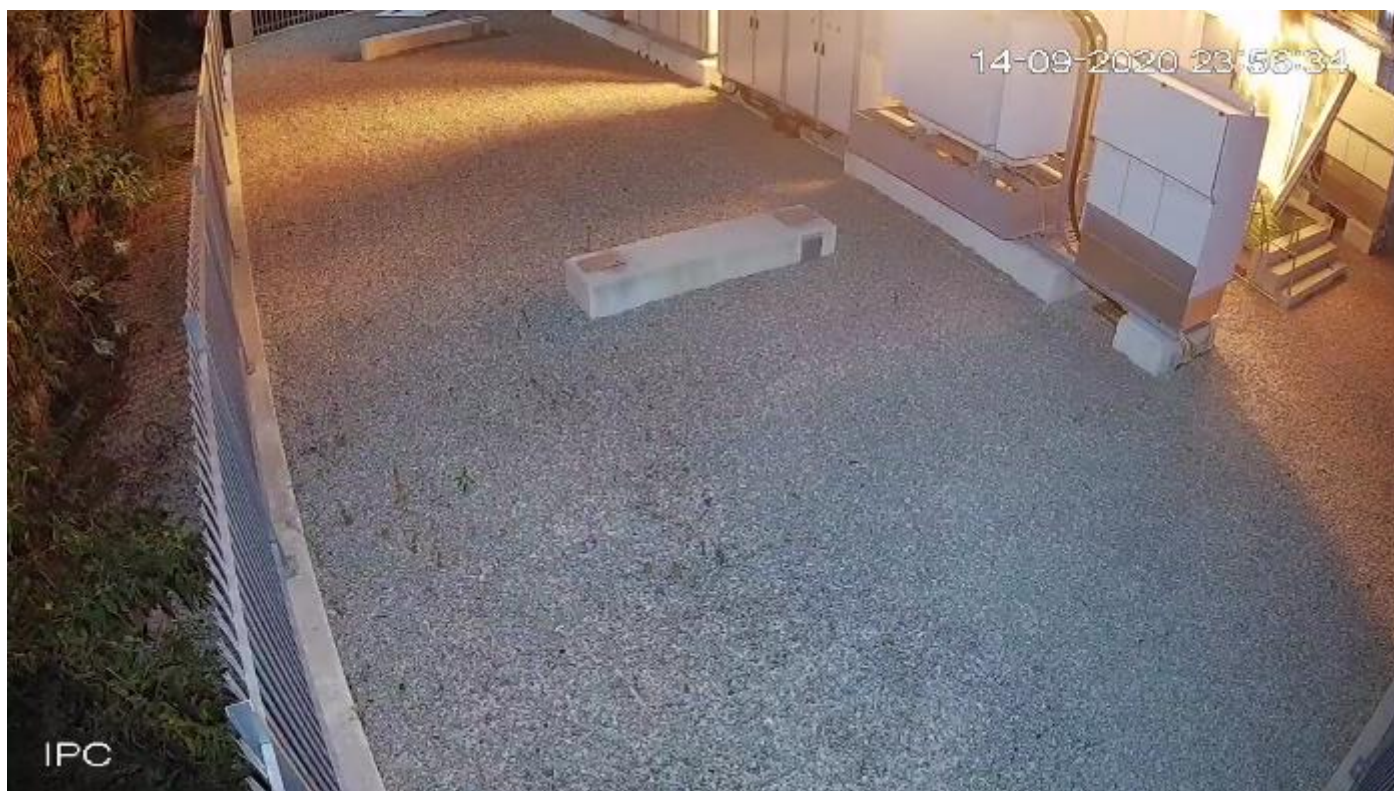
14

External CCTV showing the door being blown open and the smaller door coming detached

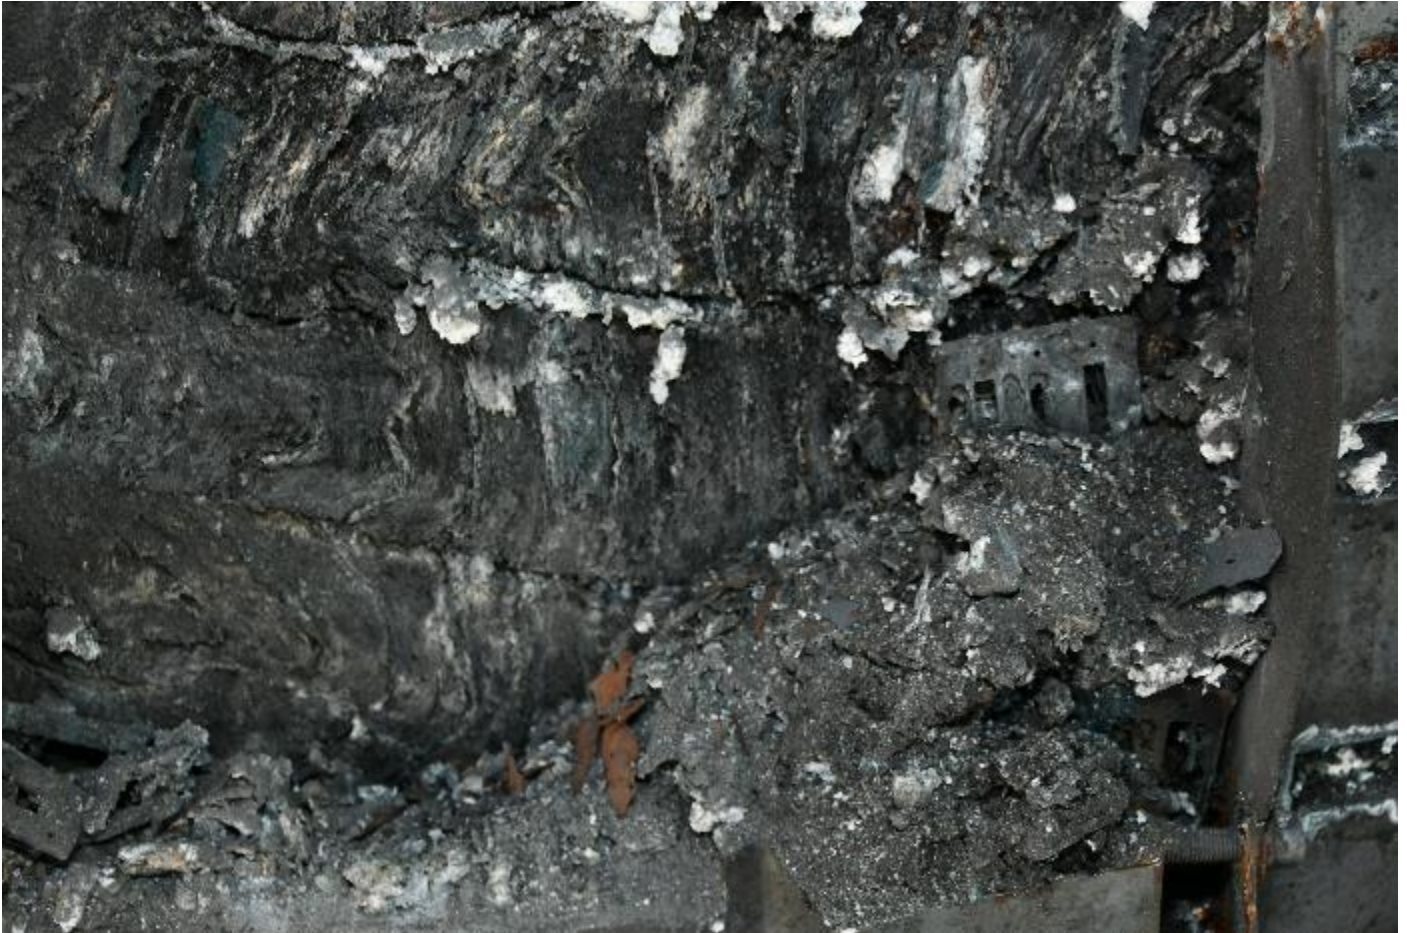
Image MB0\_7421 is a close up of the module of interest before removal.

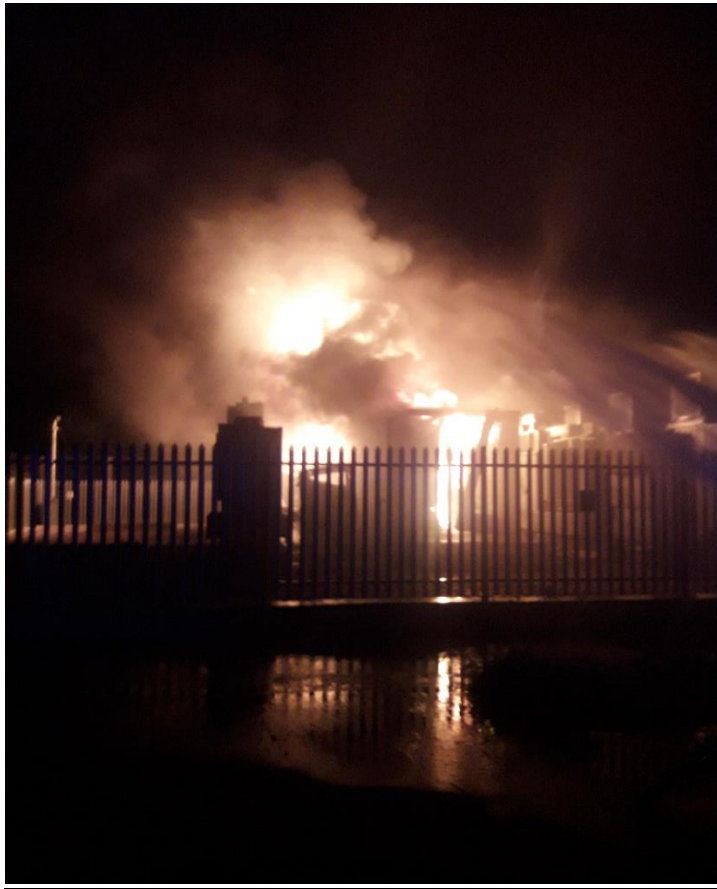
Fire development from the unit at approximately 01:30 hours.

Note the intensity of fire and therefore heat from the centre of the unit and extension of flame into the plume.

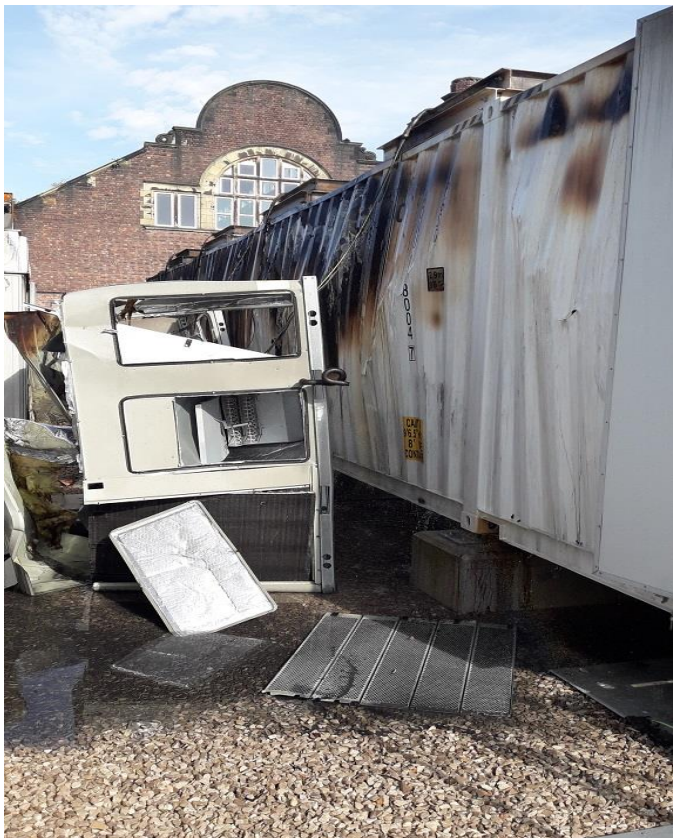
Image above: Taken from [REDACTED] AIR Unit. Full extent of damage visible. Roof mounted cooling units ejected to side of unit. Pressure damage visible along length of unit. Note scorching of top edge of second unit to mid-right of image. Firefighting tactics mitigated further spread and damaged beyond original unit and blast.

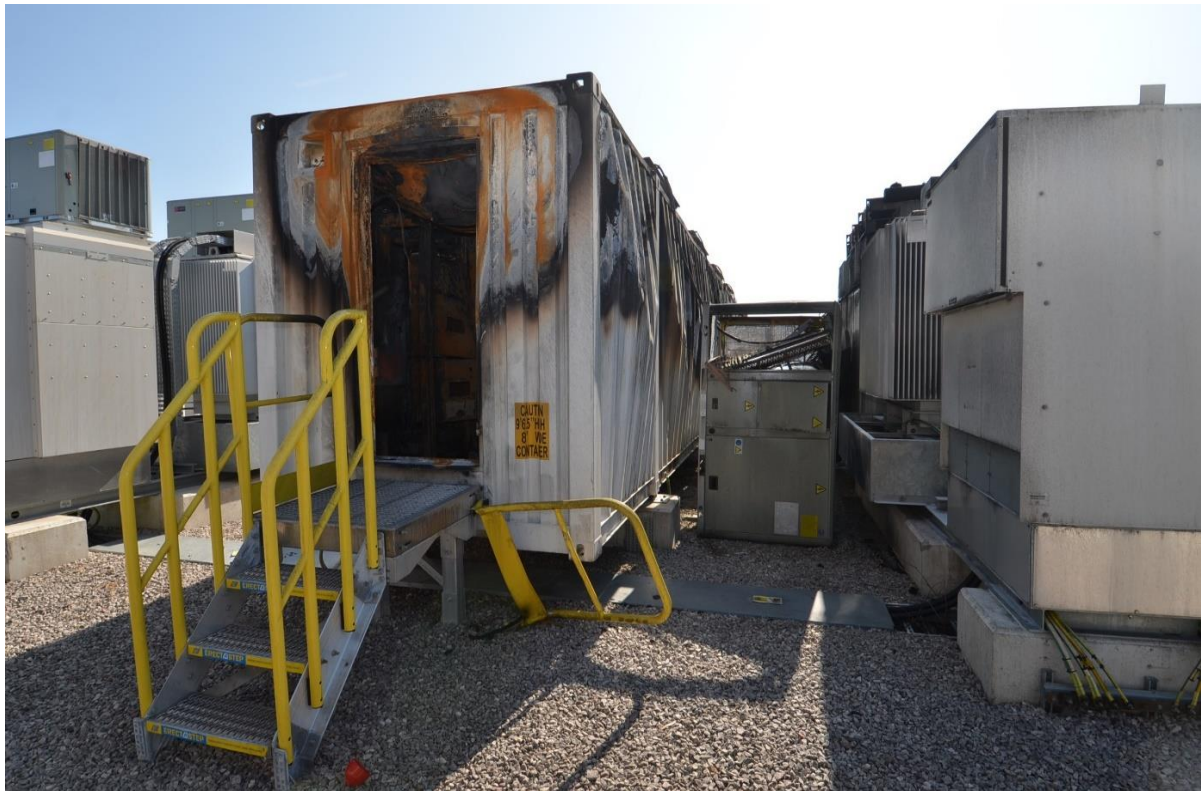
Image above: Exterior of unit with pressure damage to side.
