**Four Firefighters Injured in Lithium-Ion Battery Energy Storage System
Explosion – Arizona**

Authors: Mark B. McKinnon
Sean DeCrane
Stephen Kerber

Institution: *Underwriters Laboratories*, Firefighter Safety Research Institute,
Columbia, Maryland, USA

Date: 28 July 2020

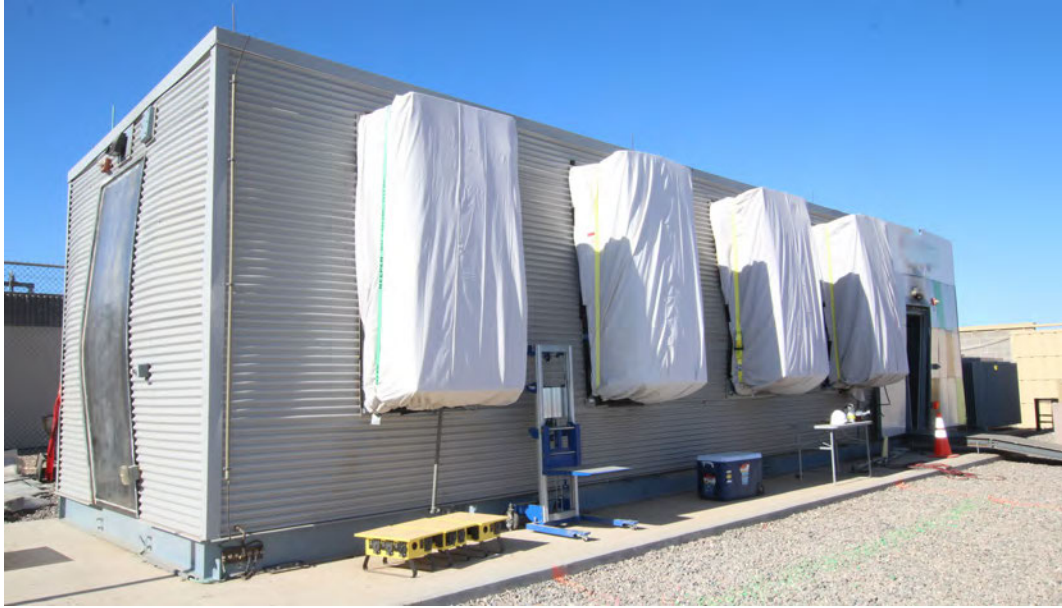
Figure 4.3: Photograph of the ESS after the incident from the southeast [13].

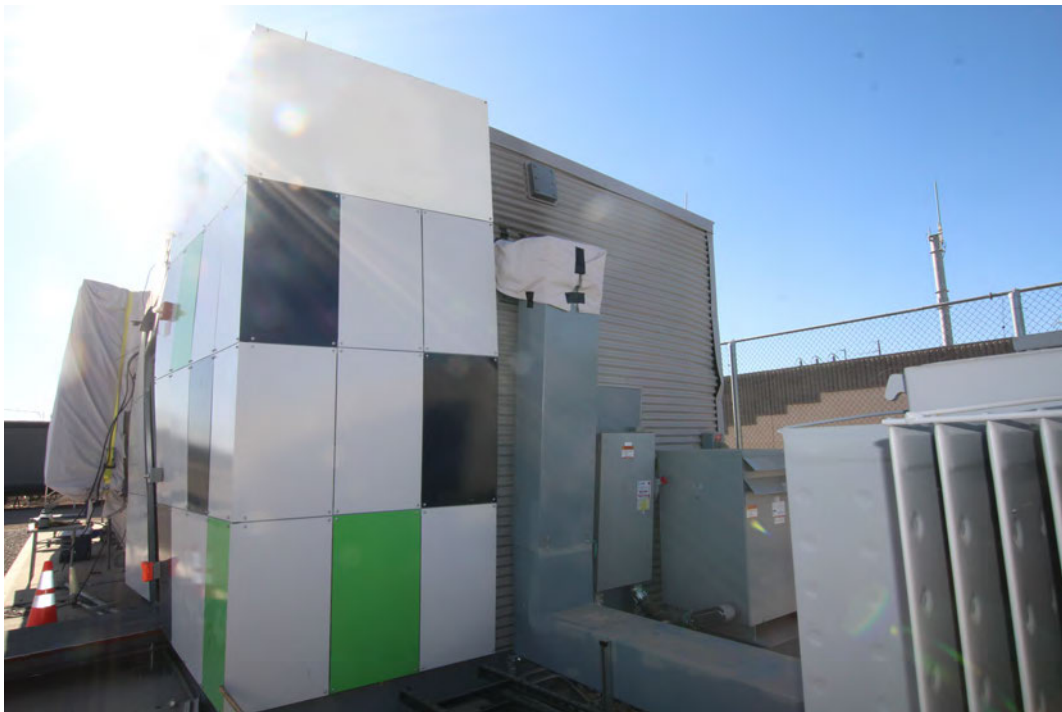
Figure 4.4: Photograph of the ESS after the incident from the northeast [13].

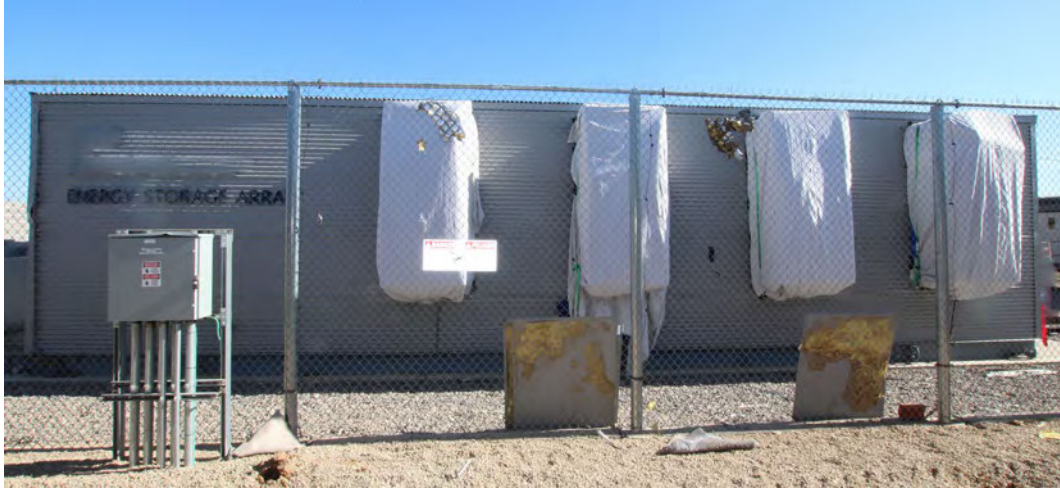
Figure 4.5: Photograph of the ESS after the incident from the northwest [13].

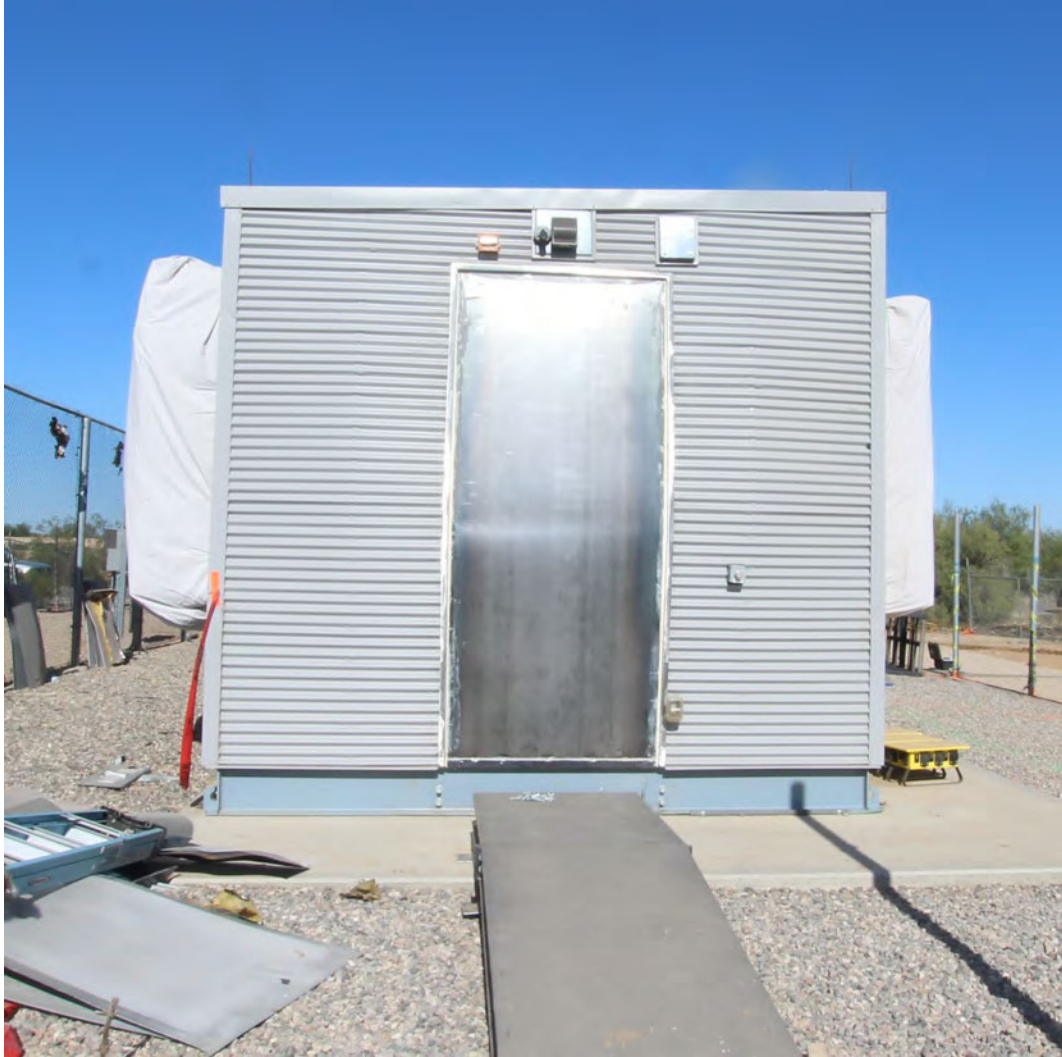
Figure 4.6: Photograph of the ESS after the incident from the southwest [13].

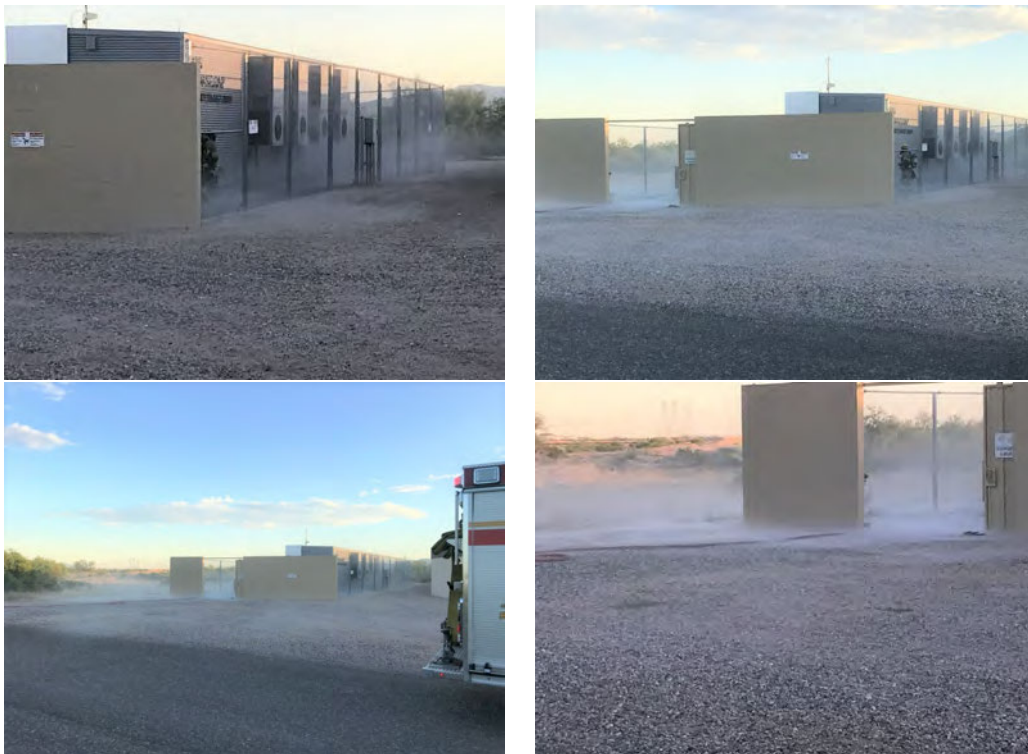
Figure 4.9: Photographs of the ESS scene taken by E193 FE upon the arrival of E193 [6].

Figure 4.9 indicates the ESS was actively leaking gases and vapors when the HAZMAT team arrived and performed a size-up approximately 100 minutes after the Novec 1230 was discharged. Based on a conservative estimate of the apparent area and depth of the vapor cloud in the photographs (100 ft x 60 ft, and a depth of 3 ft), as well as the estimated internal volume of the ESS, a volume of gas/vapor mixture sufficient for at least two complete volume changes had likely occurred. The continual leakage of a mixture of air, gases and vapors produced during thermal runaway, and Novec 1230 over time caused the concentration of the clean agent to fall below the design concentration. It is unlikely the concentration of Novec 1230 remaining in the ESS at the time the door was opened provided meaningful protection against the ignition of flammable gases and vapors that had accumulated in the ESS.

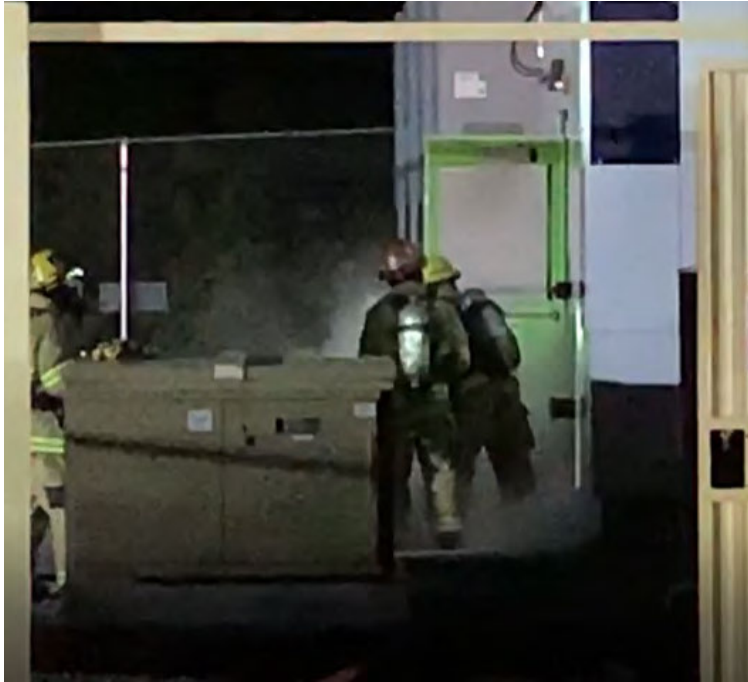
Figure 4.12: Image of the HAZMAT team 5 s after opening the door [14].

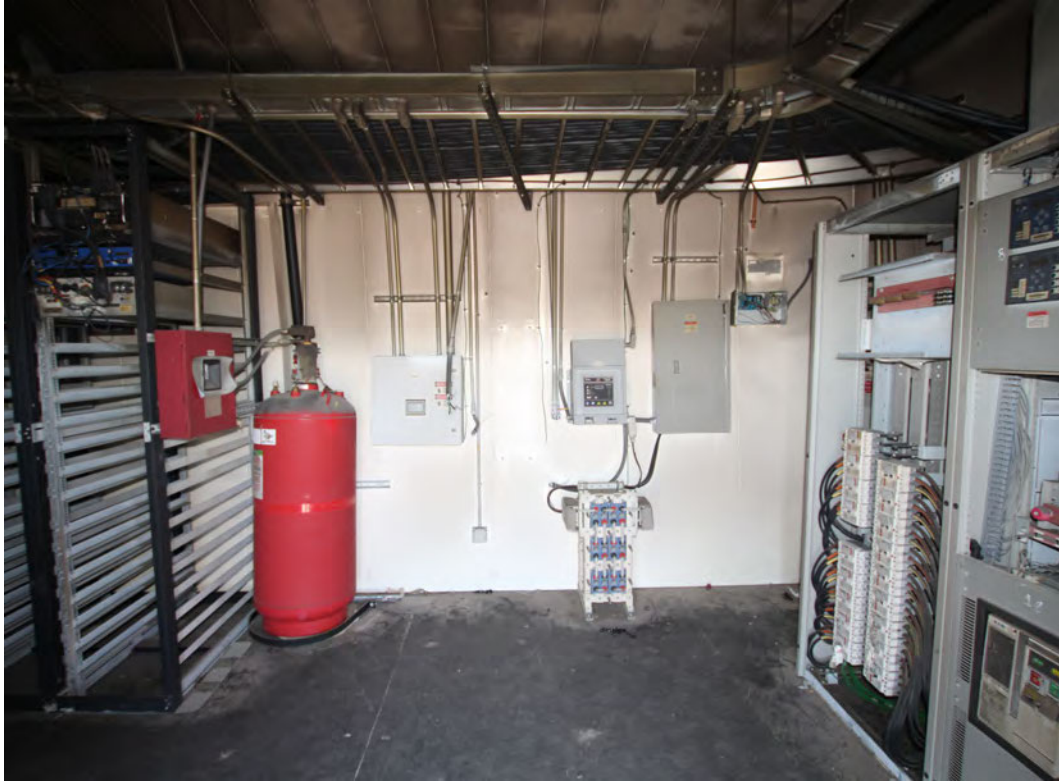
Figure 4.15: Photograph of view into the ESS from the entry door [13].

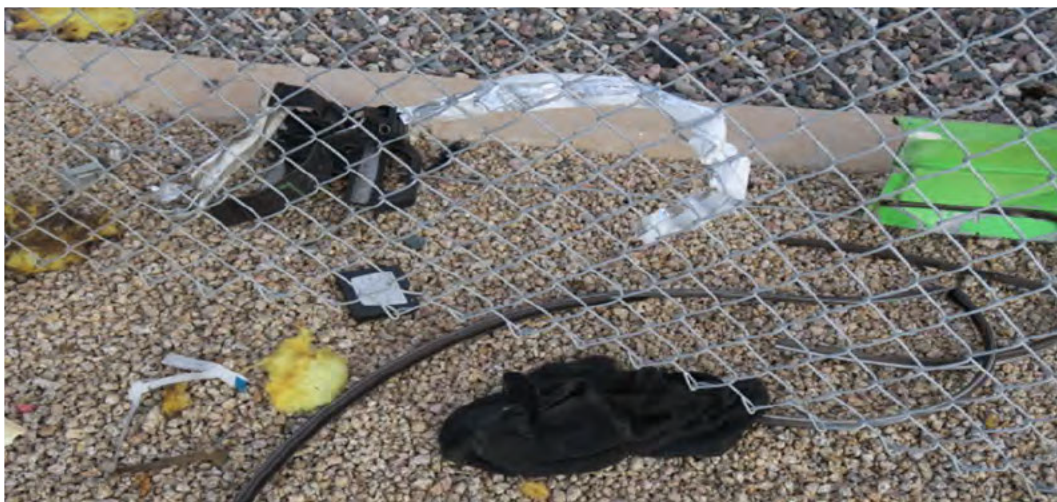
Figure 4.17: Photograph of firefighter equipment removed by the fence during the deflagration [6].

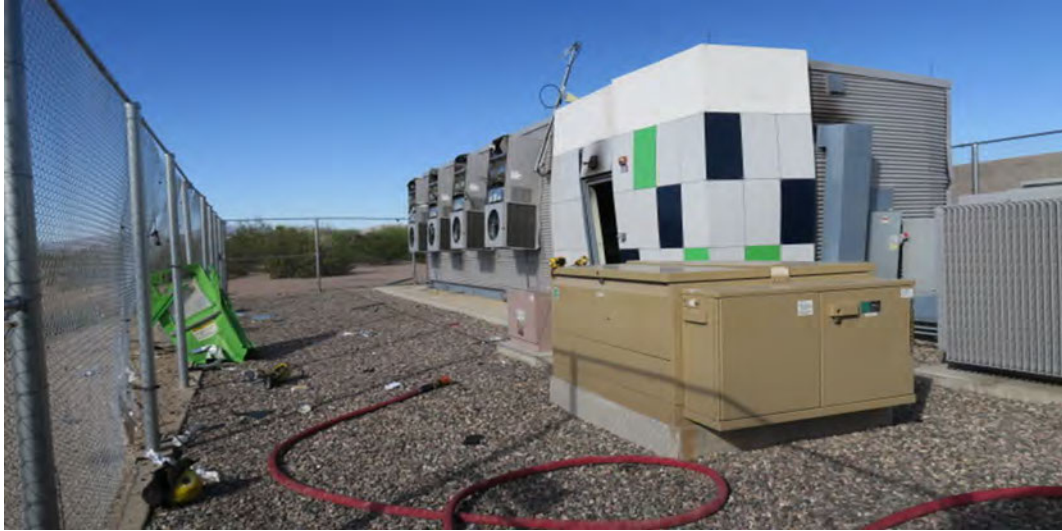
Figure 4.18: Photograph of firefighter helmets and the door to ESS removed during the deflagration [6].

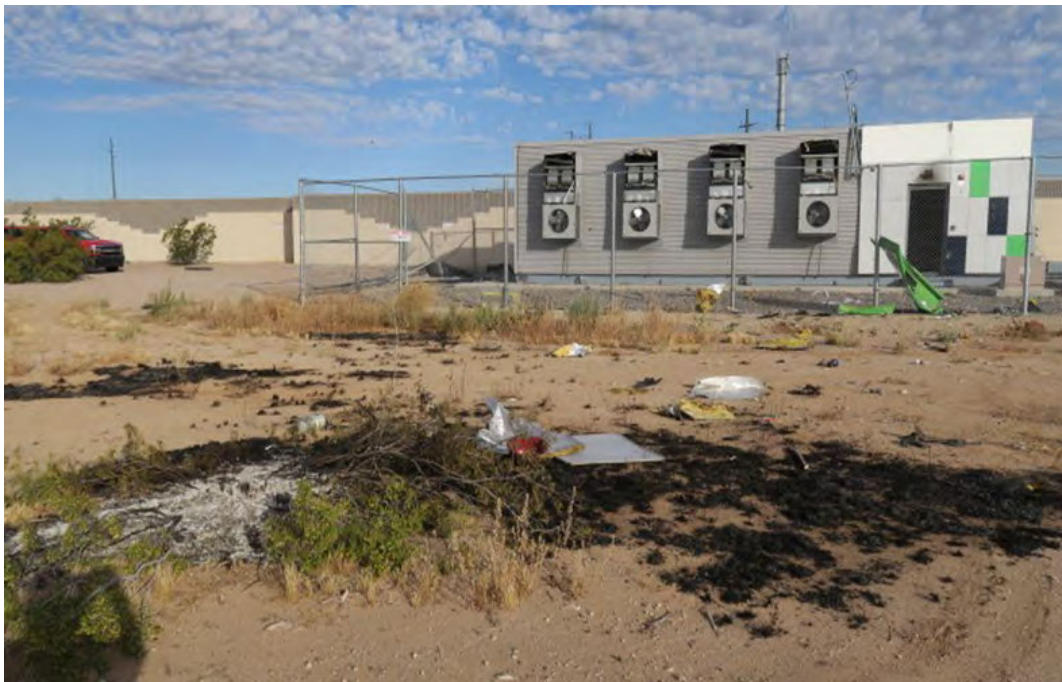
Figure 4.19: Photograph of burned bush, E193 Capt's helmet, and SCBA tank removed during the deflagration [6].

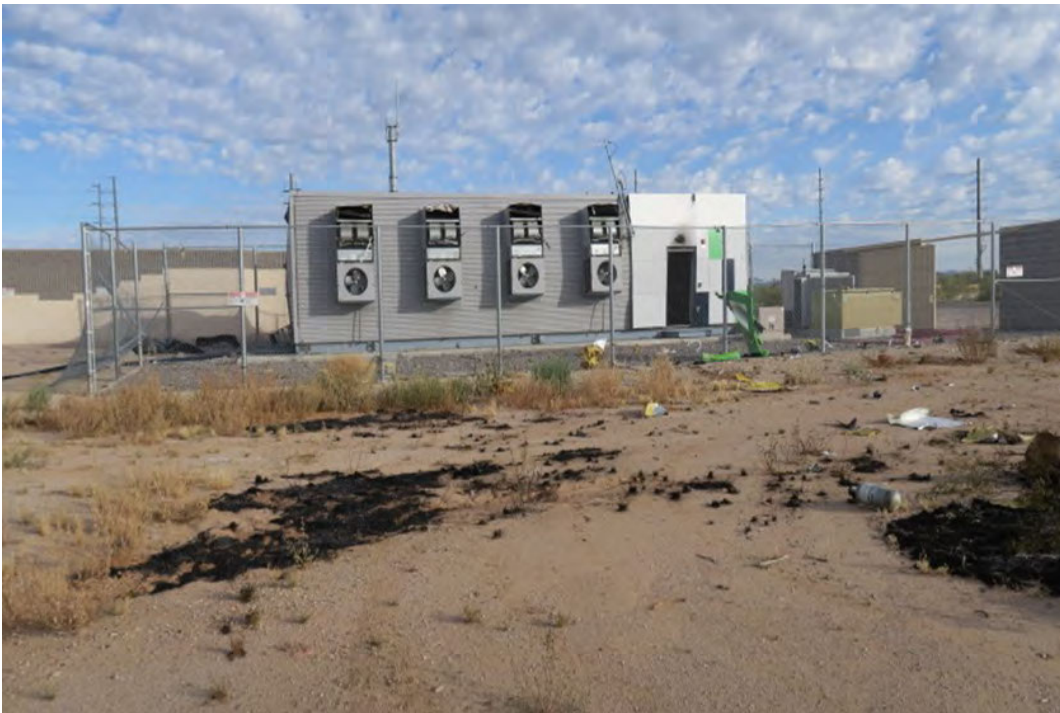
Figure 4.20: Photograph of fire debris and SCBA tank removed during the deflagration [6].

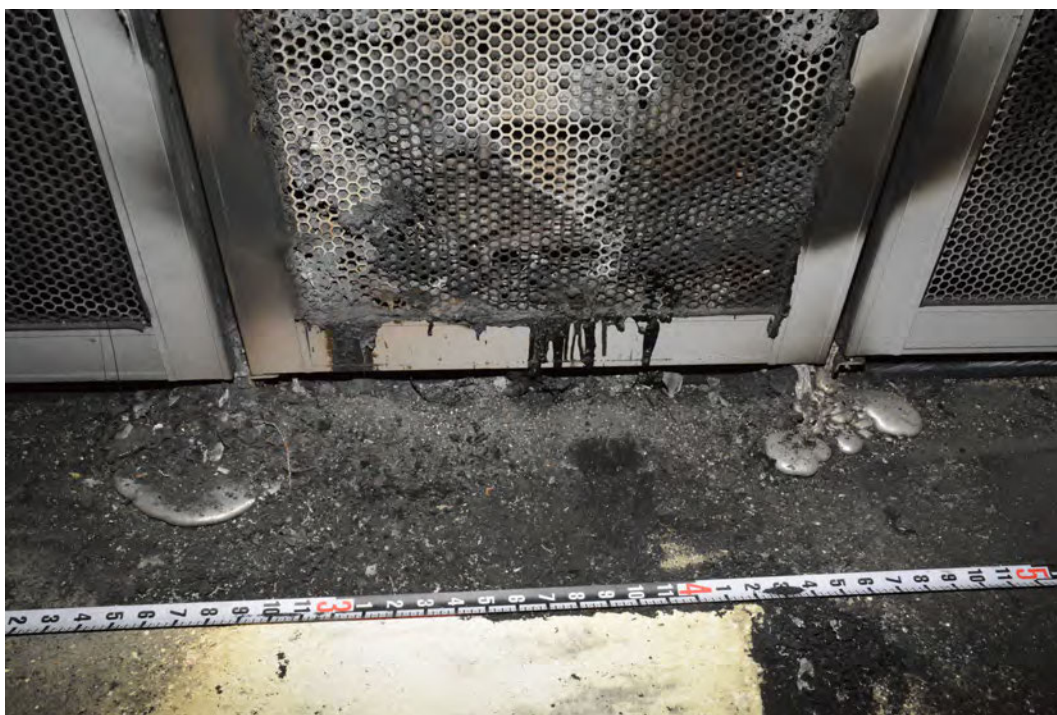
A photograph of the floor in front of Rack 15 taken during decommissioning is provided in Figure A.1. The photograph shows solidified pools of molten aluminum that apparently flowed down along the sides of the front of the rack during the incident. The melting temperature of aluminum is 1,220°F [22]. Studies conducted by the American Petroleum Institute suggest that a surface temperature approximately 360°F above the autoignition temperature is required to facilitate ignition [36]. Hydrogen as well as most hydrocarbons, which are major components of the gas mixture expected to be released from lithium-ion batteries undergoing thermal runaway, have autoignition temperatures below 860°F [37]. It has also been observed that the exothermic reactions that are a key contributor to propagation of the thermal runaway process produce temperatures that are capable of causing hot surface ignition of flammable mixtures [22].

Figure A.1: Photograph taken during decommissioning of the ESS shows a pool of solidified aluminum on the floor in front of Rack 15 [11].
