Report: Fire Investigation Report 132-20

Incident number: 018965

## 3. **Significant Incident Report**

Information relating to a fire incident at an Orsted Battery Energy Storage System (BESS) site, Carnegie Road, Liverpool on 15<sup>th</sup> September 2020.

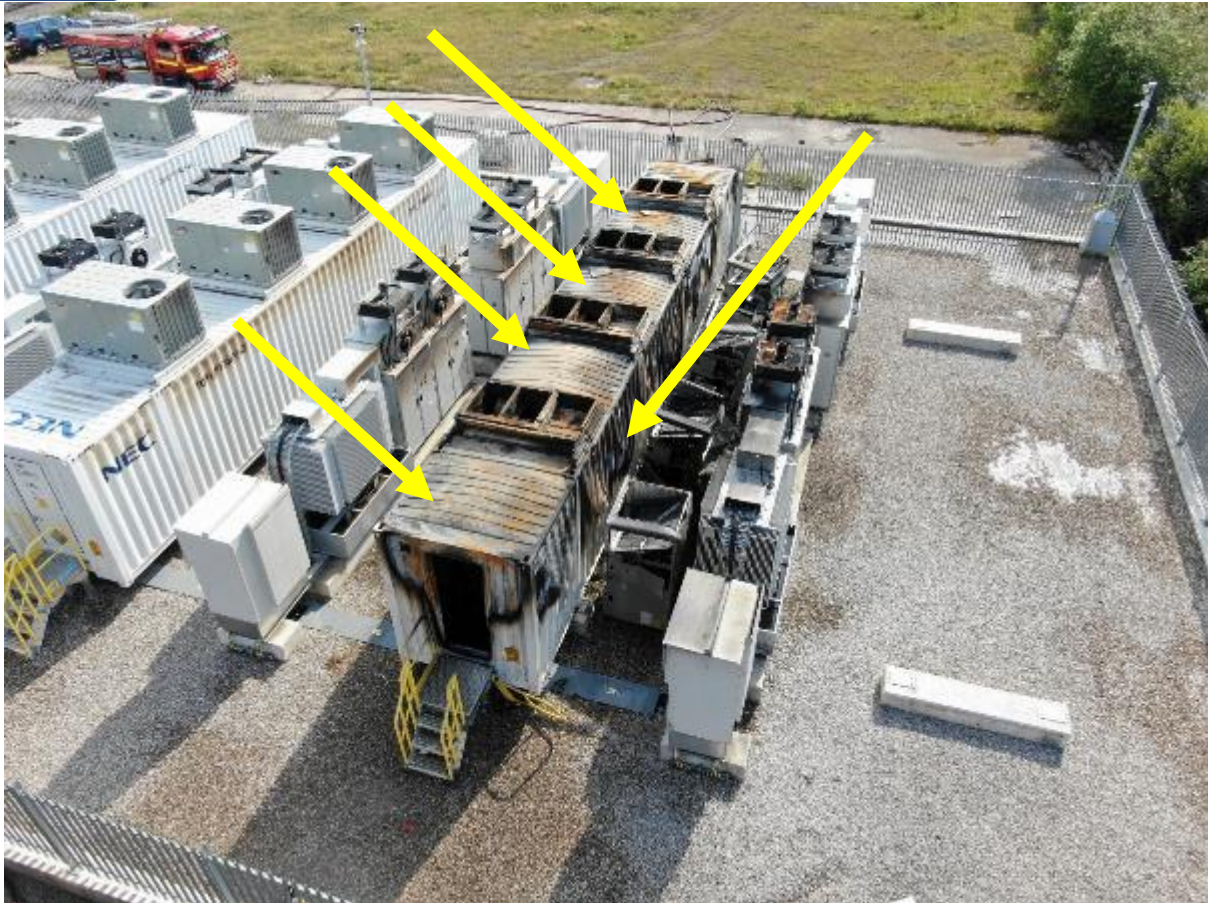
*Image 2 shows the damaged container with signs of expansion/distortion that is equal across the container and not localised to the area of the initial failure.*

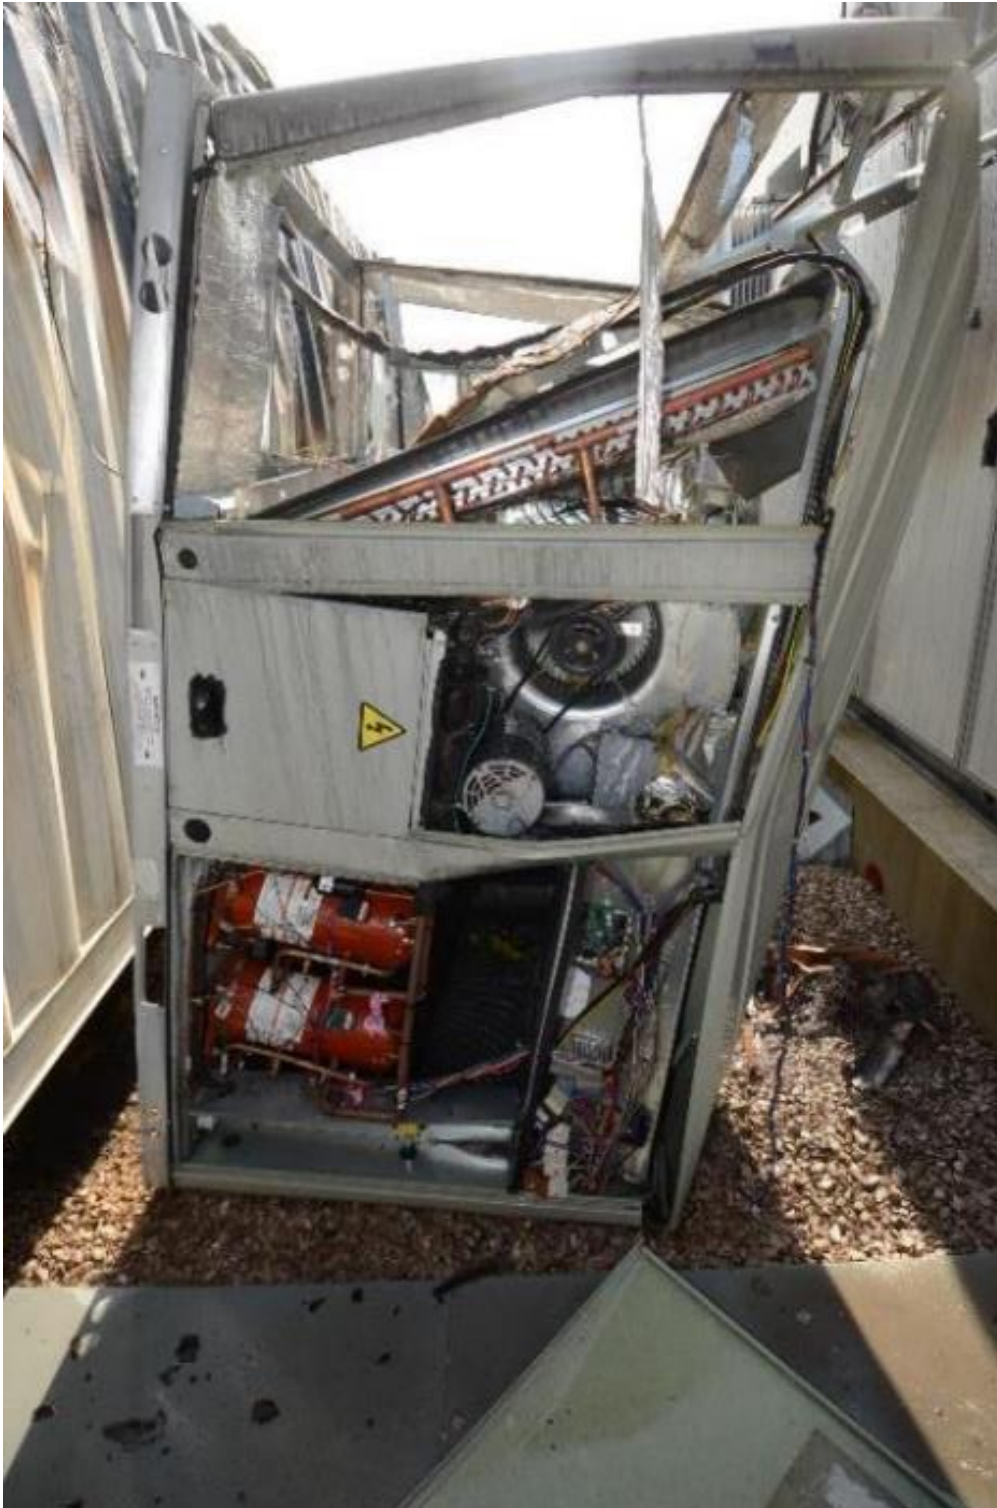
- All four HVACs had come detached from their fittings and landed in a row alongside the container and did not display much fire damage (see photo 4 & 5 in section 13).

HVACS after coming dismantled from the container roof

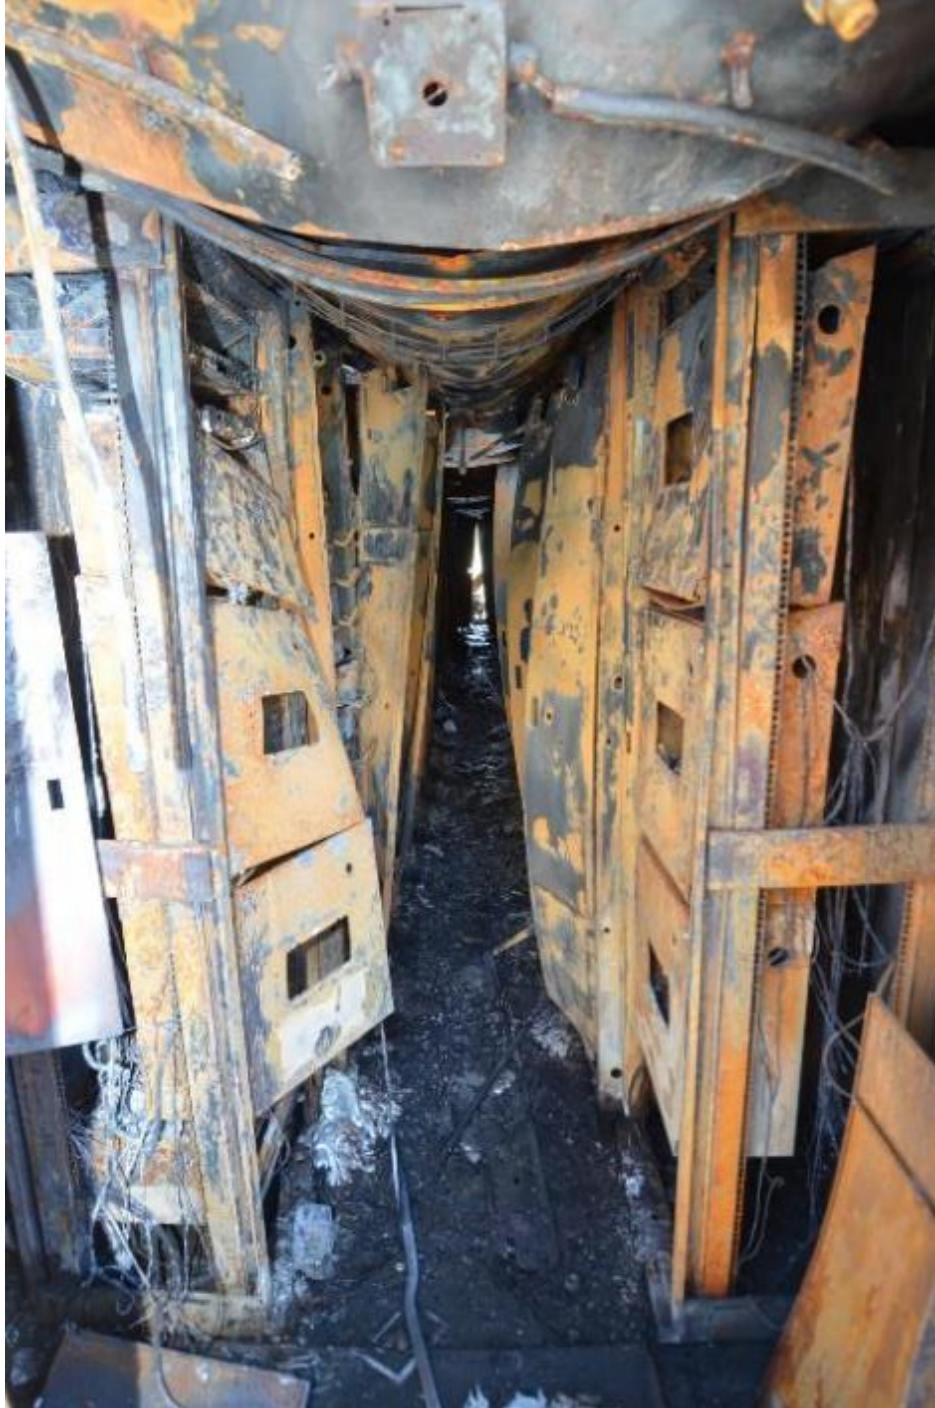
- The internal racking and contents had been extensively damaged and there was significant evidence that the internal container suffered weakening from the heat and the blast (see photo 6 section 13).

Internal view of container one from the Fisheries side

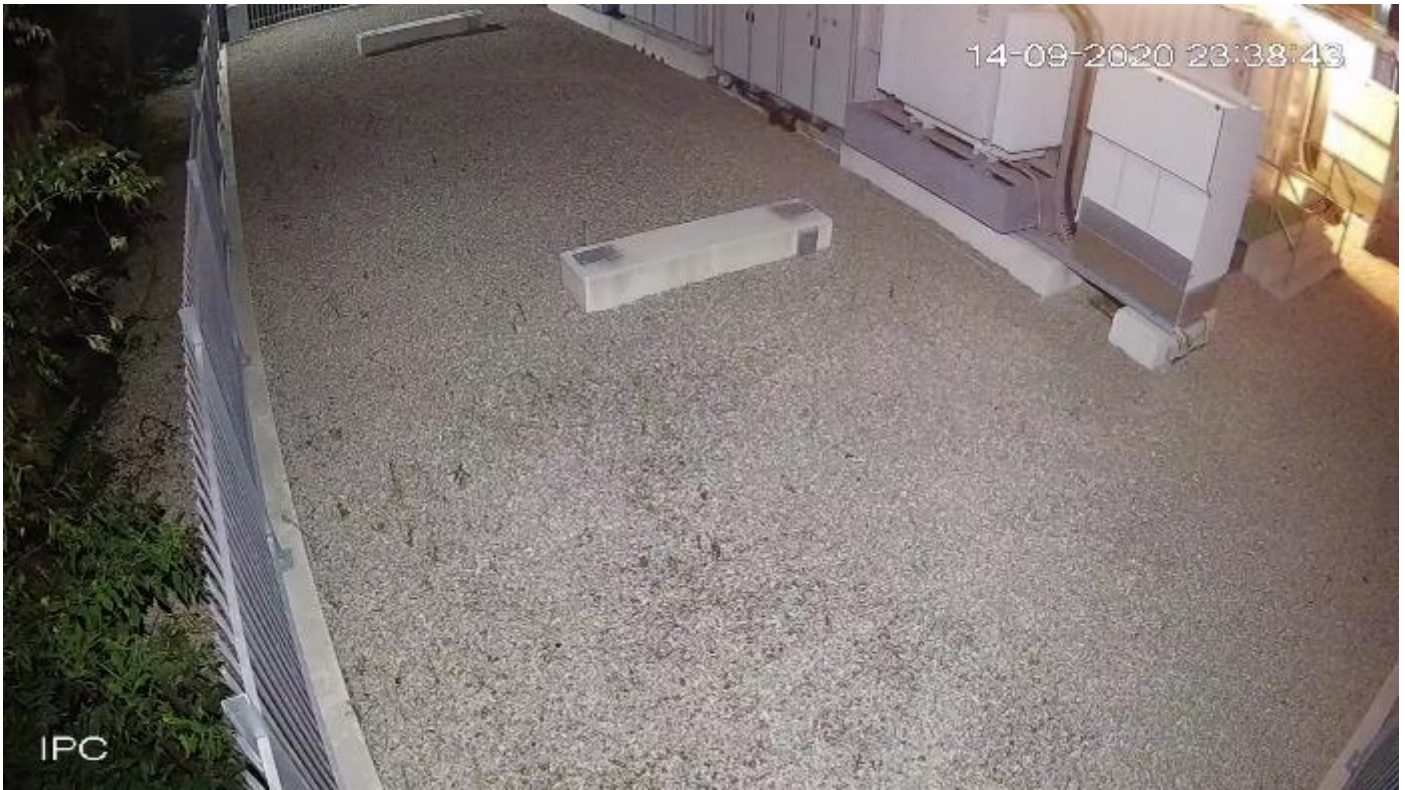
12

External CCTV at point of blast for the door fails

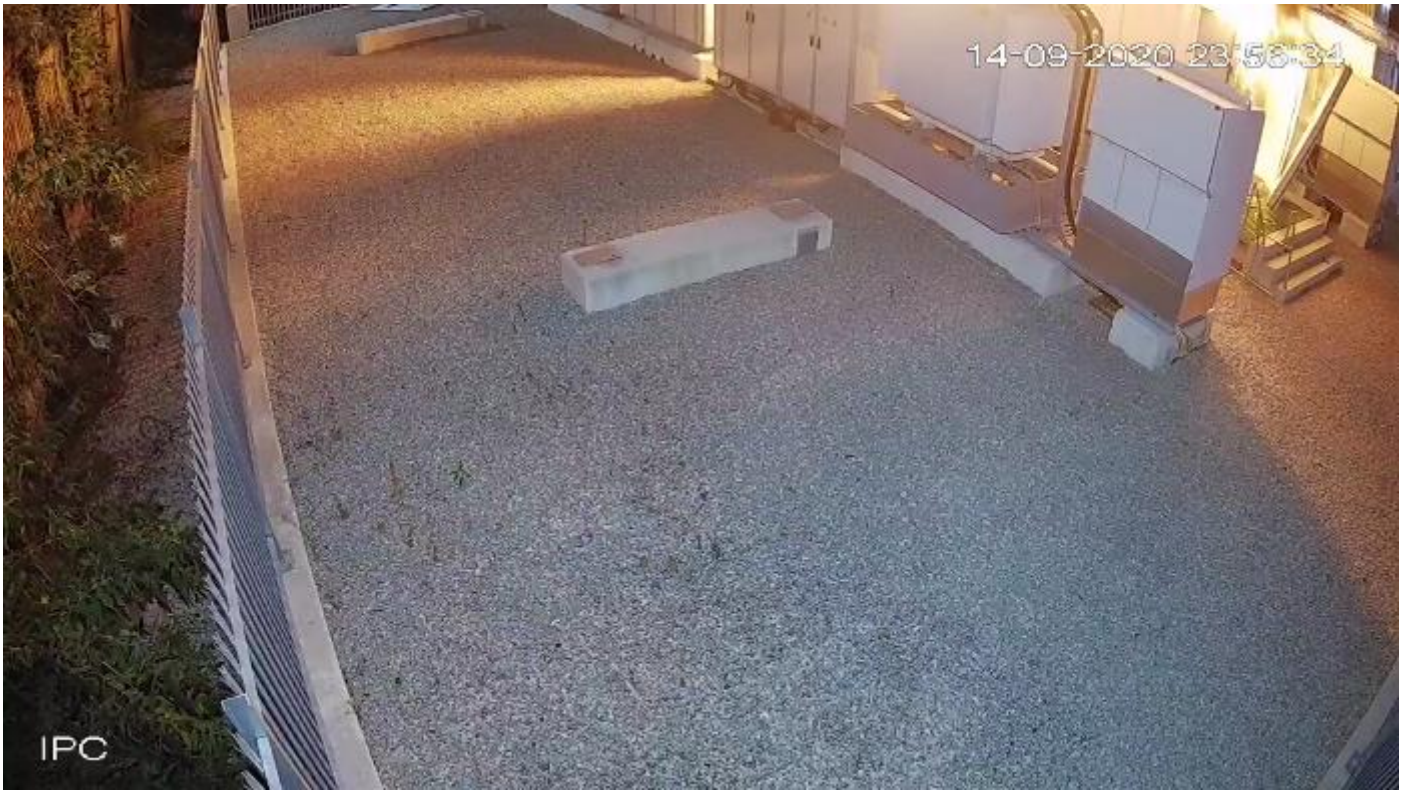
14

External CCTV showing the door being blown open and the smaller door coming detached

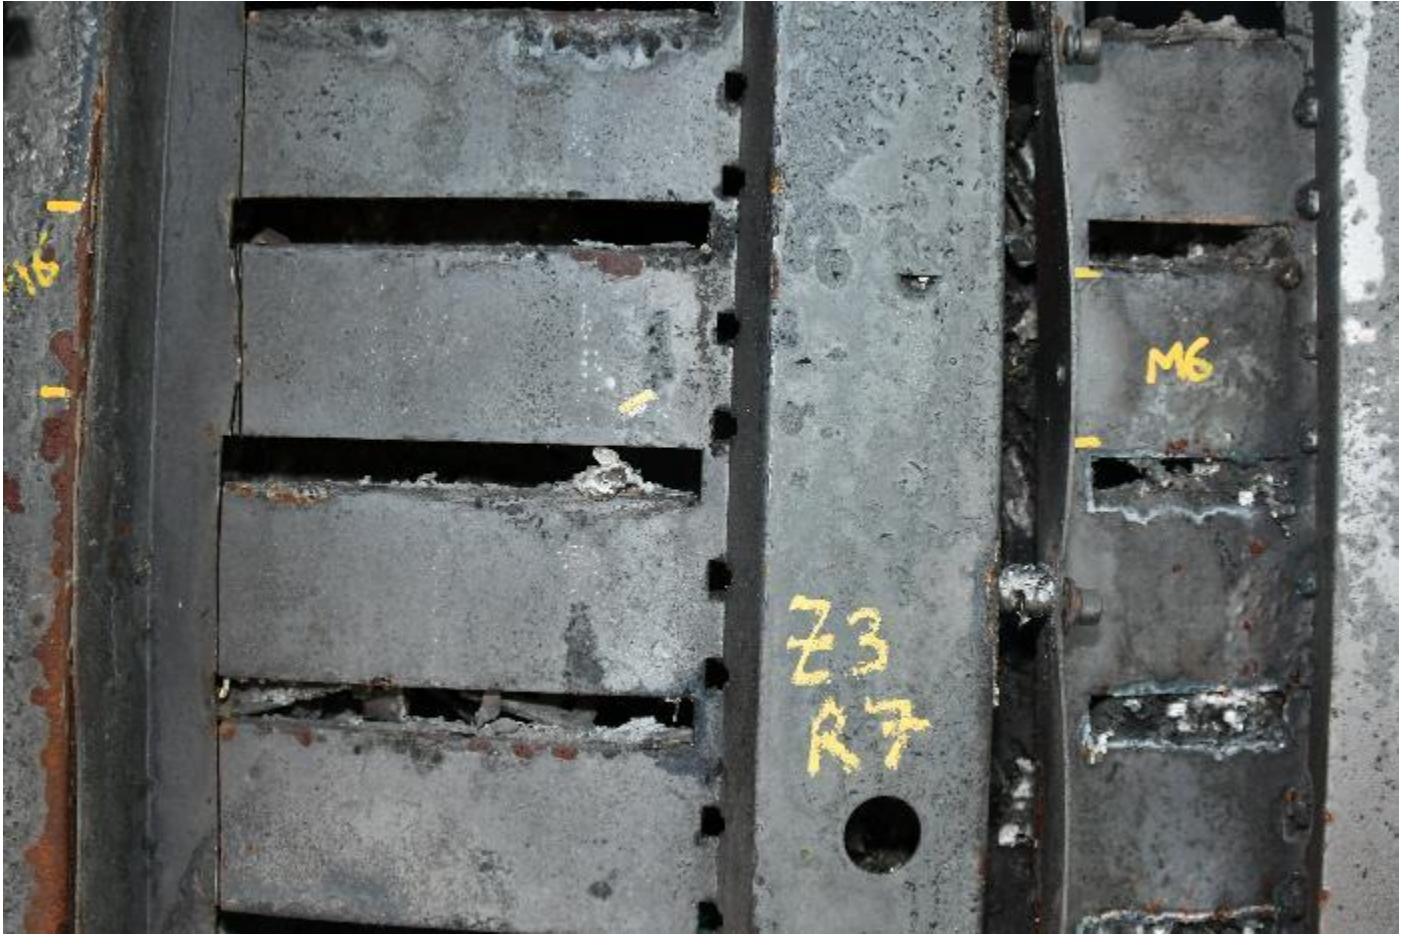
19

Image MB0\_7397 shows where module 6 would have been pre fire. The modules had melted and collapsed.

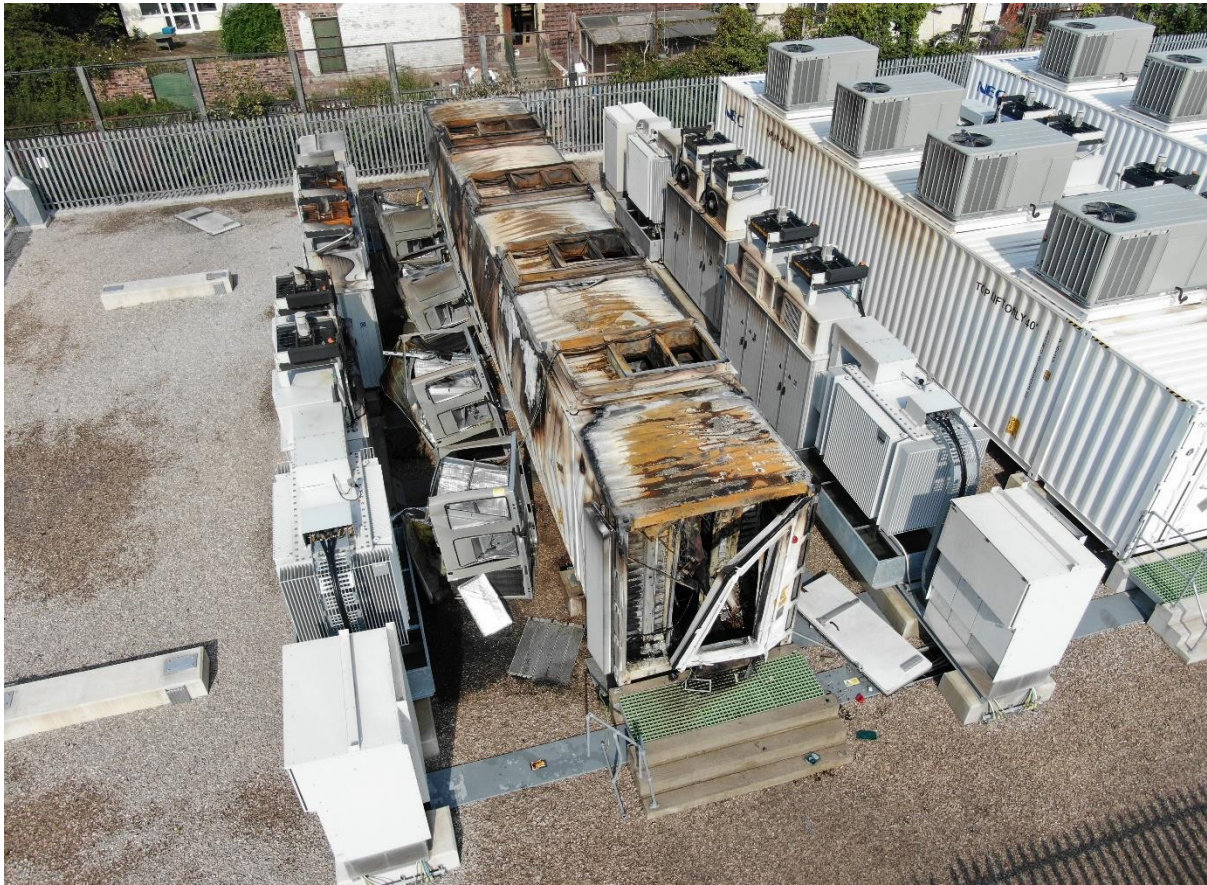
Image above: Taken from [REDACTED] AIR Unit. Full extent of damage visible. Roof mounted cooling units ejected to side of unit. Pressure damage visible along length of unit. Note scorching of top edge of second unit to mid-right of image. Firefighting tactics mitigated further spread and damaged beyond original unit and blast.

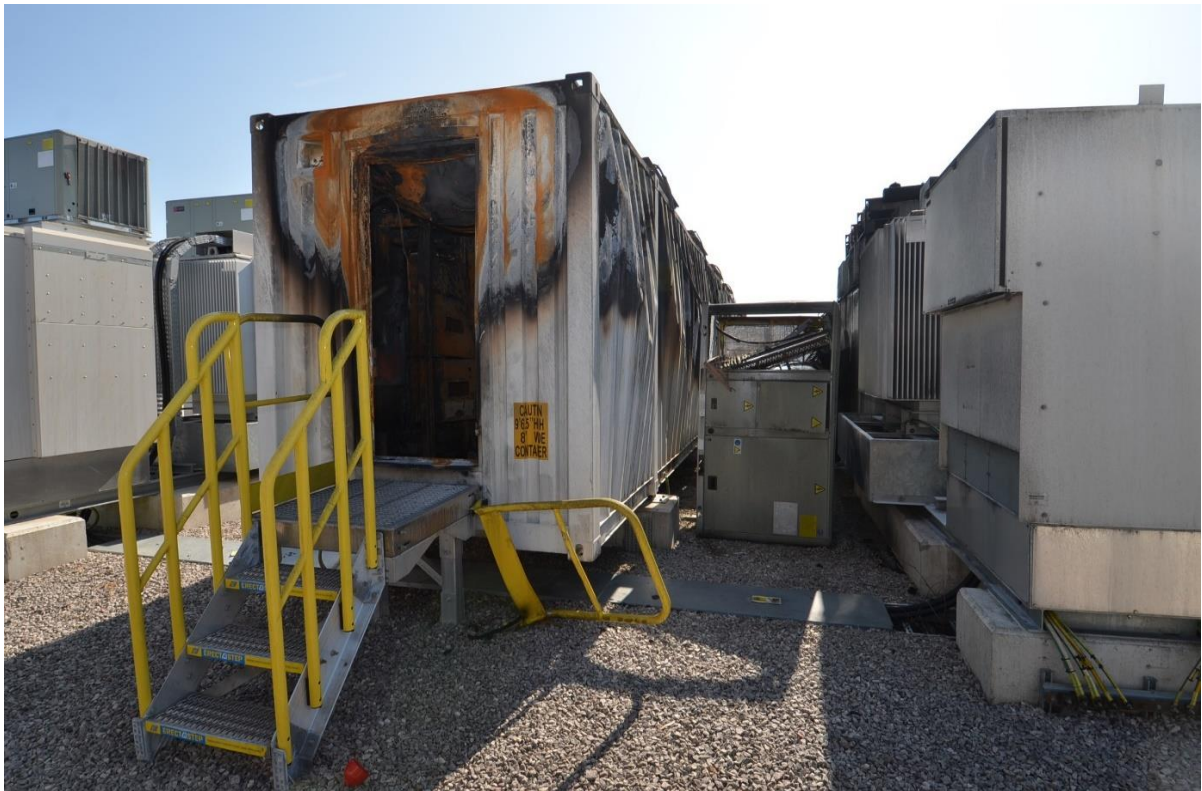
Image above: Exterior of unit with pressure damage to side.
