Sheringham Shoal and Dudgeon Offshore Wind Farm Extension Projects

Appendix 21.1 - Annex 21.1.4: Heritage Site Walkover Survey

August 2022

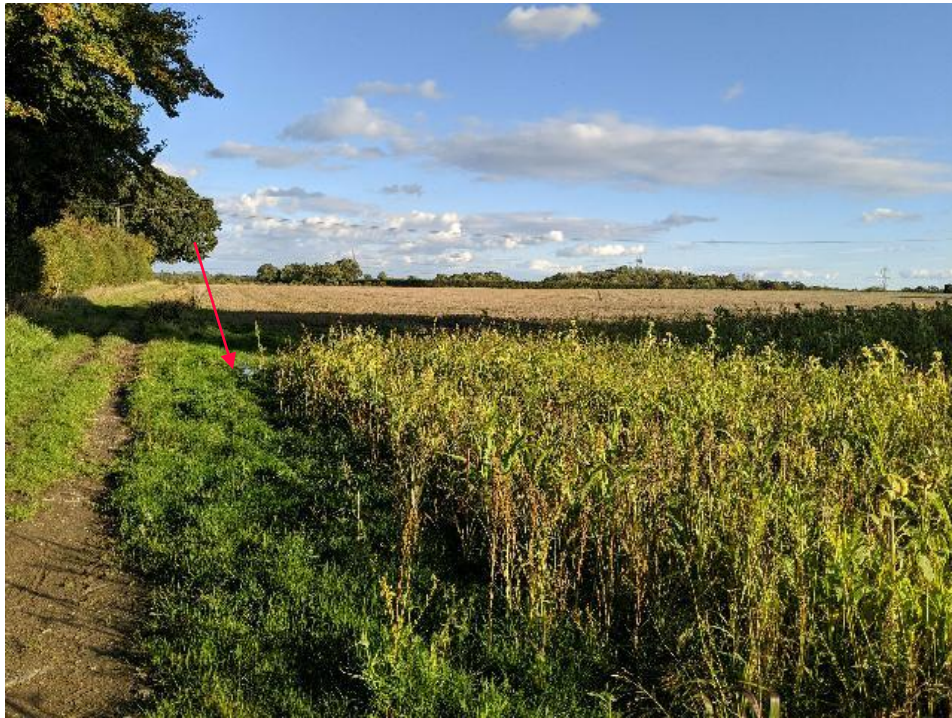
13. This area was separated into different sections of land: the northernmost field had recently been harvested; the central section was pasture (although appeared overgrown); the southern field was a mixture of recently harvested land, with sections of sunflower crop present (along the western edge); the eastern field had been harvested some time ago, and the southernmost area had also been recently harvested. The topography was generally flat with some undulations, which may be indicative of the presence of some past activity (see **Plate 21.1.4-1, Plate 21.1.4-2** and **Plate 21.1.4-3** below), although this could have also been indicative of modern farming practices, such as tractor marks or drainage. Whilst there were no obvious features, there was a collection of bricks observed on the public bridleway within the south of the area (see **Plate 21.1.4-4** below), which may be indicative of the presence of some past building in the vicinity, however they do not appear to be medieval in origin due to the smooth finish and uniform size.

Plate 21.1.4-1 View of centre of area at southern agricultural land recently harvested and containing crop, looking east. Slight undulation is indicated above.

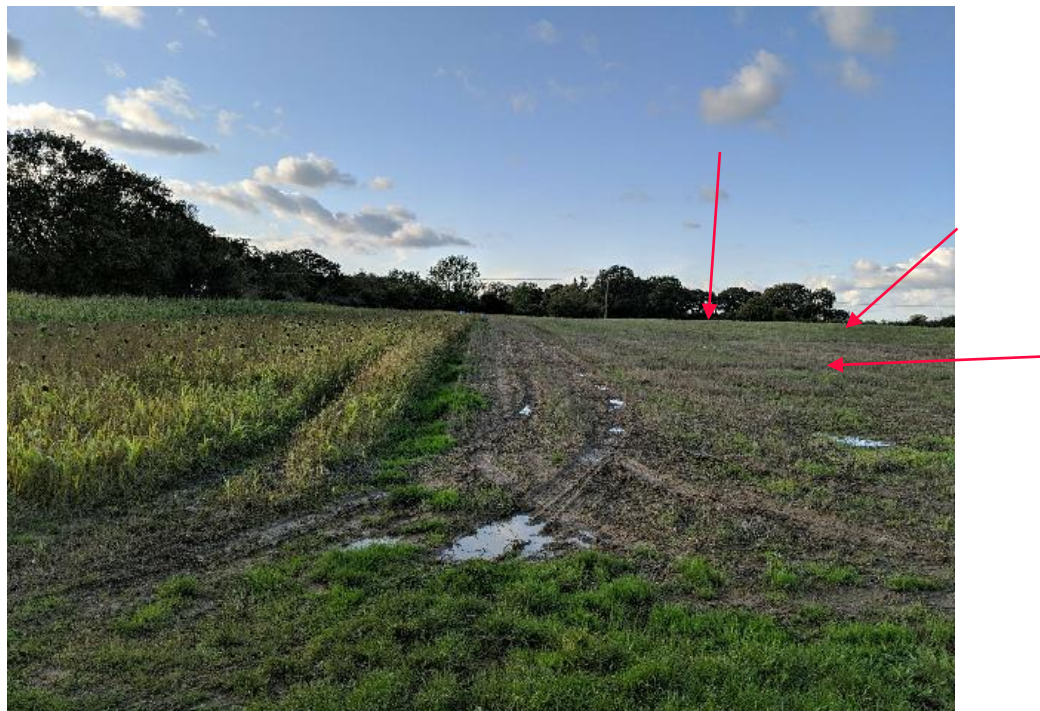
Plate 21.1.4-2 View of agricultural field within centre of area, looking north-west towards Gowthorpe Manor. Slight undulations is indicated above.

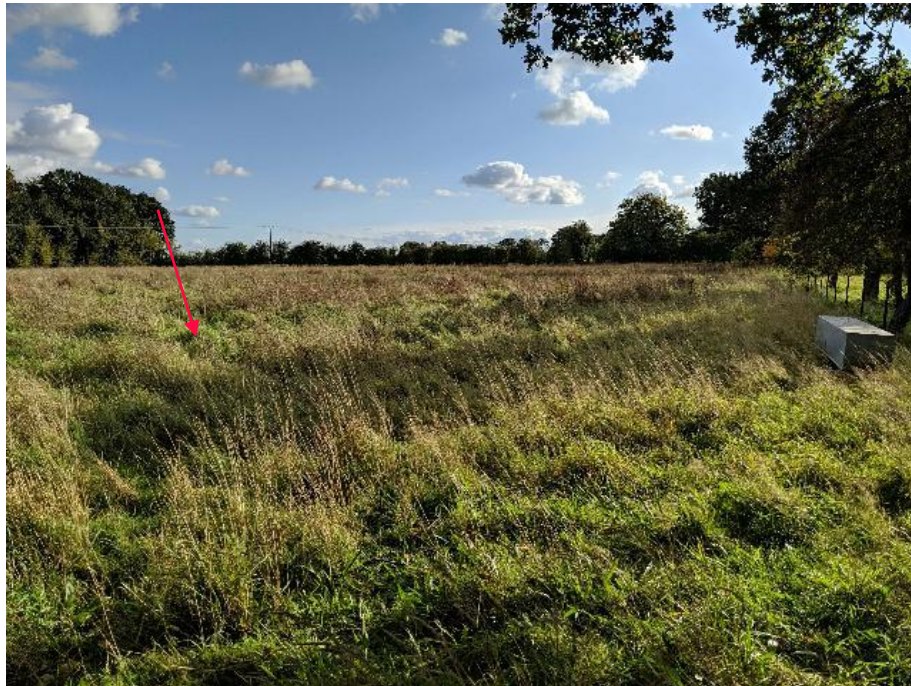
Plate 21.1.4-3 View of pasture field towards centre of area, looking eastwards. Slight undulation is indicated above.

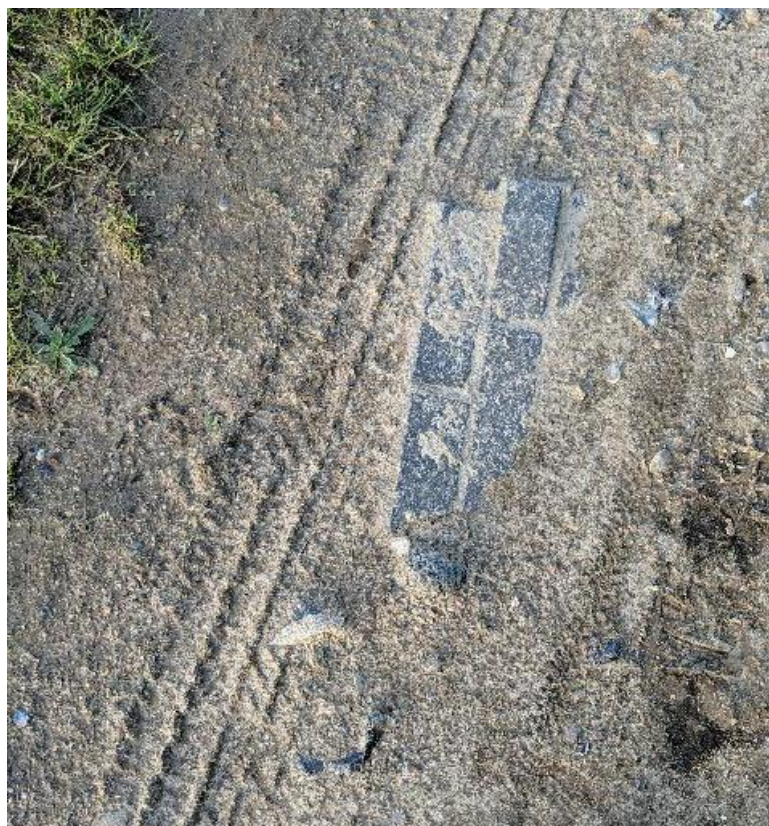
Plate 21.1.4-4 View of bricks within public bridleway within southern end of area.

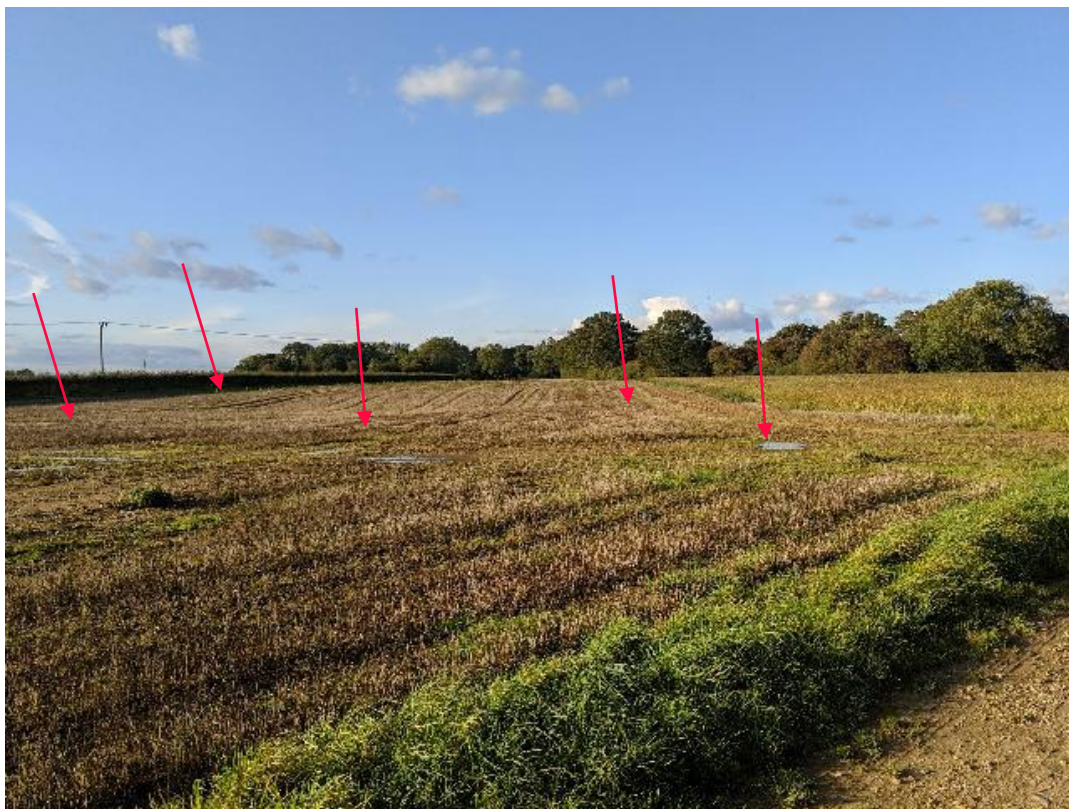
Plate 21.1.4-5 View of agricultural field in the west of the area, with wet patches and depressions, looking north-west. Depressions are indicated above.

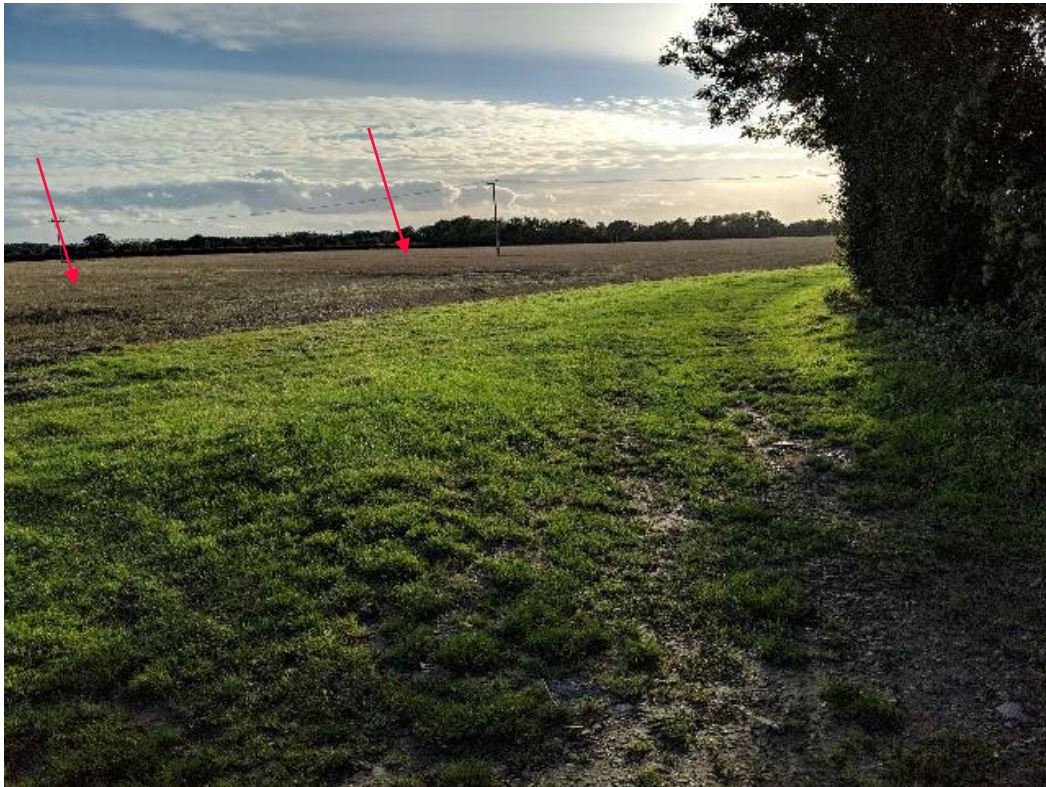
Plate 21.1.4-6 View of north-western area, looking west from centre of area. Depressions are indicated above.

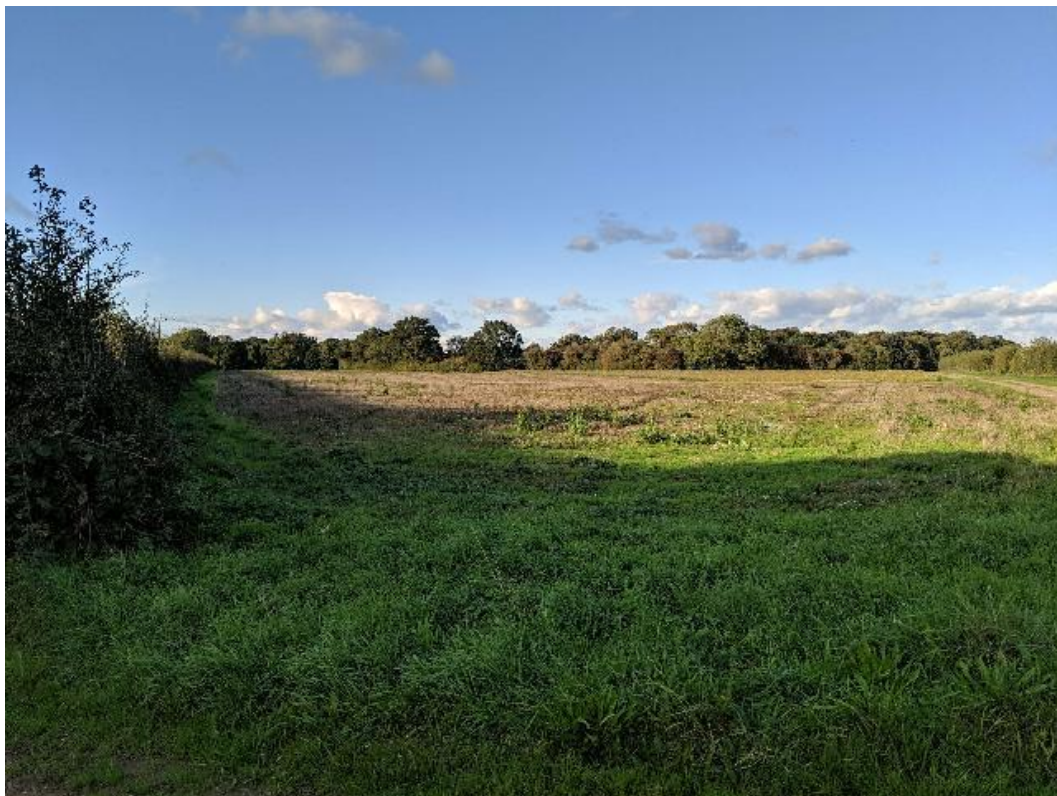
16. To the south, the rest of the area was split into two recently harvested agricultural fields that had been recently harvested, intersected by a single-track road, with the topography generally flat except for tractor marks. Scattered across the western agricultural field were wet patches indicative of depressions within the field were observed which may relate to previous extraction pits or small quarries (see **Plate 21.1.4-5** and **Plate 21.1.4-6** below). The eastern agricultural field was generally flat (see **Plate 21.1.4-7** below).

Plate 21.1.4-7 View of eastern side of area, from southern edge, looking north.

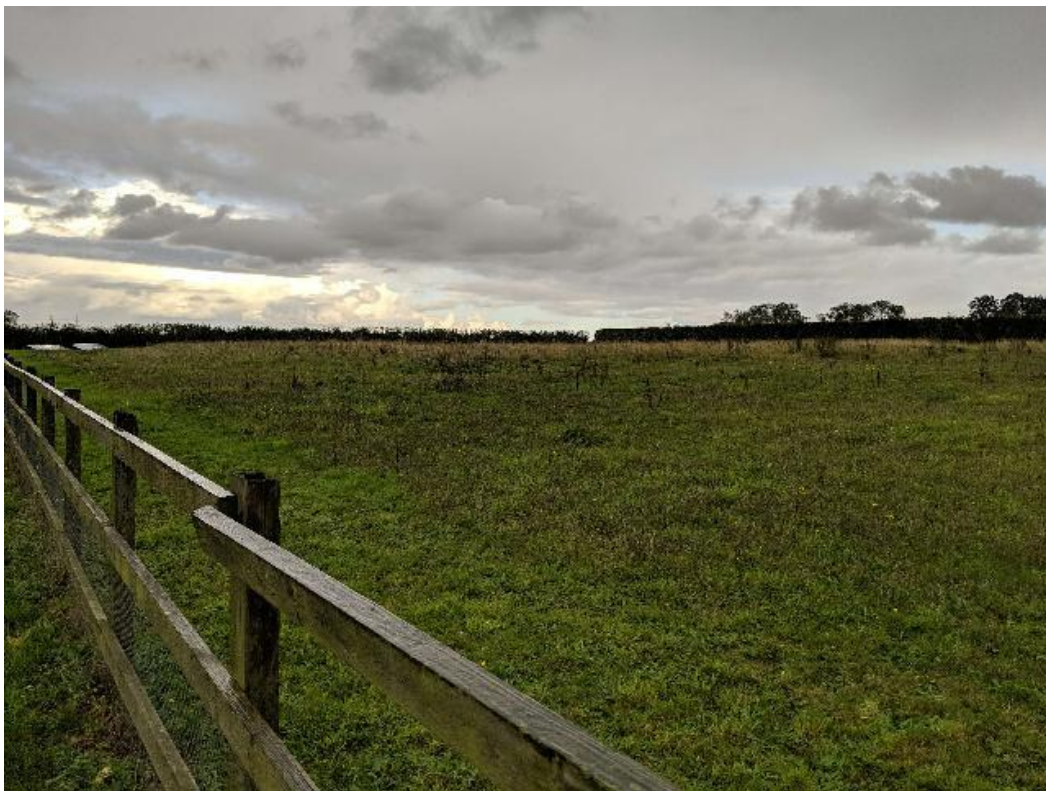
Plate 21.1.4-8 View of pasture field nearest to Mulberry House from north-western corner, looking south-east, with solar panels to the west.

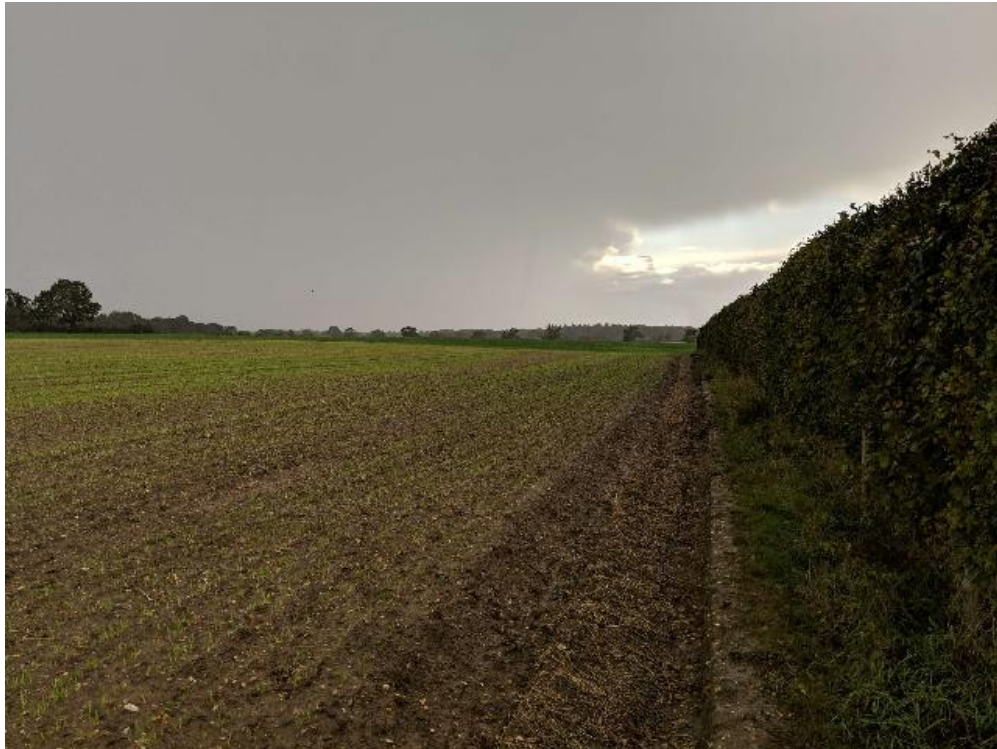
Plate 21.1.4-9 View of agricultural field from northern edge, looking west along drainage ditch.

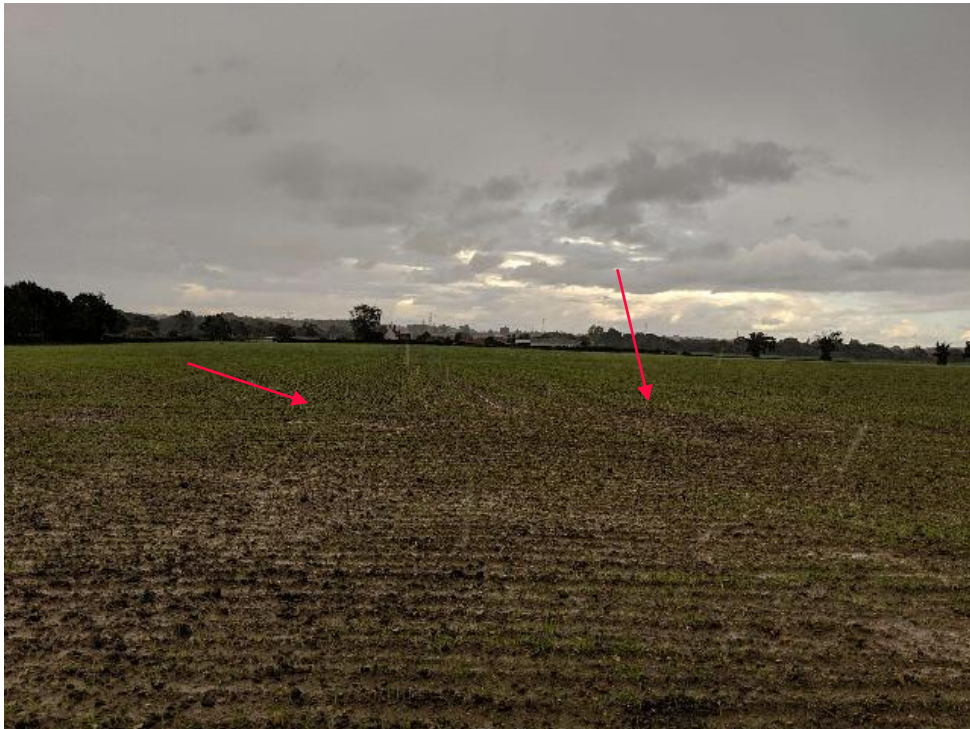
19. Behind this area to the south, accessible from the south-eastern corner of the field to the south of Mulberry House, was the surrounding agricultural field which contained a crop in seed. There was a drainage ditch going around the edge of the field, with the overall topography slightly sloping southwards (see **Plate 21.1.4-9** below), however it was generally flat. To the east of the agricultural field, towards Intwood Lane, near the centre, some undulations were noted that could have been indicative of very shallow, eroded banks or ditches, however these could also be deep tractor marks where the machine had turned due to the curvature of the undulations (see **Plate 21.1.4-10** below).

Plate 21.1.4-10 View from near centre of agricultural field, looking east towards Intwood Lane, with possible shallow ditches/eroded banks or tractor marks towards centre.

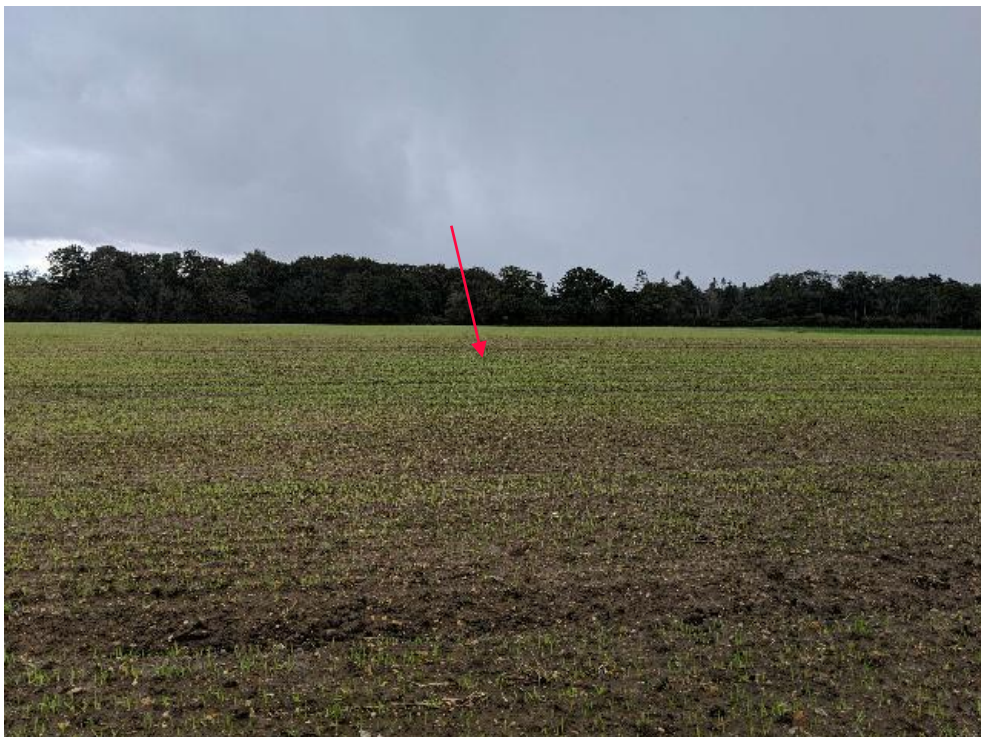
20. Towards the centre of the agricultural field, to the south of Mulberry House and the pasture, a wide shallow undulation towards the centre of the field was observed, however again this could be a feature of modern agricultural practices (see [Plate 21.1.4-11](#) below).

Plate 21.1.4-11 View of agricultural field from northern edge, looking south towards wide shallow undulation in centre.

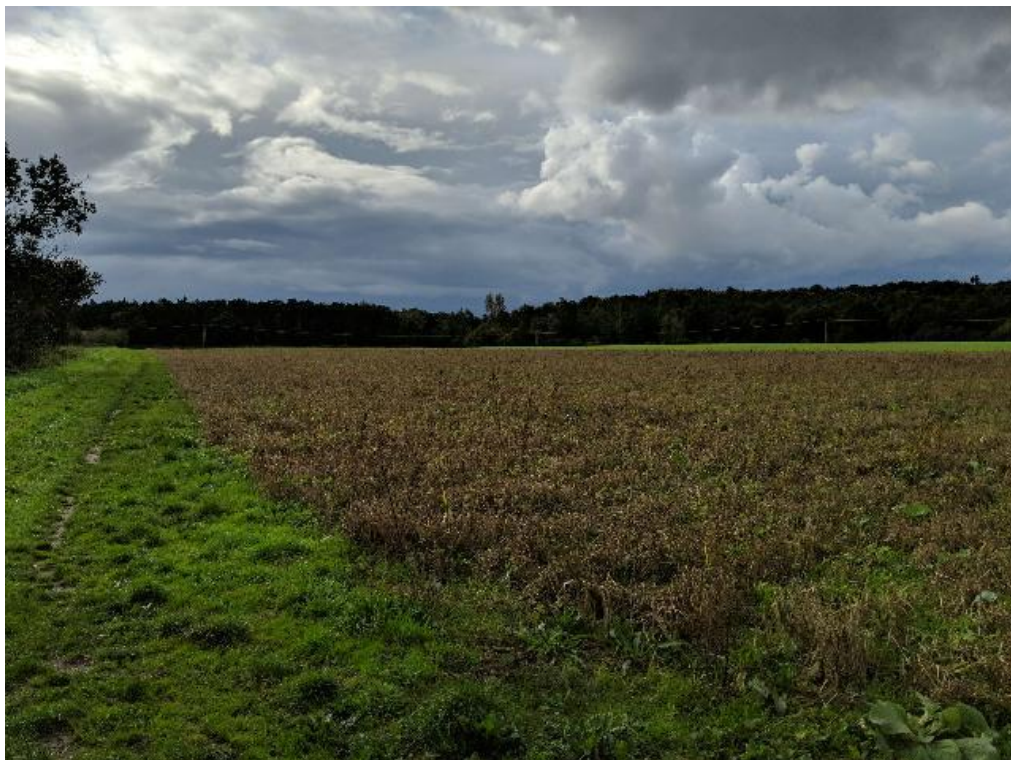
22. The area is currently in arable use with a young crop and contains a shallow drainage ditch bordering the edge. In the north-easternmost corner of the field was an area of scrubland (see **Plate 21.2.4-12** below).

Plate 21.2.4-12 View from eastern corner looking west, looking at area of scrubland in north-eastern area.

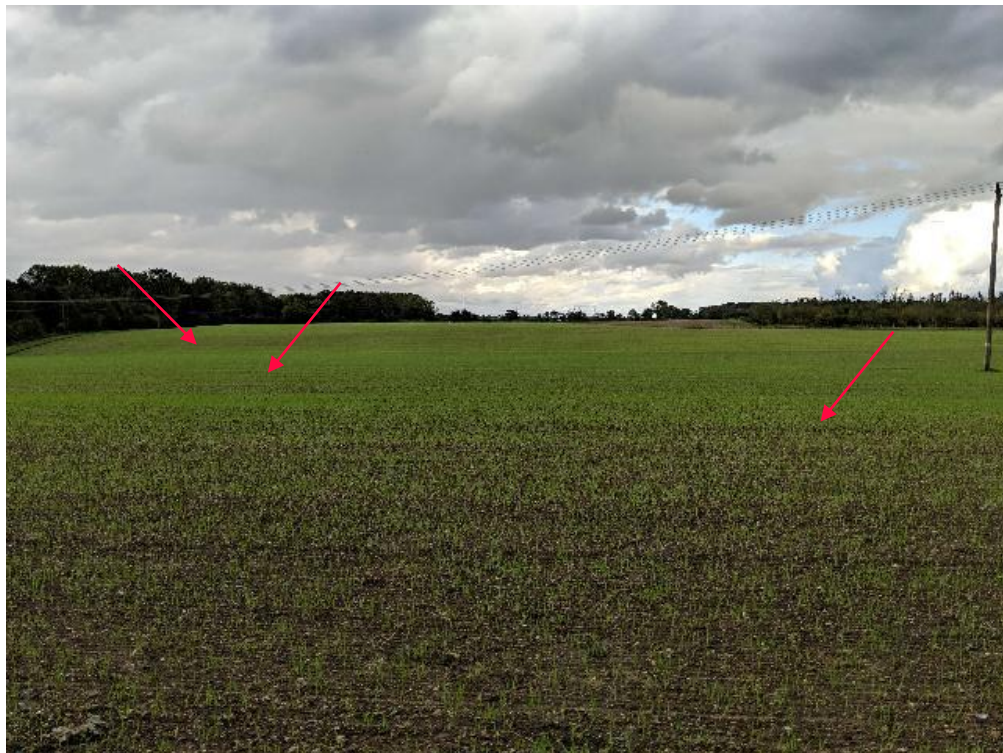
Plate 21.1.4-13 View from western edge of area, looking east towards scrubland in north-eastern area, with some areas of undulations and depressions visible.

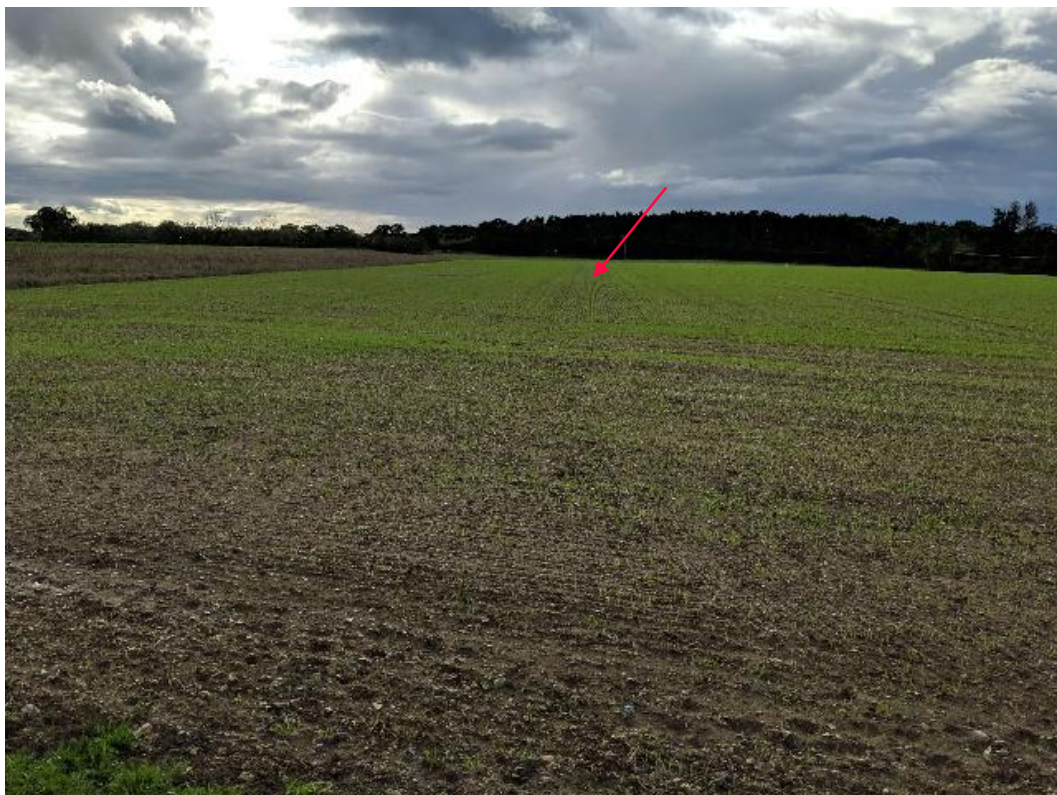
23. Generally, the topography was flat with a slight rise eastwards within the north-eastern area. Across the entire area, wet patches within the land were observed, indicative of depressions which may relate to previous extraction pits (see **Plate 21.1.4-13** below). The northern area had some undulations indicative of possible banks; however, this may have been a result of modern agricultural practices (see **Plate 21.1.4-14** below).

Plate 21.1.4-14 View from northernmost edge of area, looking south towards undulations in field, with area of scrubland towards the left.

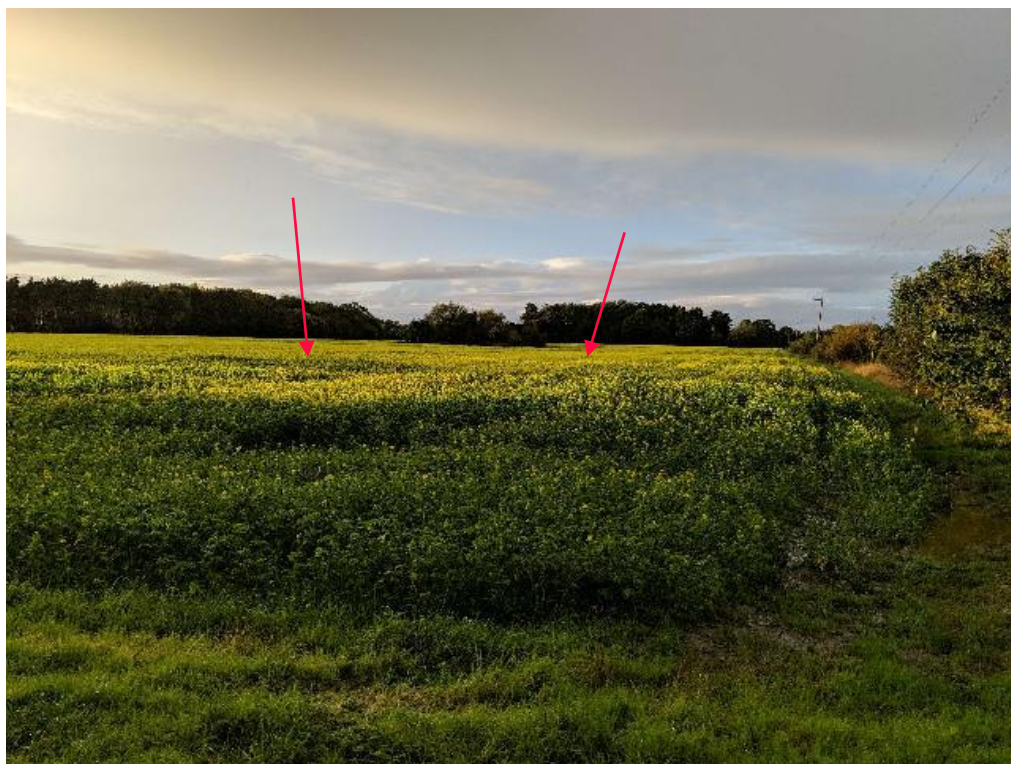
24. This area has been identified as containing an earthwork indicative of a possible post-medieval park boundary on the NHER and from aerial photographs (**SEPDEP ID 1093**) (**Annex 21.1.3, Figure 21.1.2, Map 27**). The feature lies within an arable field used which also contains records of multi-period finds from the Roman period to the 19th century (**SEPDEP ID 766**).
25. At the time of the survey, the field contained a crop of oil seed rape and was not fully accessible. However, the varying heights of the crop provided indications of some undulations in the vicinity of the where the earthwork is recorded from aerial photographs (see **Plate 21.1.4-15** and **Plate 21.1.4-16** below).

Plate 21.1.4-15 View from south-eastern corner of field, looking north towards undulations towards the centre of the field.

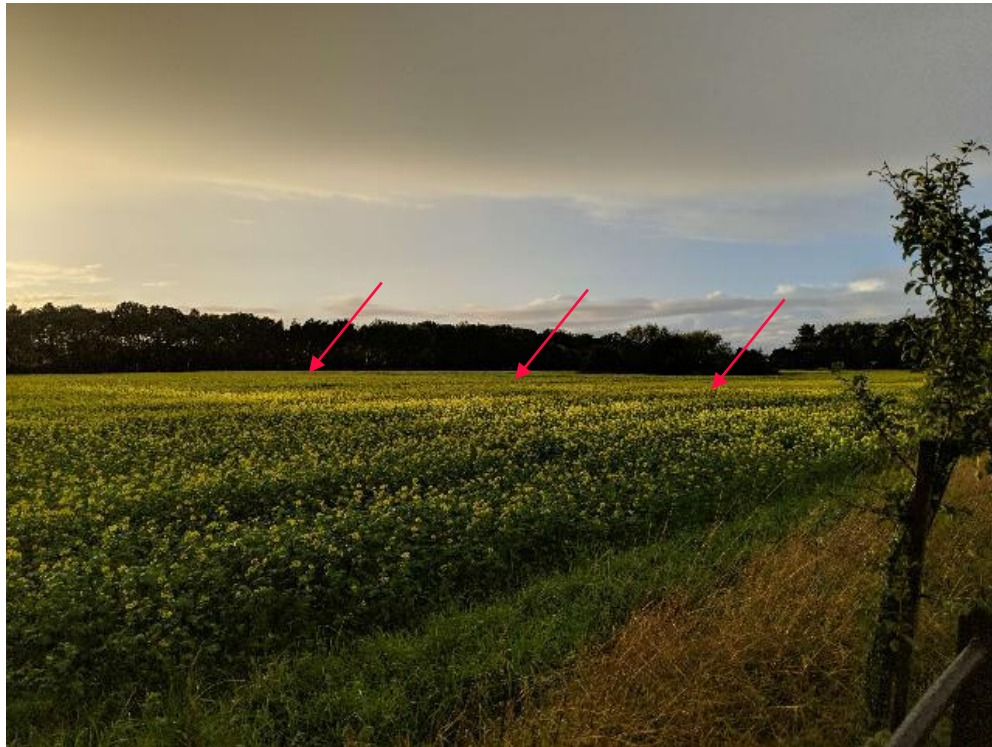
Plate 21.1.4-16 View from south-eastern edge of field, looking north-east towards undulations near the centre of the field.

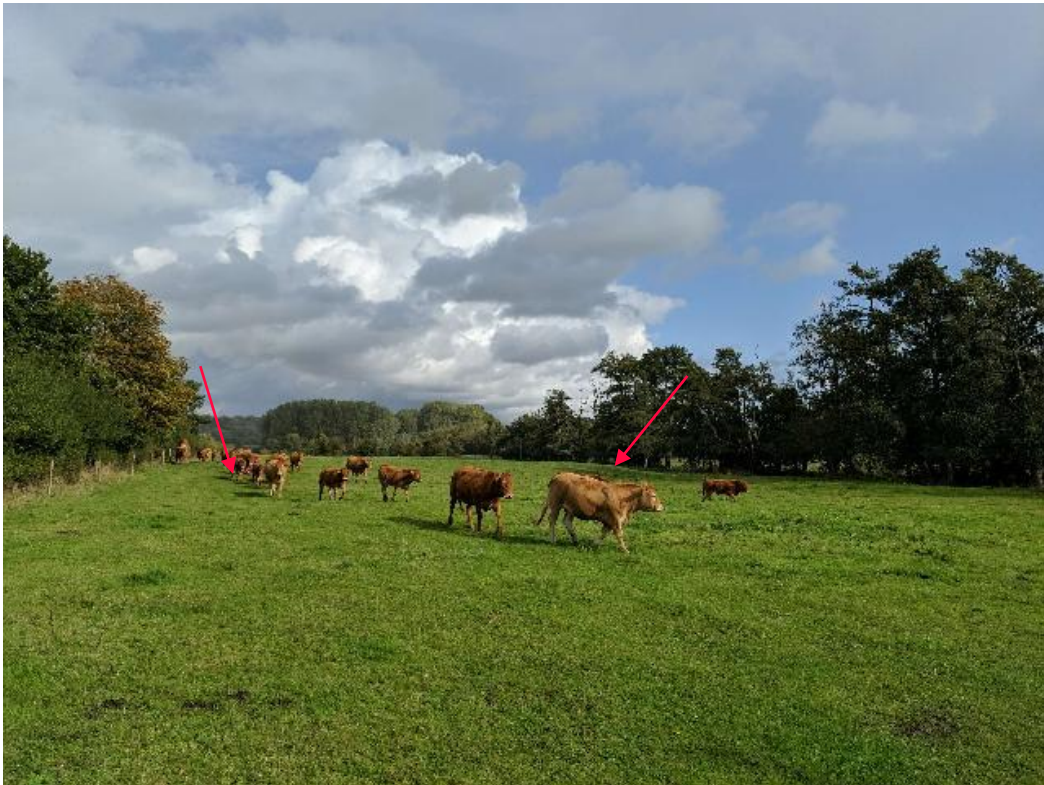
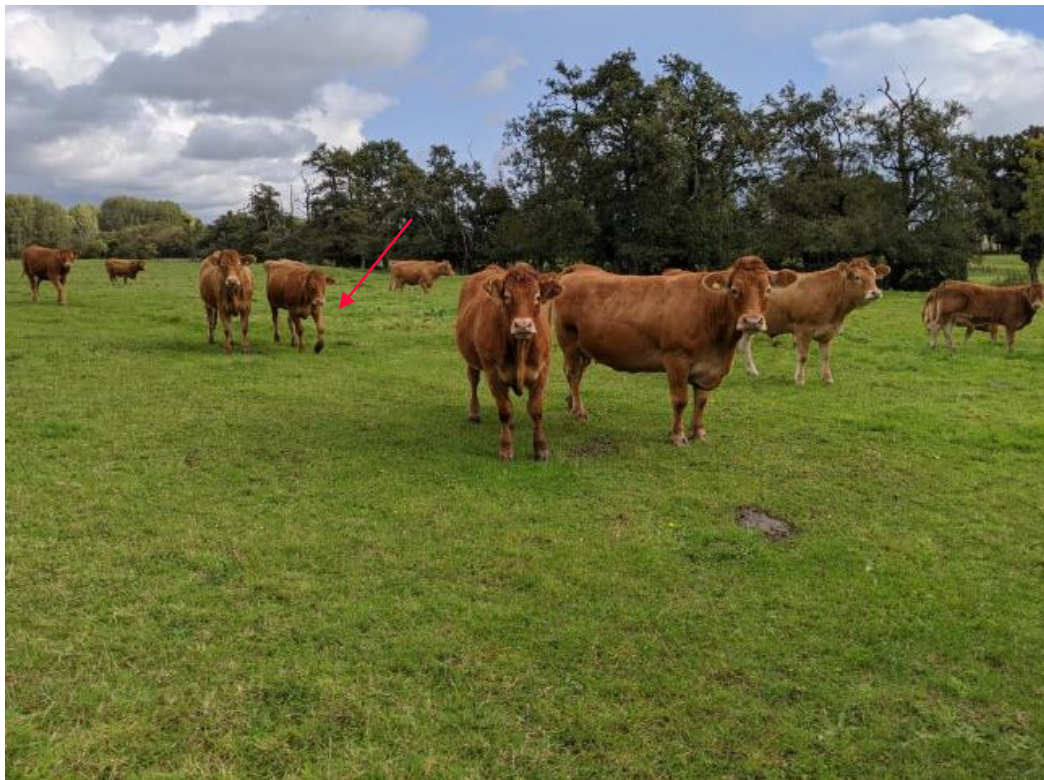
26. This area is identified by APS as containing extant platforms and ditched enclosures relating to former medieval tofts (**APS_053**), with the NHER recording a possible medieval toft within the same field (**SEPDEP ID 877**) (**Annex 21.1.3, Figure 21.1.2, Map 22**).
27. At the time of the survey, the land was not accessible due to livestock being present within the field. From the edge of the field, it was observed that whilst the general topography was flat, some undulations were visible, which may be indicative of the possible medieval toft (see **Plate 21.1.4-17** and **Plate 21.1.4-18** below).

Plate 21.1.4-17 View from western edge of area, looking east into field.

Plate 21.1.4-18 View from western edge of area, looking east into field.

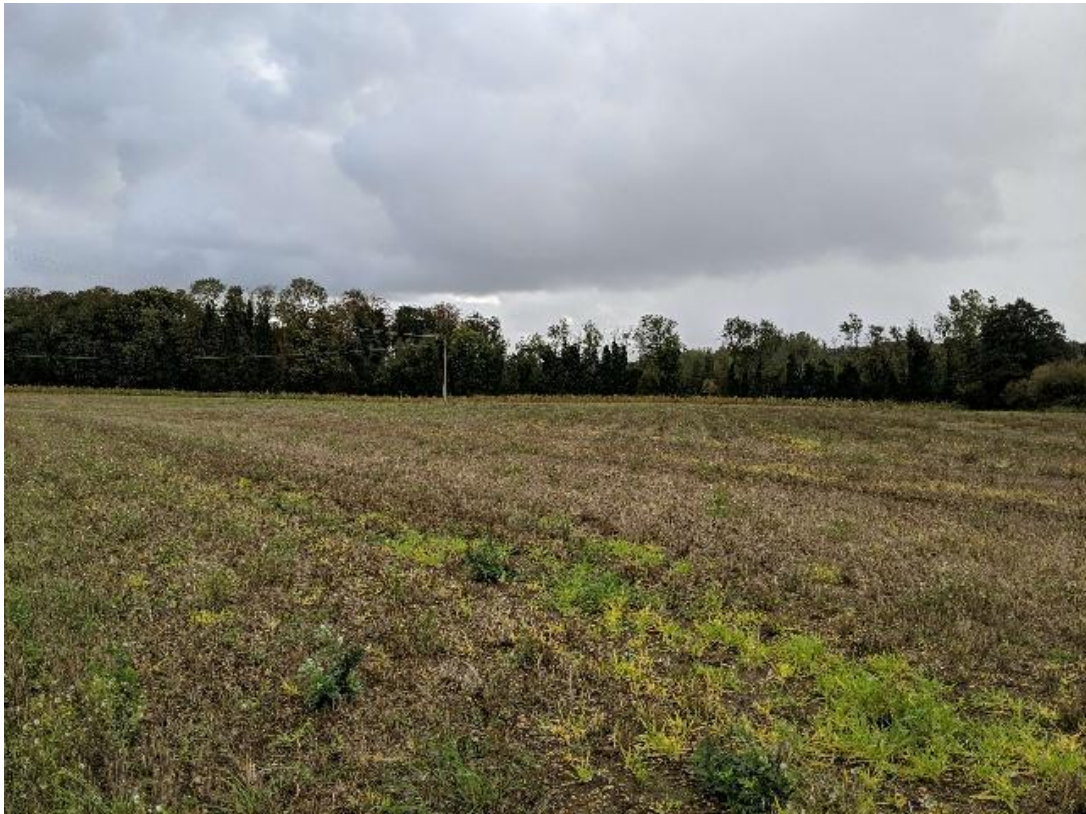
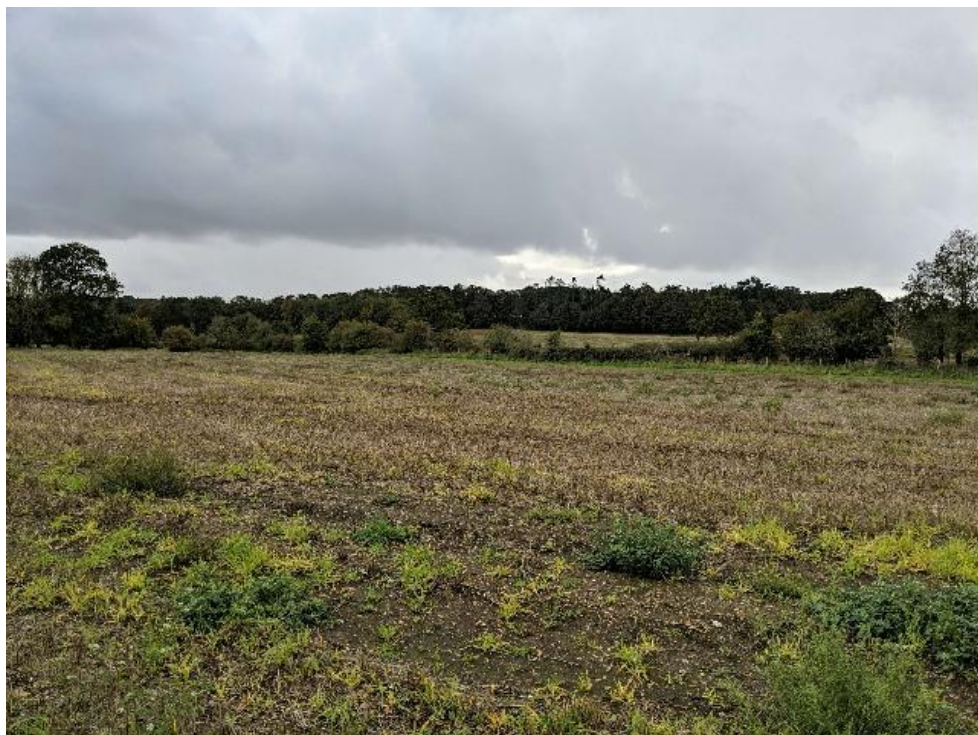
29. The area was split into several fields with a strip of woodland within the east of the area surrounding Morton Lodge to the north-east. The northern most field had been harvested although not recently, with some sunflower crop along the southern edge remaining. The topography was generally flat with wide, shallow undulations, although no historic earthworks relating to previous field boundaries and drains were apparent (see **Plate 21.1.4-19** and **Plate 21.1.4-20** below).

Plate 21.1.4-19 View from northernmost field, looking south-west across landscape – no visible earthworks.

Plate 21.1.4-20 View from northernmost field, looking south-west across landscape – no visible earthworks.

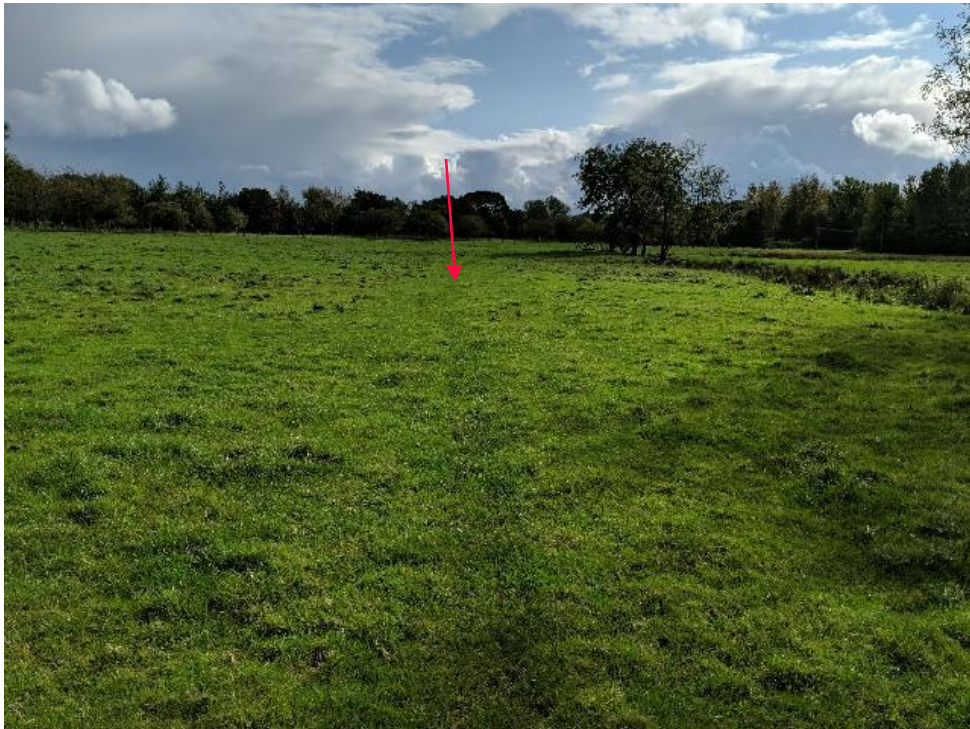
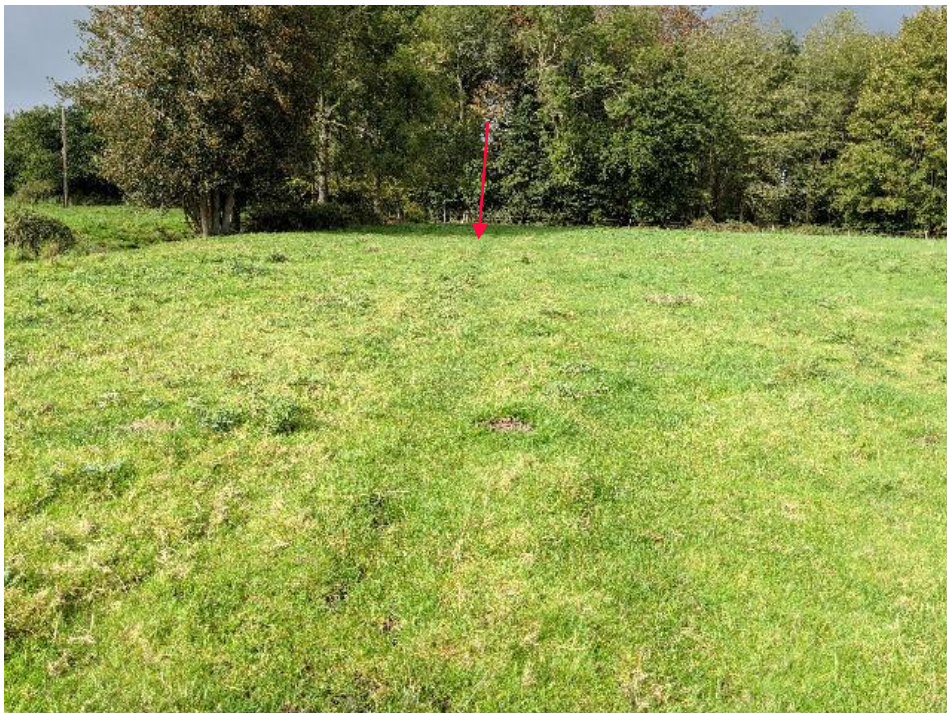
30. The southern half of the area, beyond the strip of woodland, was pasture with a few interspersed trees. Again, the topography was generally flat and intersected by large drainage ditches. There was some scarring on the land near the drainage ditches that may be indicative of medieval to post-medieval boundaries and drains (see **Plate 21.1.4-21** and **Plate 21.1.4-22** below).

Plate 21.1.4-21 View from centre of southern half of area, looking south, with possible boundary or drainage feature in centre of photograph. Existing drainage ditch in background to right of photograph.

Plate 21.1.4-22 View from centre of southern half of area, looking north, with possible boundary or drainage feature in centre of photograph. Current drainage ditch in background to left of photograph.

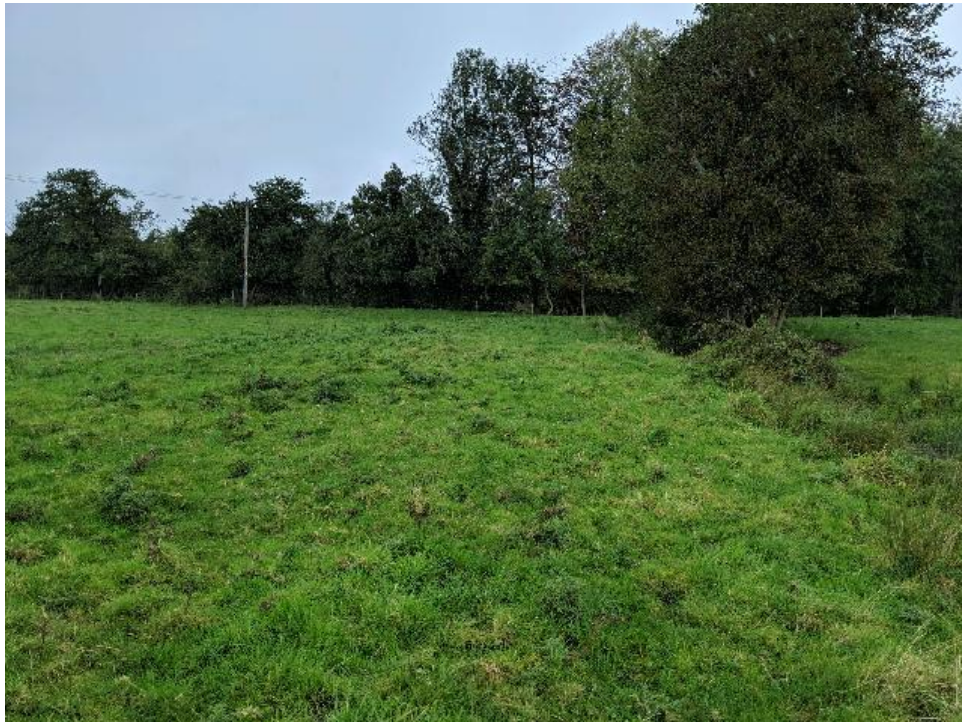
31. As for the possible medieval building platforms and possible site of St Mary's church, there was little to no evidence in the fields of earthworks relating to these heritage assets. A drainage ditch was observed as intersecting this area (see **Plate 21.1.4-23** below).

Plate 21.1.4-23 View from centre of southern area, looking towards area of medieval building platforms – no earthworks visible.

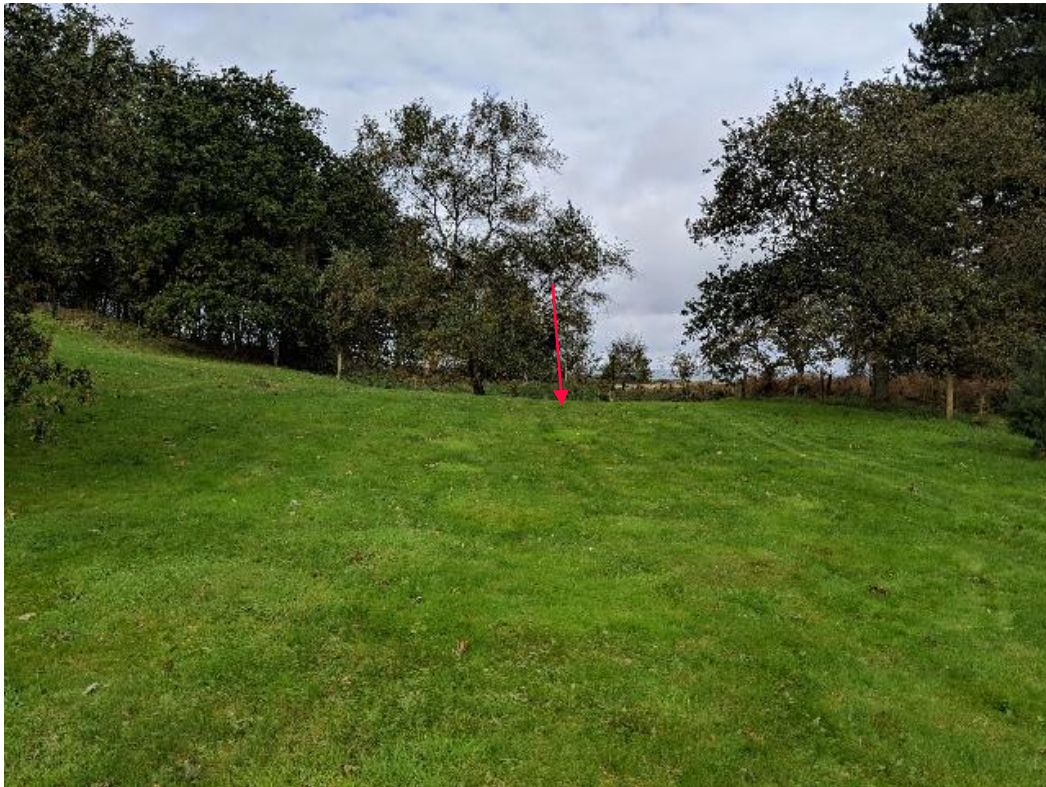
32. This area was recorded as containing possible slight earthworks of an embanked rectilinear enclosure with a sunken interior visible on aerial imagery (**APS_132**). It is recorded on the NHER as an undated hollow (**SEPDEP ID 1052**) (**Annex 21.1.3, Figure 21.1.2, Map 5**). A previous building located to the south of this asset was previously a keepers cottage (noted on the NHER as Sandy Hill Cottage: **SEPDEP ID 1213**) built in 1896, with the surrounding land (including the area of the asset) overgrown with bracken and trees, which may have damaged the asset.

Plate 21.1.4-24 View from centre of garden, looking north towards possible sunken interior of the embanked rectilinear enclosure in centre of photograph.

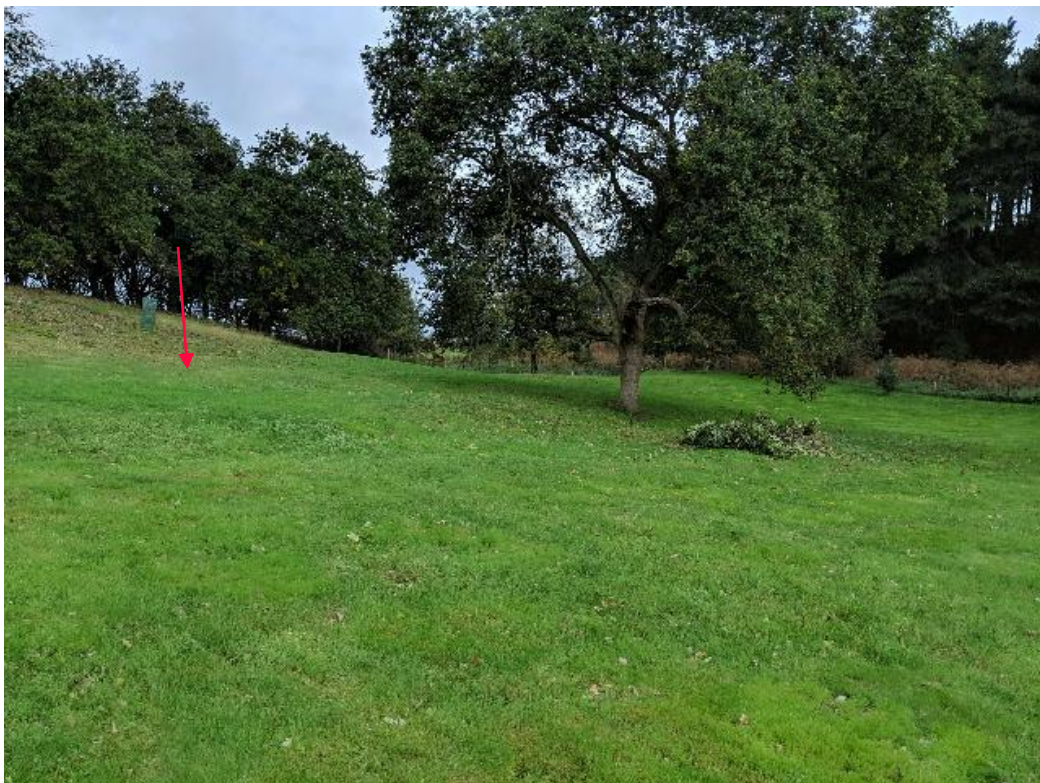
33. Whilst undulations were noted in the field, no obvious earthworks representative of an embanked rectilinear enclosure were apparent, although there was a slight depression which may relate to the sunken interior of the enclosure (see **Plate 21.1.4-24** below). However, to the immediate west of the sunken feature was a smaller possible rectilinear feature, estimated to be 3m x 2m, although it is unclear if this is in addition to the embanked rectilinear enclosure recorded on aerial imagery (see **Plate 21.1.4-25** below).

Plate 21.1.4-25 View towards smaller rectilinear feature in northern end of garden, located to the west of the tree.

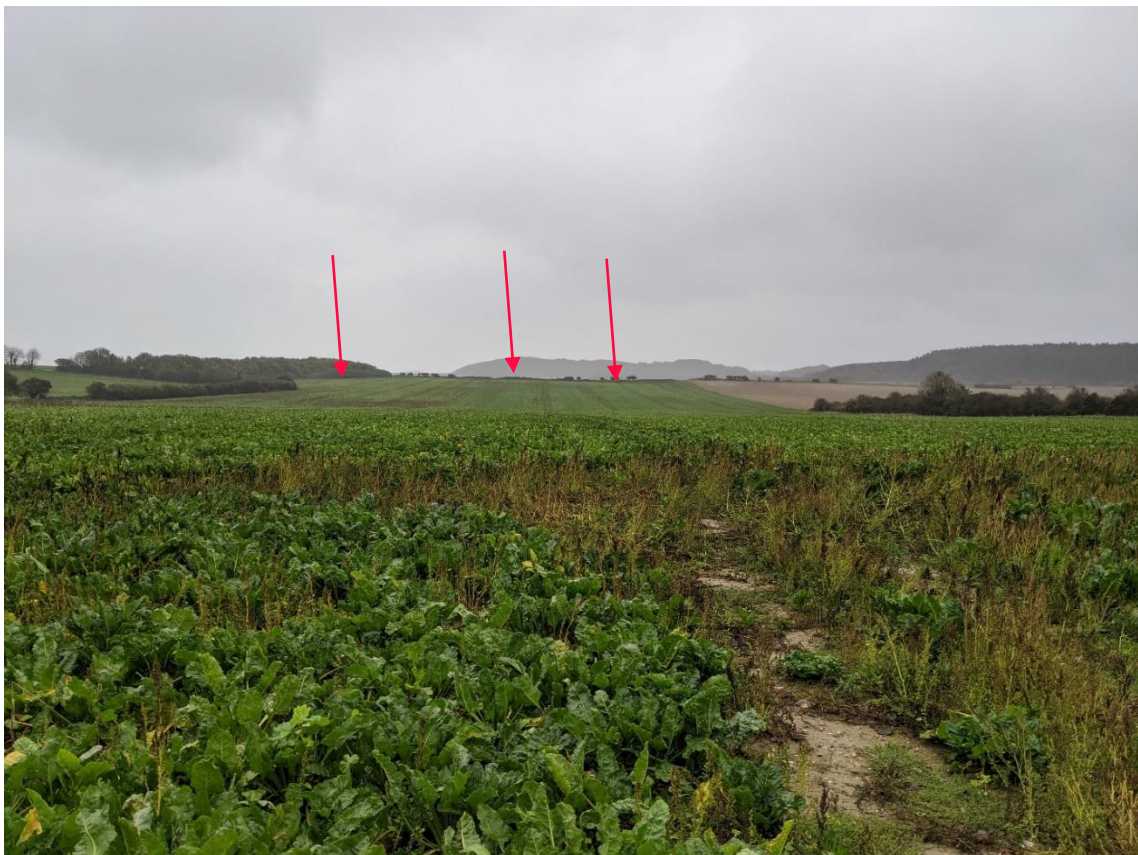
35. Access was not granted to this area at the time of the heritage walkover survey and as such could not be fully assessed, however images were taken from publicly accessible points, such as the road, from which some of the area was visible. Of that which was viewed, it was clear that the land was split into arable fields, some which contained crops and others which had recently been harvested. Some undulations were noted across the area towards the east (see **Plate 21.1.4-26**), although it is unclear whether these relate to former field boundaries.

Plate 21.1.4-26 View from western edge of area looking east, with undulations in the field in the far distance.
