Sheringham Shoal and Dudgeon Offshore Wind Farm Extension Projects

Appendix 21.1 - Annex 21.1.4: Heritage Site Walkover Survey

August 2022

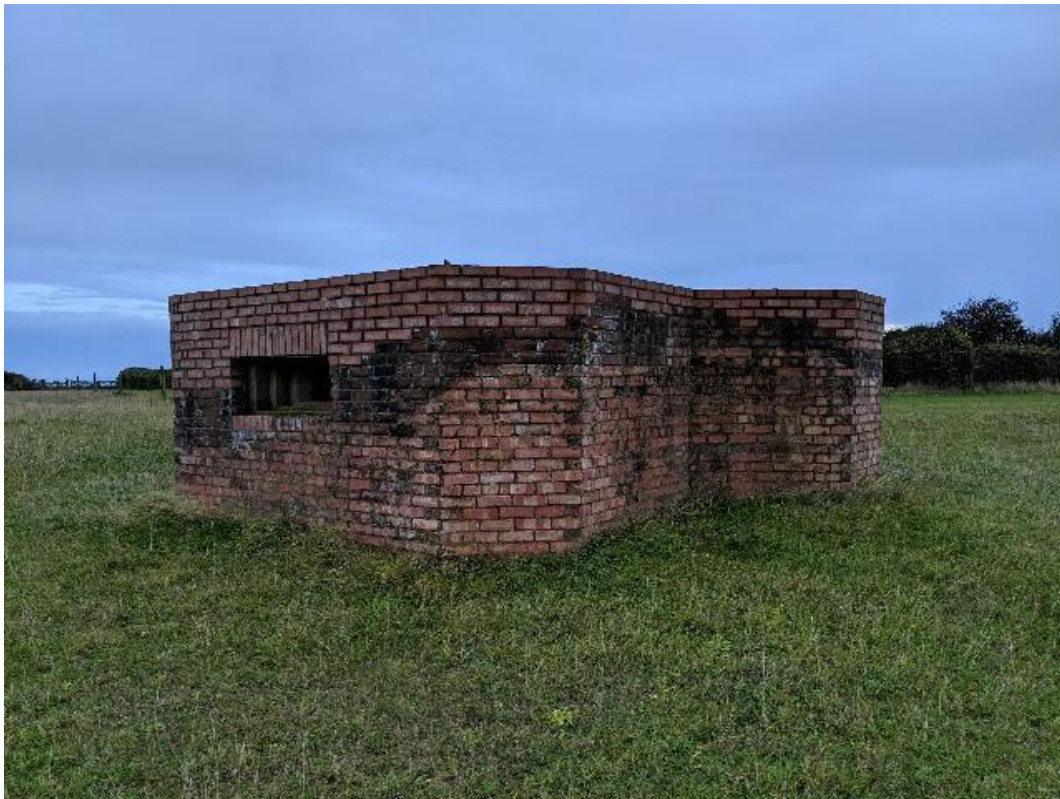
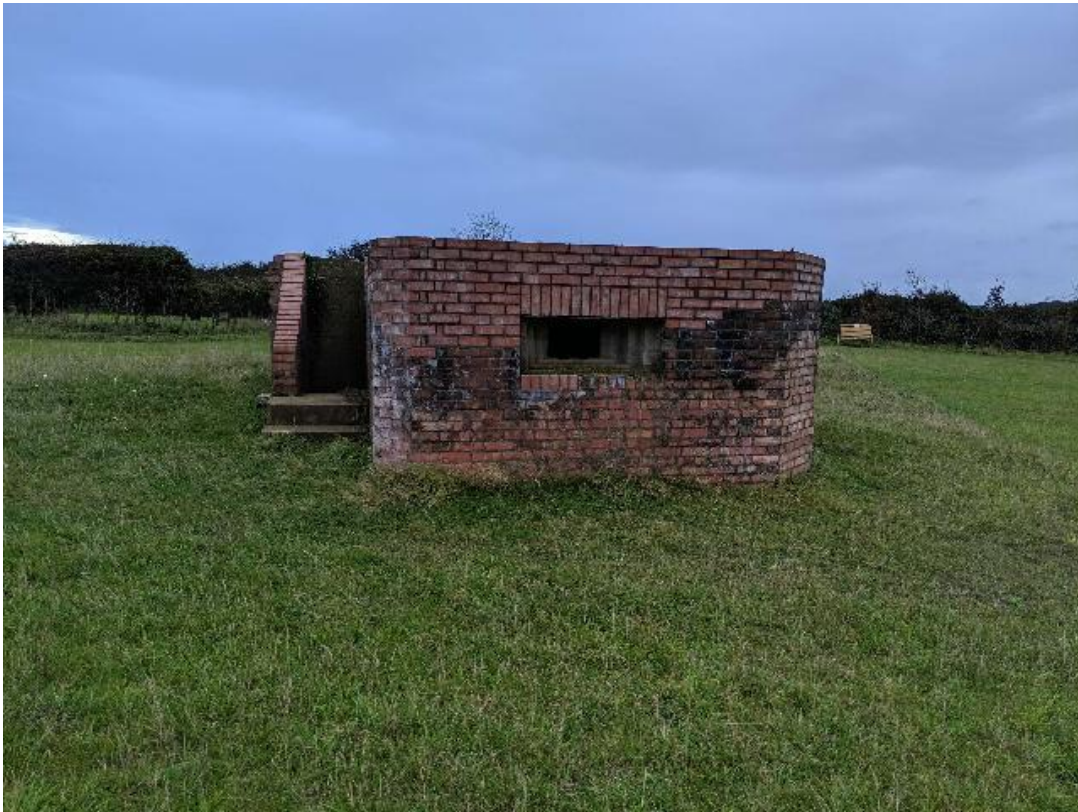
40. This is a rare type 2/20 design World War II pillbox (**SEPDEP ID 1345**) that was thought to be overgrown, however during the heritage site walkover survey it was found to be in very good condition (see **Plate 21.1.4-27** and **Plate 21.1.4-28** below) (**Annex 21.1.3, Figure 21.1.2, Map 2**).

Plate 21.1.4-27 View of southern face of pillbox, looking north.

Plate 21.1.4-28 View of south-western face of pillbox, looking east.

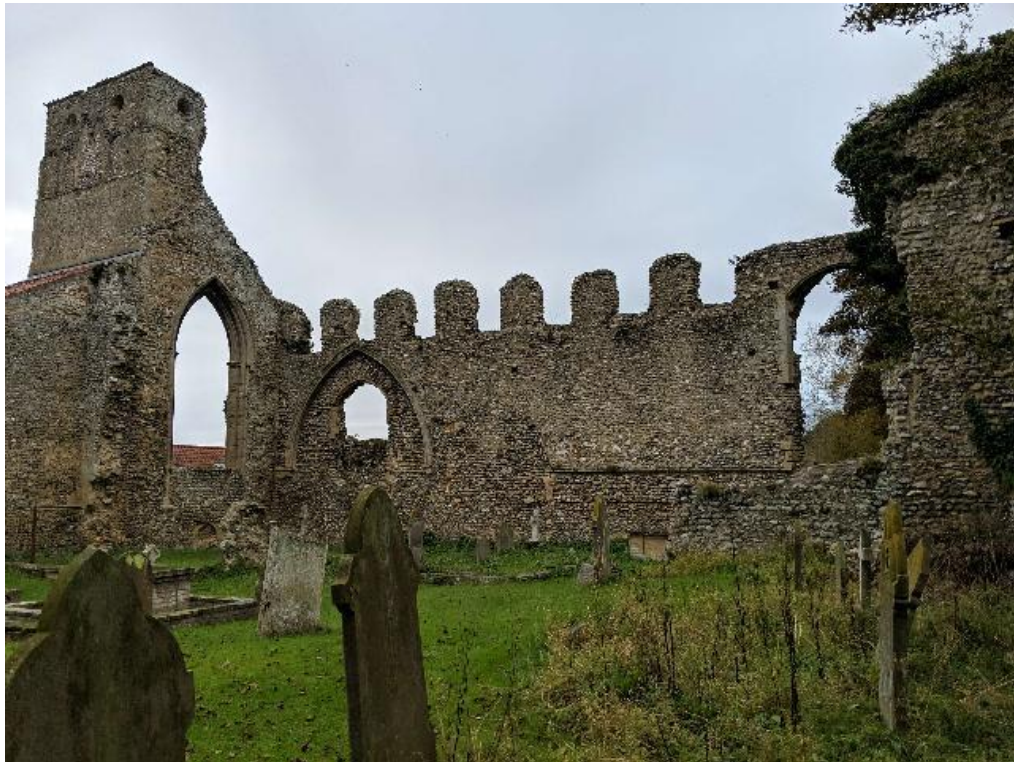
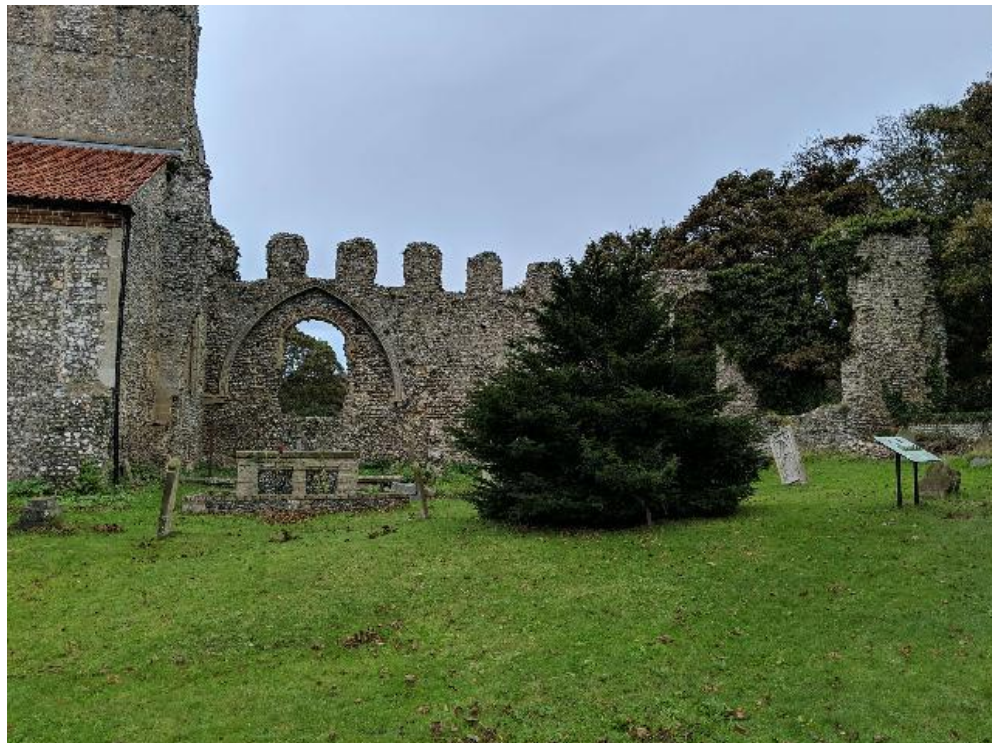
41. This area has been identified as containing the earthworks and foundations of the Late Saxon Weybourne Priory, which also includes ponds and a holloway or approach track. At the time of the heritage site walkover survey, the area was only partly accessible although views of the asset were available from publicly accessible areas. The structural remains of the ruins of Weybourne Priory are adjacent to All Saints Church (see [Plate 21.1.4-29](#) and [Plate 21.1.4-30](#) below).
42. The area is recorded on the NHER (**SEPDEP ID 852** and **918**) and is also a Scheduled Monument (**SEPDEP ID 12**) ([Annex 21.1.3](#), [Figure 21.1.1](#), [Map 2](#) and [Figure 21.1.2](#), [Map 2](#)).

Plate 21.1.4-29 View of ruins of Weybourne Priory, looking north.

Plate 21.1.4-30 View of ruins of Weybourne Priory, looking north, with All Saints Church to the left of the photograph.

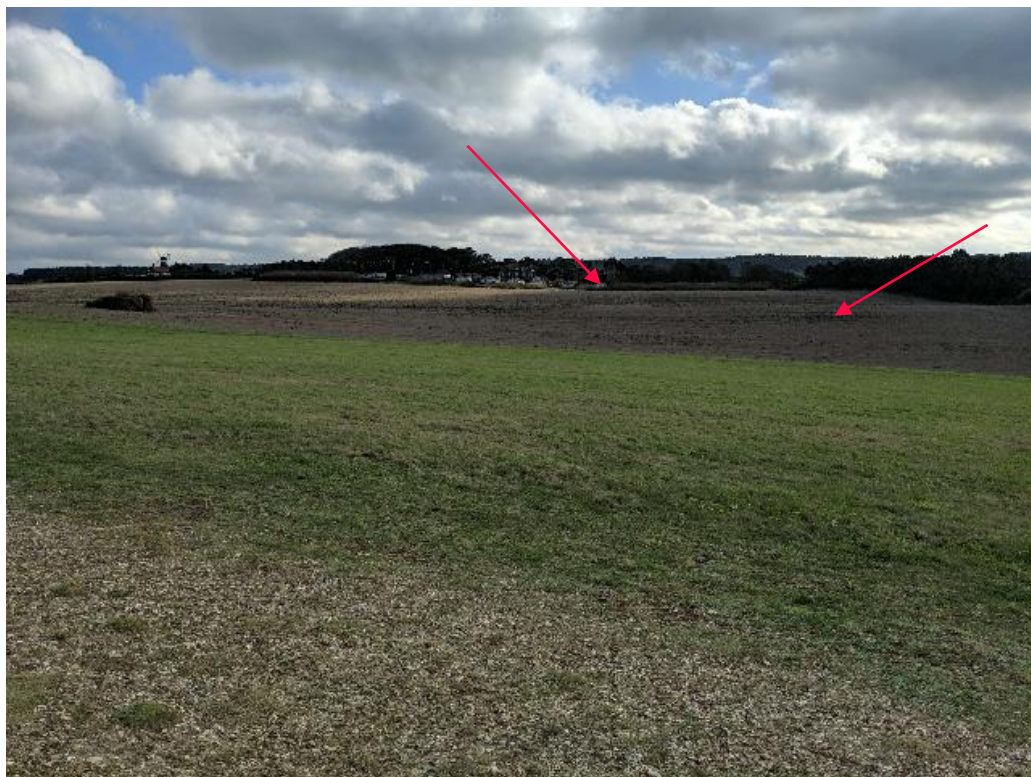
- 45. This area is identified from aerial photographs as containing eroded banks indicative of a likely post-enclosure field system which has been removed to facilitate agriculture and/or modern military activity (**APS_238**). The area is also recorded as being the site of multi-period features and finds on the NHER (**SEPDEP ID 334**) (**Annex 21.1.3, Figure 21.1.2, Map 2**).
- 46. At the time of the heritage walkover survey, access was not granted and as such could not be fully assessed, however views were available from publicly accessible points such as the Norfolk coastal walk to the north. Of that which was visible, the land was in arable use and appeared to have been recently harvested. There were some wide undulations across the field, although no obvious earthworks were visible (see **Plate 21.1.4-31** below).

Plate 21.1.4-31 View from the Norfolk coastal walk to the north, looking across the area, looking south.

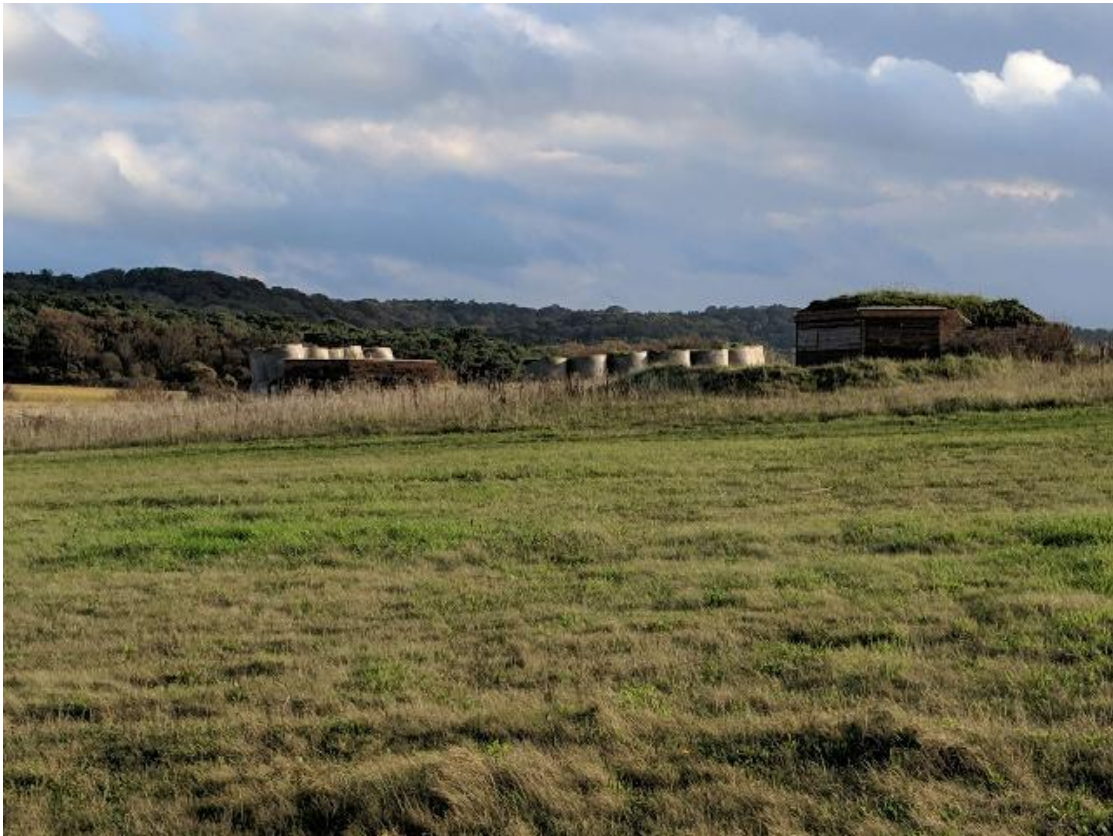
51. This area is identified as containing two World War II pillboxes; Type 24 and Type 26, which are recorded on the NHER and from aerial photographs (**NHER 19440 / APS_245**). The pillboxes are recorded on the NHER as being located within an area of World War II defensive structures (**NHER 38577**), alongside an area of multi-period finds (**NHER 41015**).
52. Both pillboxes are extant although slightly overgrown with vegetation (see **Plate 21.1.4-32** below), the window openings are boarded up and the structures are currently used for the storage of agricultural produce (grass silage bales).
53. These assets are no longer within the study area and have not been taken forward to impact assessment.

Plate 21.1.4-32 View from the north, along Norfolk coastal walk, looking south towards the pillboxes.

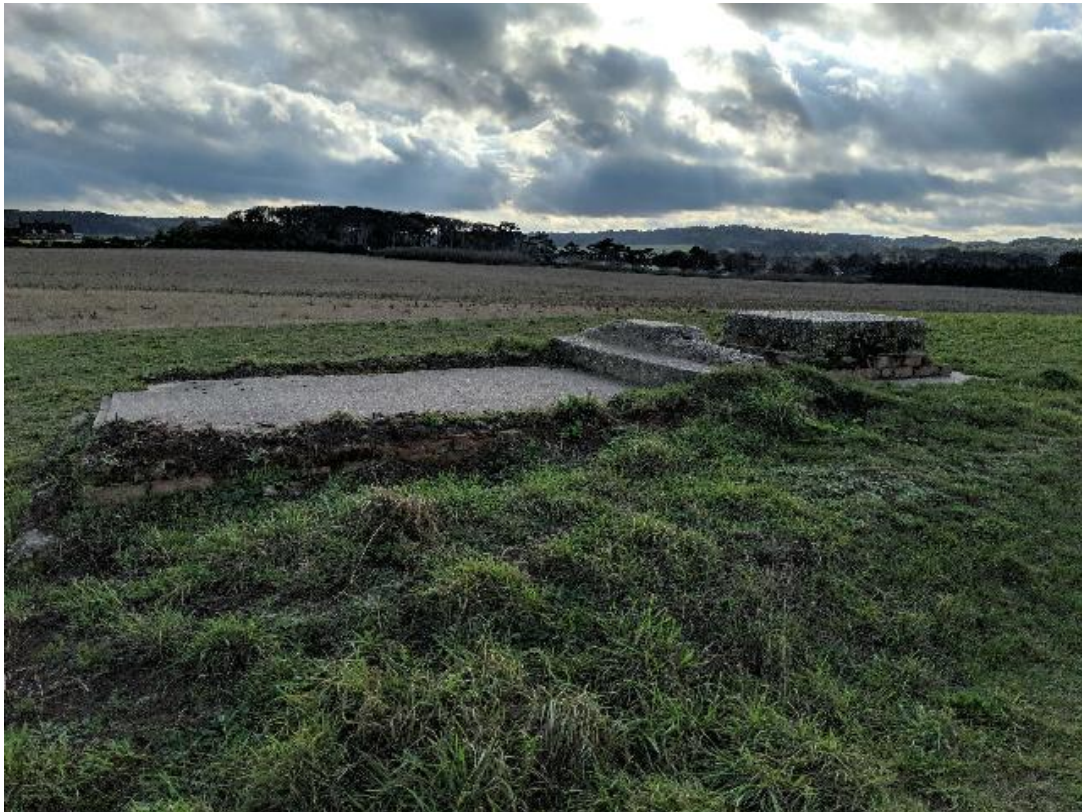
56. A concrete base of a former building was recorded which likely relates to one of the military structures recorded on the NHER, potentially a pillbox base, (see **Plate 21.1.4-33** below). No other structures or earthworks were visible.

Plate 21.1.4-33 View of concrete building base, looking south.

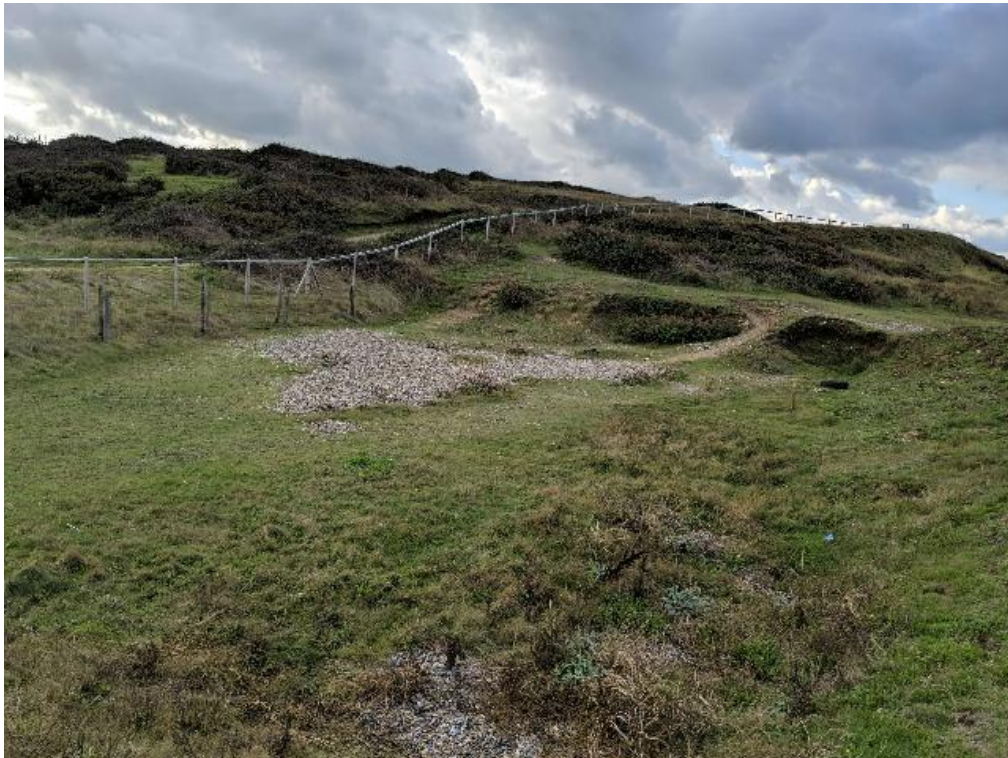
Plate 21.1.4-34 View of undulations ascending a small hill towards centre of the area, looking west.

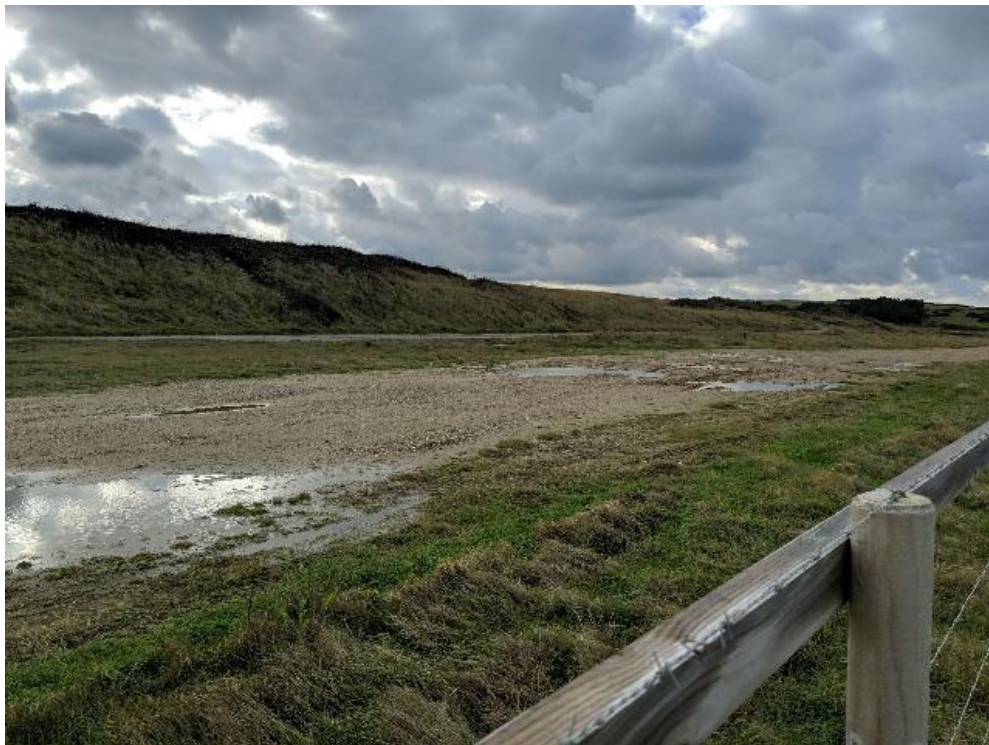
Plate 21.1.4-35 View of earthwork bank within Weybourne Camp, looking south from the Norfolk coastal walk

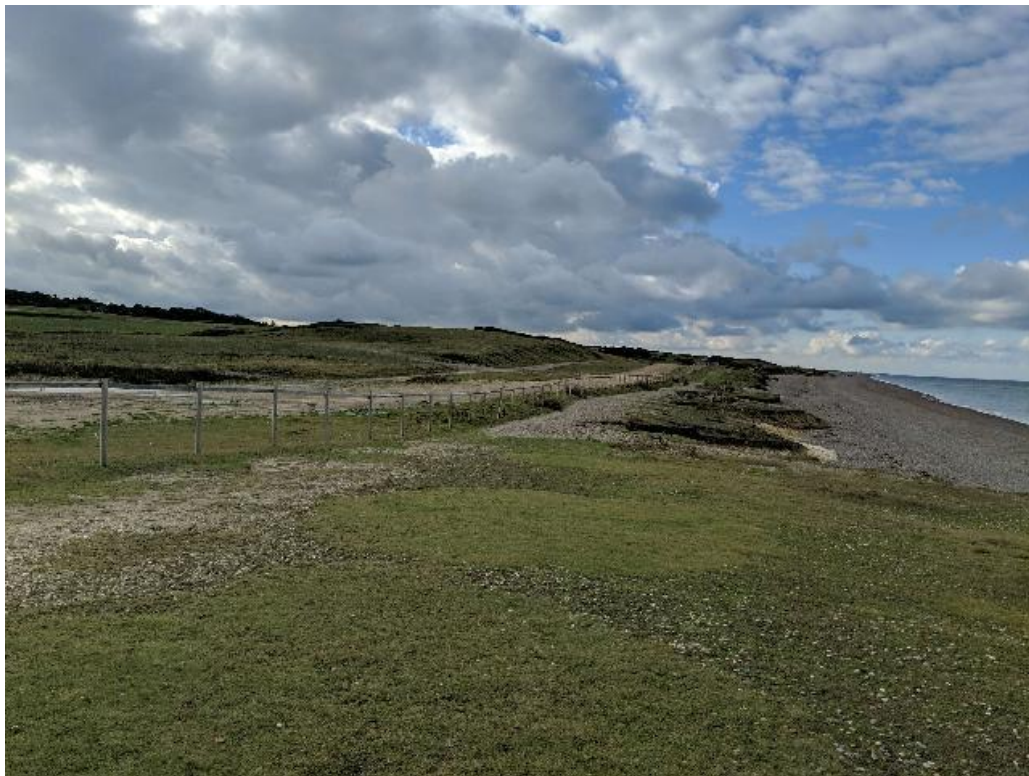
57. This area is identified as containing earthwork channels or trenches and banks that extend along the coast, possibly relating to the Armada defences and fortifications at Weybourne Hope (**SEPDEP ID 1051 / APS_166**). The area is also encompassed by Weybourne Camp (**SEPDEP ID 1228**) (**Annex 21.1.3, Figure 21.1.2, Map 2**).
58. Towards the centre, the area has some large undulations rising to a small hill (see **Plate 21.1.4-34** below). Areas of scrub made it difficult to see if any trenches or banks were extant. The topography was overall flat before reaching a large earthwork bank, which is most likely relating to the coastal defences (see **Plate 21.1.4-35** below). Generally, along the coastal walk there were no obvious features visible, only those within Weybourne Camp of large undulations that may be indicative of the earthwork channels (see **Plate 21.1.4-36** below).

Plate 21.1.4-36 Wider view of area, looking west into Weybourne Camp.
