**CONDITION SURVEY AND  
EXCEPTION REPORT  
For**

**FLIXBOROUGH WHARF  
JETTY**

**GUNNESS WHARF  
MAIN JETTY**

**PROJECT NO. 41450  
RPT001**

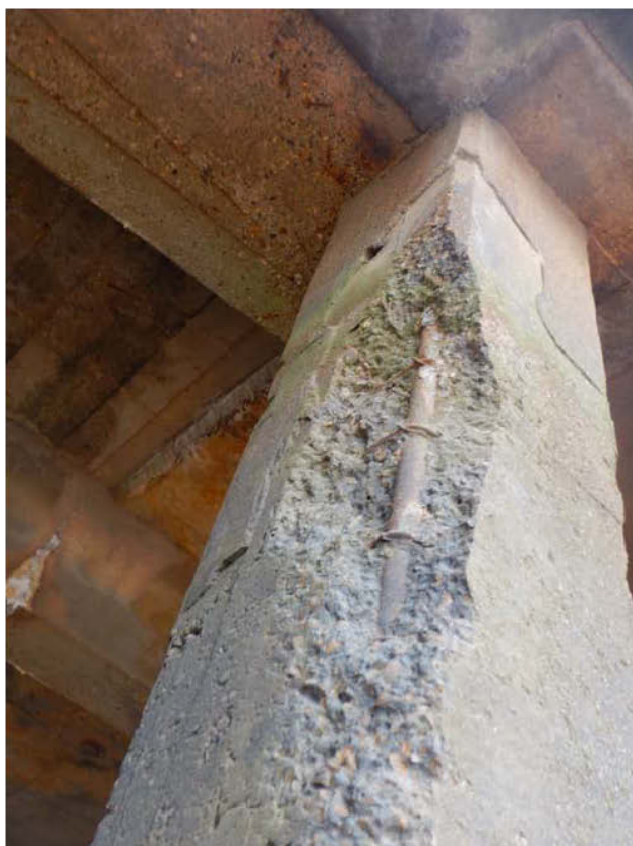
**Photograph No. 1**

**Piles** The extent of repairs required to the piles since the 2017 survey has increased from 1.5m<sup>2</sup> to 12.0m<sup>2</sup> (+700%). Although the total extent of repairs required remains small and the majority of piles are in fair condition, this is the most significant area of measurable change on the jetty. Typical pile damage is shown in photos 1 to 3). It is notable that the pile head damage tends to reveal existing corroded rebar (photos 2&3) whilst the damage lower down (photo1) reveals uncorroded rebar suggesting that this latter damage may have been caused by impact rather than structural condition.

**Intermediate Pile  
18a-A**

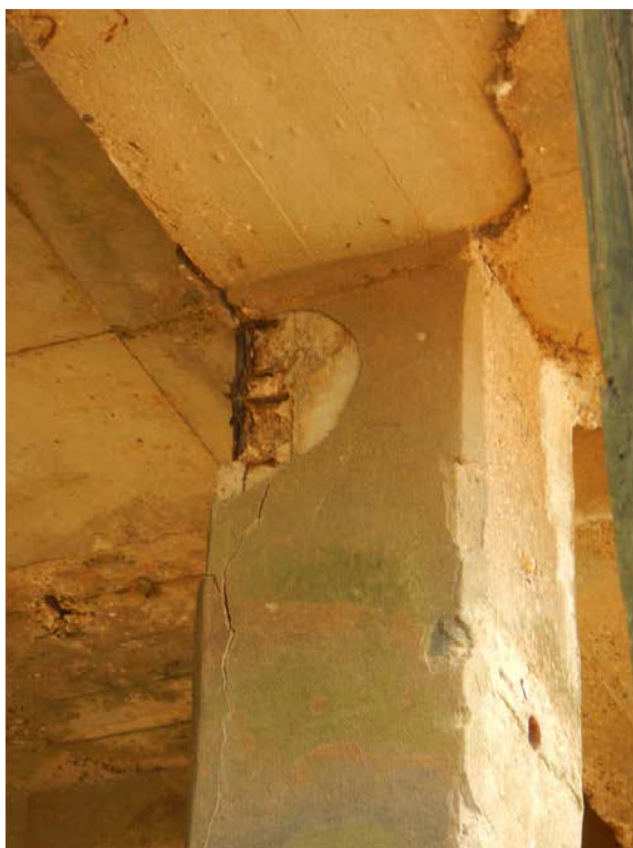
**Photograph No. 2**

**Pile 20A**

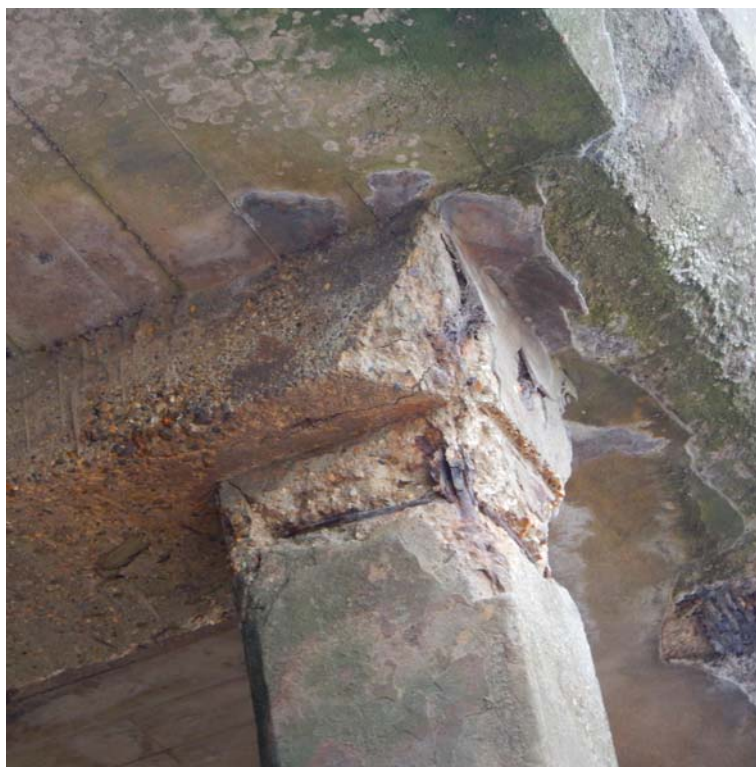
**Photograph No. 3**

**Pile 33A**

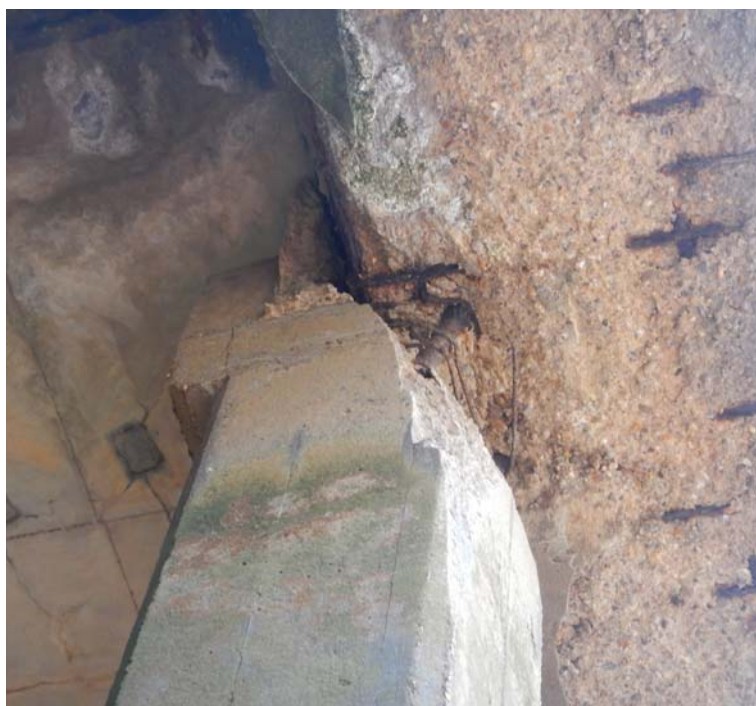
**Photograph No. 4**

**Displaced  
Intermediate  
Pile 37a-A**

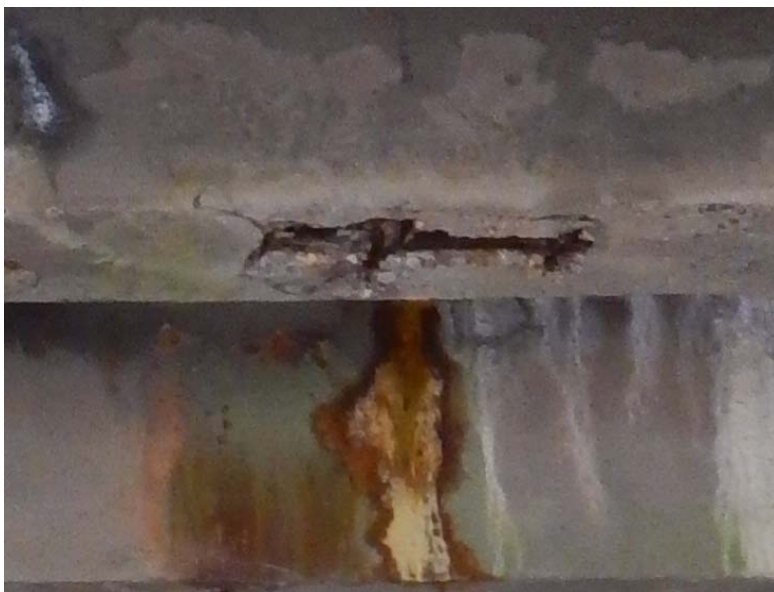
**Photograph No. 5**

**Beams  
Parallel to  
Berthing face:  
Cope, crane  
beam & rail  
beams.** The extent of repairs to the parallel beams since the 2017 survey has increased from 418.0m<sup>2</sup> to 439.5m<sup>2</sup> (+5%). Photo 5 shows a typical area of new spalling and the extent of corroded rebar revealed.

**Parallel Beam  
30-31 Rail 3**

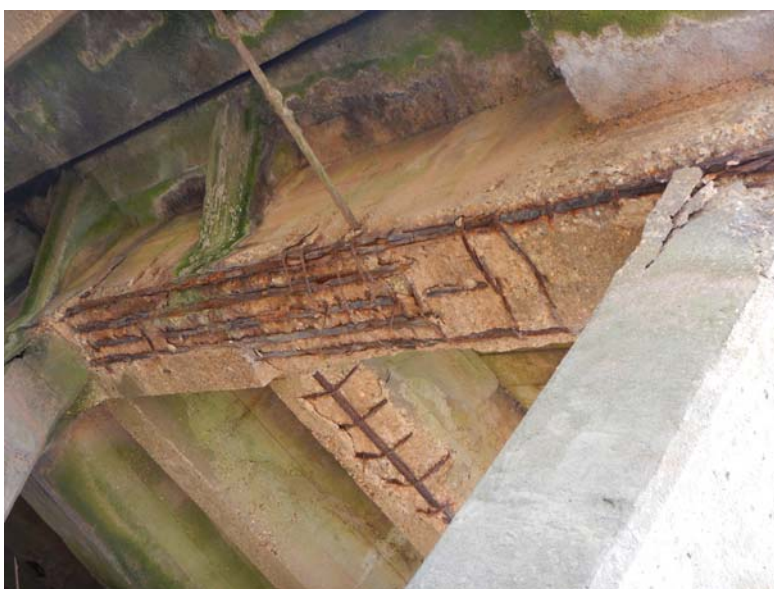
**Photograph No. 6**

**Perpendicular to Berthing face:  
A-B, B-C, C-D & D-E** the 2017 survey has increased nominally from 187.0m<sup>2</sup> to 188.0m<sup>2</sup> (+0.5%), however it is important to note that many of the A-B beams are so badly degraded that determining change from a visible inspection has limited value. Photo 6 shows a typical example. It should be noted that the rebar is very heavily corroded, and the beam will have lost a significant proportion of its design capacity.

**Perpendicular Beam  
15A-B**

It should be noted that a significant proportion of the front perpendicular beams spanning between gridlines A and B are seriously degraded and it is recommended that urgent attention should be given to addressing these or to modifying current working methods.

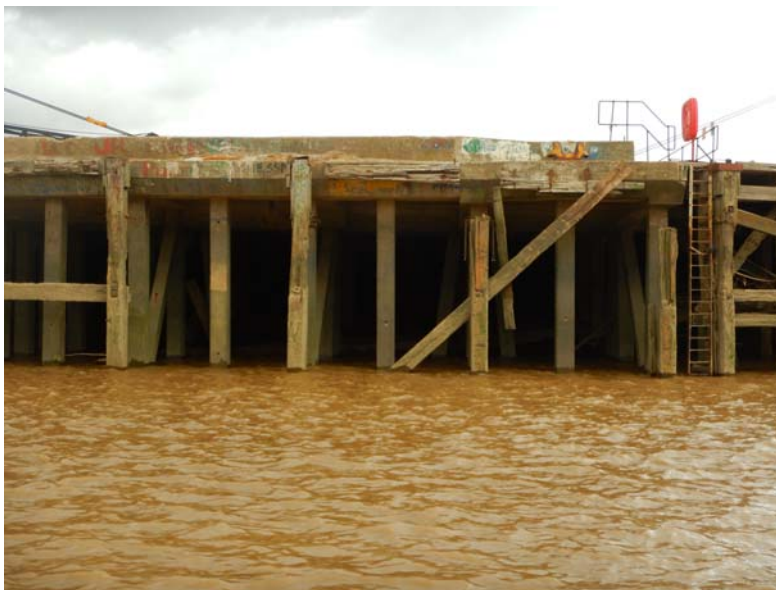
**Photograph No. 7**

**Fendering** There is little change in the fender condition except for the loss of the waling between gridlines 52 & 55 (Photo 7).

**Fender waling lost  
between GL52-55**

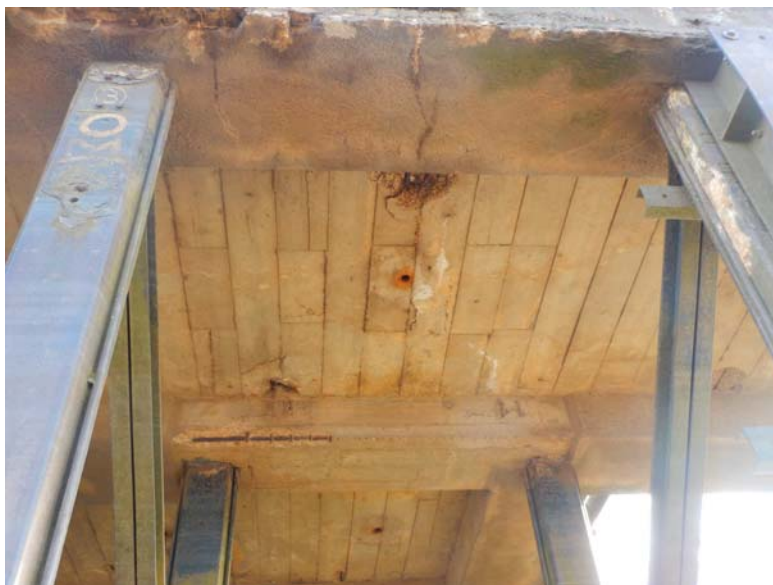
**Photograph No. 8**

<b>Piles</b>	No change in the condition of the box piles was observed.
<b>Bracings</b>	No change in the condition of the pile bracings was observed.
<b>Deck Soffit</b>	The extent of repairs to the deck soffits since the 2017 survey has increased from 34.0m <sup>2</sup> to 39.0m <sup>2</sup> (15%) with new spalled areas and cracking (Photo 8). New spalling is revealing existing corroded rebar. The infill slab remains in good condition.
<b>Beams Parallel to Berthing Face</b>	The extent of repairs to the parallel beams since the 2017 survey has increased from 25.5m <sup>2</sup> to 27.0m <sup>2</sup> (8%). Photo 9 shows increasing spalling at B7-8 and Photo 10a shows newly exposed rebar links. The infill slab beams remain in good condition.
<b>Beams Perpendicular to Berthing face</b>	The extent of repairs to the perpendicular beams since the 2017 survey has slightly increased from 4.0m <sup>2</sup> to 5.0m <sup>2</sup> (25%). A new small area of spalling can be seen to beam 5E-F in photo 10a & 10b and to beam 4E-F in photo 11. The infill slab beams remain in good condition apart from the existing cracked corner at 13F.

**A-B 2-3 Deck Soffit**

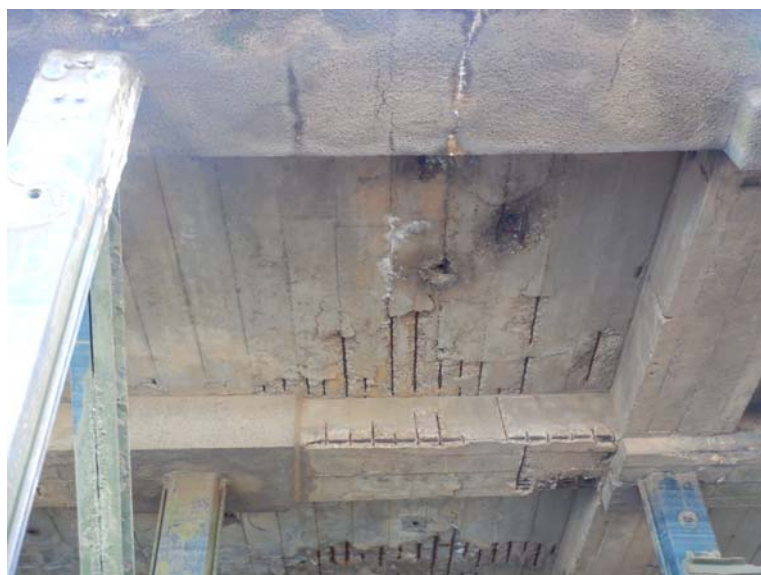
**Photograph No. 9**

**Parallel Beam B7-8**

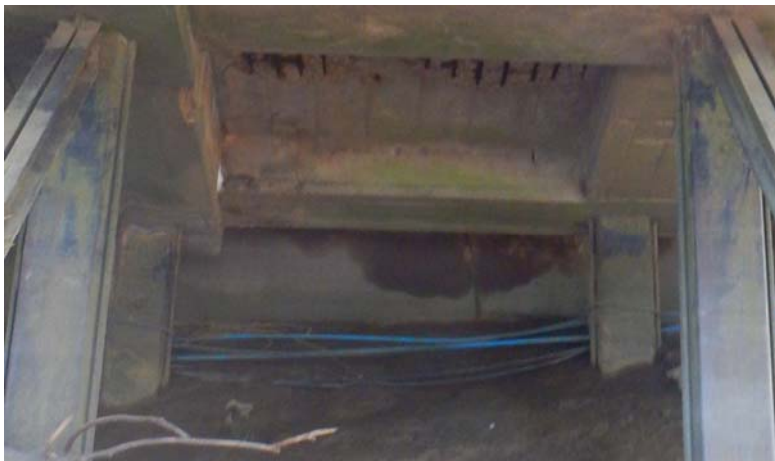
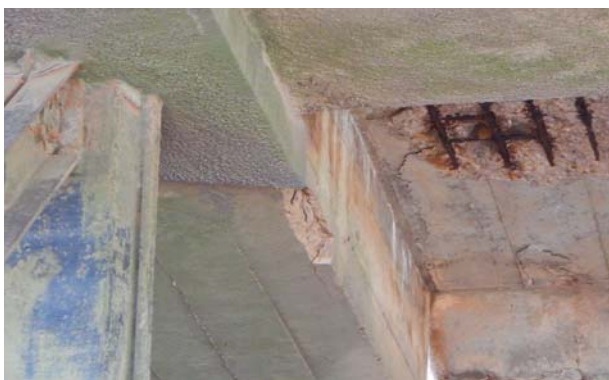
**Photograph No. 10a**

**Perpendicular beam  
5E-F spalling**

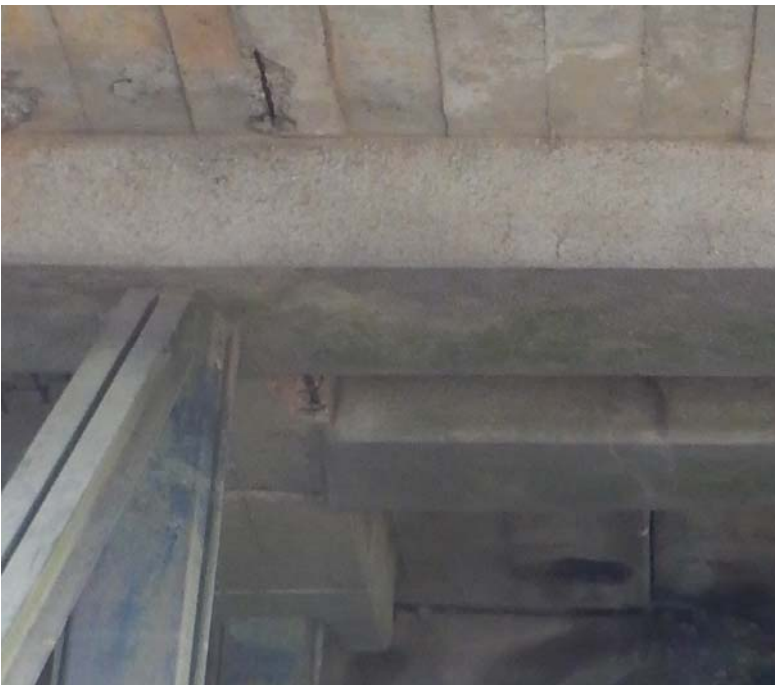
**Photograph No. 11**

**Perpendicular beam  
4E-F spalling**

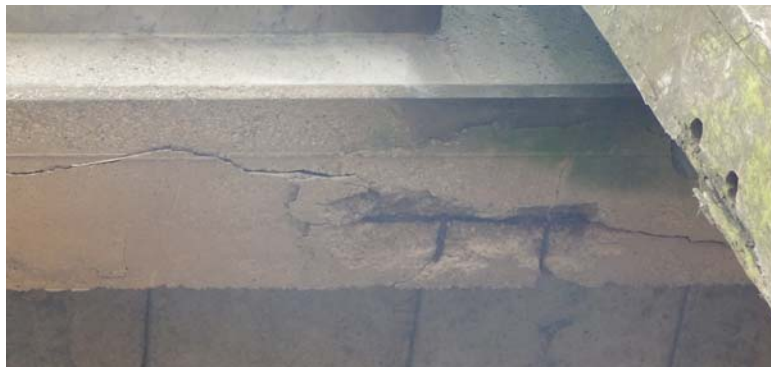
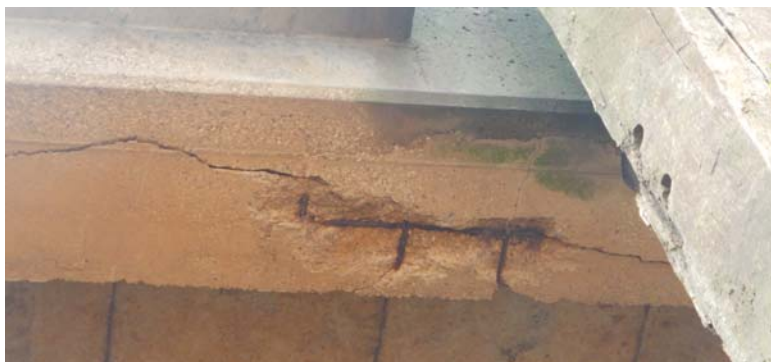
**Photograph No. 12a**

<b>Piles</b>	No change in the condition of the piles was observed.
<b>Deck Soffit</b>	The extent of repairs to the deck soffits since the 2017 survey has not increased from 15.5m <sup>2</sup>
<b>Beams Parallel to Berthing Face</b>	<p>The extent of repairs to the deck soffits since the 2017 survey has not increased from 32.8m<sup>2</sup>. There has been minor additional concrete loss from the soffit of beam A9-10 as shown in photos 12a &amp; 12b however as the beam has already failed structurally this is considered insignificant.</p> <p>Photo 13 shows the existing extent of spalling to the front beam at A11-12 and suggests that the beam might be constructed as a structural steel beam encased in reinforced concrete or a composite beam rather than just a RC beam.</p>
<b>Beams Perpendicular to Berthing face</b>	The extent of repairs to the perpendicular beams since the 2017 survey has not increased from 35.2m <sup>2</sup> . Photo 14 shows the existing typical damage to both bottom corners of beam 3A-C. Photos 15a and 15b show the existing damage to the failed beams at 9A-C and 12A-C respectively.

**Parallel Beam A9-10**

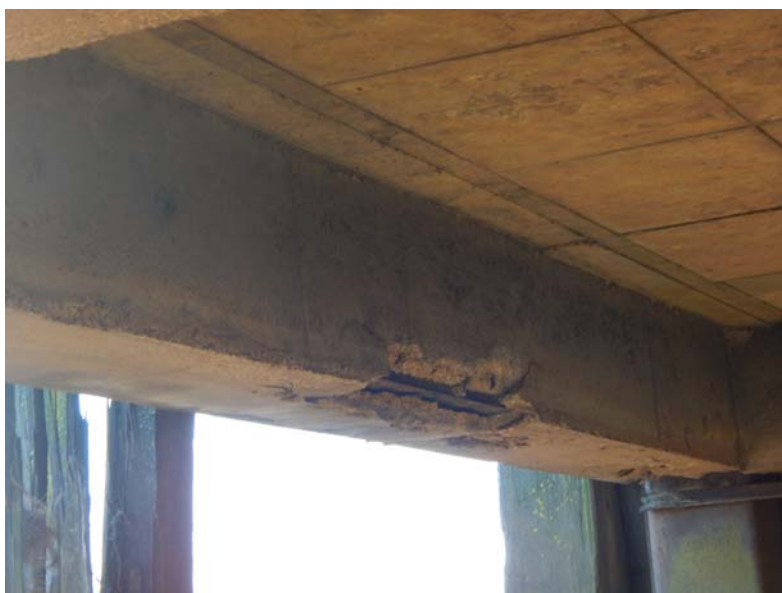
**Photograph No. 13**

It was noted during the inspection in an area of heavy spalling, that zone C may comprise structural steel sections clad in reinforced concrete rather than traditional reinforced concrete beams. If this were confirmed, it has the potential to simplify repairs in this zone however it should be noted that the extent and form of spalling present indicates overloading of the structure generating excessive deflections, and that even if repaired, the structure would still be unsuitable for the previous operational loads applied.

**Parallel Beam A11-12  
Exposed steelwork**

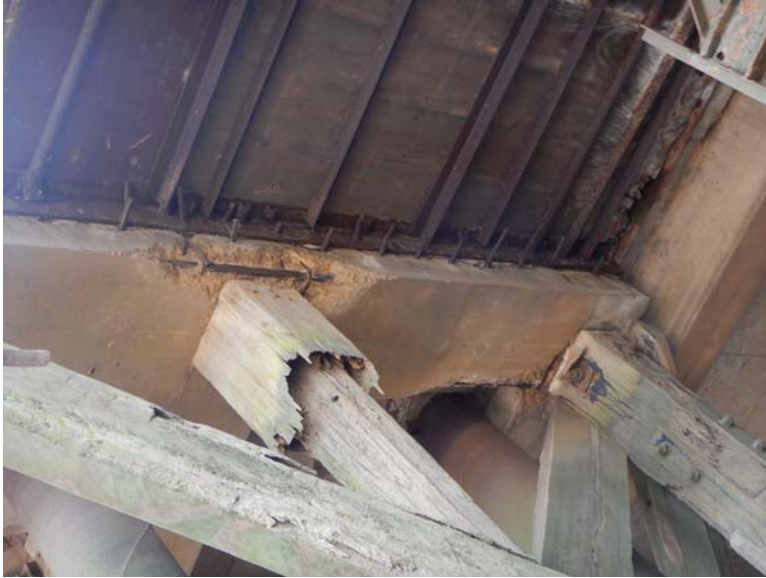
**Photograph No. 14**

**Perpendicular Beam  
3A-C**

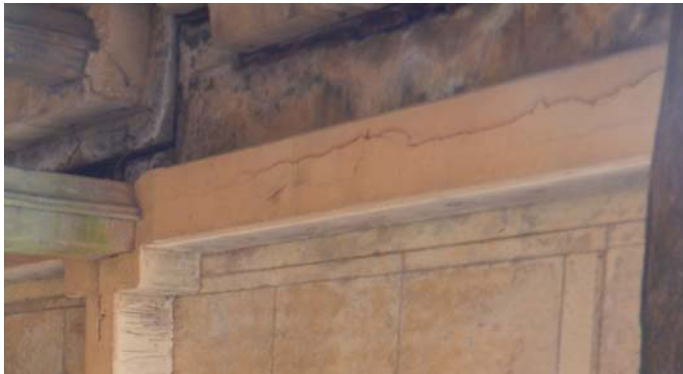
**Photograph No. 15a**

**Perpendicular Beam  
9A-C**

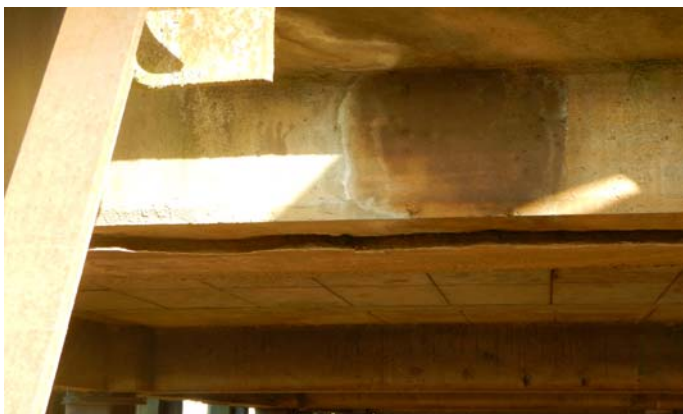
**Photograph No. 15b**

**Perpendicular Beam  
12A-C**
