NORTH FALLS

Offshore Wind Farm

ENVIRONMENTAL STATEMENT

Appendix 25.5 Heritage walkover survey

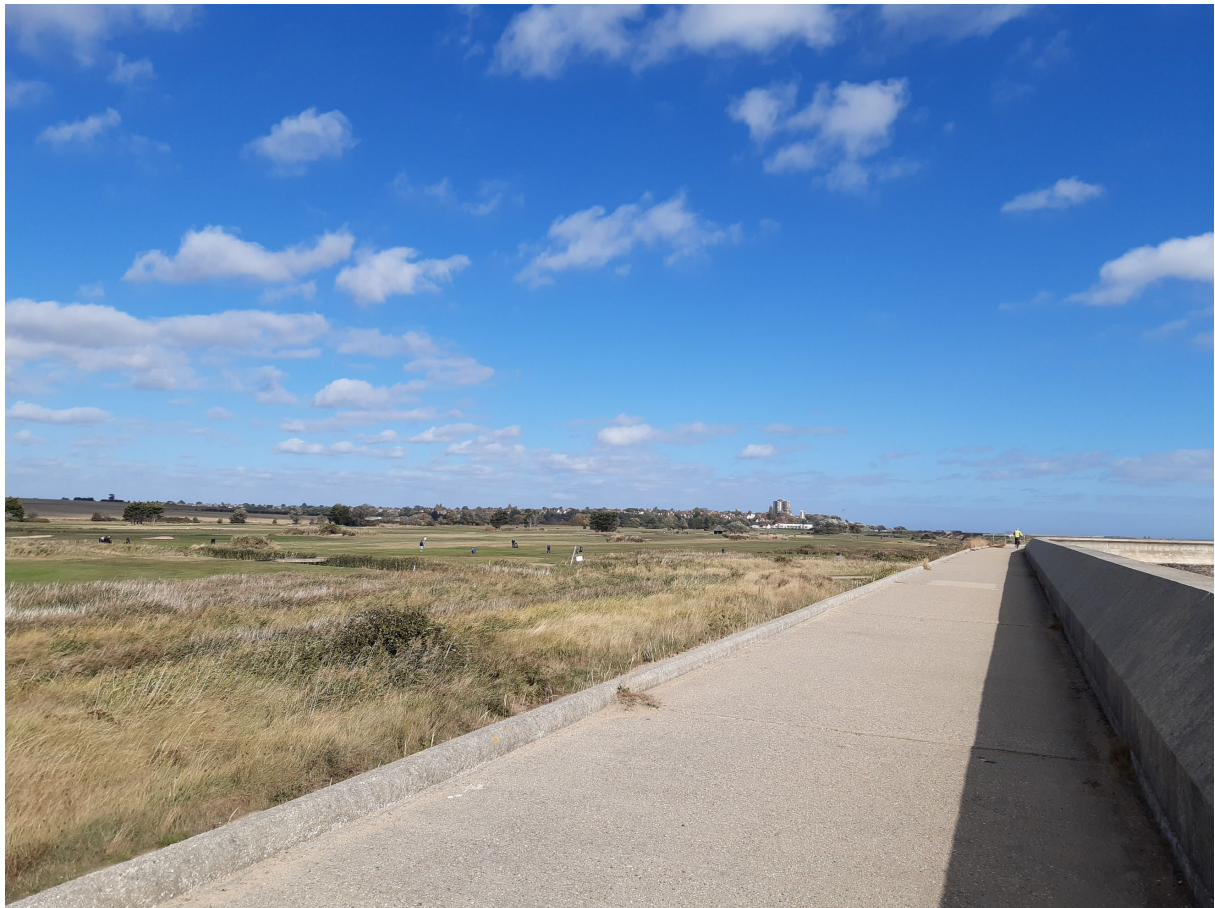
21. This area is recorded as the site of Mr Barton's Pans at the mouth of the Gunfleet Estuary. The features are thought to be copperas settling pans, however, there is no copperas house on the site although one is recorded at Walton. They are recorded on the 1783 plan of Tendring levels and now comprise a line of roughly rectangular ponds running parallel to the sea wall on the marshland side of the wall. Their dimensions vary from 20m x 10m to 175m x 25m, however their depth is unknown.
22. These features were identified during the walkover survey however the detail of the pans were difficult to establish due to the nature of the long vegetation along this stretch of the marshland (Plate 1).

Plate 1 View of Mr Barton's Pans, looking north-east

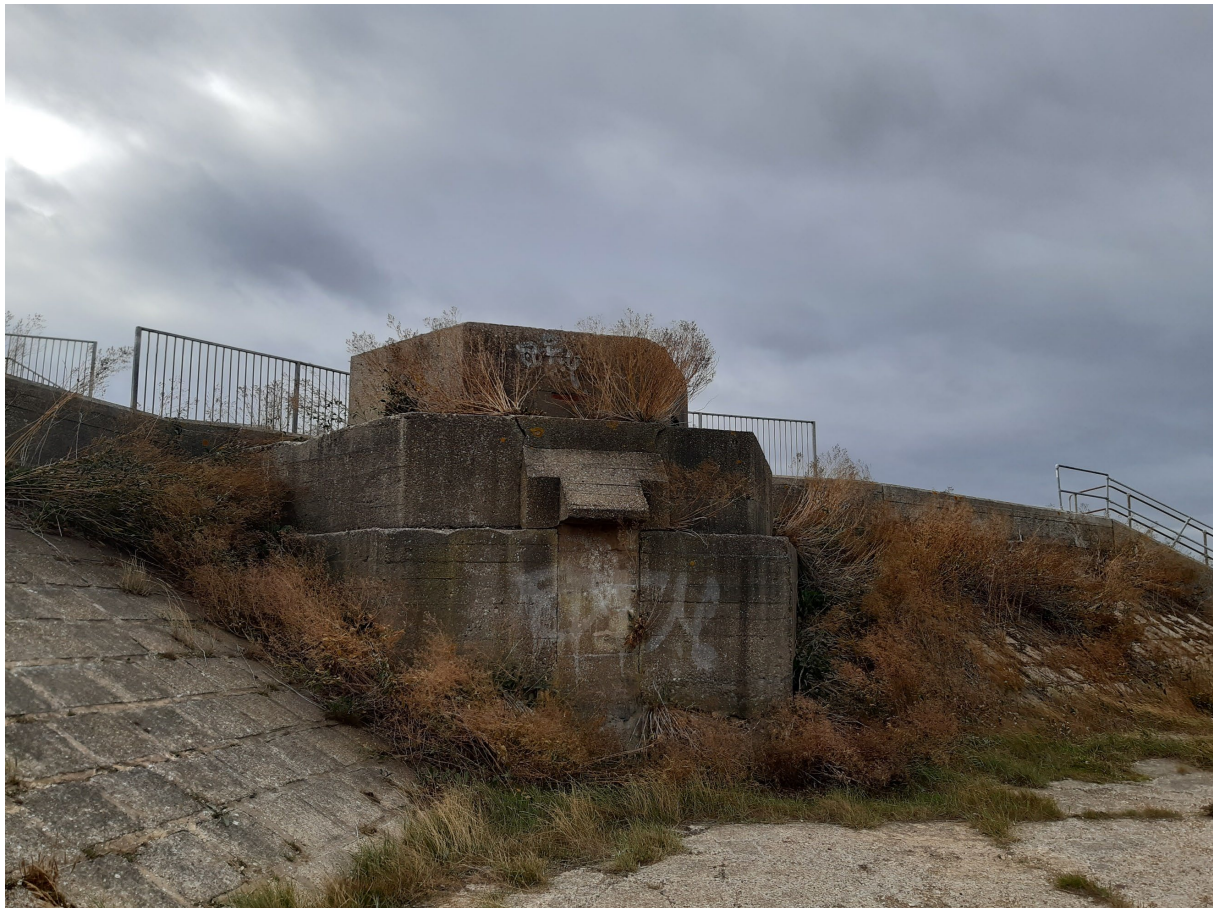
25. An FW3/22 pillbox stands on the sea wall at Sandy Point. As with the other pillboxes located along the sea wall between Holland and Frinton, it was sited to face attack both from the sea and the land and had its entrance at the lower landward side (Plate 2).
26. It is hexagonal with a protective belt of concrete up to the bottom of the loopholes. The names of the former occupants are etched in the concrete on the north-west side of the protective belt - 'Cpl. Smith, J. Campbell, P. H. Hall - 'D' Coy'.
27. The pillbox has deteriorated with small sections of concrete broken away, particularly around the loopholes, and vegetation is growing out of the concrete.

Plate 2 View of Pillbox at Sandy Point from the north-east

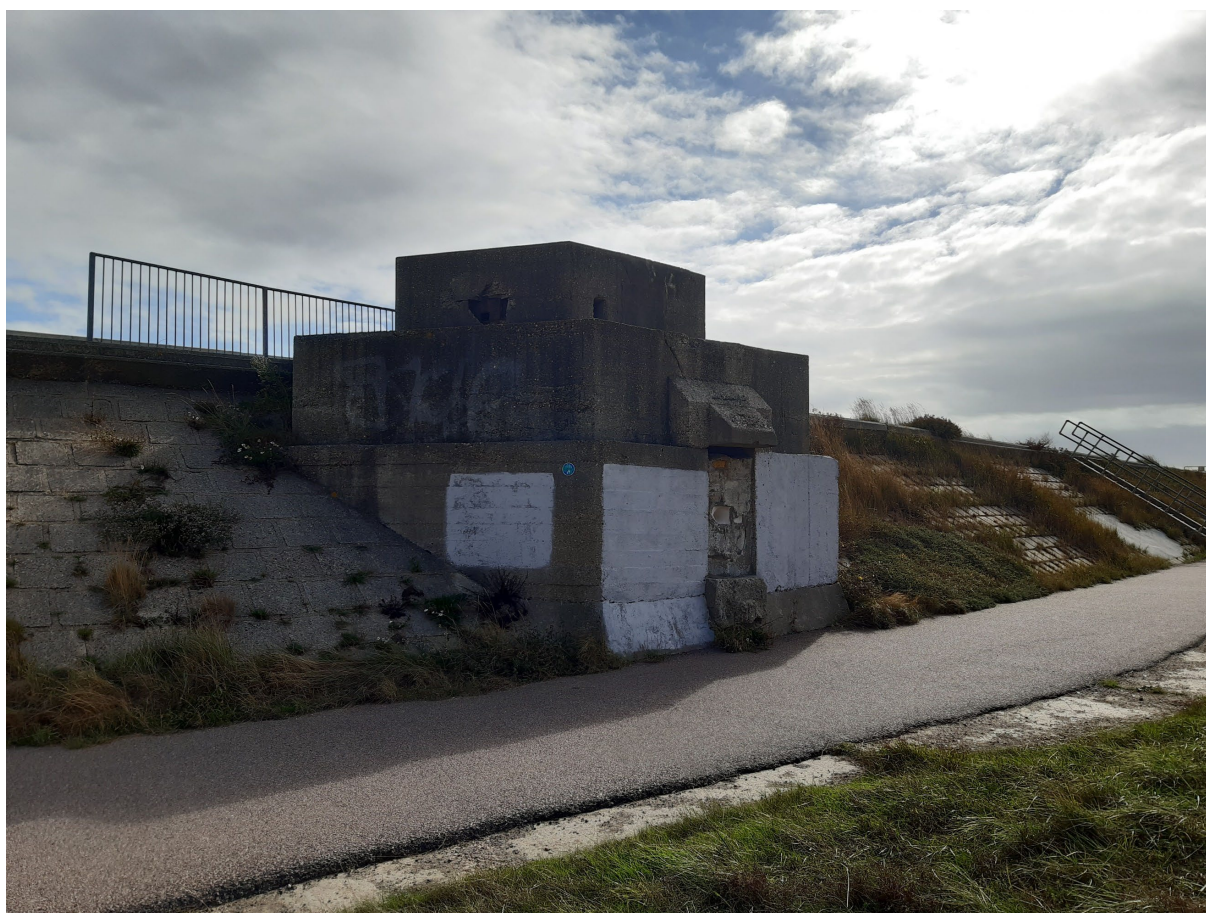
31. As with the other pillboxes located along the sea wall, it is a hexagonal concrete type FW3/22 pillbox with a protective concrete belt up to the bottom of the loopholes. The entrance is at the lower level at the base on the landward side, with interior steps visible through a hole in the block-up doorway.
32. The pillbox is in fairly good condition (Plate 3) with some deterioration around the loopholes and edges of the pillbox on the seaward side.
33. Following the refinement of the onshore cable route, this asset now lies outside of the onshore project area.

Plate 3 View of Pillbox east of Chevaux de Frise Point, looking south

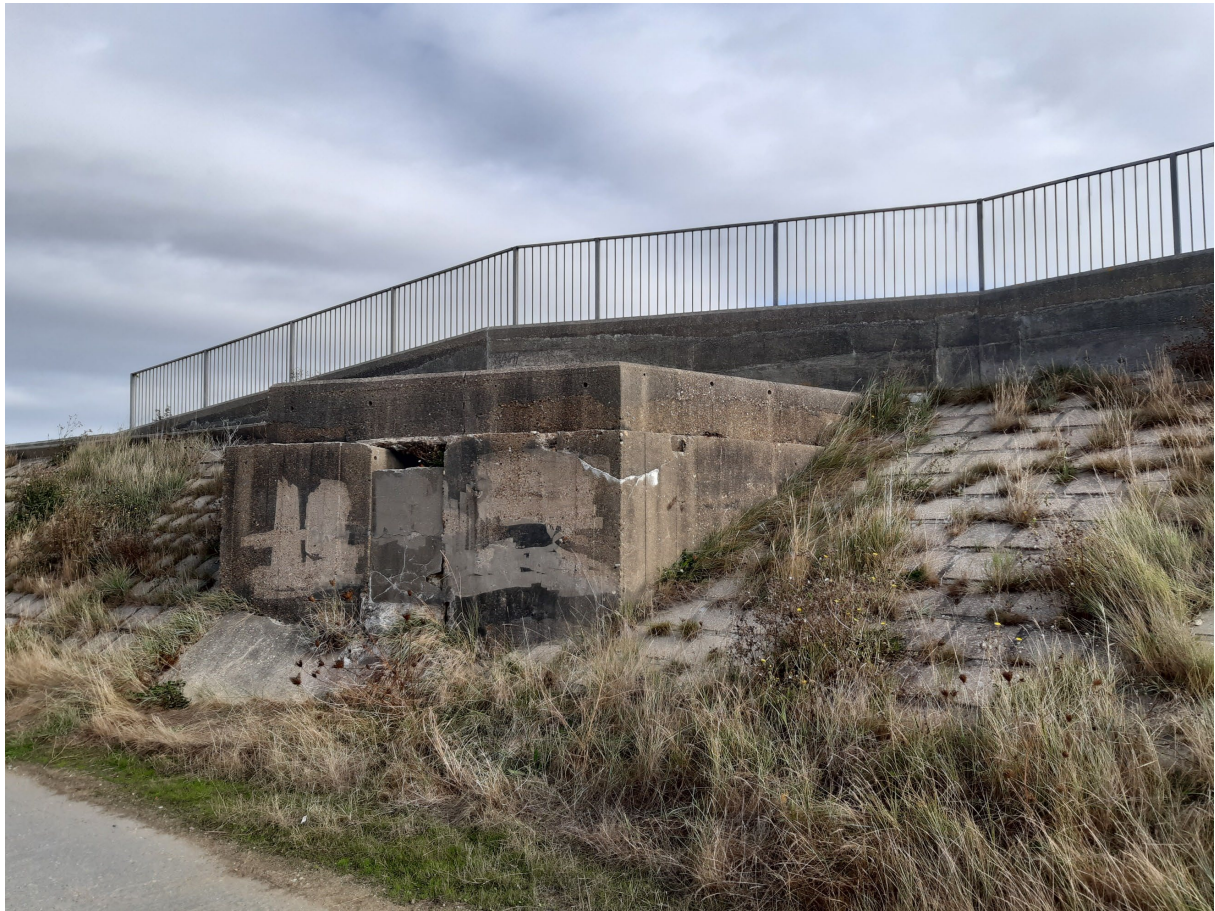
34. Similar to pillbox MEX31496, although only the base and doorway (block-up) survive (Plate 4).
35. The remaining parts of the pillbox are in fairly good condition.

Plate 4 View of Pillbox at Chevaux de Frise Point, looking east

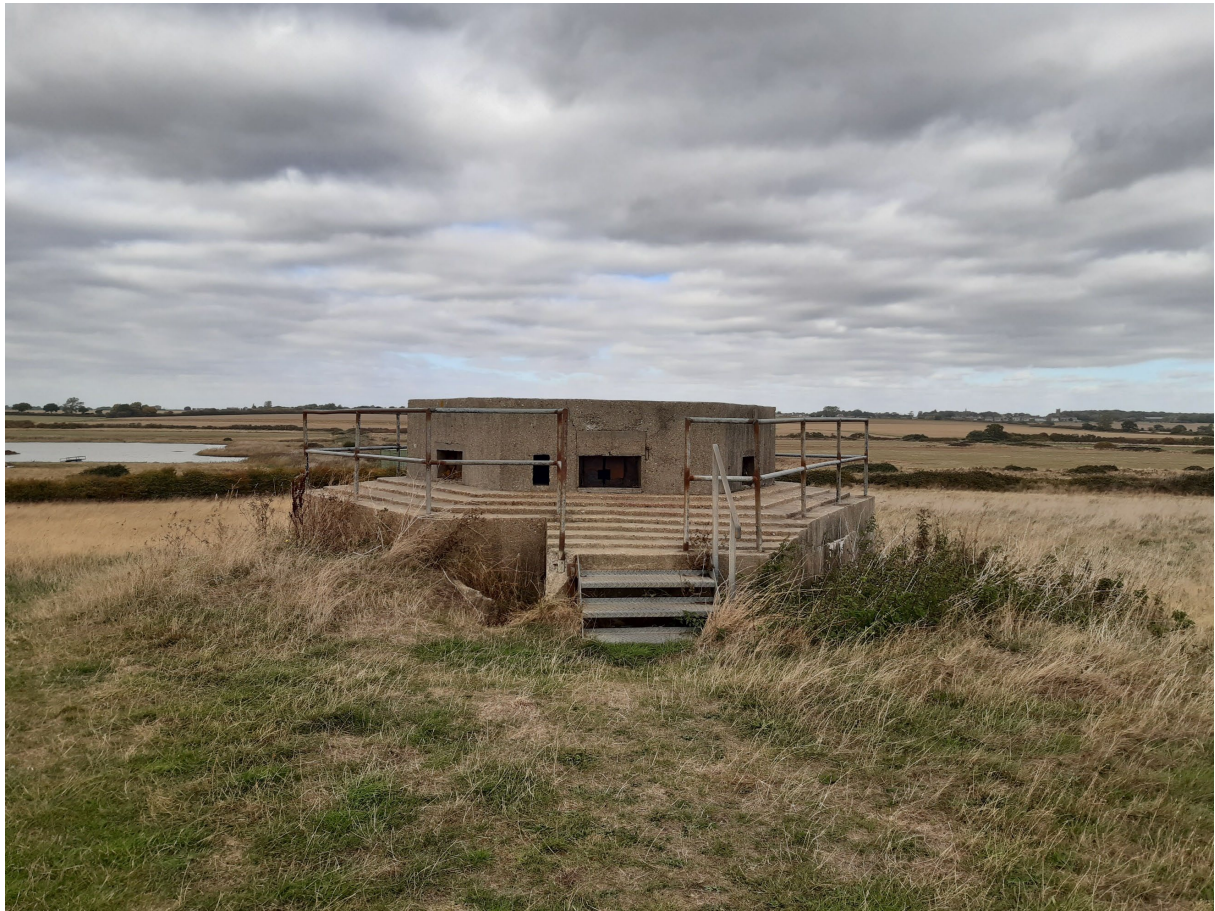
40. This pillbox is sited on high ground, approximately 60m landward from the sea wall, and dominates the open countryside with a 360 degree field of fire over the sea and flat grasslands.
41. Unlike the other FW3/22 type pillboxes along the sea wall, the entrance to this pillbox is on the seaward side suggesting that this was considered to be the rear of the pillbox.
42. The pillbox is in good condition although vegetation is growing up the sides of the pillbox, and metal railings and steps have been added to make this a viewing platform for the Holland Haven Country Park (Plate 5).

Plate 5 View of Pillbox at Holland Haven Country Park, looking north-west

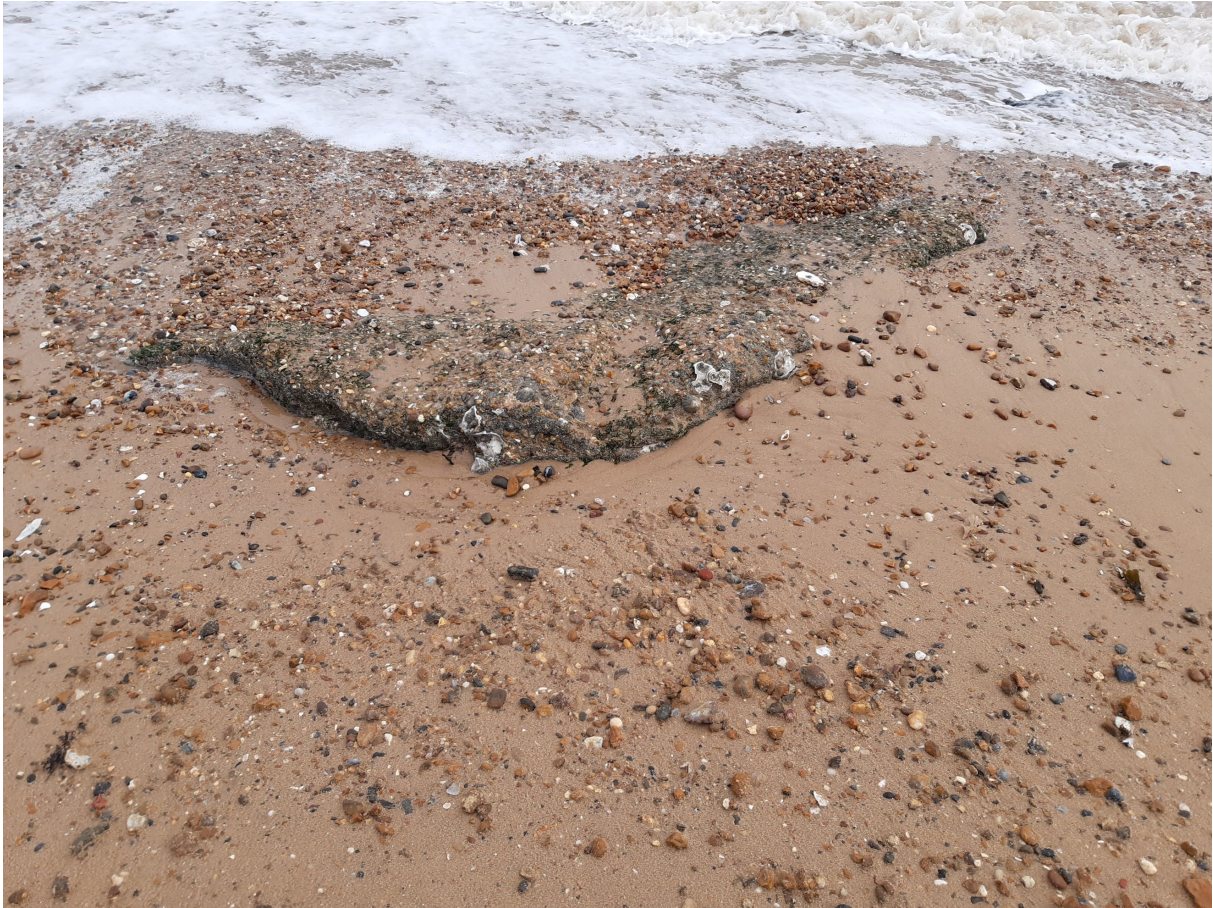
44. An aerial photograph dated 1946 records a hexagonal FW3/22 type pillbox on the cliff edge at Holland Haven. A photograph dated 1953, taken at ground level shows the pillbox on the beach where it lay after the cliff edge had eroded.
45. Possible remnants of the concrete base associated with the pillbox were recorded during the walkover survey (Plate 6). Although the location appears to be the same as that recorded on the HER, it is uncertain if this amorphous concrete block does form part of the pillbox.
46. Following the refinement of the onshore cable route, this asset now lies outside of the onshore project area.

Plate 6 Remains of Pillbox on the beach, looking south south-west

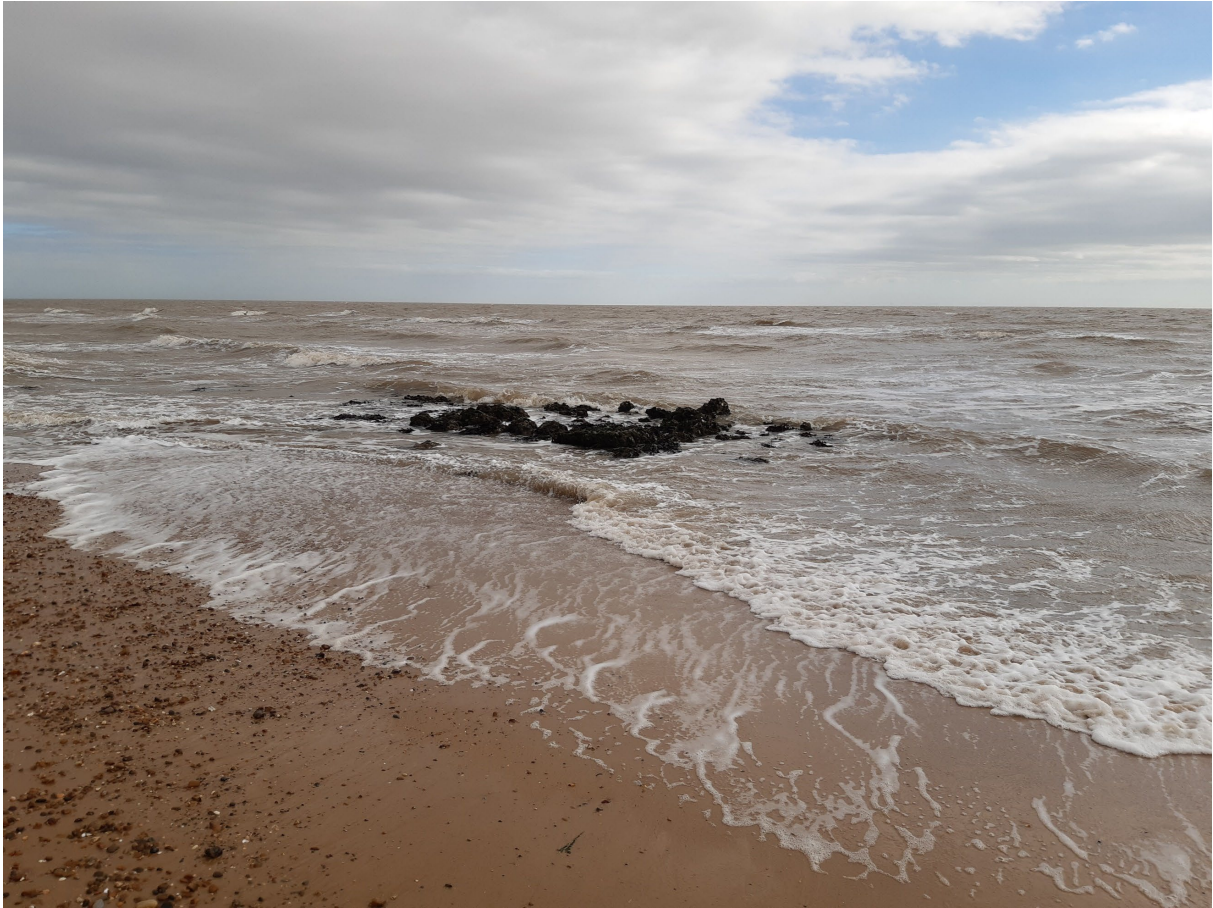
47. The HER records an undated circular earthwork within this area which may be associated with a copperas works.
48. No clear evidence for an earthwork was identified during the walkover survey, however located on the beach was a roughly rectangular-shaped area of rocks which may possibly be associated with a copperas works (Plate 7).
49. Following the refinement of the onshore cable route, this asset now lies outside of the onshore project area.

Plate 7 Possible copperas works in the vicinity of Holland Haven, looking east

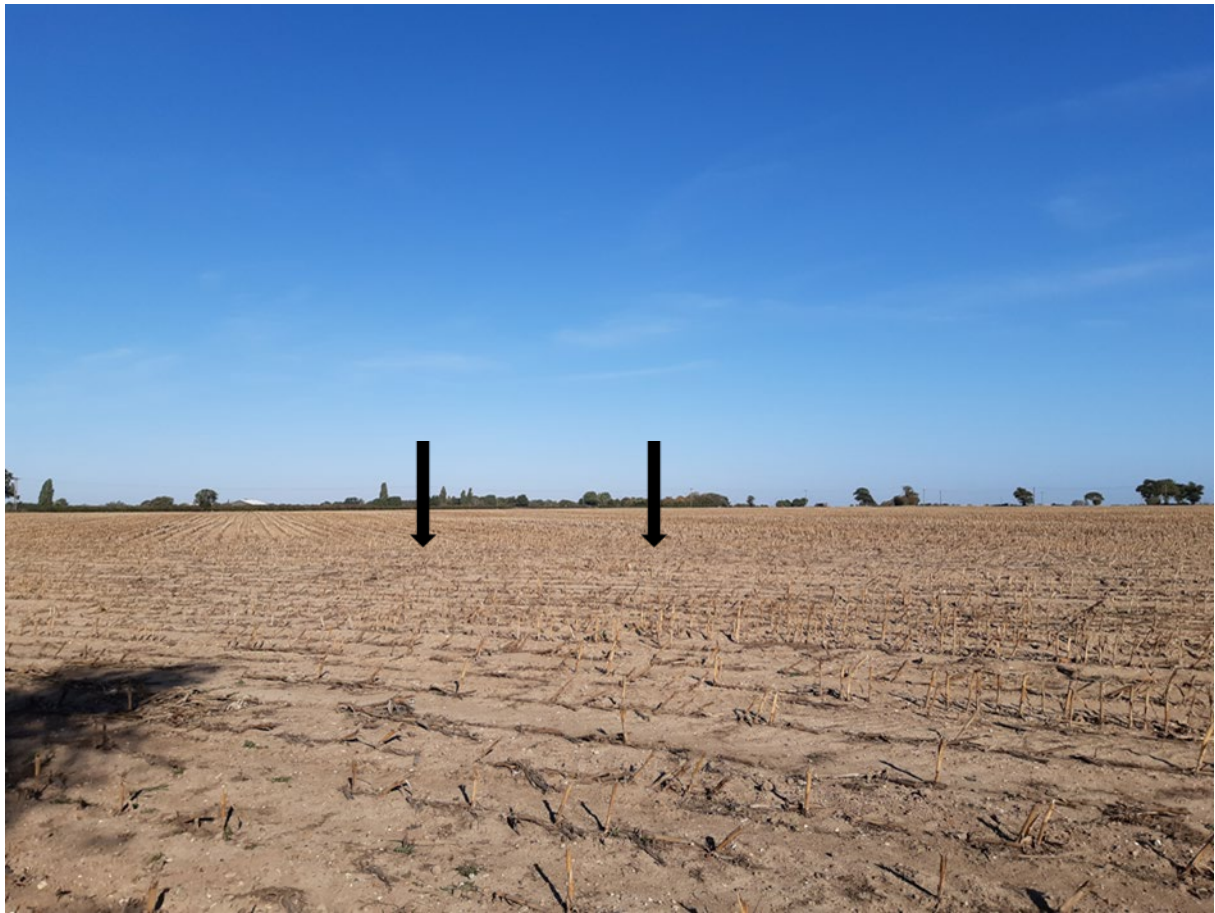
52. As part of the walkover survey, the field in which the residual enclosure was recorded from LiDAR data was visited. A slightly raised area was identified in the area of the enclosure however it was unclear if this undulation was a natural change in the topography or the result of human activity (Plate 8).

Plate 8 Possible location of enclosure (indicated by arrows) recorded as a residual earthwork from LiDAR data, looking north

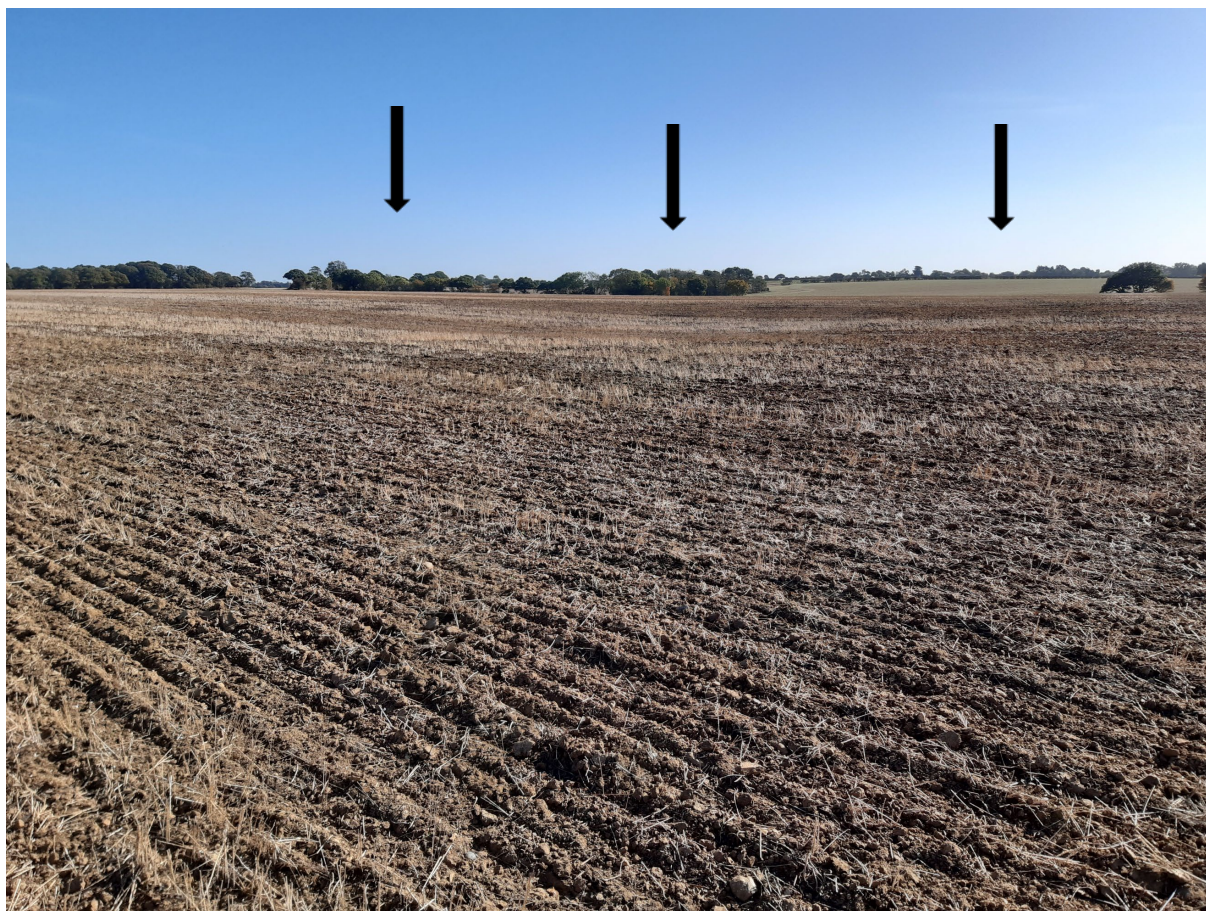
- MEX10843 – recorded as Mill Hill, a tumulus is marked on the 6' OS series of 1874-5; it is possibly a wind mill mound given its name.
55. The field in which a ring ditch was recorded as part of the aerial photographic and LiDAR assessment relates to HER record MEX10843, Mill Hill. This field was visited as part of the walkover survey. At the highest point in the field, a

large circular/oval depression was identified (Plate 9). This may represent the remains of Mill Hill or represent a large enclosure as recorded at MEX1031435.

Plate 9 View of depression possibly associated with Mill Hill - MEX10843, looking east
