Dogger Bank South Offshore Wind Farms

Environmental Statement

Appendix 22-4 Heritage Walkover Survey Report

June 2024

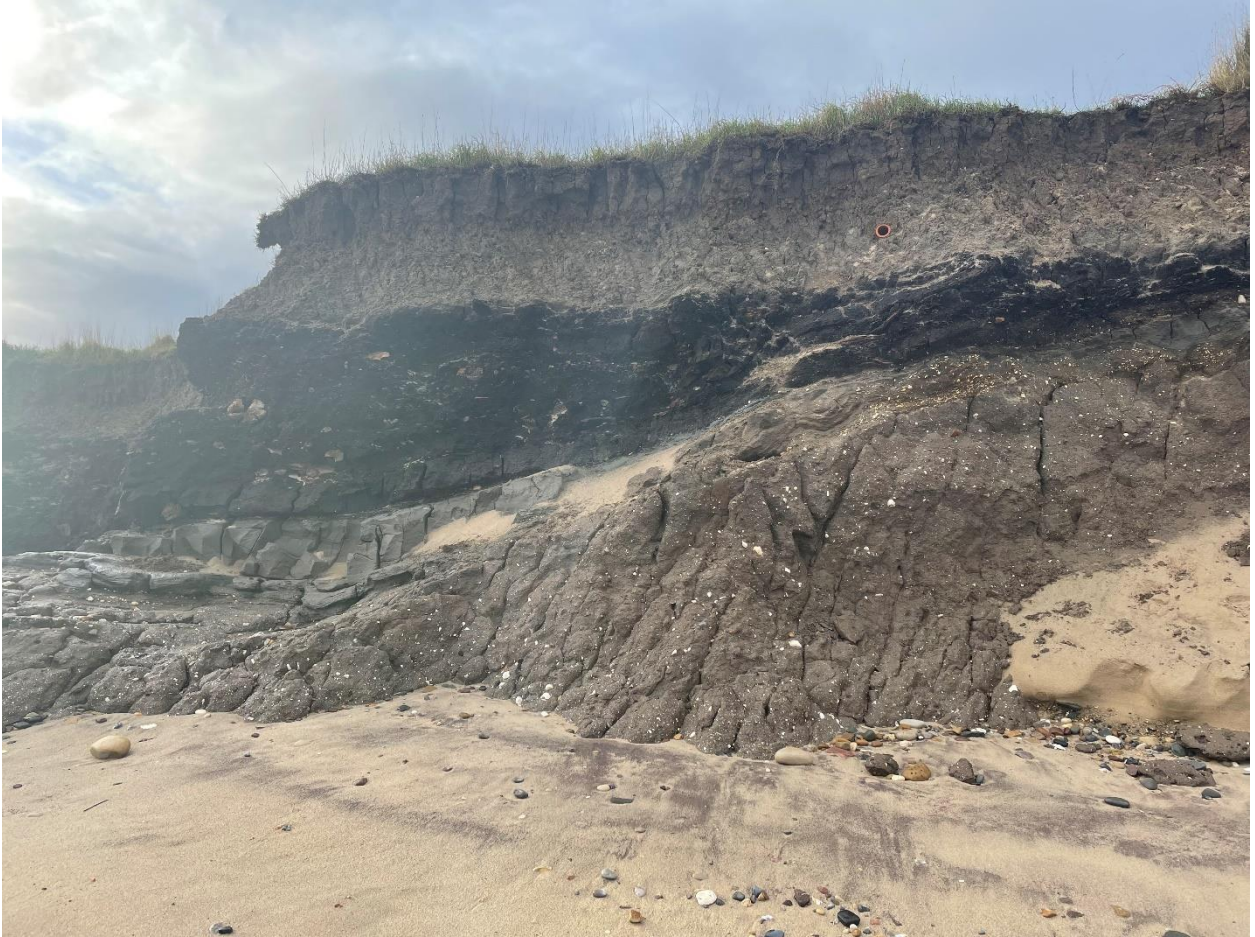
15. An organic deposit was observed in the cliffs at the recorded location (). A prehistoric animal bone was reported to have been found in the same location although no faunal remains were noted during the walkover survey.

Plate 22-4-1 Organic deposit observed in cliff during heritage walkover survey

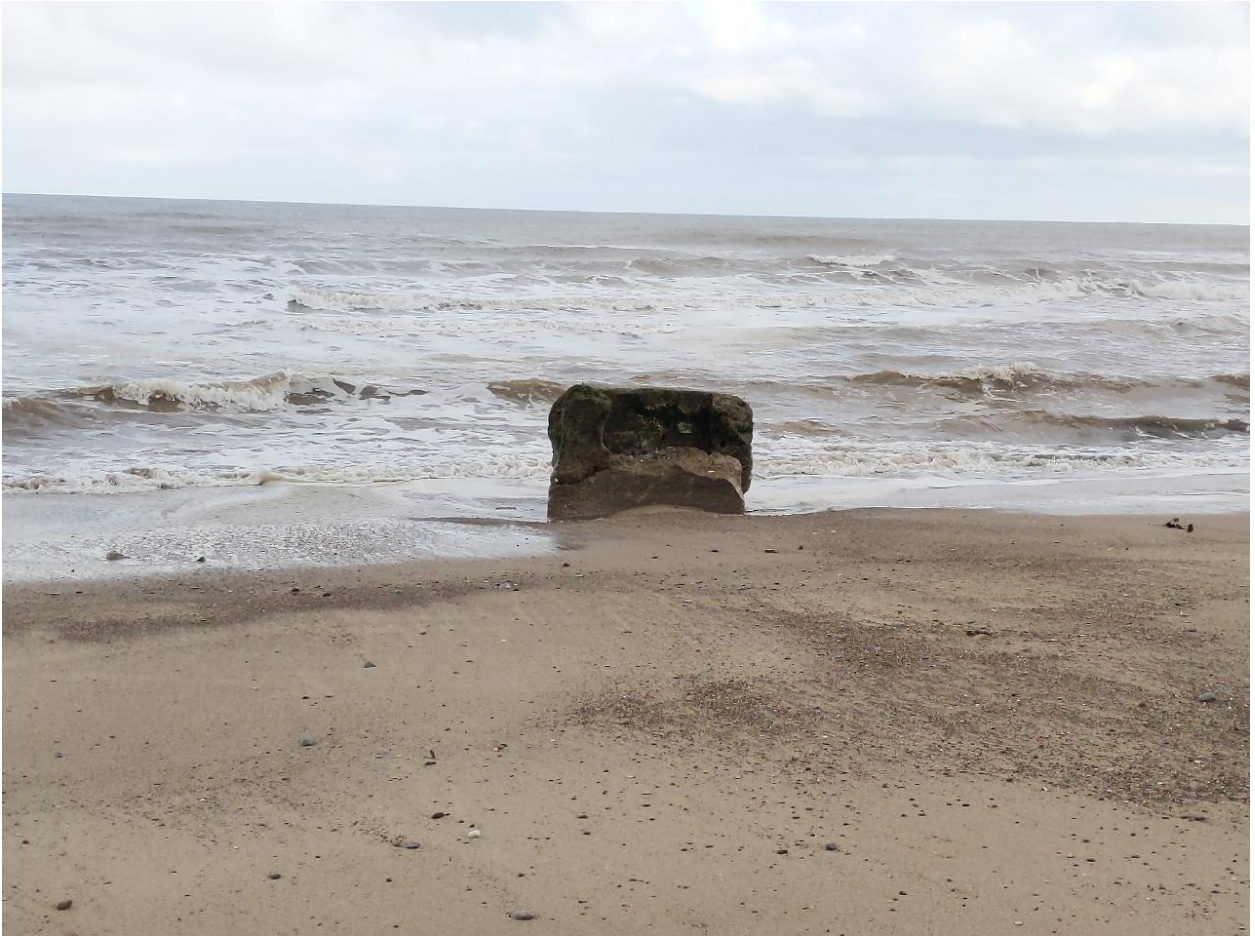
16. As recorded on the Humber HER, the remains of a WWII pillbox were observed on the beach, just to the north of the southern landfall option. These were heavily eroded with only a small corner of the pillbox surviving (**Plate 22-4-2**).

Plate 22-4-2 Remains of WWII pillbox (21224) on beach

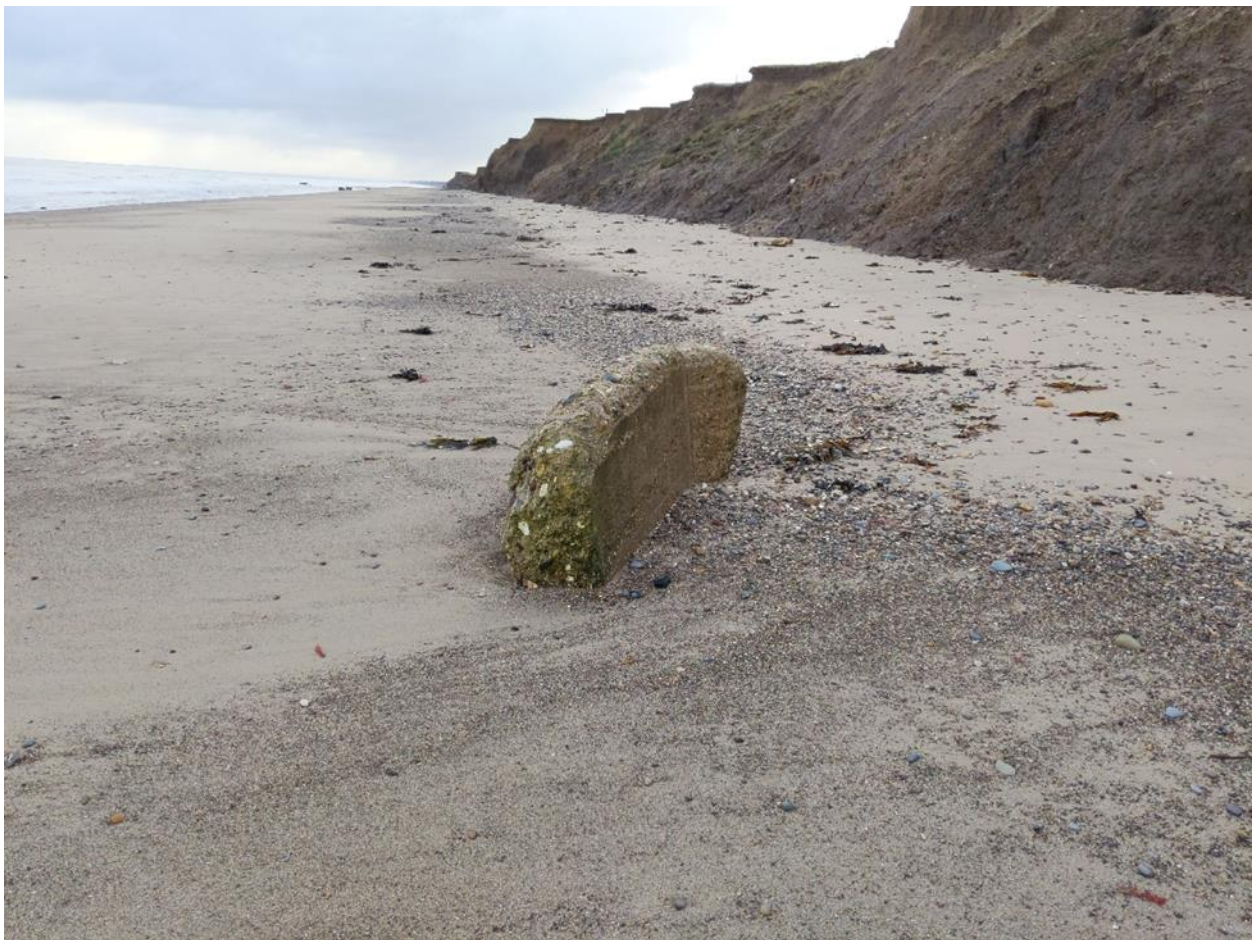
17. The Humber HER records this WWII pillbox as an eared pillbox which gets its name from its unusual entrance arrangement which from some angles appear to look like ears. This type of pillbox is only found in the North East along the stretch of coast between Scarborough and Withernsea.
18. As shown in **Plate 22-4-3** it is largely broken up with only fragments remaining and would have originally been located on the cliff. The remains of this pillbox are located in between the two landfall options.

Plate 22-4-3 View of concrete remains of WWII pillbox remains (21233)

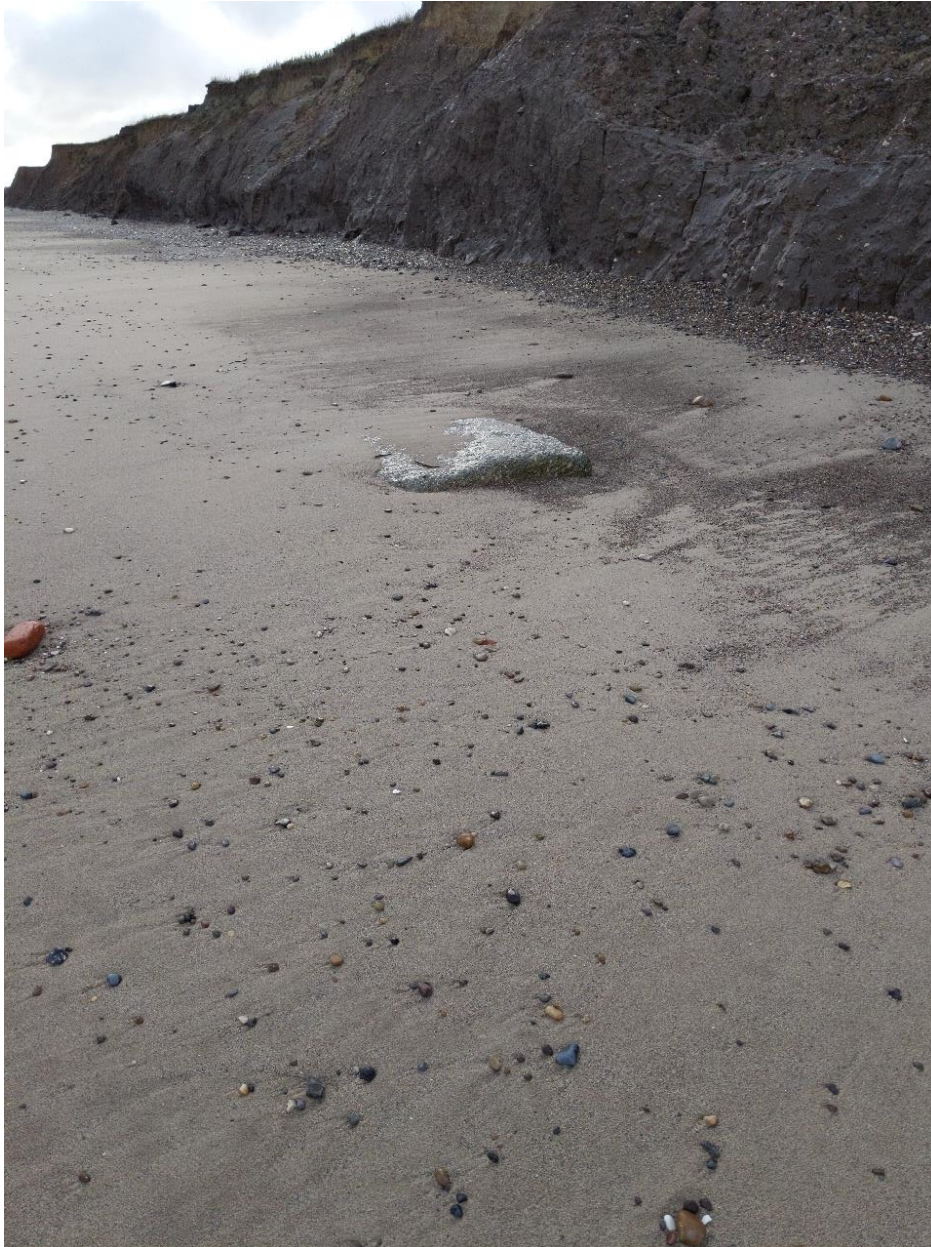
19. As with the pillboxes discussed above, the original location for this pillbox was on the cliff, however due to coastal erosion it is now on the beach with the remains only partially visible in the sand (**Plate 22-4-4**).

Plate 22-4-4 WWII pillbox (21237) remains on beach

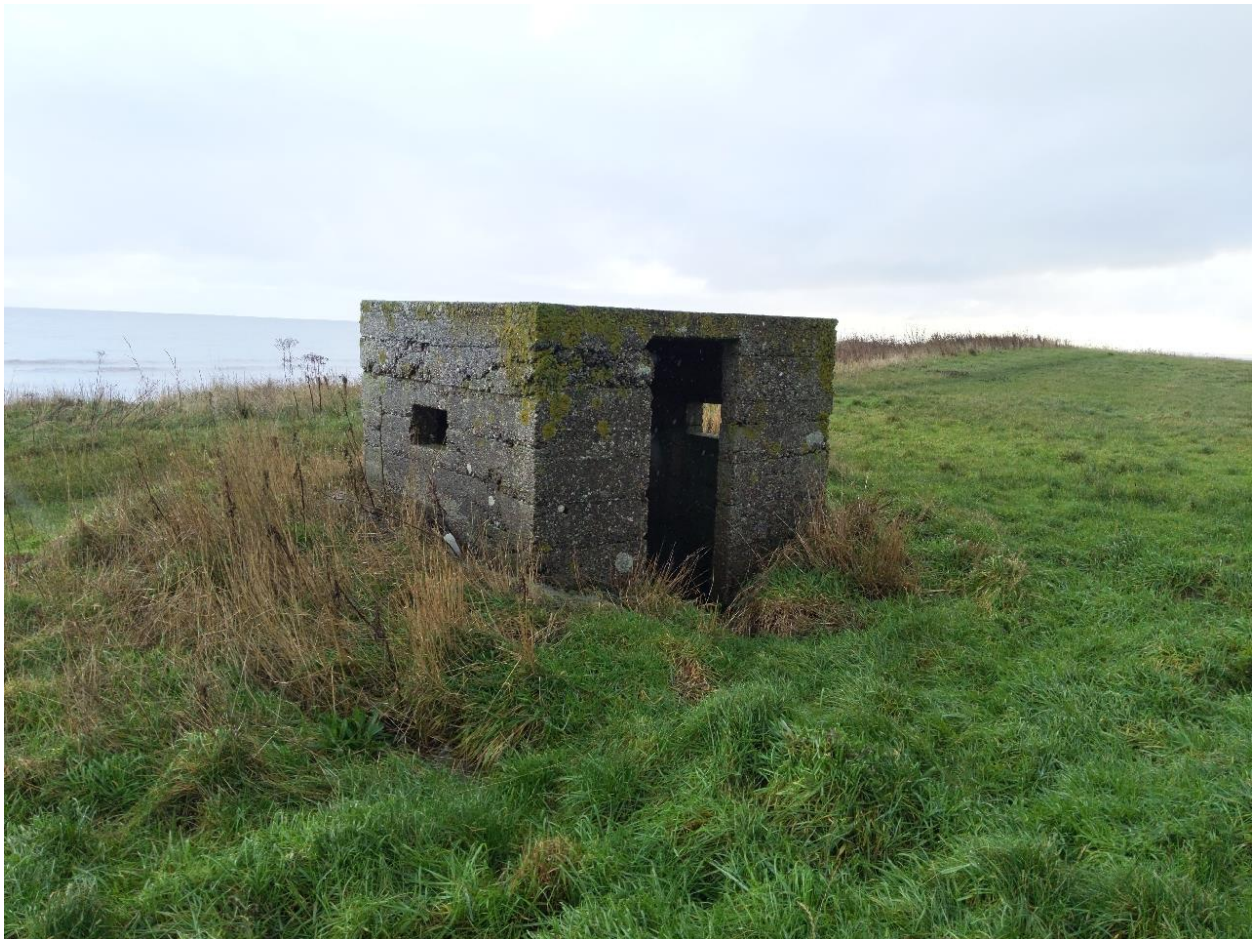
20. This WWI square pillbox is still extant on the edge of the cliff within the southern landfall option and is in good condition (**Plate 22-4-5**).
21. It was originally constructed on the line of a field boundary ditch to the east of two earlier weapons pits (no extant remains) but now lies within an enlarged field near to the cliff edge.
22. The pillbox lay within a series of WWII earthworks and defences and thought to be contemporary however it was later identified as being of WWI construction.

Plate 22-4-5 WWI Pillbox (21240) on cliff edge

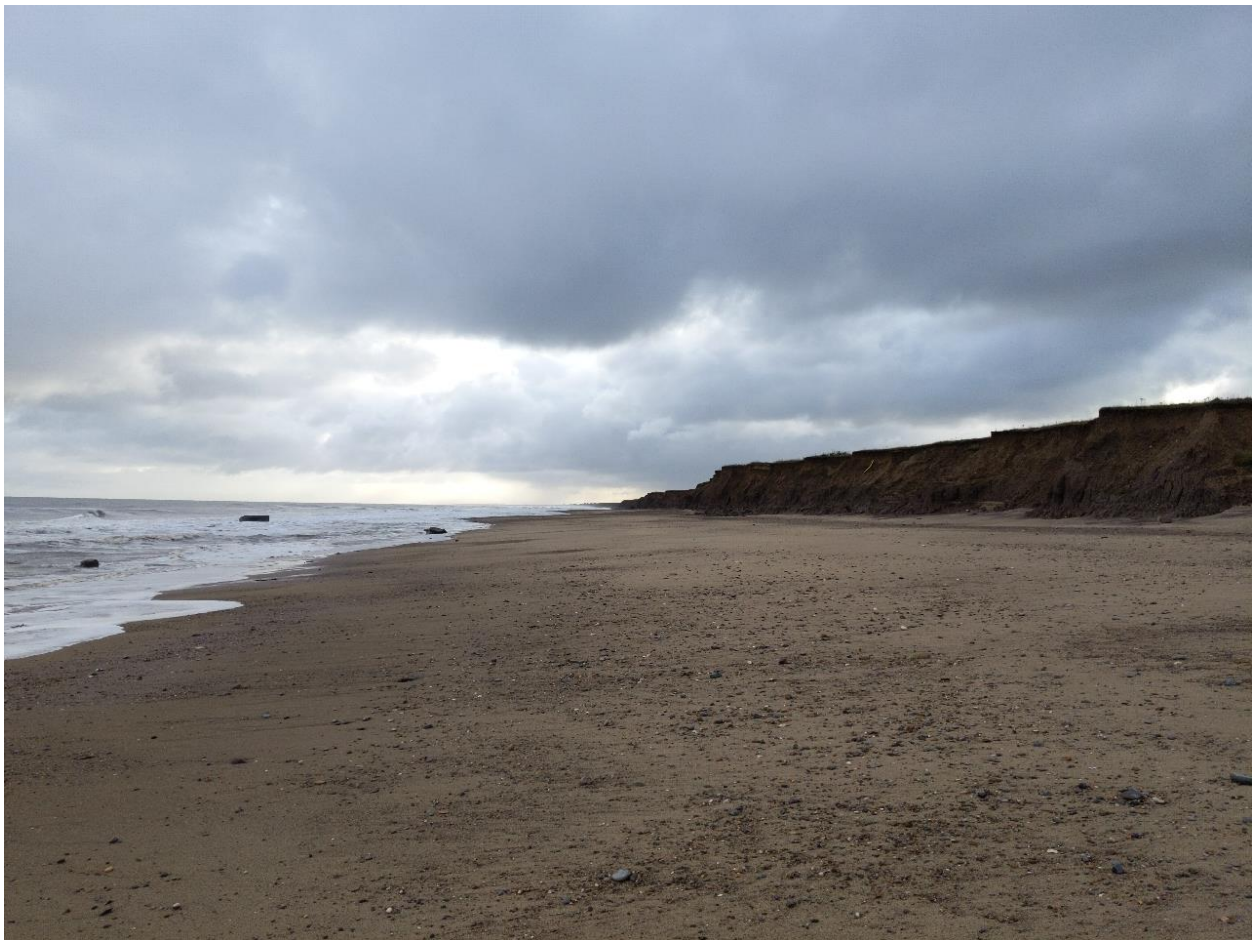
23. Located within the intertidal zone towards the northern end of the southern landfall option, were the probable remains of a WWII pillbox (**Plate 22-4-6**).
24. The Humber HER records a pillbox roof at his location. However, it was unclear during the walkover survey as to which section of the pillbox structure is represented by the remains due to the level of deterioration and their location partially within the sea at low tide.

Plate 22-4-6 Possible remains of WWII pillbox (21242) within sea

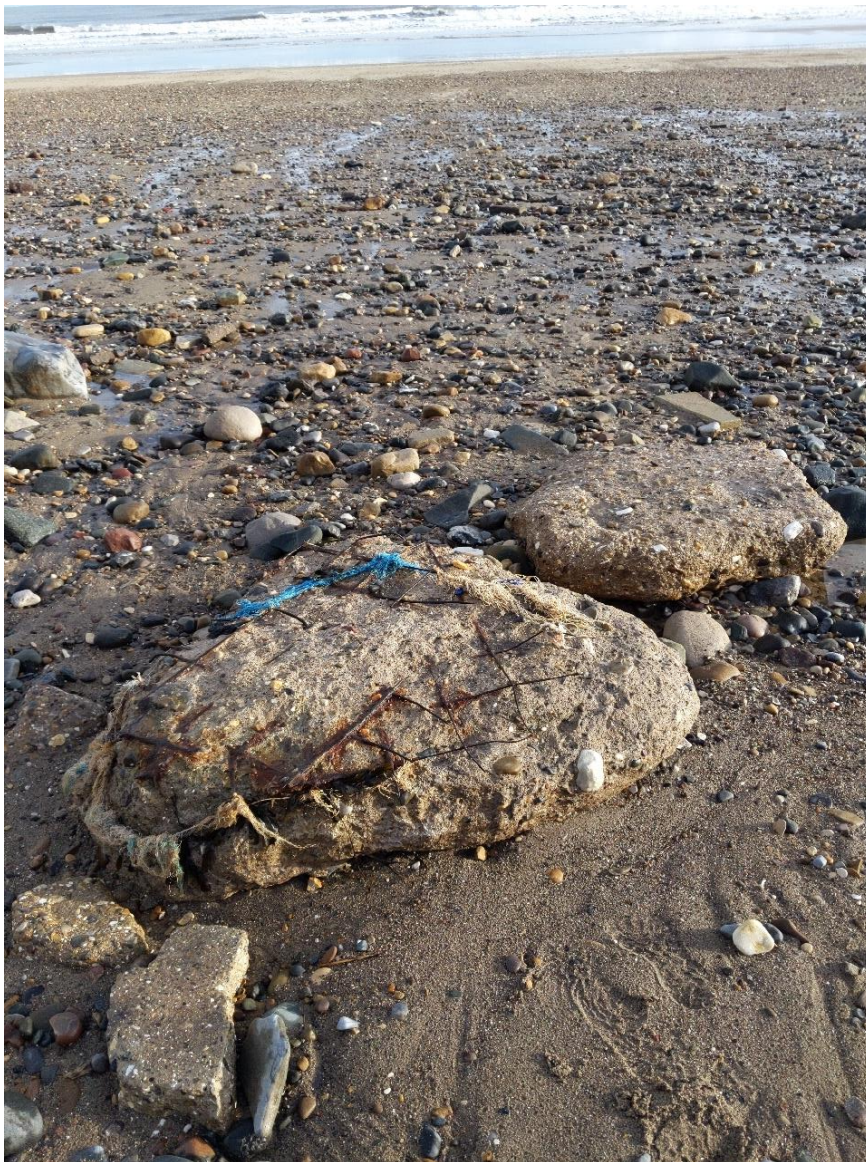
25. The Humber HER records WWII beach obstacles consisting of a concrete block with steel pipes located just to the north of the southern landfall option (**Plate 22-4-7**).
26. The beach was littered with concrete and metal debris, particularly along this stretch. However, makeshift seaside huts (MHU21797) also once stood on the cliff here and the observed remains may be associated with other such structures.

Plate 22-4-7 Possible remains of WWII beach obstacles (21244)

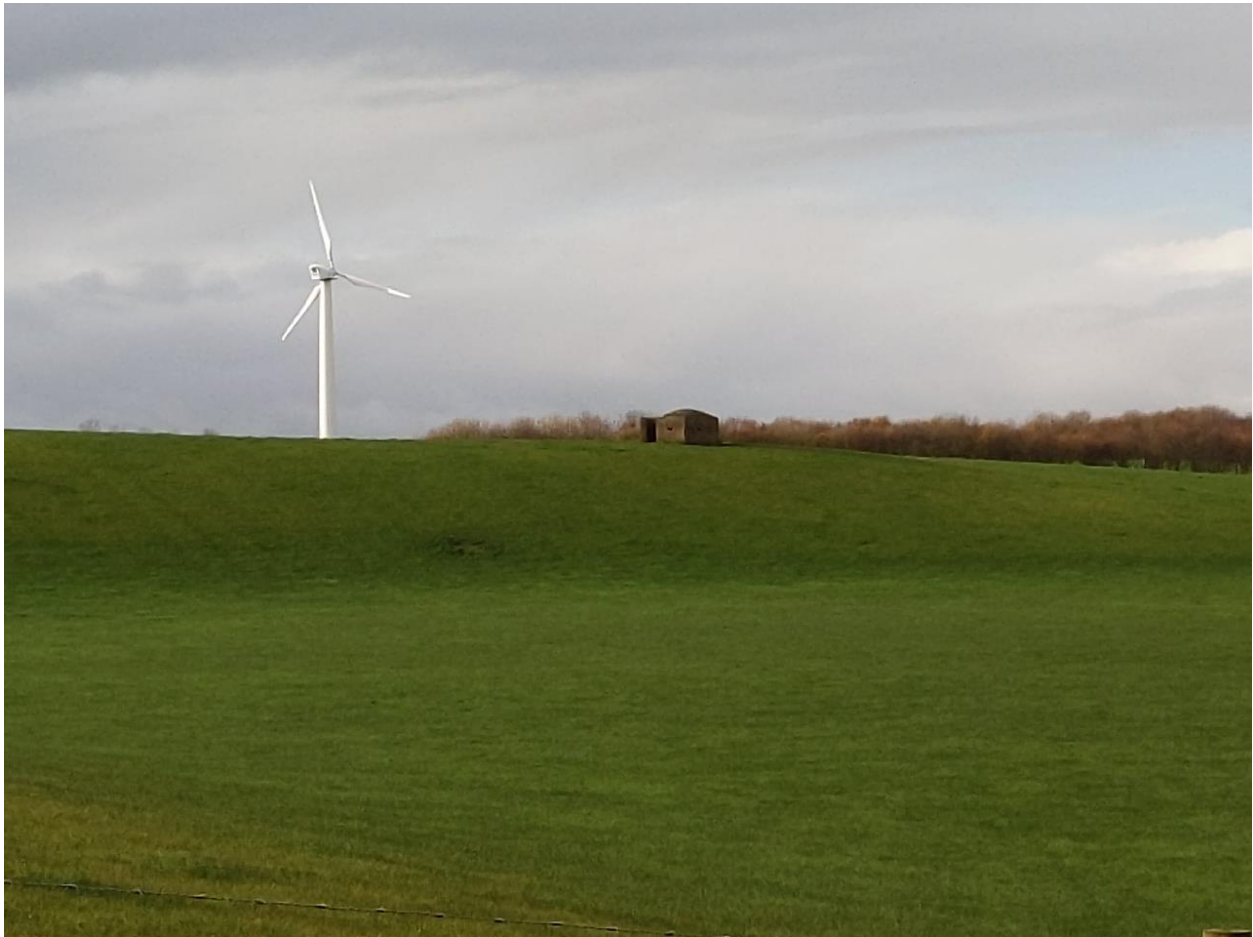
27. The WWII pillbox is recorded on the Humber HER as visible on aerial photographs, surrounded by a barbed wire perimeter. The pillbox is lozenge-shaped with a rear blast wall which was still visible in 2009. It is located within the northern section of the southern landfall option.
28. During the walkover survey, a close inspection of the pillbox was not possible due to crop cover, however the pillbox appeared to be in good condition (**Plate 22-4-8**).

Plate 22-4-8 Long distance view of WWII pillbox with blast wall still present (18422)

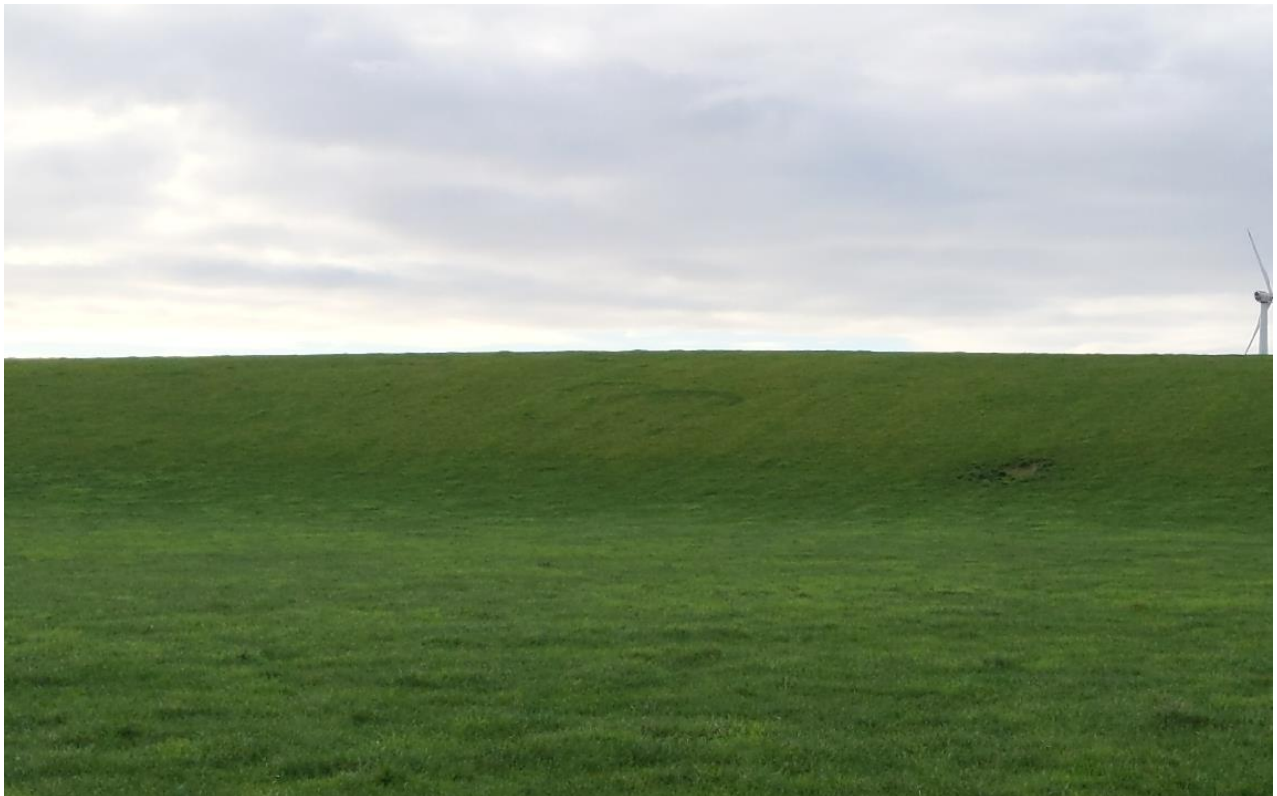
29. The Humber HER records WWII military coastal defences shown on aerial photographs in the form of barbed wire obstructions, minefield, aircraft construction and weapons pits. Whilst there were no extant features relating to these military defences observed during the survey, there were some semi-circular cropmarks visible further inland from the recorded location (**Plate 22-4-9**). It is unclear what these cropmarks represent.

Plate 22-4-9 Semi-circular cropmarks further inland from asset 21215

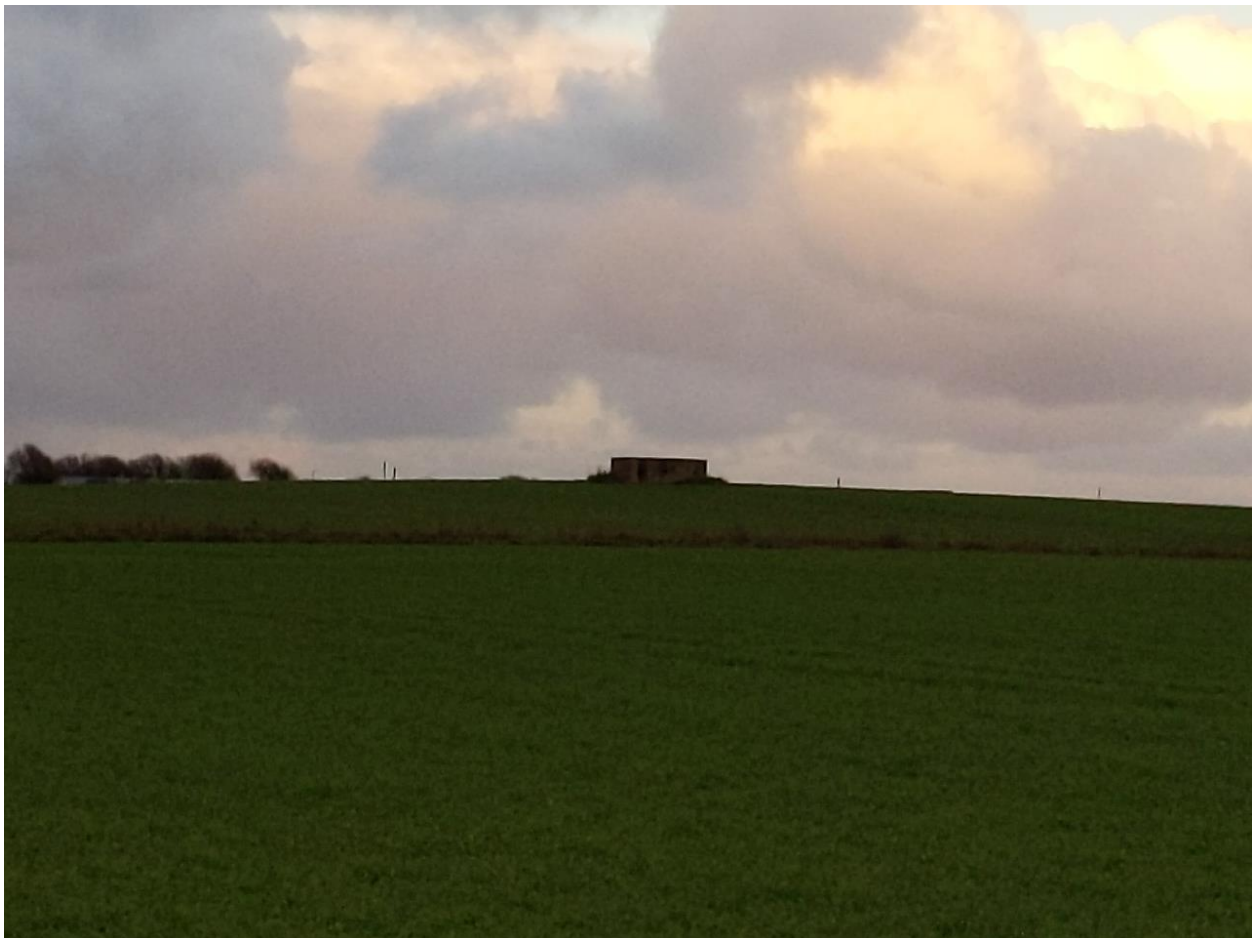
30. The WWII pillbox is located within the middle of an arable field towards the northern end of the northern landfall option. The pillbox is recorded as lozenge-shaped with a rear blast wall still visible in 2009.
31. The Humber HER also records a barbed wire obstruction surrounding the pillbox and a trackway visible on aerial photographs. A trench, two potential weapons pits and bomb craters are also visible as earthworks. The bomb craters and construction site for the pillbox are visible as earthworks on aerial photographs taken in July 1940, with the pillbox and surrounding barbed wire, the trackway, the trench, and the potential weapons pits visible on aerial photographs taken in March 1941.
32. It was not possible to get a close up view of the pillbox due to the crop cover across the field, however it appeared to be in good condition from the edge of the field (**Plate 22-4-10**).

Plate 22-4-10 Long distance view of pillbox (9990)

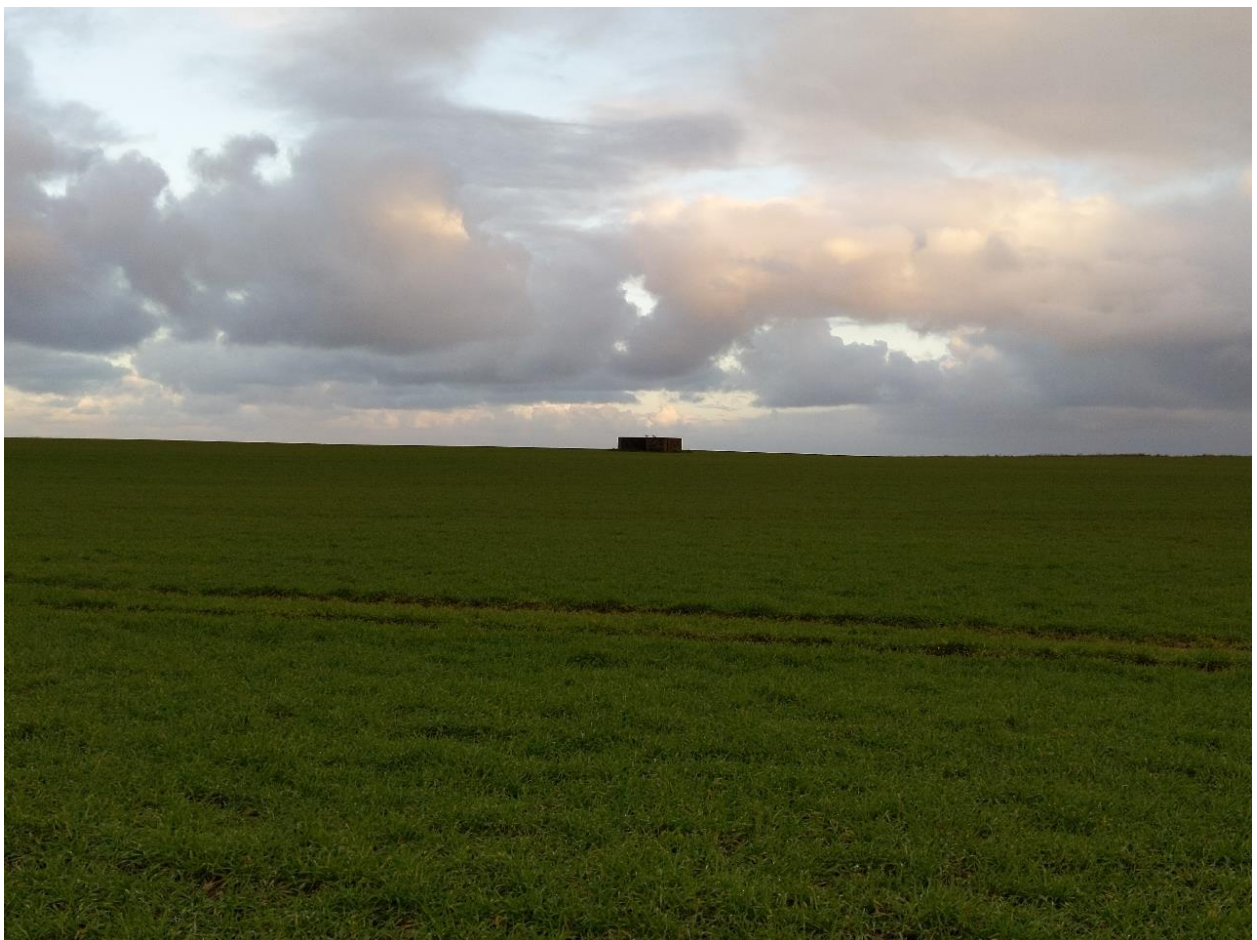
33. In the field directly south of that containing pillbox (9991), was another WWII lozenge-shaped pillbox with a rear blast wall which was recorded as extant in 2009.
34. The pillbox was located towards the centre of the field, and it was not possible to get a close up view of the pillbox due to the crop cover across the field, however it appeared to be in good condition from the edge of the field (**Plate 22-4-11**).

Plate 22-4-11 Long distance view of pillbox (9992)

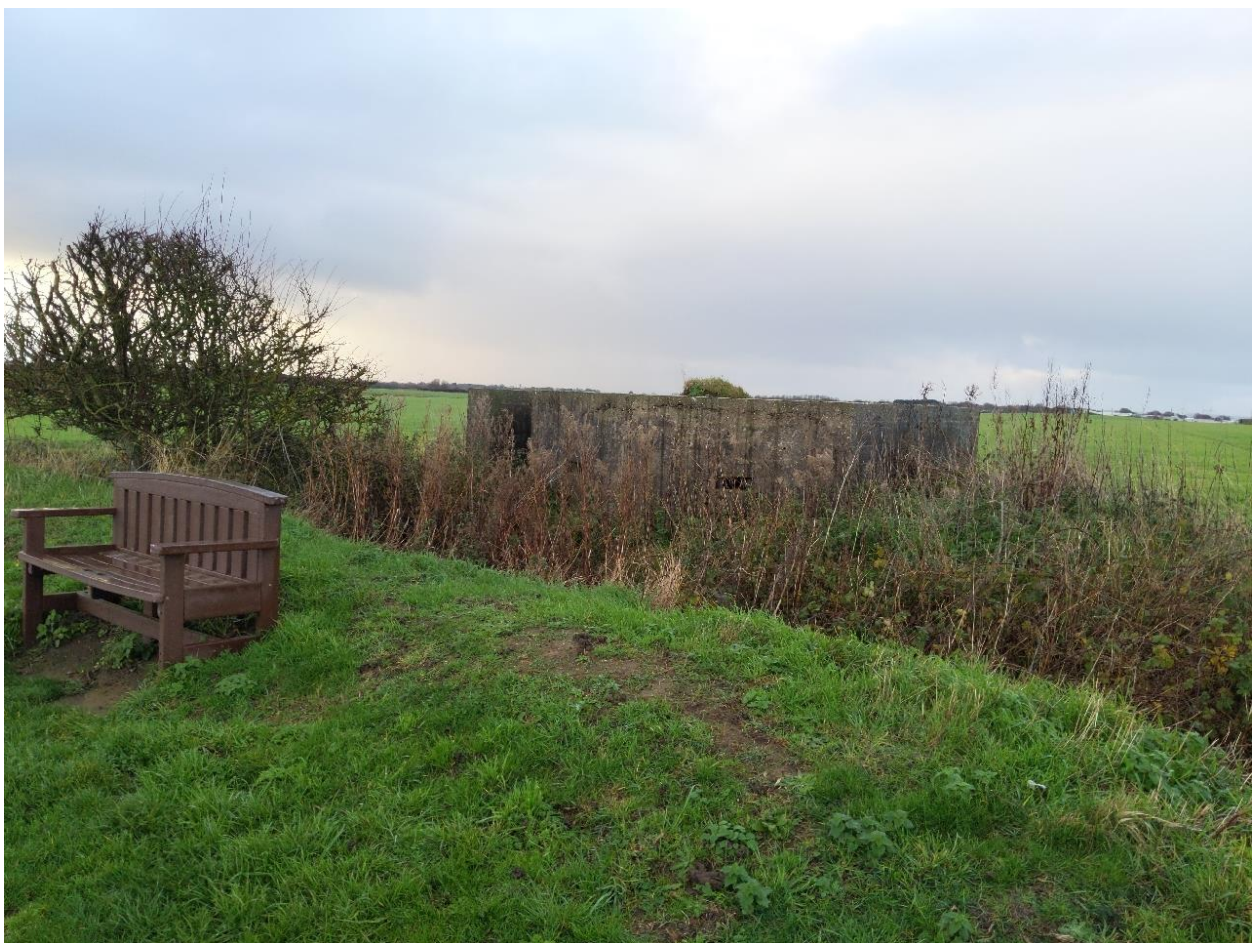
35. The WWII pillbox is situated next to the single-track road that leads to Skipsea village from the coastline along the southern boundary of the northern landfall option.
36. The pillbox is lozenge-shaped with a rear blast wall in good condition (**Plate 22-4-12**). The Humber HER records the pillbox as having a surrounding barbed wire obstruction visible from aerial photographs; however this is no longer present.

Plate 22-4-12 Pillbox at edge of field (9991)

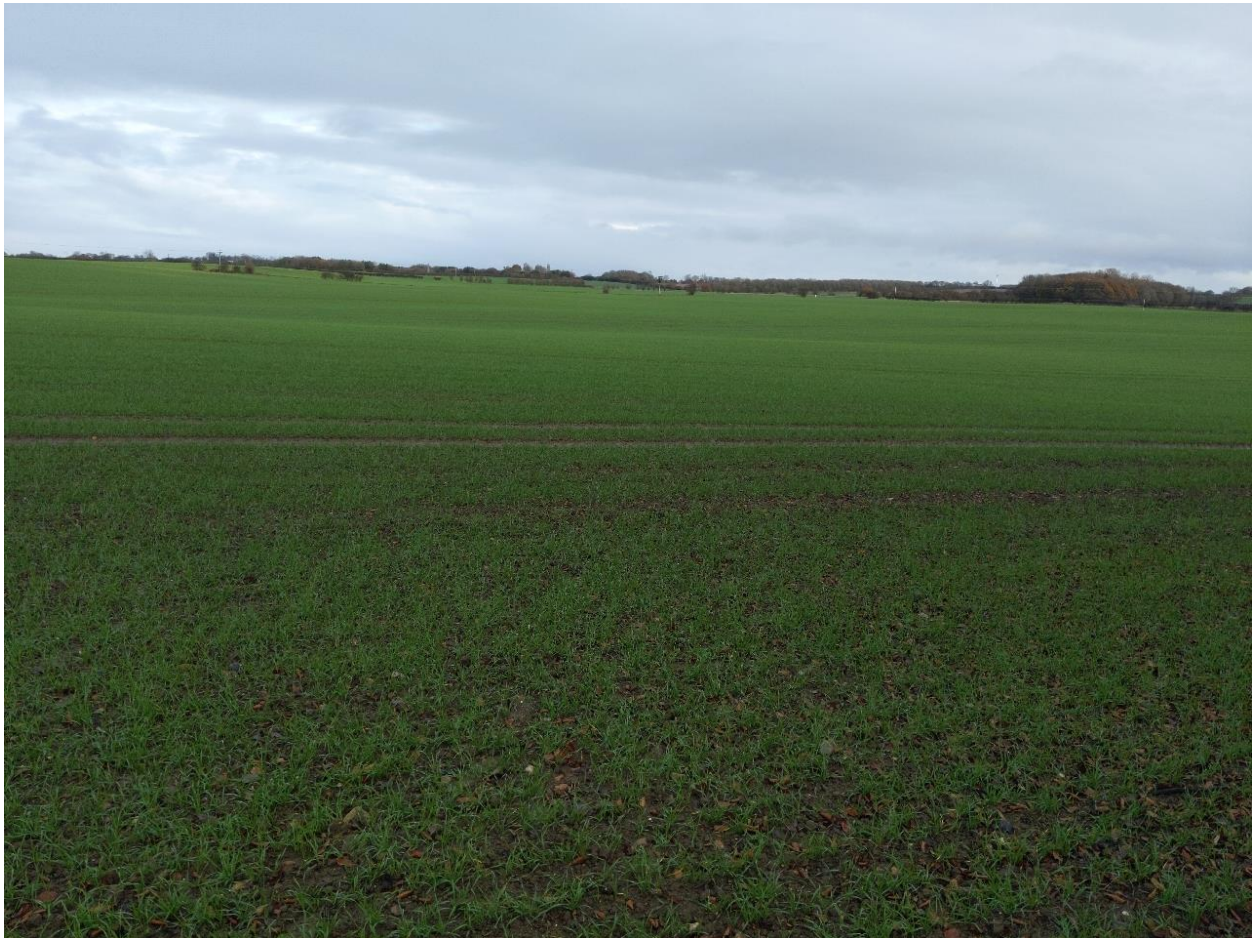
41. The Humber HER records a possible linear cropmark visible on aerial photographs.
42. During the walkover survey, no evidence of cropmarks were observed, which is typically expected for the time of year of the survey. Any differential growth as a result of buried archaeological remains is unlikely to be visible as cropmarks in the months of November to December. However, a linear earthwork was visible, which may be indicative of a former field boundary or a natural undulation across the landscape (**Plate 22-4-13**).

Plate 22-4-13 Possible linear earthwork (19463)

55. In the areas where earthworks survive as above ground heritage assets, it was noted that the majority of the earthworks were only visible as slight undulations within the landscape and were not particularly definitive as archaeological features (19463).
