Technical Note

Project name Gate Burton	Client Low Carbon	Subject Nursery House: Surface Water and Flood Risk Feedback	Date 19 May 2023
Prepared by Rob Sweet	Checked by Richard Moore	Approved by Will Barrett

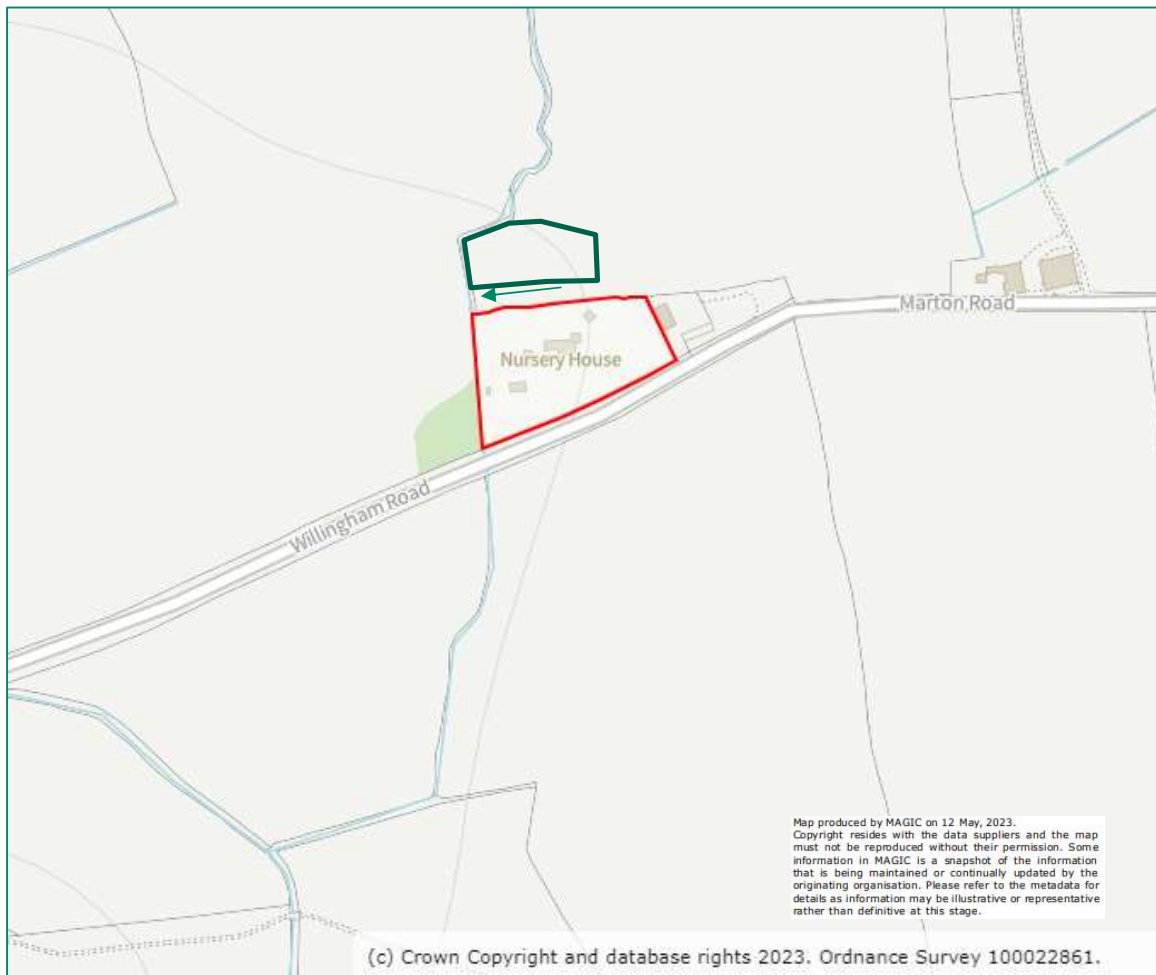
Figure 5.1 – Indicative area to north to lower/reprofile and reconnect existing ditch using open feature (arrow)

Option 1 – lower area of land to the north of Nursery House (illustrated as a green polygon in Figure 5.1) boundary and reconnect existing ditch to channel (arrow). This would create additional storage, remove the potential for the 10" diameter twin wall drainage pipe to become blocked by using an open channel feature and also provide wider potential benefits (for biodiversity).

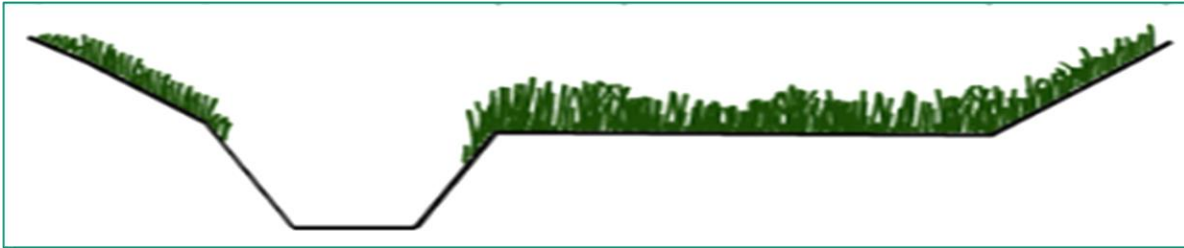
Figure 5.2 – Indicative lowering of right-hand bank (looking in a downstream direction) creating a two stage channel

Option 2 – create a two-stage channel by lowering right hand bank of the channel to the west of Nursery House. Figure 5.2 presents a schematic of how the two-stage channel could be designed while Figure 5.3 shows the indicative location of where the two-stage channel could be located.

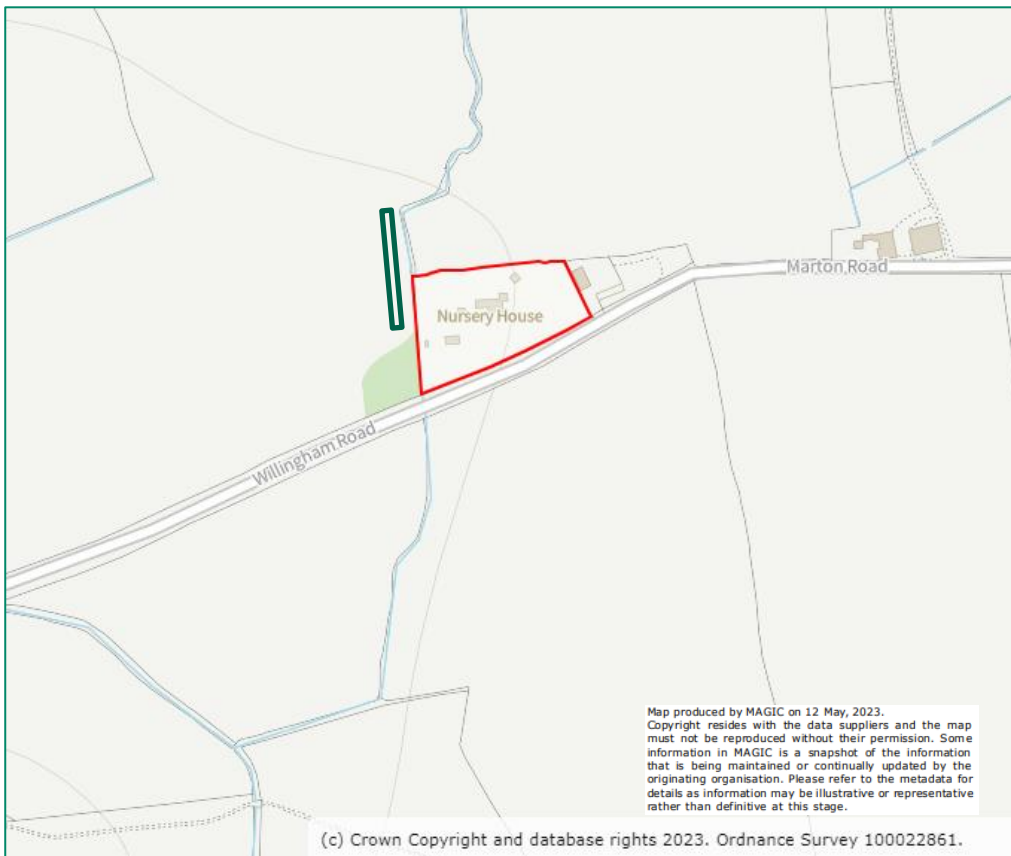
Figure 5.3 – Indicative reach for lowering right-hand bank

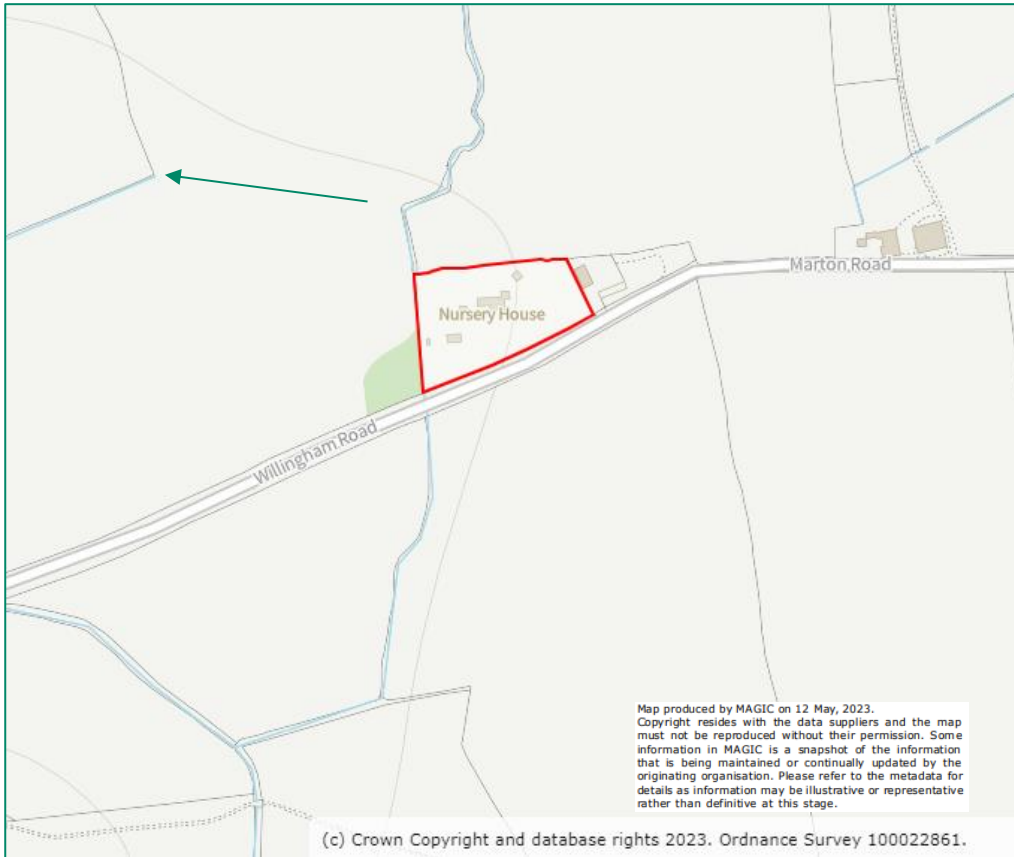
Figure 5.4 – Indicative location for connecting overland flows to existing ditch through reprofiling

Option 3 – create flow path for lower return period events to connect the channel and ditch to west (appears to be an east west flow based on the 1% AEP surface water flood map) through reprofiling of existing ground levels. Indicative location of potential flow path shown by green arrow on Figure 5.4.
