**Road Line Marking Assessment Report Covering Darlington
Borough Council Road Infrastructure Surrounding Bishopton
Parish Council Area.
Document Reference BPC/1/24/001**

This report has been written with reference to **CS 126 Inspection and assessment of road markings and road studs (formerly TD 26/17) Version 0.1.0**

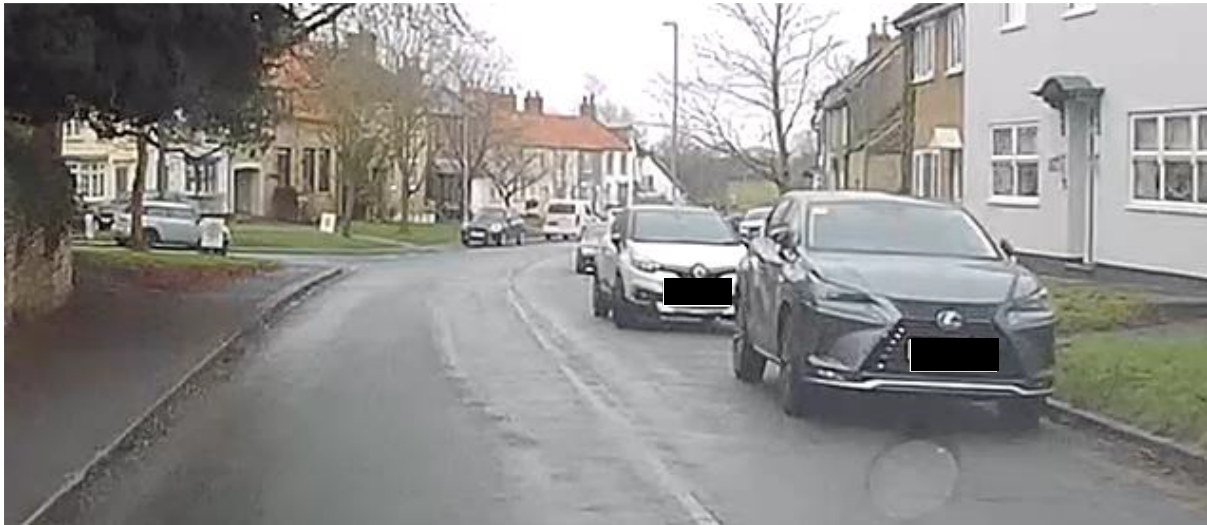
R1.2 – Condition score 10

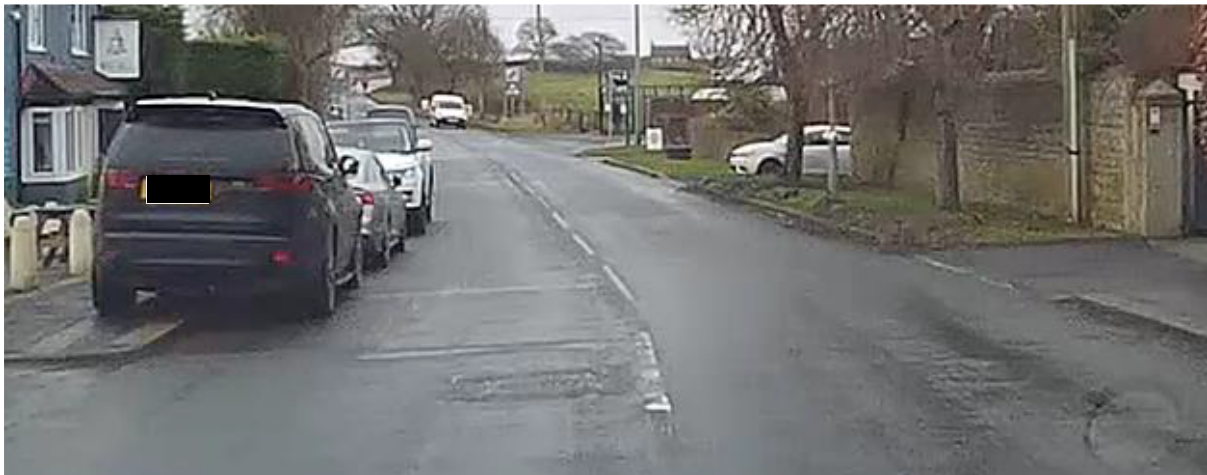
R1.3 – Condition score 10

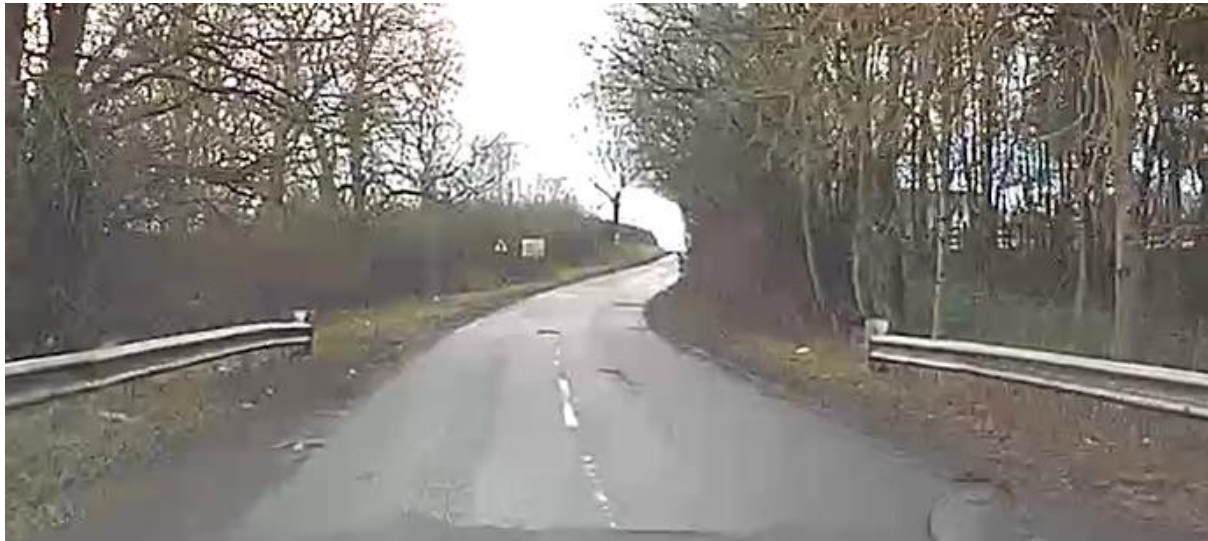
R3.25 Condition score 10

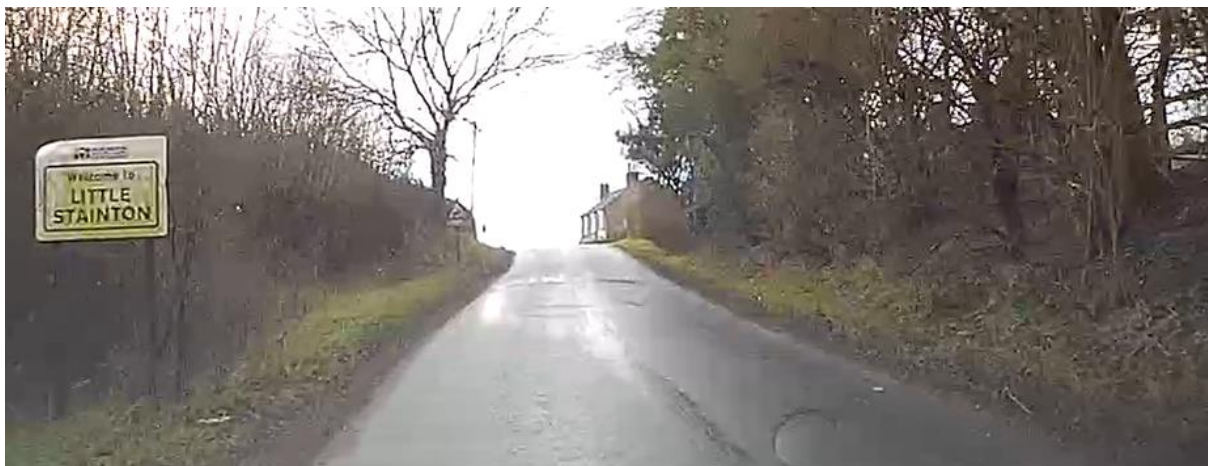
R3.26 Condition score 0

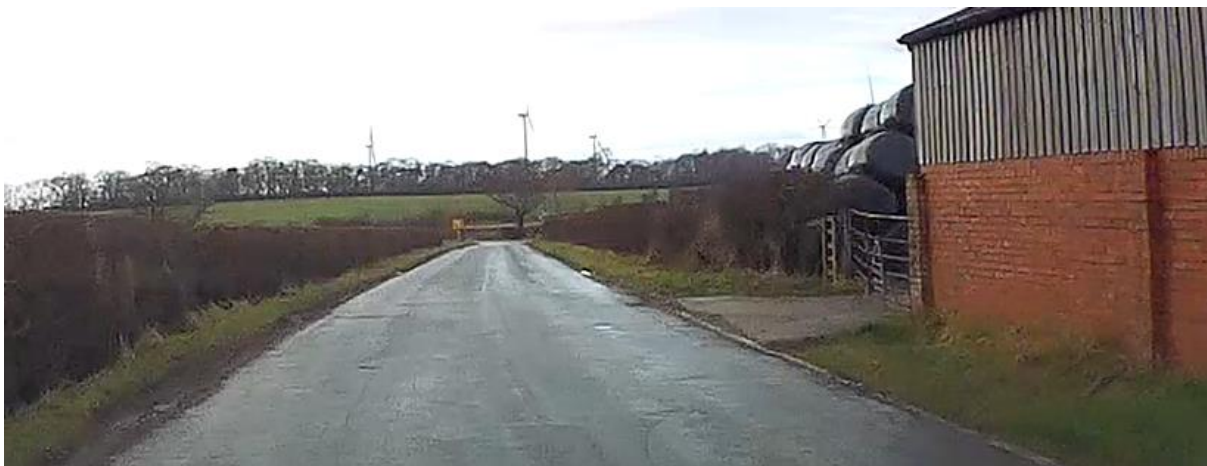
R3.31 Condition score 0

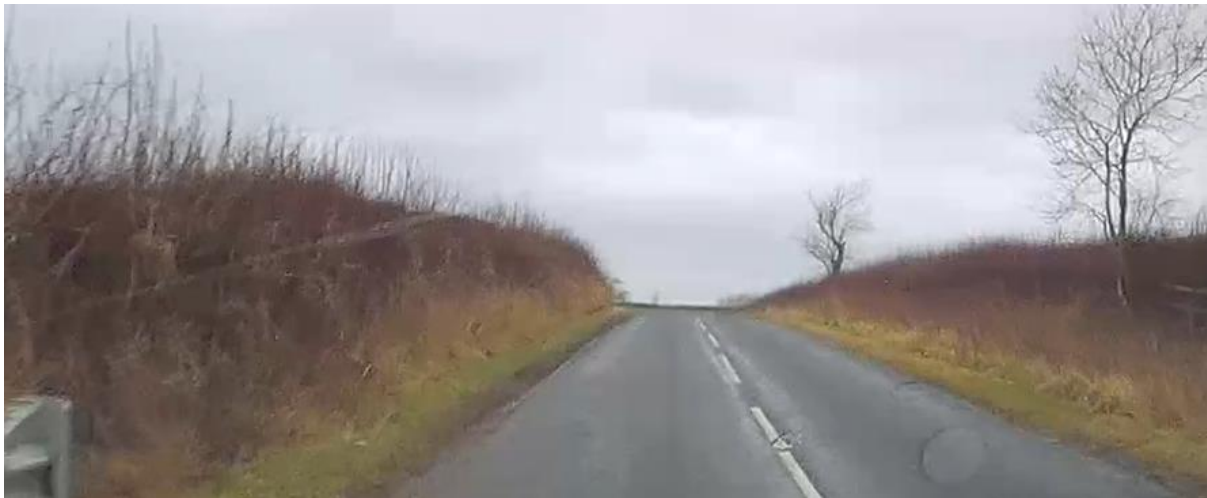
R4.12 Condition Score 30

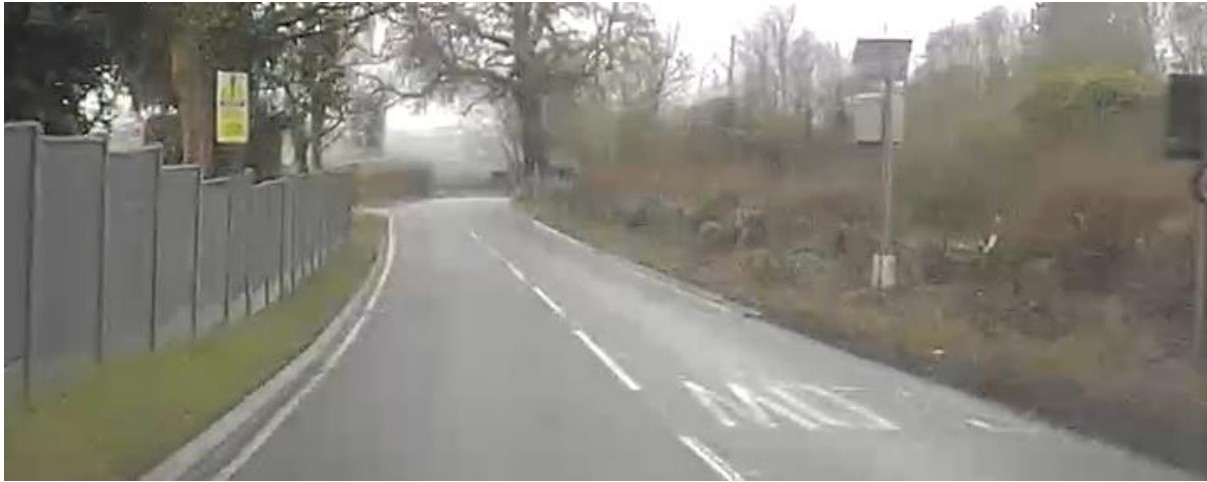
R6.13 – Condition 30 (road shoulder ,markings))

Condition 20 (slow sign)

Condition 30 (Lines)

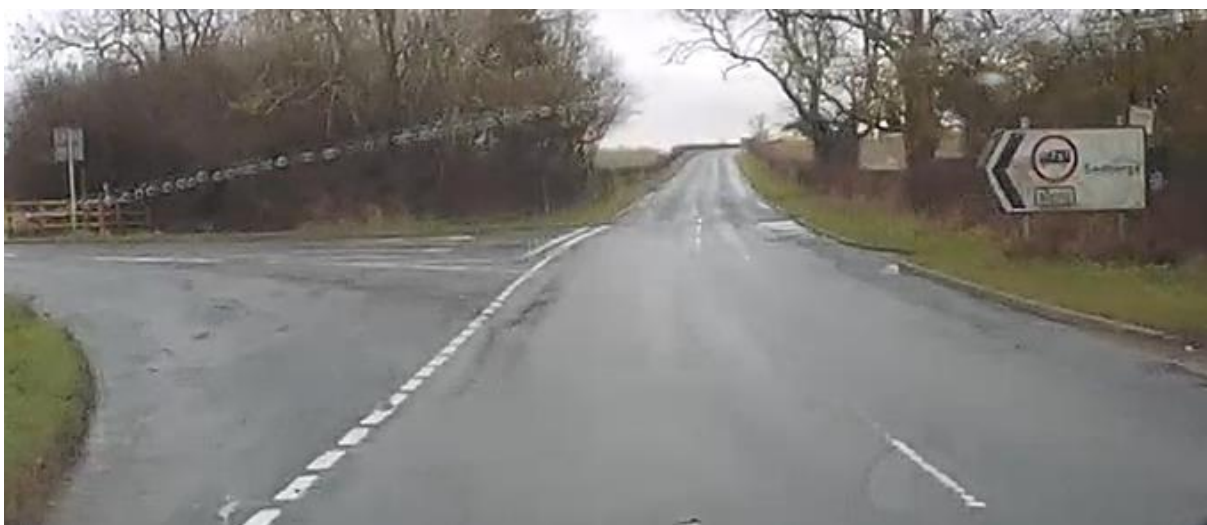
R6.41 Condition 0 Lines

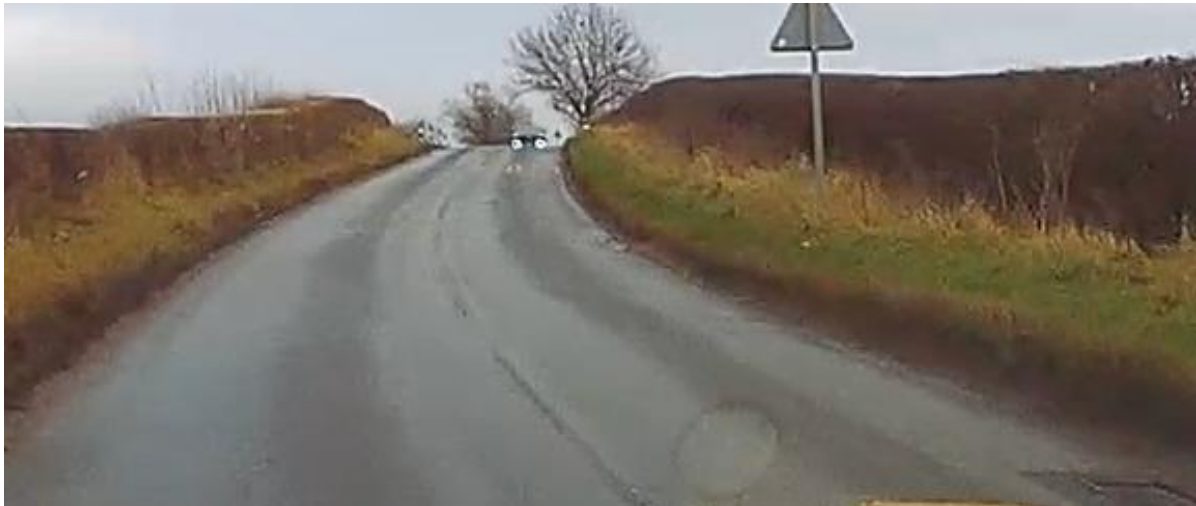
R7.8 – Condition 0

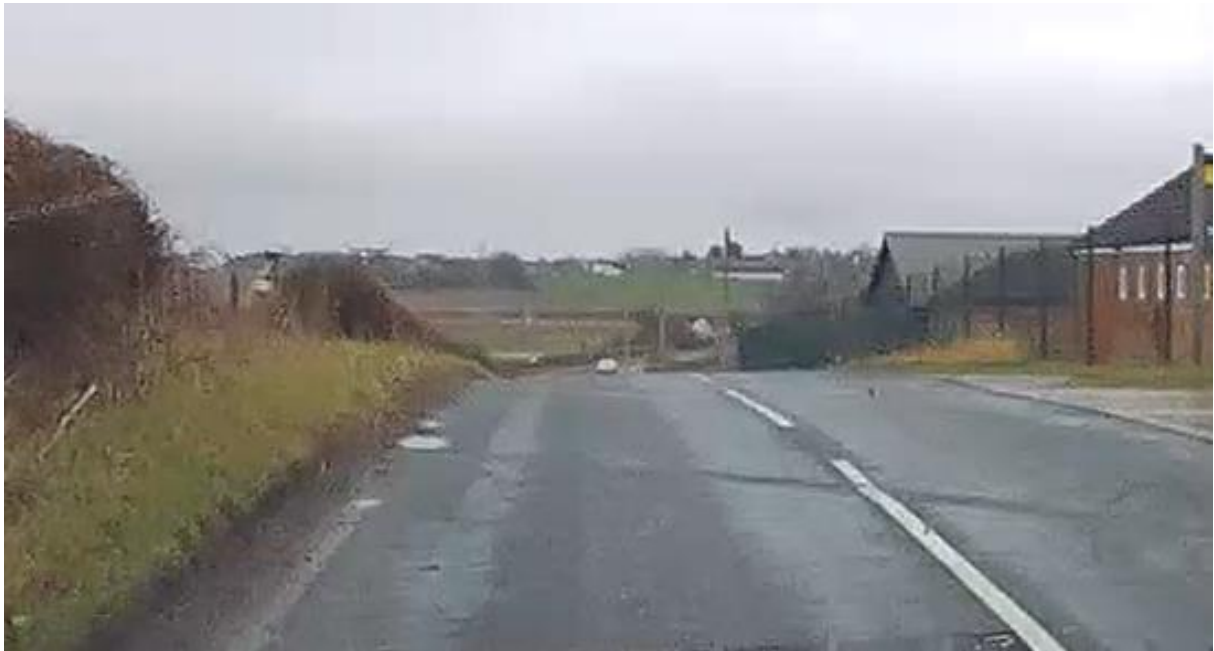
R8.11– Condition 40

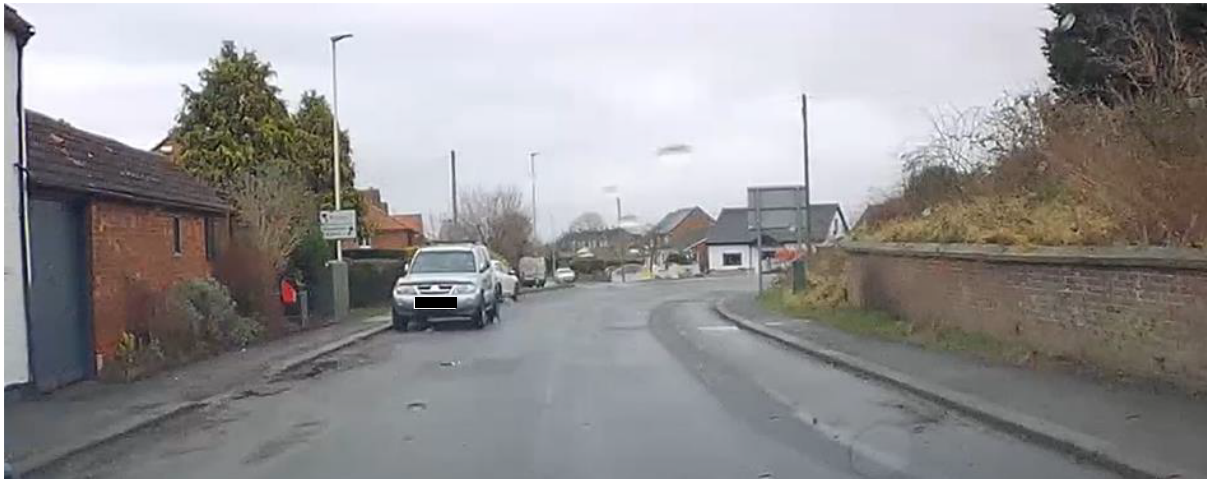
R9.2 - Condition 0

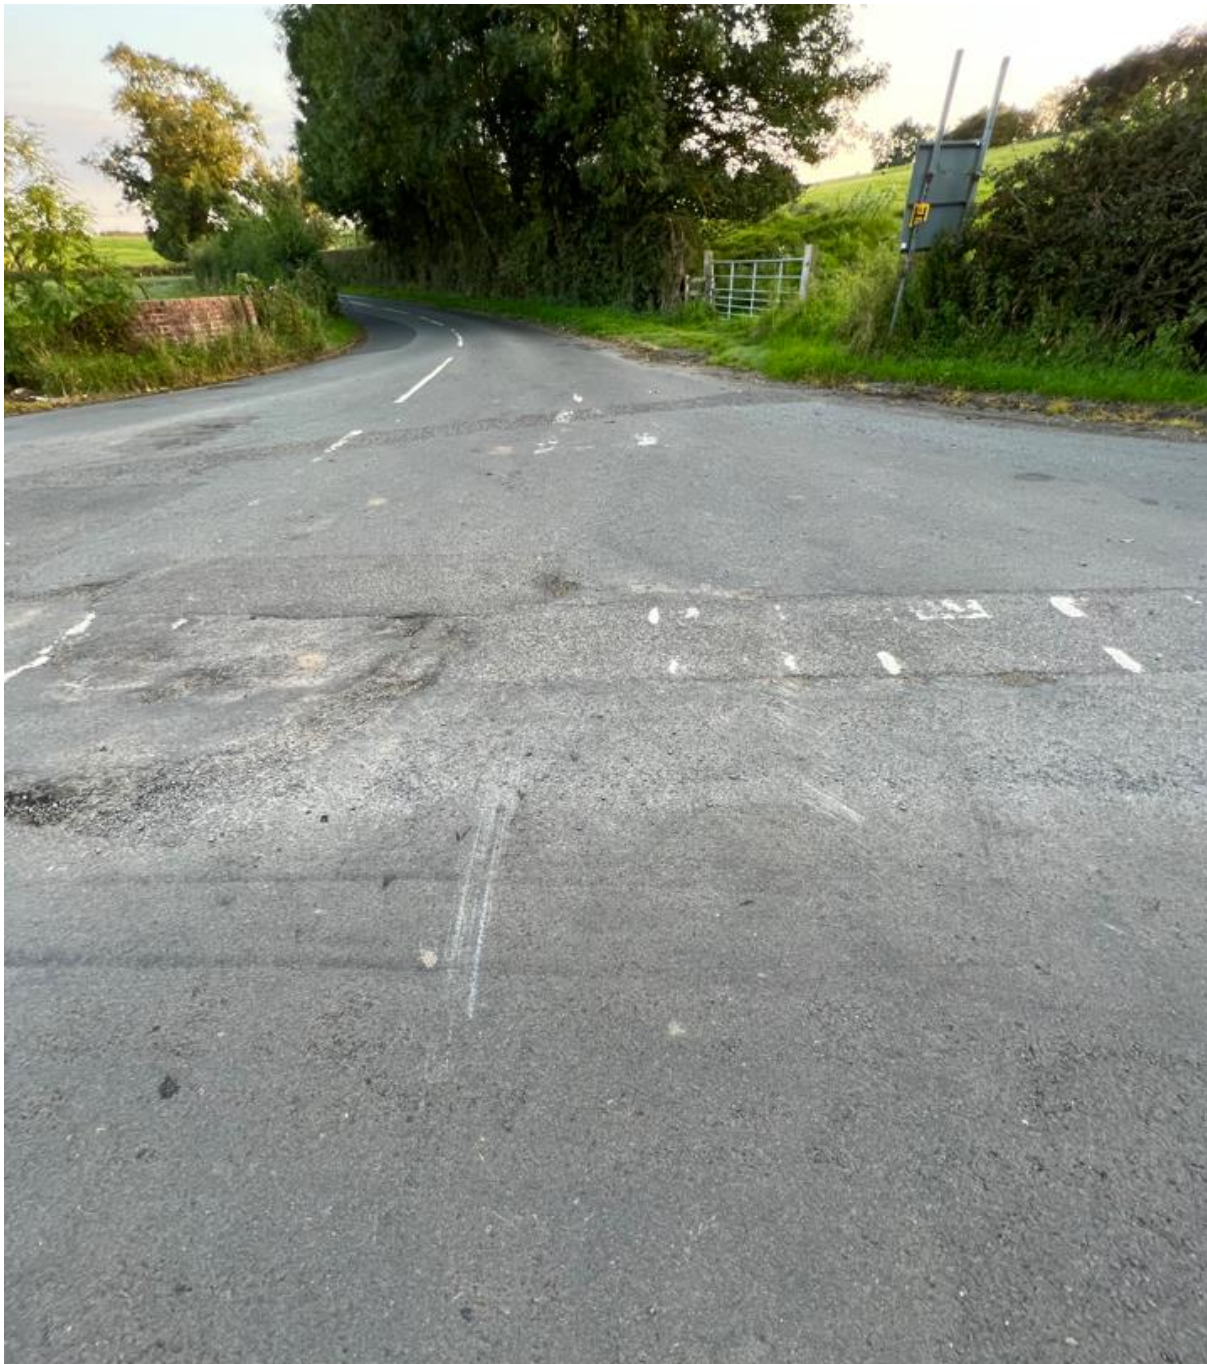
R3 Image 4

Evidence of Skid mark can be seen in gravel as vehicle failed to negotiate / stop at junction.
