**Road Line Marking Assessment Report Covering Darlington
Borough Council Road Infrastructure Surrounding Bishopton
Parish Council Area.
Document Reference BPC/1/24/001**

Document Reference	Revision	Date
BPC/1/24/001A	First issue Rev A (DRAFT internal Only)	14.01.2024
BPC/1/24/001B	Formal Issue Rev B	04.02.2024

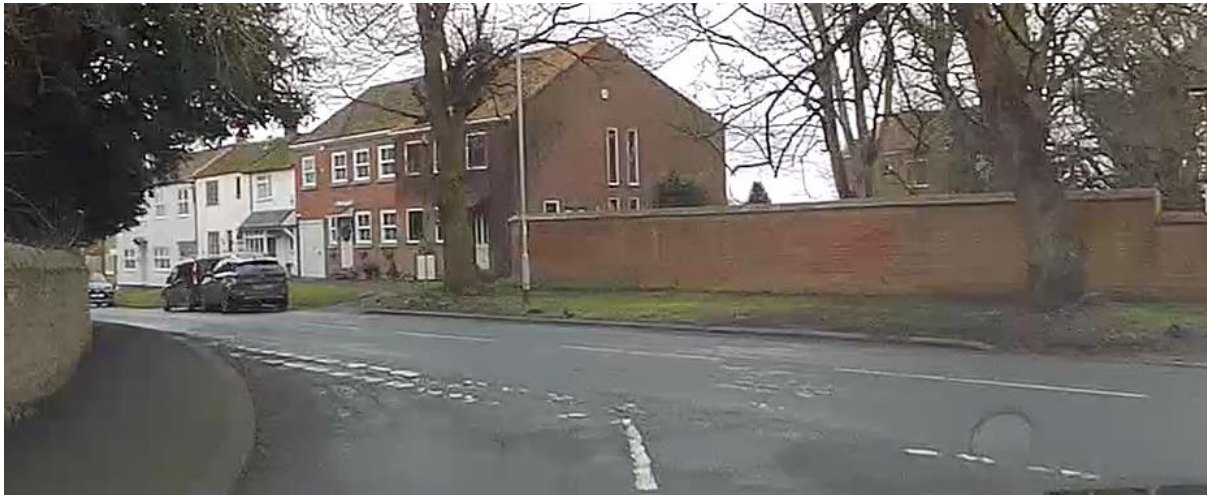
R1.1 – Condition score 10

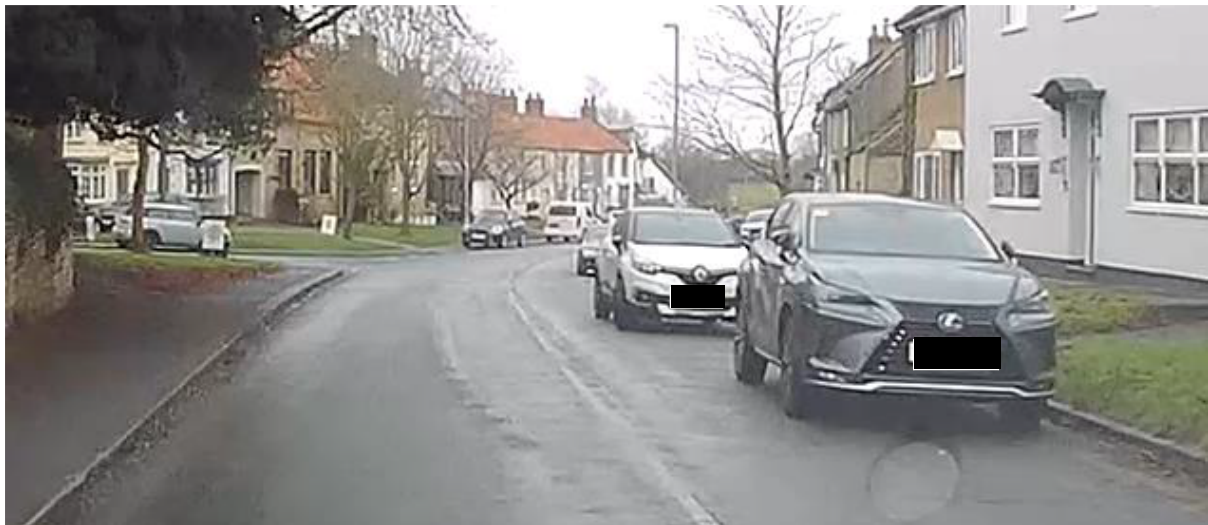
R1.2 – Condition score 10

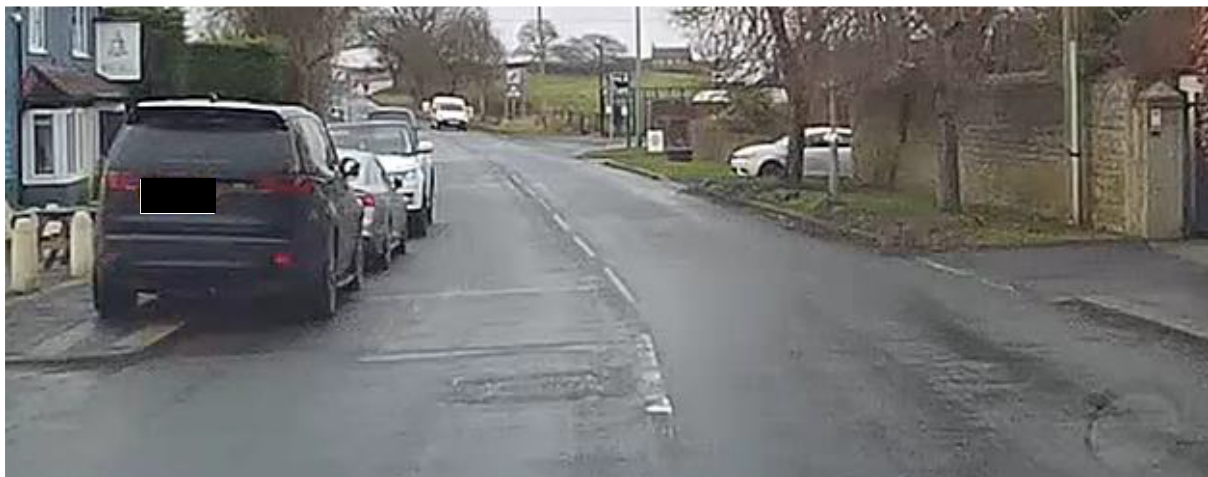
R1.3 – Condition score 10

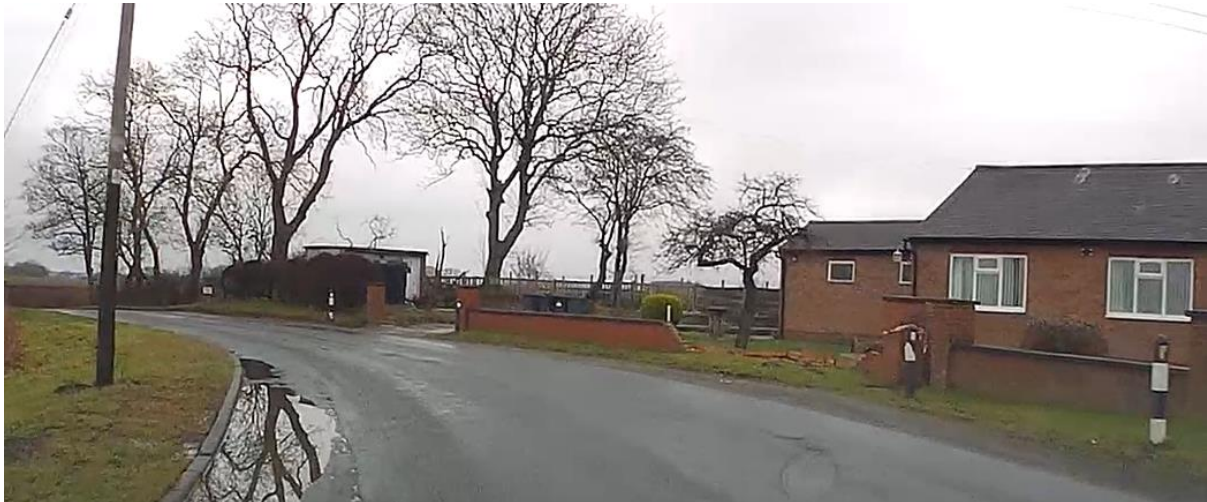
R1.19 – Condition score 20

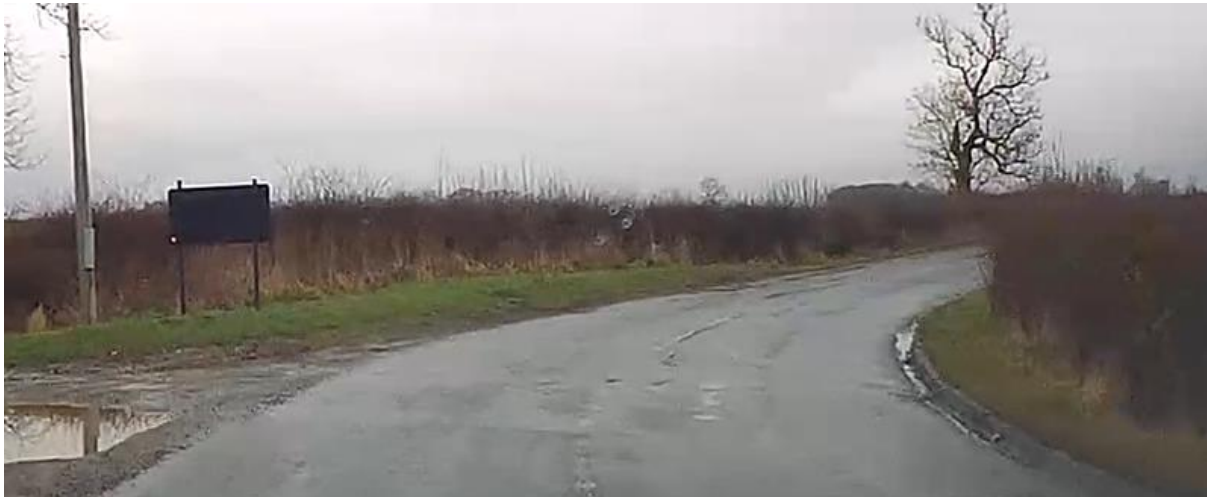
R1.22 – Condition score 10 (entering Stockton-on-Tees)

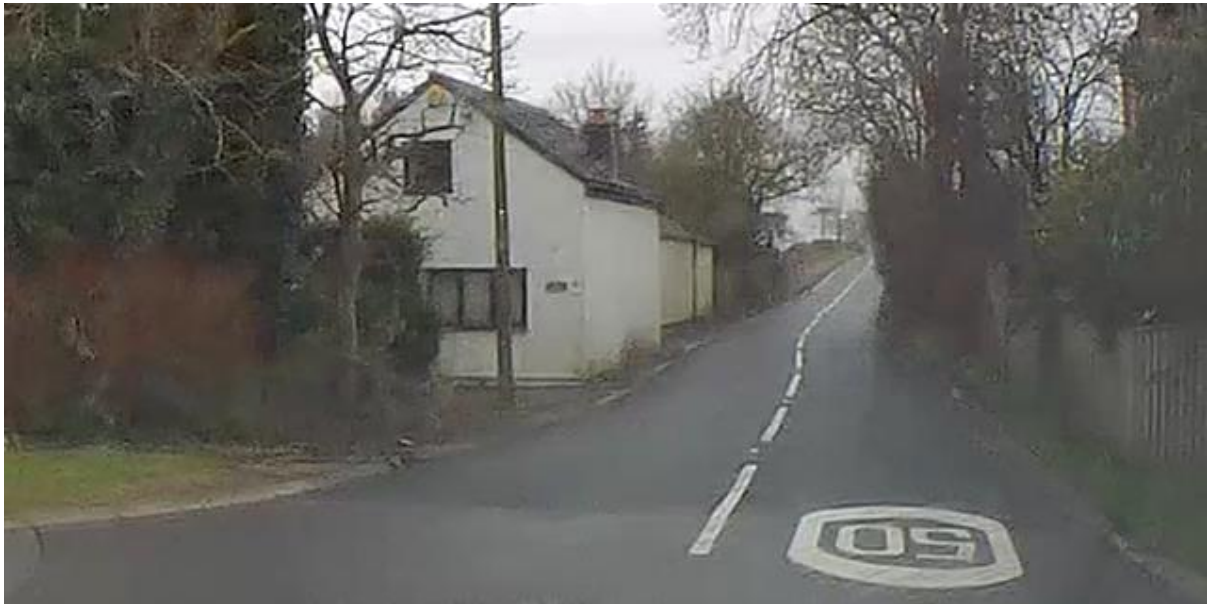
R2.2 – Condition score 50 (Stockton Borough Council infrastructure)

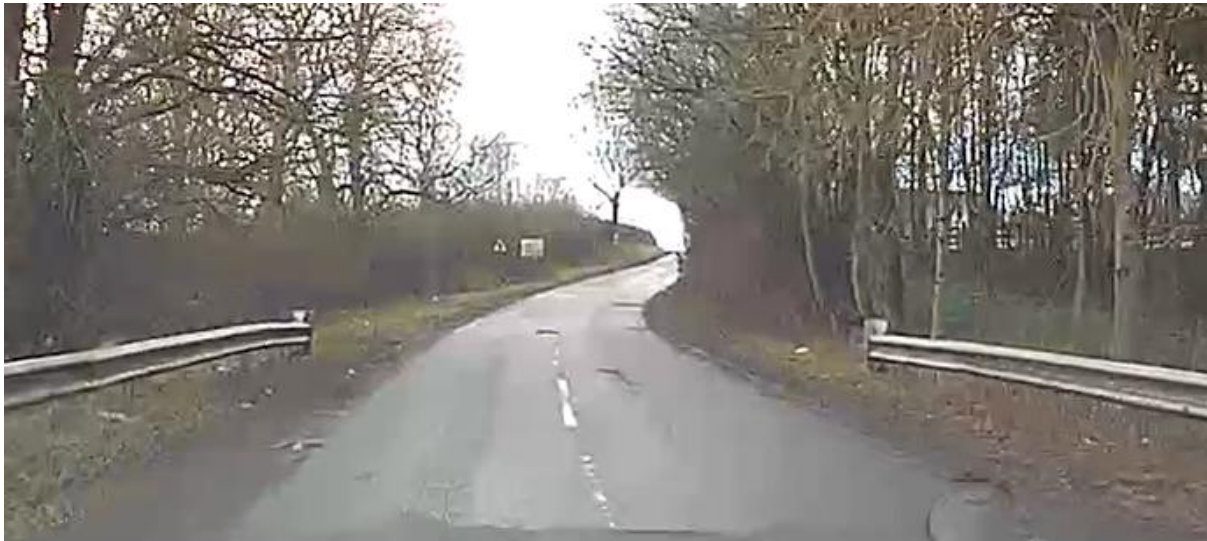
R3.26 Condition score 0

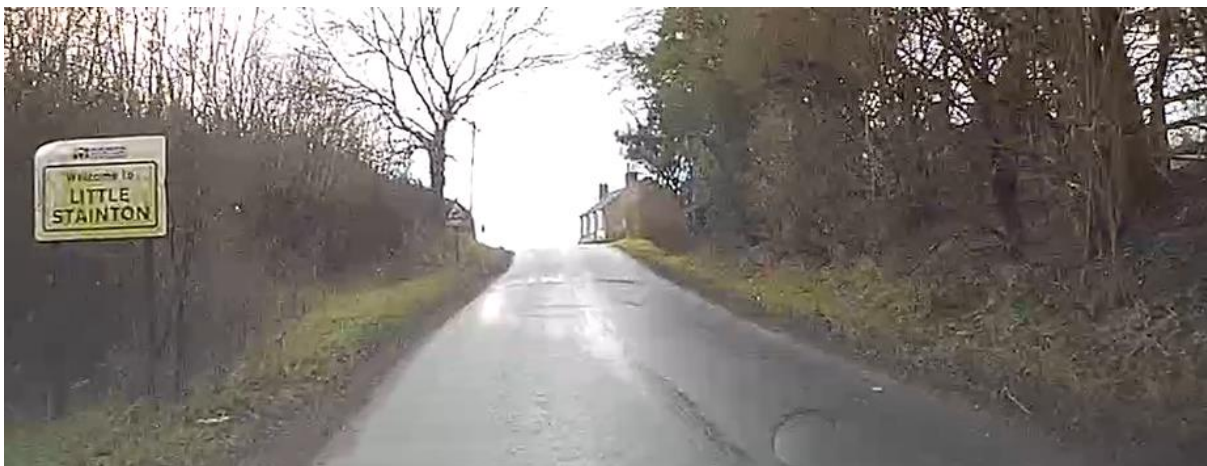
R3.27 Condition score 0

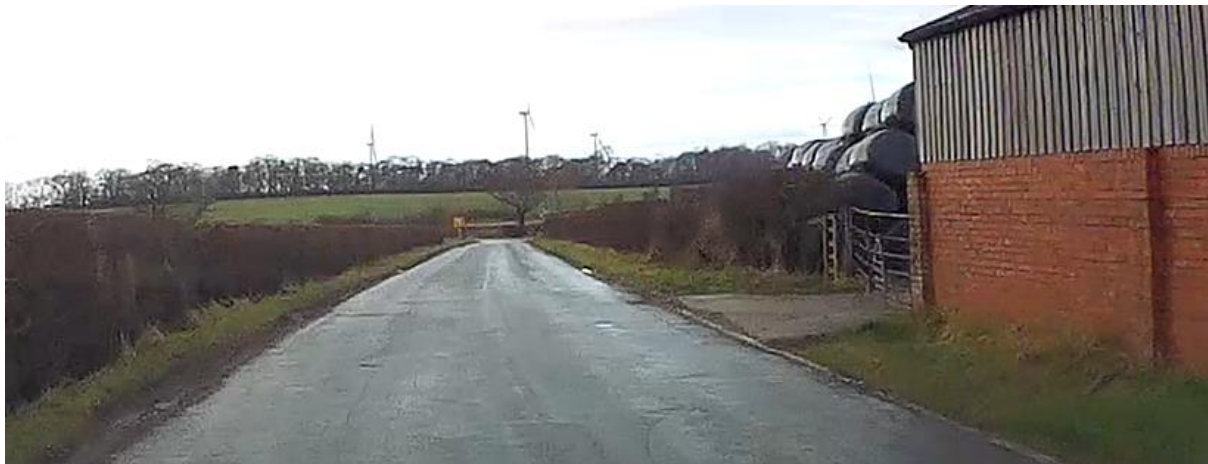
R3.26 Condition score 50 (Prior to Junction)

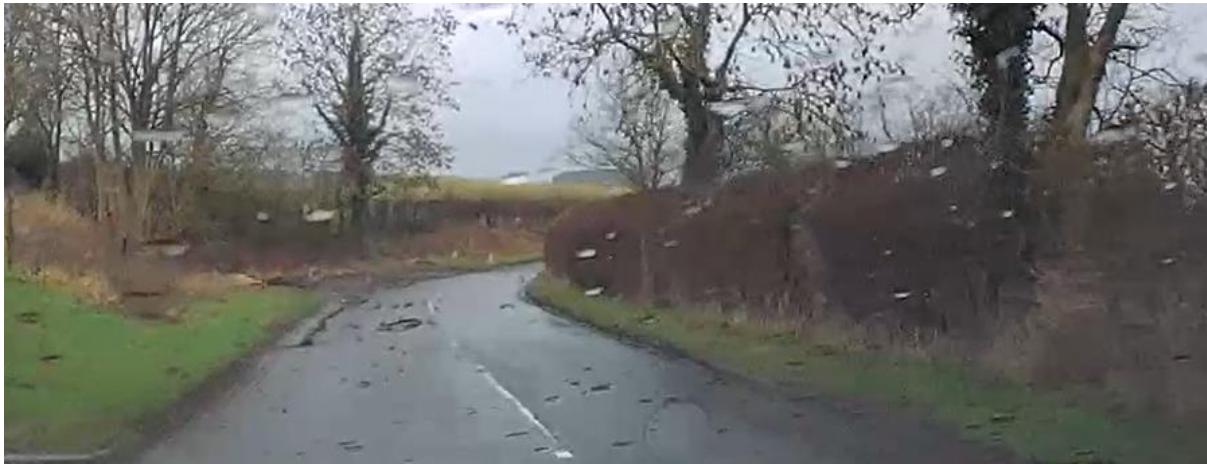
R4.3 Condition Score 10

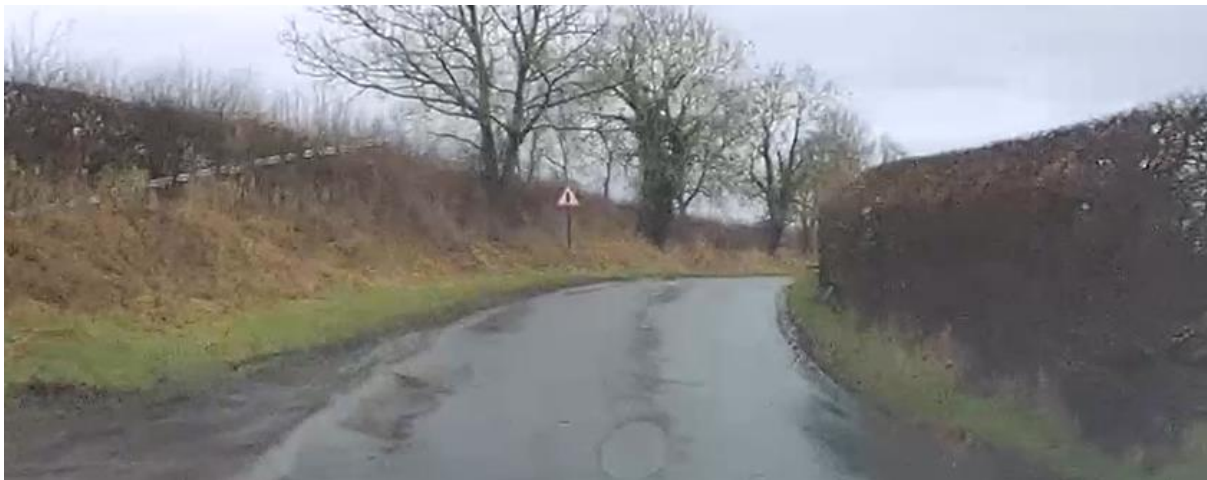
R4.5 Condition Score 0 (slow marking almost completely work away)

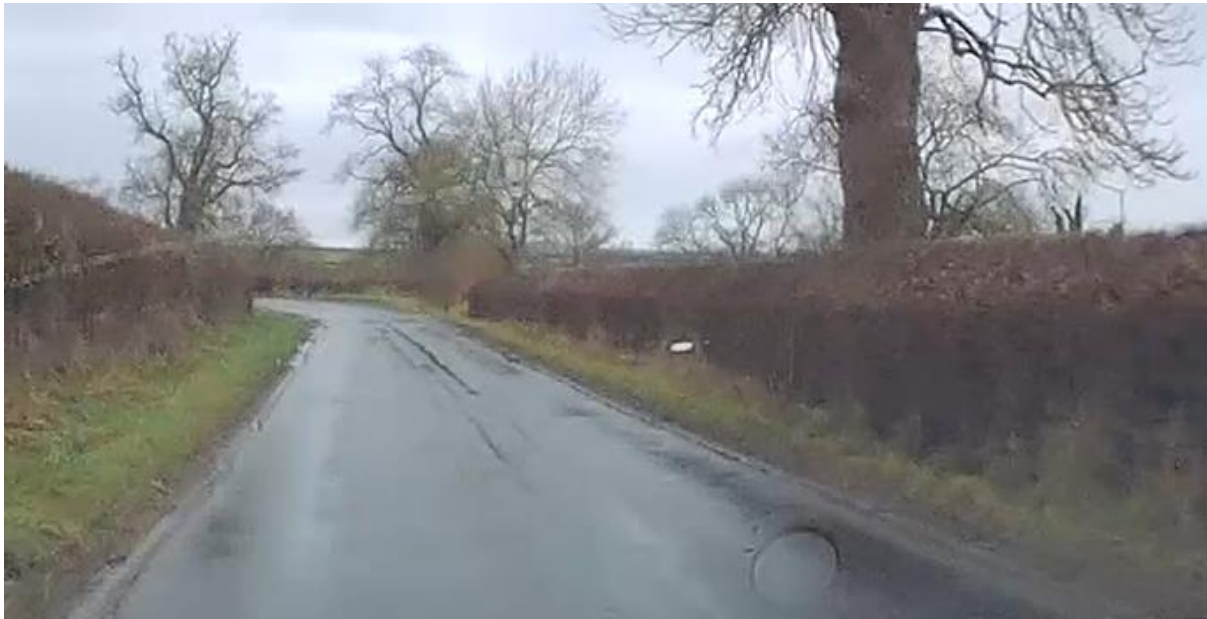
R4.9 Condition Score 0

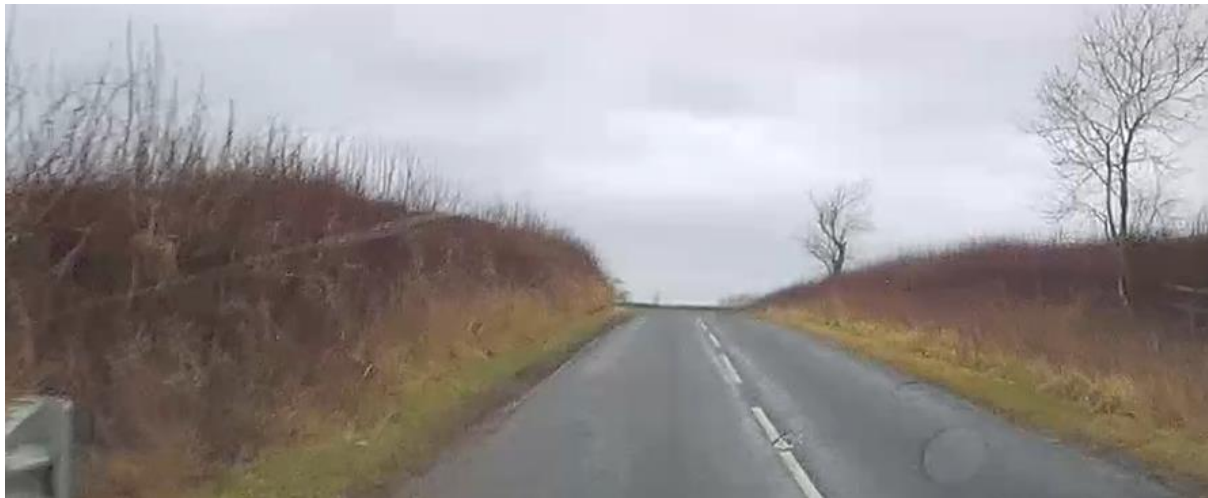
R4.13 Condition Score 40

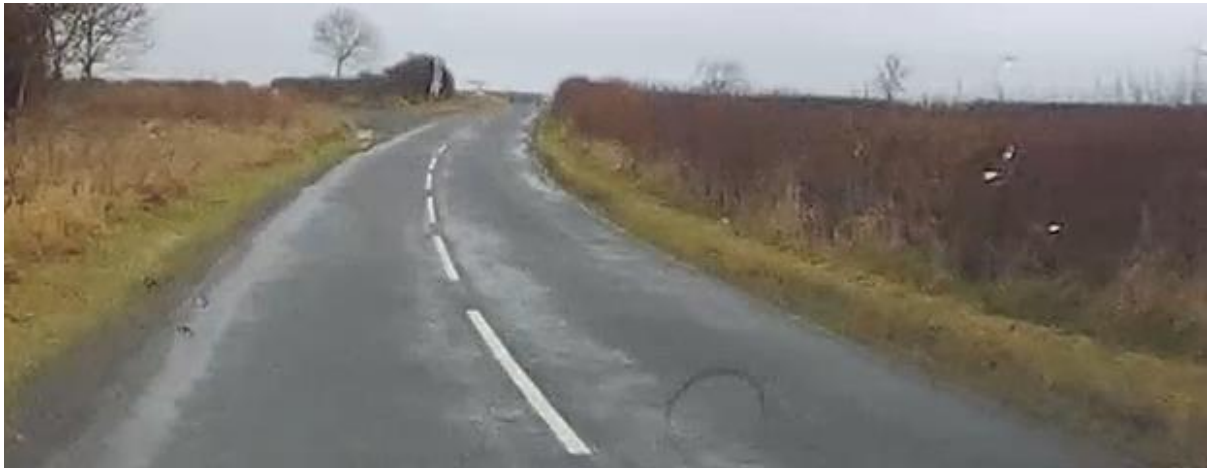
R4.15 Condition Score 30 (At Junction)

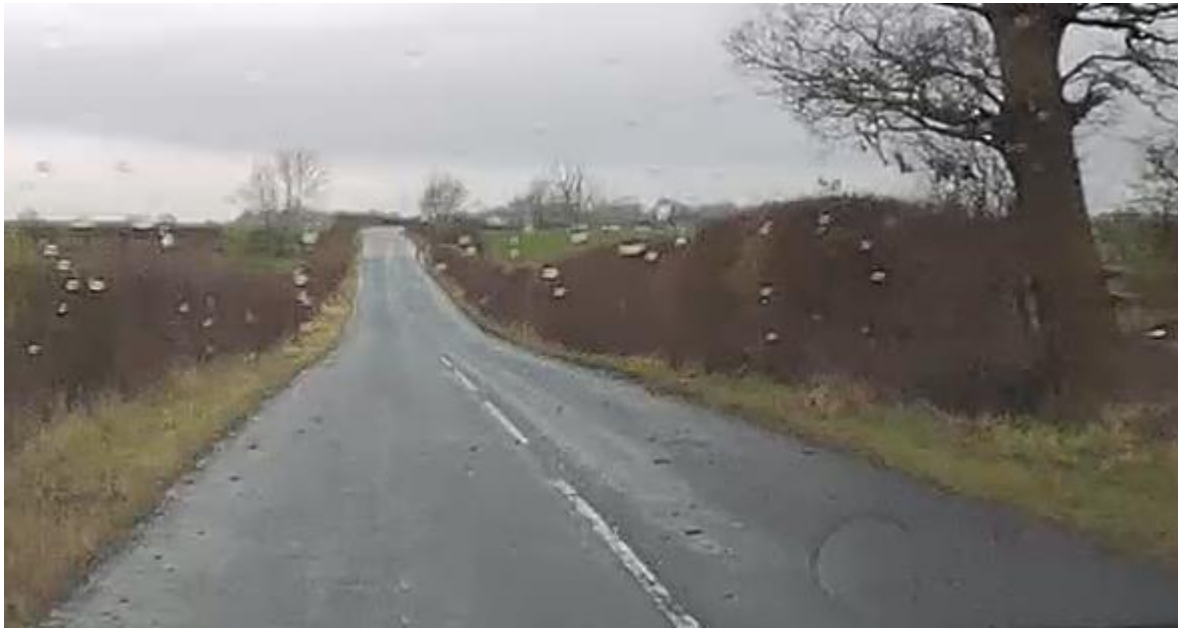
R4.22 Condition Score 0

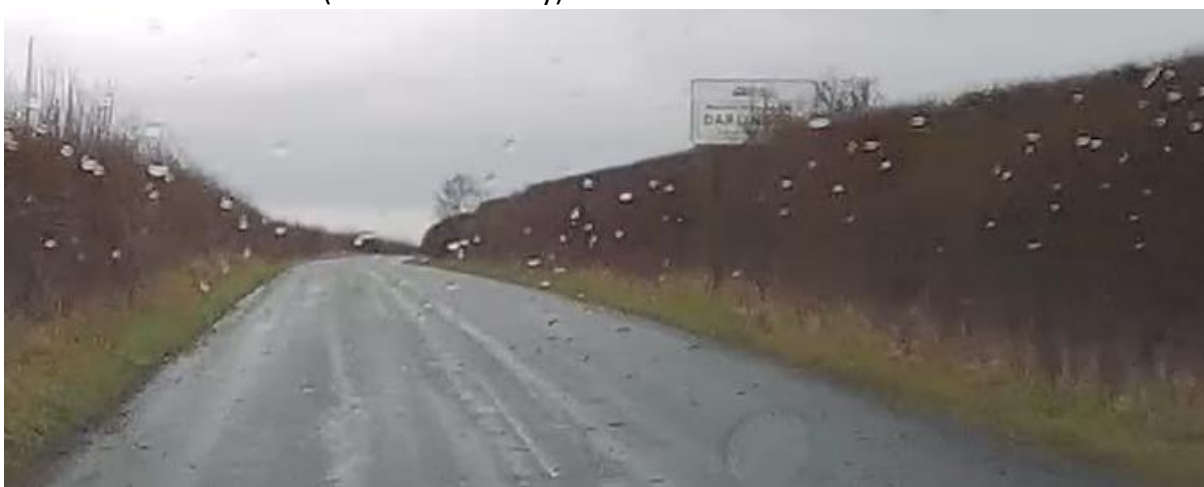
R4.23 Condition Score 0

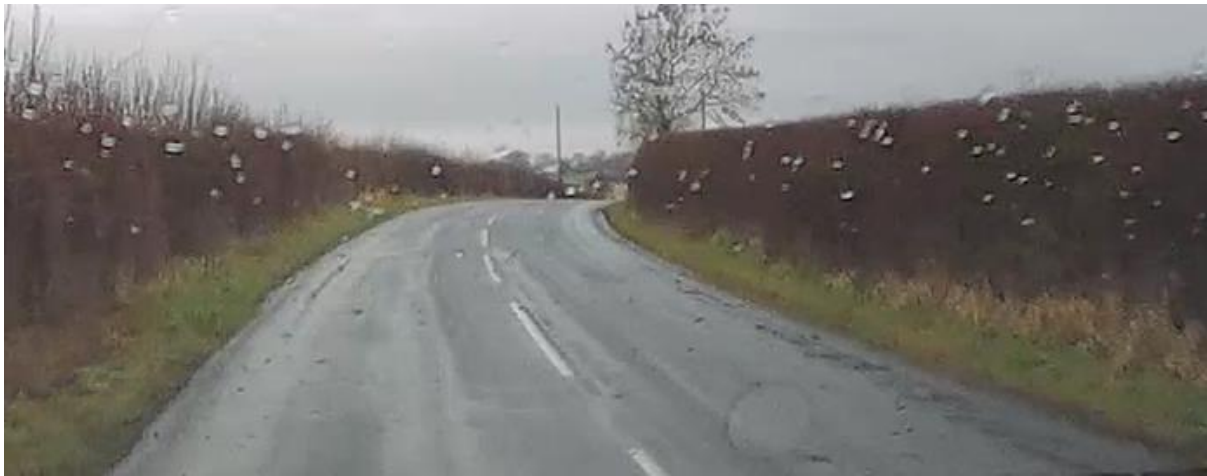
R4.25 Condition Score 0

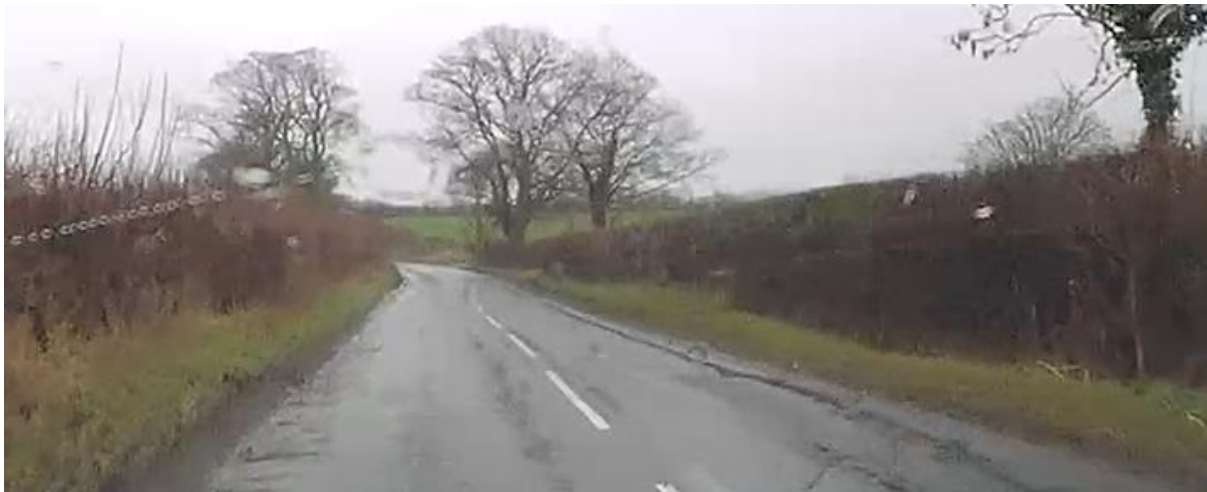
R5.20 - Condition Score 50

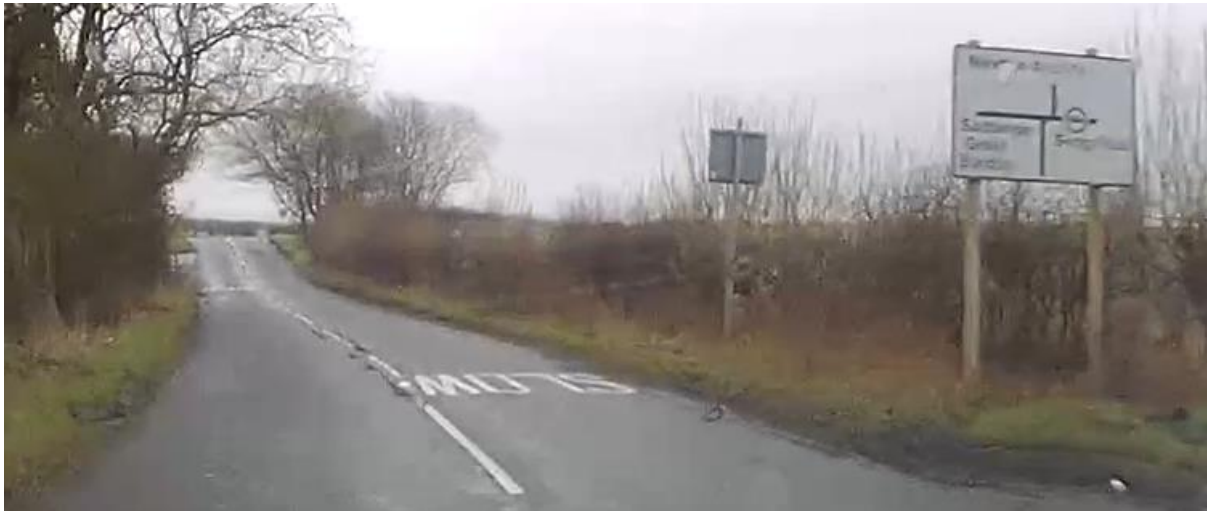
R5.25 - Condition Score 50

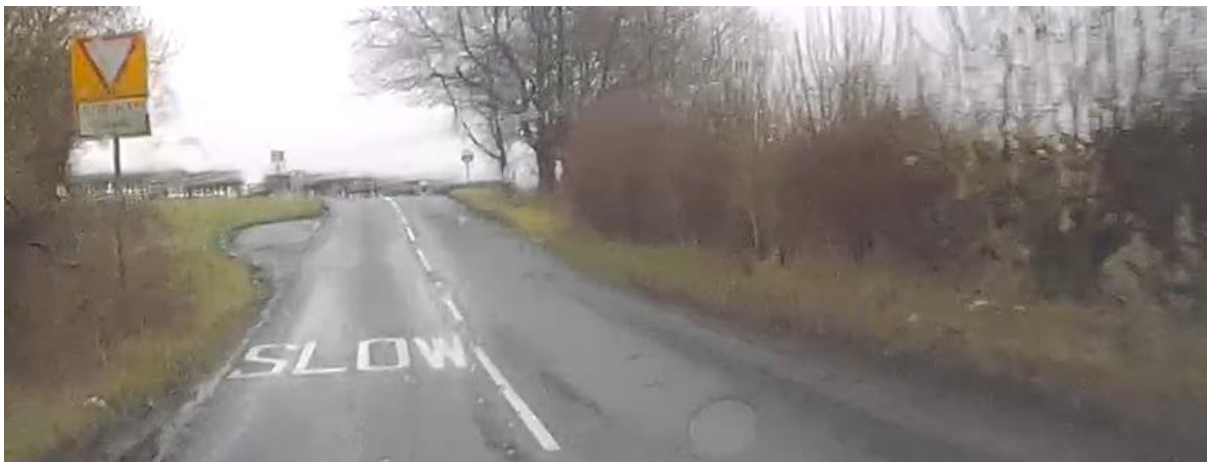
R5.26 - Condition Score 40 (Junction markings)

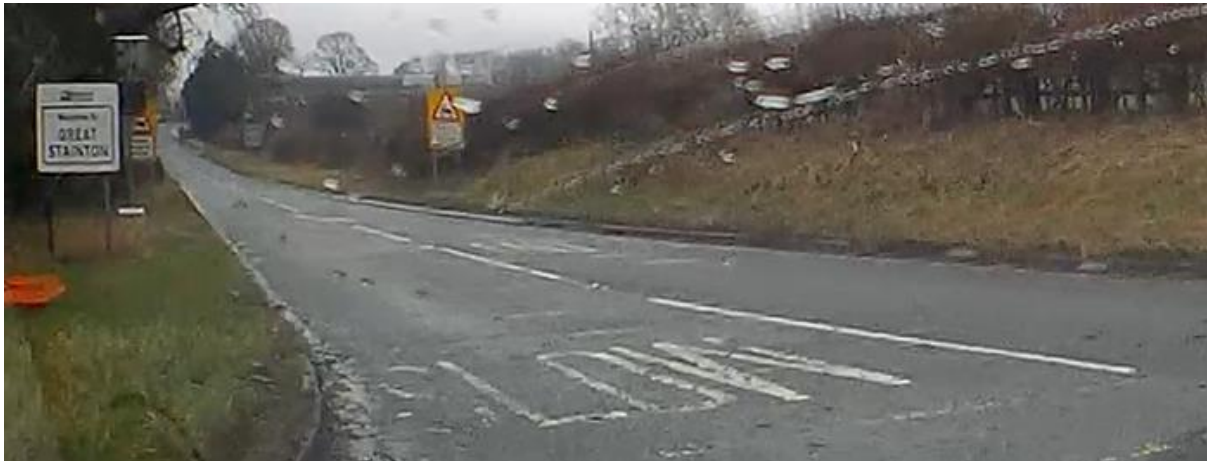
R6.2– Condition 20 (Slow Sign North)

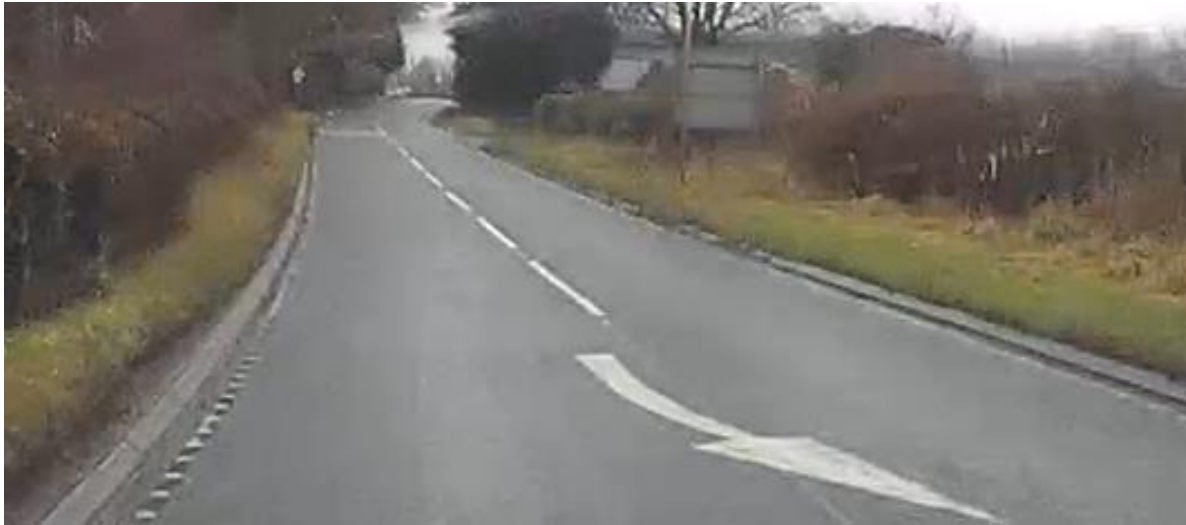
- R6.5 – Condition 0 (road shoulder ,markings))
Condition 30 (slow
Condition 40 (Lines)

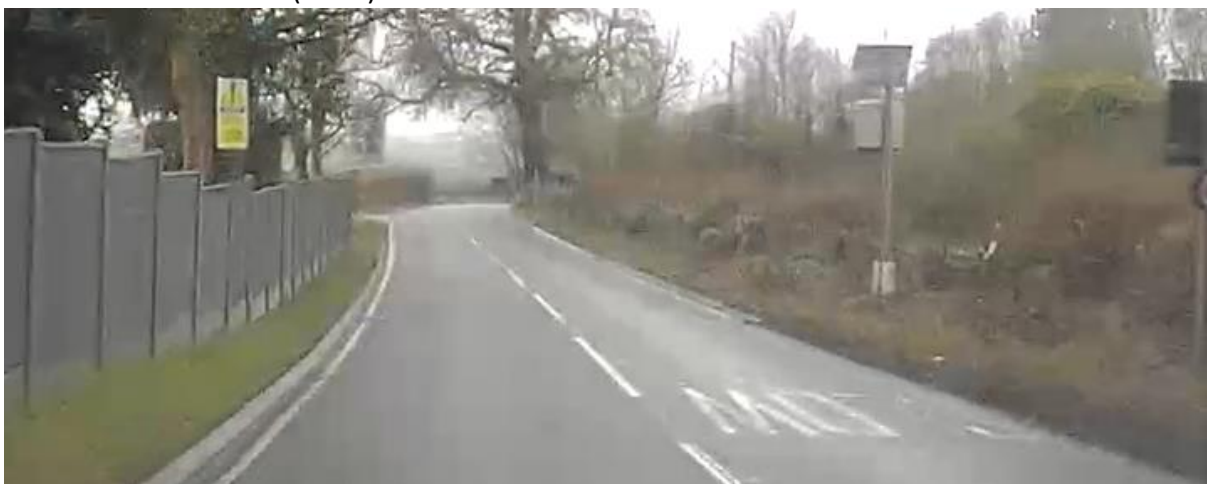
R6.13 – Condition 30 (road shoulder ,markings))

Condition 20 (slow sign)

Condition 30 (Lines)

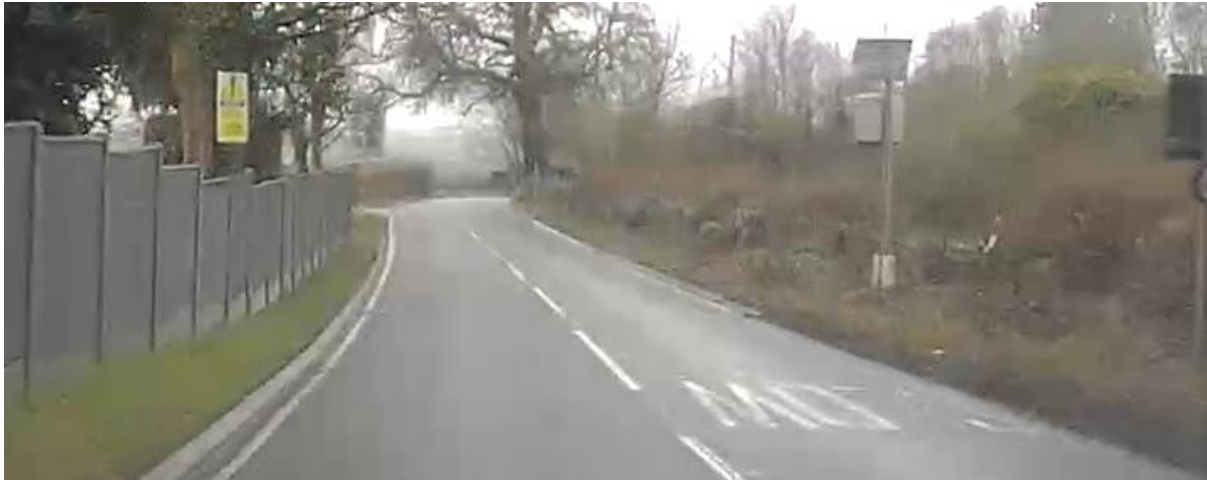
R6.14 – Condition 20 (road shoulder ,markings))

Condition 30 (slow sign)

Condition 30 (Lines)

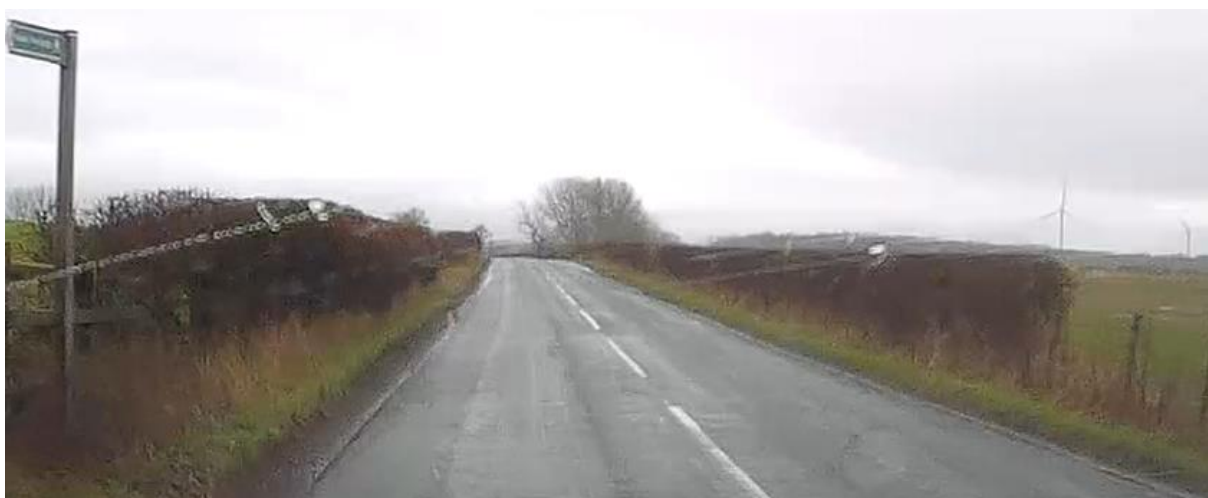
R6.25 Condition 40 Lines

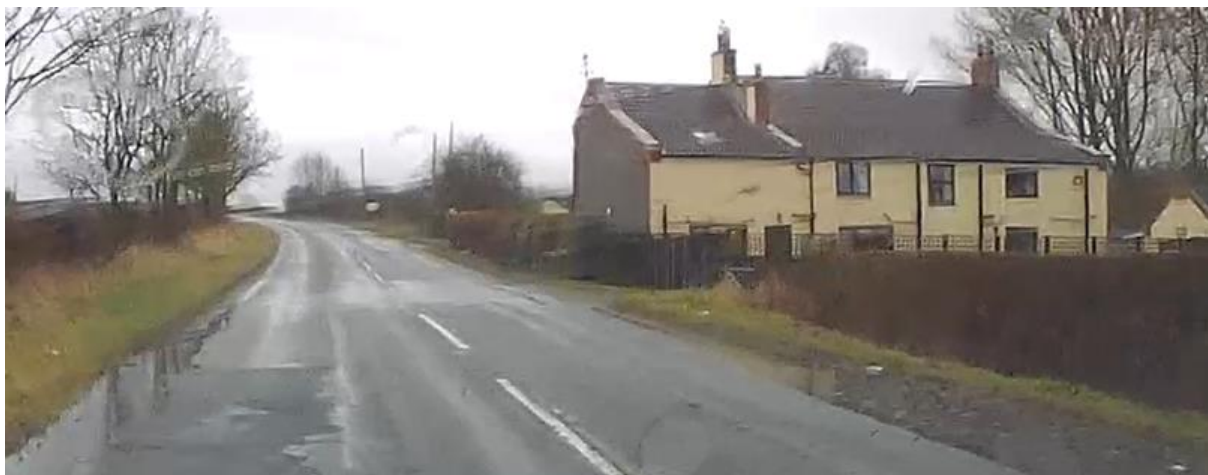
R6.26 Condition 20 Lines

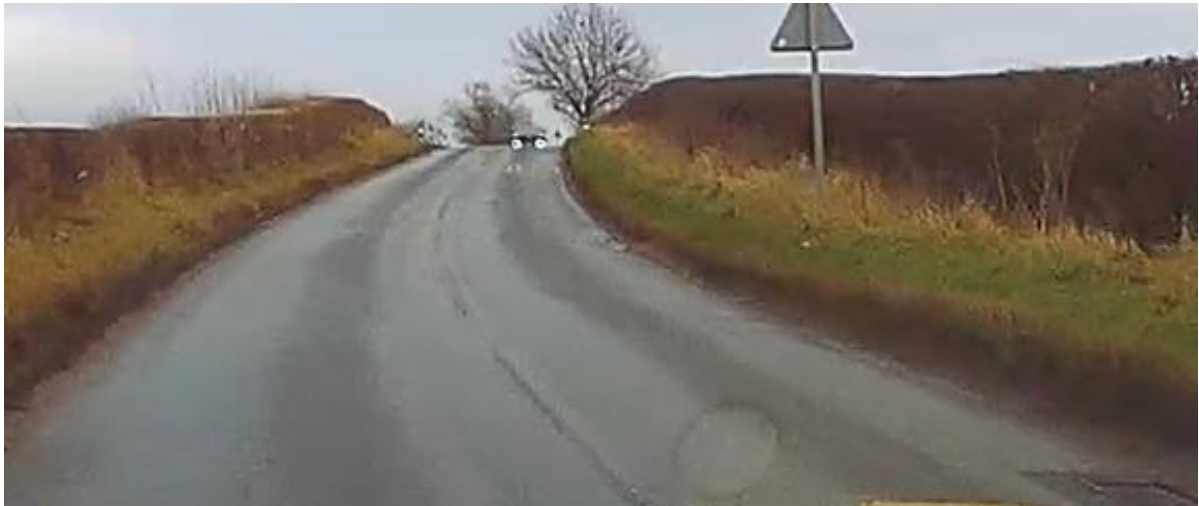
R7.9 – Condition 0 (line)
Condition 10 (slow)

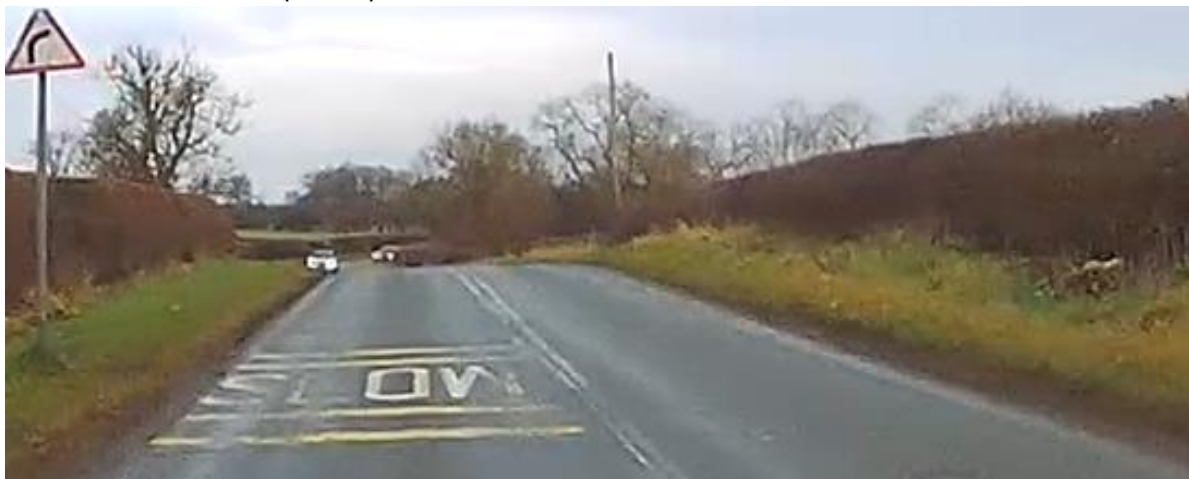
R7.17 – Condition 0

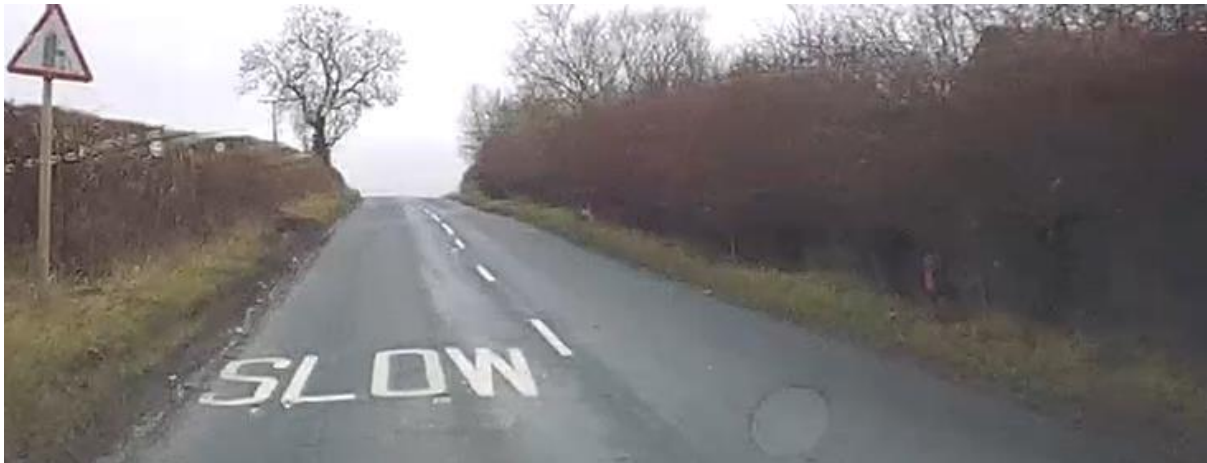
R8.10 – Condition 50

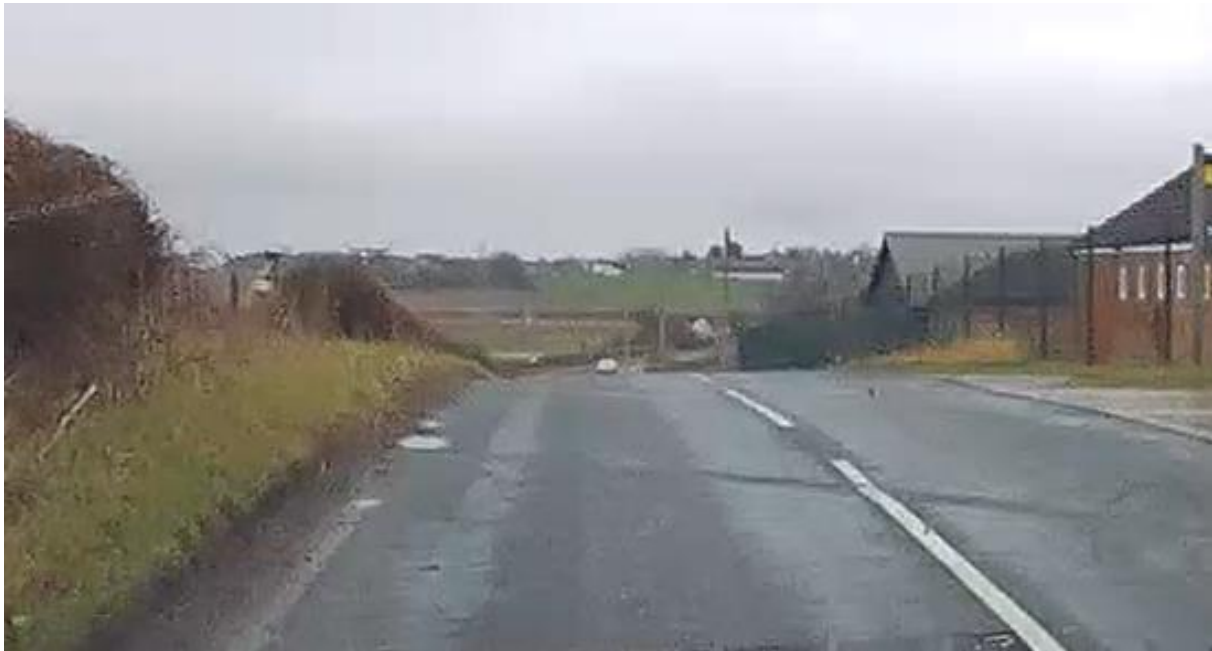
R8.12– Condition 50

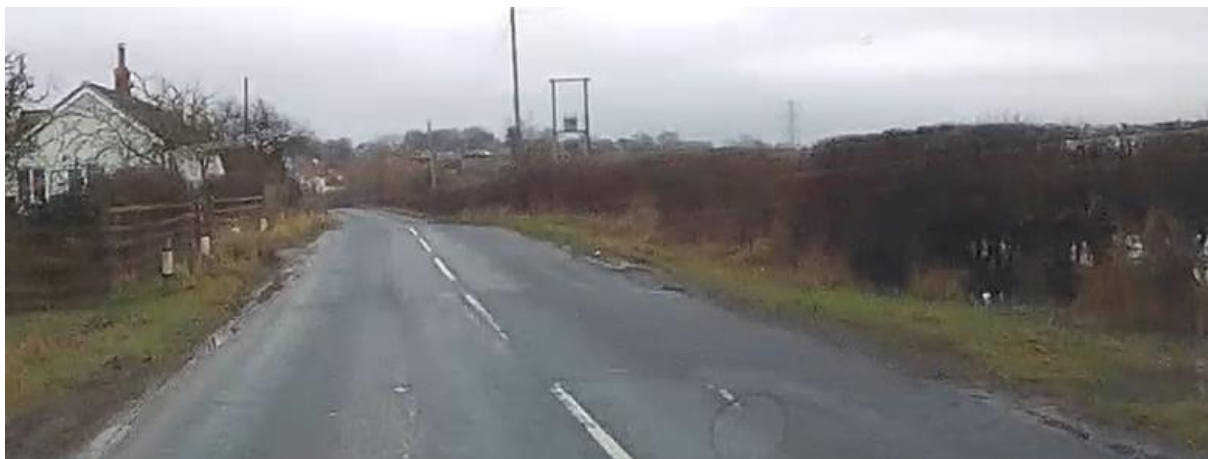
R8.17 – Condition 50

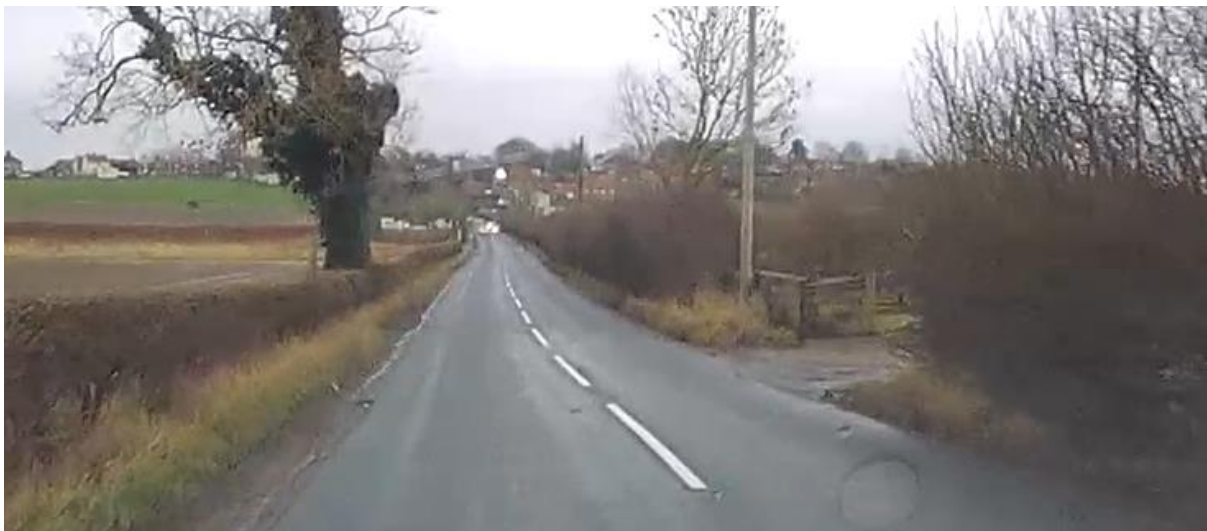
R8.19 – Condition 30

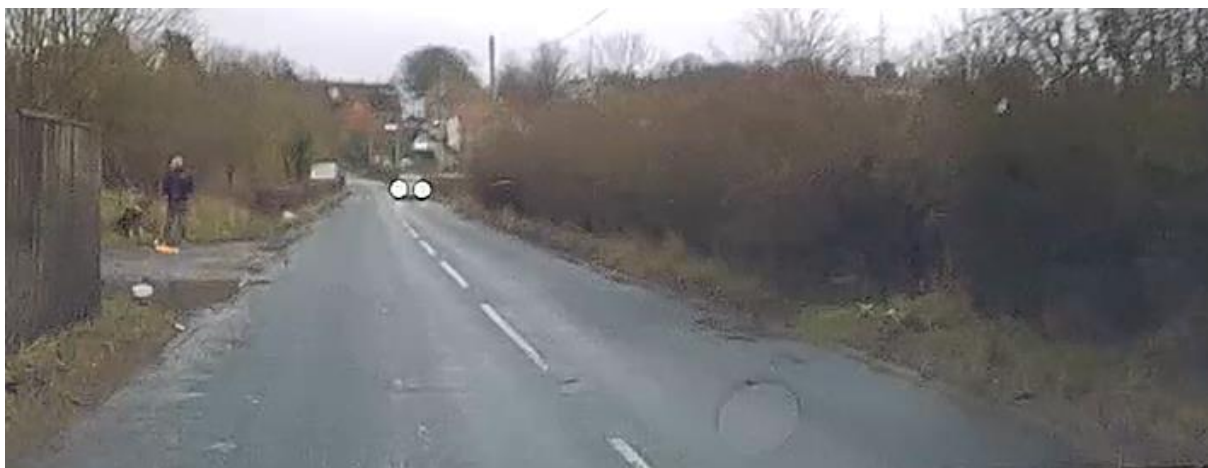
R8.22 – Condition 50

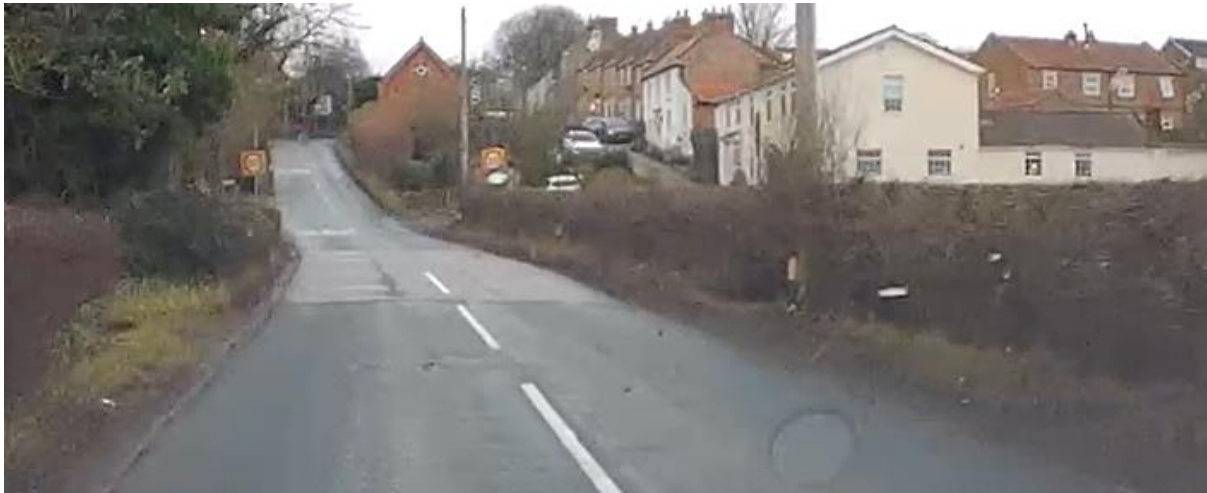
R8.27 - Condition 20 (LINES)
Condition 40 (SLOW)

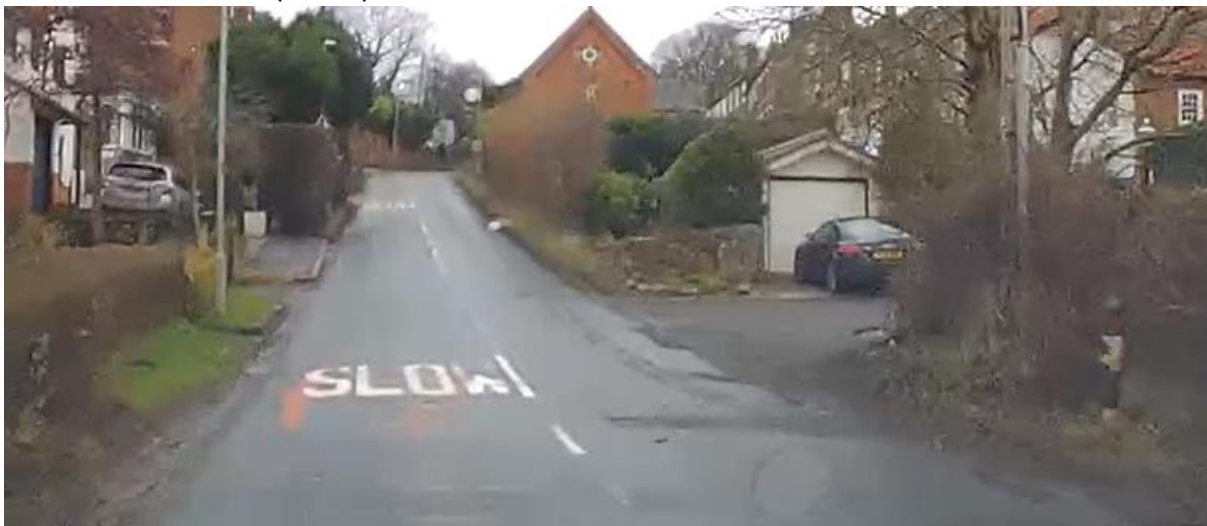
R8.28 – Condition 20 (LINES)

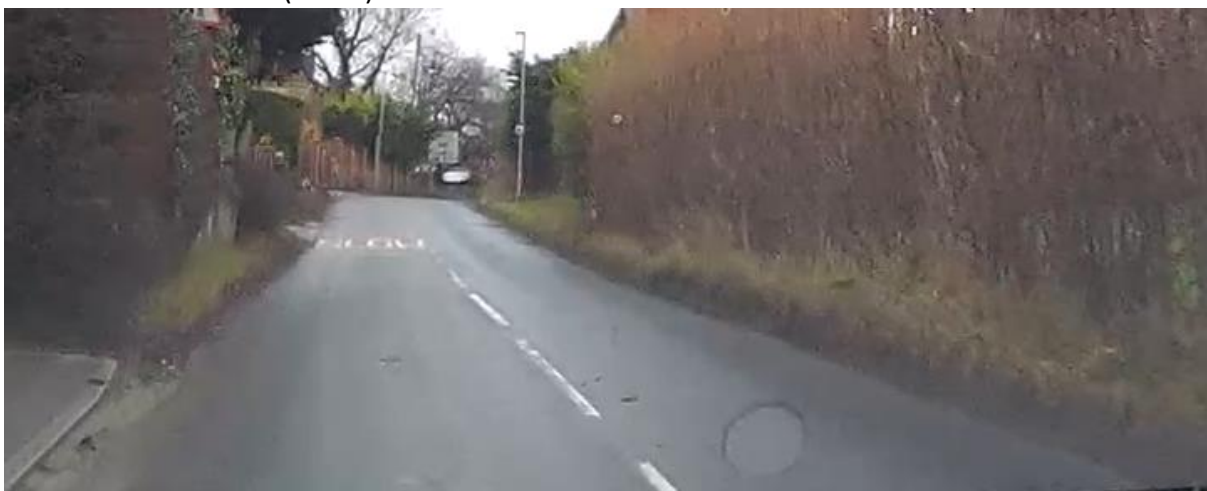
R8.29 – Condition 10 (LINES)
Condition 50 (SLOW)

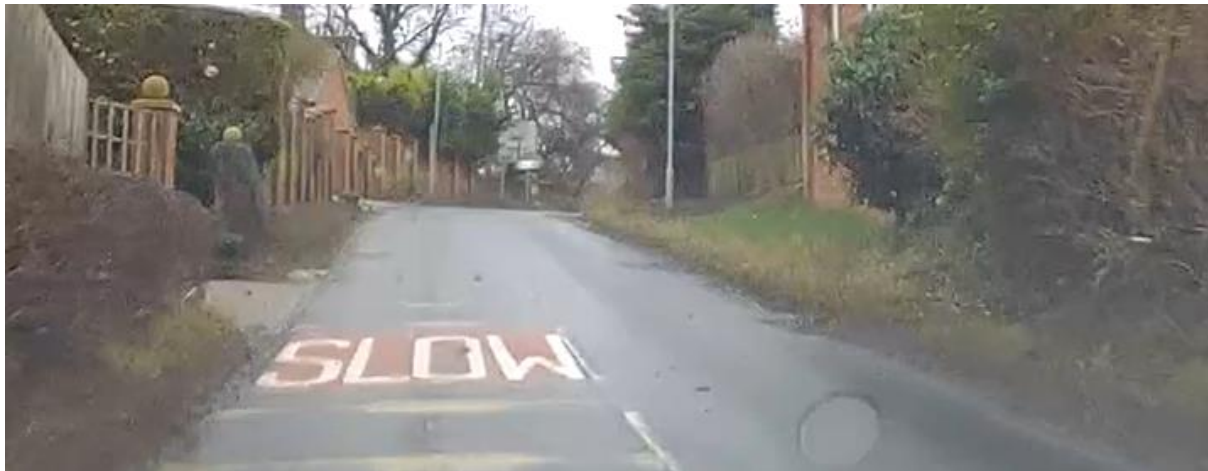
R8.30 – Condition 0
