**Road Line Marking Assessment Report Covering Darlington
Borough Council Road Infrastructure Surrounding Bishopton
Parish Council Area.
Document Reference BPC/1/24/001**

Document Reference	Revision	Date
BPC/1/24/001A	First issue Rev A (DRAFT internal Only)	14.01.2024
BPC/1/24/001B	Formal Issue Rev B	04.02.2024

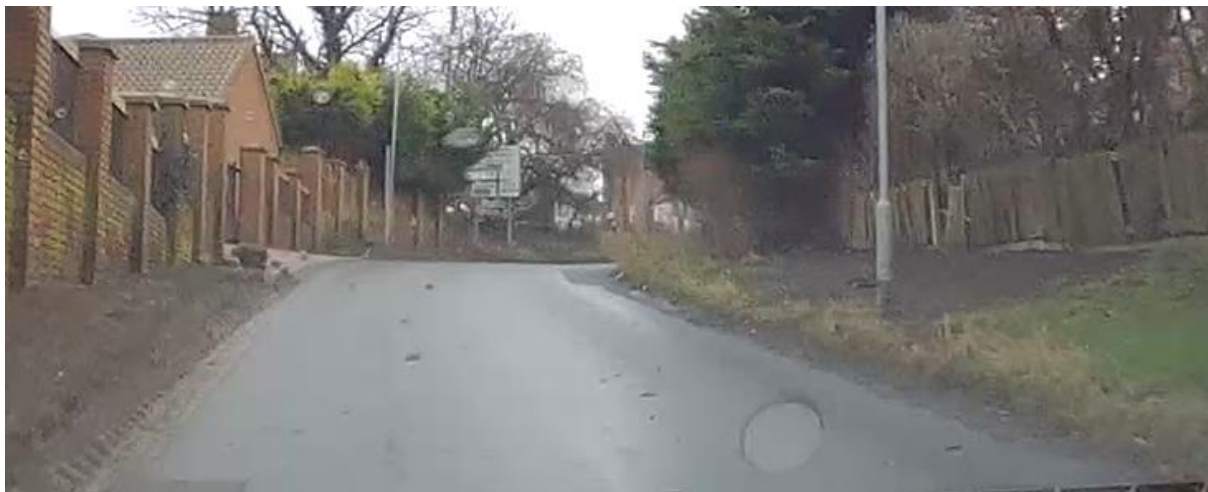
R8.31 – Condition 0

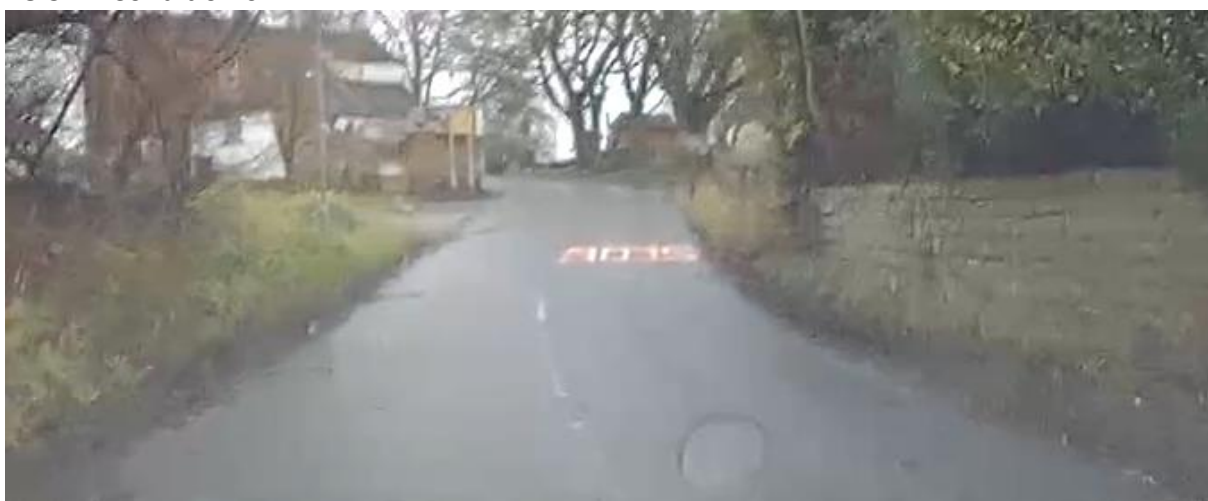
R8.32 – Condition 0 (LINES)
Condition 40 (SLOW)

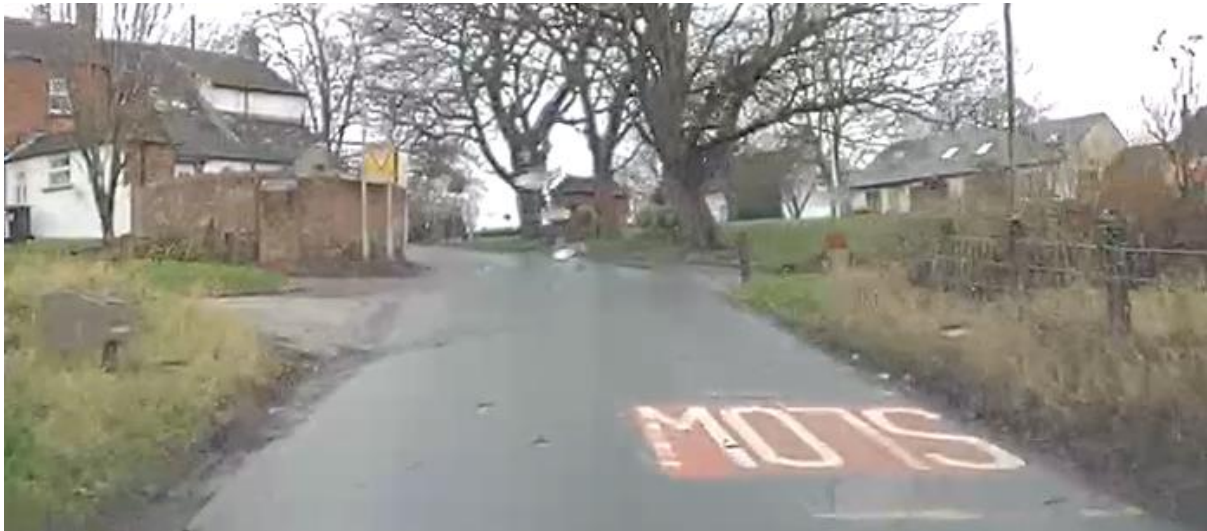
R8.33 – Condition 10

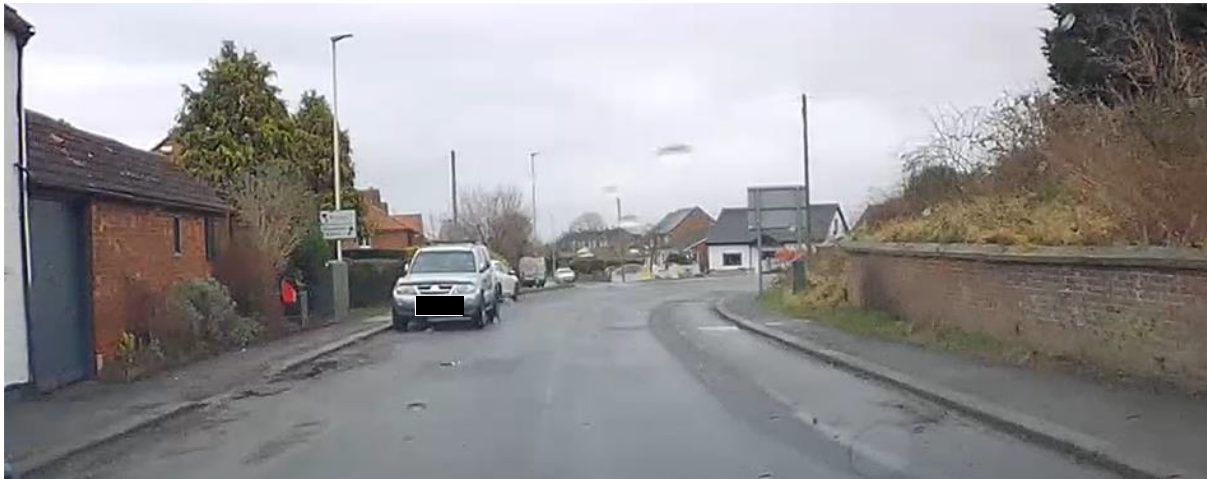
**R9.3 - Condition 0 (Lines)
Condition 20 (Junction Markings)**

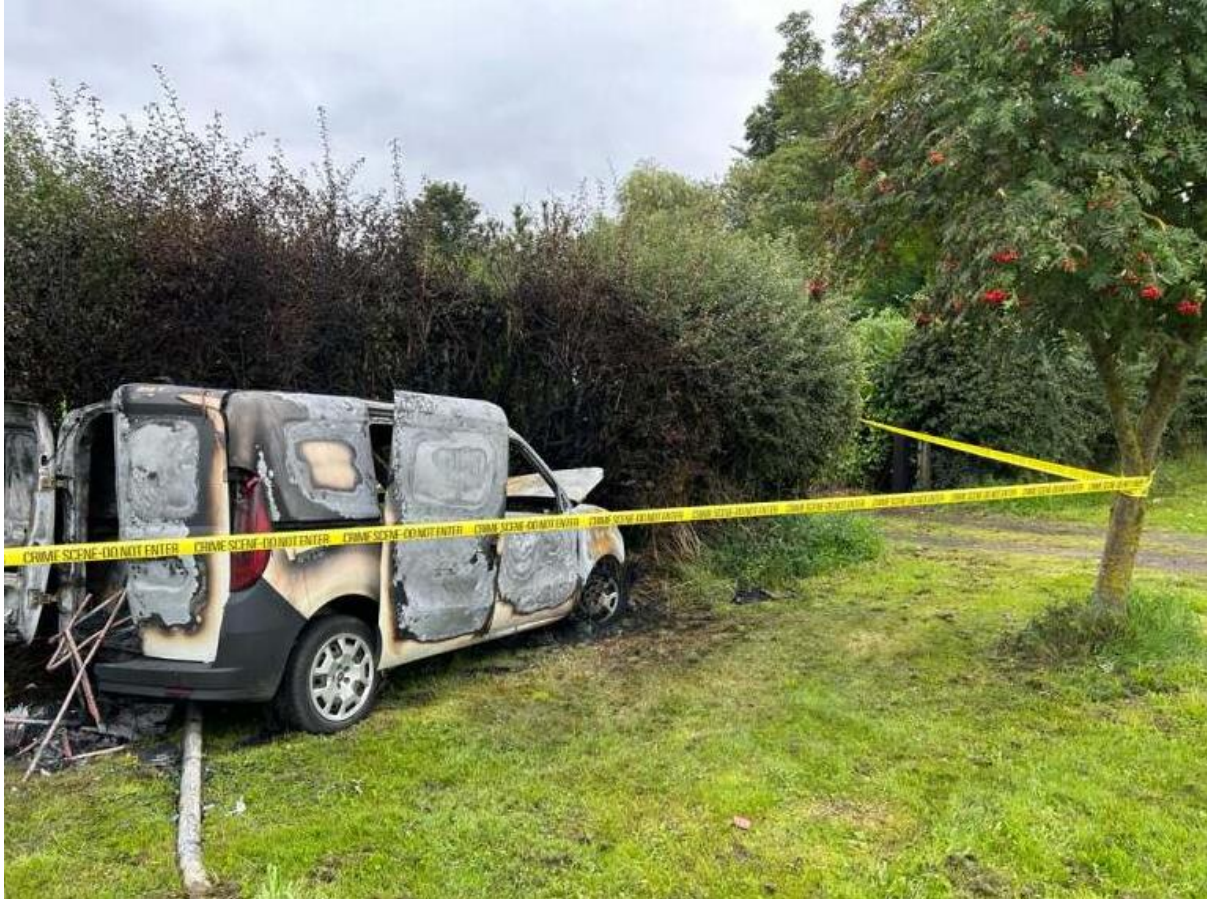
R3 Image 1

A vehicle descending Folly Bank approaching Bishopton failed to stop at the Junction and left the road and crashed into trees knocking down street furniture. A vehicle fire ensued.

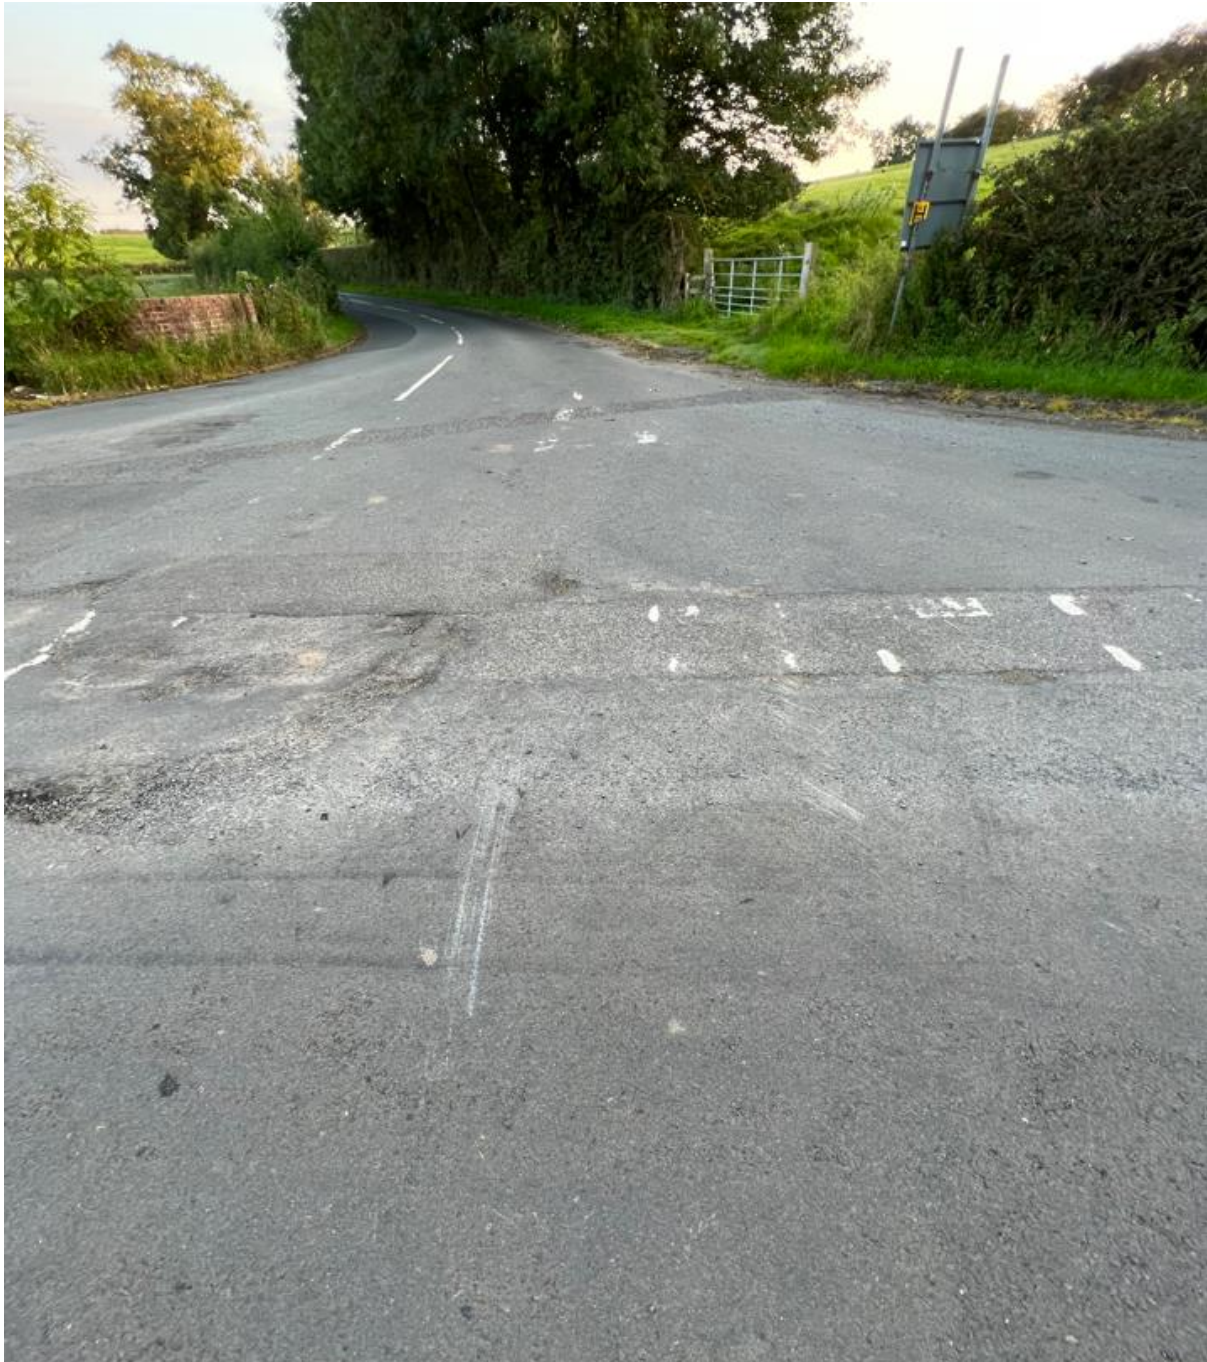
R3 Image 4

Evidence of Skid mark can be seen in gravel as vehicle failed to negotiate / stop at junction.

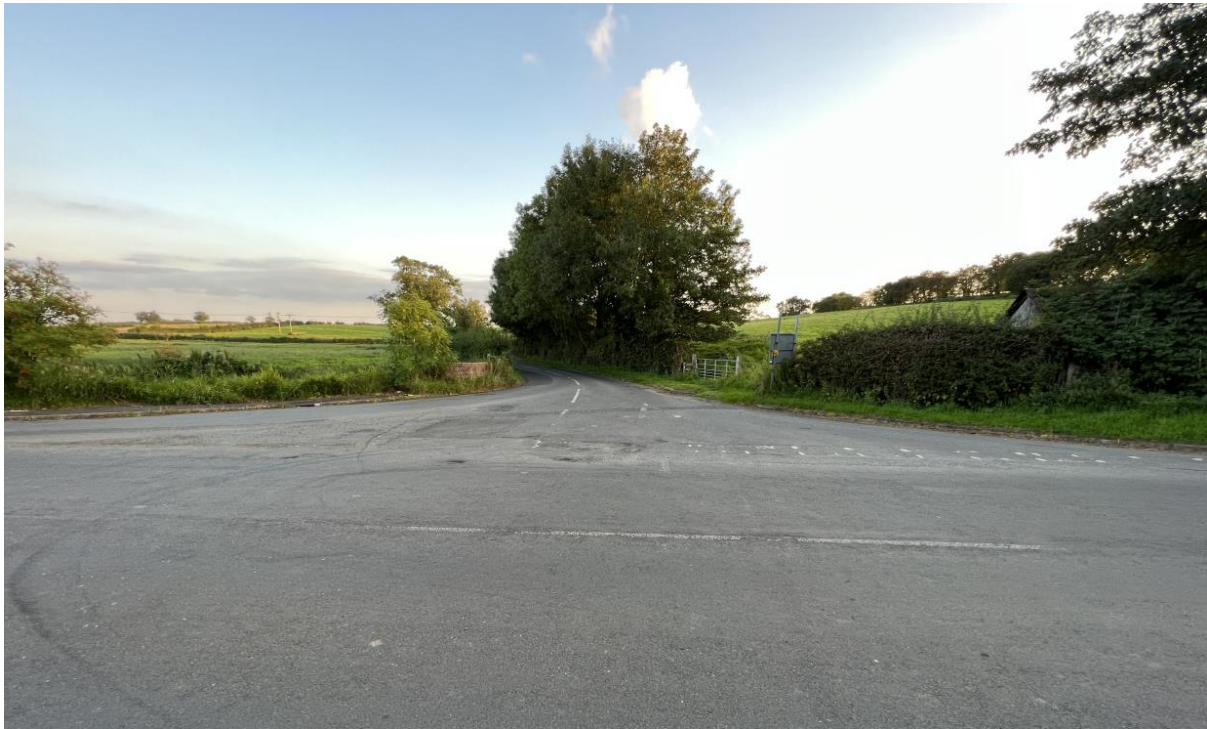
R3 Image 4

Poor road markings categorised as 'Critical defect' may have been a contributing factor to this Road Traffic Incident (date of RTI 27.08.23 approx 0100hrs)

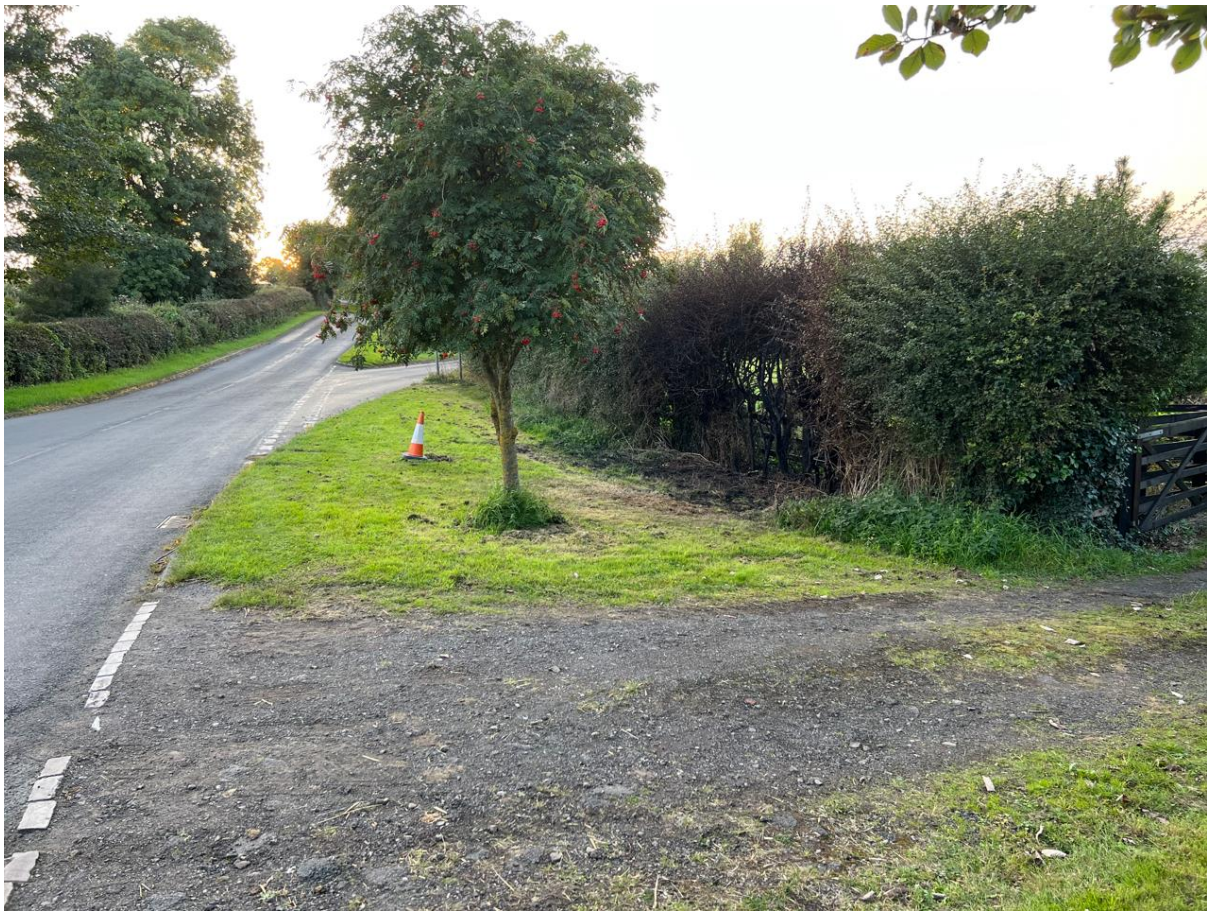
R3 Image 5

Fire damage can be seen in highways verge and cone indicates where road furniture was knocked over.
