Walkover Survey

Chapter 11 – Appendix 5

National Grid (North Wales Connection Project)

Document 5.11.2.5 Appendix 11.5 Walkover Survey

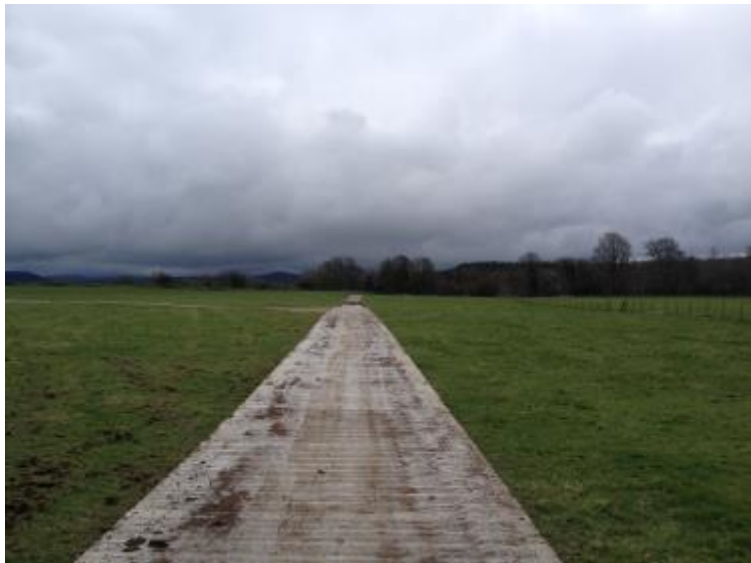
PHOTOGRAPHIC LOG Braint THH/CSEC		
Photo No. 1	Date: 22/03/17

Direction Photo Taken: Southerly		
Description: General site conditions from. Note trackway from Ground Investigation works.

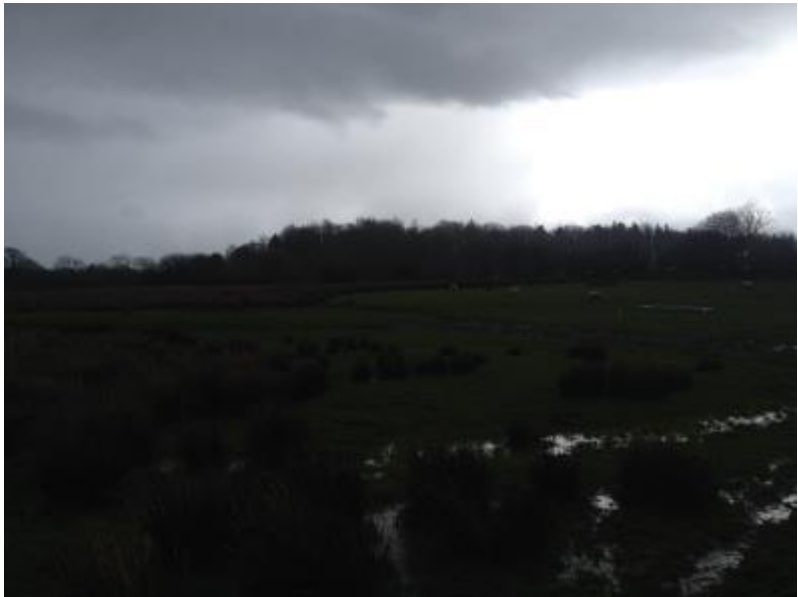
Photo No. 2	Date: 22/03/17

Direction Photo Taken: Westerly		
Description: General Site Conditions

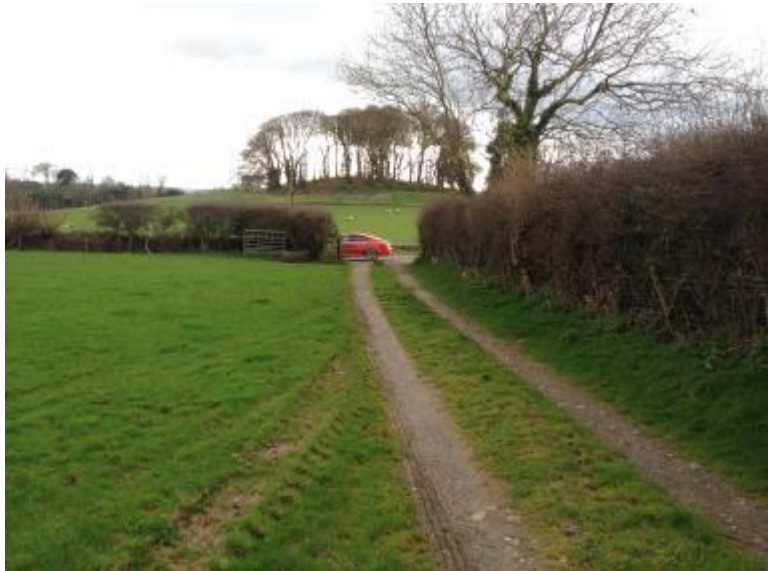
Photo No. 1	Date: 22/03/17

Direction Photo Taken: South-westerly		
Description: General condition of access to proposed compound area and track.

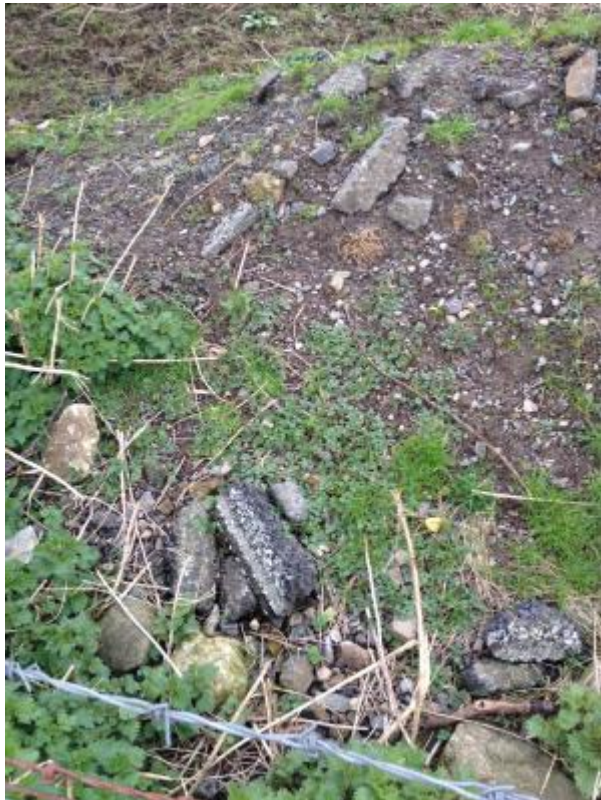
Photo No. 5	Date: 22/03/17

Direction Photo Taken: Westerly		
Description: Tarmacadam within the historical Ty'n-y-felin quarry adjacent to the Penmynydd Road Construction Compound.

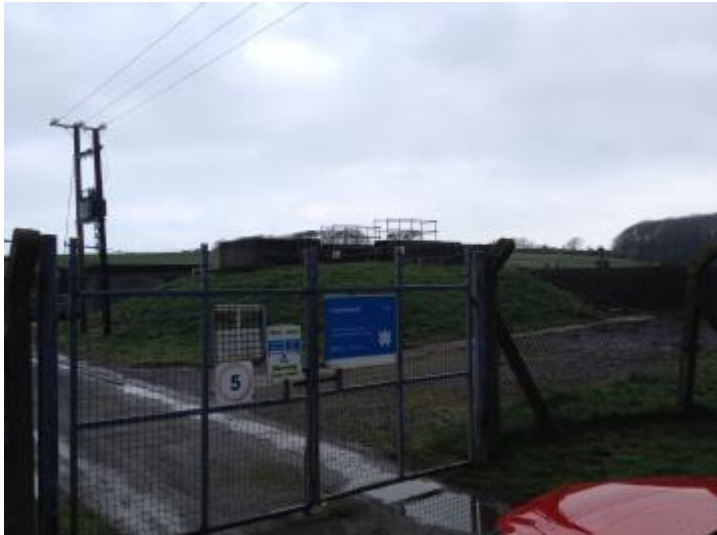
Photo No. 1	Date: 23/03/17

Direction Photo Taken: North-westerly		
Description: Llanfechell Water Treatment Works. OHL alignment is located to the south west of this feature with proposed access utilising existing access tracks. This site was identified as an

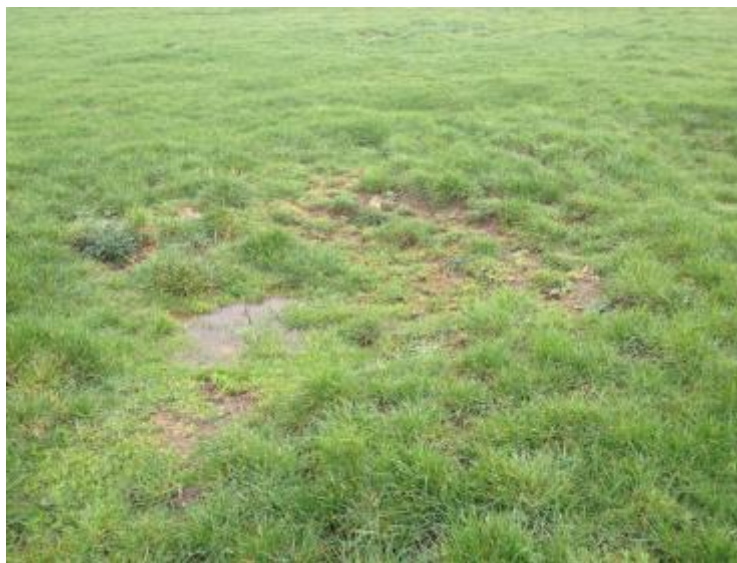
PHOTOGRAPHIC LOG Local Authority Contaminated Land Features Refs 1248 and 2162		
Photo No. 1	Date: 22/03/17

Direction Photo Taken: Easterly		
Description: Small Depression located within centre of field where this feature is indicated to be on the corresponding map figure. This may be associated with the former pit. Located at 242462,387311

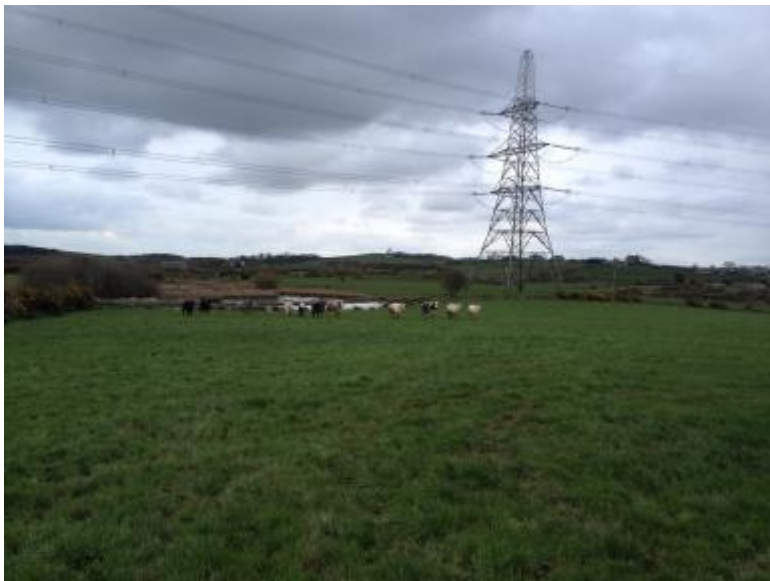
PHOTOGRAPHIC LOG Surface Working Features Refs 30, 194-328, 506 and 687 (Pond)		
Photo No. 1	Date: 22/03/17

Direction Photo Taken: Easterly		
Description: Historical mapping showed a pond as a surface working feature within a construction area. This pond was positively identified. The ground conditions were extremely soft.

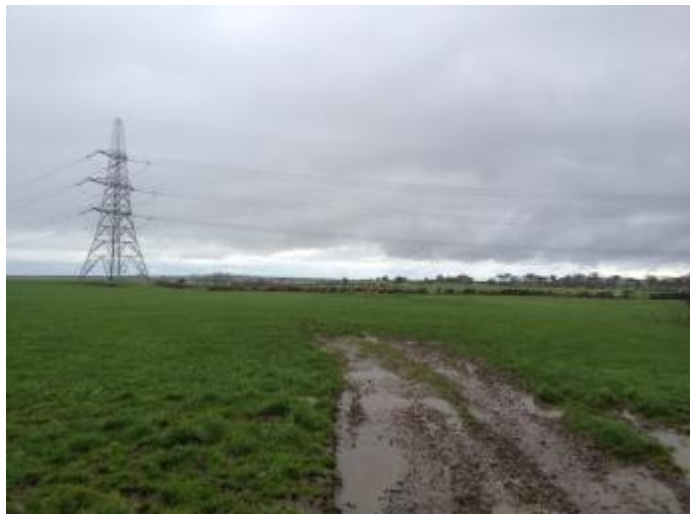
PHOTOGRAPHIC LOG Surface Working Feature (Quarry) at Pylon 4ZA078 (Figure Refs 340, 772)		
Photo No. 1	Date: 22/03/17

Direction Photo Taken: North-easterly		
Description: General site conditons at the location of the former quarry. Extents are potentially from the vincinty of the the pylon (left) to the small rise in ground level in the

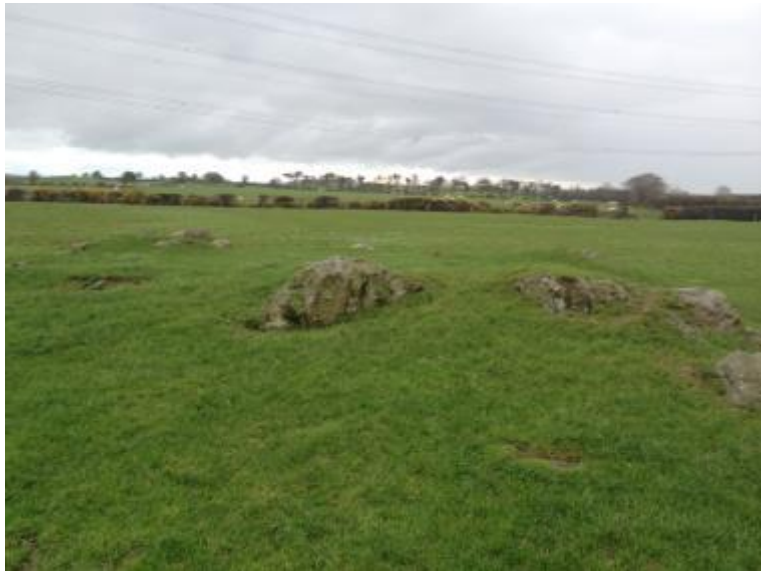
Photo No. 2	Date: 22/03/17

Direction Photo Taken: North-easterly.		
Description: Evidence of quarrying activity within working area. This is the small rise in ground level shown in the previous photograph.

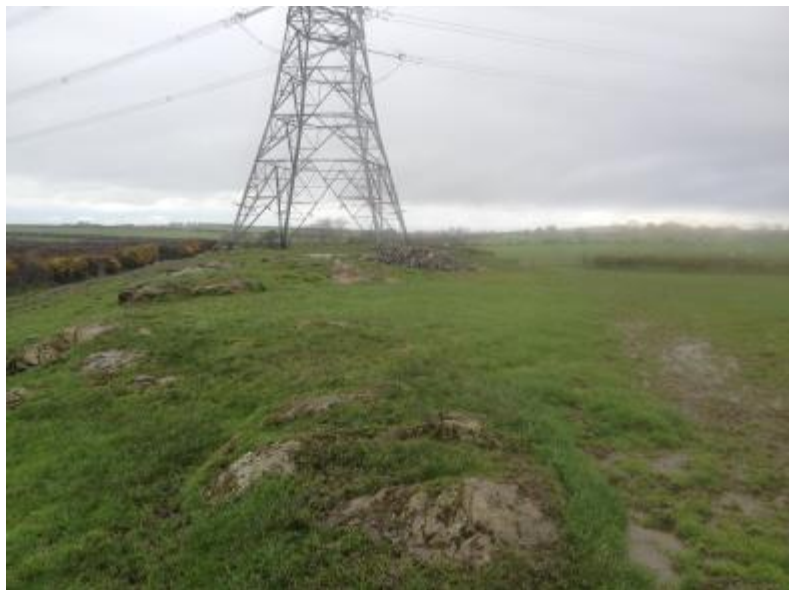
Photo No. 3	Date: 22/03/17

Direction Photo Taken: Northerly		
Description: Former quarry located on the left of the first photograph in this series. It is possible that this quarry was more extensive, if infilling has occurred then it has not been recent.

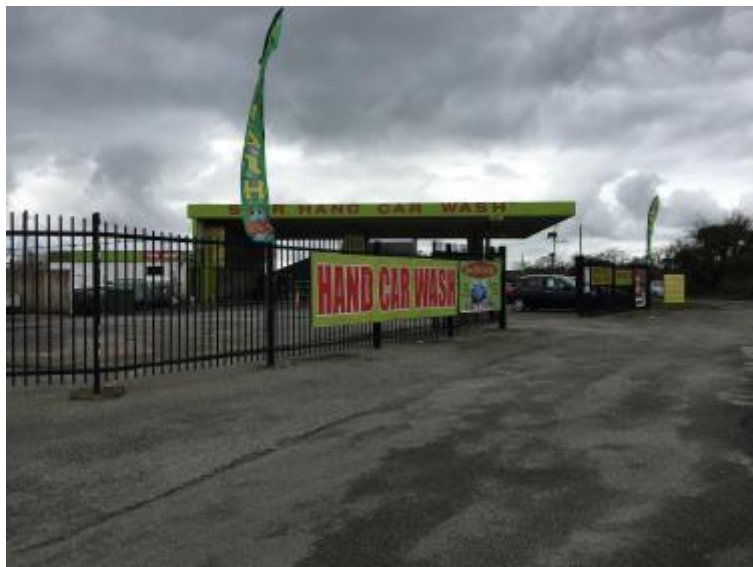
Photo No. 1	Date: 22/03/17

Direction Photo Taken: Westerly		
Description: The former petrol station is now a hand car wash and is not deemed to pose a risk to the Proposed Development.

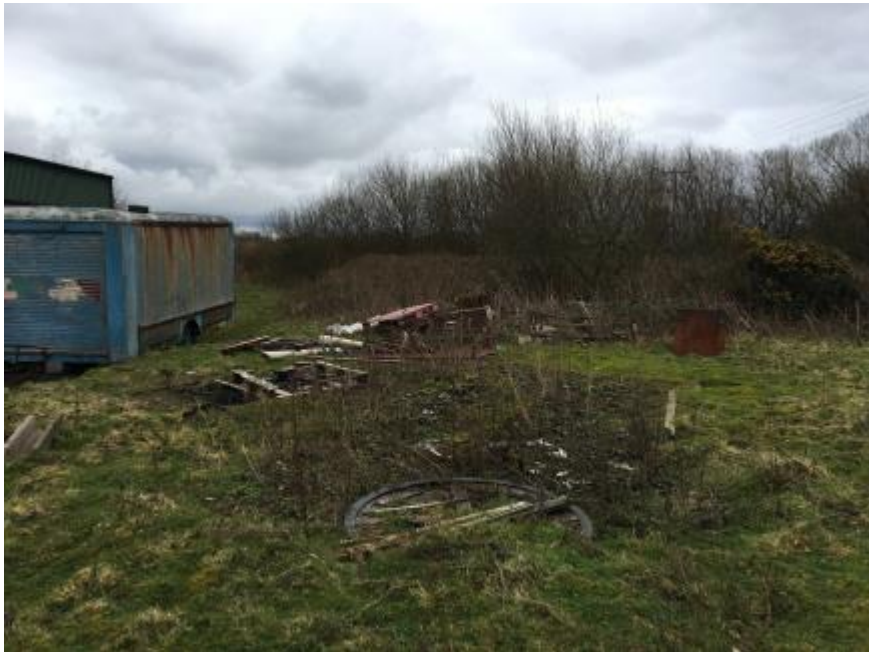
Photo No. 3	Date: 22/03/14

Direction Photo Taken: Easterly		
Description: Some minor fly tipping had occurred behind the furniture store where the access track meets the railway.

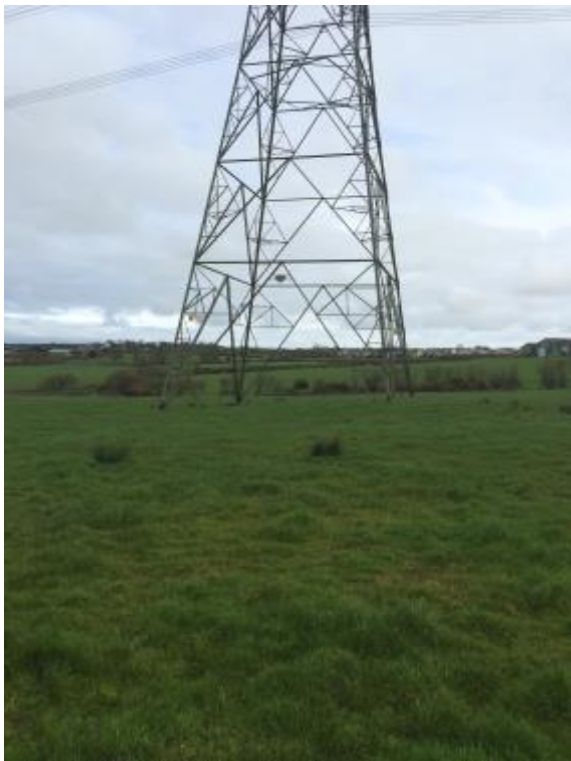
PHOTOGRAPHIC LOG Former Private Water Supply – Dryll		
Photo No. 1	Date: 22/03/17

Direction Photo Taken: Easterly		
Description: General ground conditions where private water supply was indicated to have been.

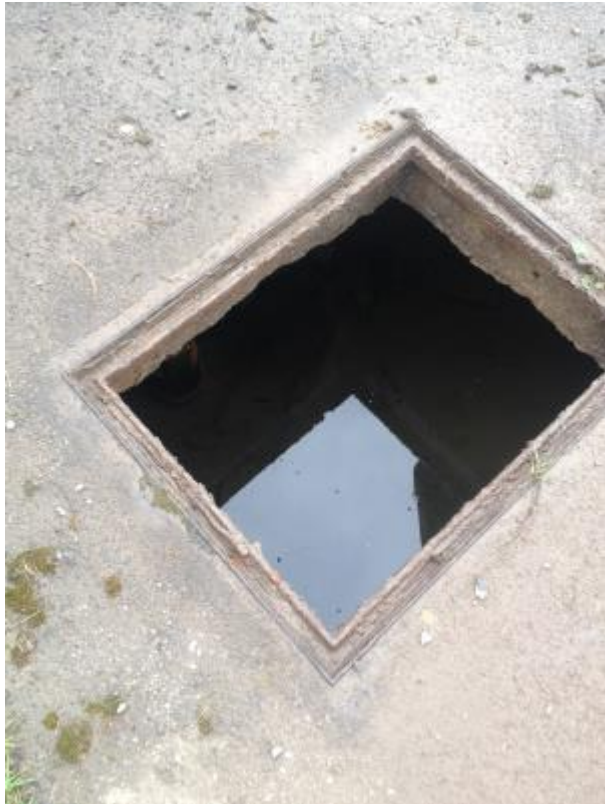
Photo No. 1	Date: 22/03/17

Direction Photo Taken: N/A		
Description: The spring feeding the private water supply arises and is collected within this sump and is fed to the property with an electric pump.

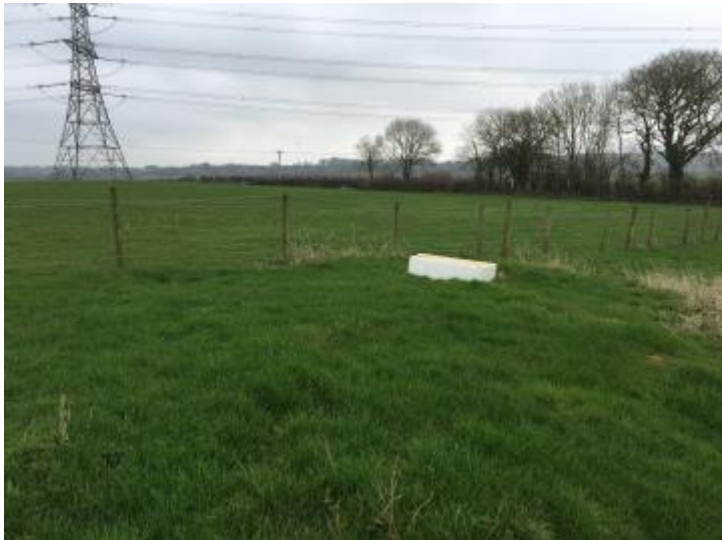
PHOTOGRAPHIC LOG Private Water Supply Maen Eryr		
Photo No. 1	Date: 23/03/17

Direction Photo Taken: North-easterly		
Description: Porcelain sink covers borehole well-head

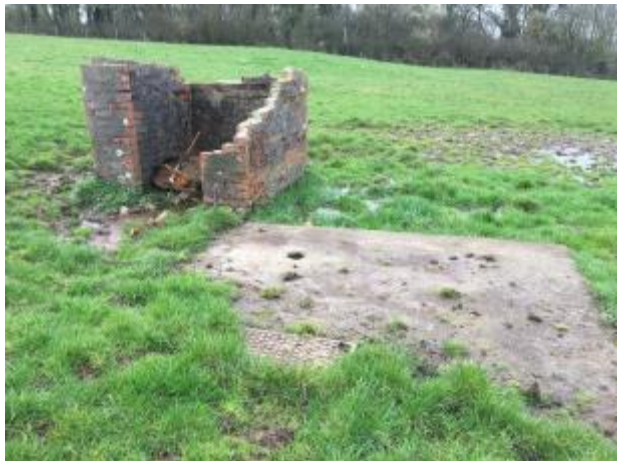
Photo No. 2	Date: 23/03/17

Direction Photo Taken: Westerly		
Description: Location of well at property. Note dilapidated pump house. Whilst the well is not currently in use the owner indicated that it is possible that it could be utilised in the future.

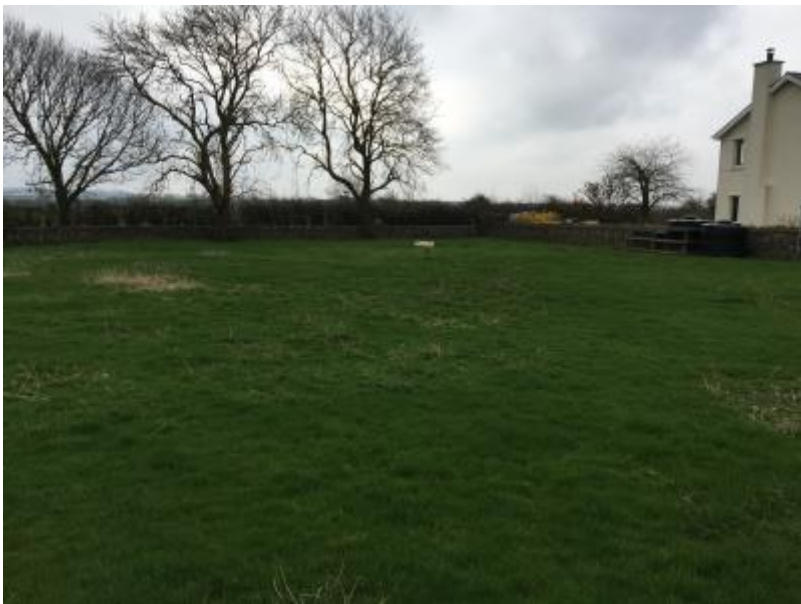
Photo No. 3	Date: 23/03/17

Direction Photo Taken: Southerly		
Description: Porcelain sink (background centre) covers another borehole well-head. The boreholes feed into the two black water tanks(background right)
