Viking CCS Pipeline

**Environmental
Statement Volume IV –
Appendix 11-2: Site
Visit Technical Note -
Water**

Document Reference: EN070008/APP/6.4.11.2

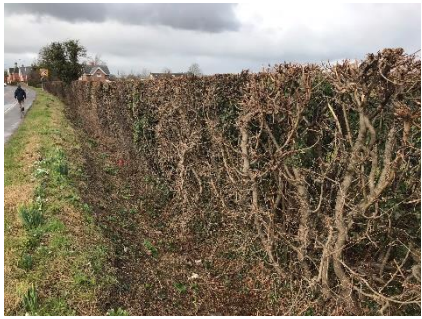
Parameter	Details	Photograph
Channel Form	Straight, artificial drainage ditch which runs along boundary between road and agricultural field. A hedgerow ran along one of the banks, whilst the other bank was steep and grassed.

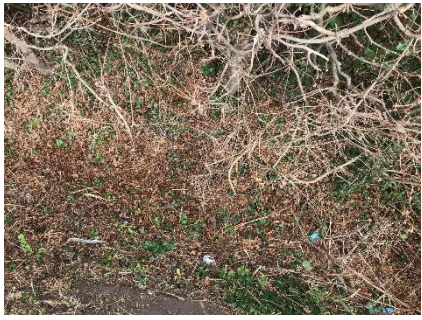
Substrate Conditions	The bed comprised soil and short grasses.

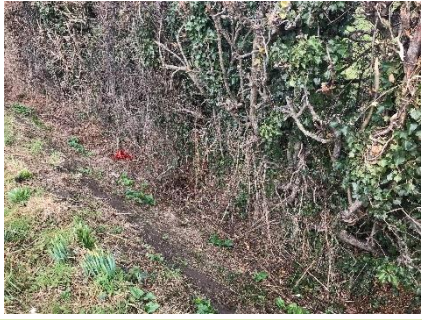
Flow Conditions	The ditch was dry at the time of survey and is likely dry for much of the year.

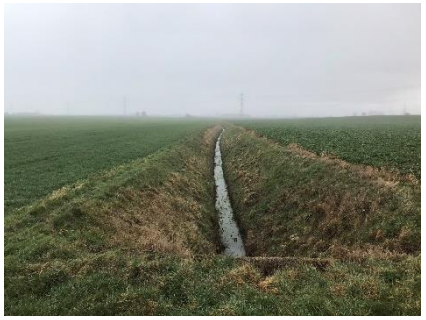
Parameter	Details	Photograph
Channel Form	Straight, artificial or heavily modified drainage channel with trapezoidal cross section. The channel was set between agricultural fields.

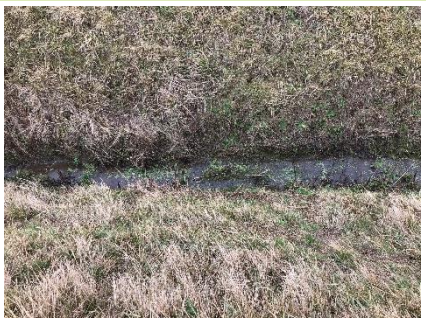
Substrate Conditions	Bed sediment comprised silt. The agricultural setting likely contributes a considerable amount of fine sediment.

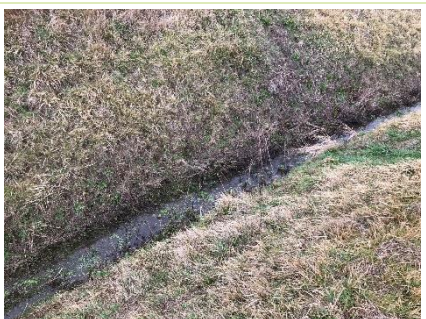
Flow Conditions	There was standing water in the channel but no perceptible flow.

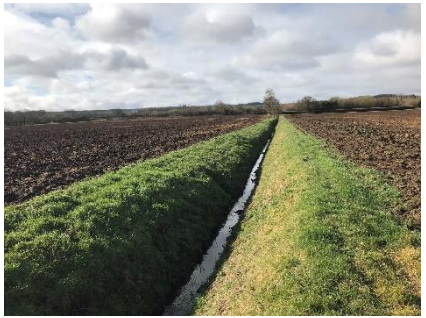
Parameter	Details	Photograph
Channel Form	This watercourse comprised a straight, artificial or heavily modified channel with a trapezoidal cross section.

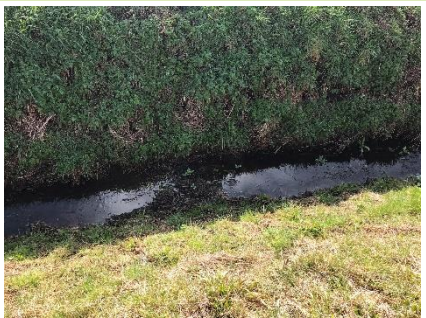
Substrate Conditions	The bed was silty.

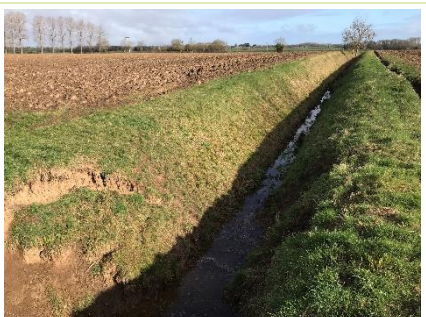
Flow Conditions	Flow was predominantly gliding, although there was some rippled flow where bank slumping and vegetation caused the channel to narrow.

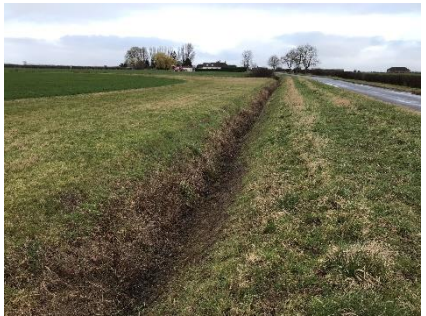
Parameter	Details	Photograph
Channel Form	This watercourse comprised a straight, artificial or heavily modified channel with a trapezoidal cross section.

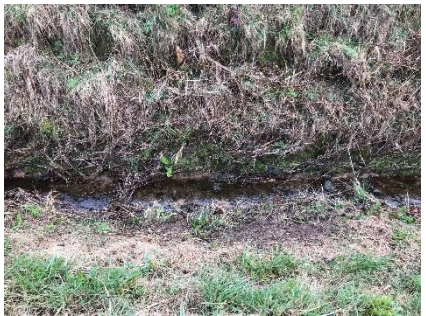
Substrate Conditions	The bed was grassed along much of its length, although sand and silt were present where water was flowing.

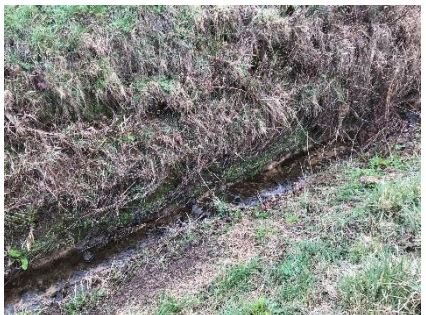
Flow Conditions	The channel was dry through much of its length, although flow did develop through the downstream length.

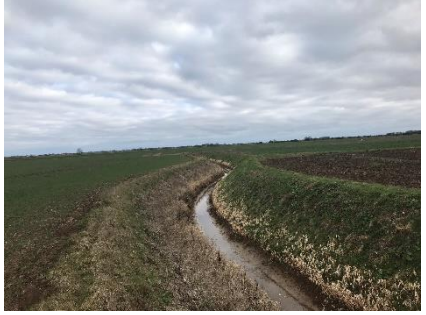
Parameter	Details	Photograph
Channel Form	This watercourse comprised a straight, artificial or heavily modified channel with a trapezoidal cross section. The channel appears to have been dredged.

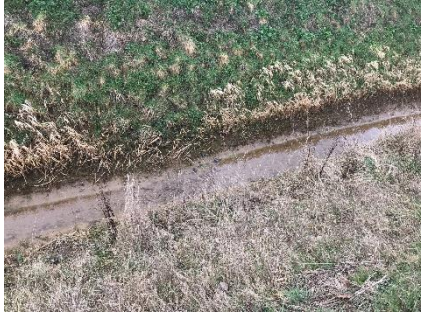
Substrate Conditions	The bed was silty with some small areas of exposed gravels.

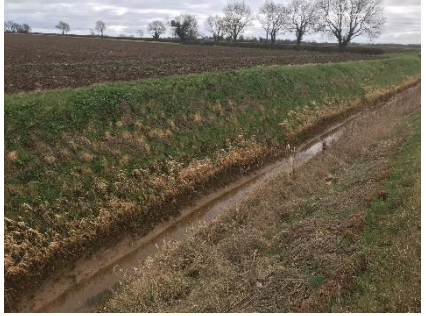
Flow Conditions	Flow was gliding, with some rippled flow over coarser substrate.
