Alan Wood & Partners

STRUCTURAL REPORT ON THE FORMER EARL DE GREY PUBLIC HOUSE, CASTLE STREET, HULL

Date: 29th May 2019

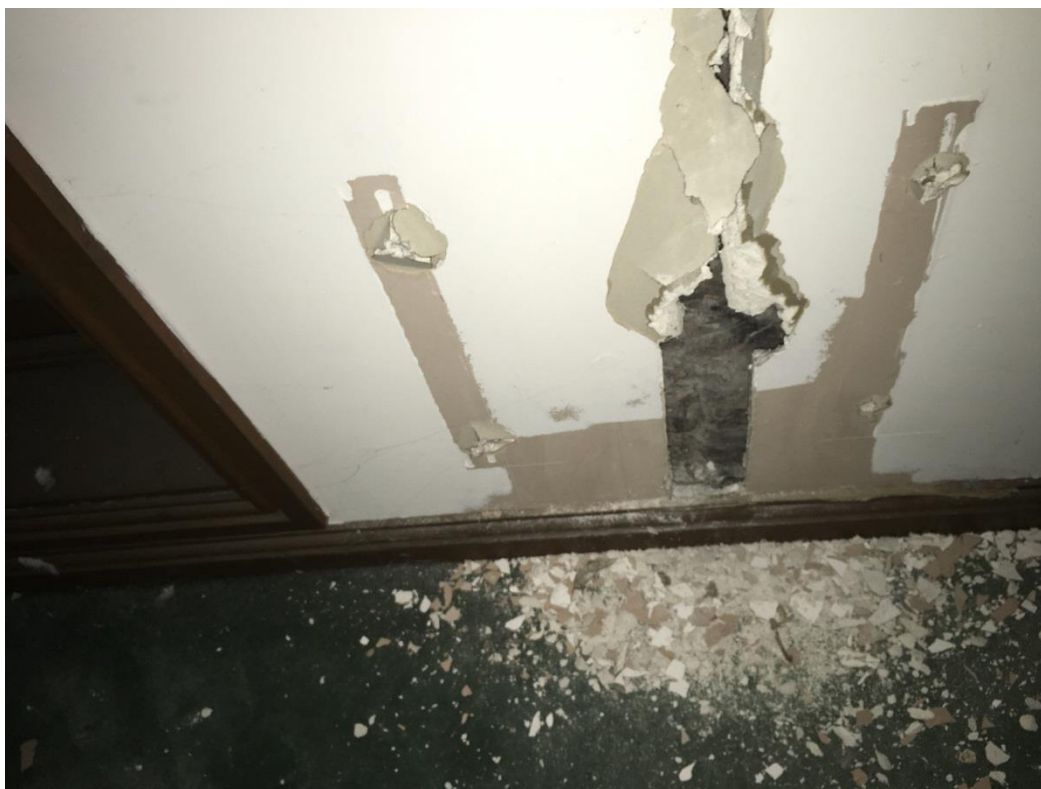
3.2.1 The interior of the building was inspected at ground, first and second floor level, focussing on the Castle Street elevation of the building only. A refurbishment scheme by previous owners, understood to have been completed in the late 1990's/early 2000's removed almost all of the original features, leaving very little of historical significance in place. All the walls inspected had modern plaster board finishes with modern skirting boards and no cornice. Similarly, the doors and main staircases had been replaced with modern softwood versions. Many of the original floorboards had also been replaced with modern boarding.

Image 1: Modern plasterboard and skirting.

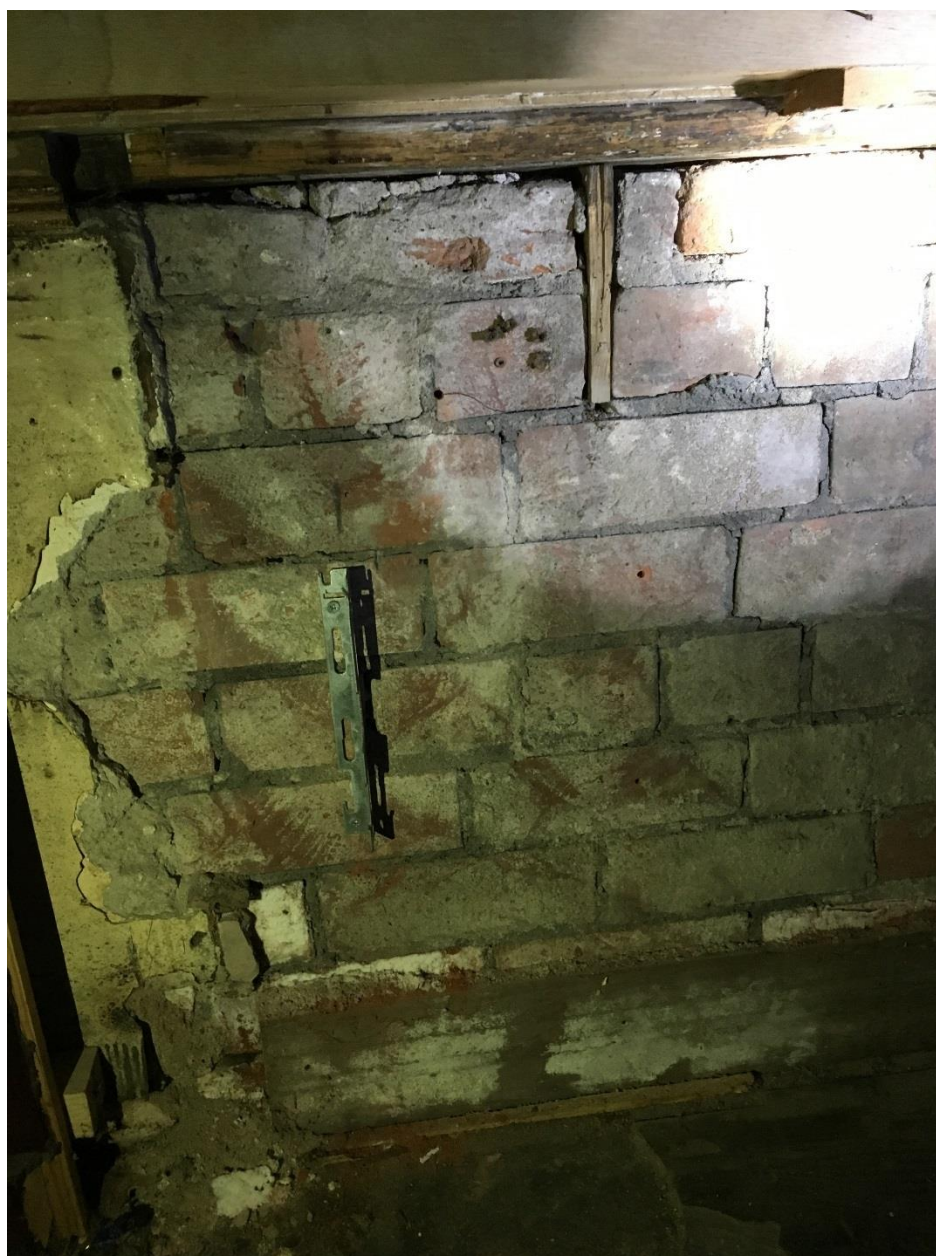
3.2.2 The plasterboard finish offered limited opportunity to inspect the brickwork, however, some holes within the plaster boarding at first floor level allowed inspection of the brickwork here. Similarly, the plaster had been stripped off below the window cills within the ground floor rooms. The internal face of the brick walls was generally in good condition. The header bricks were visible confirming the expectation that the walls would be solid 9" construction. The age and type of construction as well as the visual evidence present indicate that the mortar will be lime based.

Image 2: Lower level brick at ground floor with visible headers.

- 4.1 Generally, the structural units were in fair to good condition and would be suitable for re-use.
- 4.2 The brickwork inspected is generally suitable for reuse (90% +) to the inside face. The outer face could not be inspected therefore a realistic assessment could not be made. The bricks should be cleaned off and sorted during the dismantling process, those with light weathering or damage could still be used for applications other than in the fair face. As the building as a whole is to be dismantled the remainder of the building could be used as a source of reclaimed bricks to match any that are deemed unsuitable for re-use.

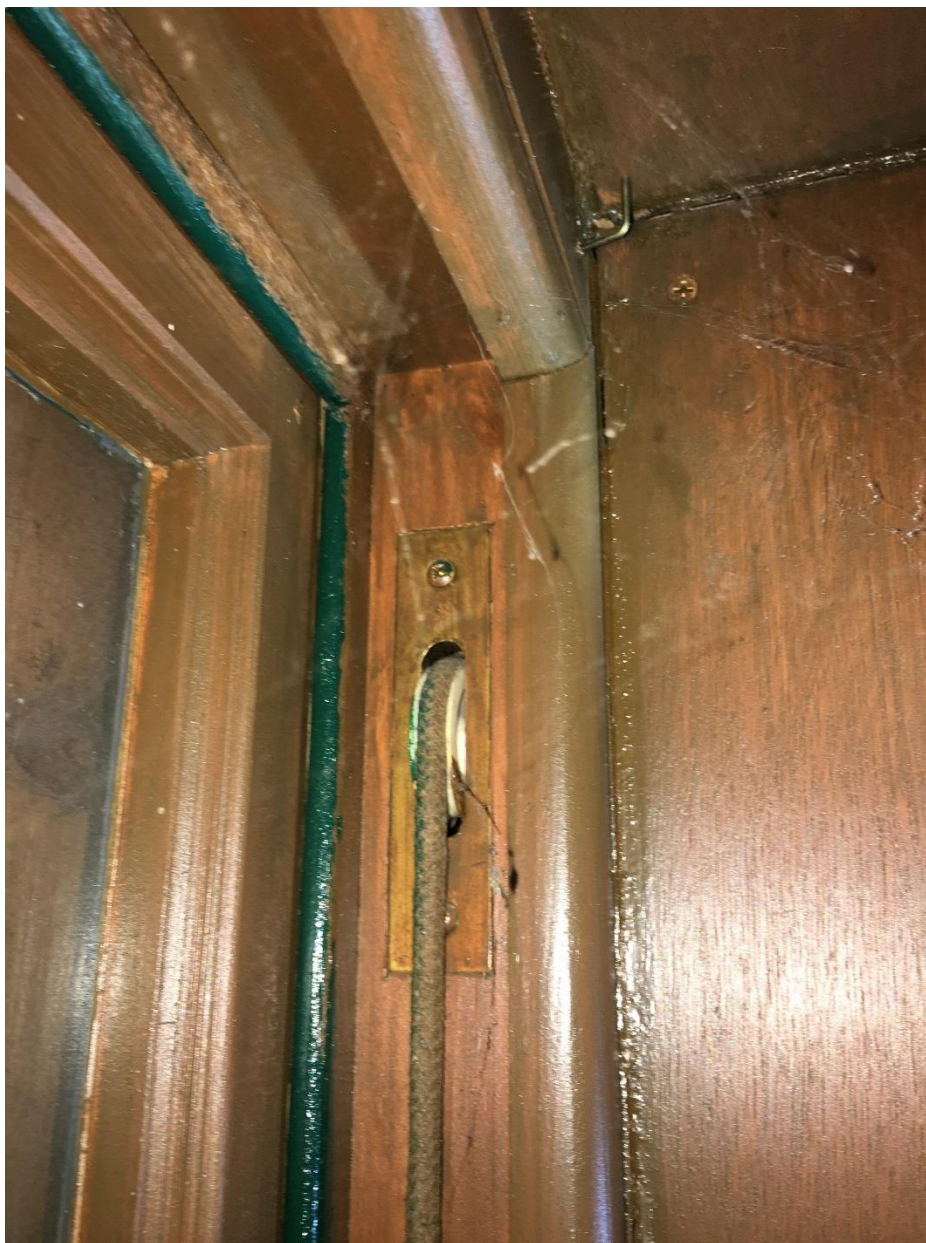
3.2.3 Inspection of the windows to the frontage at both first and second floor level revealed that the windows were single glazed sash units. They were in good condition, aside from an individual broken windowpane noted at second floor. The units were relatively modern replacements. All of the joinery was formed in soft wood and the sash mechanisms included plastic elements. The glazing was modern float glass rather than drawn. The quality of workmanship and detailing to the sash windows was not particularly good. The units are in sufficiently good condition to be re-used, if it were felt that this would be of any merit to the finished rebuild.

Image 3: plastic mechanism and softwood joinery to upper sash windows.

- 4.3 The window frames are suitable for re-use, although they are not original and are considered to be good facsimiles of the originals. It may therefore be considered more appropriate to have new, heritage units made to suit.

- 4.4 The majority of the glass (95% +) will suitable for re-use, subject to breakage during dismantling. Again, this is modern single glazing and it may be considered more appropriate to replace this with a more in-keeping glass.

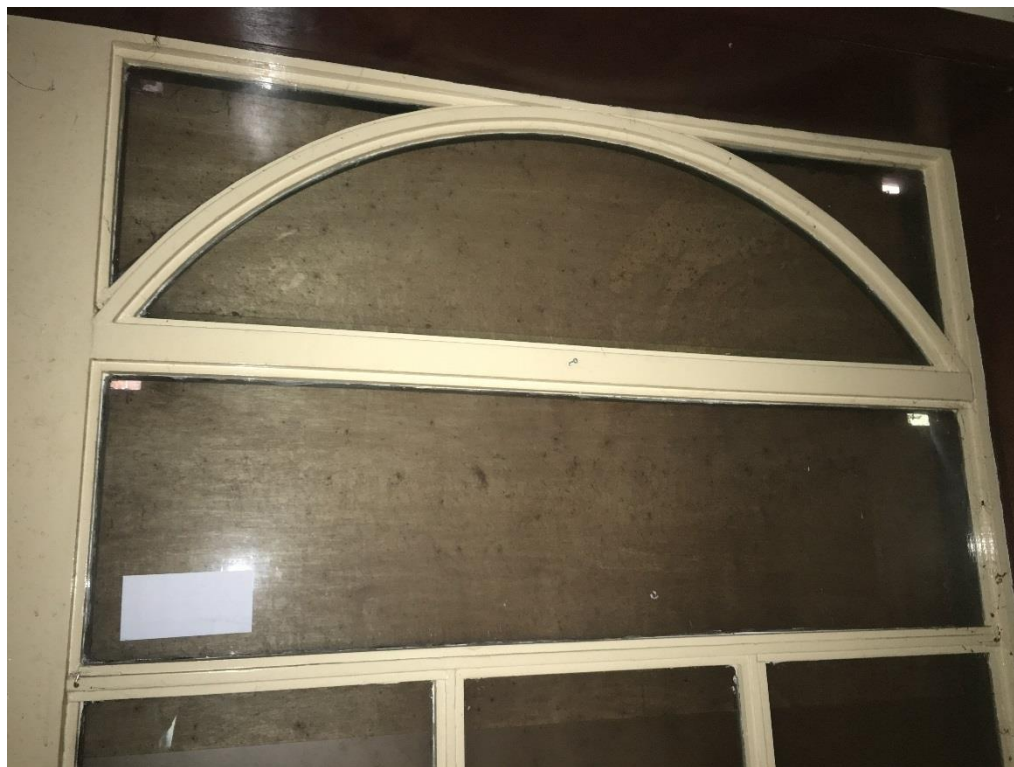
3.2.4 The windows to the ground floor frontage were more detailed and featured no opening lights. They were again in good condition and suitable for re-use, if this were felt to be appropriate. They were also, as with the sash windows, more modern replacements for the originals. The joinery was again softwood and the glazing was modern float glass.

Image 4: Softwood fixed pane windows to ground floor.

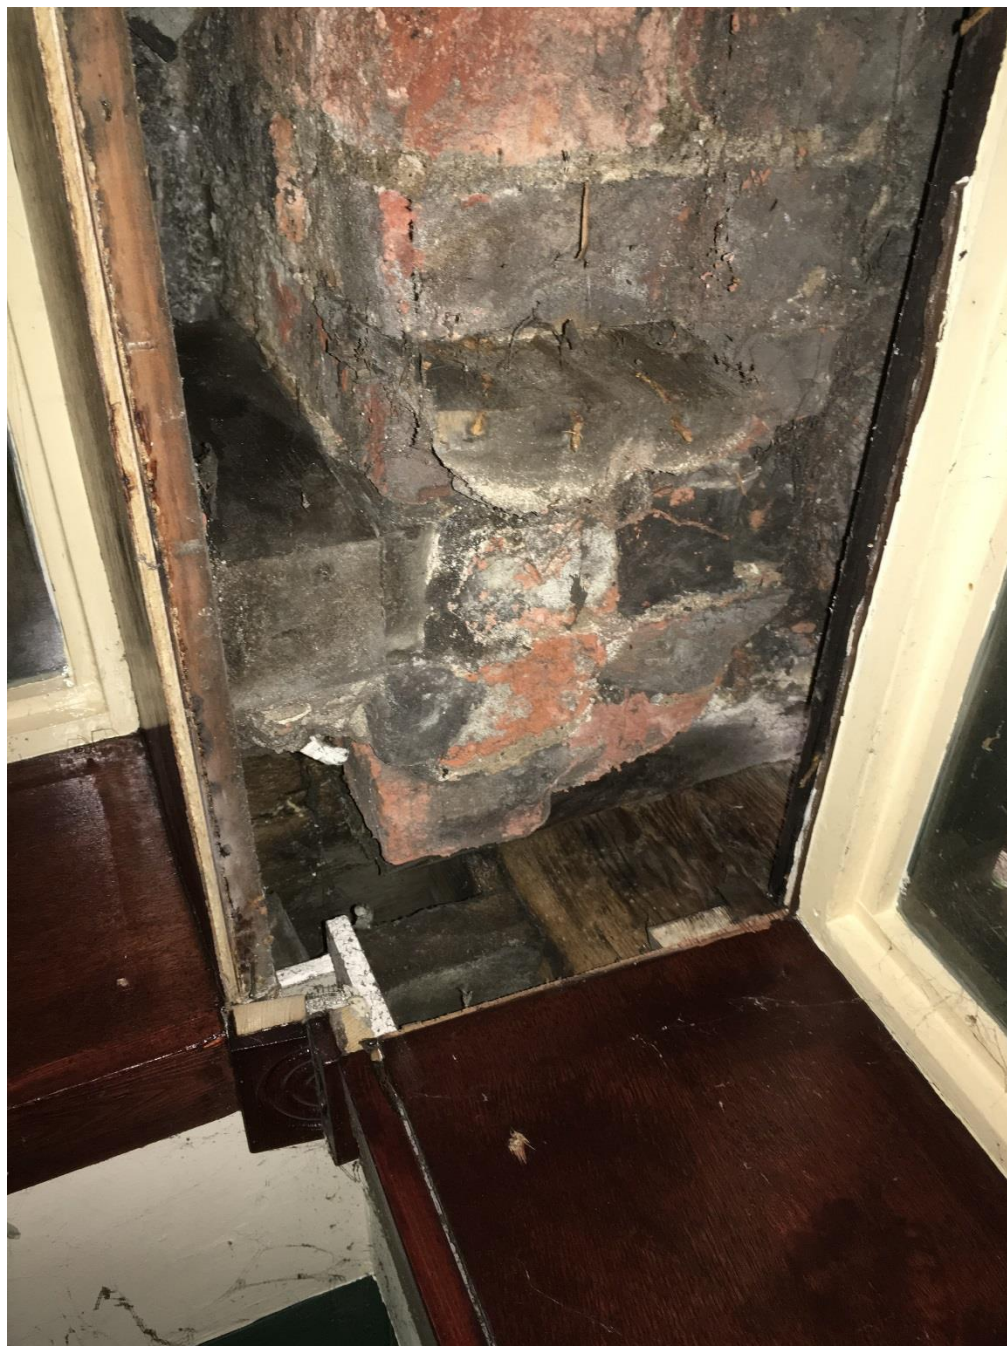
- 3.2.5 At ground floor level the soft wood cladding which cloaked in the brickwork corner pier was opened up to allow inspection of the construction in this area. The brickwork here was in poorer condition with some damaged and weathered bricks and poor mortar joints. Approximately 90% of the brickwork visible would be subject to reuse following the dismantling works.

Image 5: Brickwork quality to window reveal

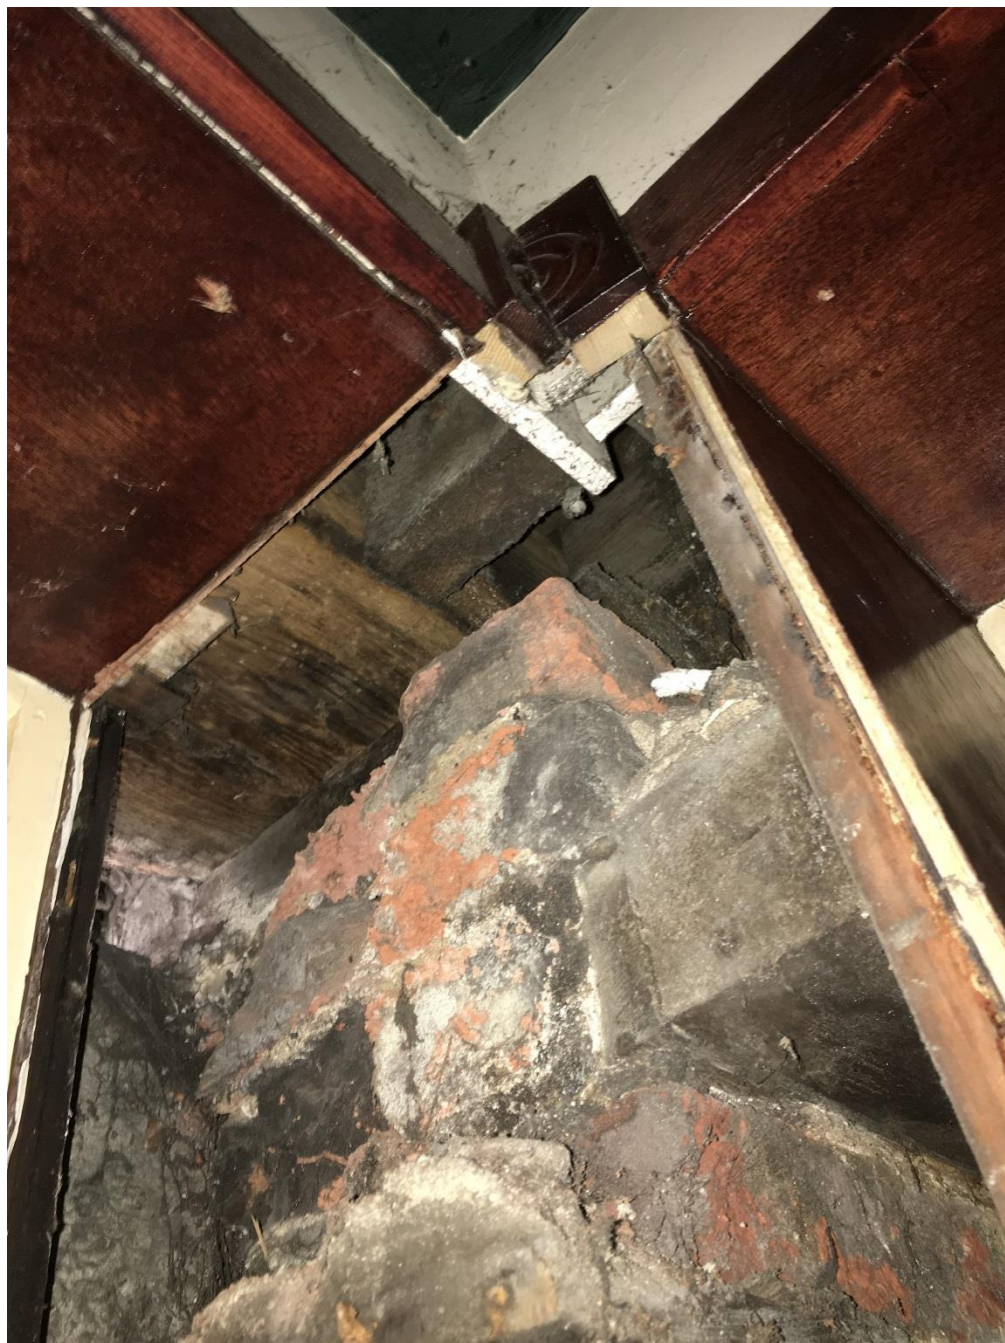
- 3.2.6 Detailed inspection of this corner brickwork revealed timber boarding which ran over the top of the brick pier at approximately window head level. This is likely to form part of the support system for the external faience.

Image 6: Timber boarding at window head level

4.9 It is recommended that a specialist damp and decay timber survey is carried out utilising micro-drilling techniques to establish the extent to which the timber elements forming the boxing out and support to the frontage can be re-used.

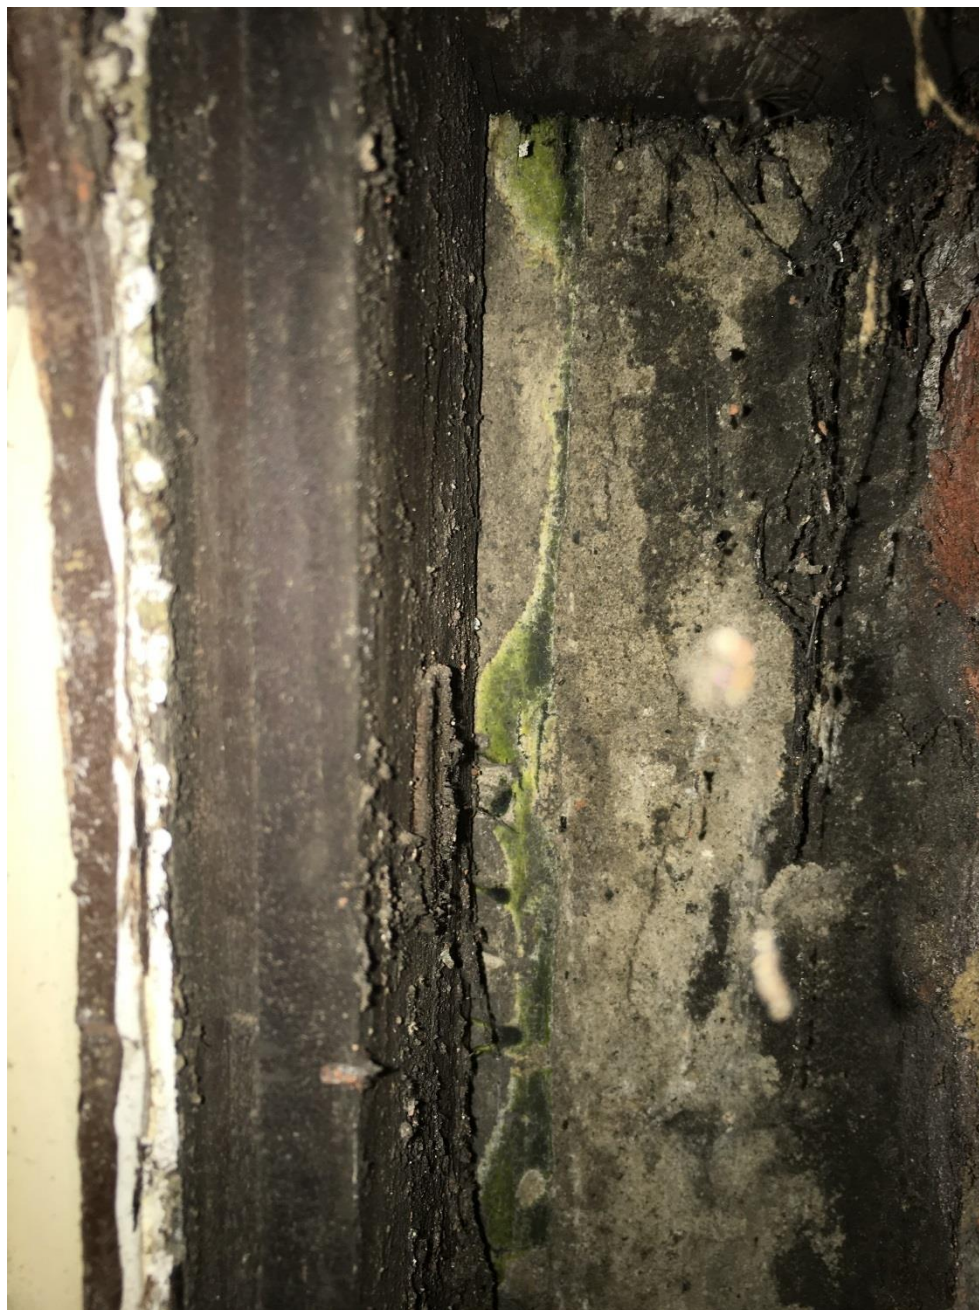
The gap between the window carcassing and the brick pier allowed a view of the rear face of part of the faience tiling, with the edge of the glazed finish visible.

Image 7: Rear view of faience tiling

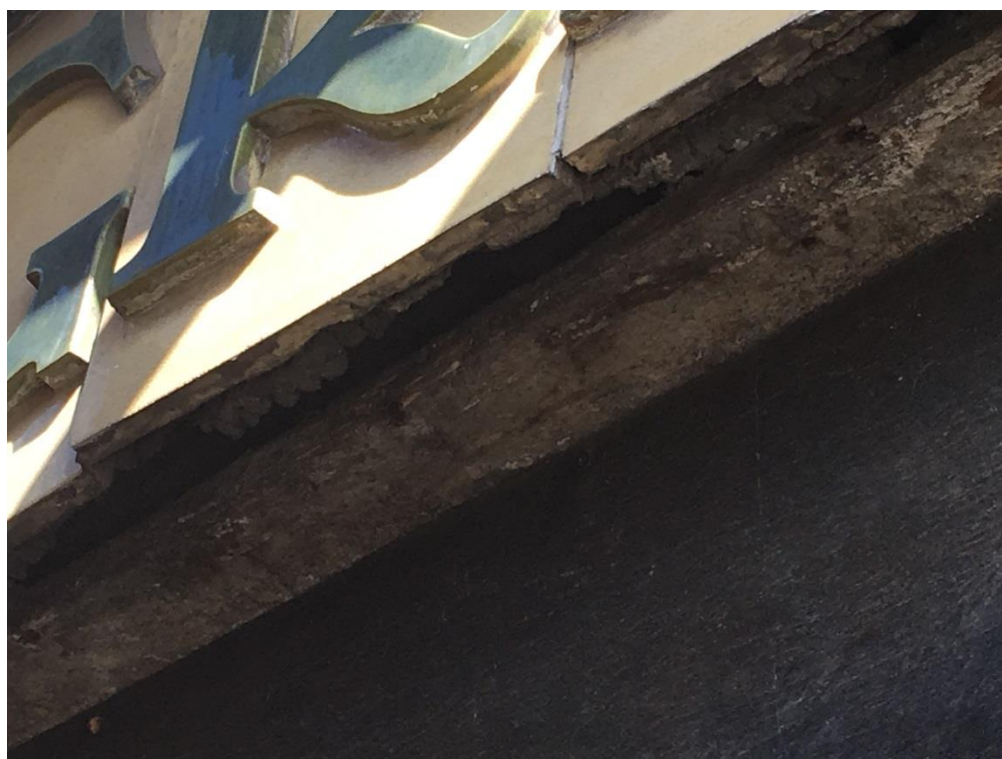
- 3.3.1 The exterior was inspected from street level. The protective hoarding which had been erected to the Castle Street façade was partially removed to allow access to the frontage.
- 3.3.2 The external face of brick was entirely rendered therefore the condition of the brick faces cannot be commented on in any detail. No significant cracks or other defects were noted in the render finish.
- 3.3.3 Externally the Earl de Grey Signage was directly applied to thick glazed tiles. Some missing soffit boarding allowed for some inspection of the construction behind. In the locations of the signage the tiles were mounted on timber boxing out. Removal of the soffit boarding beneath this should make the careful dismantling of the tiling relatively straightforward.

Image 8: Timber Boxing Construction behind signage tiling

- 4.5 The tiling which forms the signage can be removed from the exterior following the full removal of the soffit boarding beneath. This will give access to the timber boxing out which supports the tiles and allow their careful removal.

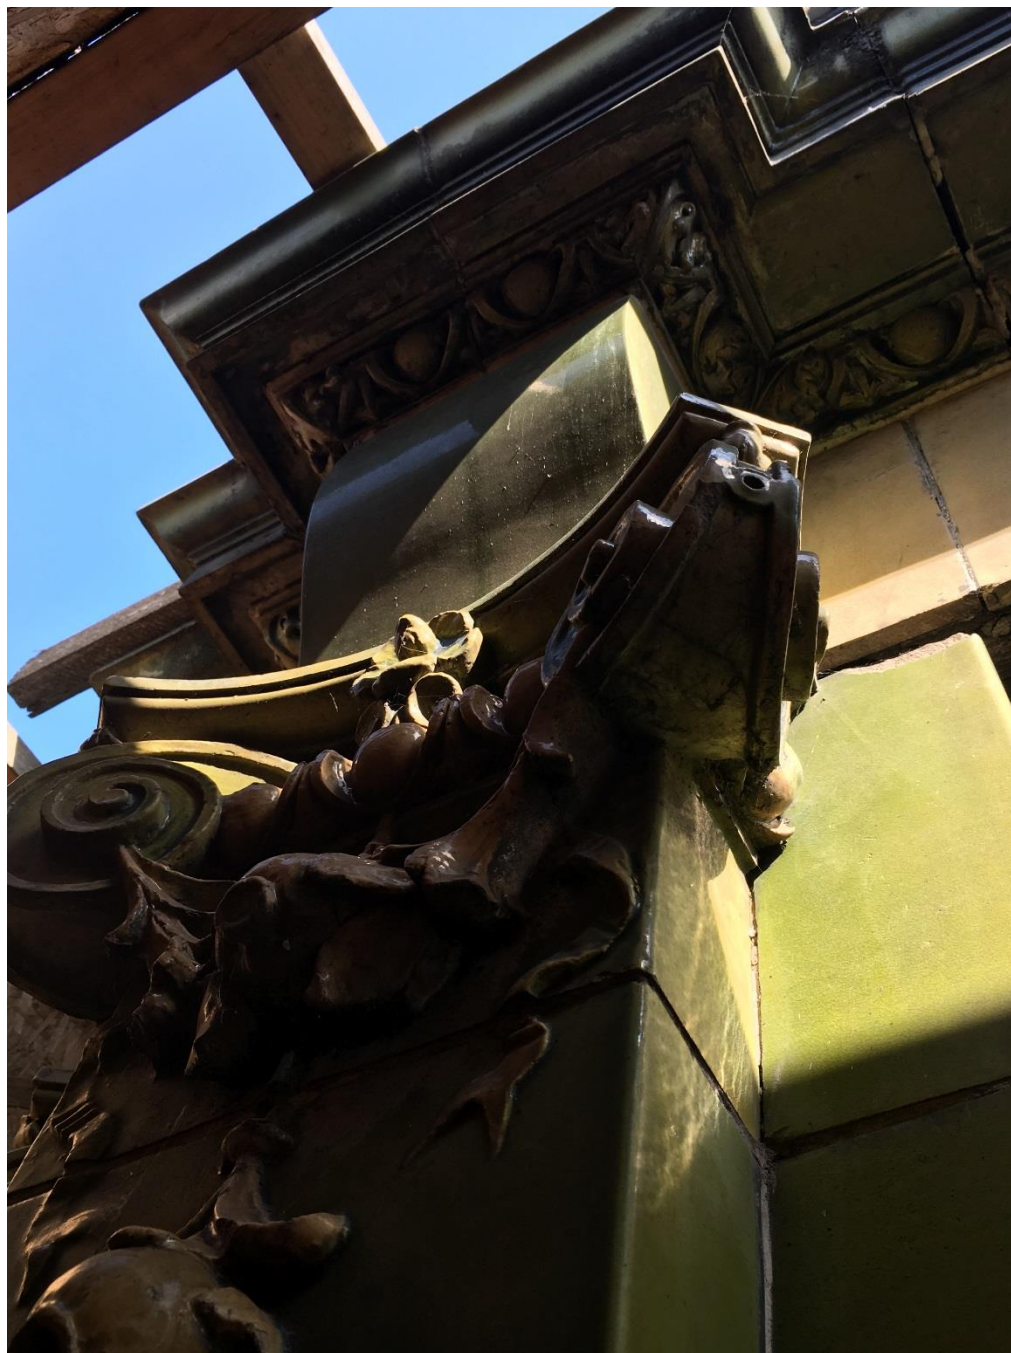
- 3.3.4 The remainder of the faience tiling appeared more complex. Faience as a technique is the forming of fired terracotta units with a glazed face. Inspecting the format of the larger decorative units at high level it is likely that these are fired, terracotta blocks, possibly hollow in the case of some of

Image 9: High level detailed faience tiling

- 4.6 It is likely that the both the removal of the tiled signage and the removal of the remainder of the window carcassing and the ground floor windows will allow a more detailed assessment to be made on how the rest of the faience is constructed. It is likely that the dismantling process will need to be carried out from both the interior and the exterior. A suitable temporary works scheme should be developed to give support to both faces while simultaneously allowing safe working room.

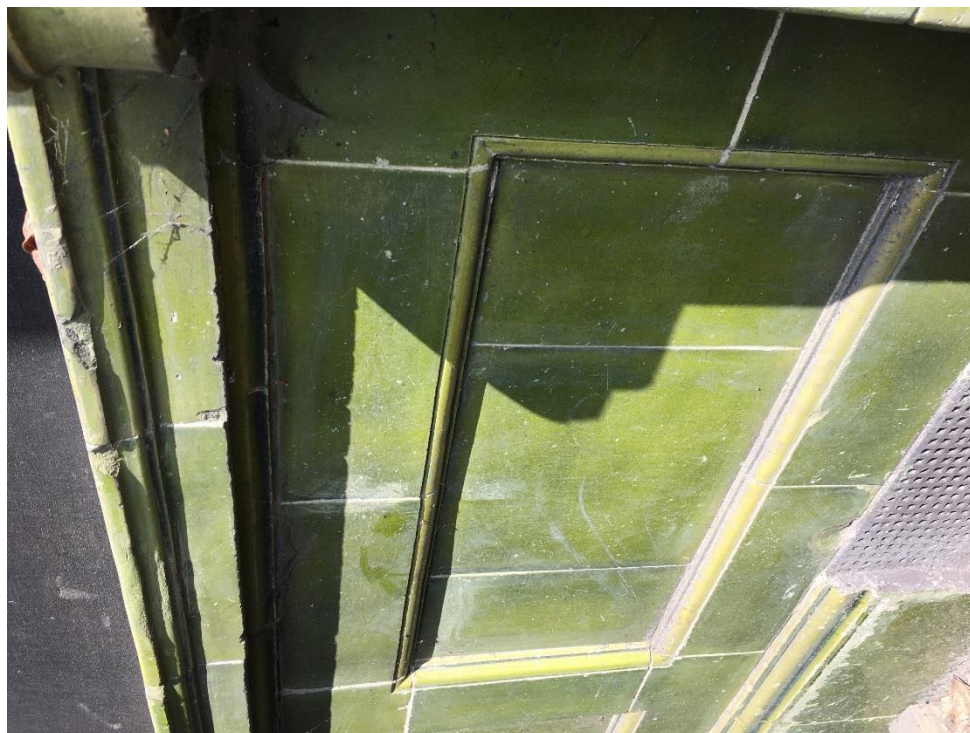
the larger units. These are likely to be integrated into the wall construction. Measurement of the mortar joints on the front face gave a dimension of 2-3.5mm per joint, which would make dismantling from the front elevation without damage to the faience difficult.

Image 10: Narrow joints between faience tiles

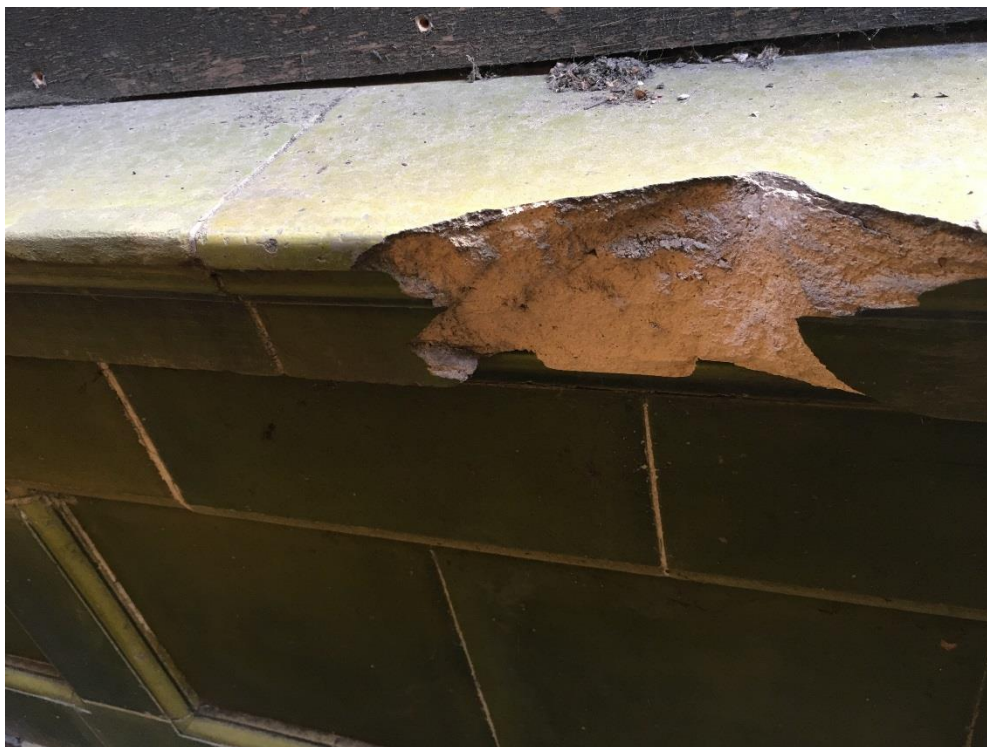
- 3.3.5 Some of the tiling was damaged, with sections chipped off, glazed finish to faience missing or, in other locations attempts had been made to repair missing finish with a cementitious mortar and green colouring. Cracks were visible in some of the higher-level units.

Image 11: Damaged edge showing terracotta beneath

- 4.7 Some of the faience as noted above, has already been damaged, agreement will have to be reached with all interested parties over whether these elements should be reinstated in their damaged state, repaired or replaced with facsimiles.

- 4.8 As it cannot be guaranteed that the dismantling process will not cause damage to some of the faience it is suggested that in addition to thorough recording of the existing, that a specialist terracotta and faience manufacturer be contacted, and allowance be made for taking moulds of the decorative units. This would allow for replacements to be made should breakage occur. Such a manufacturer could also provide further guidance on how these elements are fixed.

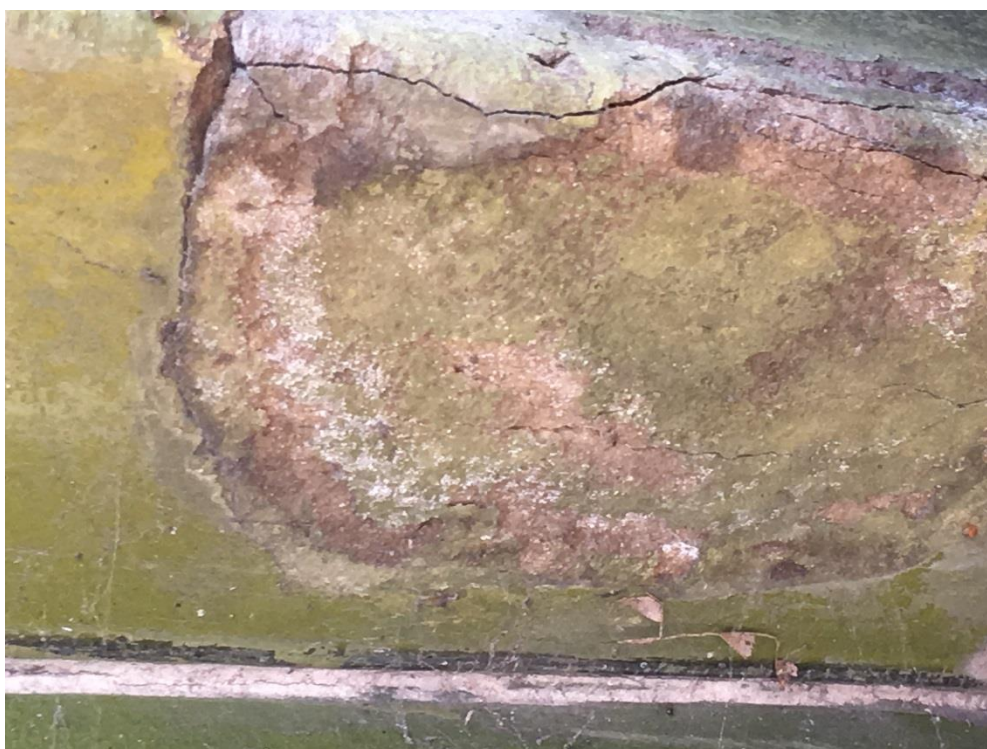
Image 12: Green coloured repair to glazing finish

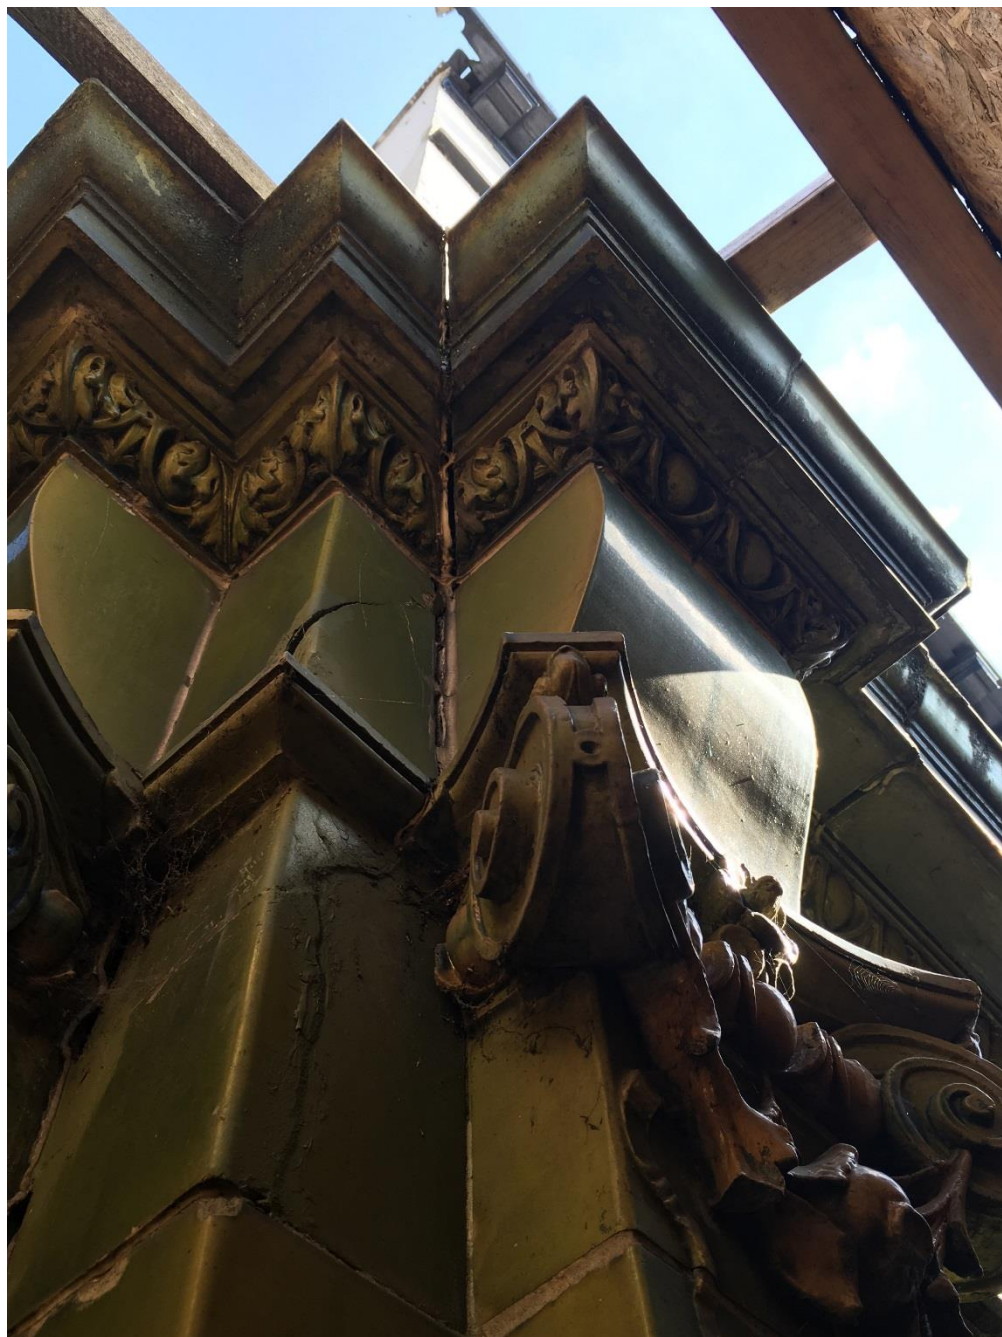
Image 13: Cracked faience
