Smart Motorways Programme

M4 J3 – 12

Package 1 (J8/9 to J12) Road Safety Audit Stage 2

Date: 21 October 2020

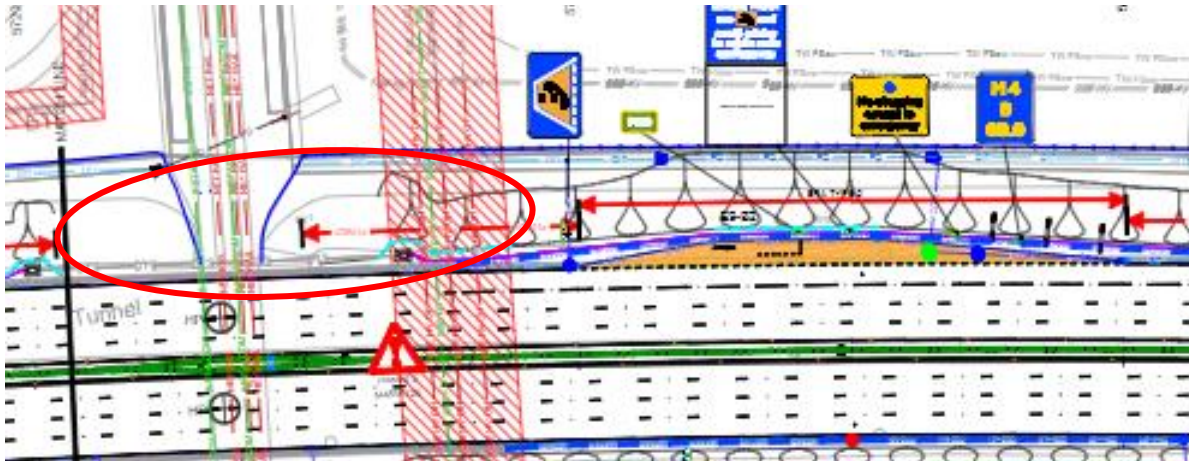
Extract from drawing HA514451-HGN-S1_ML000000_Z-DR-CH-1017 Rev C02

Summary: Reduced visibility to EA E9-B2 may result in EA entry conflicts

Forward visibility to EA E9-B2 is potentially restricted by the parapet for Mortimer Line Railway underbridge which could also restrict visibility to the EA sign, depending on the mounting height. Drivers intending to use the EA may not appreciate its position so close behind the parapet and miss the EA increasing the risk of a live lane stop collision.

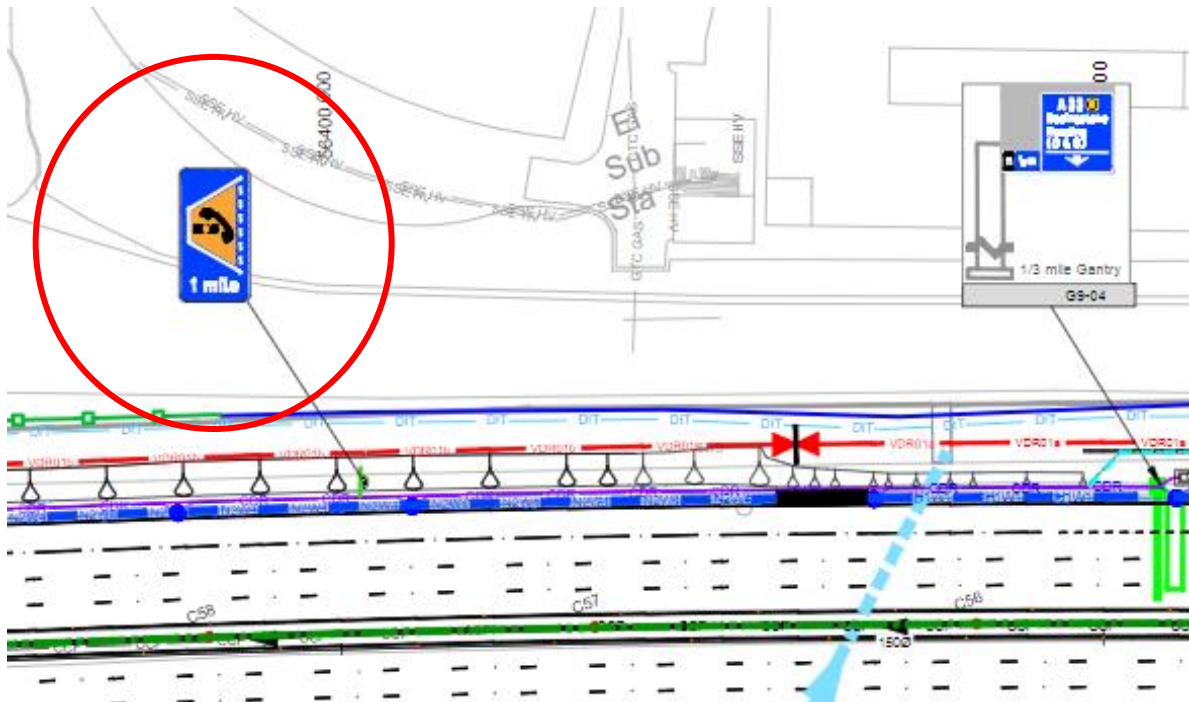
Extract from drawing HA514451-HGN-S1_ML000000_Z-DR-CH-1019 Rev C02

reference a place of relative safety at junction 11, it is not clear where this is and that drivers would have to leave the mainline carriageway. The use of an EA sign with orange coloring could also be misleading.

This increases the risk of live lane breakdowns which could result in further collisions.

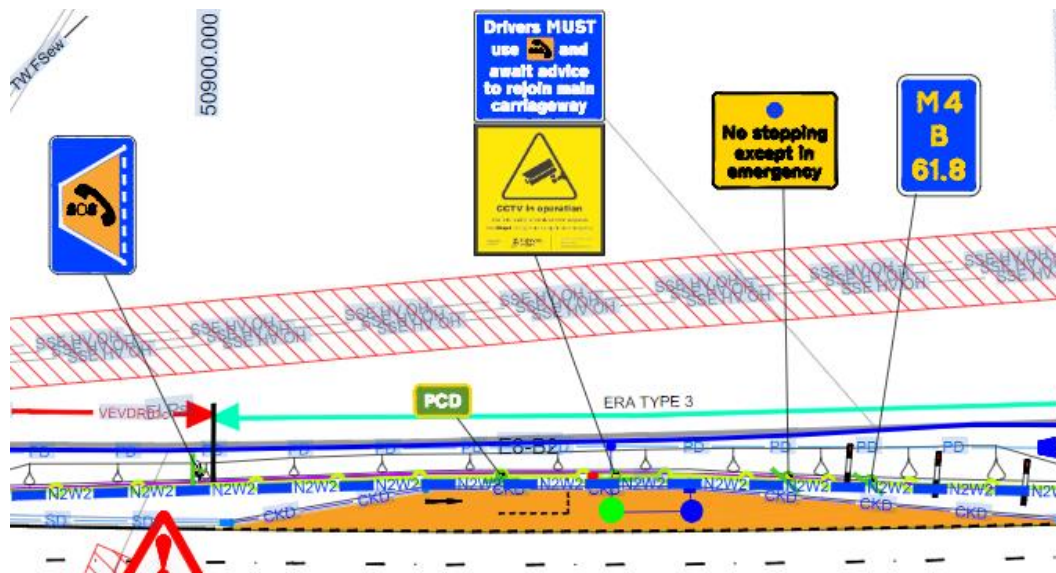
Extract from drawing HA514451-HGN-S1_ML000000_Z-DR-CH-1034 Rev C02

EA E8-B2 is provided at chainage 50900 eastbound. At the rear of the EA is a combination of road restraint system (RRS), EA signing, the emergency telephone and 2.5m high environmental barrier. The area behind the RRS appears too narrow (to wait outside the barriers working width) and cluttered to represent a safe place for pedestrians/operatives to be should they have exited their vehicles.

This could result in further collisions and increase the risk of injuries to pedestrians and operatives who may attempt to seek refuge between the RRS and the environmental barrier or should they attempt to find alternative safe areas by walking onto or near the live carriageway.

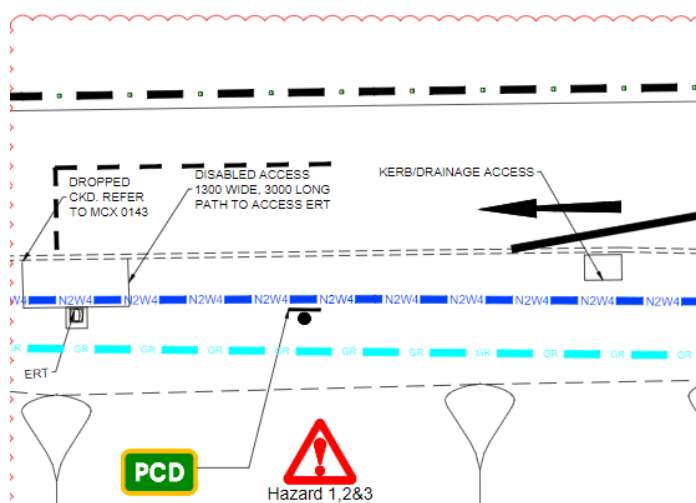
Extract from drawing HA514451-CHHJ-HGN-S1_MLZZZZZZ_Z-DR-CH-0003 Revision C03

Summary: Provision of dropped kerbs at ERTs

The police observation platform (POP) specification drawings indicate a 3m dropped kerb at the ERT to enable disabled access to the telephone following the recommendation to alight the vehicle via the passenger side. The EA markings proposed to indicate to drivers where to stop their vehicle may inadvertently block the dropped kerbs, reducing accessibility to the ERT, particularly for those with mobility impairment. It is noted that although drivers are advised to exit their vehicle via the passenger seat both able-bodied drivers and those mobility impaired are likely to struggle to exit most modern UK vehicles in that manner and are likely rather to choose to exit via the driver's side accordingly. There is a risk that in blocking access to the dropped kerbs this could result in a motorist being unable to access the phone without positioning their vehicle in a potentially more vulnerable position closer to the live carriageway.

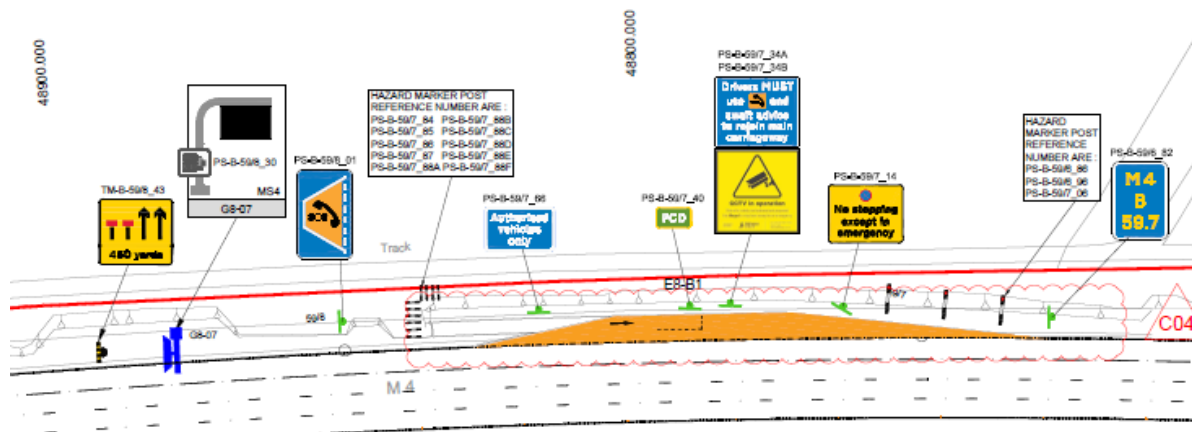
Extract from drawing HSN-S1_77777777_Z-DR-CH-12040 Revision C04

Summary: Unauthorised use of Police Observation Platforms/Areas may lead to collisions

At a number of EA's an overlapped break in RRS is provided to accommodate a police observation platform or area. Examples include EA E8-B1 at chainage 48800, E7-B1 at chainage 36800 and E8-A2 at chainage 50550.

In addition there is a break in the RRS at chainage 37300 eastbound that coincides with the access to an existing POP. It is unclear if the POP is to remain as part of the scheme.

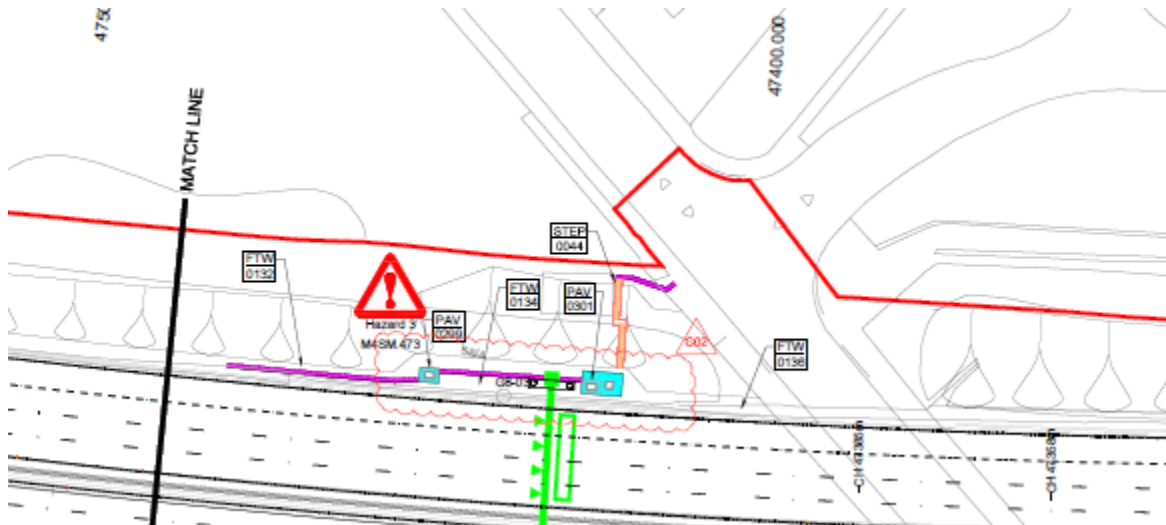
Extract from drawing HKF-S1_ZZ000000_Z-DR-CH-11044 Revision C2

The kerbs and footways drawings detail a new maintenance access to the M4 carriageway, via a footway and access steps, at chainage 47420. It is unclear how the access will interact with the existing Reading Road footway and the post and rail fence. The direct, paved access to the M4 at this location could result in unauthorised use of the access and increase the

potential for pedestrians to be alongside or within the M4 carriageway. In turn this increases the potential for collisions involving pedestrians.

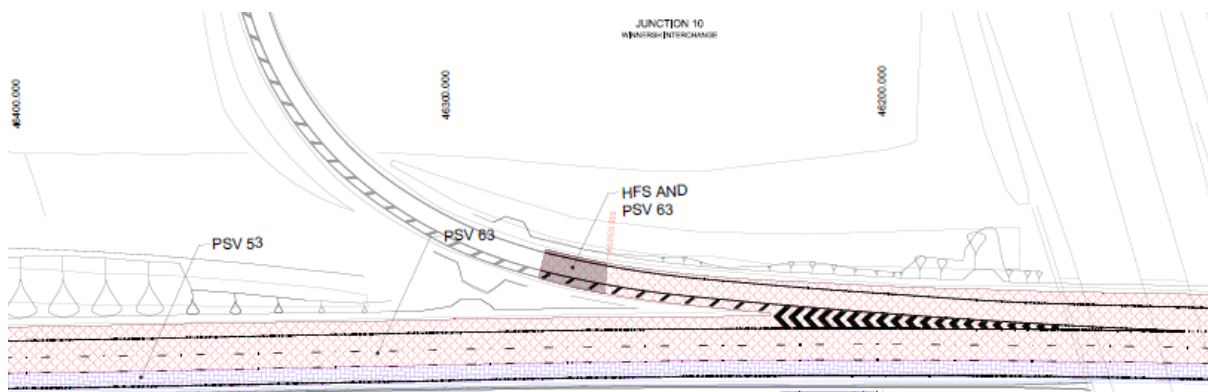
Extract from drawing HPV-S1_ML000000_Z-DR-CH-0747 Revision C01

HFS is provided for very short lengths on a number of junction merge and diverge slip roads. These short lengths tie in to the existing, often worn, provision. This is particularly of note on the A329 (M) northbound to eastbound merge slip (chainage 46300).

The proposed HFS is likely to have a considerably greater braking coefficient than the existing and will be much more visible. This may confuse motorists resulting in late braking and an increased risk of loss of control collisions particularly for motorcyclists.

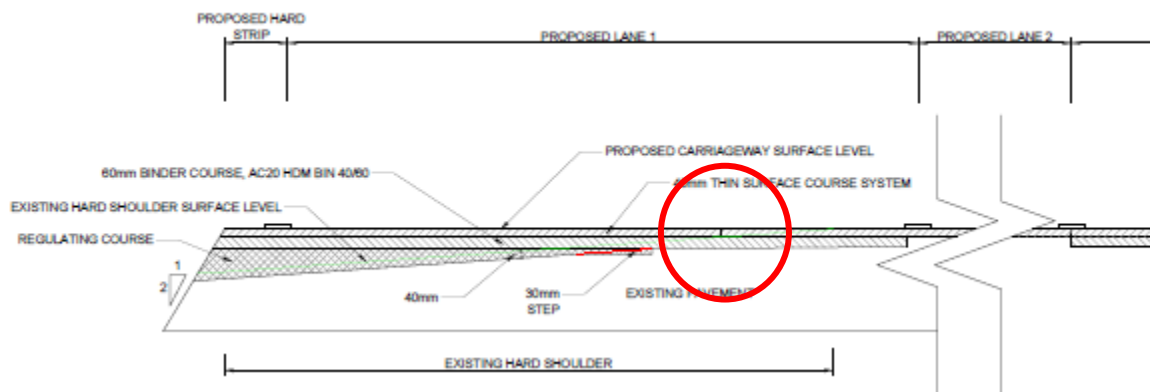
Extract from drawing HA514541-CHHJ-HPV-SZ_ZZZZZZZ_Z-DE-CH-0001 Revision C01

Summary: Surface joints in wheel tracks

Throughout the scheme there are short lengths of lane one and lane two subject to different surfacing arrangements to the surrounding lanes (most often pavement type P1 – resurfacing). The pavement and cross section drawings provided indicate that a surface course joint may be present within the lane extents and in a wheel track. Given that lanes one and two are subject to the highest volume of vehicles, particularly heavy vehicles, there is increased potential for this joint to fail over time. This can reduce the quality of the surface, effect vehicles under braking conditions and may hold standing water, increasing the risk of loss of control collisions. The Audit Team also noted that some sections of the surfacing reinstatement appeared to disturb or influence the direction of travel, and that this is likely to have a greater impact on powered-two-wheelers.

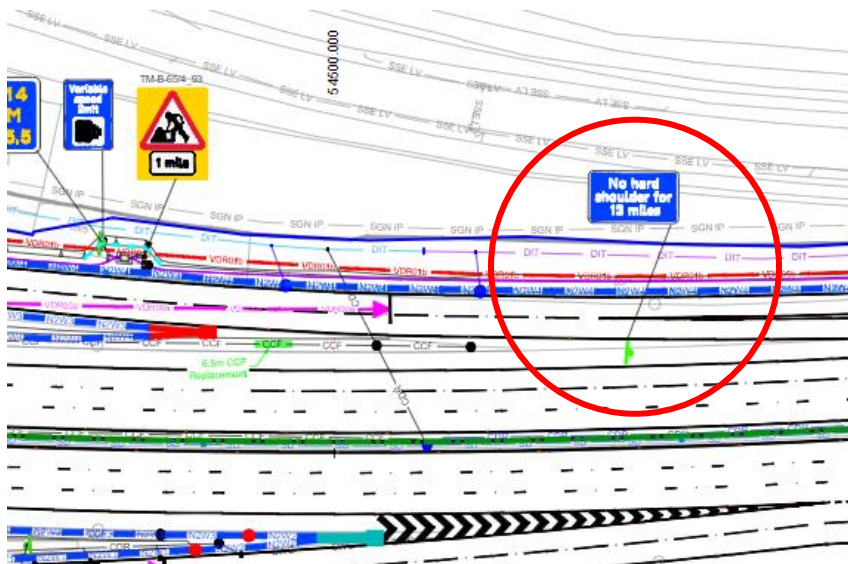
Extract from drawing HA514451-HGN-S1_ML000000_Z-DR-CH-1024 Rev C03

In the event of a vehicle leaving the carriageway they could strike or be led into the signs and post arrangements, potentially increasing the severity of the collision or generating a secondary collision.

With respect to marker post B 53.0 (circled below) this sign would also prevent a vehicle using the gap in the event of a breakdown in order to limit the effect of a live lane breakdown collision.

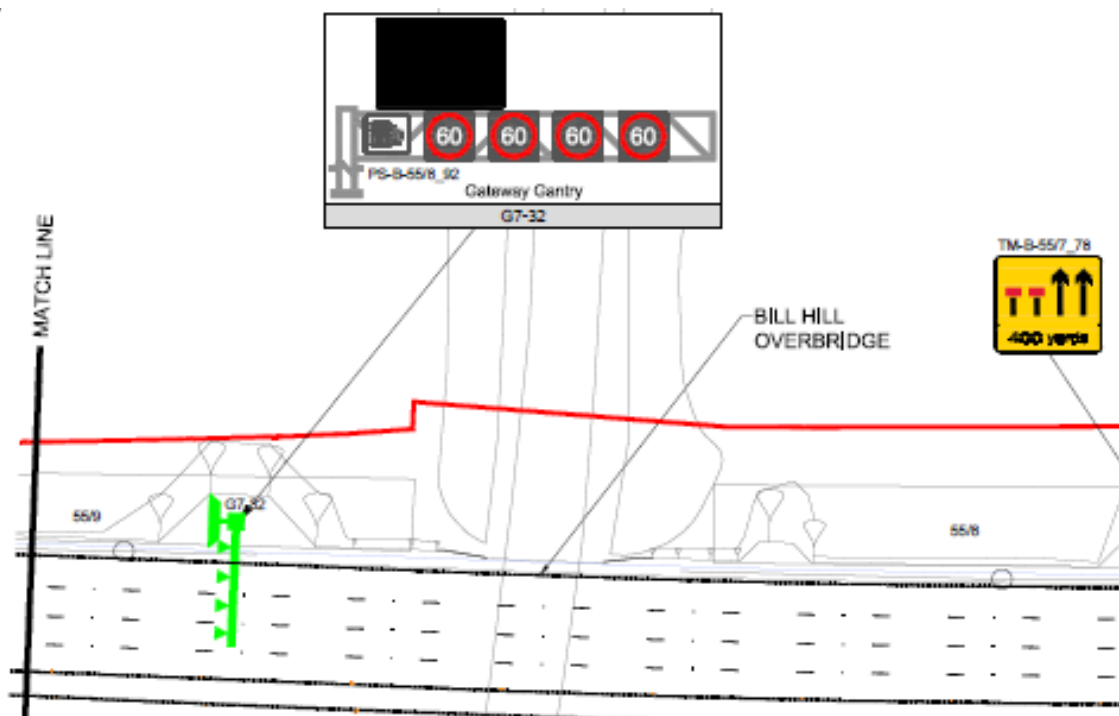
Extract from drawing showing G7-32 (chainage 44900),

Summary: Gantry signs not aligned over the offside lane (lane 4)

The plans provided show gantries that appear not to extend across the whole carriageway while including signs relevant to the offside lane (LBS4 4). This includes but is not limited to eastbound gantries G7-32 (chainage 44900), G7-31 (chainage 44750) and G7-23 (chainage 41750) and westbound gantries G7-21 (chainage 41100), G7-22 (chainage 53600) and G7-31 (chainage 44750). This could result in driver confusion, particularly with regards to 'red-x' emergency lane closures and lane designation, increasing the risk of secondary and lane change collisions.

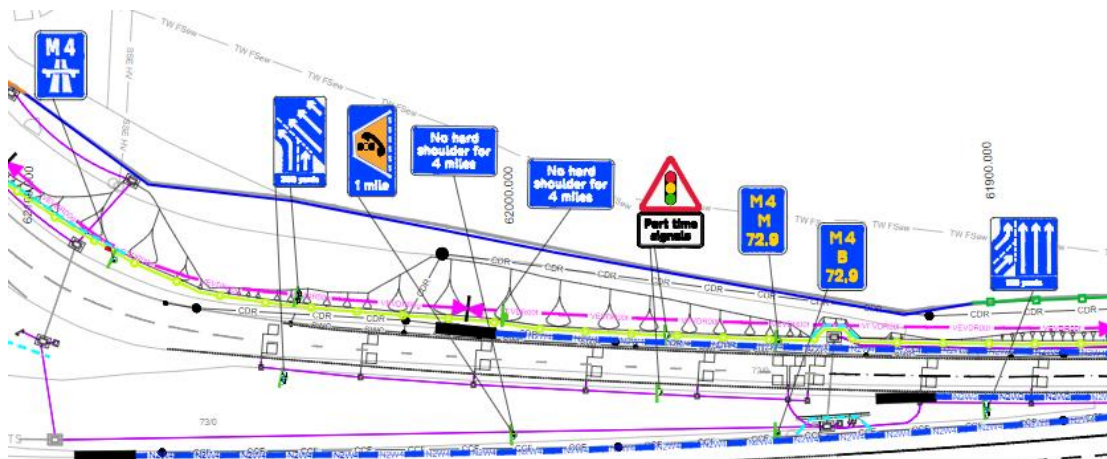
Extract from drawing HA514451-HGN-S1_ML000000_Z-DR-CH-1003 Rev C02

Summary: Sign clutter resulting in reduced visibility to sign faces

Nine signs are provided in the nearside verge of the eastbound merge at junction 12. The number of signs and the spacing between them is likely to result in information overload and reduced visibility to sign faces. This could result in drivers being unaware of hazards or the upcoming merge layout. In turn this could lead to rear shunt type collisions at the ramp metering or side impact collisions at the merge.

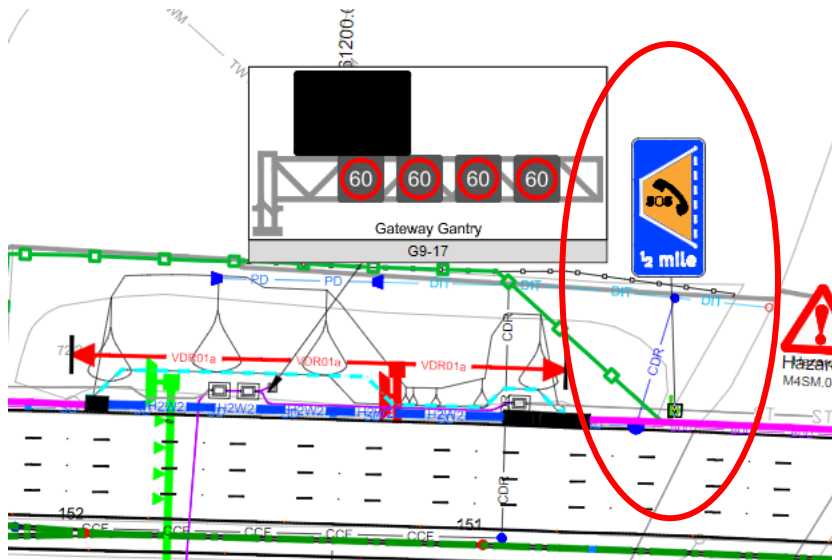
Extract from drawing HA514451-HGN-S1_ML000000_Z-DR-CH-1005 Rev C02

- Lane merge sign (eastbound) at chainage 62000
- No hard shoulder sign (eastbound) at chainage 62000
- Lane merge sign (eastbound) at chainage 61750
- ½ mile EA sign (eastbound) at chainage 61200 (shown below)
- Deer warning sign and services distance sign (eastbound) at chainage 61000
- 1 mile EA sign (eastbound) at chainage 56400
- 1 mile EA sign (eastbound) at chainage 52500
- ½ mile EA sign (eastbound) at chainage 51650
- EA sign (eastbound) at chainage 48900
- 500 yards EA sign (eastbound) at chainage 39300
- Lane designation sign (eastbound) at chainage 35500
- 300 yards EA sign (westbound) at chainage 38000
- Deer warning sign (westbound) at chainage 47000
- Route confirmatory sign (westbound) at chainage 47200
- Services 6 mile sign (westbound) at chainage 48700
- 1 mile EA sign (westbound) at chainage 48900

- TTM 1 mile road works warning sign (westbound) at chainage 55100
- EA sign (westbound) at chainage 50500
- ½ mile EA sign (westbound) at chainage 51800
- Motorway and merge 100 yards on the junction 11 westbound merge slip chainage 55000
- Variable speed limit sign (westbound) at chainage 55200
- 300 yard EA sign (westbound) at chainage 57700.

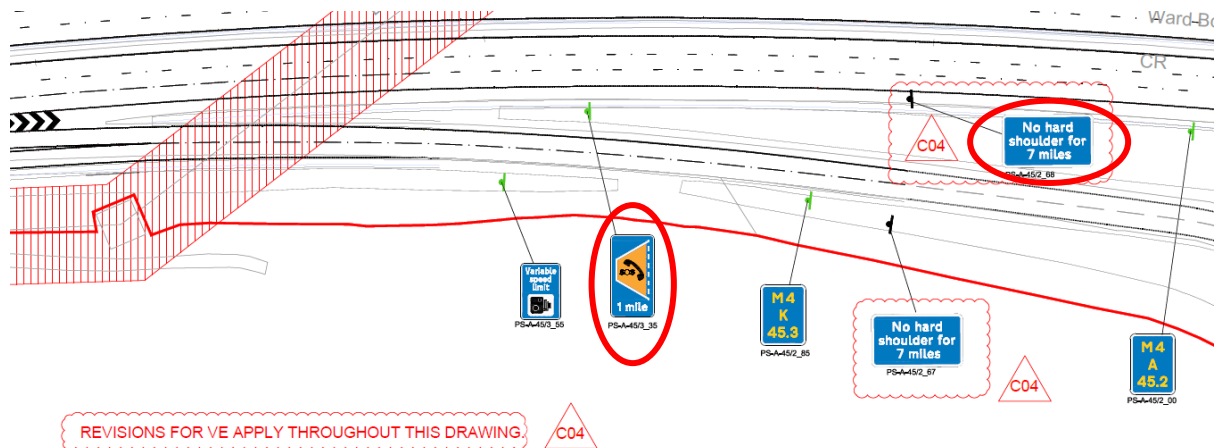
Extract from drawing HSN-S1_ZZZZZZZ_Z-DR-CH-12080 Revision C04

Summary: Proposed signs may restrict visibility for merging vehicles

An emergency telephone one mile ahead sign (PS-A-45/3_35) is provided on the westbound merge nosing and a no hard shoulder sign (PS-A-45/2_68) is provided to the east of this. Given the alignment of the carriageway, these signs may reduce visibility to the mainline for merging vehicles, resulting in increased collisions at the merge.

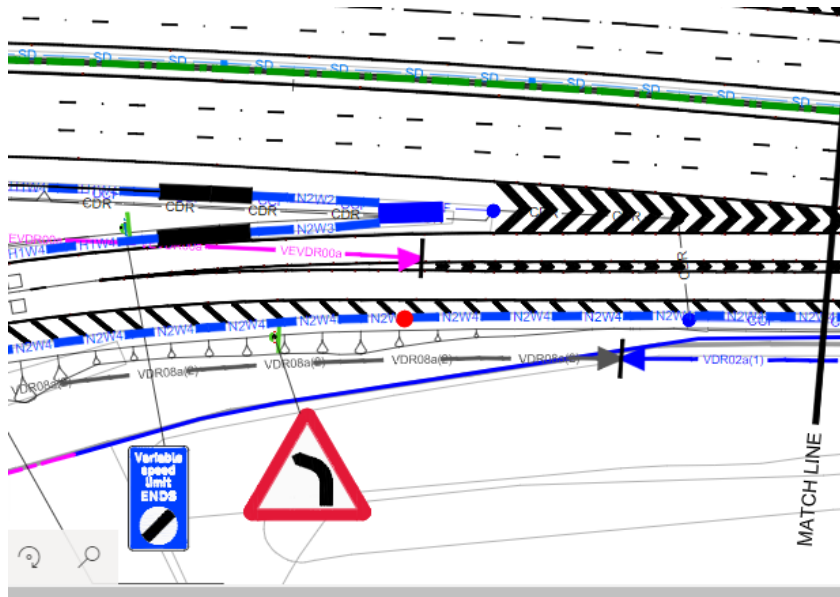
Extract from drawing HA514451-HGN-S1_ML000000_Z-DR-CH-1049 Rev C02

Variable speed limit ends sign is provided on the nosing between the M4 carriageway and the junction 8/9 east and westbound diverges. The position and orientation of the sign face may result in driver confusion as to which route is subject to the end of the variable speed limit, increasing the risk of inappropriate speeds and collisions.

At the junction 10 westbound diverge the same sign provision is shown.

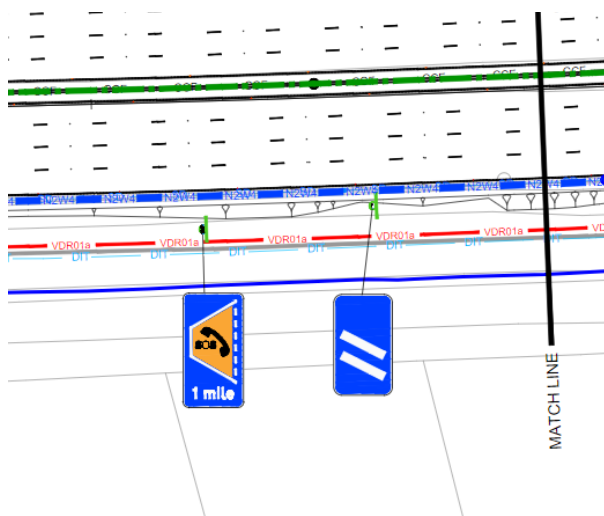
Extract from drawing HA514451-CHHJ-HSN-S1_ZZZZZZZZ_Z-DR-CH-12012 Rev C04

Summary: Visibility to EA/emergency roadside telephone sign compromised

EA/emergency roadside telephone sign PS-A-69/6_45 is provided in the nearside verge but is positioned approximately 25m in front of the countdown marker sign PS-A-69/6_19. Visibility to the EA sign is likely to be compromised which could lead to drivers being unaware of the next EA. This may result in drivers seeking alternative refuge in the diverge increasing the risk of shunt collisions and collisions with drivers outside of their vehicle.

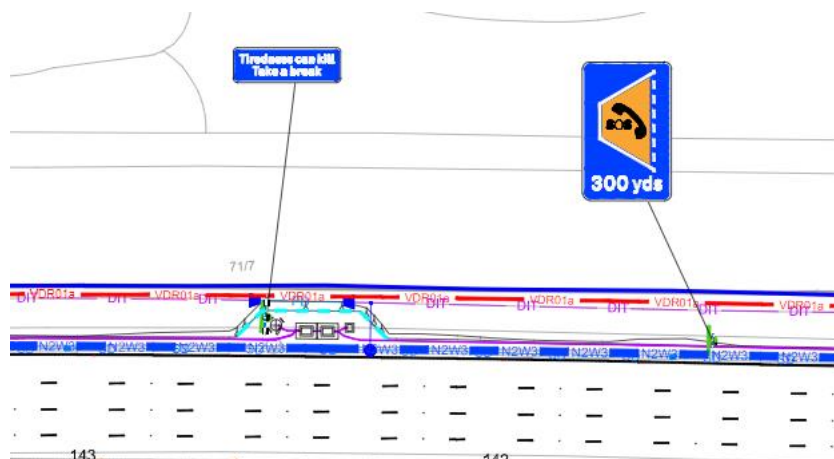
Extract from drawing HA514451-CHHJ-HSN-S1_ZZZZZZZZ_Z-DR-CH-12007 Rev C04

Summary: Position of 'Tiredness can kill take a break' signs

A 'Tiredness can kill take a break' sign is located immediately before the 300 yard sign for EA E9-B3 and immediately before EA E9-A2. Drivers may be tempted or consider the EAs as suitable places in which to stop rather than continuing on to Reading MSA. Unauthorised use of the EAs without use of the ERT will result in drivers having to re-join the live carriageway merging with fast traffic increasing the risk of lane changing collisions.

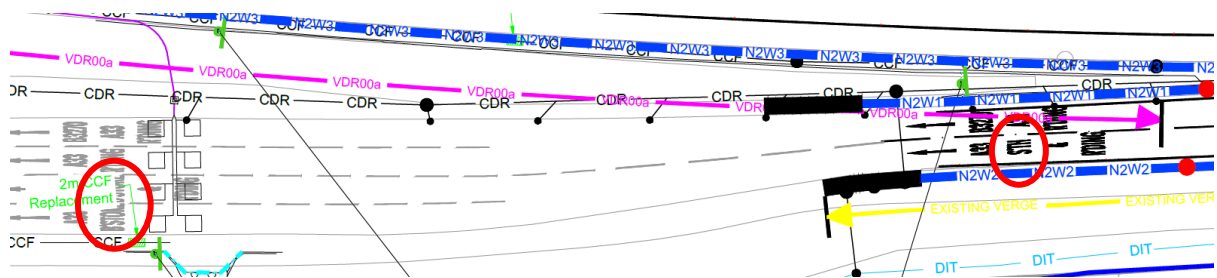
Extract from drawing HGN-S1_ML000000_Z-DR-CH-1024 Revision C03

Summary: Inconsistency between lane designation carriageway markings

On the westbound approach to junction 11, proposed carriageway markings in lane one of the two lane diverge includes the use of 'A33 STH & R'DING', but the existing carriageway markings within the four lane section of the diverge use 'A33 B'STOKE' or 'A33 B'STOKE & R'DING'. The use of A33 South carriageway markings could be confusing and result in lane changes on the diverge, increasing the risk of collisions.

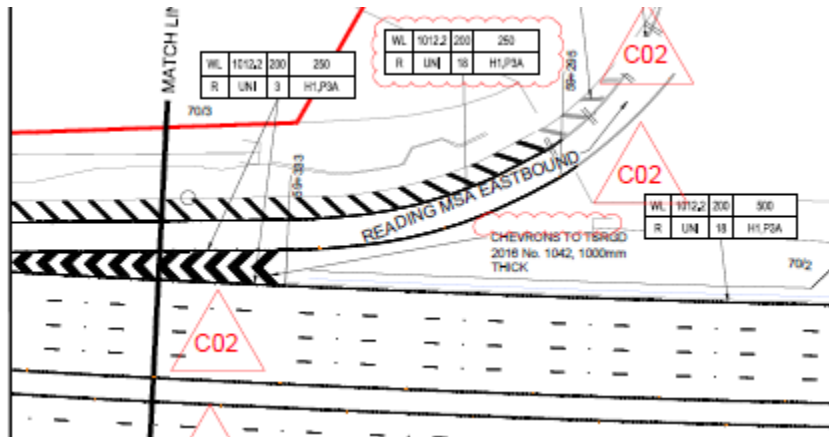
Extract from drawing HMK-S1_ML000000_Z-DR-CH-1211 Revision C02

Summary: Removal of 'SLOW' carriageway markings

The eastbound and westbound diverge lanes to the Reading MSA are to be resurfaced. The existing 'SLOW' markings are not detailed to be reinstated following the resurfacing. Given the short diverge length and tight left-hand bends the removal of the 'SLOW' markings could result in late braking and vehicle loss of control.

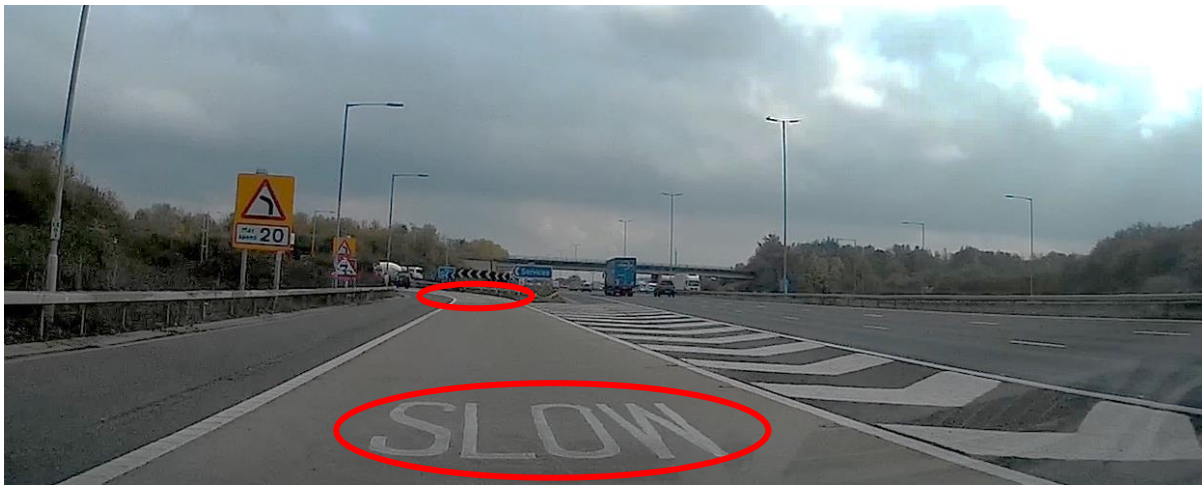
Reading Motorway Services eastbound diverge lane - image captured October 2018

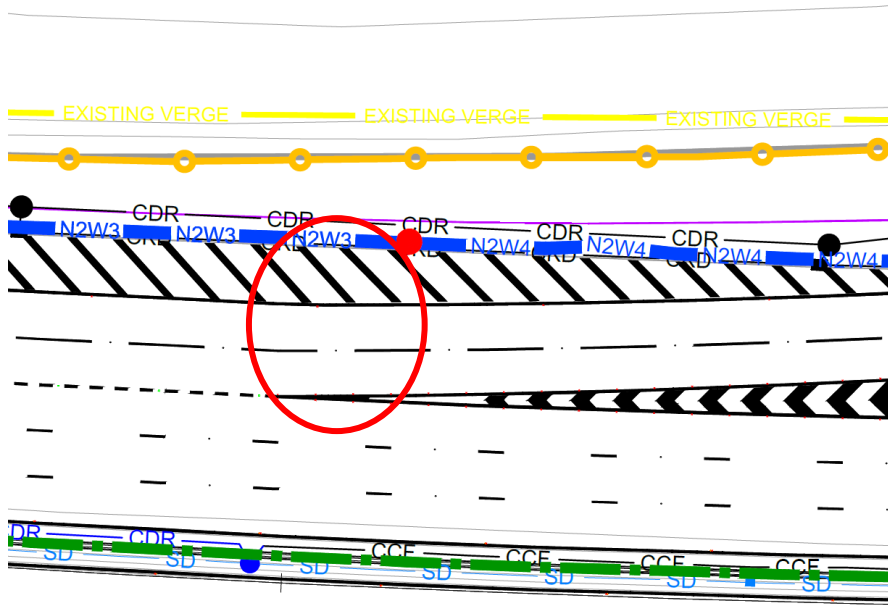
Extract from drawing HGN-S1_ML0000000_Z-DR-CH-1022 Rev C03

Summary: Lane carriageway making configuration may lead to side-swipe collisions

The lane warning markings separating the nearside and offside eastbound offslip approach to junction 11 consists of a notable localized deviation opposite the diverge nosing arrangement. There is a risk that motorists exiting the M4 mainline carriageway and negotiating the localized deviation at speed may lead to poor lane discipline and side-swipe collisions (see excerpt).

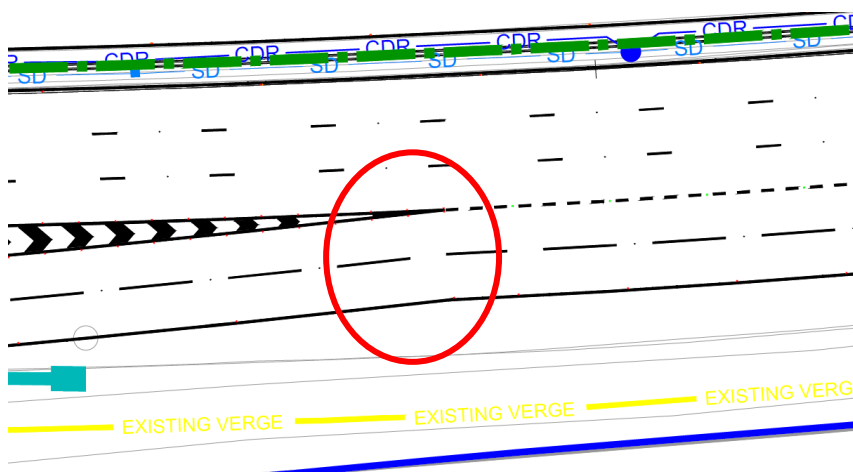
Extract from drawing HGN-S1_ML0000000_Z-DR-CH-1024 Rev C03

Summary: Lane carriageway making configuration may lead to side-swipe collisions

The lane warning markings separating the nearside and offside westbound offslip approach to junction 11 consists of a notable localized deviation. There is a risk that motorists exiting the M4 mainline carriageway and negotiating the localized deviation at speed may lead to poor lane discipline and side-swipe collisions (see excerpt).

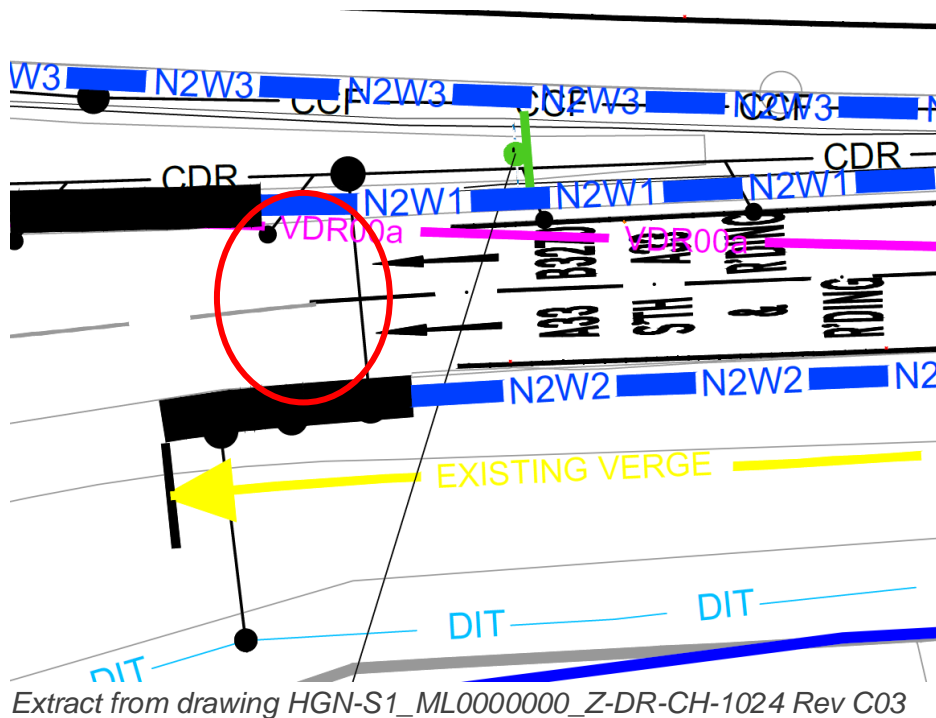
Summary: Lane carriageway making configuration may lead to side-swipe collisions

The lane warning markings separating the nearside and offside westbound offslip approach to junction 11 prior to the two lanes merging into four consists of a notable localized double-bend deviation. There is a risk that motorists exiting the M4 mainline carriageway and negotiating the localized double-bend deviation at speed may lead to poor lane discipline and side-swipe collisions (see excerpt).

Ensure that the warning markings where they expand from two lanes to four provide a smooth transition.
