Smart Motorways Programme

M4 J3 – J12

Package 2 (J3 to 8/9) Designer's Response to Road Safety
Audit (Stage 2)

Document Number: HA514451-CHHJ-GEN-SZ_ZZZZZZZZ_Z-RP-ZZ-0004

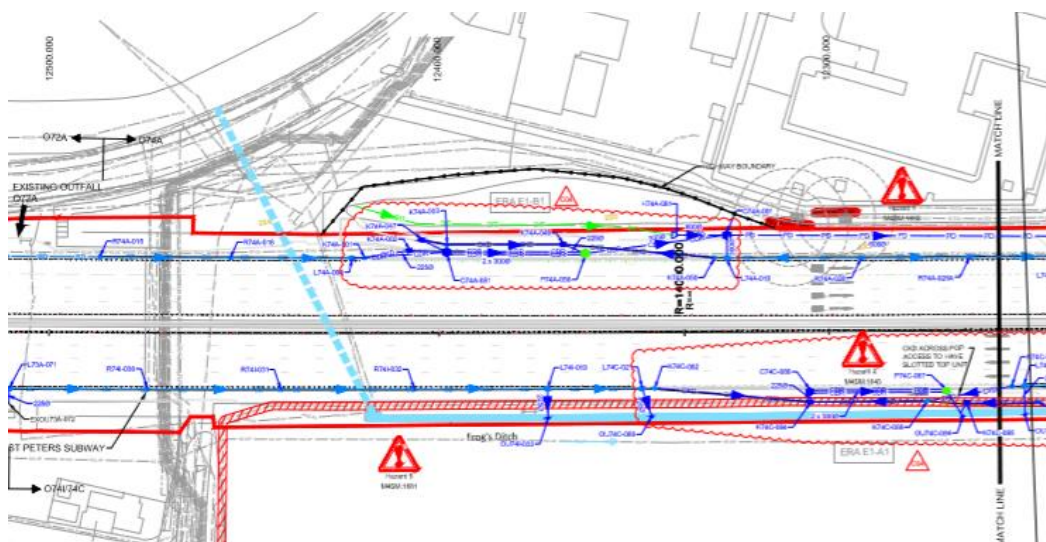
Extract from drawing HA514451-CHHJ-HDG-S2_DGZZZZZZZ_Z-DR-CD-5165 Rev C04

Summary: Lack of drainage provision

No drainage provision along the central reservation is indicated between chainages 12625 and 12255 although a filter drain is shown immediately up and down stream of this location. Without drainage through this section there is a risk of water standing in the carriageway, increasing the risk of loss of control type collisions.

It is recommended that drainage provision along the central reservation is continued through this section.

Designer disagrees with the RSA problem and recommendation raised.

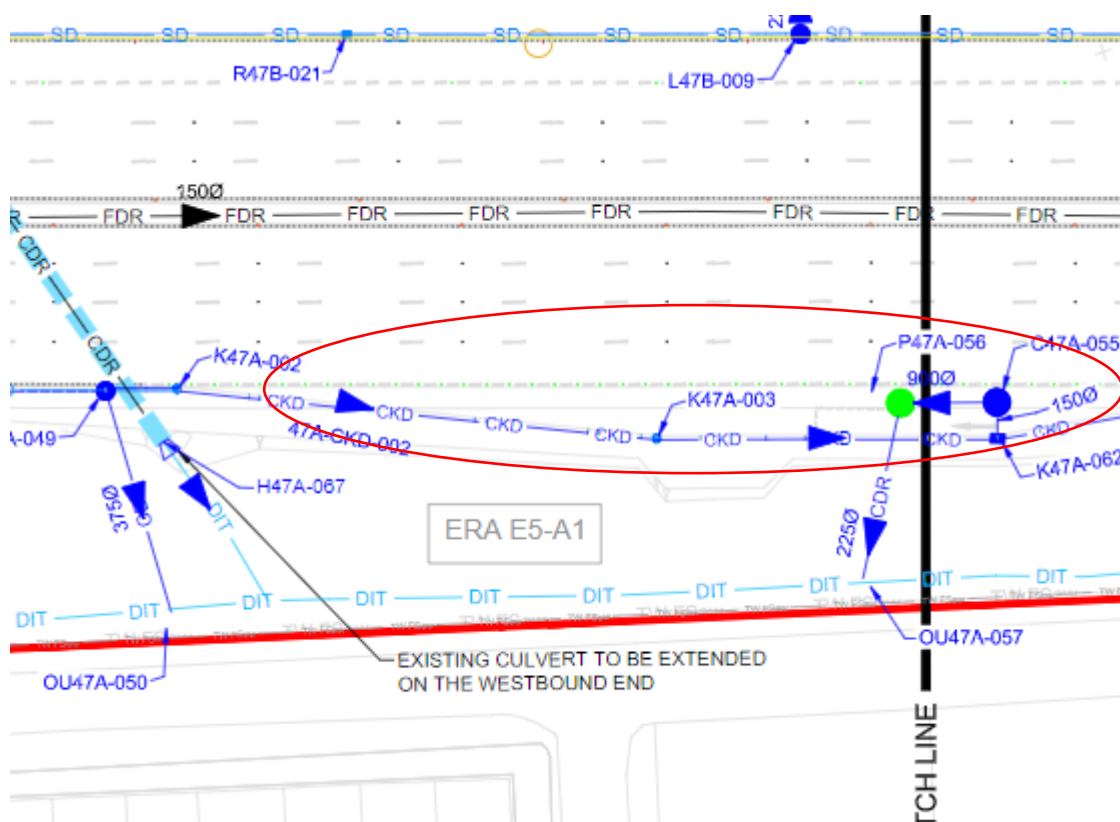
Extract from drawing HA514451-CHHJ-HDG-S2_DGZZZZZZZZ_Z-DR-CD-5121 Rev C02

Summary: Lack of drainage provision

EA E5-A1 only has combined kerb drainage at the rear of the EA compared to other EAs where there is also a carrier drain provided along the interface with lane 1, for example E5-B1. It is not clear from the provided drawings if the cross section profile of the EA requires drainage along the interface with lane 1. A lack of drainage could result in water standing within the EA and adjacent carriageway increasing the risk of loss of control collisions, particularly at a location where vehicles could be braking.

It is recommended that drainage provision is provided along the front face of EAs where required.

Designer disagrees with the RSA problem and recommendation raised.

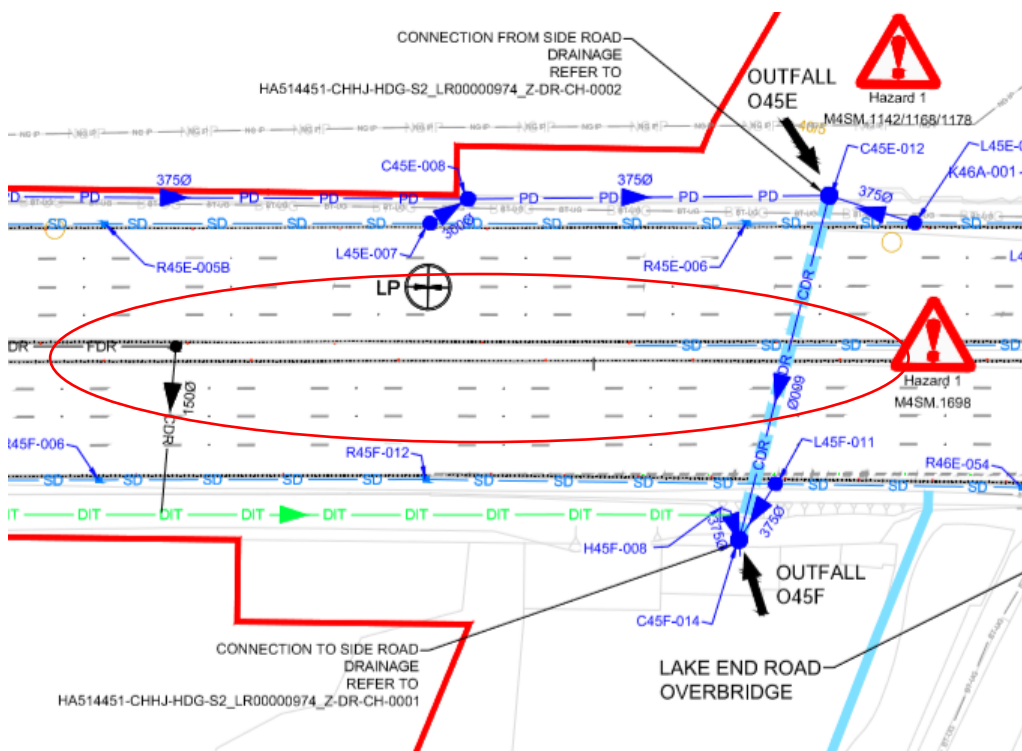
Extract from drawing HA514451-CHHJ-HDG-S2_DGZZZZZZZZ_Z-DR-CD-5113 Rev C02

Summary: Lack of drainage provision

No drainage is provided along the central reservation between chainages 29600 and 17650. Without drainage through this section there is a risk of water standing in the carriageway, increasing the risk of loss of control type collisions.

It is recommended that drainage provision along the central reservation is continued through this section.

Designer disagrees with the RSA problem and recommendation raised.

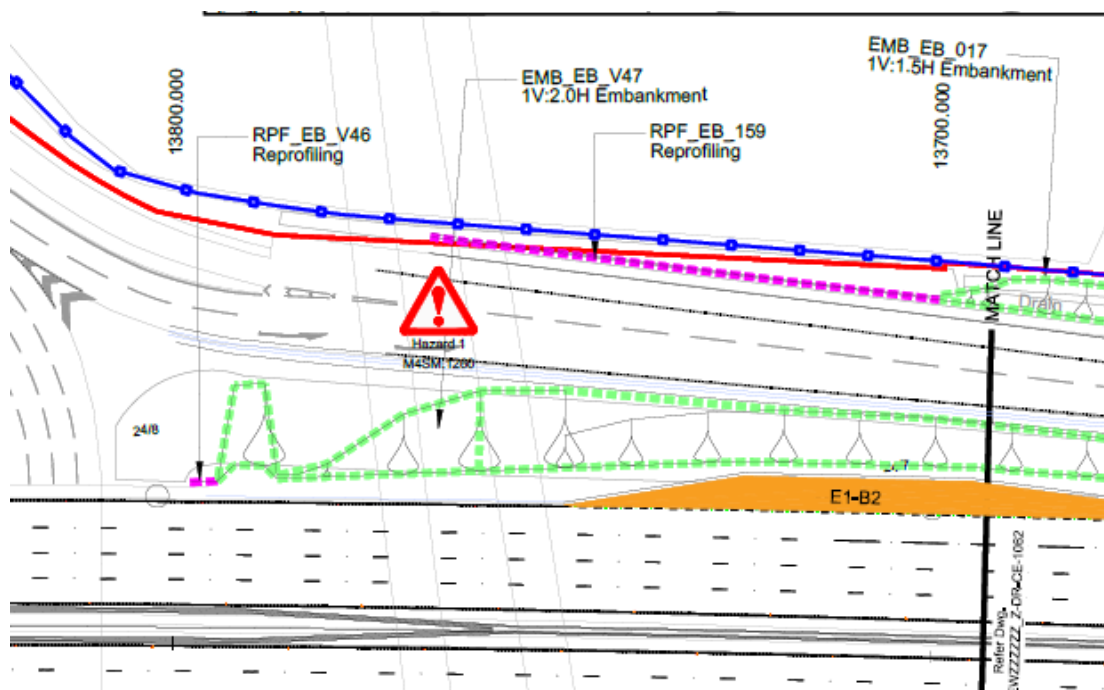
Extract from drawing HA514451-CHHJ-HFE-S2_ZZ000000_Z-DR-CH-3059

Summary: Lack of pedestrian guardrail at rear of EA may lead to injury

EA E1-B2 is located in an elevated position above the eastbound merge from Junction 4. Immediately behind the EA is embankment down to the merge. In the event that motorists using the EA leave their vehicle to wait behind the vehicle restraint barrier there is a risk of slips and falls down the embankment to the carriageway below. This could result in injuries and potentially collisions involving vehicles on the slip road.

It is recommended that pedestrian guard rail is provided at the rear of the EA.

Designer accepts the RSA problem and recommendation made by the RSA team.

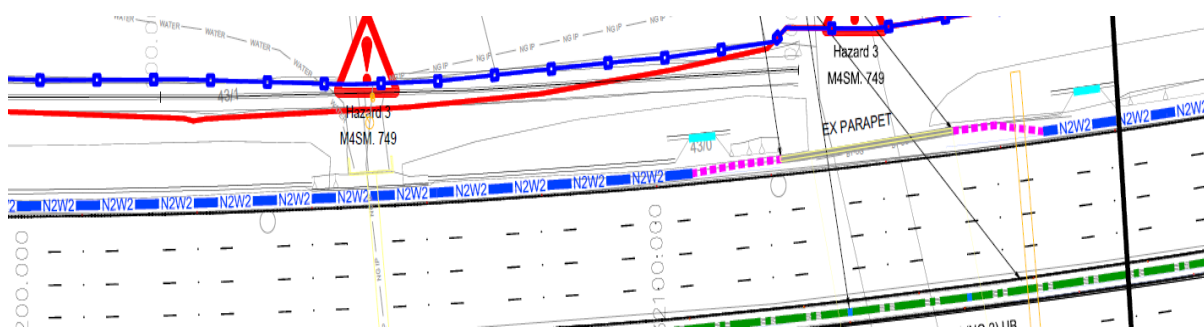
Extract from drawing HRR-S2_ML000000_Z-DR-CH-4006 Rev C01

Summary: Risk of unauthorised vehicles stopping in hard verge area

On the north side of the carriageway an existing parapet is to remain. The parapet is set back approximately 2m from the edge of carriageway behind a strip of hard verge. There is a risk that drivers could be tempted to use this area as a place of relative safety, resulting in collisions between vehicles in lane one and the stationary vehicle or a driver/passenger outside of the vehicle. It is noted that this is an existing layout however the risk is increased by virtue of traffic travelling immediately adjacent to the RRS and bridge parapet.

It is recommended that measures are installed to avoid or discourage unauthorised vehicles stopping in hard verge area.

The designer has considered the use of collapsible hazard marker but they these elements will introduce additional maintenance activities exposing the road workers to unnecessary risks. The current design is the optimal solution considering the circumstances above.

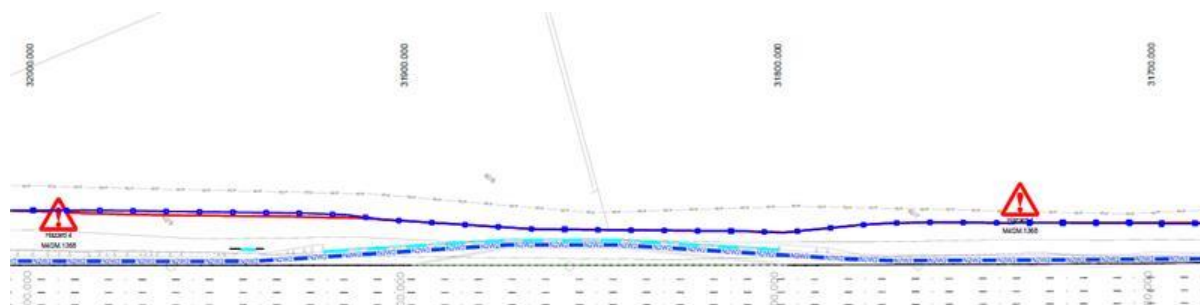
Extract from drawing HRR-S2_ML000000_Z-DR-CH-4007 Rev C01

Pedestrian restraint barrier appears to be detailed within the working width of the RRS at eastbound EA E6-B2 (chainage 31850)

This could increase the severity of a loss of control collision, result in secondary collisions and increase the risk of injuries to pedestrians and operatives who may be between the RRS and the pedestrian restraint barrier.

It is recommended that all pedestrian restraint barrier is located outside the working width of the RRS.

Designer accepts the RSA problem and recommendation made by the RSA team.

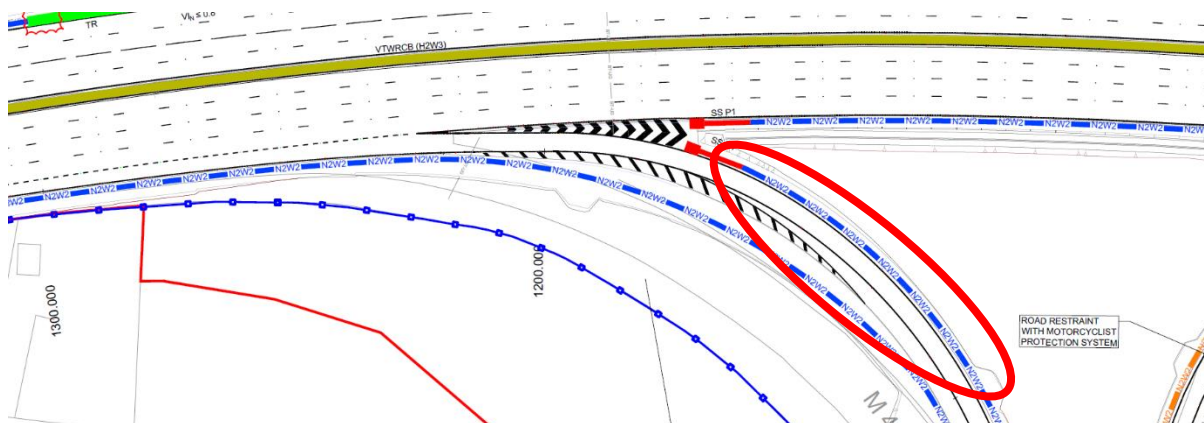
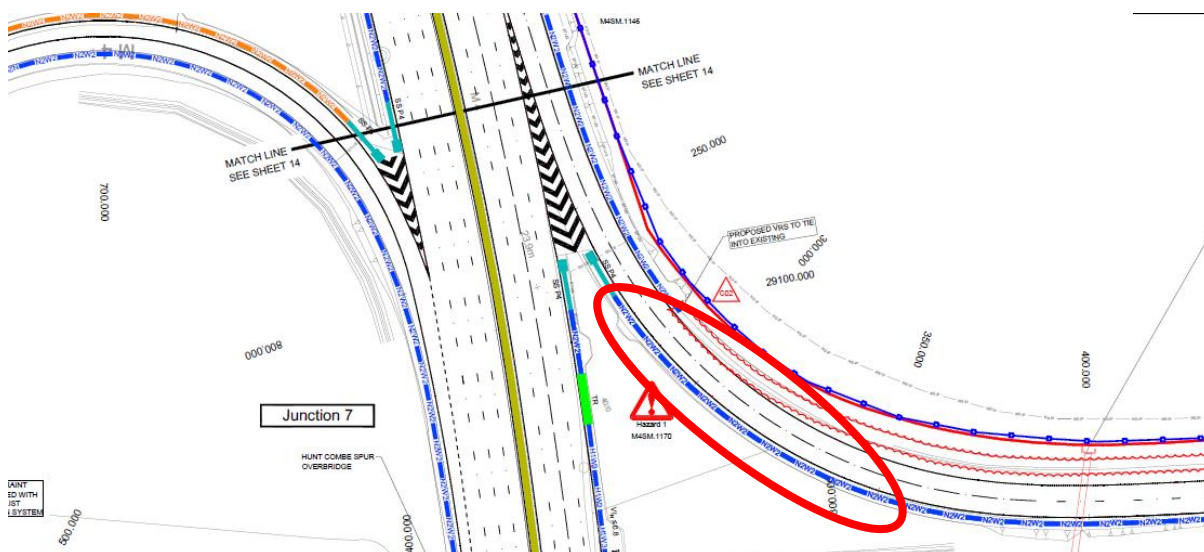
Summary: Risk of increased injuries to motorcyclists

The proposed Junction 7 westbound merge involves a tight left hand bend before aligning with the M4 carriageway, while the eastbound diverge also involves a tight left hand bend before joining the Huntercombe Spur road. The RRS provided on the outside of these bends does not include a motorcycle protection system, which could increase the severity of injuries should a rider be unseated at these locations and collide with the RRS stanchions.

It is recommended that motorcycle barriers be incorporated within the RRS at these locations.

Designer accepts the RSA problem and recommendation made by the RSA team.

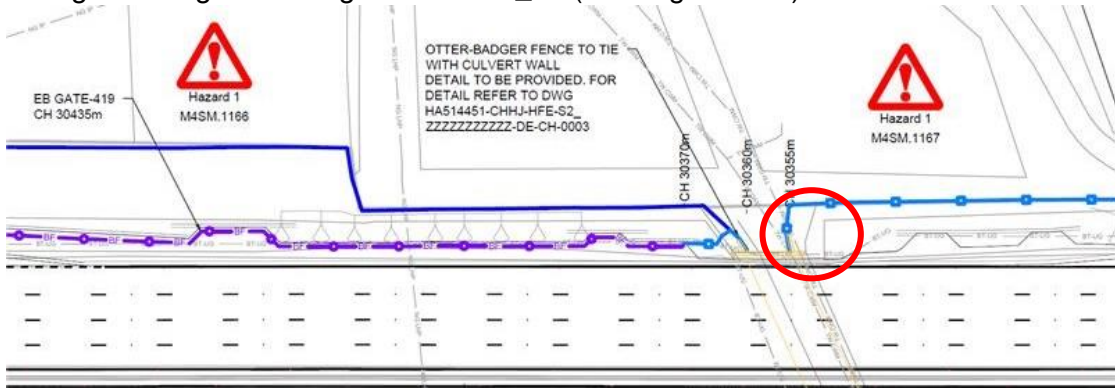
Extract from drawing HFE-S2_ZZ000000_Z-DR-CH-3011 Rev C01

At certain locations the alignment of environmental barrier or other fencing could result in sign faces being partially or fully obscured. Examples of this occur at:

- ‘Slough Trading Estate’ sign PS-B-41/2_80 (chainage 30350)

It is recommended that signs are either relocated so that sign faces are not obscured or mounted at suitable heights to ensure adequate forward visibility is provided.

Designer accepts the RSA problem and recommendation made by the RSA team.

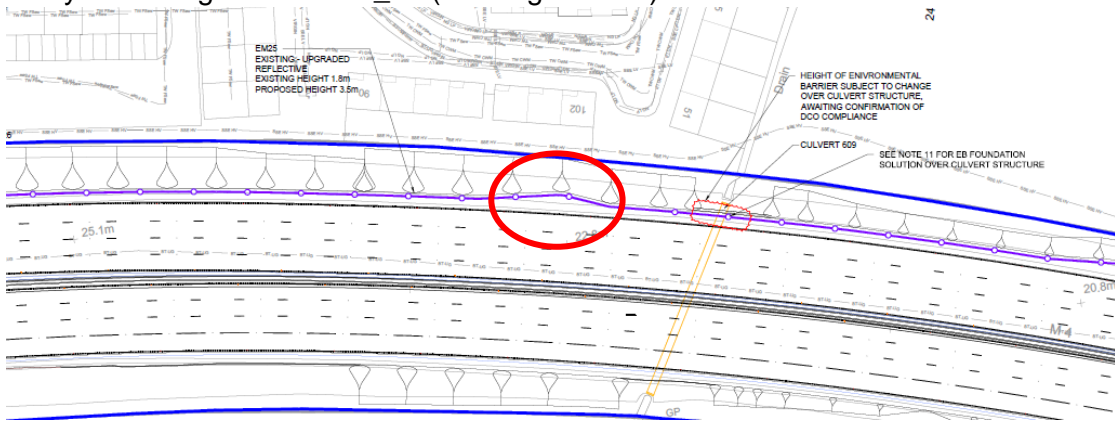
Extract from drawing HFE-S2_ZZ000000_Z-DR-CH-3029 Rev C02

- EA 300 yard sign PS-B-41/7_55 (chainage 30800)
- Lane sign PS-B-37/0_65 (chainage 26130)
- 300 yard EA sign PS-B-35/7_06 (chainage 24750)

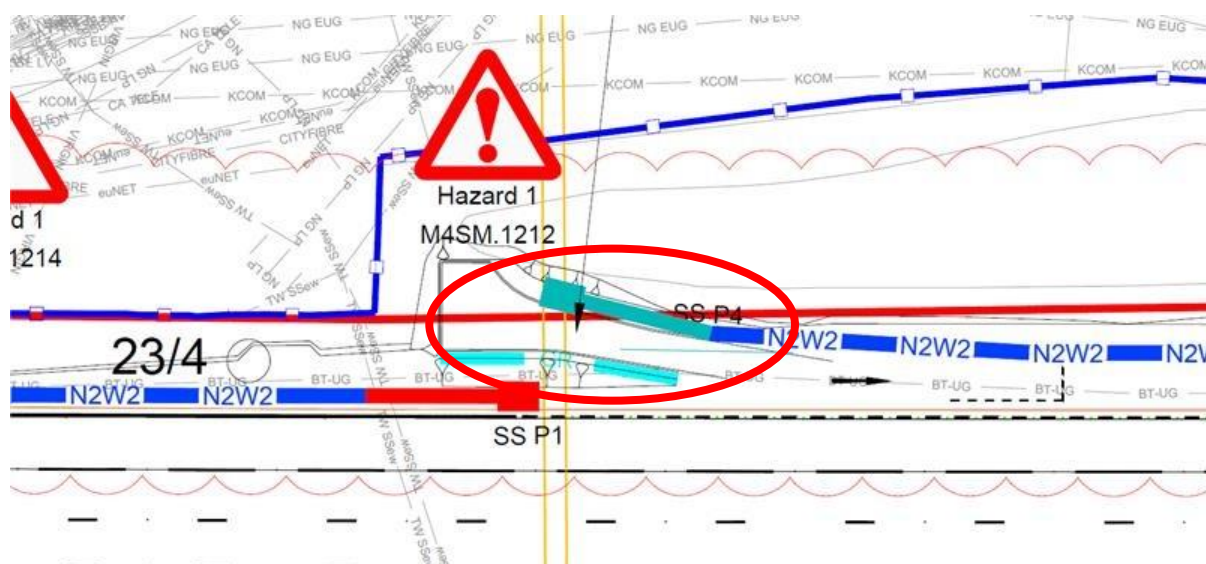
Extract from drawing CHHJ-HRR-S2_ML000000_Z-DR-CH-4065 Rev C02

Summary: Extent of mainline RRS may lead to vehicles striking infrastructure or users of the EA

The restraint system drawings detail arrangements at some of the EAs, such as EA E1-B1, where the extent of the mainline RRS does not protect the raised platform, observation area or associated infrastructure (such as guard railing). This layout could also result in vehicles being retained by the RRS being directed into the EA, where vehicles, drivers and passengers could be located. This arrangement could increase the severity of a loss of control collision and result in a secondary incident involving users of the POP or EA.

It is recommended that the mainline RRS at EAs incorporating POPs covers all vertical infrastructure (elevated sections, ramps, guard rails etc.) and provides sufficient overlap.

Designer disagrees with the RSA problem and recommendation made by the RSA team.

Retaining Wall designed for impact loading as per HA514451-CHHJ-HGN-S3_MLZZZZZZ_Z-DR-CH-0002 and provides sufficient containment of all hazards associated with the POP.

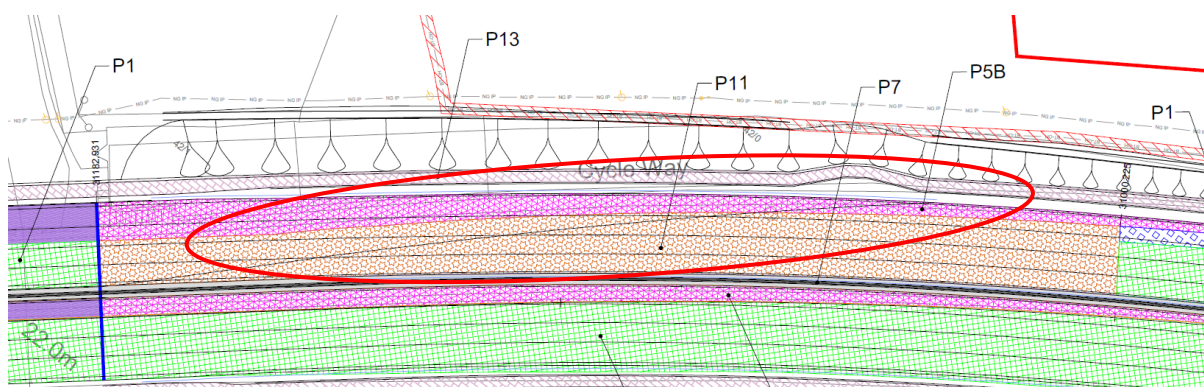
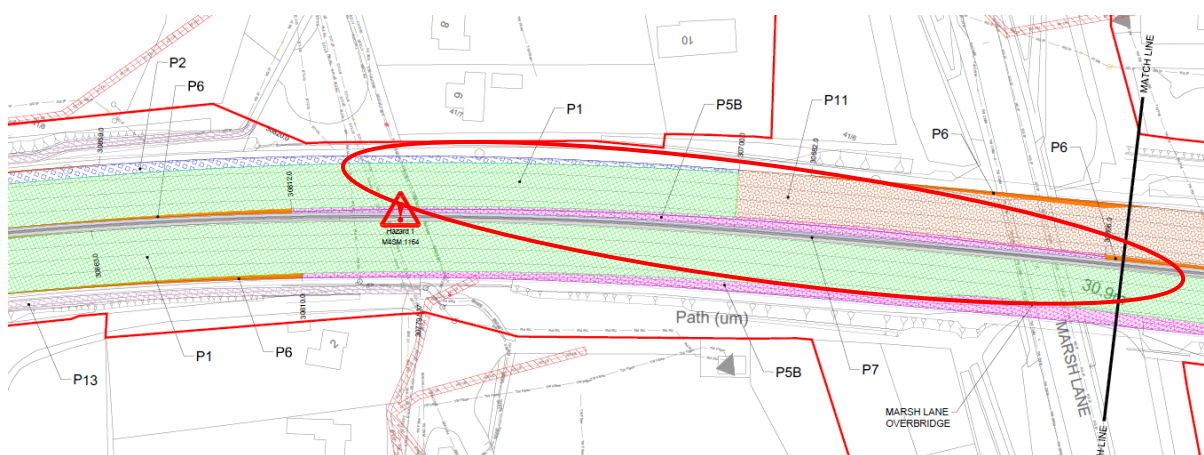
Throughout the scheme there are different surfacing arrangements. Where these different surfacing arrangements meet, the drawings provided indicate that both longitudinal and perpendicular surface course joints may be present within the lane extents and in wheel tracks. Examples of where this occur include chainages 31200, 30850, 29950, 28450, at various locations between 27200 and 26500, and around 14600.

The presence of longitudinal and perpendicular surface course joints in wheel tracks increases the potential for joints to fail over time. This can reduce the quality of the surface, effect vehicles under braking conditions and may hold standing water, increasing the risk of loss of control collisions.

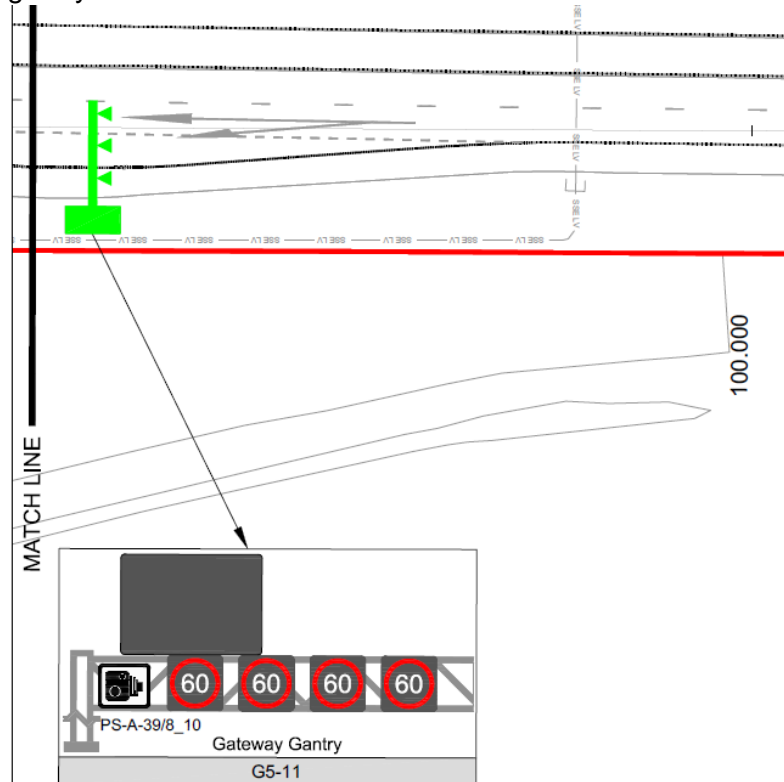
Extract from drawing CHHJ-HSN-S2_ZZZZZZZ_Z-DR-CH-12017 Rev C01

A number of gantry signs include lane designation signage and gantry layouts that do not appear to correspond or align with the carriageway running lanes, as designated by the road markings. This includes instances of where the gantry does not appear to cover the number of lanes required by the sign layout or the sign layout differs to the carriageway layout. Examples include, but are not limited to:

- gantry G5-11 north of Junction 7

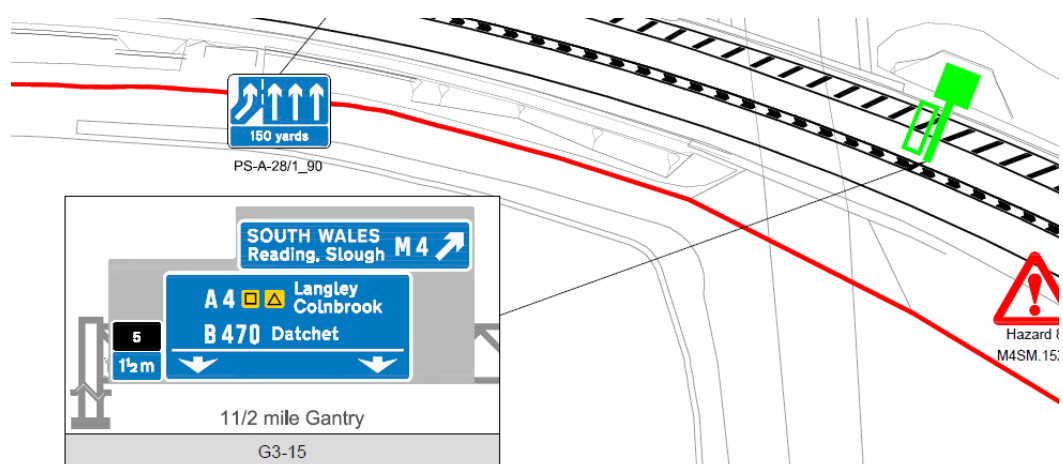
Extract from drawing CHHJ-HSN-S2_///////_Z-DR-CH-12050 Rev C01

- gantry G4-17 (chainage 25450)
- gantry G4-07 (chainage 22500)
- gantry G3-12 (chainage 19370)
- gantry G3-15 (chainage 17120)

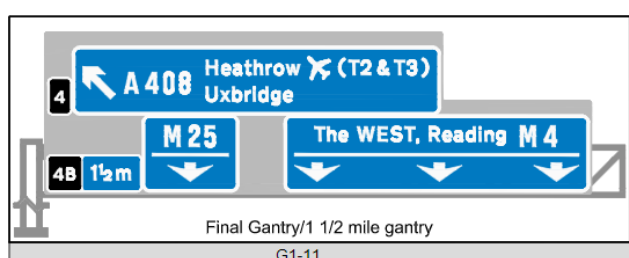
Extract from drawing CHHJ-HSN-S2_#####_Z-DR-CH-12063 Rev C01

Summary: Information on sign may be conflicting

Junction numbers 4 and 4B are incorporated into the gantry sign at the westbound diverge for junction 4. The x-height and positioning of the junction numbers 4 and 4B could be confusing for motorists resulting in late lane changing conflicts.

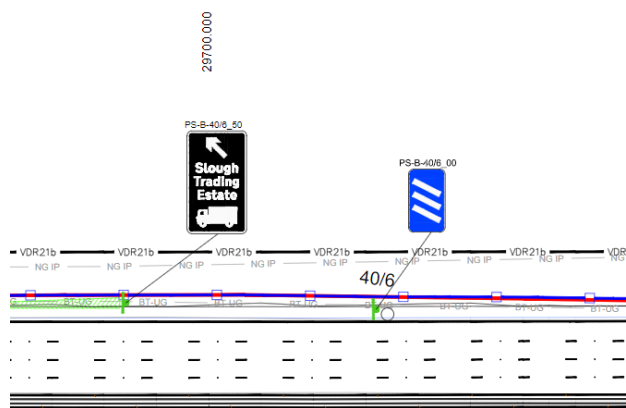
Extract from drawing HGN-S2_ML000000_Z-DR-CH-1013 Rev C01

A number of signs are positioned where they are likely to impact on forward visibility to subsequent signs. This includes, but is not limited to, the following obscured sign faces:

- Route marker sign PS-B-44/3_80 (chainage 33450)
- 300 yard countdown sign PS-B-40/6_00 (chainage 29670)

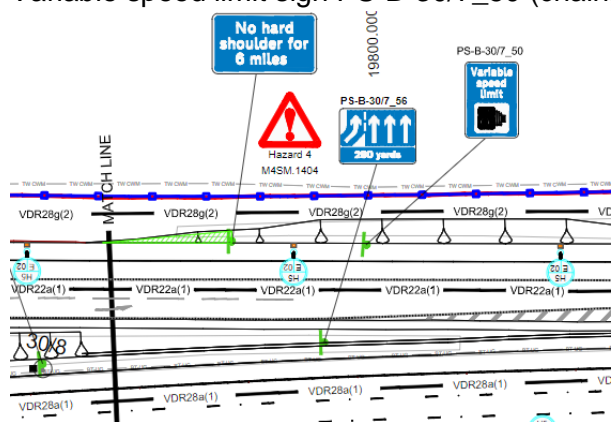
Extract from drawing HGN-S2_ML000000_Z-DR-CH-1043 Rev C01

- Variable speed limit and No hard shoulder signs PS-B-39/8_32A & B (chainage 28900)
- Variable speed limit sign PS-B-30/7_50 (chainage 19800)

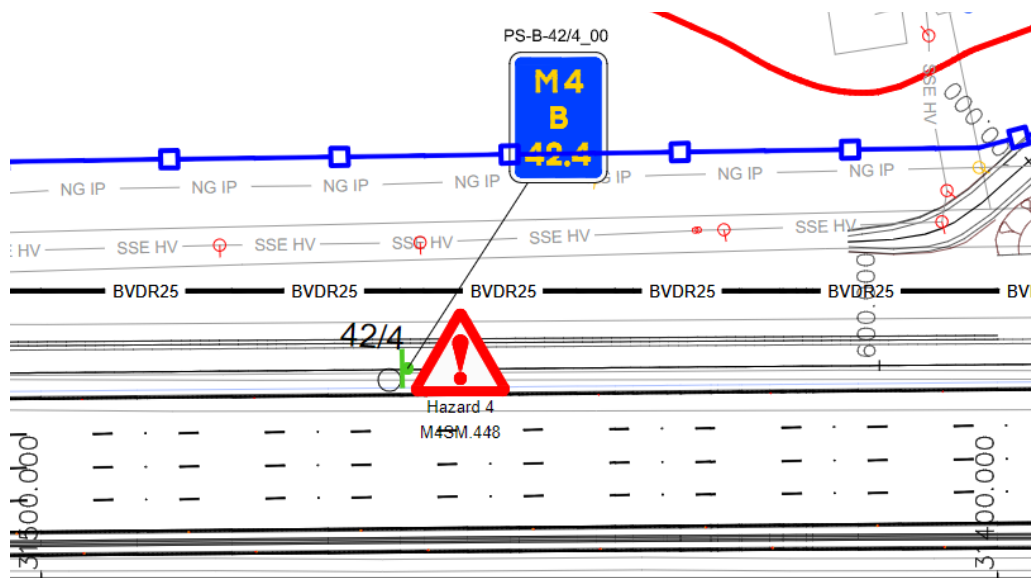
Extract from drawing HA514451- HGN-S2_ML000000_Z-DR-CH-1008 Rev C01

Summary: Sign located within adjacent footway

Marker sign M4 B 42.4 is located within the footway which runs adjacent to the eastbound carriageway of the M4 between Monkey Island Lane and Marsh Lane. If the sign is located in the footway pedestrians using the route are at risk of striking the sign, resulting in injuries.

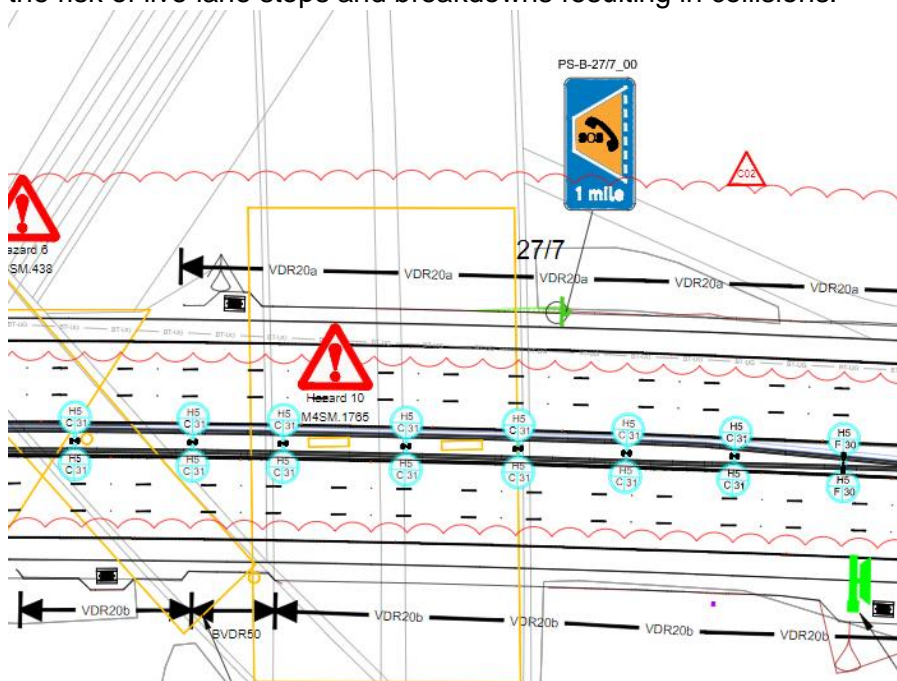
Extract from drawing HA514451- HGN-S2_ML000000_Z-DR-CH-1051

Summary: 1 mile EA sign for EA E2-B1

The 1 mile EA sign for EA E2-B1 is located close to the M25 overbridge. At this location the M4 carriageway is in shadow due to the structure and the EA sign may be less obvious to drivers. This could result in drivers being less aware of the location of the next EA increasing the risk of live lane stops and breakdowns resulting in collisions.

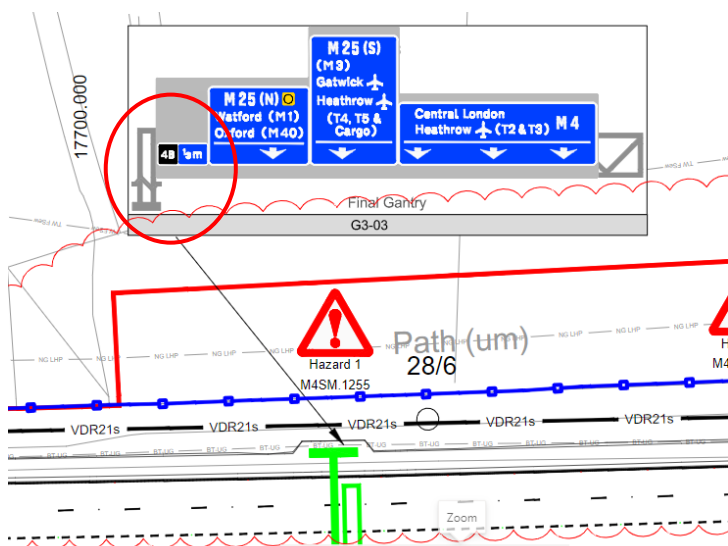
Extract from drawing HA514451- HGN-S2_ML000000_Z-DR-CH-1049 Rev C02

Summary: Final gantry for Junction 4B (G3-03) has a distance plate

Final gantry sign G3-03 for Junction 4B incorporates a 1/3 mile distance plate. This could be confusing to drivers as this gantry is located immediately prior to the diverge for Junction 4B and could imply that drivers have more time to make any lane changing decisions resulting in side-swipe collisions.

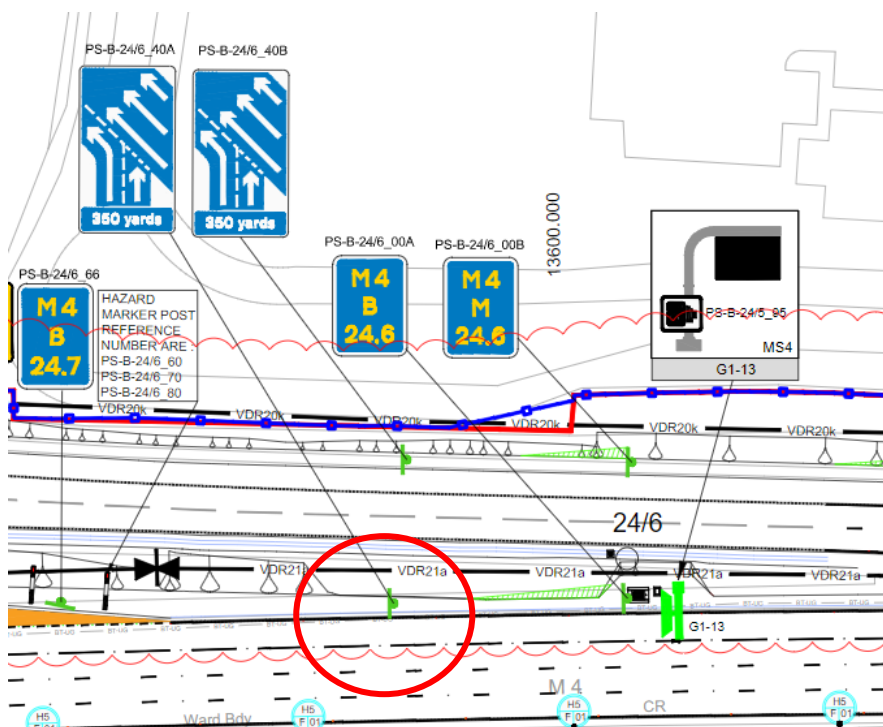
Extract from drawing HA514451- HGN-S2_ML000000_Z-DR-CH-1062 Rev C02

Summary: Position of sign may be misleading

The offside 350 yard side indicating the merge layout from the slip road is located significantly closer to the mainline carriageway than the slip road and drivers may assume it relates to the mainline. This could result in driver confusion and potentially late lane changing manoeuvres.

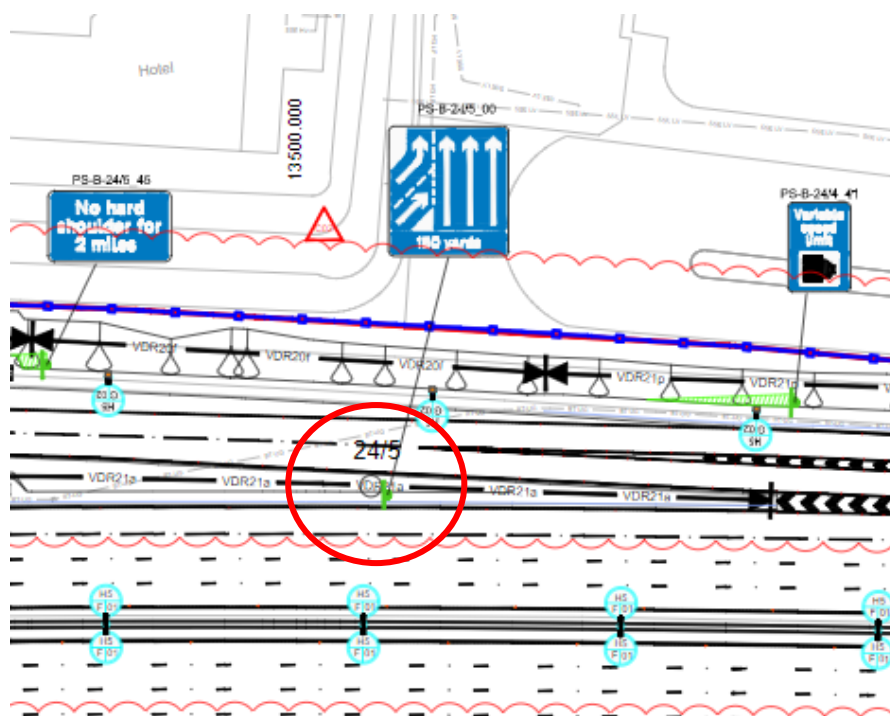
Extract from drawing HA514451- HGN-S2_ML000000_Z-DR-CH-1062 Rev C02

Summary: Insufficient room to accommodate sign

The 150 yard side indicating the merge layout from the slip road is located within the nosing between the merge and mainline carriageways. At this location it is unlikely that the sign can be accommodated without impacting on the working width of the RRS or potentially overhanging the carriageway. This increases the risk of the sign being struck by vehicles or the RRS not performing effectively in the event of an errant vehicle striking it.

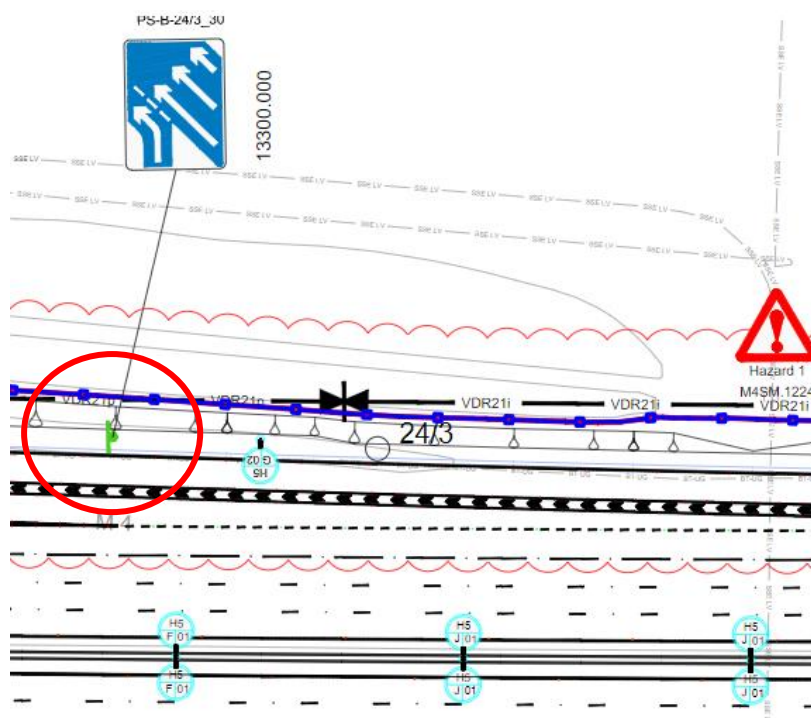
Extract from drawing HA514451- HGN-S2_ML000000_Z-DR-CH-1063 Rev C02

Summary: Incorrect sign face

The proposed sign face for merging traffic indicates three mainline carriageway lanes. At this location there are four lanes on the mainline M4 carriageway which drivers may not appreciate. This could result in driver confusion and potentially late lane changing.

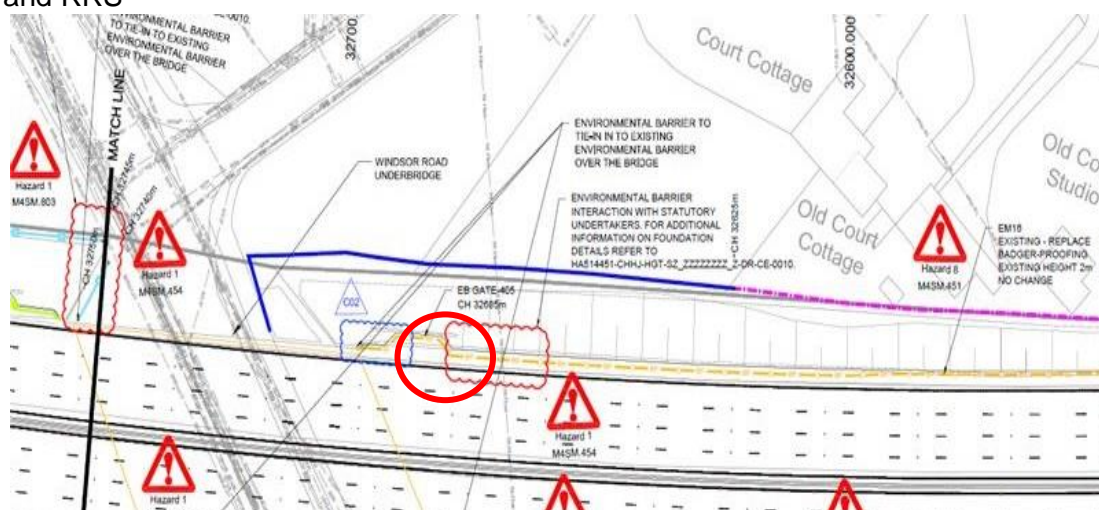
Extract from drawing HFE-S2_ZZ000000_Z-DR-CH-3005 Rev C02

A number of signs are located at vulnerable locations and it is not clear if the signs and post arrangements can be accommodated and/or are passively safe. Examples include:

- 1/2 mile EA sign at eastbound chainage 32650, which is located between fencing and RRS

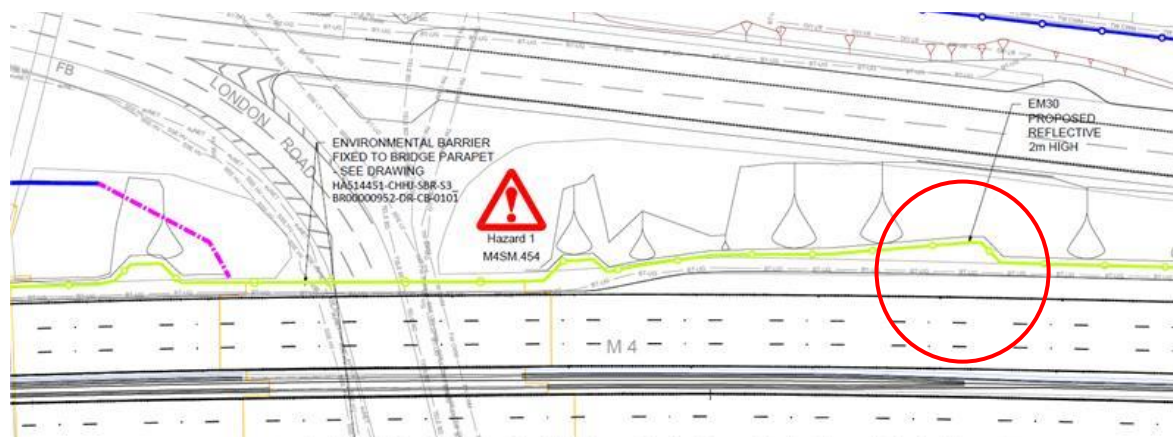
Extract from drawing CHHJ-HFE-S2_ZZ000000_Z-DR-CH-3042

Summary: Risk of late lane changing

The 550 yards lane merge sign for Junction 5 eastbound is set back further from the edge of carriageway due to the introduction of hard shoulder and environmental barrier. This may restrict forward visibility to the sign, reduce driver awareness of merging traffic and increase the risk of side impact and late lane changing collisions.

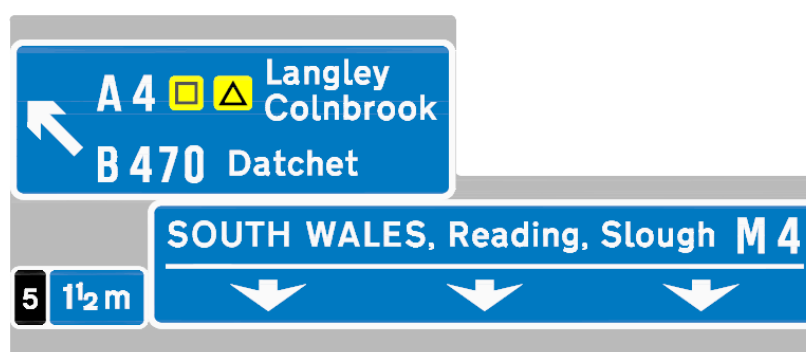
Extract from drawing HSN-S2_ZZZZZZZ_Z-DR-CH-12051 Rev C01

Summary: Risk of gantry lighting resulting in collisions

It is unclear how a number of irregularly shaped gantry signs faces, such as G03-16 at Junction 5, are to be lit. Inappropriate illumination could result in the sign faces being difficult to read, increasing the risk of late vehicle movements and side impact collisions. If the lighting provided is visible on the opposing carriageway this could result in glare and/or driver confusion, leading to collisions.

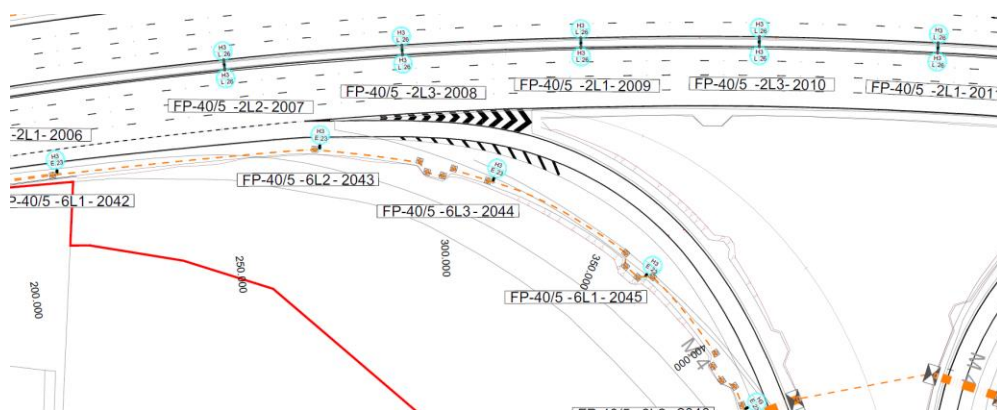
Extract from drawing HEL-S2_ZZZZZZZZ_Z-DR-EE-1314

Summary: Lighting arrangement may lead to confusion

The street lighting provided at the Junction 7 westbound merge follows the alignment of the existing merge lane rather than the proposed. Locating the columns set back from the proposed carriageway could result in dark areas and driver confusion. This could be exacerbated by the RRS, which also follows the alignment of the existing merge lane. This could increase the risk of night-time collisions and vehicles leaving the carriageway at this location where the lighting doesn't follow the extent of the alignment.

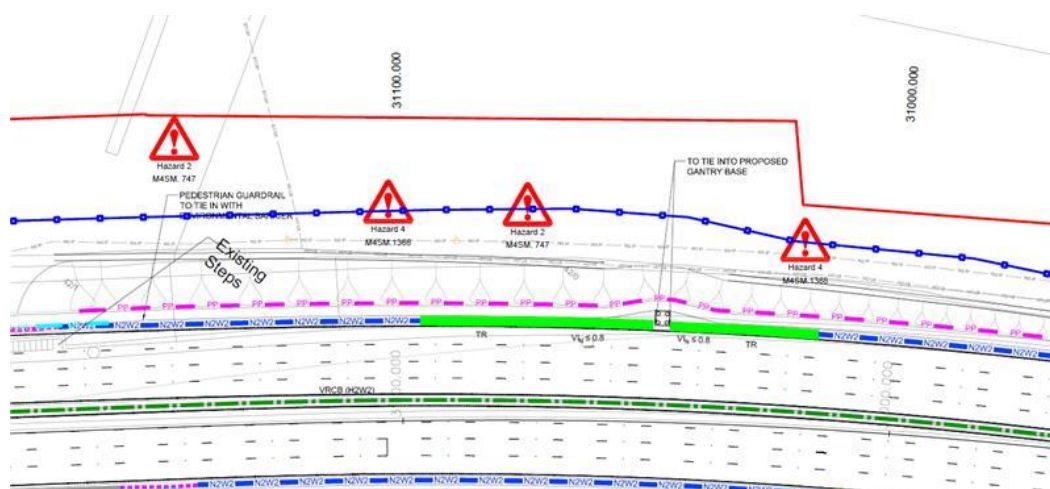
Extract from drawing HGN-S2_ML0000000_Z-DR-CH-1009 Rev C01

Summary: Protection for pedestrians

It is unclear from the VRS drawings how pedestrians using the footway adjacent to the M4 will be protected from the carriageway or how access onto the network will be discouraged. Inadequate protection may increase the risk of injury in the event that a vehicle leaves the carriageway at this location. There is also an increased risk that pedestrians will access the network resulting in collisions.

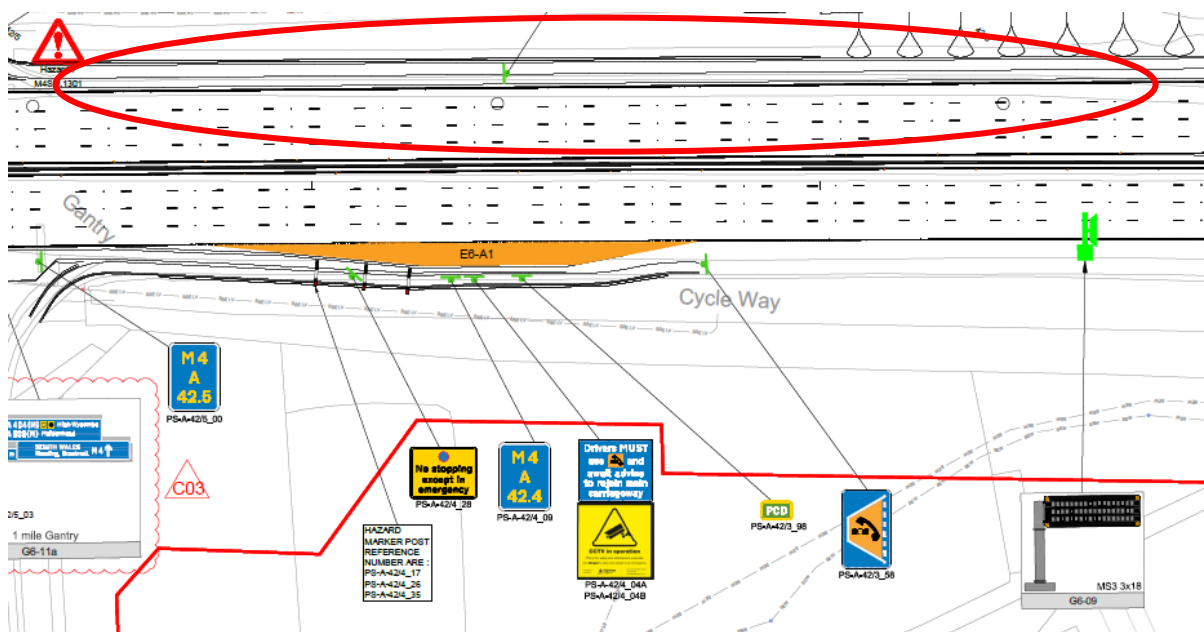
Extract from drawing HSN-S2_////-DR-CH-12008 Rev C03

Summary: Risk of hazards at the shared use facility

An existing shared use path is provided parallel to the M4 between Monkey Island Road and Meadow Way, which crosses the River Thames and provides access to the Thames path via steps. No cross sections have been provided so it is not clear how this shared use facility will be accommodated within the constraints of the M4 corridor. The inclusion of RRS, pedestrian guard rail and environmental barrier are likely to impact on the effective width of the shared use increasing the risk of conflicts between pedestrians and cyclists.
