Smart Motorways Programme

M4 J3 – J12

Package 1 (J8/9 to J12) Designer's Response to Road
Safety Audit (Stage 2)

Document Number: HA514451-CHHJ-GEN-S1_ZZZZZZZZ_Z-RP-ZZ-0004

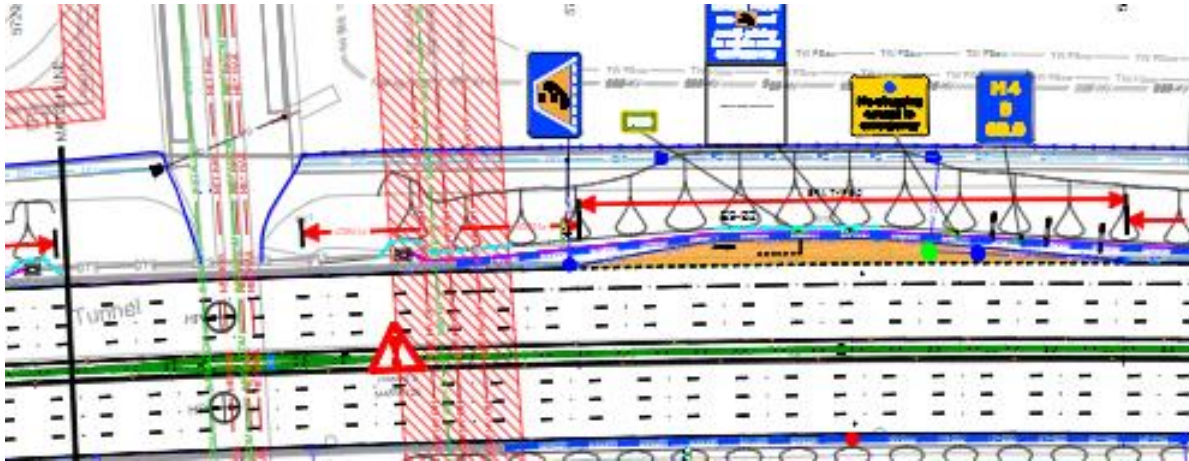
Extract from drawing HA514451-HGN-S1_ML000000_Z-DR-CH-1017 Rev C02

Summary: Reduced visibility to EA E9-B2 may result in EA entry conflicts

Forward visibility to EA E9-B2 is potentially restricted by the parapet for Mortimer Line Railway underbridge which could also restrict visibility to the EA sign, depending on the mounting height. Drivers intending to use the EA may not appreciate its position so close behind the parapet and miss the EA increasing the risk of a live lane stop collision.

It is recommended that the sign for the emergency area is mounted so that the bridge parapet does not obscure the sign face.

Designer accepts the RSA problem and recommendation made by the RSA team.

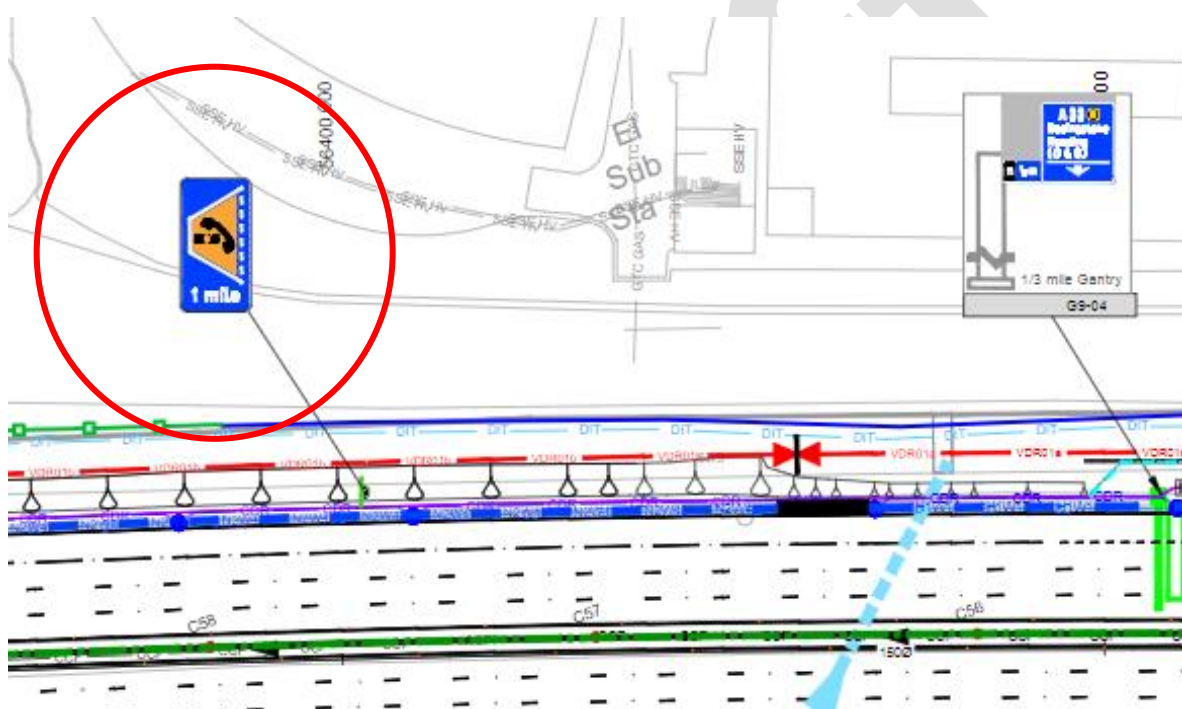
Extract from drawing HA514451-HGN-S1_ML000000_Z-DR-CH-1019 Rev C02

The eastbound 1 mile EA sign PS-B-67/3_50 provided at chainage 56400 does not correlate with an EA, as the next mainline EA is 2.2 miles/3.6km to the east. If the sign is intended to reference a place of relative safety at junction 11, it is not clear where this is and that drivers would have to leave the mainline carriageway. The use of an EA sign with orange colouring could also be misleading.

This increases the risk of live lane breakdowns which could result in further collisions.

It is recommended that the referenced EA is clarified and the sign removed or replaced accordingly. If the sign is referencing a place of relative safety additional signing should be provided to advise drivers, such as 'follow junction 11 for emergency telephone/layby', or that hard shoulder is available intra junction at junction 11.

Designer accepts the RSA problem and recommendation made by the RSA team.

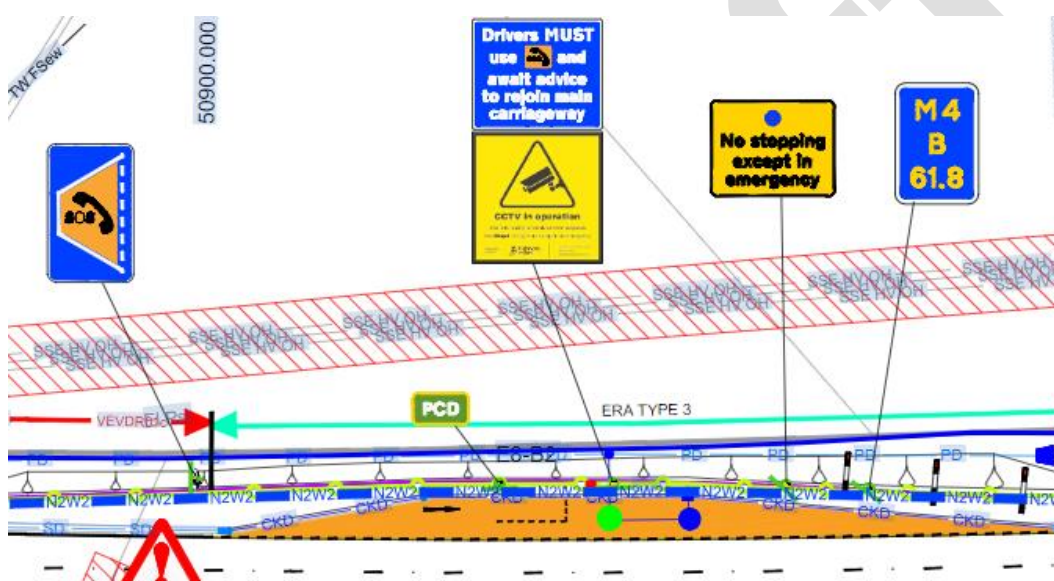
Extract from drawing HA514451-HGN-S1_ML000000_Z-DR-CH-1034 Rev C02

EA E8-B2 is provided at chainage 50900 eastbound. At the rear of the EA is a combination of road restraint system (RRS), EA signing, the emergency telephone and 2.5m high environmental barrier. The area behind the RRS appears too narrow (to wait outside the barriers working width) and cluttered to represent a safe place for pedestrians/operatives to be should they have exited their vehicles.

This could result in further collisions and increase the risk of injuries to pedestrians and operatives who may attempt to seek refuge between the RRS and the environmental barrier or should they attempt to find alternative safe areas by walking onto or near the live carriageway.

It is recommended that the environmental barrier is set back, allowing for a place of safety outside of the RRS working width.

Designer disagrees with the RSA problem and recommendation raised

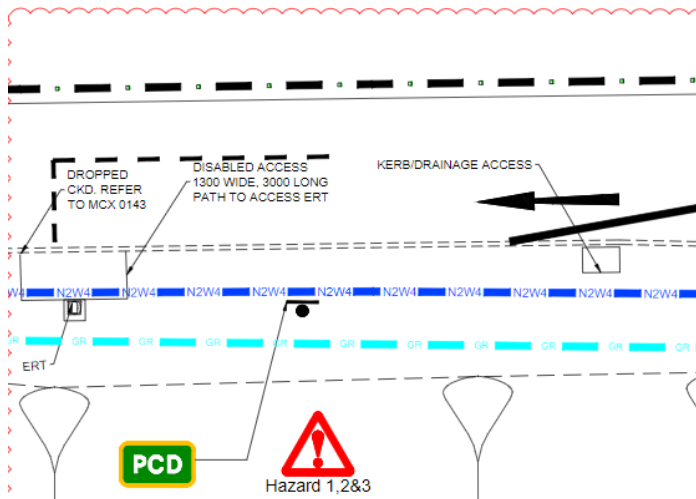
Extract from drawing HA514451-CHHJ-HGN-S1_MLZZZZZZ_Z-DR-CH-0003 Revision C03

Summary: Provision of dropped kerbs at ERTs

The police observation platform (POP) specification drawings indicate a 3m dropped kerb at the ERT to enable disabled access to the telephone following the recommendation to alight the vehicle via the passenger side. The EA markings proposed to indicate to drivers where to stop their vehicle may inadvertently block the dropped kerbs, reducing accessibility to the ERT, particularly for those with mobility impairment. It is noted that although drivers are advised to exit their vehicle via the passenger seat both able-bodied drivers and those mobility impaired are likely to struggle to exit most modern UK vehicles in that manner and are likely rather to choose to exit via the driver's side accordingly. There is a risk that in blocking access to the dropped kerbs this could result in a motorist being unable to access the phone without positioning their vehicle in a potentially more vulnerable position closer to the live carriageway.

It is recommended that the markings indicating where to stop within the EA are revised to ensure that the dropped kerbs can be accessed.

Designer accepts the RSA problem and recommendation made by the RSA team.

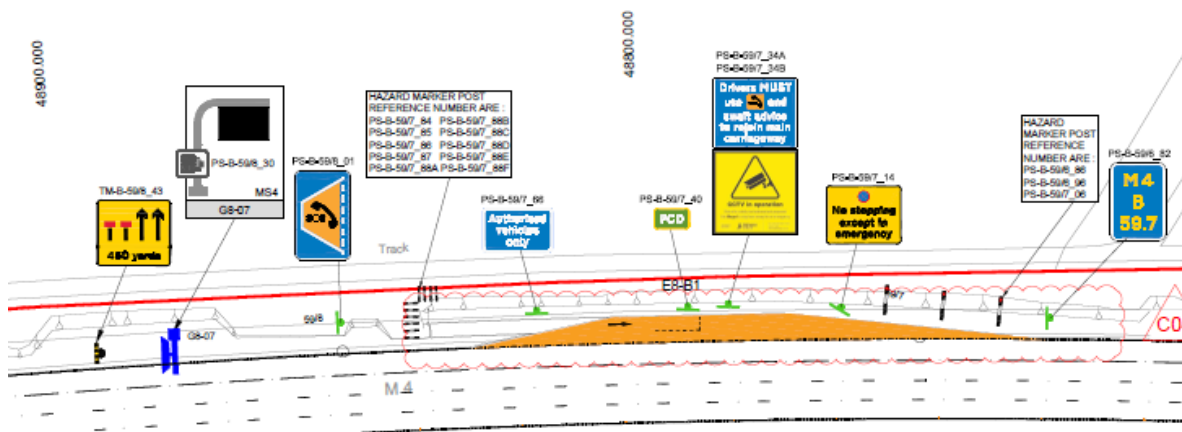
Extract from drawing HSN-S1_ZZZZZZZ_Z-DR-CH-12040 Revision C04

Summary: Unauthorised use of Police Observation Platforms/Areas may lead to collisions

At a number of EA's an overlapped break in RRS is provided to accommodate a police observation platform or area. Examples include EA E8-B1 at chainage 48800, E7-B1 at chainage 36800 and E8-A2 at chainage 50550.

In addition, there is a break in the RRS at chainage 37300 eastbound that coincides with the access to an existing POP. It is unclear if the POP is to remain as part of the scheme.

It is recommended that all police observation platforms/areas are clearly signed and demarcated to discourage use by unauthorised vehicles and occupants.

DESIGNERS RESPONSE: Designer accepts the RSA problem and recommendation made by the RSA team.

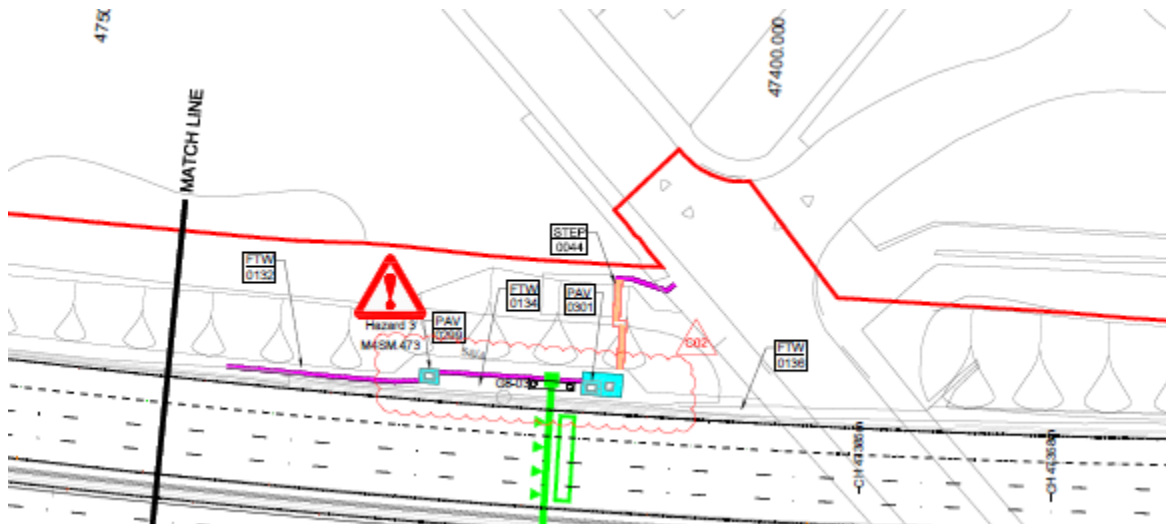
Extract from drawing HKF-S1_ZZ000000_Z-DR-CH-11044 Revision C2

Summary: Potential unauthorised access to the M4 carriageway

The kerbs and footways drawings detail a new maintenance access to the M4 carriageway, via a footway and access steps, at chainage 47420. It is unclear how the access will interact with the existing Reading Road footway and the post and rail fence. The direct, paved access to the M4 at this location could result in unauthorised use of the access and increase the potential for pedestrians to be alongside or within the M4 carriageway. In turn this increases the potential for collisions involving pedestrians.

It is recommended that all operative access footways and steps that interact with public footways include controlled access and are clearly signed to enforce this

DESIGNERS RESPONSE: Designer accepts the RSA problem and recommendation made by the RSA team.

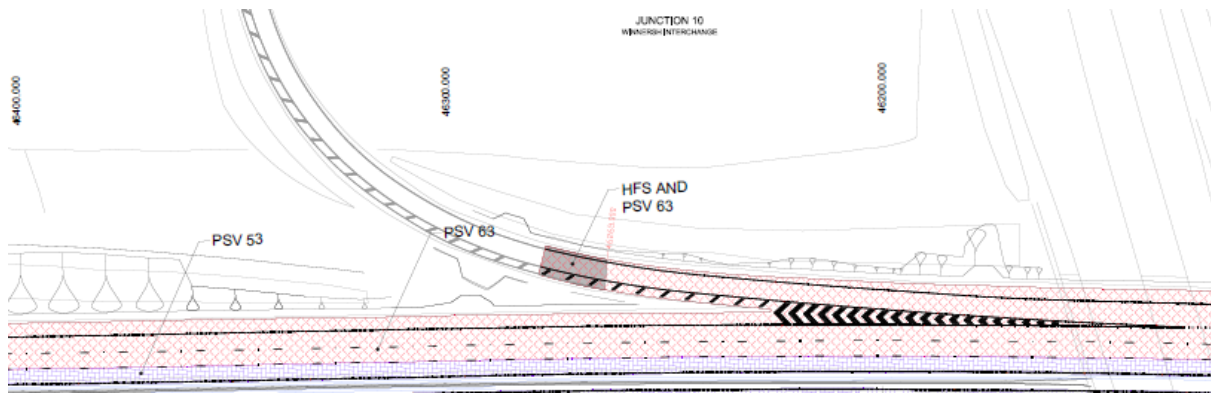
Extract from drawing HPV-S1_ML000000_Z-DR-CH-0747 Revision C01

HFS is provided for very short lengths on a number of junction merge and diverge slip roads. These short lengths tie in to the existing, often worn, provision. This is particularly of note on the A329 (M) northbound to eastbound merge slip (chainage 46300).

The proposed HFS is likely to have a considerably greater braking coefficient than the existing and will be much more visible. This may confuse motorists resulting in late braking and an increased risk of loss of control collisions particularly for motorcyclists.

It is recommended that where HFS ties into an existing provision, new HFS is provided for the full length of the existing provision.

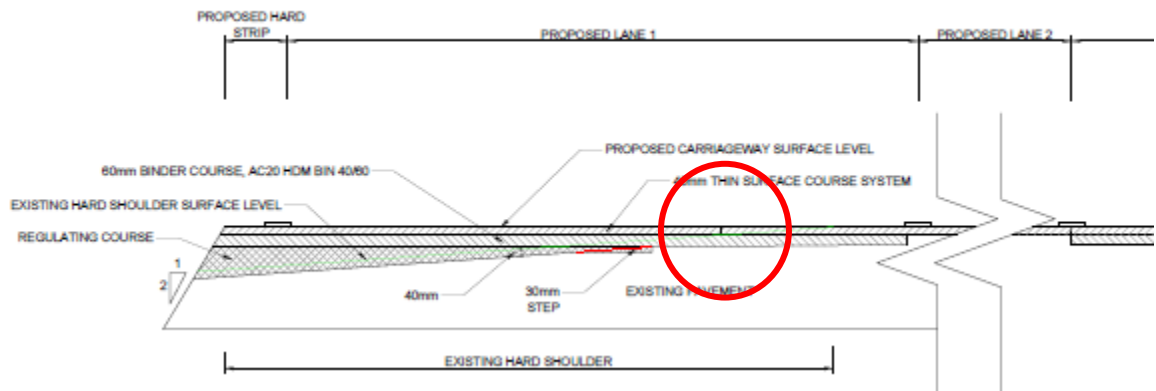
Extract from drawing HA514541-CHHJ-HPV-SZ_ZZZZZZZZ_Z-DE-CH-0001 Revision C01

Summary: Surface joints in wheel tracks

Throughout the scheme there are short lengths of lane one and lane two subject to different surfacing arrangements to the surrounding lanes (most often pavement type P1 – resurfacing). The pavement and cross section drawings provided indicate that a surface course joint may be present within the lane extents and in a wheel track. Given that lanes one and two are subject to the highest volume of vehicles, particularly heavy vehicles, there is increased potential for this joint to fail over time. This can reduce the quality of the surface, effect vehicles under braking conditions and may hold standing water, increasing the risk of loss of control collisions. The Audit Team also noted that some sections of the surfacing reinstatement appeared to disturb or influence the direction of travel, and that this is likely to have a greater impact on powered-two-wheelers.

It is recommended that all pavement joints are located outside of wheel tracks.

Designer accepts the RSA problem and recommendation made by the RSA team.

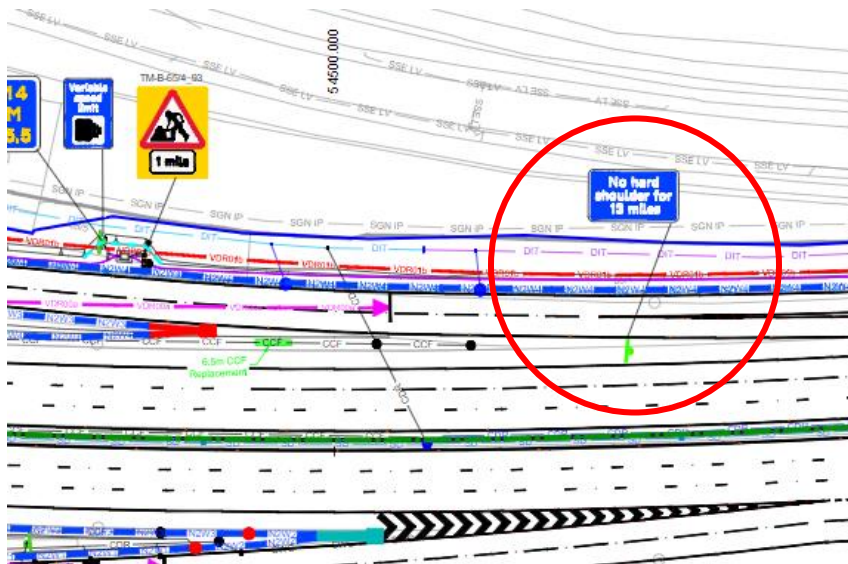
Extract from drawing HA514451-HGN-S1_ML000000_Z-DR-CH-1024 Rev C03

In the event of a vehicle leaving the carriageway they could strike or be led into the signs and post arrangements, potentially increasing the severity of the collision or generating a secondary collision.

With respect to marker post B 53.0 (circled below) this sign would also prevent a vehicle using the gap in the event of a breakdown in order to limit the effect of a live lane breakdown collision.

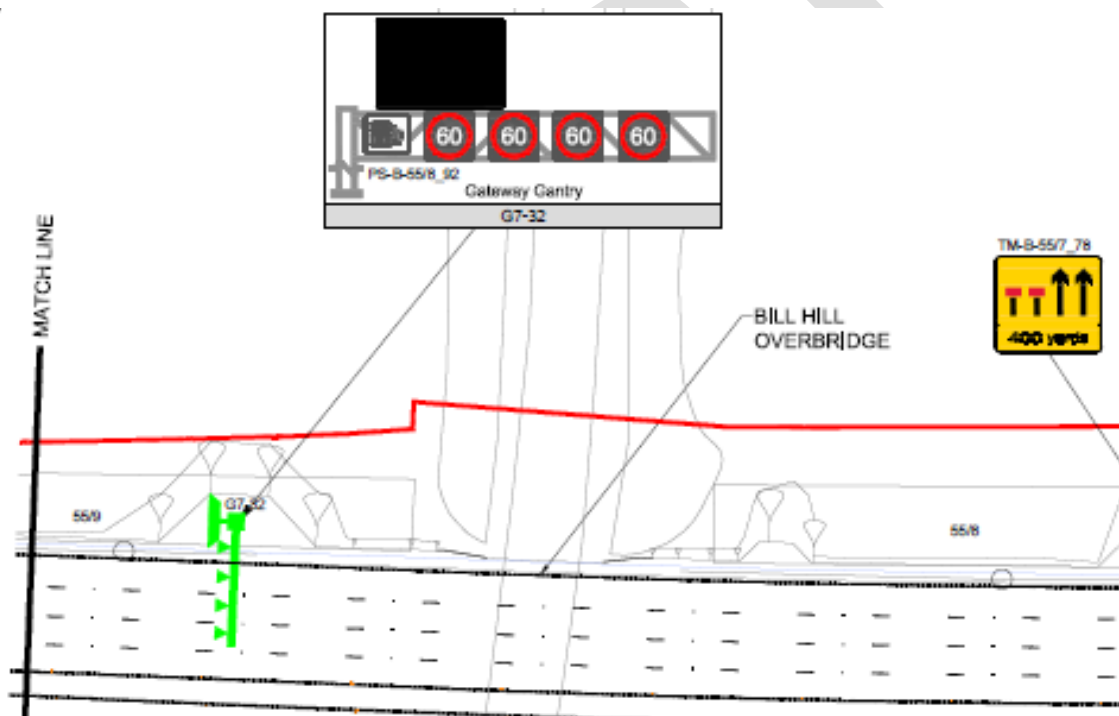
Extract from drawing showing G7-32 (chainage 44900),

Summary: Gantry signs not aligned over the offside lane (lane 4)

The plans provided show gantries that appear not to extend across the whole carriageway while including signs relevant to the offside lane (LBS4 4). This includes but is not limited to eastbound gantries G7-32 (chainage 44900), G7-31 (chainage 44750) and G7-23 (chainage 41750) and westbound gantries G7-21 (chainage 41100), G7-22 (chainage 53600) and G7-31 (chainage 44750). This could result in driver confusion, particularly with regards to 'red-x' emergency lane closures and lane designation, increasing the risk of secondary and lane change collisions.

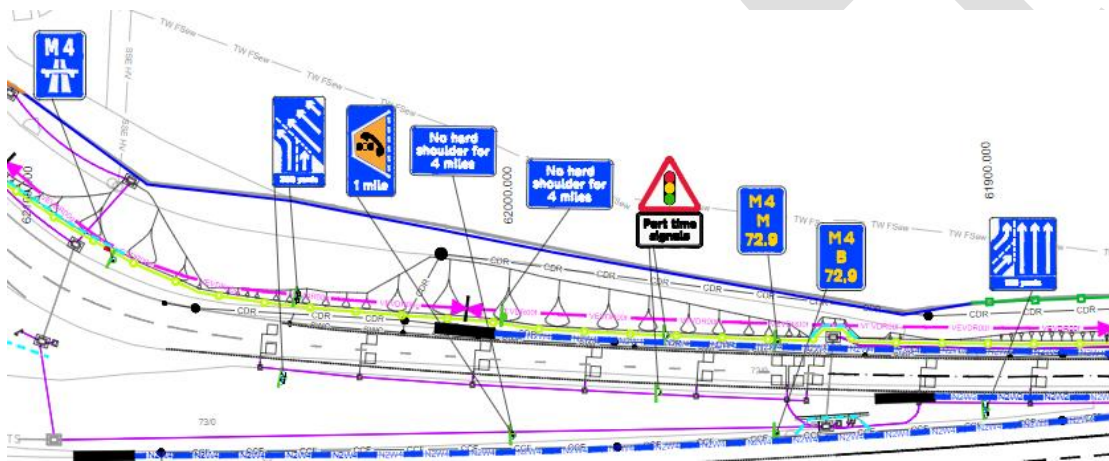
Extract from drawing HA514451-HGN-S1_ML000000_Z-DR-CH-1003 Rev C02

Summary: Sign clutter resulting in reduced visibility to sign faces

Nine signs are provided in the nearside verge of the eastbound merge at junction 12. The number of signs and the spacing between them is likely to result in information overload and reduced visibility to sign faces. This could result in drivers being unaware of hazards or the upcoming merge layout. In turn this could lead to rear shunt type collisions at the ramp metering or side impact collisions at the merge.

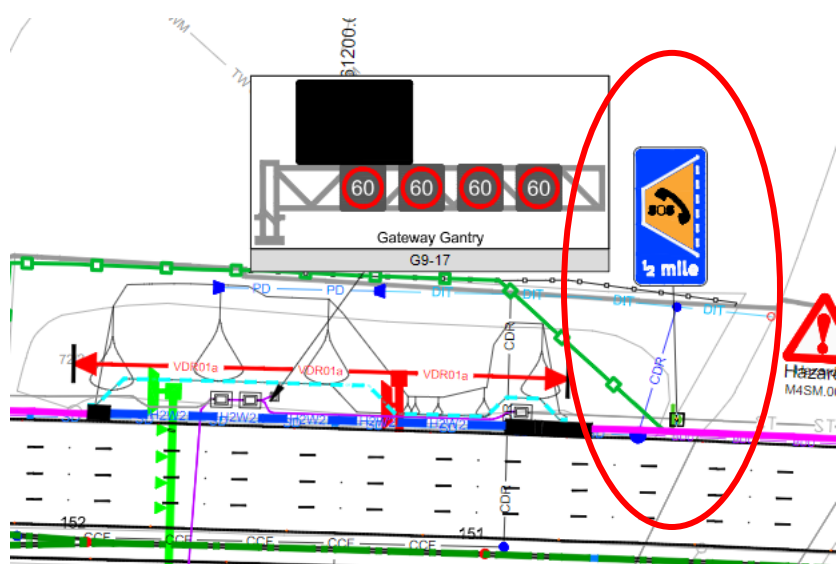
Extract from drawing HA514451-HGN-S1_ML000000_Z-DR-CH-1005 Rev C02

- EA sign (westbound) at chainage 50500
- ½ mile EA sign (westbound) at chainage 51800
- Motorway and merge 100 yards on the junction 11 westbound merge slip chainage 55000

- Variable speed limit sign (westbound) at chainage 55200
- 300 yard EA sign (westbound) at chainage 57700.

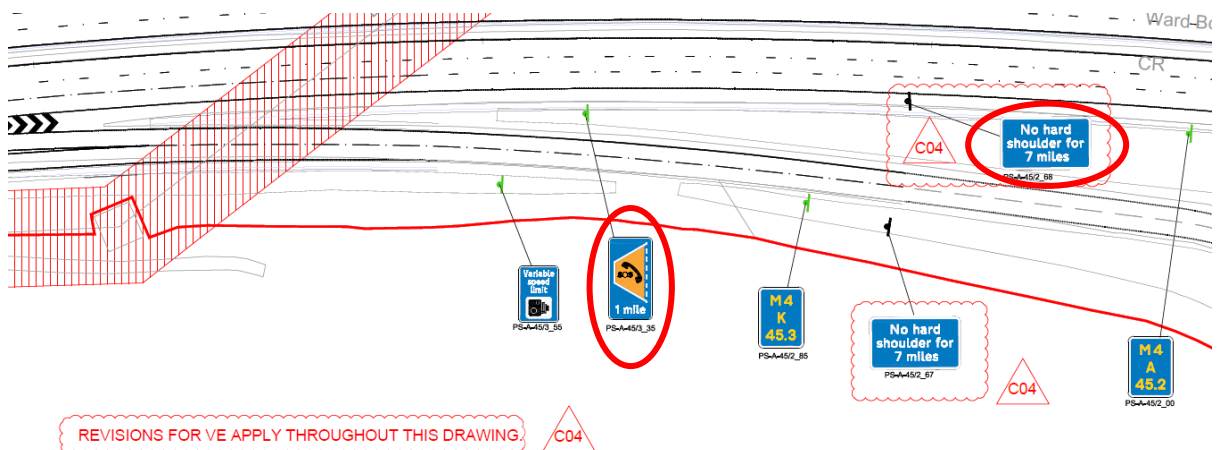
Extract from drawing HSN-S1_ZZZZZZZZ_Z-DR-CH-12080 Revision C04

Summary: Proposed signs may restrict visibility for merging vehicles

An emergency telephone one mile ahead sign (PS-A-45/3_35) is provided on the westbound merge nosing and a no hard shoulder sign (PS-A-45/2_68) is provided to the east of this. Given the alignment of the carriageway, these signs may reduce visibility to the mainline for merging vehicles, resulting in increased collisions at the merge.

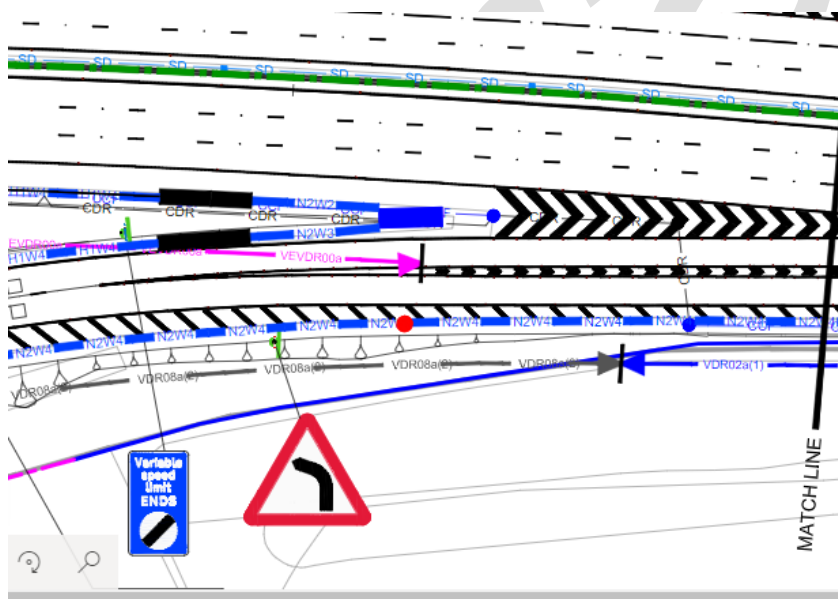
Extract from drawing HA514451-HGN-S1_ML000000_Z-DR-CH-1049 Rev C02

Variable speed limit ends sign is provided on the nosing between the M4 carriageway and the junction 8/9 east and westbound diverges. The position and orientation of the sign face may result in driver confusion as to which route is subject to the end of the variable speed limit, increasing the risk of inappropriate speeds and collisions.

At the junction 10 westbound diverge the same sign provision is shown.

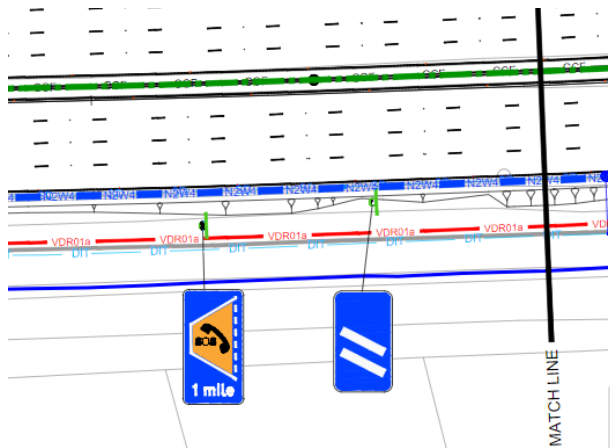
Extract from drawing HA514451-CHHJ-HSN-S1_ZZZZZZZZ_Z-DR-CH-12012 Rev C04

Summary: Visibility to EA/emergency roadside telephone sign compromised

EA/emergency roadside telephone sign PS-A-69/6_45 is provided in the nearside verge but is positioned approximately 25m in front of the countdown marker sign PS-A-69/6_19. Visibility to the EA sign is likely to be compromised which could lead to drivers being unaware of the next EA. This may result in drivers seeking alternative refuge in the diverge increasing the risk of shunt collisions and collisions with drivers outside of their vehicle.

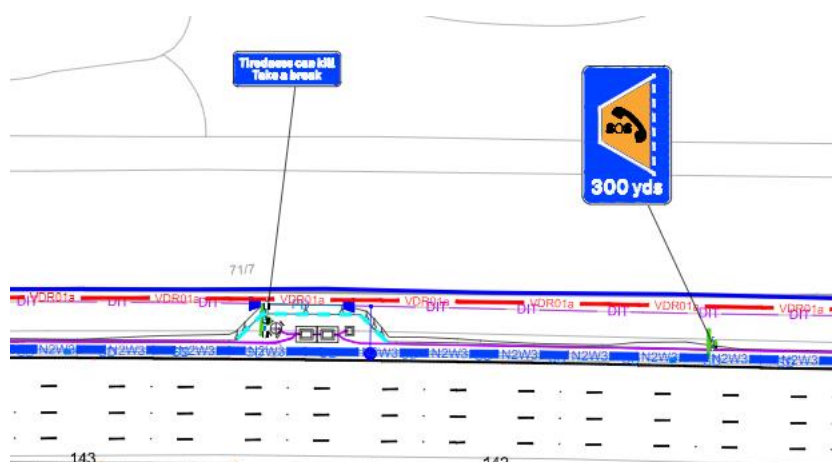
Extract from drawing HA514451-CHHJ-HSN-S1_#####_Z-DR-CH-12007 Rev C04

Summary: Position of '*Tiredness can kill take a break*' signs

A '*Tiredness can kill take a break*' sign is located immediately before the 300 yard sign for EA E9-B3 and immediately before EA E9-A2. Drivers may be tempted or consider the EAs as suitable places in which to stop rather than continuing on to Reading MSA. Unauthorised use of the EAs without use of the ERT will result in drivers having to re-join the live carriageway merging with fast traffic increasing the risk of lane changing collisions.

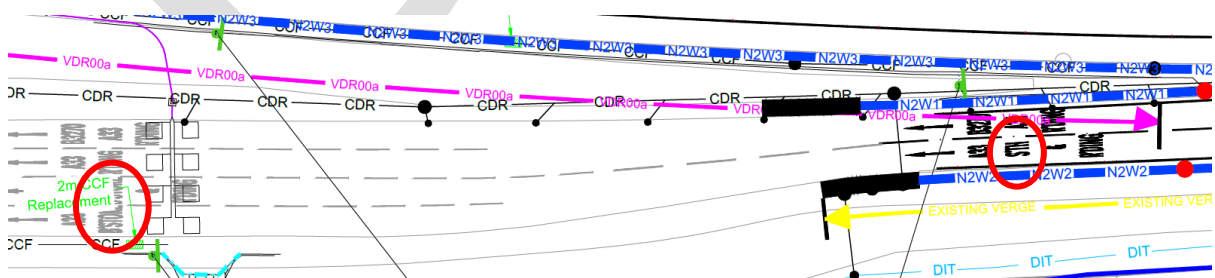
Extract from drawing HGN-S1_ML000000_Z-DR-CH-1024 Revision C03

Summary: Inconsistency between lane designation carriageway markings

On the westbound approach to junction 11, proposed carriageway markings in lane one of the two lane diverge includes the use of 'A33 STH & R'DING', but the existing carriageway markings within the four lane section of the diverge use 'A33 B'STOKE' or 'A33 B'STOKE & R'DING'. The use of A33 South carriageway markings could be confusing and result in lane changes on the diverge, increasing the risk of collisions.

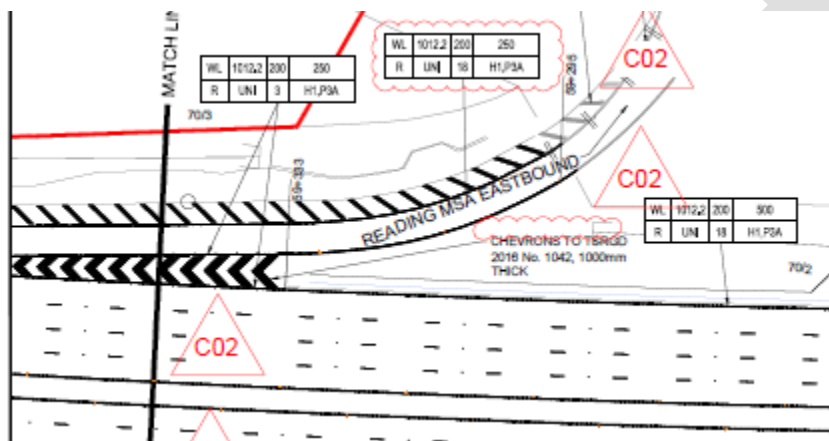
Extract from drawing HMK-S1_ML000000_Z-DR-CH-1211 Revision C02

Summary: Removal of 'SLOW' carriageway markings

The eastbound and westbound diverge lanes to the Reading MSA are to be resurfaced. The existing 'SLOW' markings are not detailed to be reinstated following the resurfacing. Given the short diverge length and tight left-hand bends the removal of the 'SLOW' markings could result in late braking and vehicle loss of control.

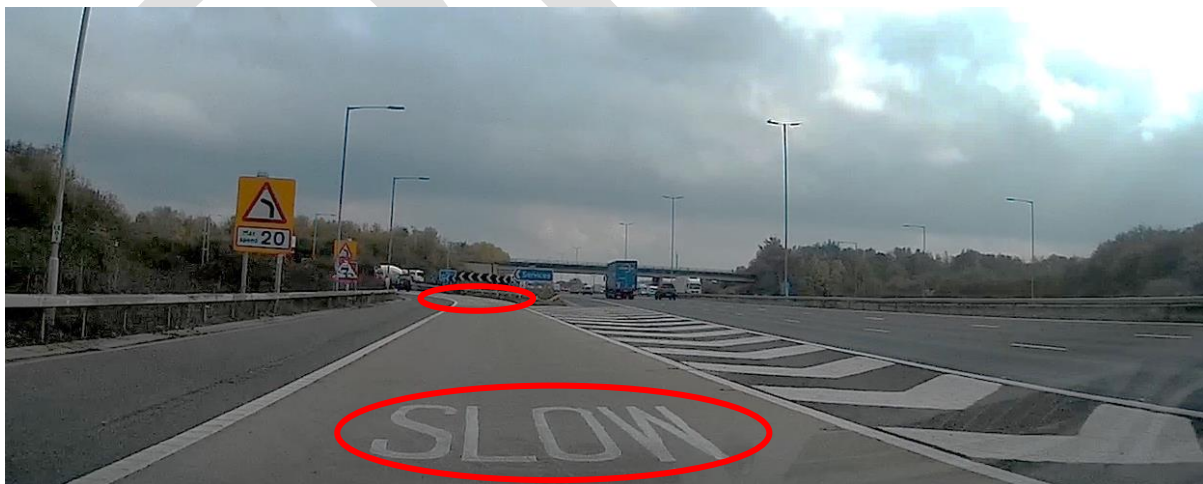
Reading Motorway Services eastbound diverge lane - image captured October 2018

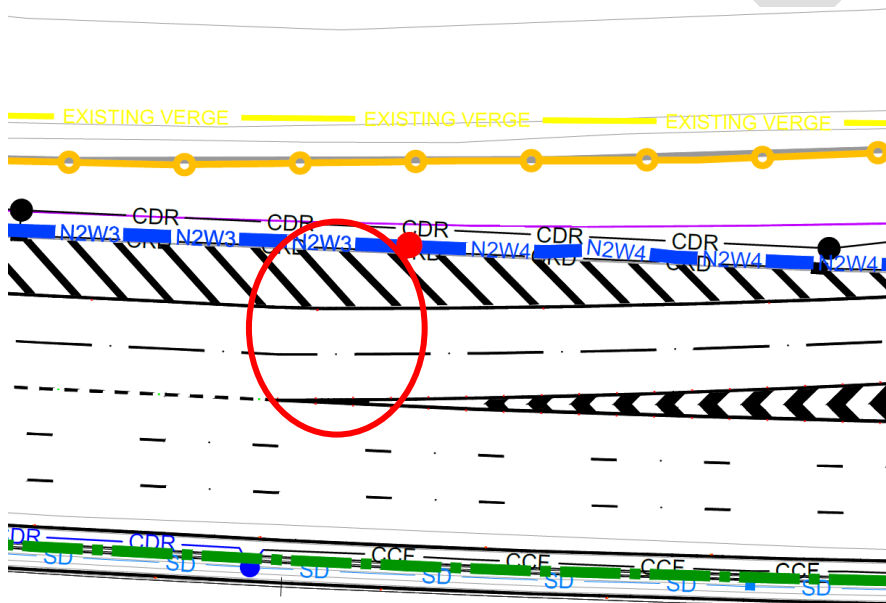
Extract from drawing HGN-S1_ML0000000_Z-DR-CH-1022 Rev C03

Summary: Lane carriageway making configuration may lead to side-swipe collisions

The lane warning markings separating the nearside and offside eastbound offslip approach to junction 11 consists of a notable localized deviation opposite the diverge nosing arrangement. There is a risk that motorists exiting the M4 mainline carriageway and negotiating the localized deviation at speed may lead to poor lane discipline and side-swipe collisions (see excerpt).

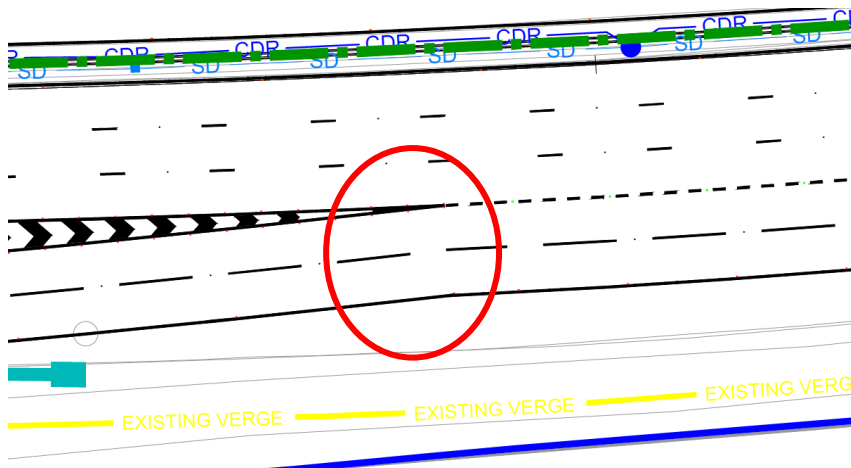
Extract from drawing HGN-S1_ML0000000_Z-DR-CH-1024 Rev C03

Summary: Lane carriageway making configuration may lead to side-swipe collisions

The lane warning markings separating the nearside and offside westbound offslip approach to junction 11 consists of a notable localized deviation. There is a risk that motorists exiting the M4 mainline carriageway and negotiating the localized deviation at speed may lead to poor lane discipline and side-swipe collisions (see excerpt).

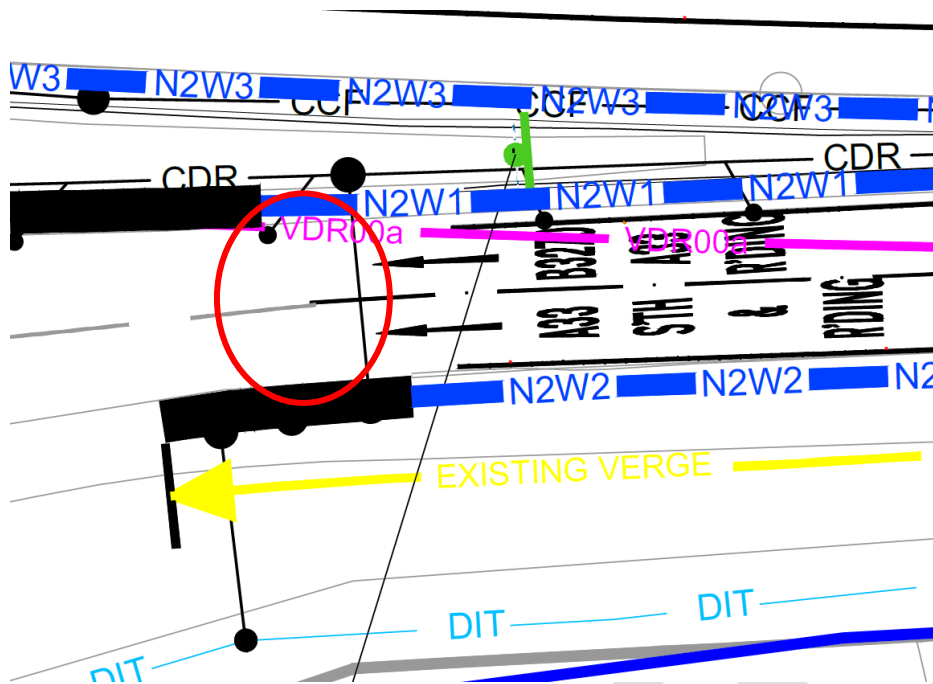
Extract from drawing HGN-S1_ML0000000_Z-DR-CH-1024 Rev C03

The lane warning markings separating the nearside and offside westbound offslip approach to junction 11 prior to the two lanes merging into four consists of a notable localized double-bend deviation. There is a risk that motorists exiting the M4 mainline carriageway and

negotiating the localized double-bend deviation at speed may lead to poor lane discipline and side-swipe collisions (see excerpt).
