Safety Review

A38 Markeaton Roundabout Improvements and Road Safety Audit

MAL/A38MOA-Rev0

03 March 2020

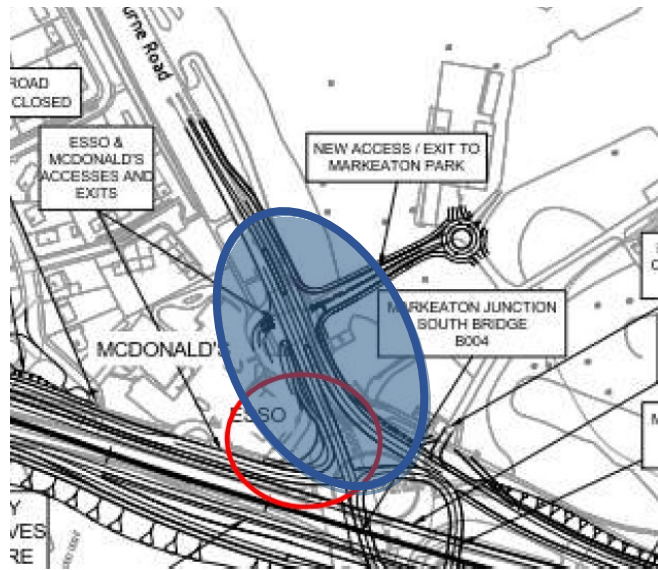
Image 2: Area of Safety Review Shown in Blue

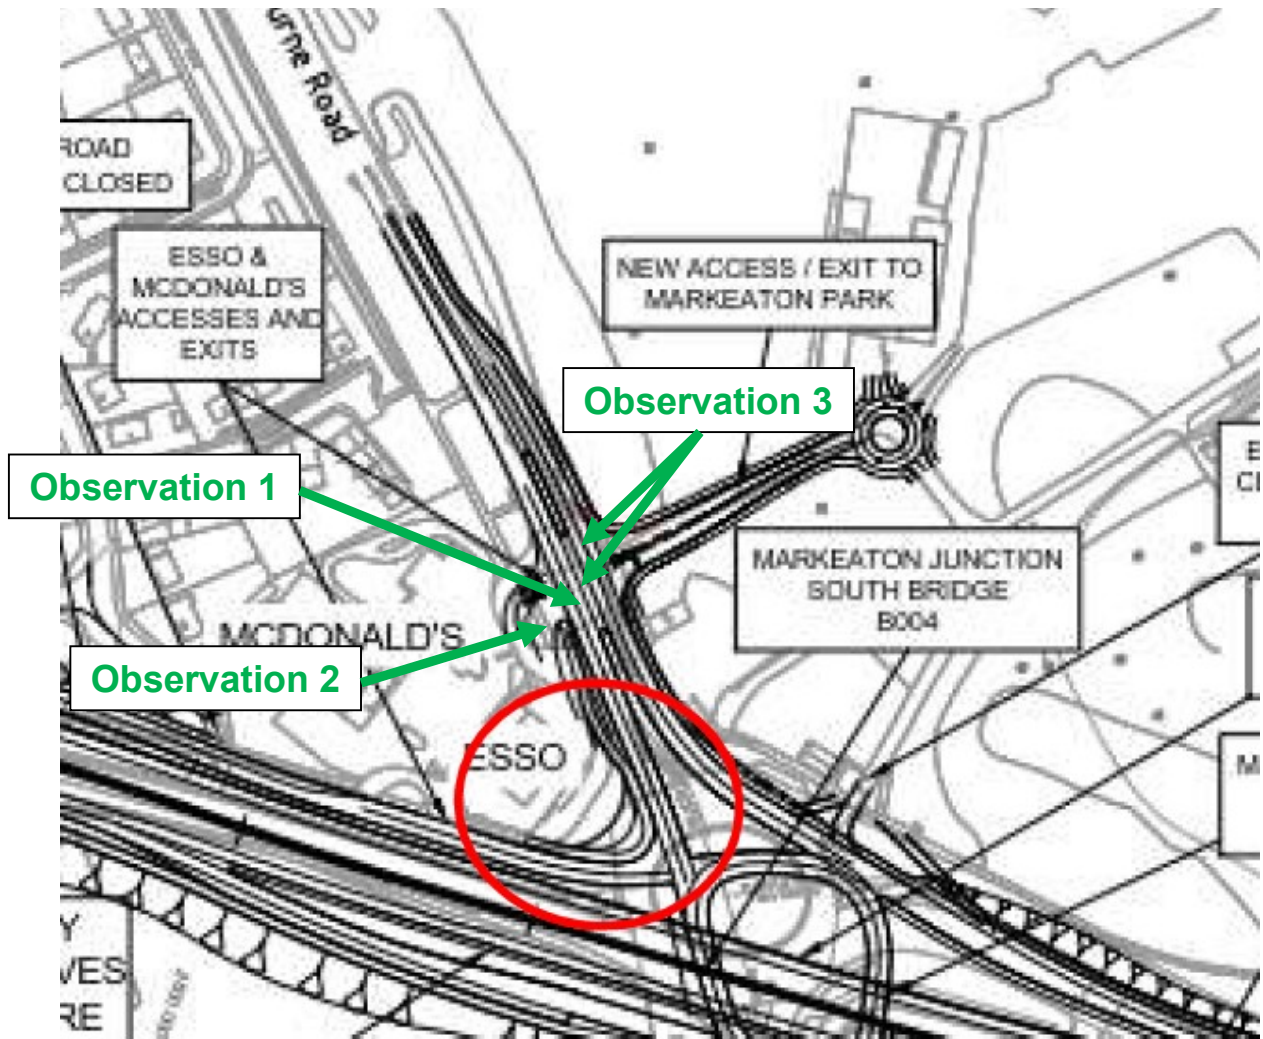
Observations and Recommendation Plan

- 2.1.1 Significant changes are proposed at the Markeaton roundabout to improve safety and congestion. The existing entry into the site from the A38 north eastbound direction will be closed. Access to the site will only be available from the A52 Ashbourne Road located to the north of the site.

- 2.1.2 To facilitate these increased turning movements a new signalised junction will be constructed close to the existing Esso/McDonalds access onto the A52 Ashbourne Road. As part of these works the access into Markeaton Park will be incorporated into this junction. Examination of the preliminary layout indicates that the left turn into the site is a radius of 3.5m.

- 2.1.3 The issue of the left turn has been considered within the RSA problem 4.3.5. However, it has not considered the full implications of this extremely tight radii and its effect on the access arrangements for Heavy Commercial Vehicle (HCV) entering the site from A52 Ashbourne Road.

- 2.1.4 An articulated HCV will have considerable difficulty in turning left from the A52 into the site. Details of tracking have been considered but the reality may not be quite so easy to achieve.

- 2.1.8 Details of the traffic modelling of the new A52 Ashbourne Road/McDonalds/Esso traffic signalised junction is unavailable and as such there is no understanding of how the improvements will impact on the Markeaton junction. There is concern that the Esso/McDonalds arm will only run for a limited green time every cycle. The McDonalds site is one of the busiest in the country with up to 3000 unique visits a day and the Esso garage 1350 a total of 4350 two-way trips. It is expected that upwards of 2800 vehicles will use the A52 junction to exit the site (allowing 33% to use the A38 exit). These can be particularly high in the morning and more specifically the evening peak period where the peak trips to the restaurant will coincide with the peak period on the A52.

- 2.1.13 Details of the proposed pedestrian facilities at the junction have been only partly considered as part of the RSA Problem 4.3.7. It does not consider NMU movements across the A52 to and from Markeaton Park. The park is well used with established trips between the park and the Esso/McDonalds site. No details have been provided on how pedestrian movements will be accommodated across the A52. A lack of suitable NMU facilities can increase the risk of NMU/vehicle collisions.

2.1.7 Undertake detailed traffic modelling of the junction and ensure that realistic tracking of left turn HCV's into the site are undertaken. Implement additional signing works for the right turn into the McDonalds.

- 2.1.12 Undertake detailed traffic modelling of the junction and if queues block the entrance into McDonalds consider the use of "Keep Clear" markings and perhaps ensure that detection used on the exit from the site is positioned appropriately ensuring that queues are kept to a minimum.

- 2.1.14 Undertake detailed observations including NMU counts (Saturdays and Sundays) to determine the NMU demand at the proposed junction and if necessary, consider including signalised/un-signalised facilities at the junction (covering the A52 and site access). If traffic signal control of the NMUs is required, then detailed modelling of the changes will be required. This could have a material impact on the capacity of the junction.
