Hole Farm Woodland Creation Project

Structural Survey Report (December 2022)

Structural Survey Report

Hole Farm, Great Warley, Brentwood, CM13 3JD

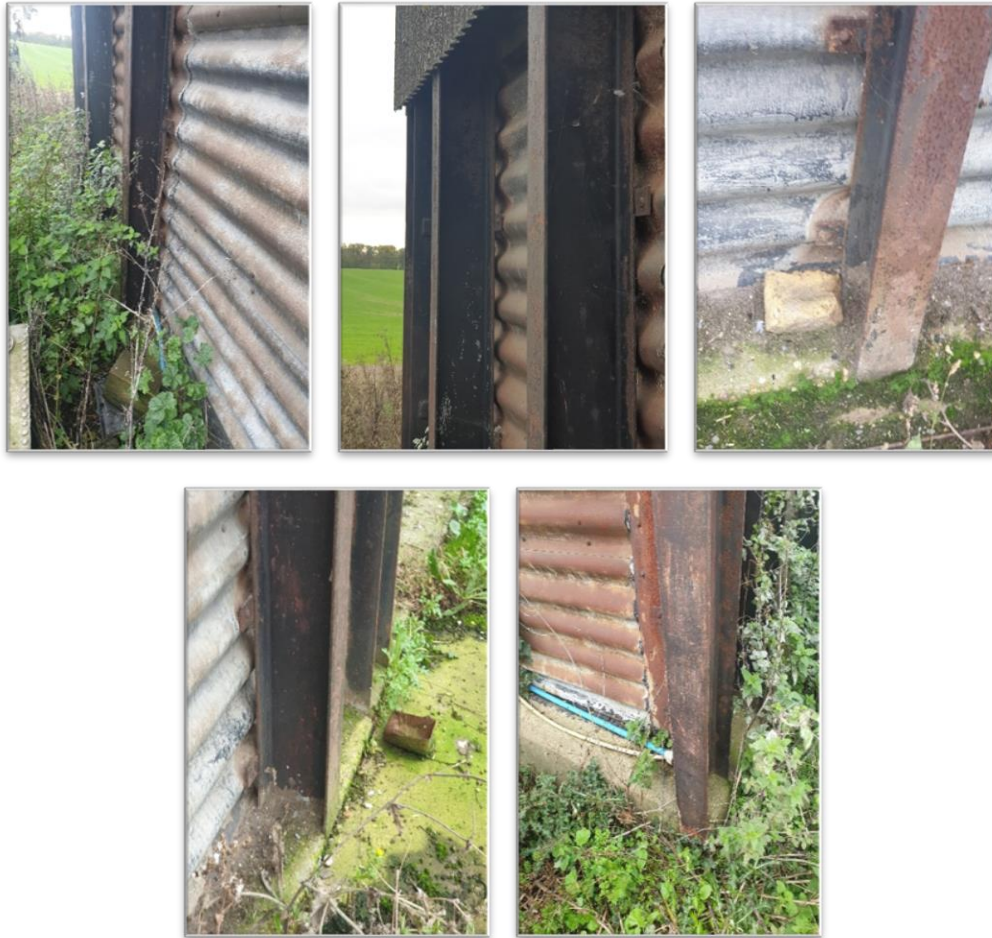
A. Defects with the steel frame structure

1. Presence of corrosion on the steel column
2. Rust on the steelwork

1. There is a need to gain access to the interior of the structure, to enable a full structural assessment of the steel framed structure.
2. We recommend salvaging the steelwork by using a wire brush to scrub partially rusted areas to remove flakes and powdery surface rust. Then all steelwork should be blast cleaned to SA2½ given 1 coat of H.B. zinc phosphate primer dry film thickness of 80 microns and then painted with intumescent paint for further protection in the event of a fire.

3. Also, if during the repair works, the rusting has led to holes in the steelwork, this would immediately indicate its loss of tensile and compressive strength. We recommend replacing the damaged area with a galvanized option.

4. Based on the atmospheric corrosivity and high-risk situation of this area, the solution provided above will provide a protective coating for some years only. Once, the corrosion begins to occur, we recommend a repeat of these remedial works be carried out.

5. In a more long-lasting solution, these will involve the metals being Hot dip galvanized to BS EN ISO 1461 with a minimum coating thickness of 460 gms/m². This needs to be determined by a corrosion expert.

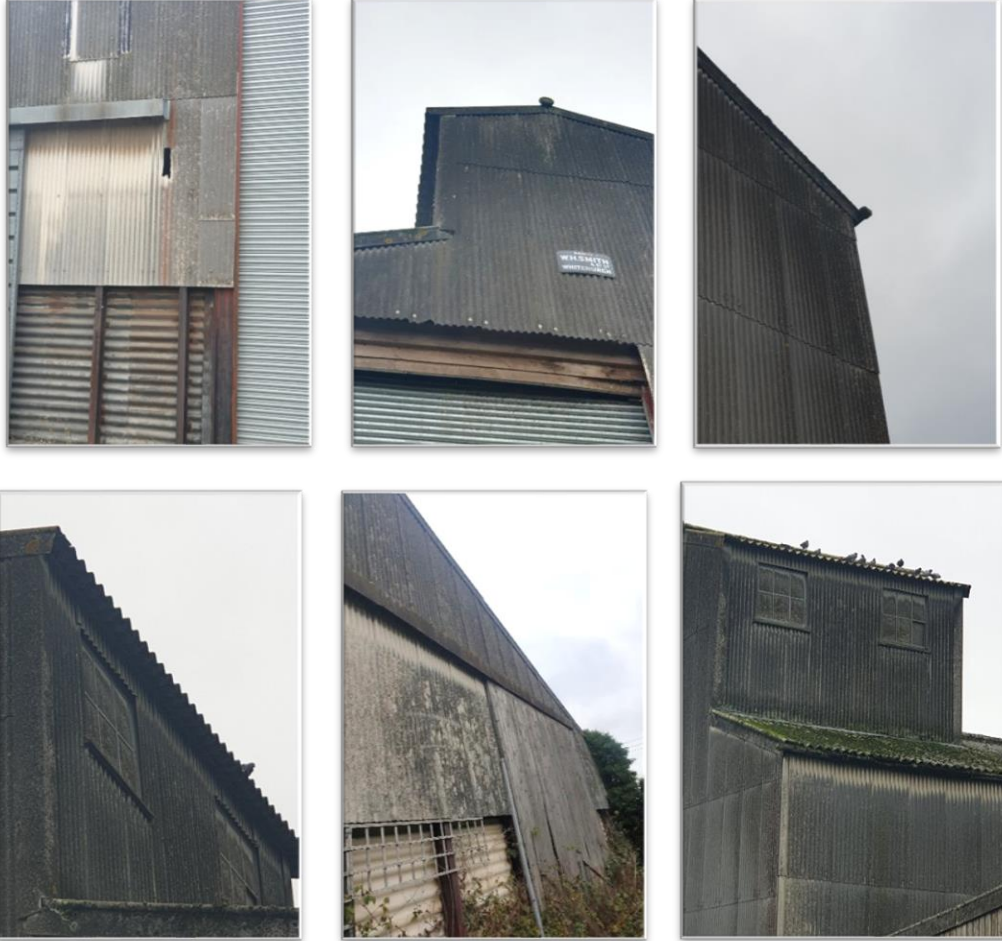
B. Defects with the wall

1. The wall panels are in poor condition
2. Broken sections on some of the wall panels
3. Presence of moss growth
4. Presence of lichen growth

1. The wall panels are in poor condition and can be regarded as unsafe. There is a need to replace all defective sections.
2. Remove all moss/lichen growth on the wall panels
3. We recommend stripping off the wall panels completely.
4. An asbestos survey was carried out and the findings are provided with the report

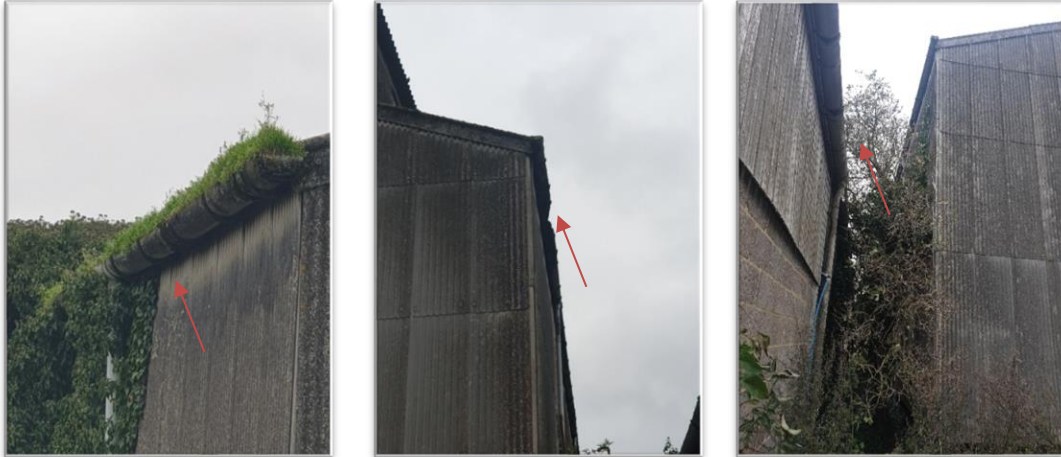
C. Defects with the gutter

1. Leaking roof gutter
2. Vegetation growth in the gutter
3. Cracking to the gutter

1. Lack of maintenance
2. Dirt or debris in the gutters
3. Loose connection
4. It appears that the gutter is not adequately receiving the rainwater from the roof
5. The gutter is not adequately slopped into the required downpipe
6. Lack of maintenance

1. Remove all vegetation and debris growth from the gutters.
2. We recommend replacing all defective gutters within the property.
3. The existing gutters or new gutters should be fitted in such a way that rainwater from the roof completely discharges into the gutter
4. We suggest immediate repairs to all defective gutter joints and fittings. For aesthetic purposes, existing gutters can be repainted.
5. We suggest regular maintenance of the gutters. If defective gutters are left long term it can lead to undermining of the foundations, dampness, and water ingress.

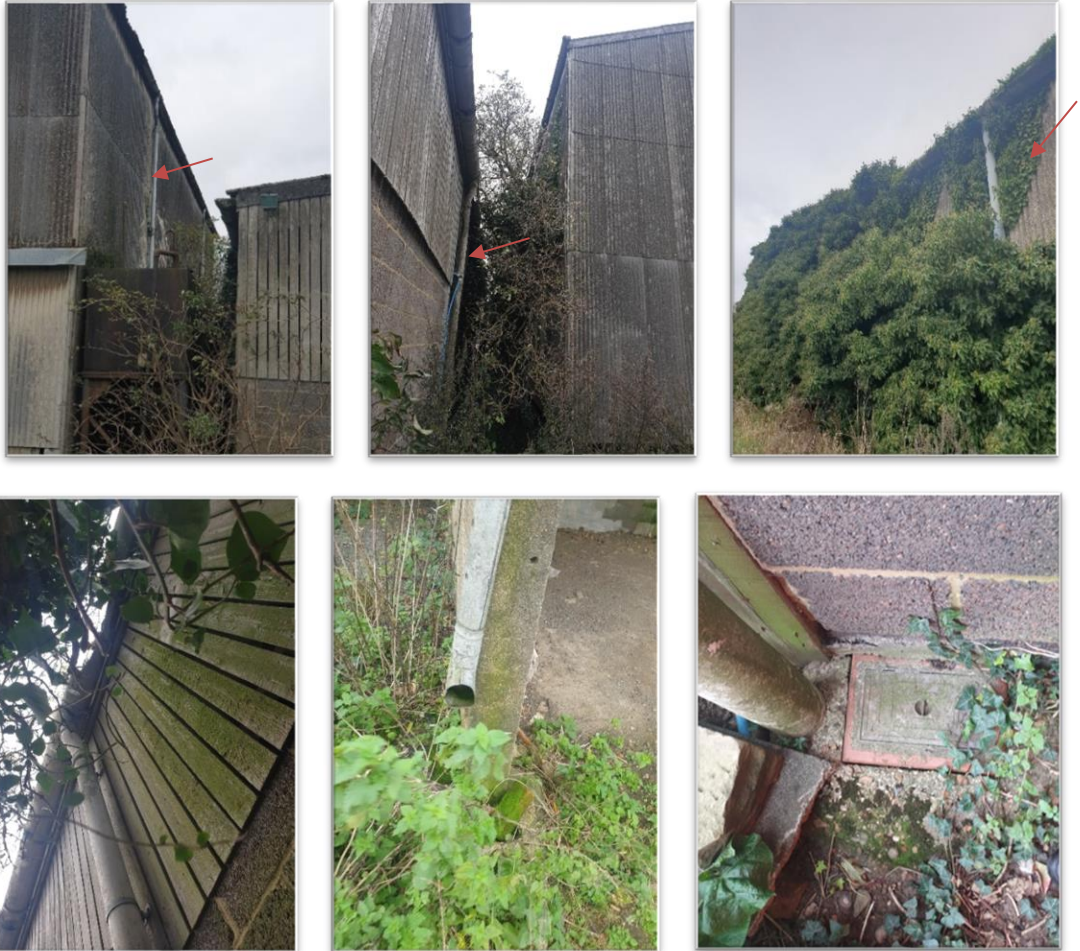
D. Defects with the rainwater downpipes

1. Loose connections
2. Rainwater downpipe showing signs of water leakage
3. Moss growth
4. Downpipe is not discharging into the required drain
5. vegetation growth around the downpipe

1. We recommend that the rainwater downpipe should be checked for loose connections. This should be fixed immediately.
2. All downpipes should be adequately channelled into a drainage system.
3. Remove all vegetation and debris from the rainwater pipe and drains.
4. We suggest regular maintenance of the downpipes and drains. If defective downpipes are left long term it can lead to the undermining of the foundations.
5. We recommend contacting a drainage specialist to have the drainage system checked and all the pipework systems at the rear of the property. Immediate remedial works should be carried out.
6. The pipework network should be checked for blockages.
7. Remove all vegetation and debris from the drains.

These remedial works should be applied to other areas with defective rainwater downpipes.

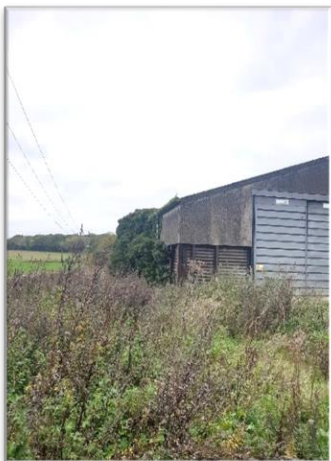
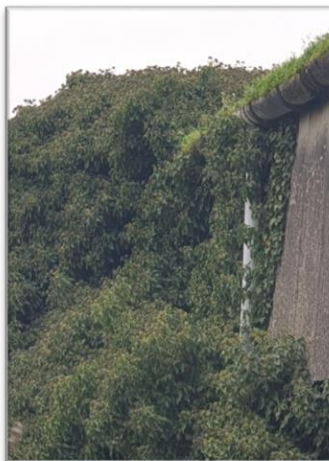
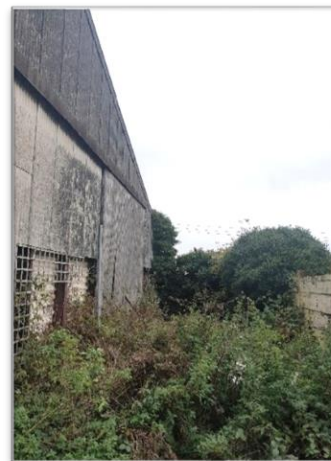
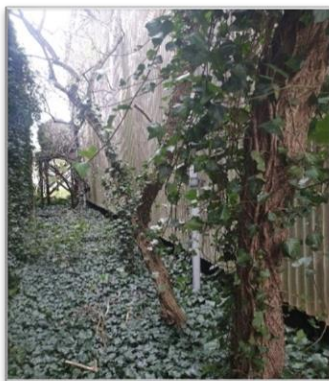
E. Vegetation and Plant growth

1. Excessive vegetation growth
2. Plant growth on the internal side of the wall
3. Presence of trees

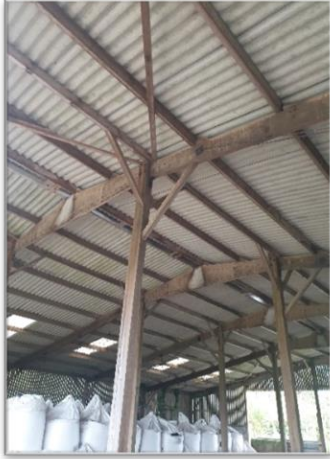
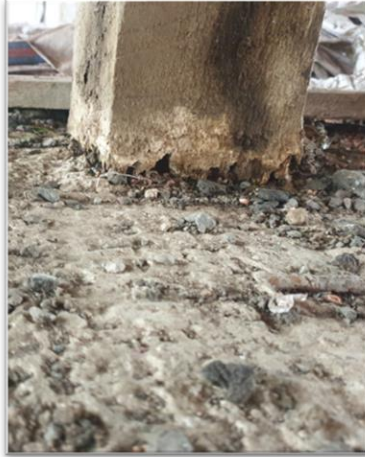
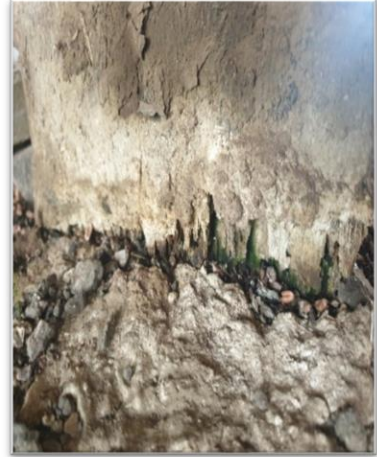
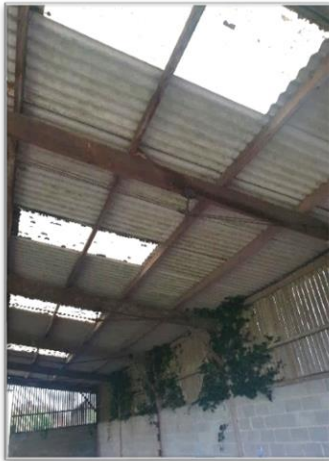
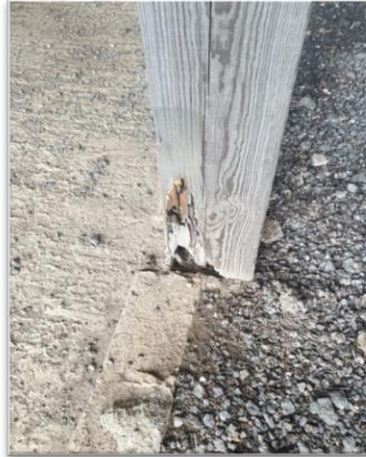
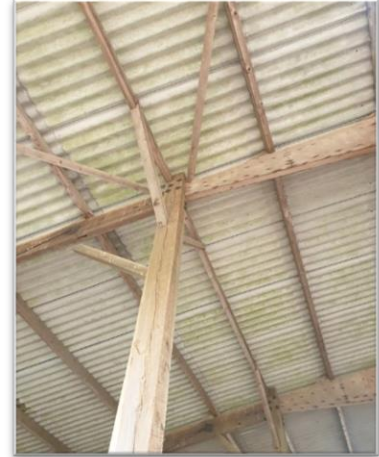
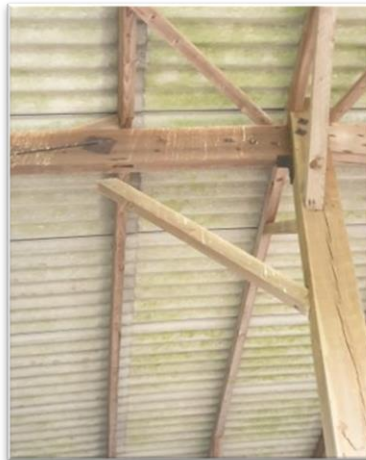
A. Defects with the timber frame

1. Presence of damp timber
2. Timber rot (some of the timber columns have lost contact with the ground, due to timber rot_
3. Disconnected struct members

1. We recommend replacing all defective timber columns and elements
2. The struct members should be replaced with new members. The new member to match the existing one.
3. The timber element must be properly connected.

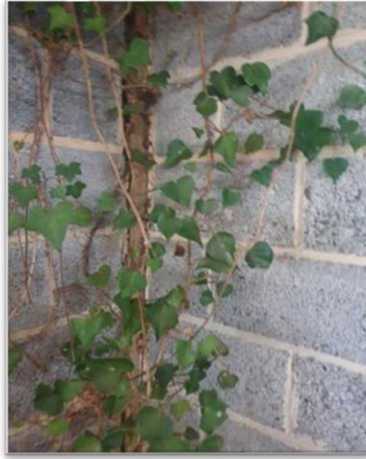
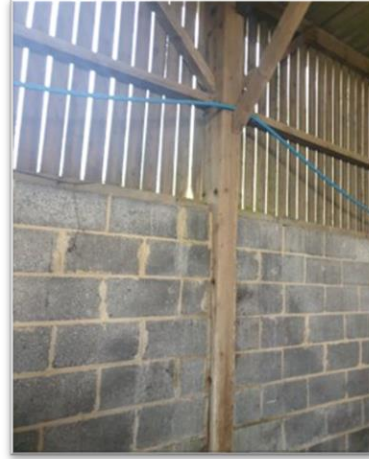
B. Defects with the blockwork

1. Cracking to the junction.
2. Presence of damp
3. Lack of lateral restraint straps
4. Presence of vegetation growth
5. Perishing mortar joints
6. Presence of trees behind the wall

1. Once the issue with the vegetation and trees is solved, we recommend that a specialist-approved contractor is instructed to apply a Heli-fix solution to install L-shaped bars to tie the external walls together.
2. Alternatively, the walls can be restitched and toothed together course by course creating a robust connection. However, this would require partial demolishing of the external walls.
3. Another alternative would be to partially demolish the external wall and install a Simpson Strong-tie Crocodile Wall Starter Kit to tie the walls together.

4. Replace all defective blockwork and repoint any defective mortar joint

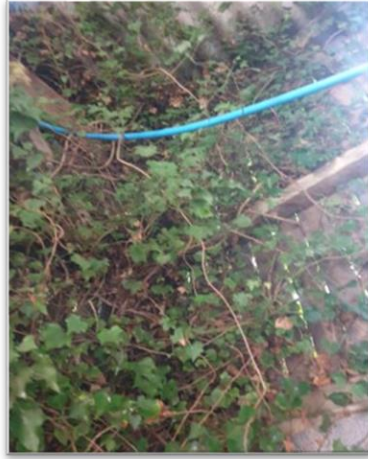
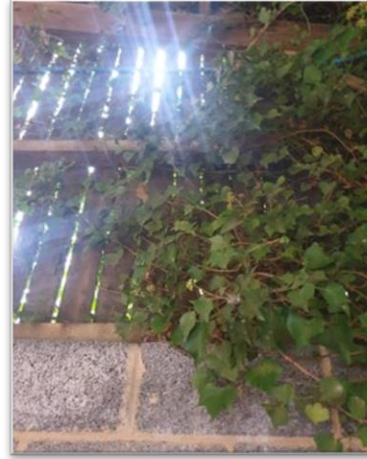
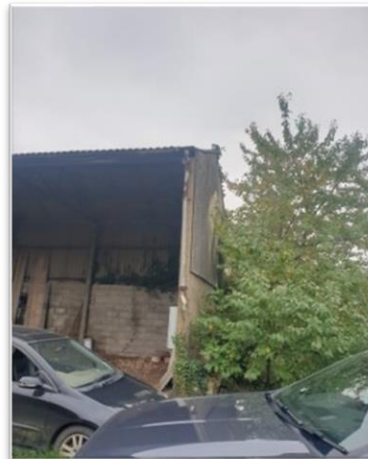
C. Vegetation and Plant growth

1. Excessive vegetation growth
2. Plant growth on the internal side of the wall
3. Presence of trees

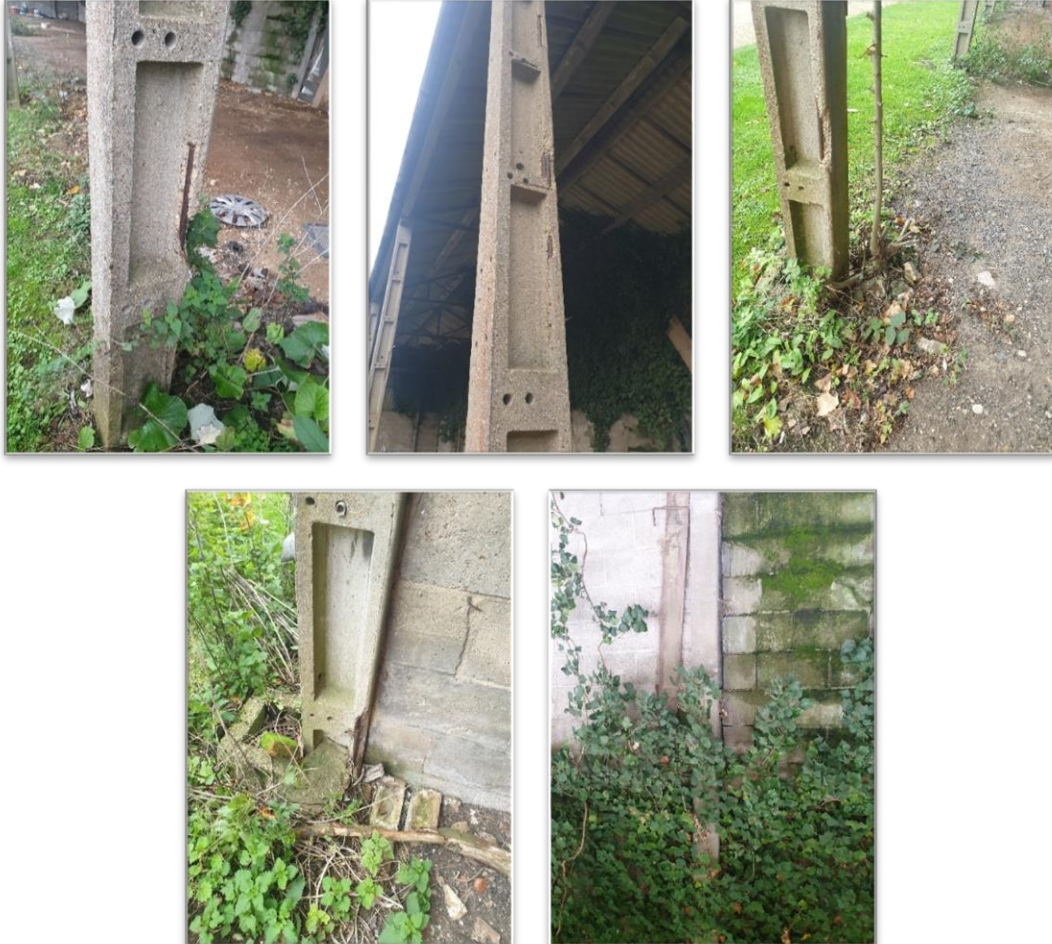
A. Defects with the concrete frame structure

1. Cracking to the concrete column
2. Presence of rust on the exposed reinforcement bars
3. Damp wall
4. The concrete column is leaning, showing signs that it has started to fail

1. Age
2. Poor workmanship
3. Lack of maintenance
4. Water ingress
5. Impact damage, possibly vehicular impact to some of the concrete column

1. Replace the concrete column that has started to lean.
2. The exposed section should be treated for rust, where excessive rust is seen, we recommend replacing the concrete column.
3. There is a need to install a concrete balustrade close to each of the concrete columns to prevent future vehicular impact

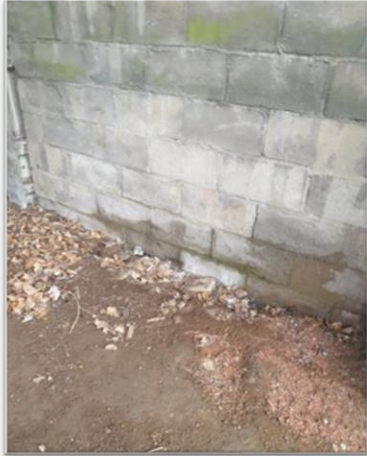
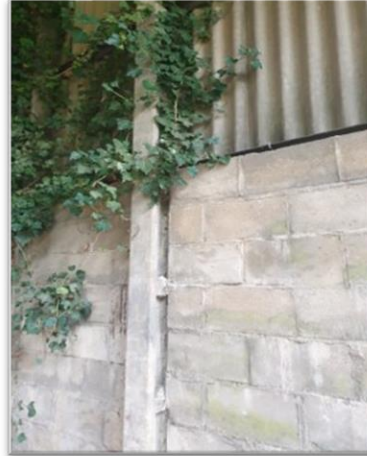
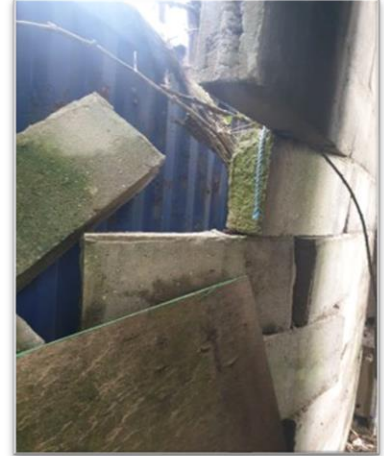
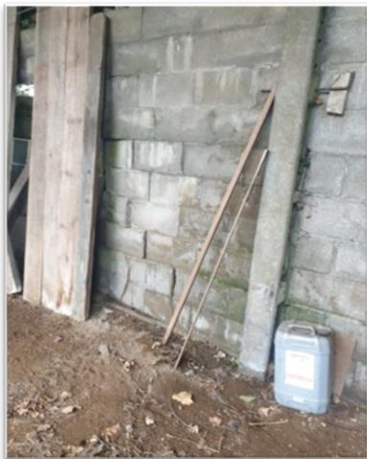
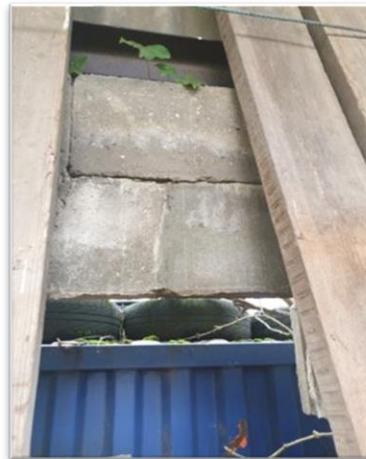
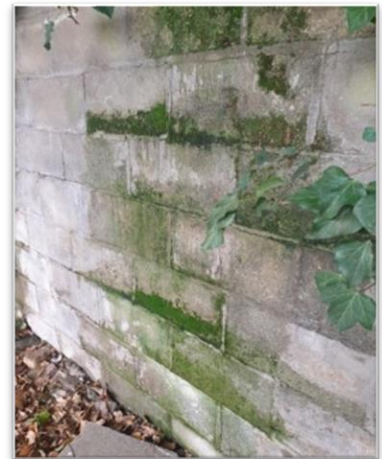
B. Defects with the blockwork

1. Cracking to the junction.
2. Presence of damp wall
3. Presence of vegetation growth
4. Collapsed section of the blockwork
5. Suspended blockwork

1. We recommend resolving the issue with the vegetation and tree growth close to the concrete frame structure. See the "Vegetation and plant growth" section of this report.
2. We recommend carefully deconstructing all the blockwork and rebuilding the blockwork.

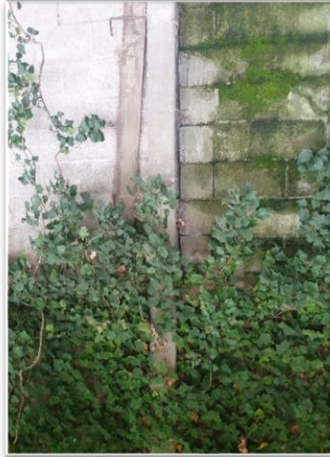
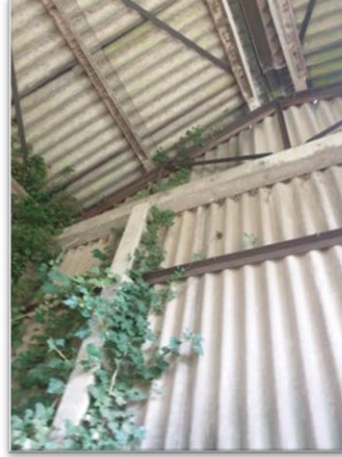
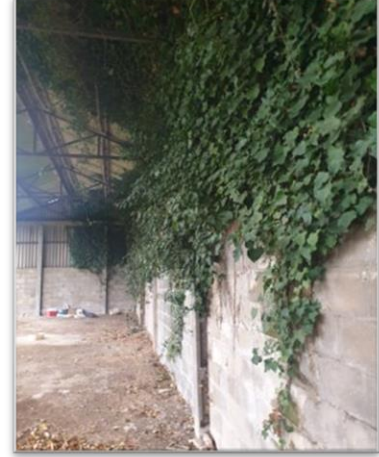
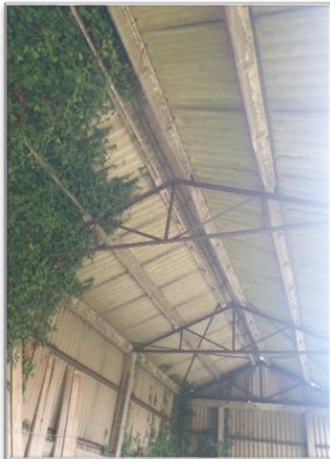
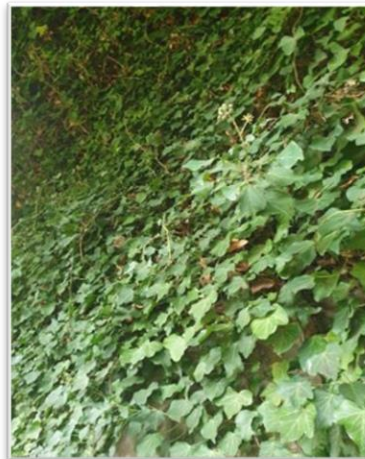
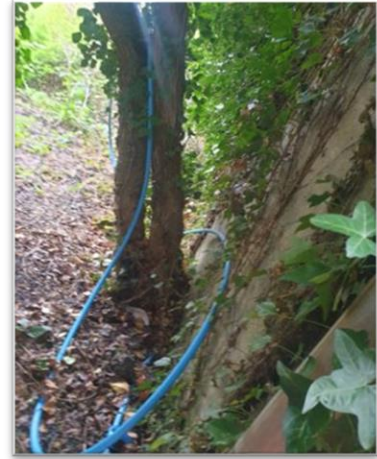
C. Vegetation and Plant growth

1. Excessive vegetation growth
2. Plant growth on the internal side of the wall
3. Presence of trees

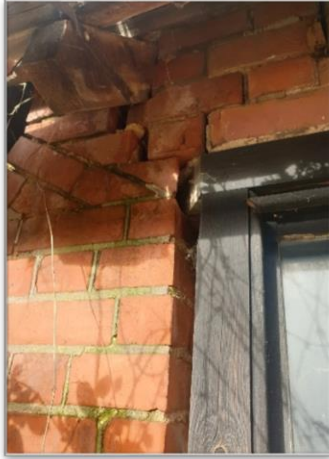
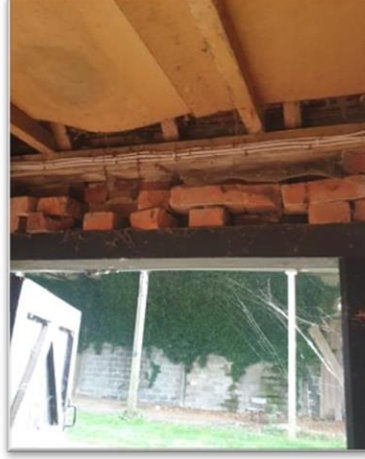
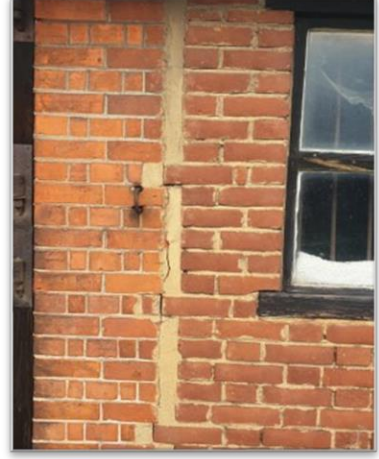
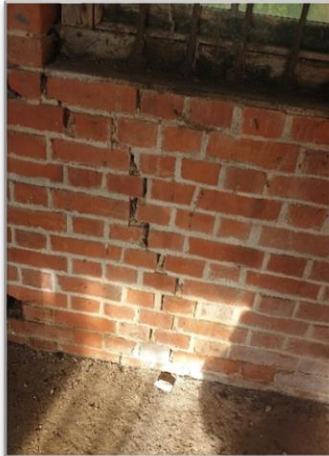
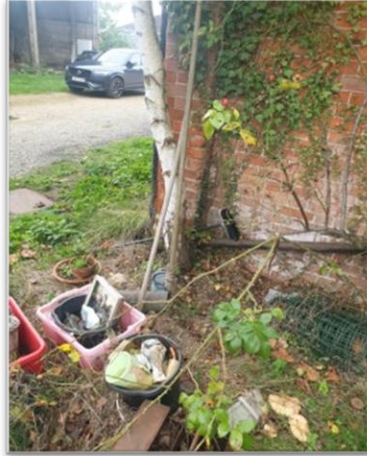
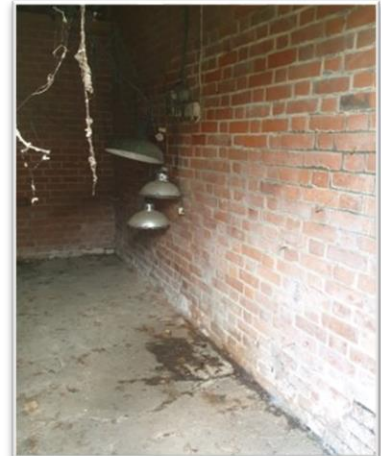
A. Defects with the masonry's walls

1. Presence of step cracking
2. Missing brick
3. Collapse section
4. Lintel failure
5. Water ingress
6. Poor connection between the main structure and the extensions
7. Blown mortar joints
8. Perishing mortar joints
9. Presence of tree growth
10. Crumbling brickwork
11. Cracking to the brickwork
12. Cracking below the window
13. Daylight through the walls

1. Age and weathering
2. Poor workmanship
3. Lack of maintenance
4. Defective/undersized lintel
5. Insufficient bearing length
6. Wall movement
7. Subsidence

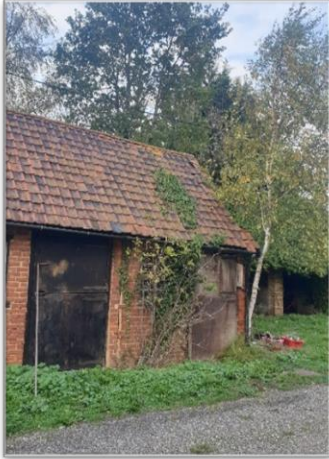
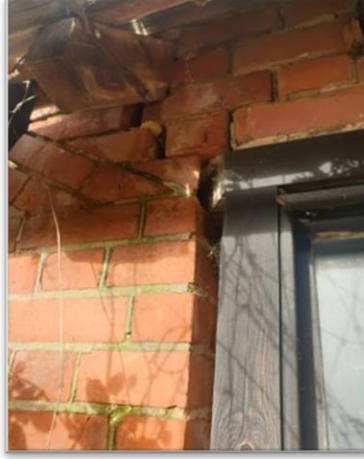
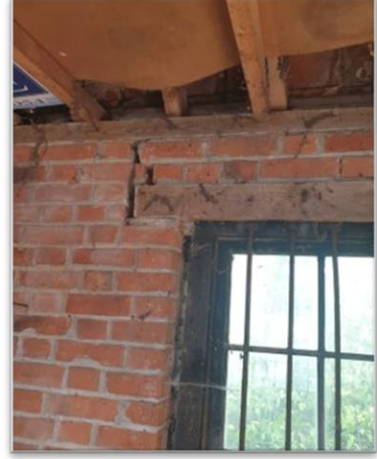
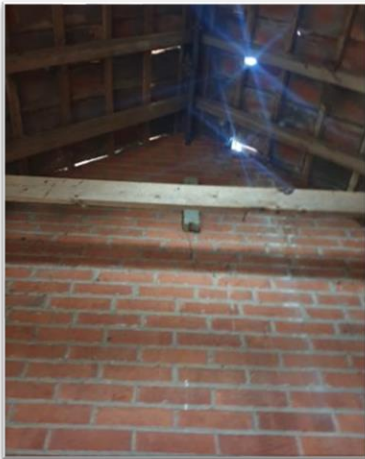
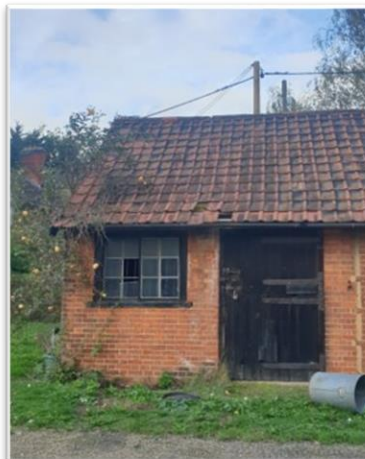
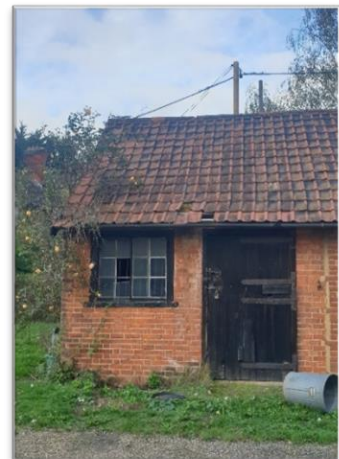
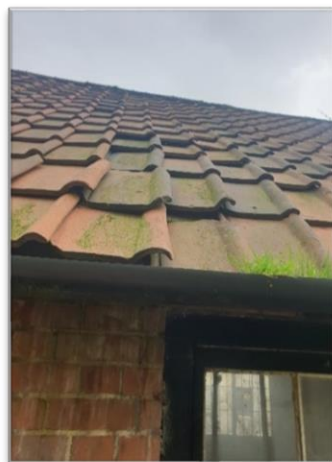
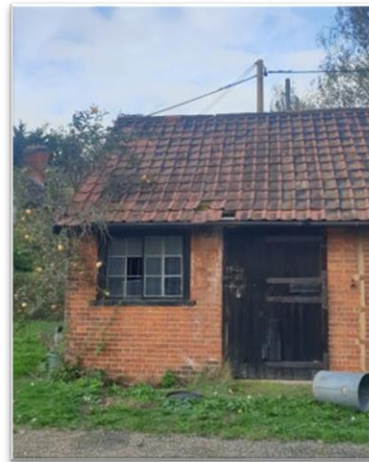
B. Defects with the masonry's roof structure

1. Presence of roof dishing

2. Missing roof tiles
3. Daylight through the roof
4. Presence of roof spread
5. Moss growth on roof tiles
6. Vegetation growth on the roof tiles
7. Presence of timber rot

We recommend carefully deconstructing the whole roof and having it rebuilt. The new roof needs to be designed by a structural engineer.

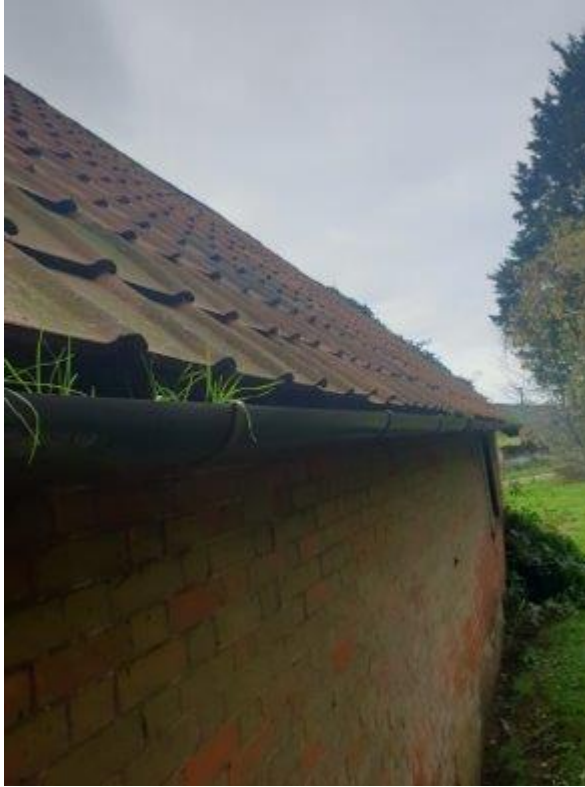
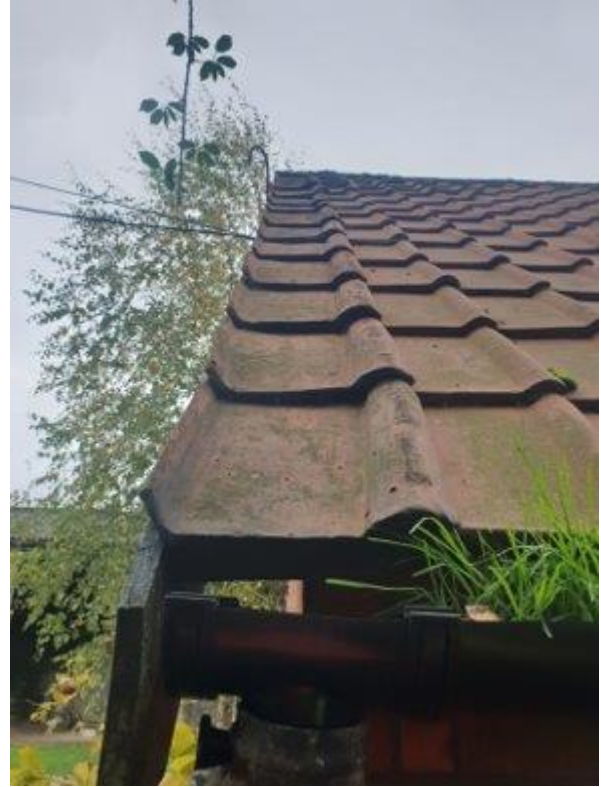
C. Defects with the gutter

1. Leaking roof gutter
2. Vegetation growth in the gutter
3. Cracking to the gutter

1. Lack of maintenance
2. Dirt or debris in the gutters
3. Loose connection
4. It appears that the gutter is not adequately receiving the rainwater from the roof
5. The gutter is not adequately slopped into the required downpipe
6. Lack of maintenance

6. Remove all vegetation and debris growth from the gutters.
7. We recommend replacing all defective gutters within the property.
8. The existing gutters or new gutters should be fitted in such a way that rainwater from the roof completely discharges into the gutter
9. We suggest immediate repairs to all defective gutter joints and fittings. For aesthetic purposes, existing gutters can be repainted.
10. We suggest regular maintenance of the gutters. If defective gutters are left long term it can lead to undermining of the foundations, dampness, and water ingress.

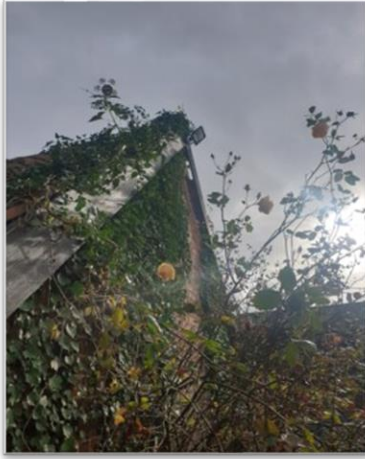
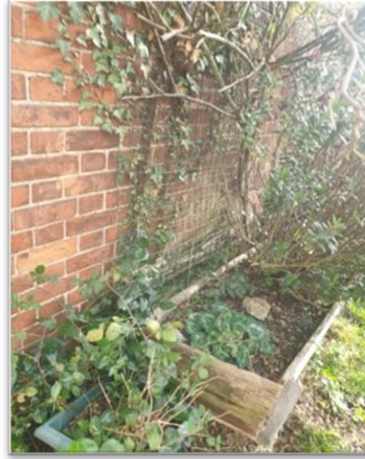
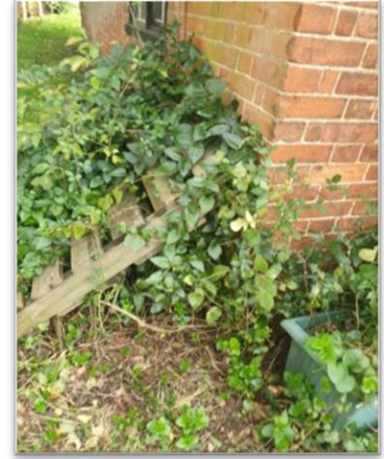
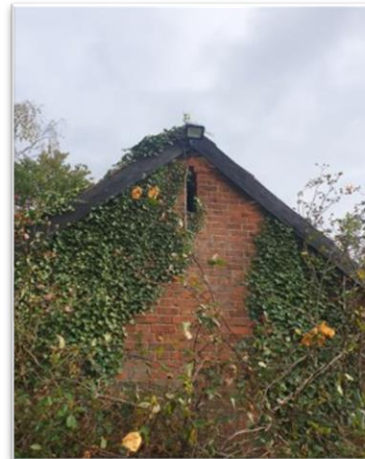
D. Vegetation and Plant growth

1. Excessive vegetation growth
2. Plant growth on the internal side of the wall
3. Presence of trees
