Hole Farm Woodland Creation Project

Asbestos Survey Report (November 2022)

Asbestos Survey Report 10/11/2022
Refurbishment Survey
Refurbishment Survey - Report Reference - FS28554

NS18241
Specified areas of 3 Farm Buildings in Hole Farm
3 Farm Buildings in Hole Farm, Brentwood

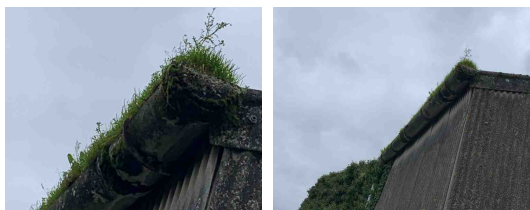
Location	Item
Item ID	007(VRS)
Sample Linked/ID	NS18241-002
Property Name	Specified areas of 3 Farm Buildings in Hole Farm
Area/floor	003 - Building 3 - Ground Floor
Room/location	004
Specific location	Other Rainwater goods
Product/debris type	Cement Product(s) Rainwater Good(s)
Asbestos type	Strongly Presumed Chrysotile
Extent	40 m
Licensed/non-licensed	N/A
Air Test	
Actions/recommendations	
Action/recommendations	Remove Remove ACM (Bonded) under PCC by FLC

Product Type (a)	1
Extent of Damage (b)	1
Surface Treatment (c)	1
Asbestos Fibre (d)	1
Total (a+b+c+d)	04
