# A47 DUALLING – NORTH TUDDENHAM TO EASTON

APPENDIX 4 to  
STATEMENT OF [REDACTED] of the Berry Hall Estate

# BERRY HALL ESTATE NORFOLK

### **ESTATE BUILDINGS REPORT**

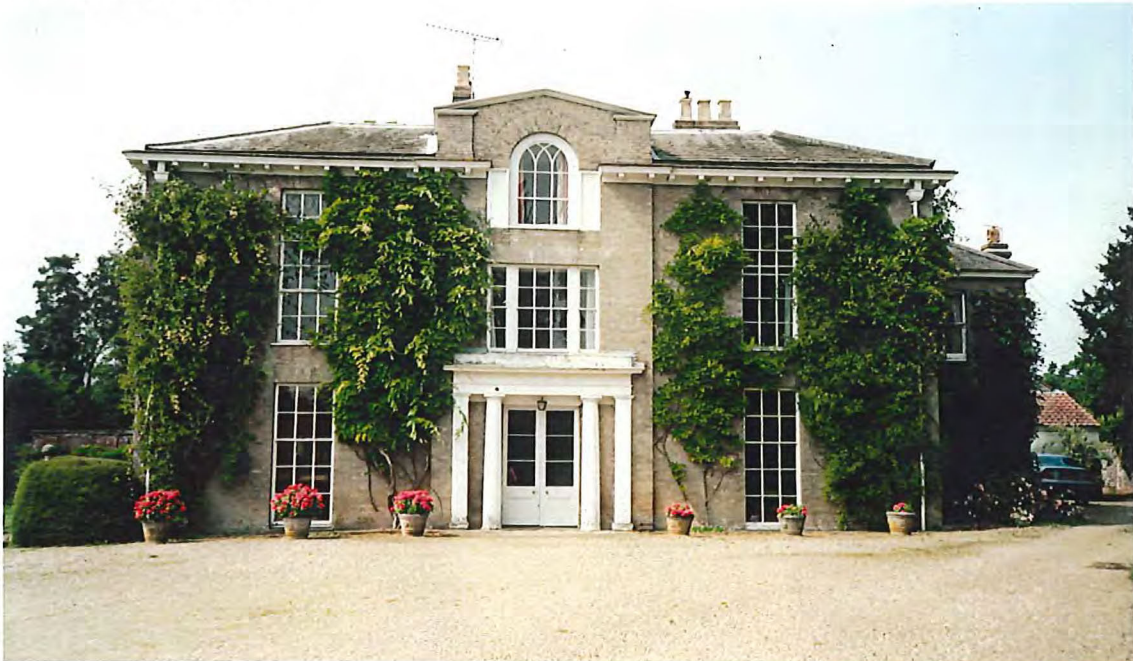
East elevation of Berry Hall

**CONDITION** Generally good

The cornice gutter requires urgent repair as the asphalt is cracked and there are indications of water ingress which may lead to serious timber decay along the wall tops. All crack and open joints in the brick work should be repointed including minor repairs to the chimney stacks. The rainwater goods that are rusting should be redecorated and those that are cracked replaced, and the joinery throughout redecorated and repaired where necessary. The drains on the west side of the house ought to be investigated as they may be contributing to the rising damp in the west wall.

**WORKS** From the external inspection, where access was gained onto the north roofs and up to the south cornice gutter, the fabric is generally good although the following items require attention during the forthcoming quinquennium.

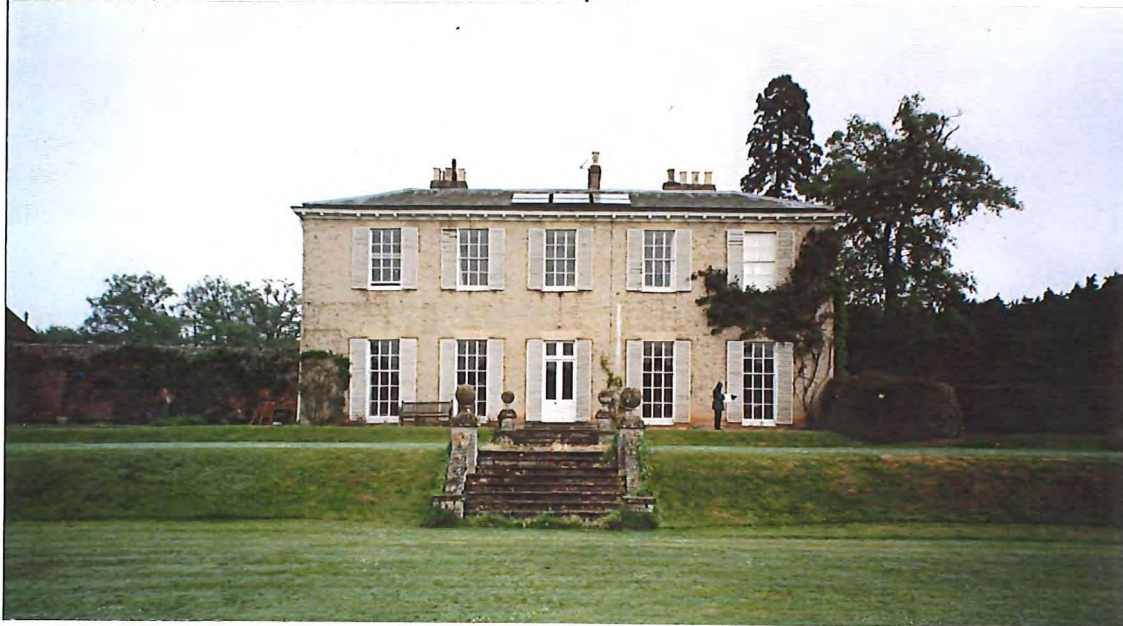
South elevation of Berry Hall

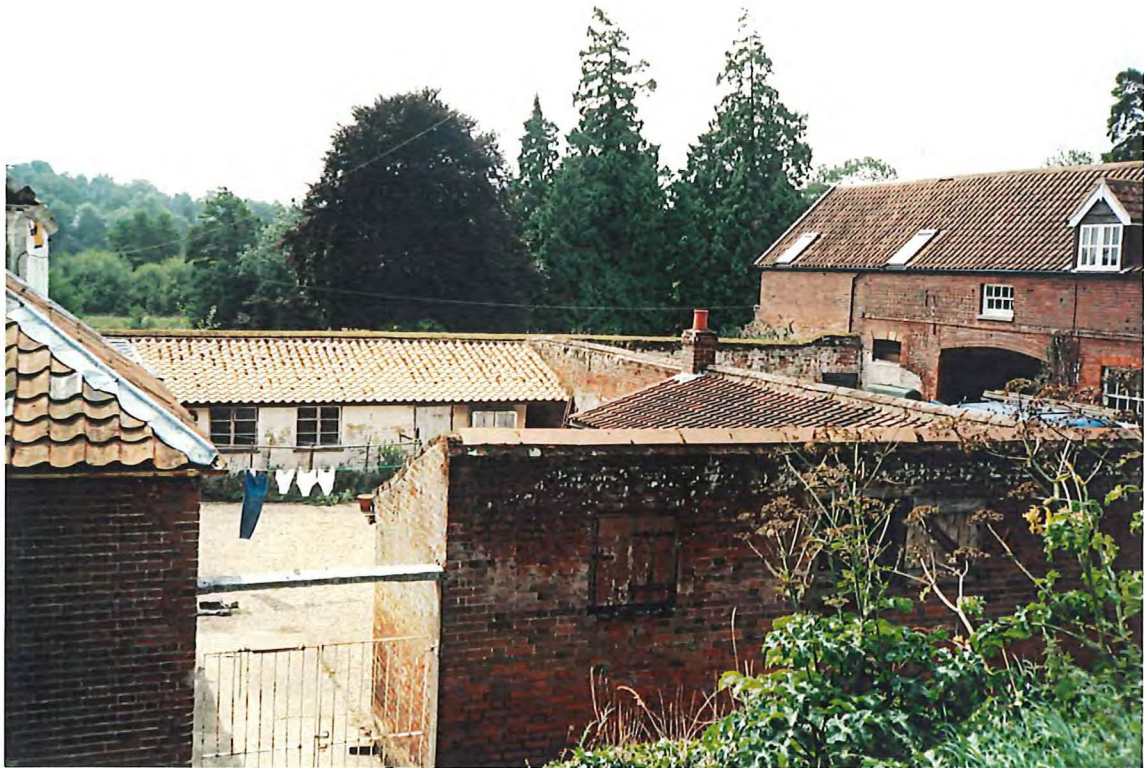
**CONDITION** Generally good

The Log Store in the foreground with the garden shed across the courtyard

**WORKS REQUIRED** This range of buildings is generally in good order apart from some minor repairs to the brickwork and joinery.

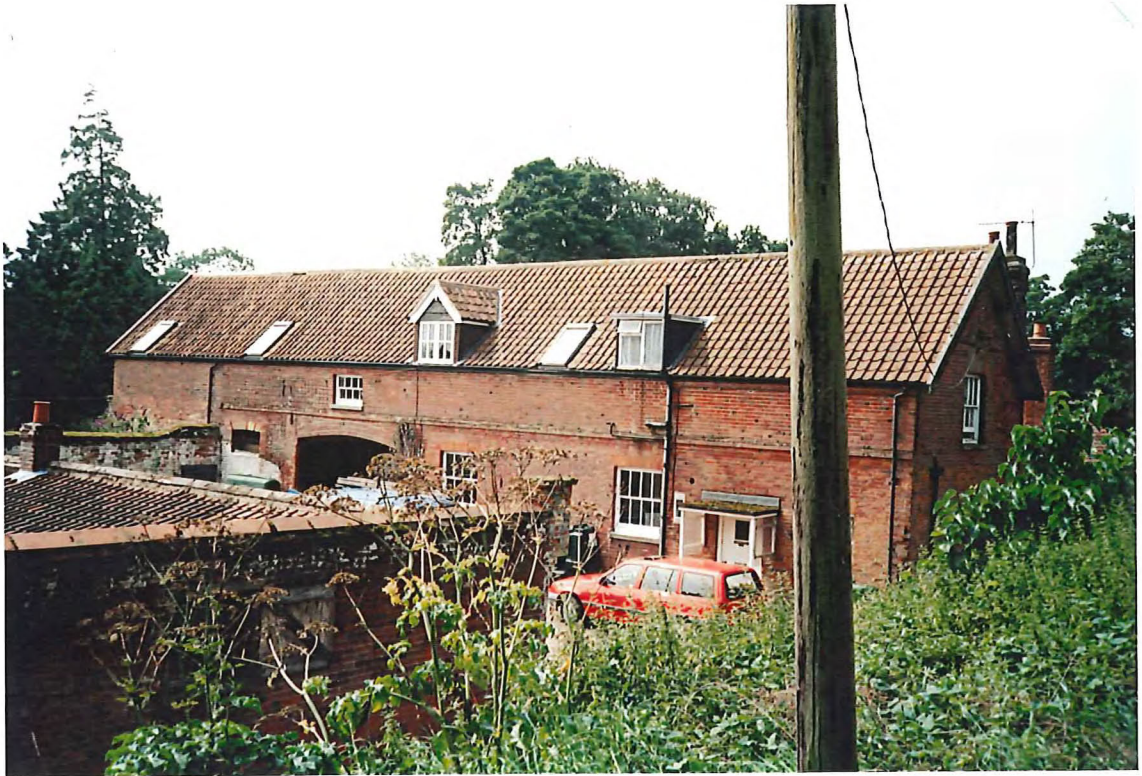
The east elevation Stables with Rosemary Cottage to the right seen from the north east

**WORKS REQUIRED** This is currently undergoing conversion and appears to be generally sound. However, minor brick work repairs ought to be carried out, joinery painted and rusting rainwater goods redecorated.

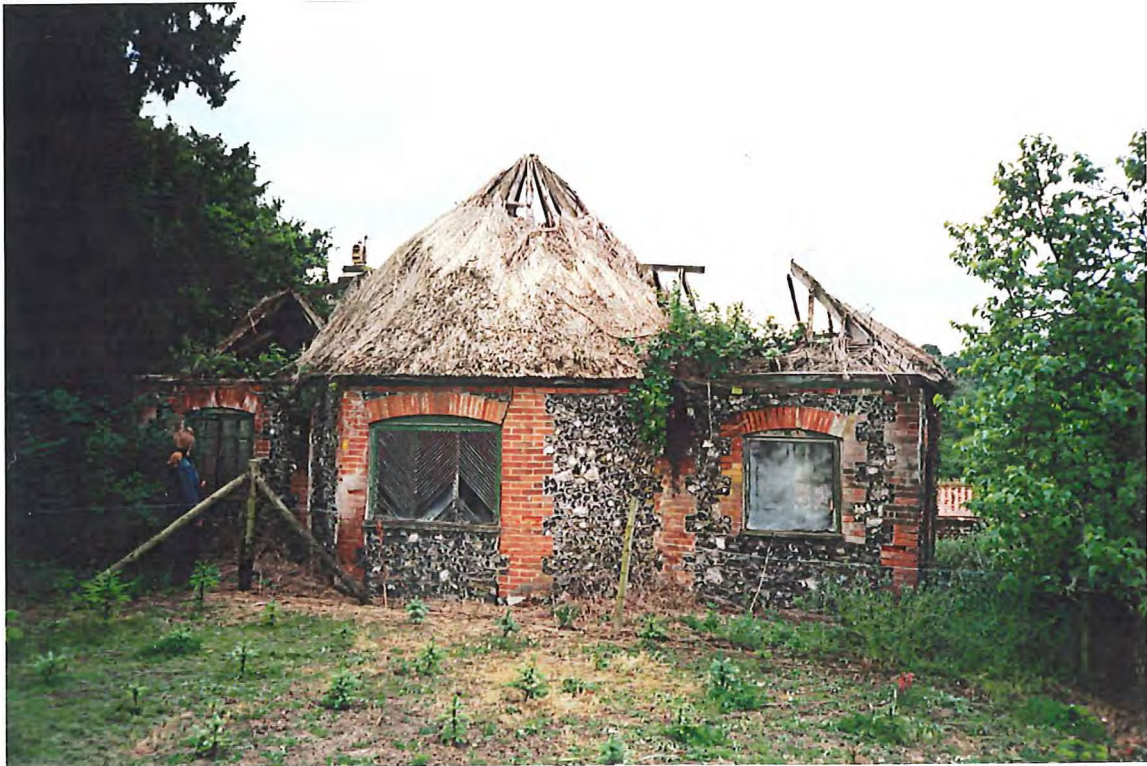
**CONDITION** Poor

**WORKS REQUIRED** This building is in a very poor state of repair. The thatch has deteriorated, parts of the ceilings have collapsed, vegetation is growing on the wall tops and cracks have developed through the walls. A temporary roof covering ought to be placed over the building immediately and temporary shoring put in place. Vegetation on and around the walls should be killed and removed. In the longer term, the roof should be repaired and rethatched, the walls consolidated, including the stitching of cracks, floors cleared and internal walls and ceilings repaired together with all joinery.

The Old Dairy seen from the north

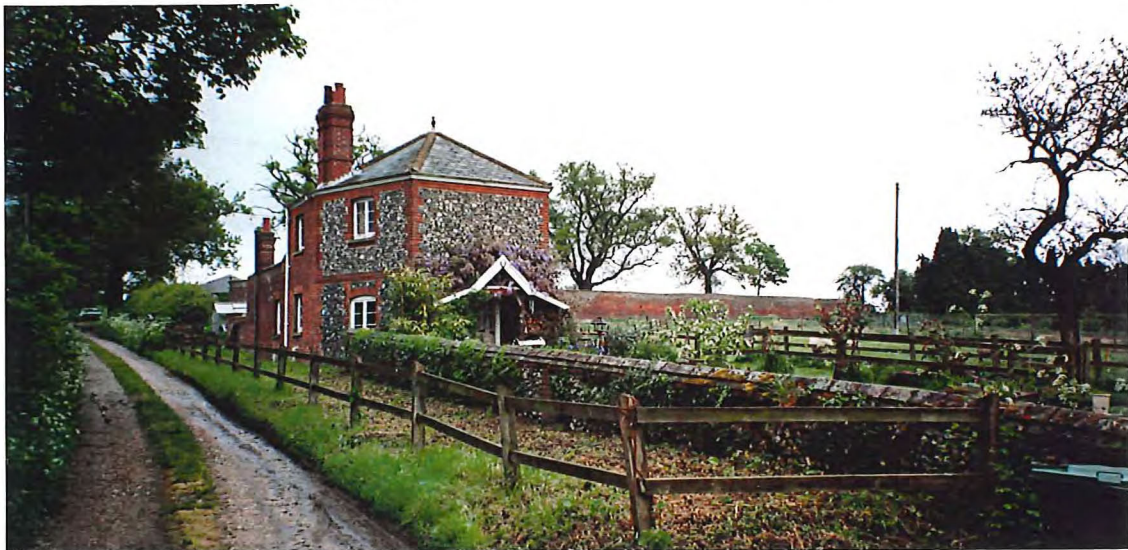
**CONDITION** Generally in good order

Wisteria Cottage seen from the south west

**WORKS REQUIRED** Minor repairs are necessary to the roof and gutters and the open joints to the brickwork on the chimney stacks, and cracks through the south stack, ought to be repaired. Minor repairs are necessary to the joinery which requires redecoration and further minor repairs are necessary to the brickwork of the garden wall to the cottage.

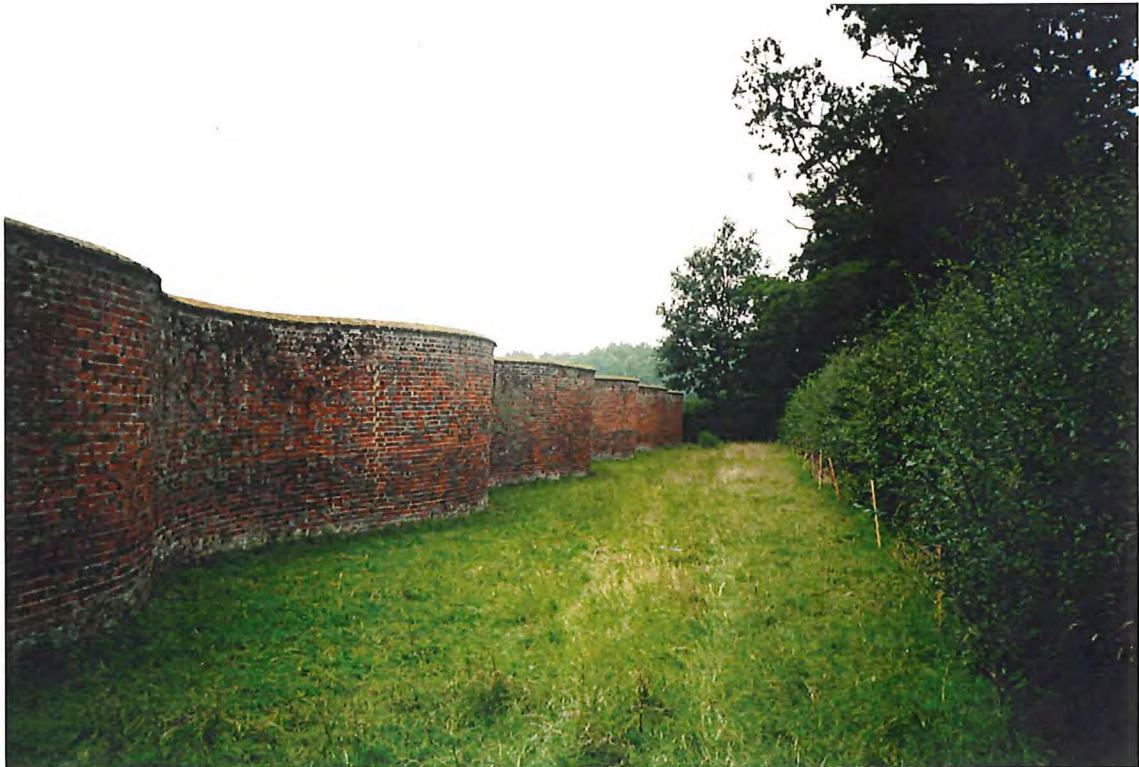
**CONDITION** Fair

The north wall of the kitchen garden seen from the north east

**WORKS REQUIRED** This is generally in good repair although there are some bricks on the wall tops that ought to be rebedded, minor repointing repairs need to be undertaken including the pointing of cracks, and the rebedding of loose bricks, above the west door. At the east end of the north wall the broken hinge on the door ought to be repaired and the crack above the door pointed. Rodents in this area appear to be undermining the wall where there has been some structural movement. Vegetation against the wall ought to be cleared and this activity deterred.

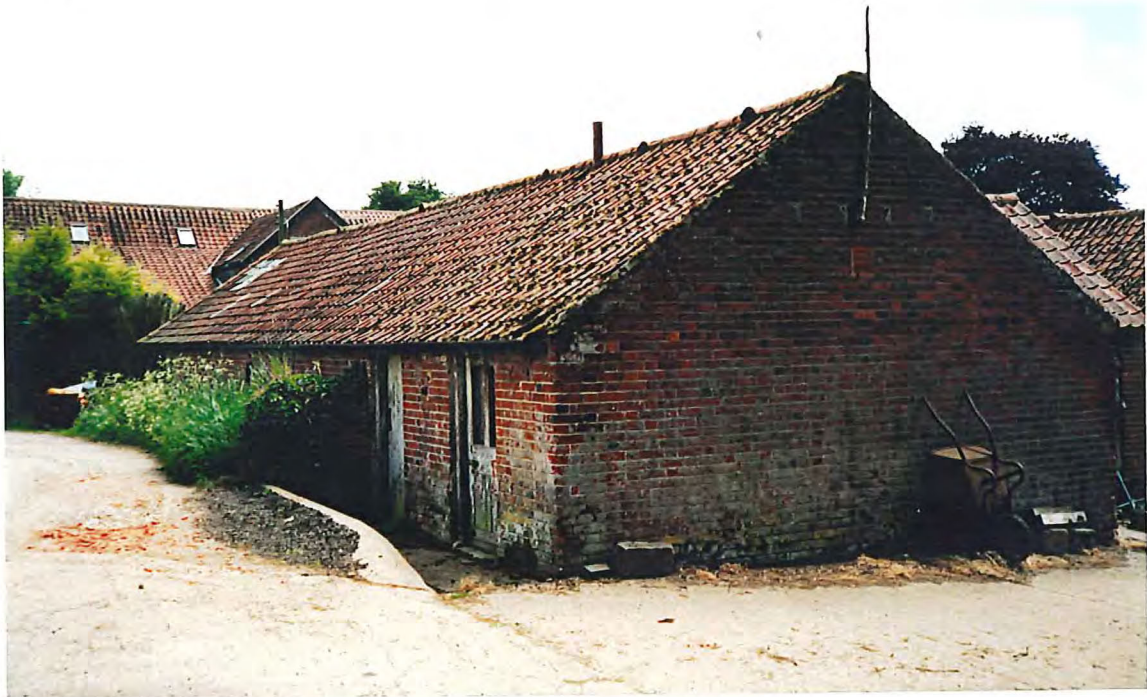
The north and west elevations of range B seen from the north west

Building B - Urgent repairs are necessary to the roof to remove moss, replace dislodged and broken tiles, rebed loose verge tiles and repoint ridge tiles. Minor repairs might be carried out to the brickwork including the removal of ivy. Rainwater goods should also be regularly be cleaned out. The roof to the garden shed, at the east end, requires repair and the brickwork on the east gable, and at low level requires attention.

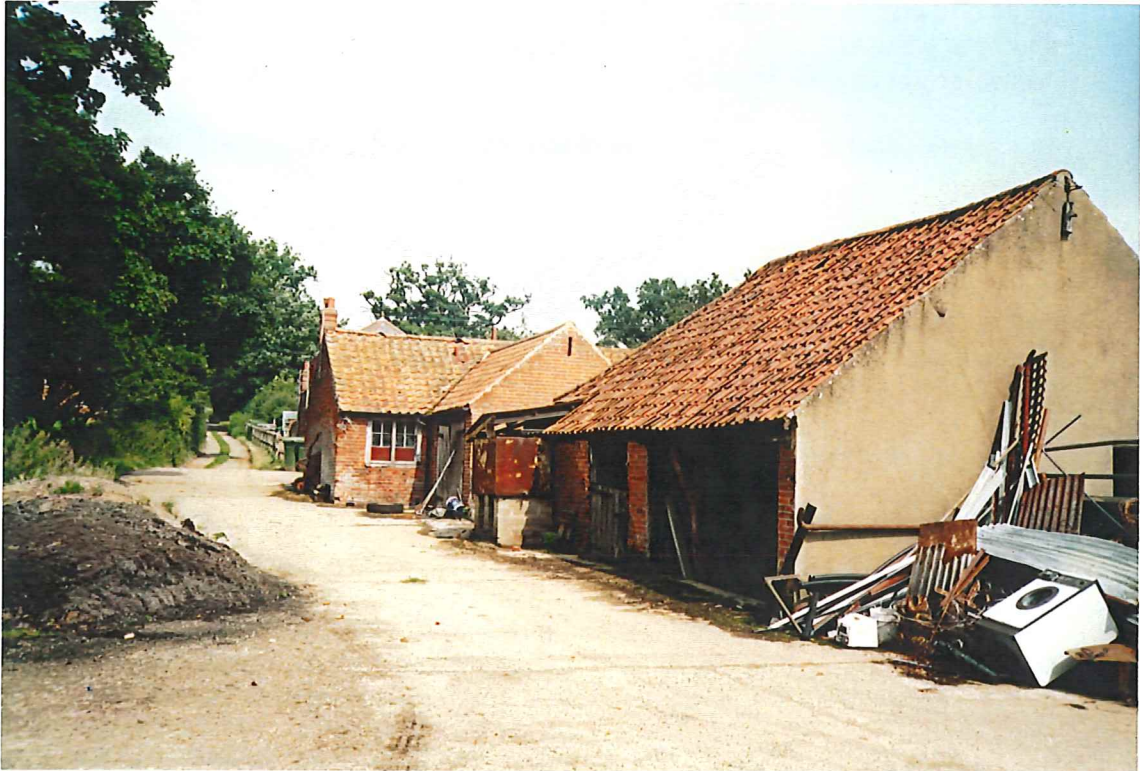
Range D seen from the south west with range A and B in the background

Building D - Urgent repairs are necessary to the north east hip and when this work is carried out rainwater collection at eaves level ought to be improved. The south east hip also requires urgent attention including the adjacent valley gutter. Moss on the roof slope should be cleared and all broken, decayed and dislodged pantiles replaced. All areas of timber decay beneath the defective roof coverings should be repaired. Minor repairs are necessary to the brickwork including the pointing of open

joints and cracks and the rebedding of loose bricks. The loose timber frame to the southern window should be propped and floors thoroughly cleaned out and all rainwater goods should be regularly cleared and repaired as necessary.

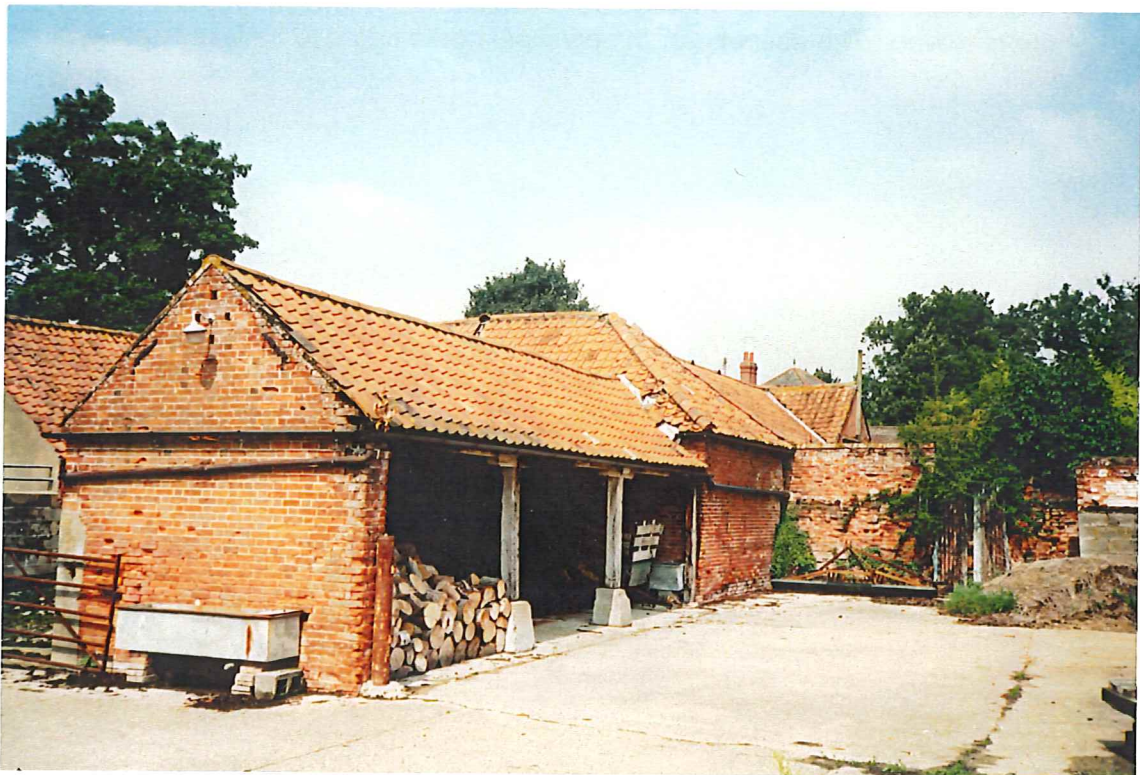
Range E seen from the south east

Building E - Loose ridge tiles ought to be rebedded and missing verge tiles replaced. The valley leadwork ought to be inspected for any faults and the deteriorating southern rafter replaced if necessary when reinstating missing tiles. Repairs are necessary to the brickwork on the south east and south west corners. The small sycamore sapling should be removed.

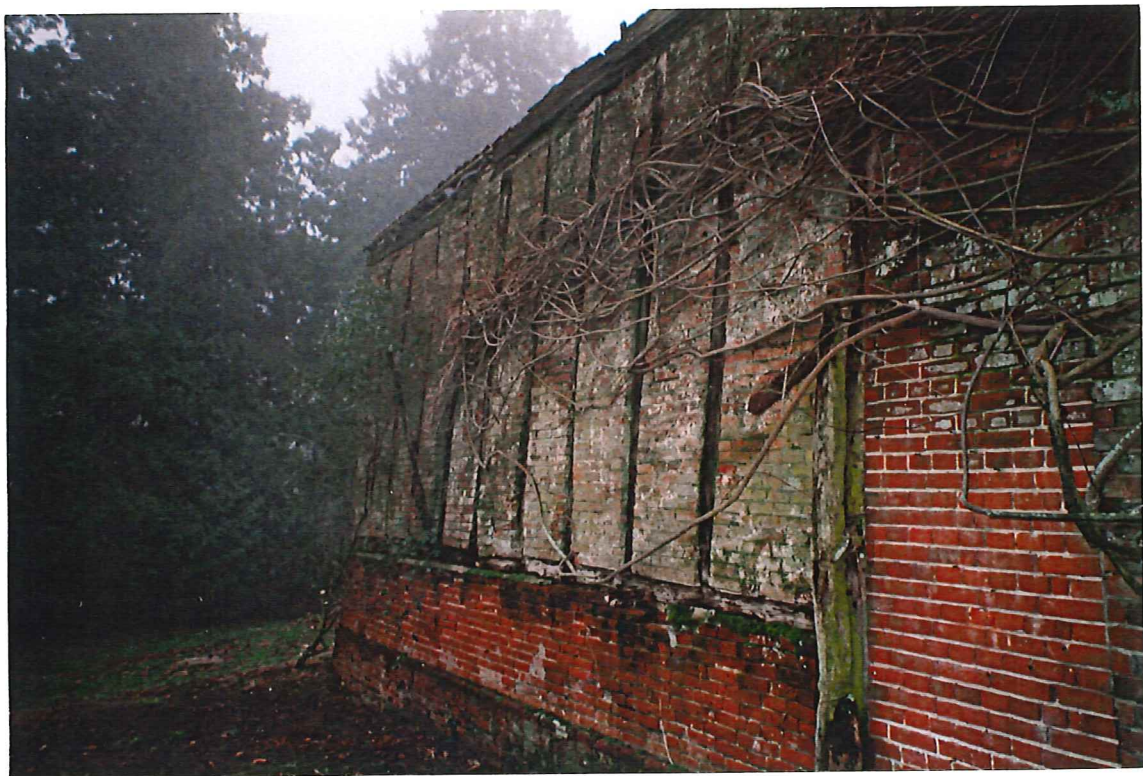
The east elevation of range G showing the timber framing and brick panels

Building G - Repairs are necessary to the timber framed east wall which ought to include protecting the wall plate at high level, securing loose panels of brickwork and rebedding loose bricks and stitching cracks. Broken and laminating tiles should be replaced, loose tiles rebedded and moss removed from the whole roof slope. Protection is required to the rafter feet that are suffering from water ingress and the missing barge boards and capping to the south gable ought to be reinstated.

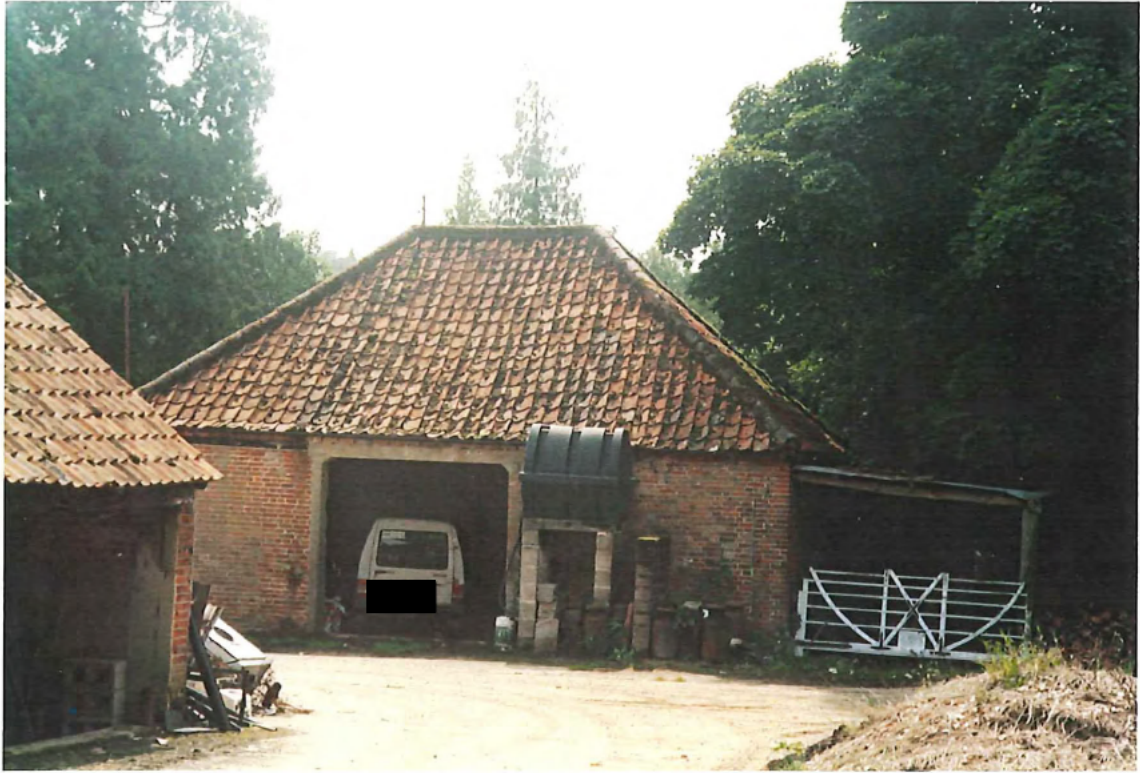
North elevation of range H

Building H - Areas of uneven, missing and broken tiles ought to be replaced and moss should be removed. Minor repointing repairs are necessary to the ridge. In the long term consideration might be given to improving the detail along the eaves.

Cracks through the walls ought to be pointed and some minor repairs carried out to the brickwork. The east end of the principal beam ought to be inspected within the wall.

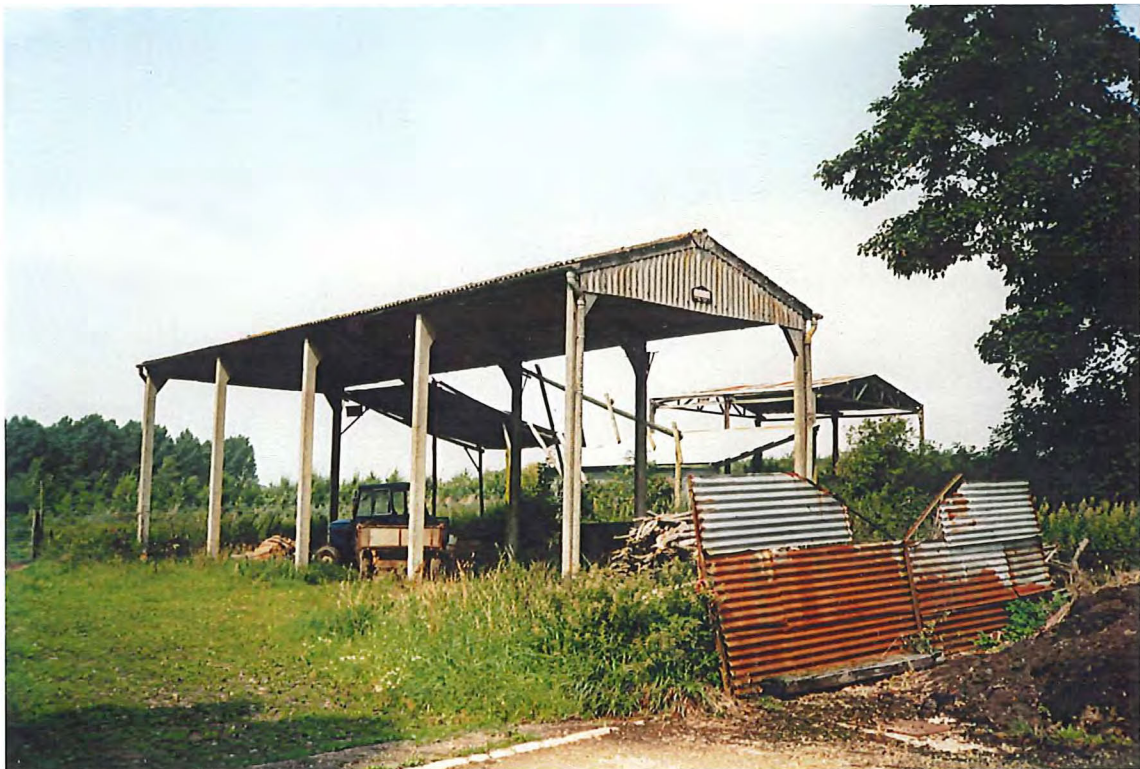
**CONDITION** Fair

The Dutch Barns seen from the south east

**WORKS REQUIRED** Repair lean to on Agrecon barn or take structure down. Remove vegetation from vicinity of barns and ensure adequate drainage. Remove metal sheeting.

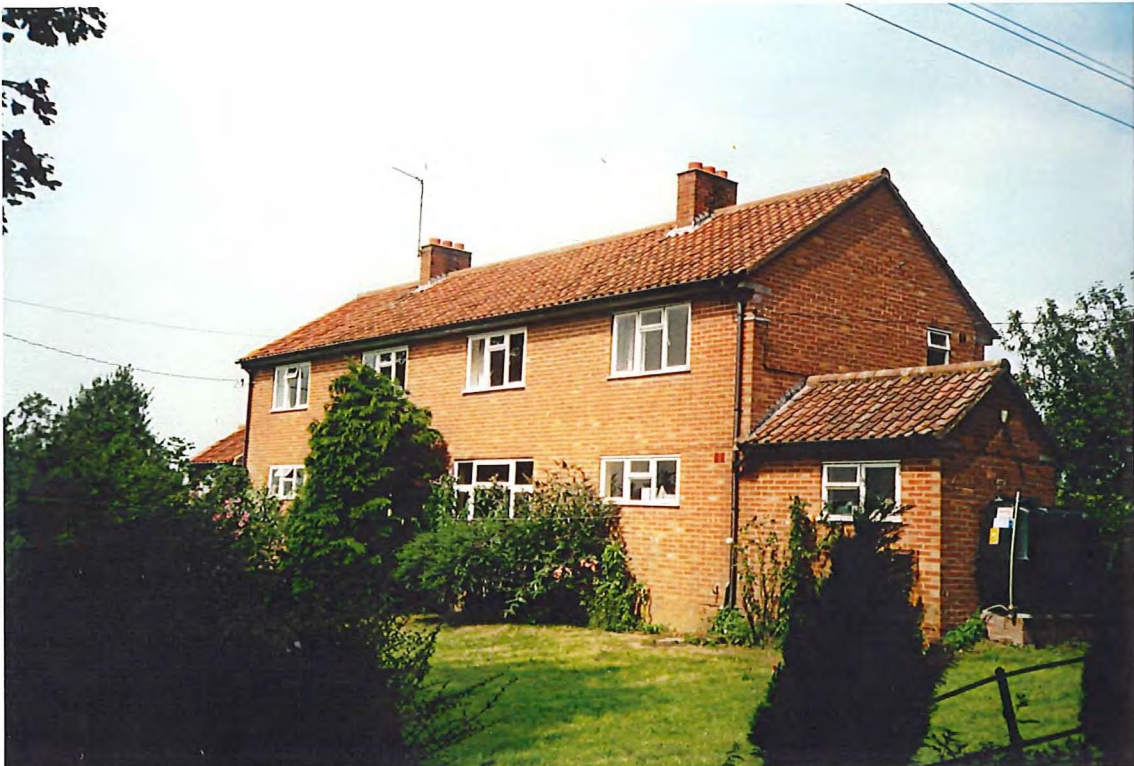
**CONDITION** Good

The semi-detached cottages seen from the south east

**WORKS REQUIRED** Minor repointing is necessary to the verge mortar on the outbuilding to the east. Redecoration of the external woodwork will be required within the next 5 years.

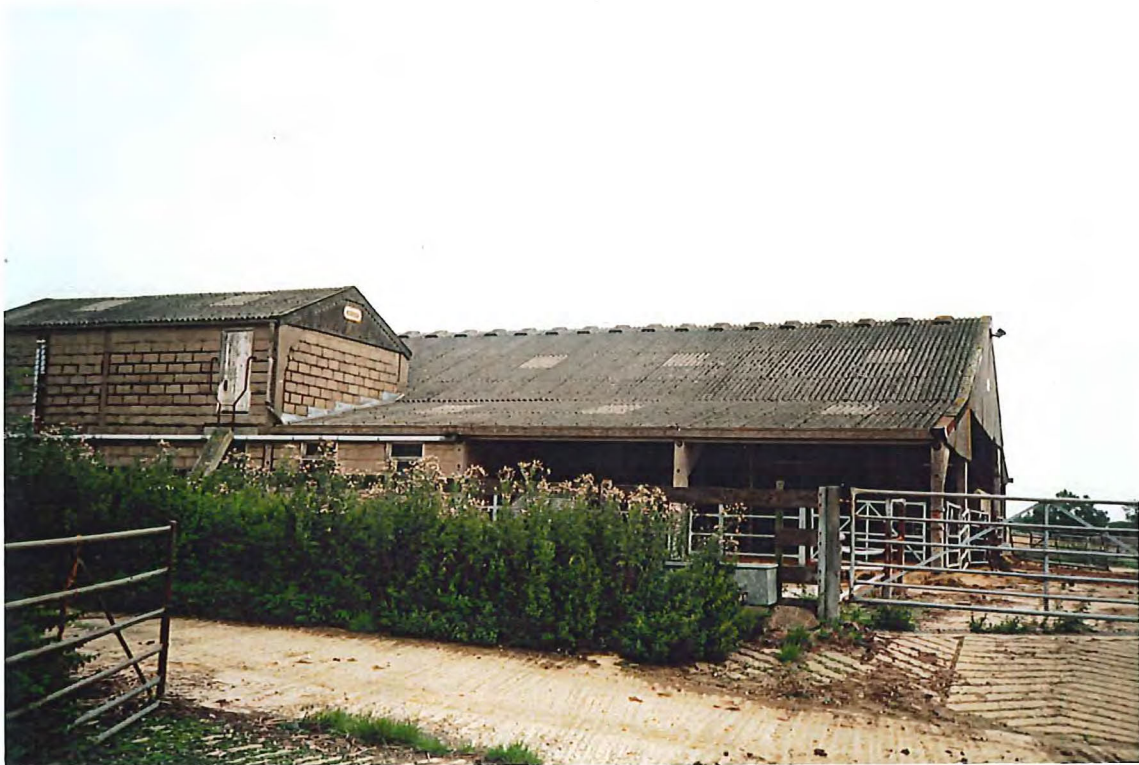
**CONDITION** Fair

The agricultural buildings seen from the track to the west

**WORKS REQUIRED** Minor repairs/replacement of sheeting required. Minor repairs to guttering also needed.

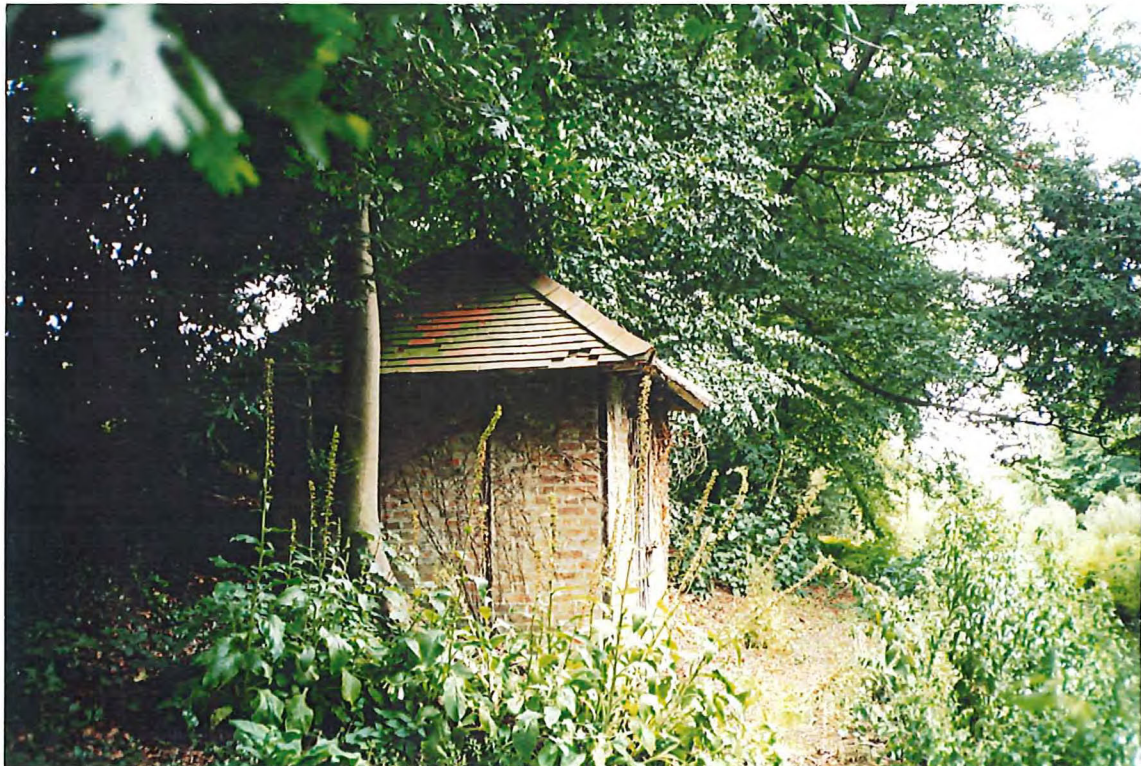
**CONDITION** Fair to poor

The Pump House seen from the west

**WORKS REQUIRED** Replace missing, dislodged or slipped tiles on the roof. Remove vegetation from walls and roof space. Improve drainage on north side of the building. Carry out repointing to walls, replacing brickwork as necessary.

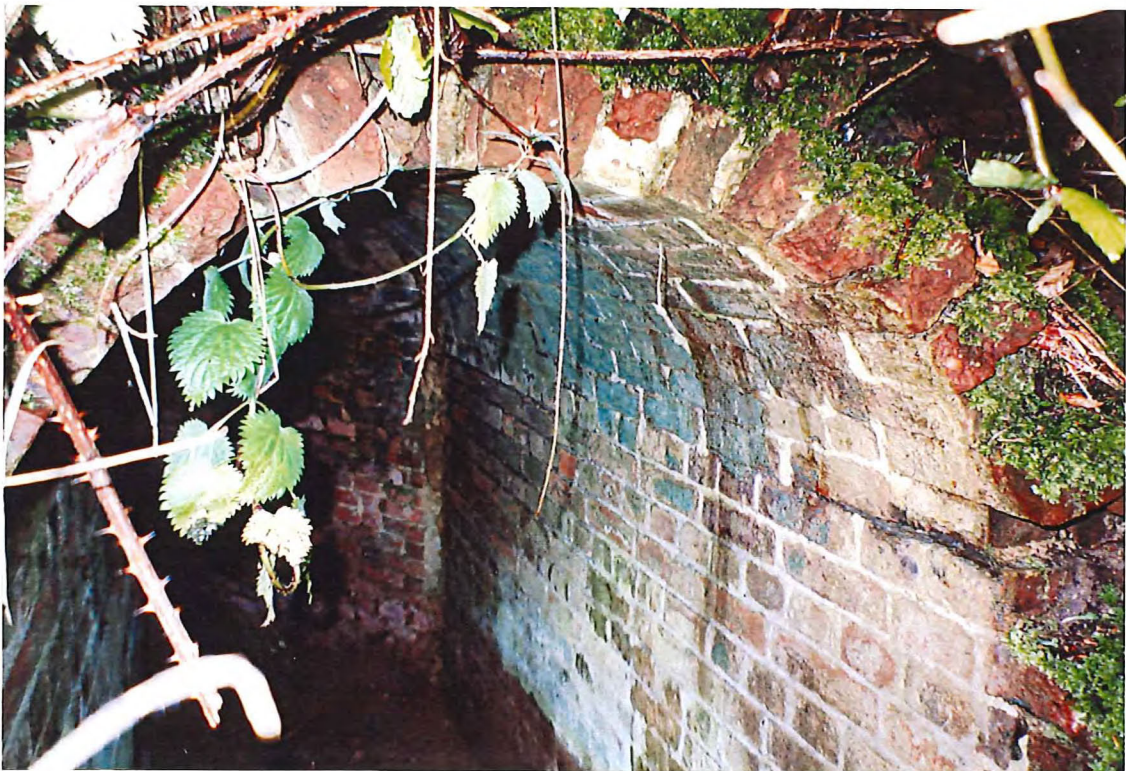
**CONDITION** Generally good

Entrance arch to Icehouse

**WORKS REQUIRED** This is generally in good order although the trees above and adjacent to the structure ought to be removed and the brickwork around the entrance consolidated.
