A47 North Tuddenham to Easton Dualling

Scheme Number: TR010038

Volume 9 **9.17 Stage 1 Road Safety Audit** **Designer's Response**

STAGE 1 ROAD SAFETY AUDIT DESIGNER'S RESPONSE

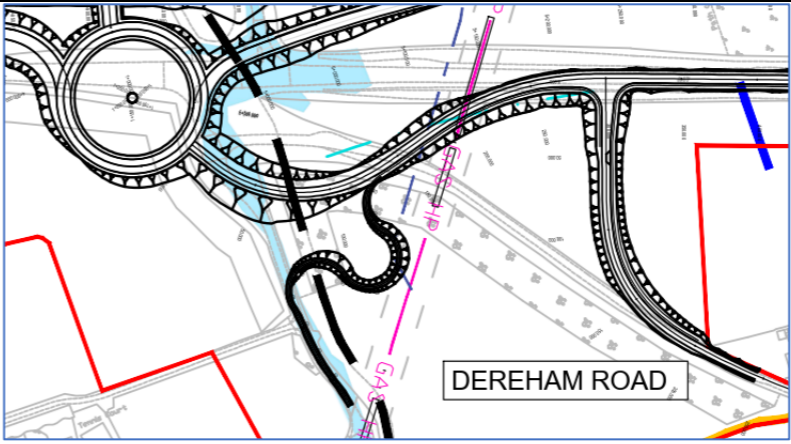
<p>DEREHAM ROAD</p> <p>Refer to HE551489-GTY-HOS-000-RP-ZS-30004 for the Safety Risk Assessment in accordance with GG 104.</p>		
5	<p>Location: Norwich Road Junction, north and south roundabouts (drawing HE551489-GTY-HML-000-DR-CH-30010-P03)</p> <p>Summary: Multiple conflict points in close proximity and lack of weaving lengths at roundabouts.</p> <p>Description: As with the Wood Lane junction, the north and south roundabouts at the Norwich Road junction do not appear to have yet been designed with adequate entry and exit flaring and deflection on the arms. When designed fully, the resulting design will likely have very little, if any, weaving length between arms. This coupled with the proposed number of arms (5 at each roundabout) will mean there will be five conflict points within close proximity to one another. Drivers entering the roundabout will potentially be in conflict with vehicles leaving the roundabout at the next arm, leading to side-swipe collisions.</p>	<p>Enlarge the inscribed circle diameters of the roundabouts in order to increase the distance between arms and therefore the circulatory weaving lengths. Increased roundabout diameters allow better positioning of traffic signs, which will aid driver safety. It may also be beneficial to re-site the roundabouts further away from the mainline to allow better alignment of the arms into the roundabout</p>	<p>The Designer disagrees with this RSA problem and recommendation. Whilst the entry and exit flaring has not been fully detailed on the roundabout layouts, an allowance has been made for them in the positioning of the arms on the roundabout such that there won't be a conflict with vehicles entering as other vehicles manoeuvre to exit the roundabout.</p> <p>ARCADY assessments have been run for each roundabout layout and all confirm that the RFC value and queuing are all within the necessary thresholds.</p> <p>The number of arms at the northern roundabout has been reduced following the removal of the link to Church Lane (Easton) (north east arm on the roundabout) from the Works. The screenshot below demonstrates the change in layout.</p>

<p>Refer to HE551489-GTY-HOS-000-RP-ZS-30005 for the Safety Risk Assessment in accordance with GG 104.</p>	<p>I am content with the level of assessment at present however, will need to be revisited in the RSA stage 2. It is important that assessments at this stage are robust enough such that the level of change at a later date does not significantly modify the junction arrangements as it will impact the DCO submission and may warrant a material change. I do note the reduction in arms following the link removal which may reduce the severity of this RSA problem. As per initial comments I would expect future assessments to consider roundabout forms such as number of lanes and / or type (e.g. spiral).</p>	<p>Roundabout entry and exit flaring, and associated road markings, to be fully developed at Stage 5. This issue shall then be reviewed again during the Stage 2 RSA.</p>

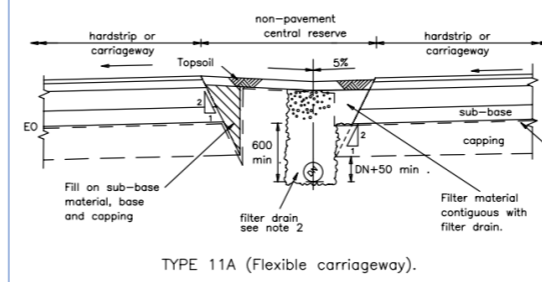
<p>TYPE 11A (Flexible carriageway).</p> <p>Highway Construction Detail B5, Type 11A (Flexible carriageway)</p>

21	<p>Location: Mainline, past Hockering and through Norwich Road junction.</p> <p>Summary: Overgrown grass leads to lack of forward visibility.</p> <p>Description: A wide central reserve is proposed along two sections of the new mainline, on the section past Hockering, and on the section through the Norwich Road junction. If these central reserves are grassed this could lead to forward visibility issues, which in turn could result in shunt or side-swipe collisions.</p>	<p>Provide paved central reserves to ensure forward visibility can be easily maintained through the life of the scheme.</p>	<p>The Designer disagrees with this RSA problem and recommendation.</p> <p>Following a review of the standards and the associated risks and opportunities associated with a paved or unpaved central reserve construction the Designer considers an unpaved central reserve construction to offer a better solution.</p> <p>An unpaved central reserve offers improved environmental mitigation as well as advantages with respect to surface runoff and downstream attenuation. It also has a significantly better carbon impact compared to a hardened alternative.</p> <p>The Designer proposes to have an unpaved central reserve in line with Highway Construction Detail B5 (see figure below) with measures taken to limit vegetation growth. Another option would be to provide a detail in line with Highway Construction Detail B15 (see second figure below) which would further serve to reduce the vegetation growth in the central reserve and prevent an obstruction to forward visibility.</p>
