# A428 Black Cat to Caxton Gibbet improvements

## 9.18 Brook Cottages Technical Note

**9.18 Brook Cottages Technical Note**

<b>Regulation Reference:</b>	Rule 8(1)(k)
<b>Planning Inspectorate Scheme Reference</b>	TR010044
<b>Application Document Reference</b>	TR010044/EXAM/9.18
<b>Author</b>	A428 Black Cat to Caxton Gibbet Improvements Project Team, Highways England

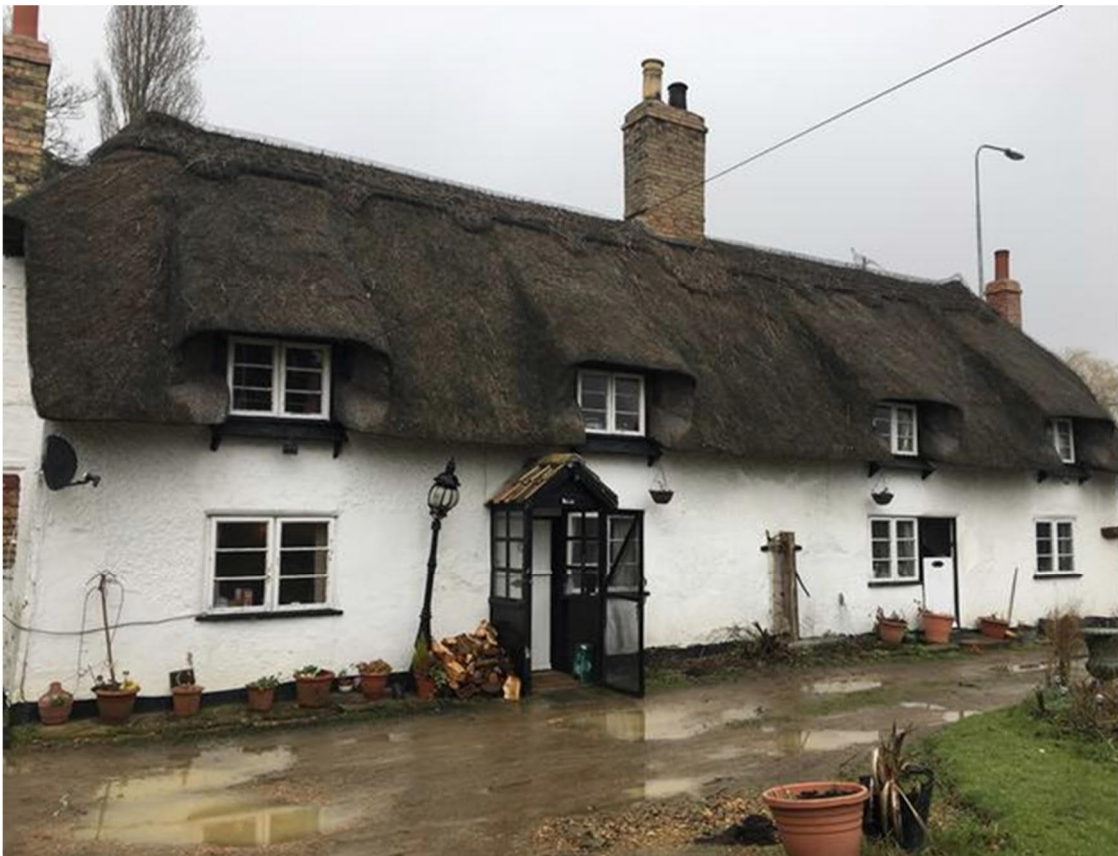
1

- 3.1.3 The south façade contains two entrance doors, both of 20<sup>th</sup> century plank wood construction in stable door style (Plate 1). The entrance door to No.2 has a 20<sup>th</sup> century pantile gabled porch. Each door is off-centre, providing access directly into a room rather than an entrance hall. Within No.2 there is evidence in the external render for a blocked doorway adjacent to the west window, supporting the evidence that this was originally two dwellings (Plate 2). No such evidence is present to No.1. Each cottage has two windows to each floor. These are early 20<sup>th</sup> century 6-light wooden casements. These windows are repeated at first floor as eaves (‘eyebrow’) windows (i.e. sitting on the top of the wall). Under each window is a sloping sill board.

South façade with No.1 to the east and No.2 to the west

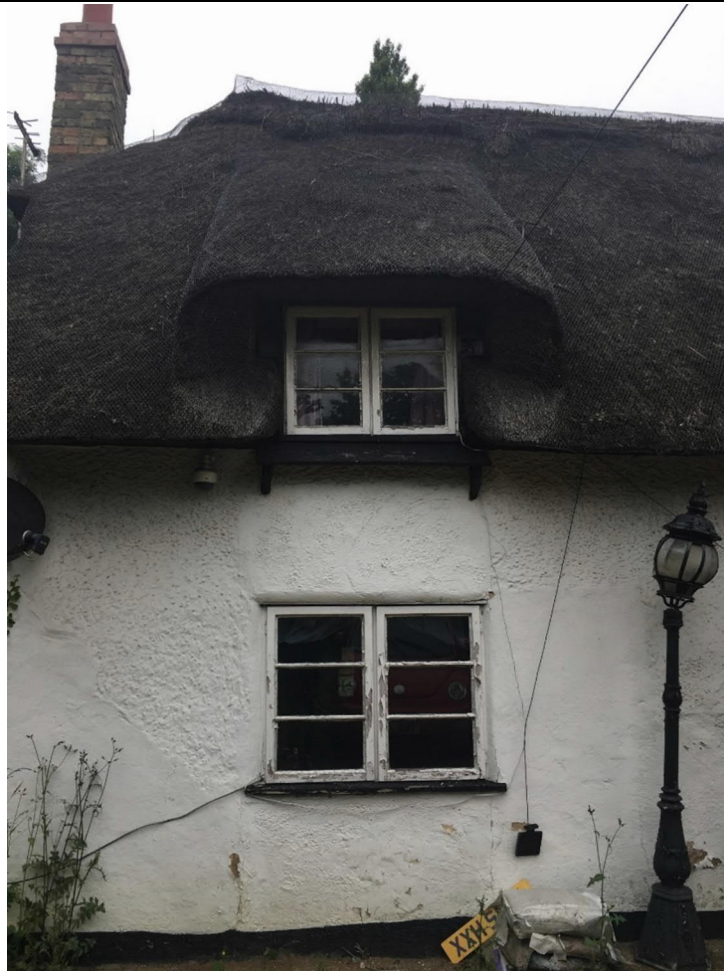
- 
- 2 Western bay of south façade showing window arrangement. To the right of the window is evidence for a former entrance door suggesting this was once two dwellings.

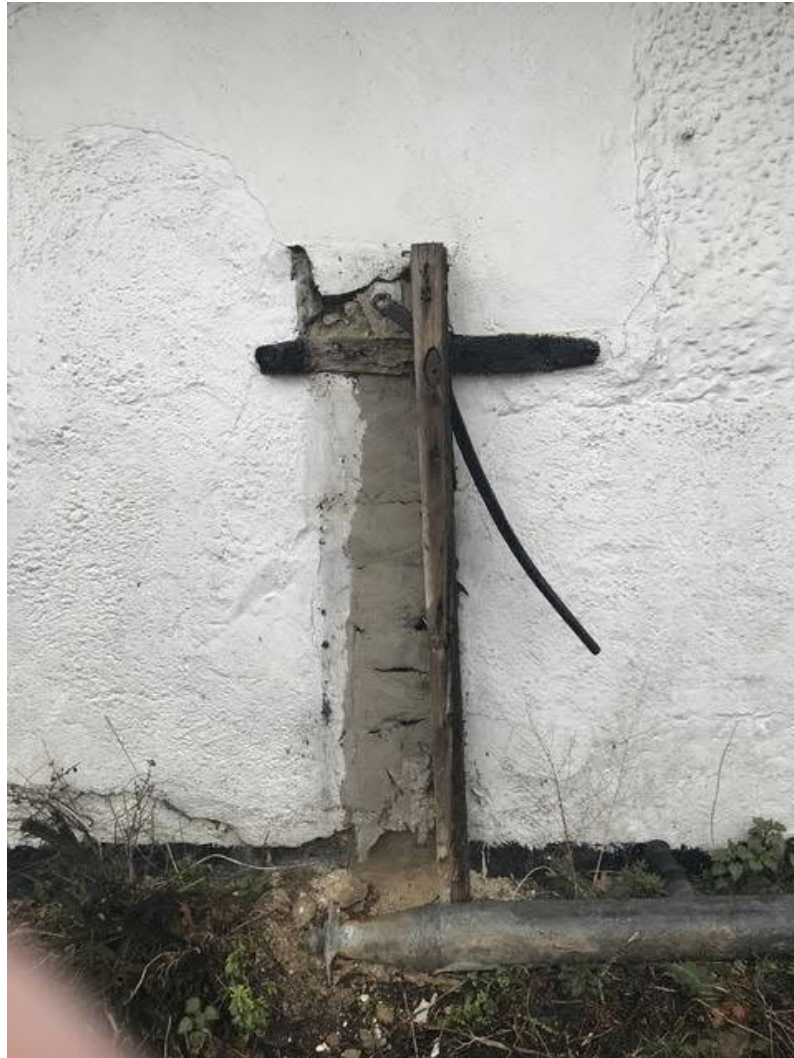
- 3.1.4 Also notable on the south elevation are the remains of a centrally placed water pump (Plates 3 and 4). Some cement repair has been made where the pump has been removed from the wall; however, a small patch of lost render above reveals part of the timber frame with evidence for lath and daub infill present. It also shows the use of nails to fix the horizontal rail to the upright.

3 Remains of water pump attached to south façade. Area of cement repair below.

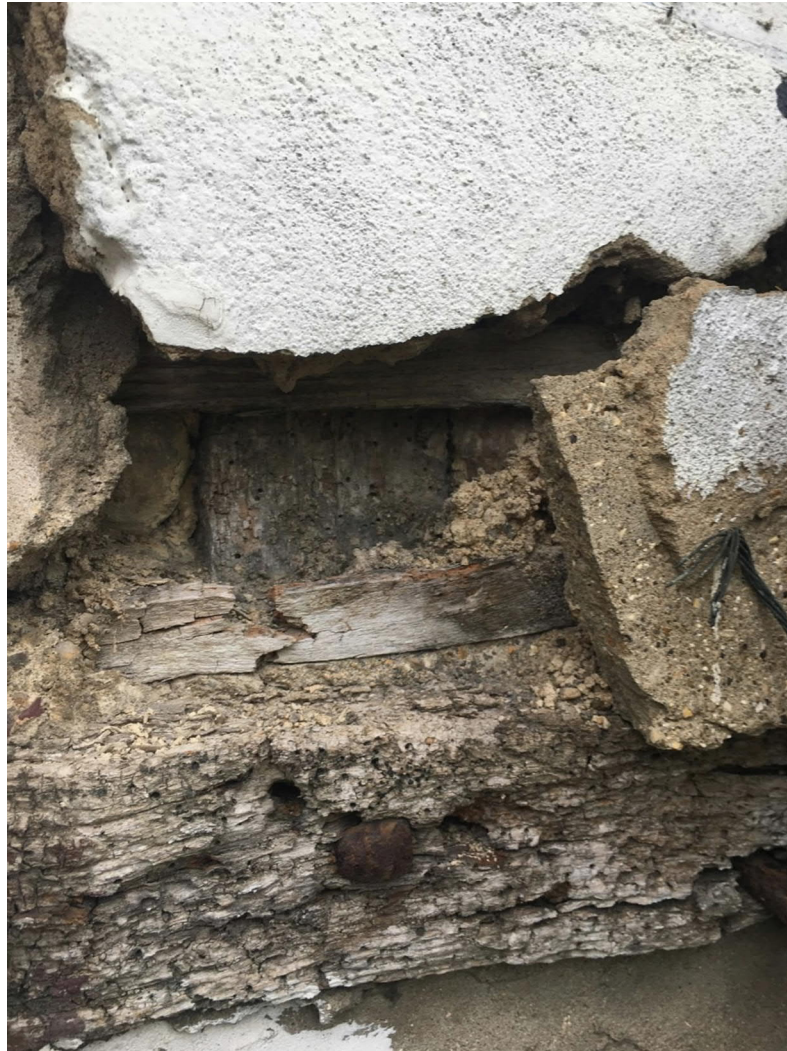
4      Damage caused by removal of pump showing remains of horizontal beam and lath and daub infill.

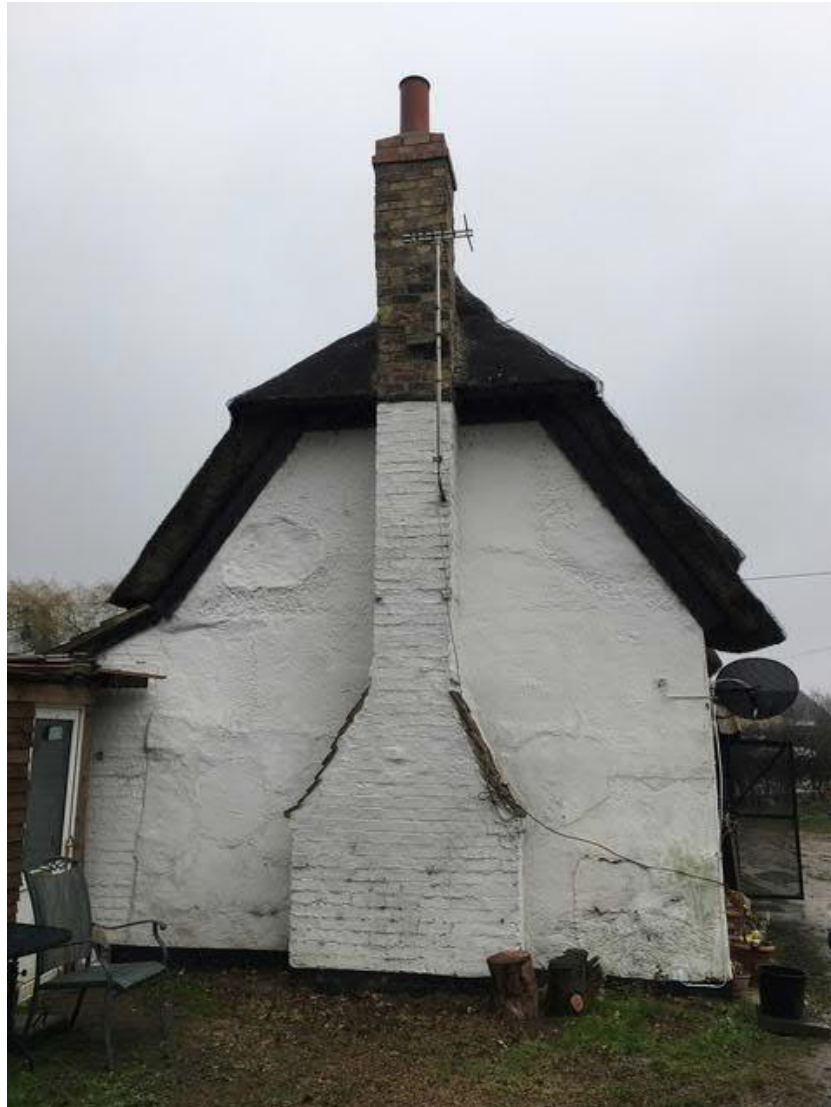
- 3.1.5 The gable ends feature battered stacks (Plates 5 and 6). That to the east is flanked by an inserted fixed window and has been rebuilt in red brick. The chimneys rise above the half-hipped roof. In addition to the gable stacks is a central chimney. All three only provide heat to the ground floor.

West gable elevation with external chimney

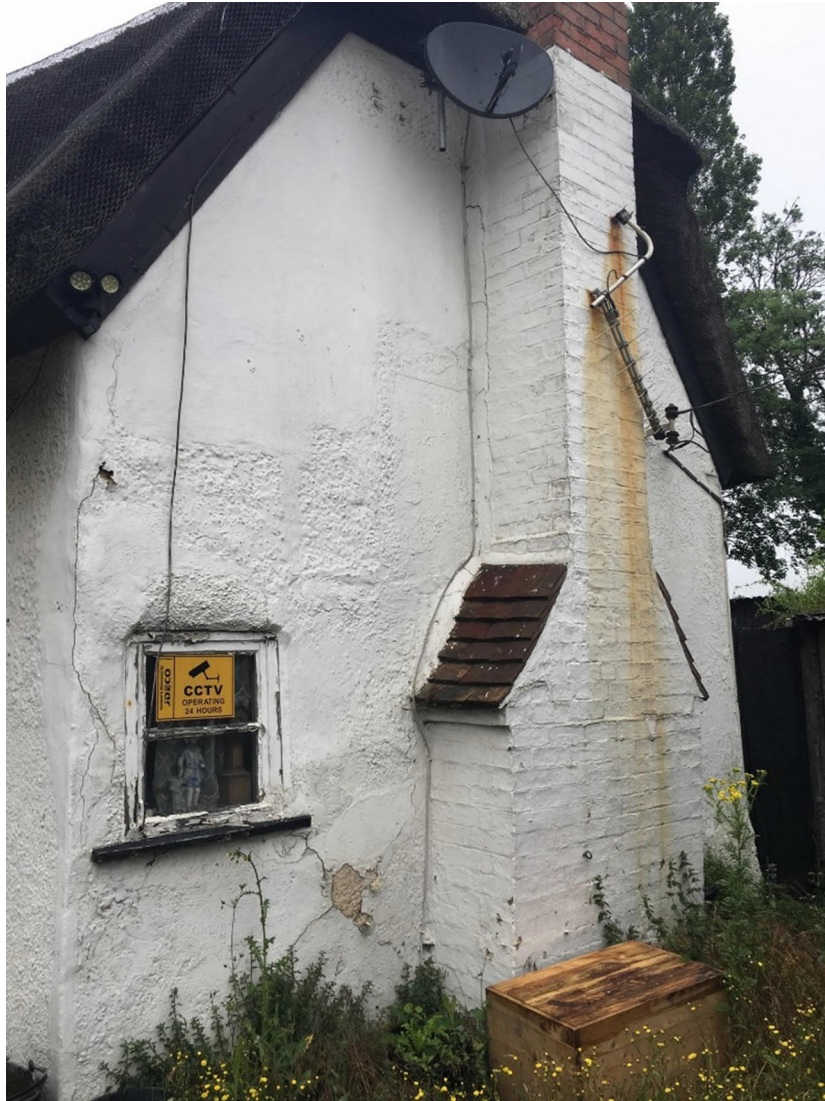
6

East gable elevation with external chimney and inserted window.

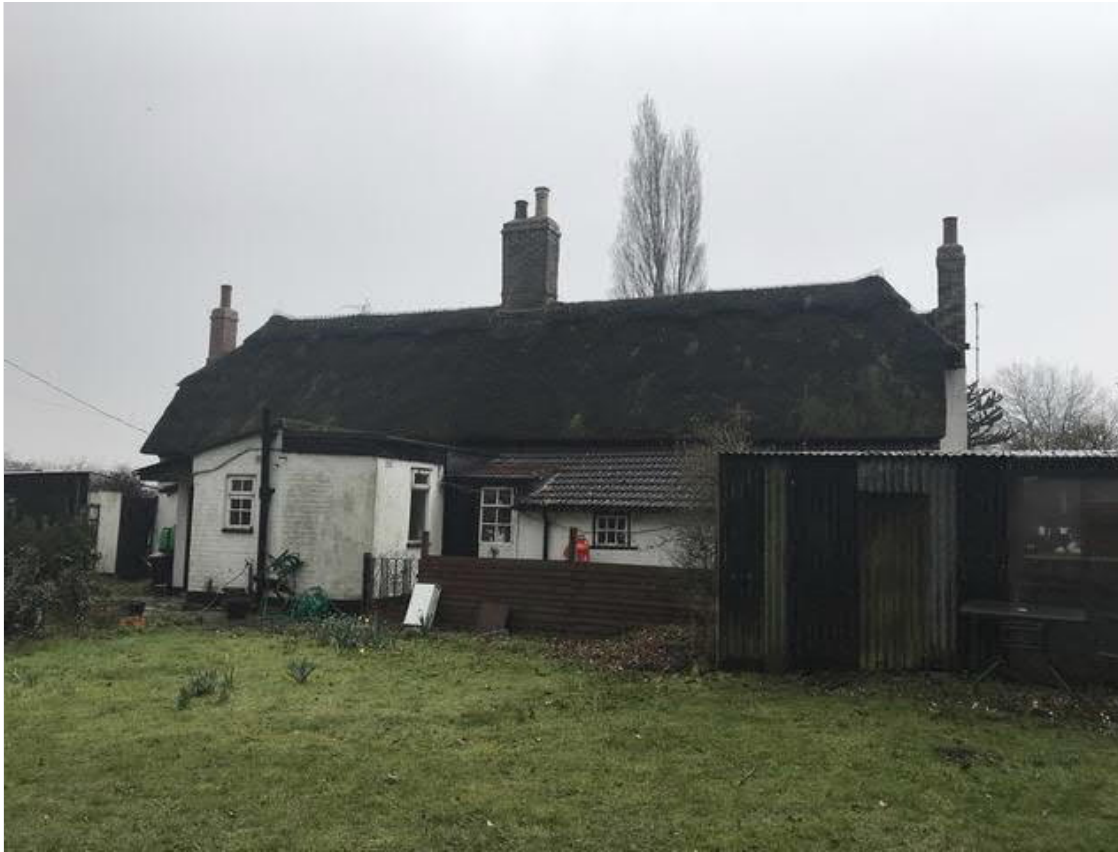
- 3.1.6 The rear (north) elevation represents a collection of brick outshots added variously throughout the 20<sup>th</sup> century (Plate 7). The earliest, probably dating to the early 20<sup>th</sup> century, are to No. 2 and are single storey under sloping pantile roofs (Plate 8). These house the kitchens internally. Each have a combination of fixed timber windows suggesting different phases of insertion. Centrally placed between these are later bathroom extensions. These project further than the kitchens with roofs which slope perpendicular to them. Those to No.1 and No.2 appear to have been constructed at different dates.

- 
- 7 Rear (north) elevation showing outshots. The central projections house the sanitary facilities and are of a later date to the flanking catslide extensions.

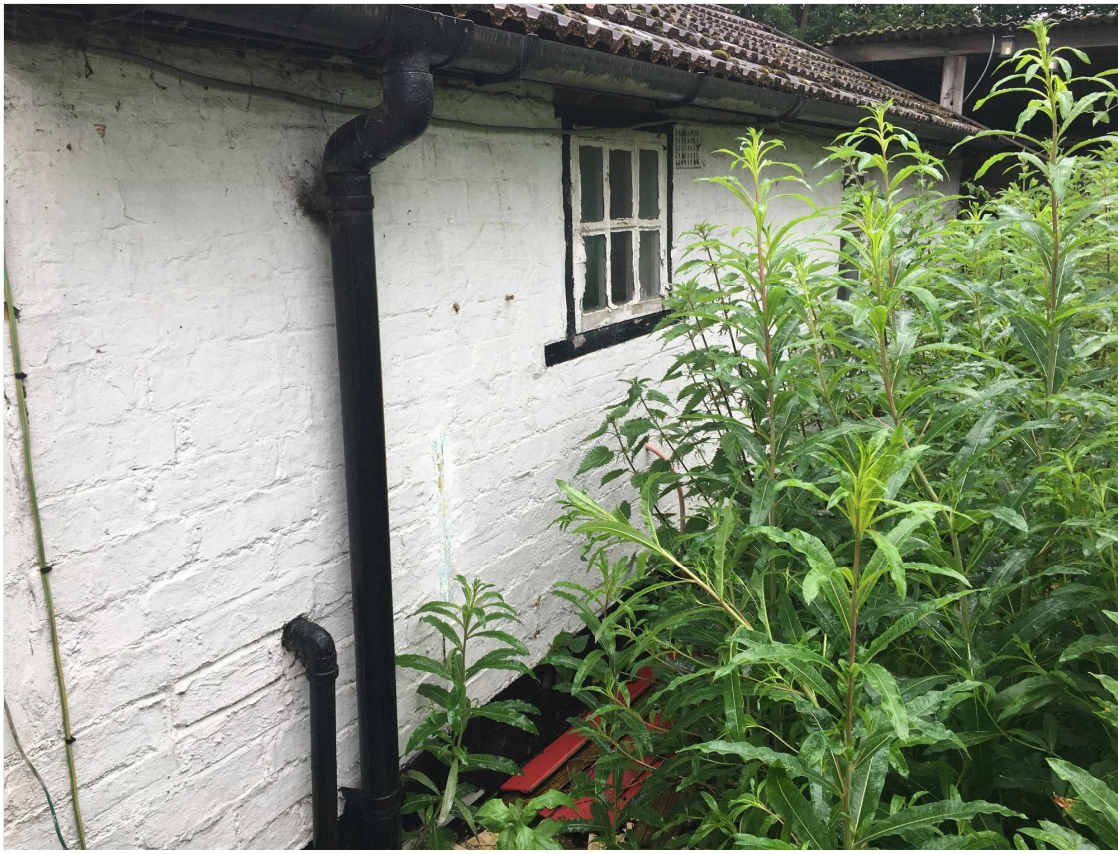
8

Detail of outshot to No.2

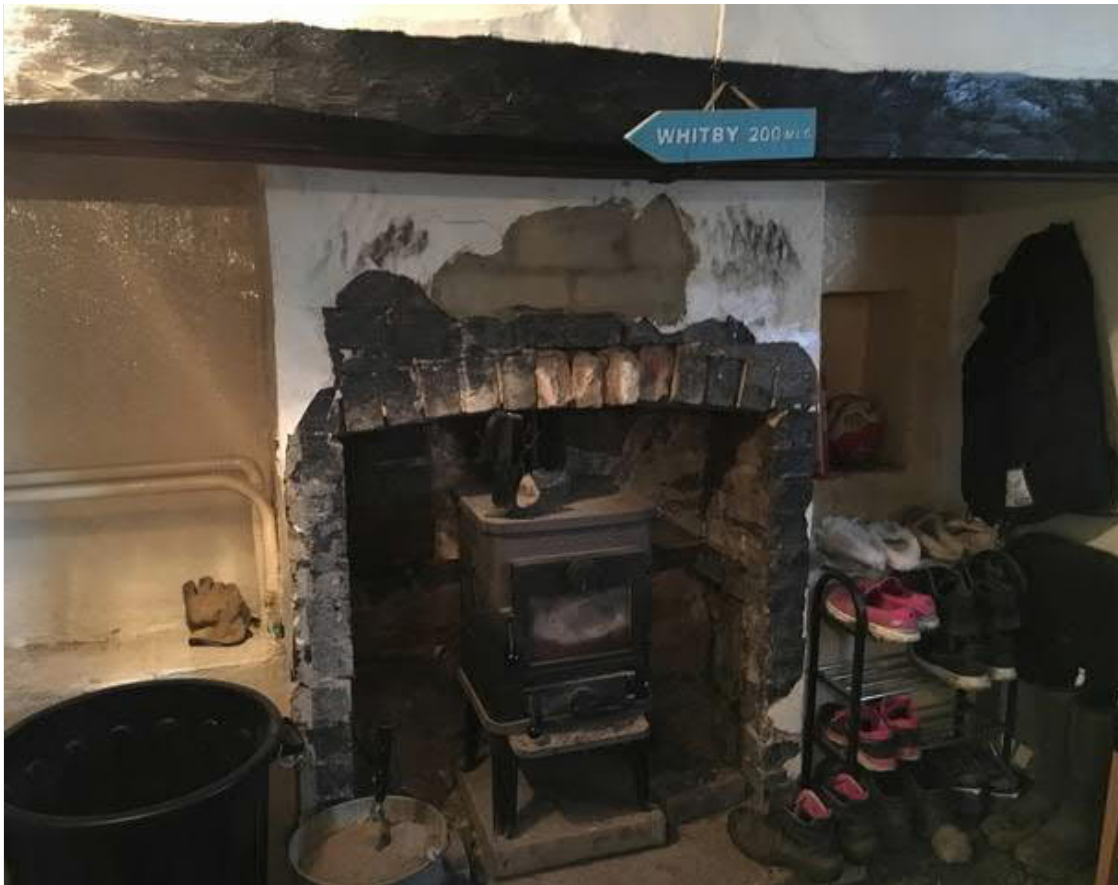
9

Fireplace in main room to No.2 with inserted fireplace and stove

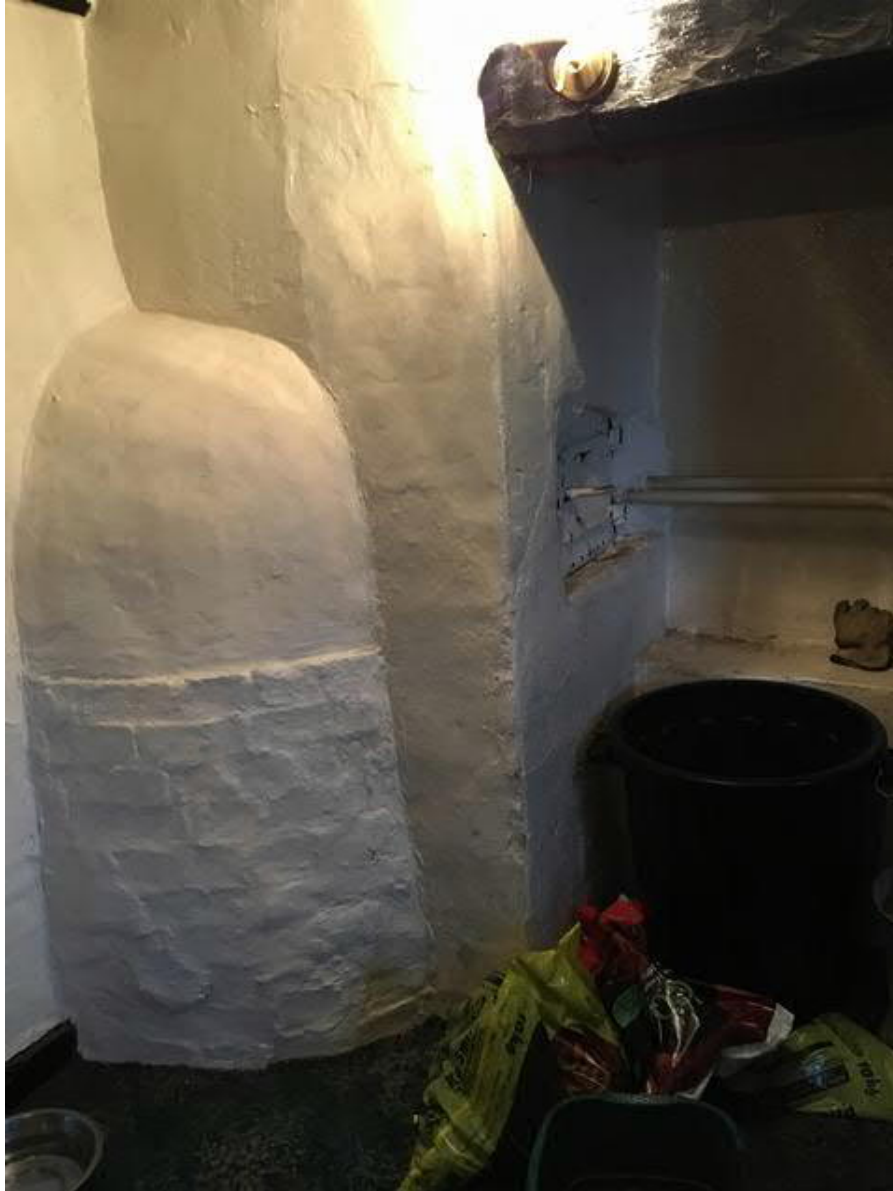
10

Bread oven in No.2

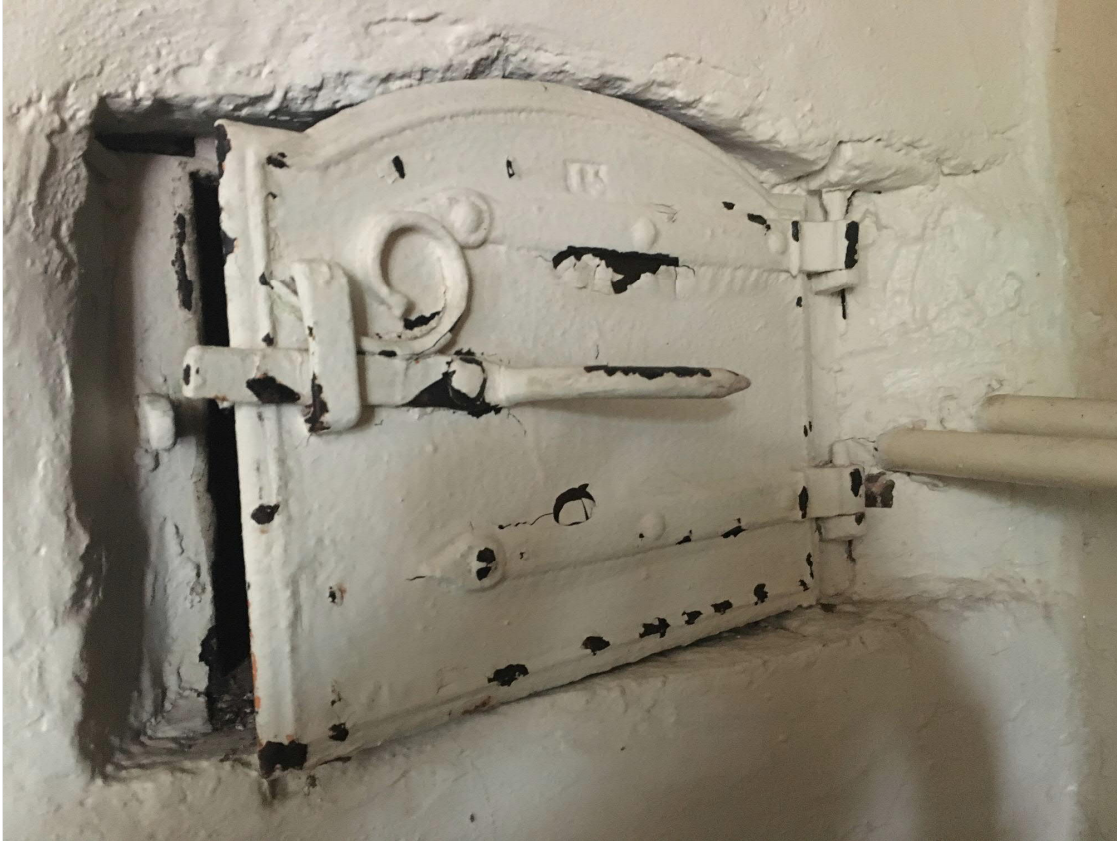
11

Door detail to bread oven in No.2

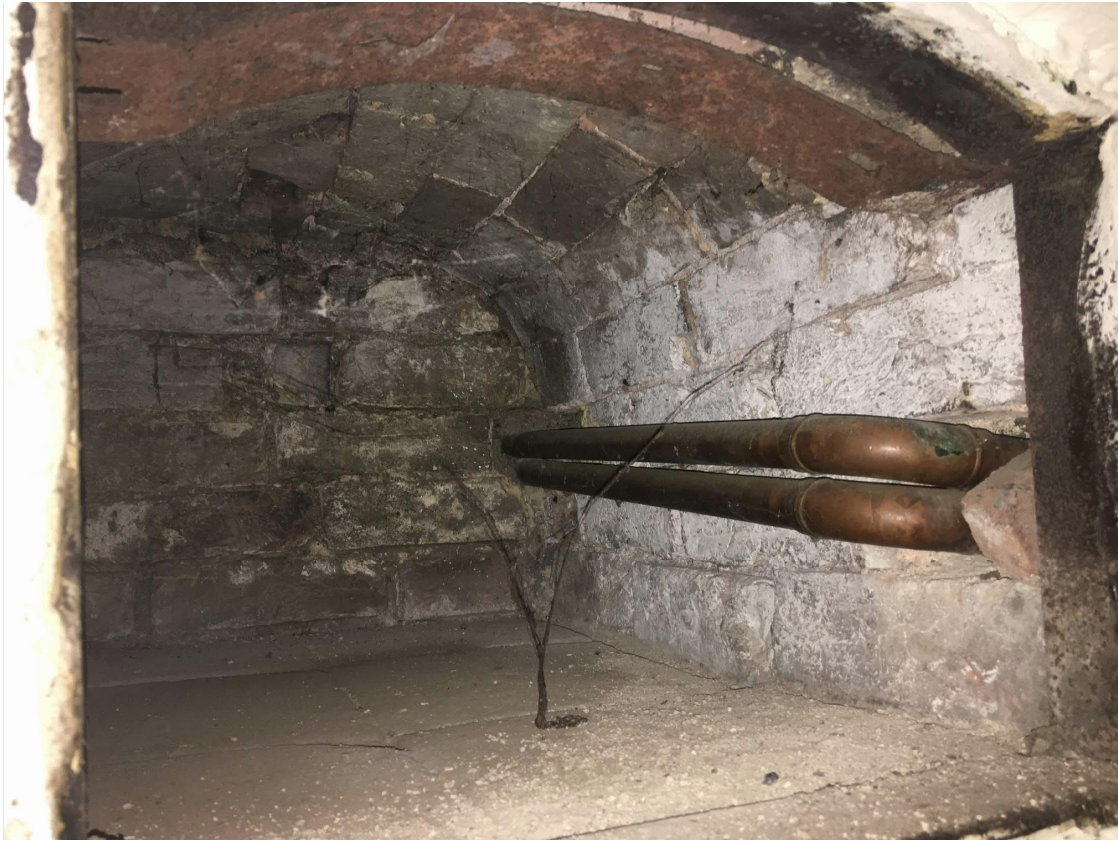
12

Interior of bread oven in No.2 with later gas pipes running through

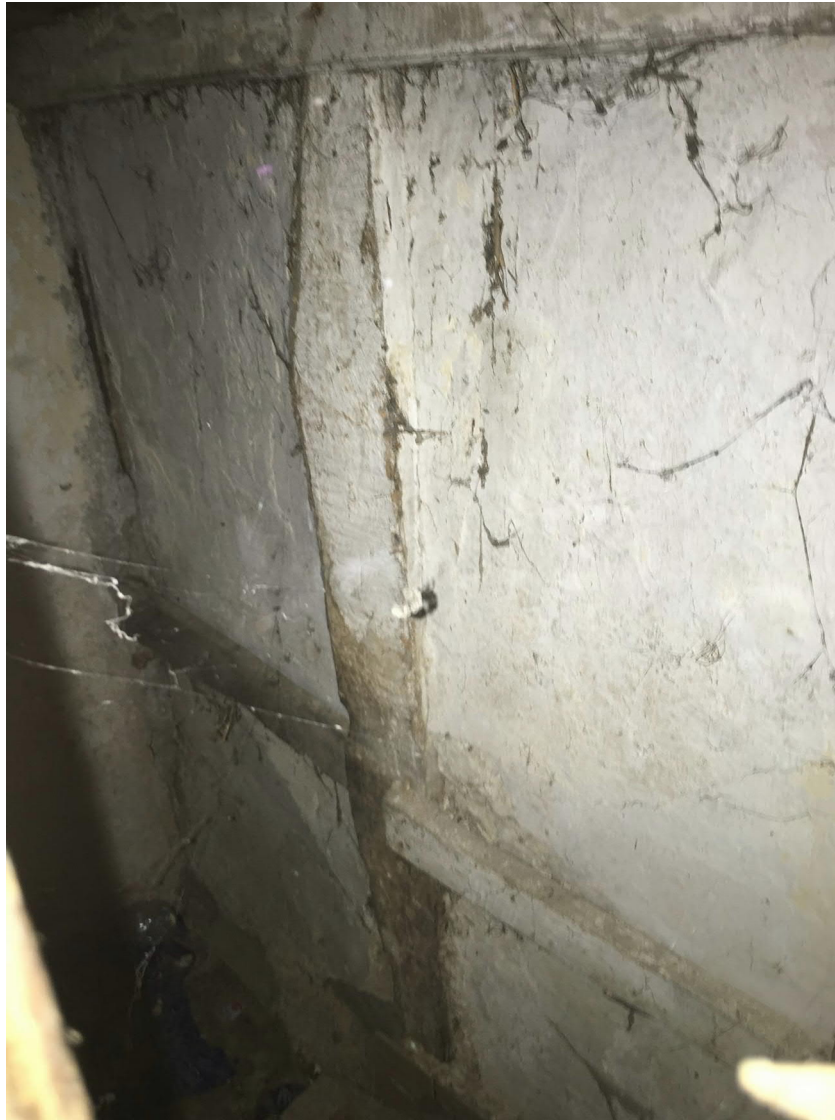
13

Framing detail visible in cupboard to south of fireplace in No.2

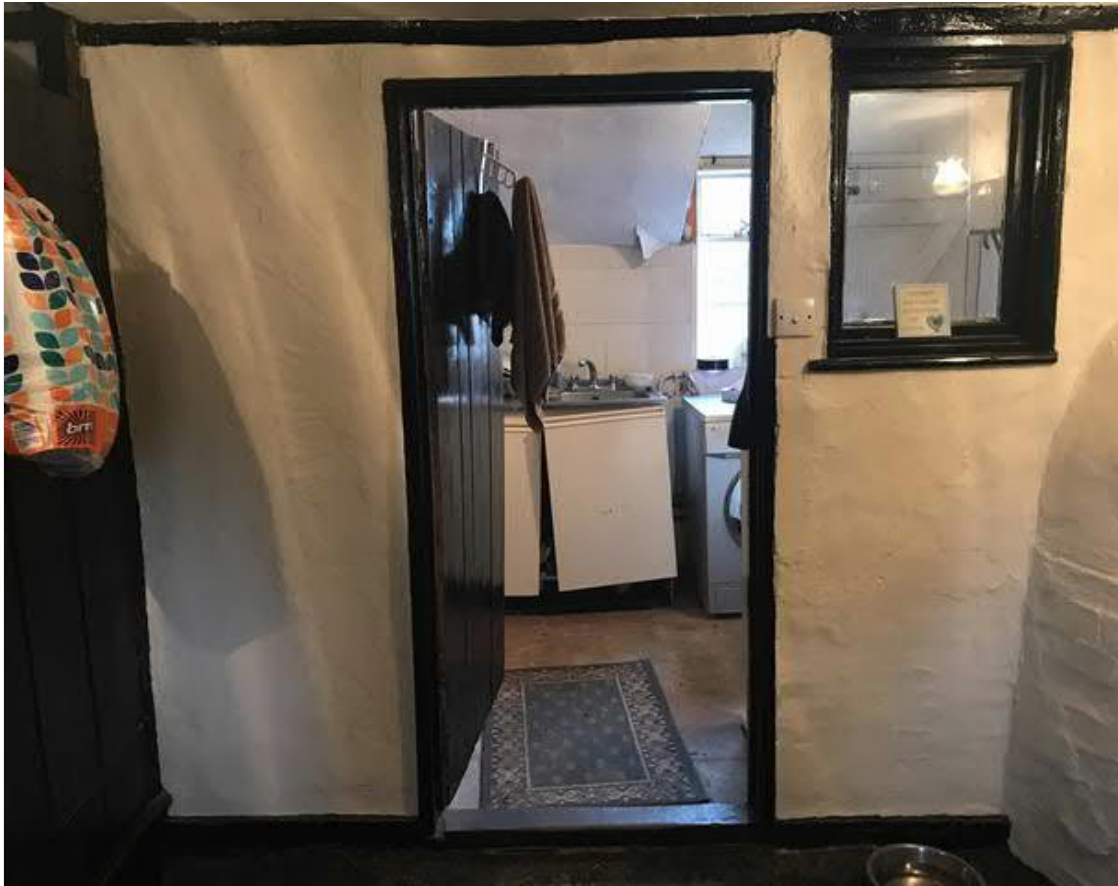
14

- 3.1.11 On the north elevation there is a, probably, inserted door and window giving access to the kitchen in the later outshot (Plate 14). The stair is also located on this wall in the northwest corner of the room within a plank board enclosure (Plate 15). The stair is quarter turn and an under-stair cupboard reveals a simple plank construction (Plate 17). Within the stairwell the frame is visible with thin close studs and intermediate beam (Plate 16).

Inserted door and window into kitchen extension of No.2

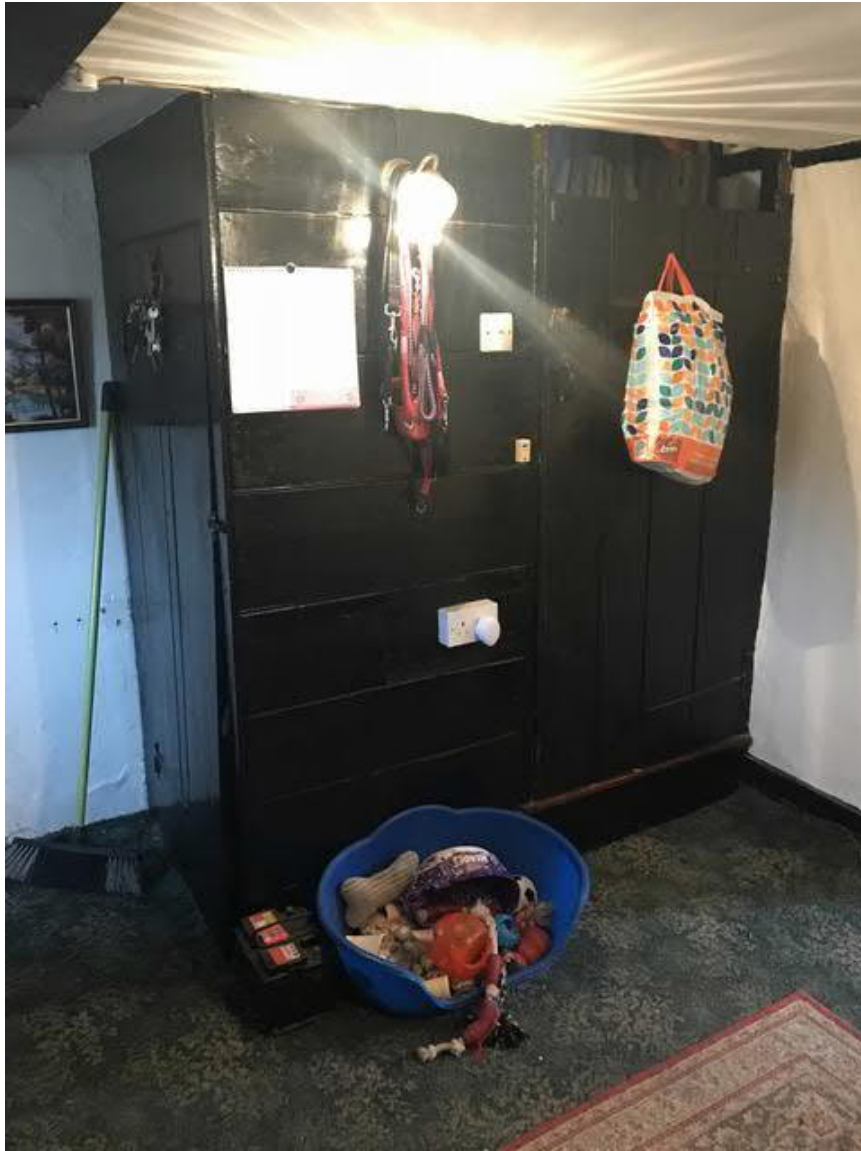
15

Stair enclosure in No.2

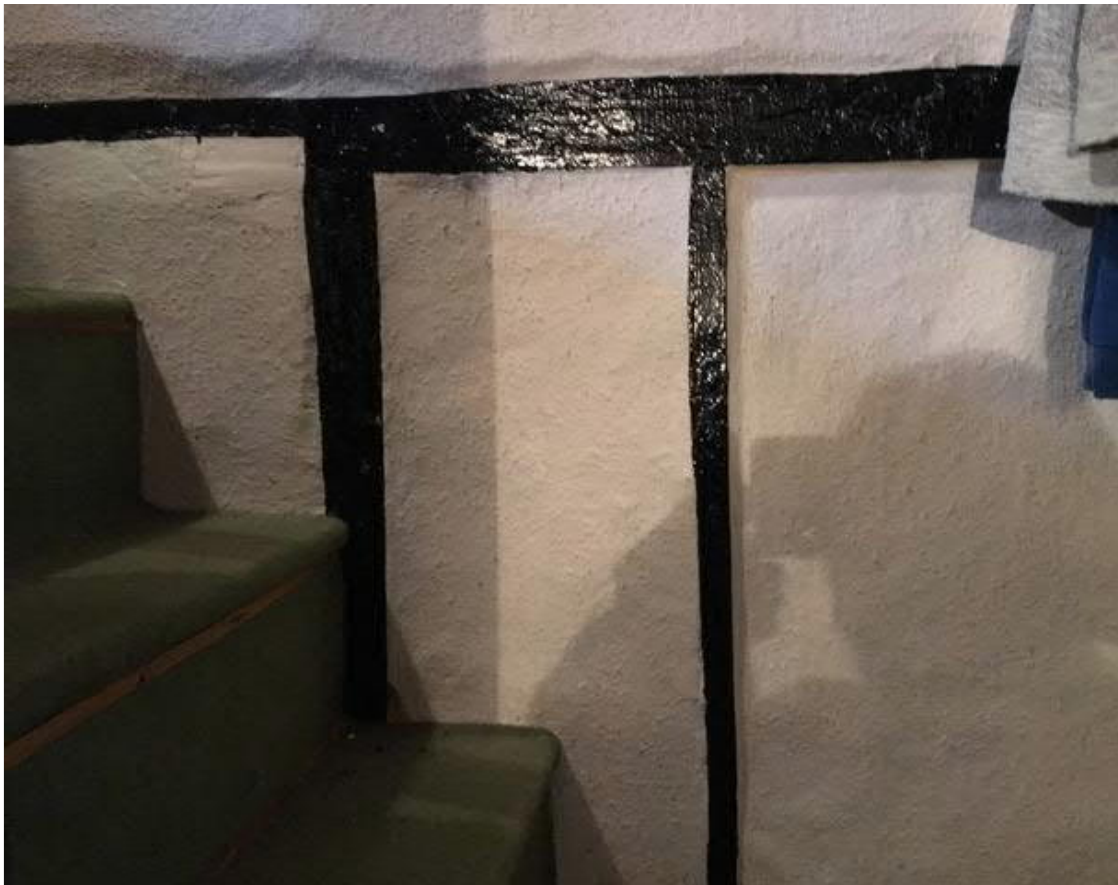
16

Detail of framing visible in stairwell of No.2

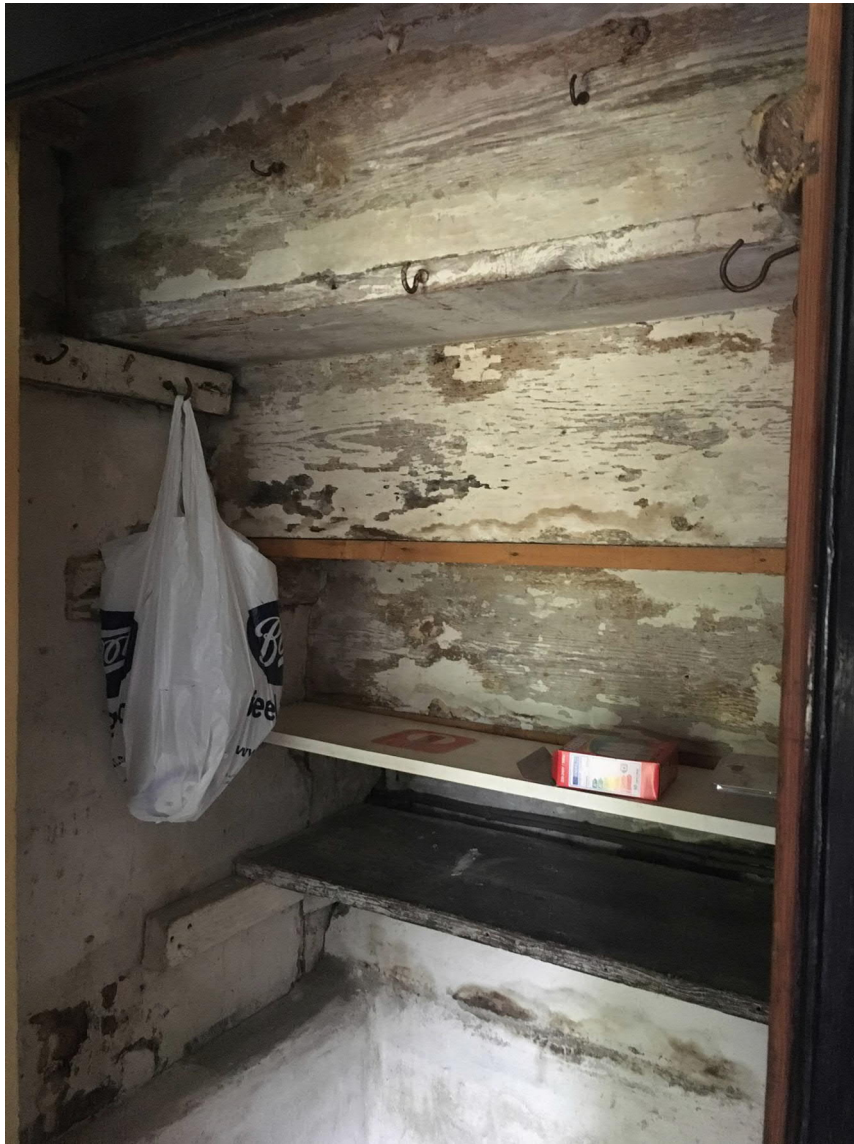
17

Under stairs cupboard in No.2 showing stair construction

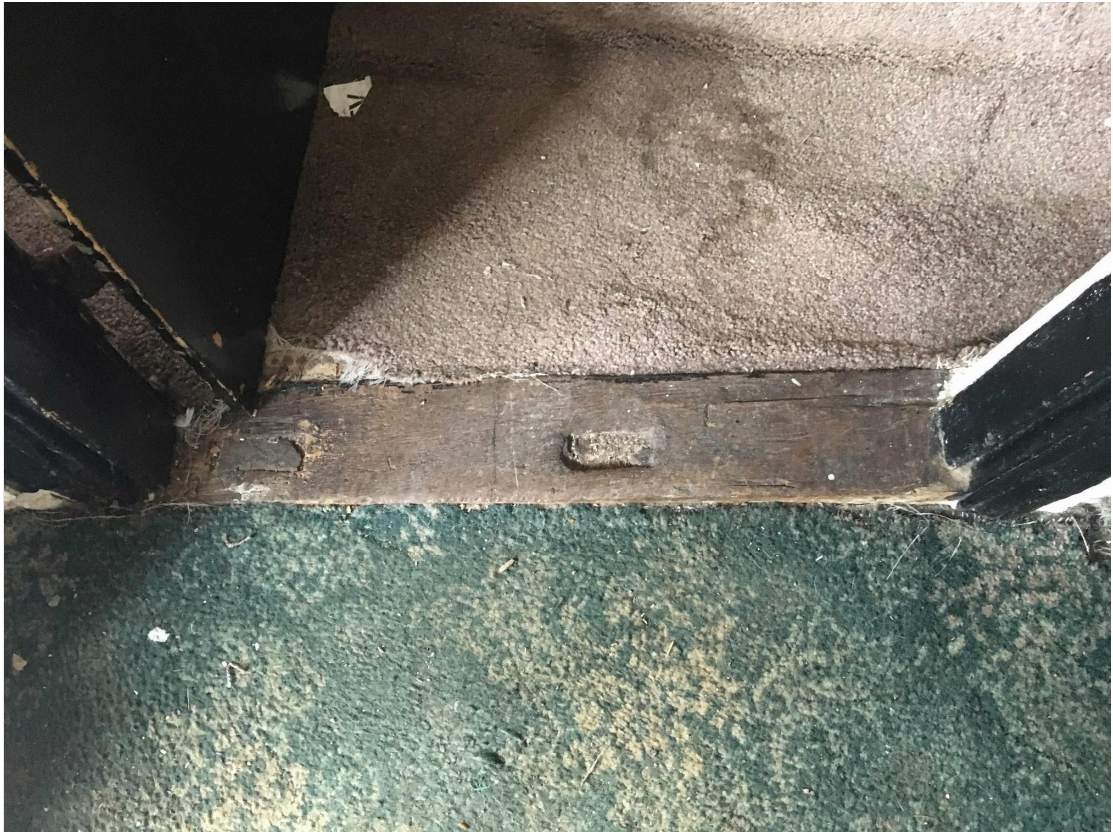
- 3.1.12 The doorway into the second room is inserted. The sill reveals empty mortices, supporting the theory that No.2 was originally two cottages (Plate 18). The room itself is a single open space with inserted fireplace in the west elevation (Plate 19). To the east of the window in the south elevation there is some evidence of a former doorway, although it is not clear. Further evidence for separation is located in the northeast corner where the plasterwork in the ceiling is different, suggesting the possible location of a former stair (Plate 20). Within the ceiling is a central cross beam and the wall plates are visible to south and north. In the north elevation is an inserted doorway into the rear extension. The extension itself has modern kitchen fittings, although was predominantly used as a store to the west end. Of note is the brick floor, with a distinct change in level to access the later bathroom extension (Plate 21).

- 
- 18 Threshold to second ground-floor room in No.2. Cill beam contains empty mortices supporting evidence that this was previously two dwellings.

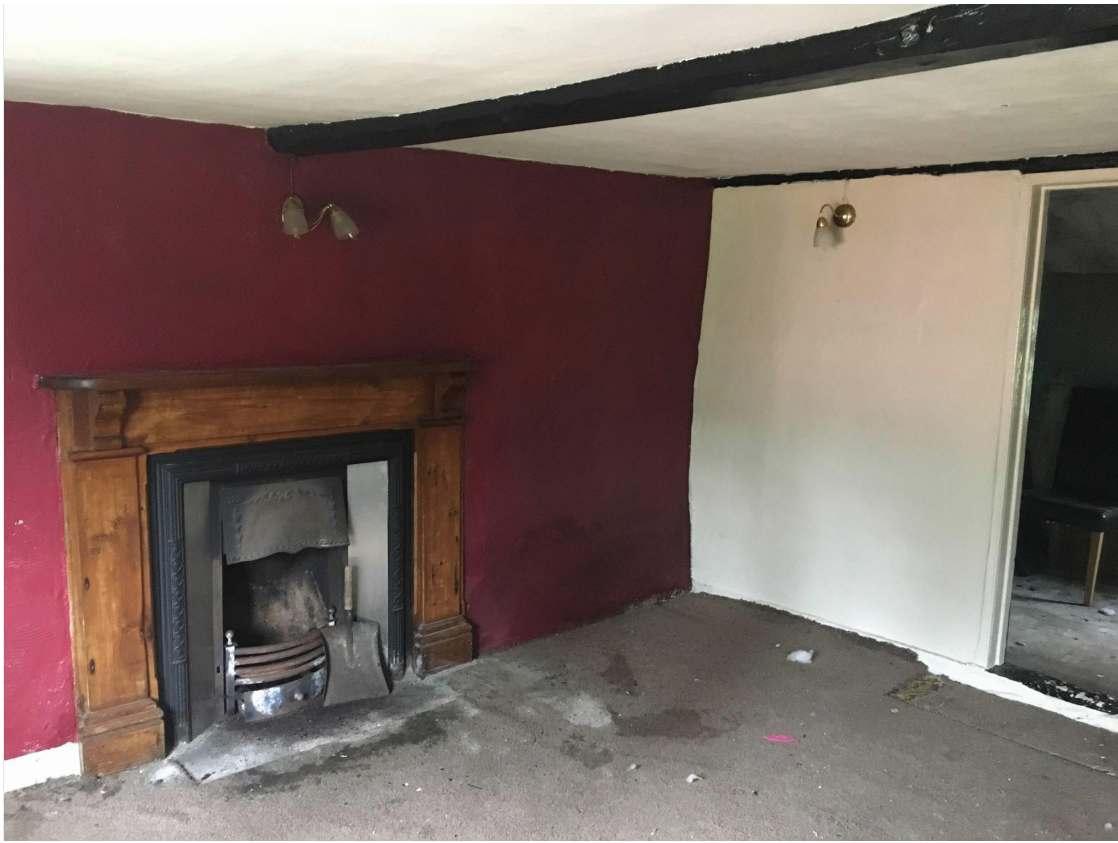
19

Second ground-floor room to No.2

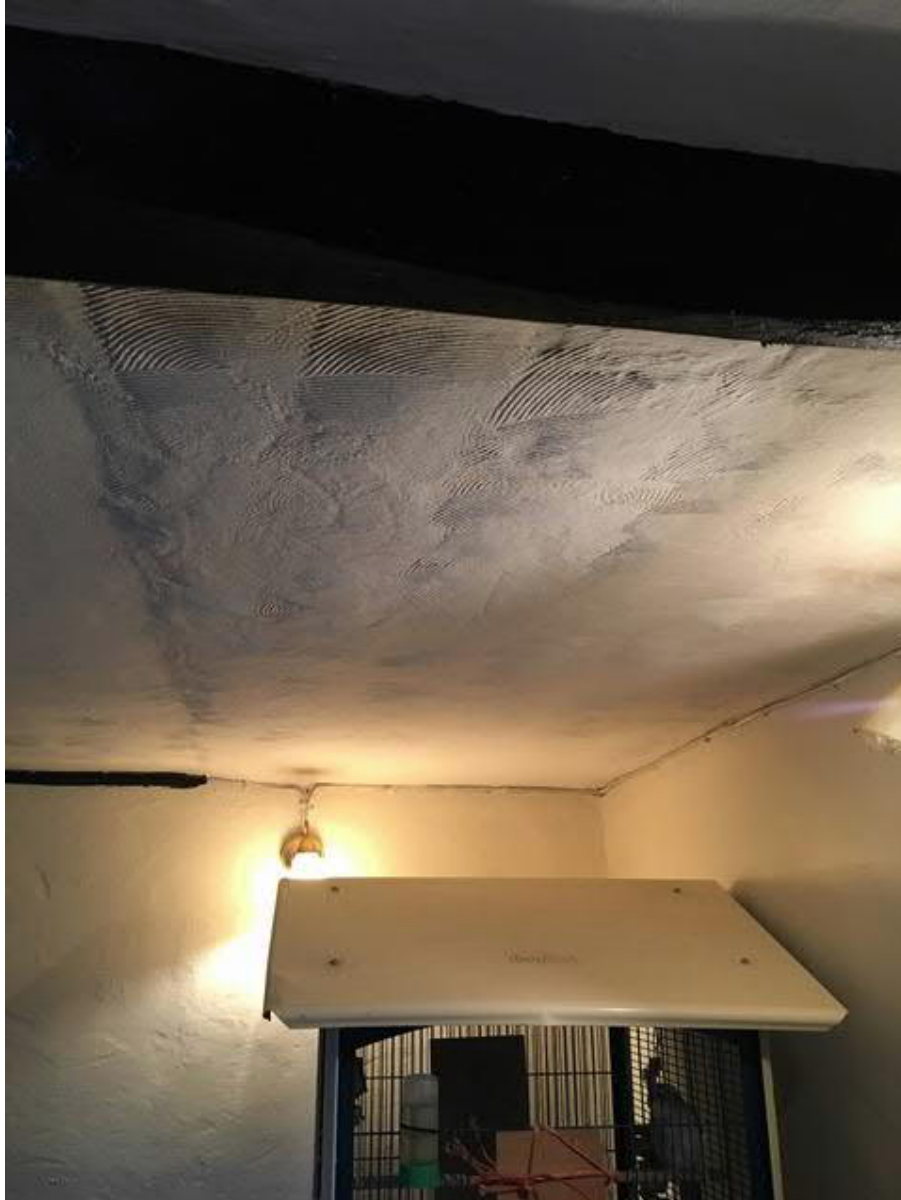
20

Patched area in ceiling of No.2 suggesting location of former stair

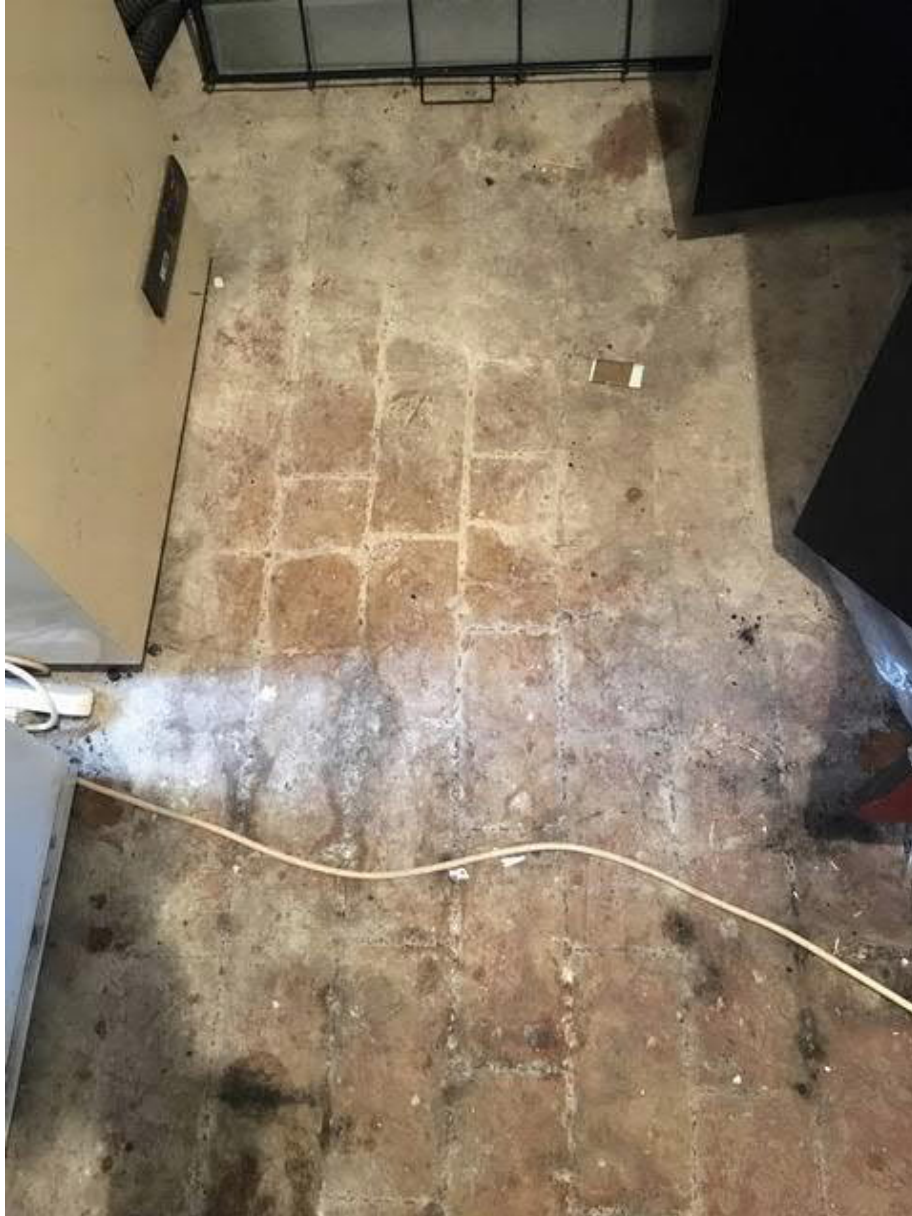
21

Brick floor to outshot in No.2

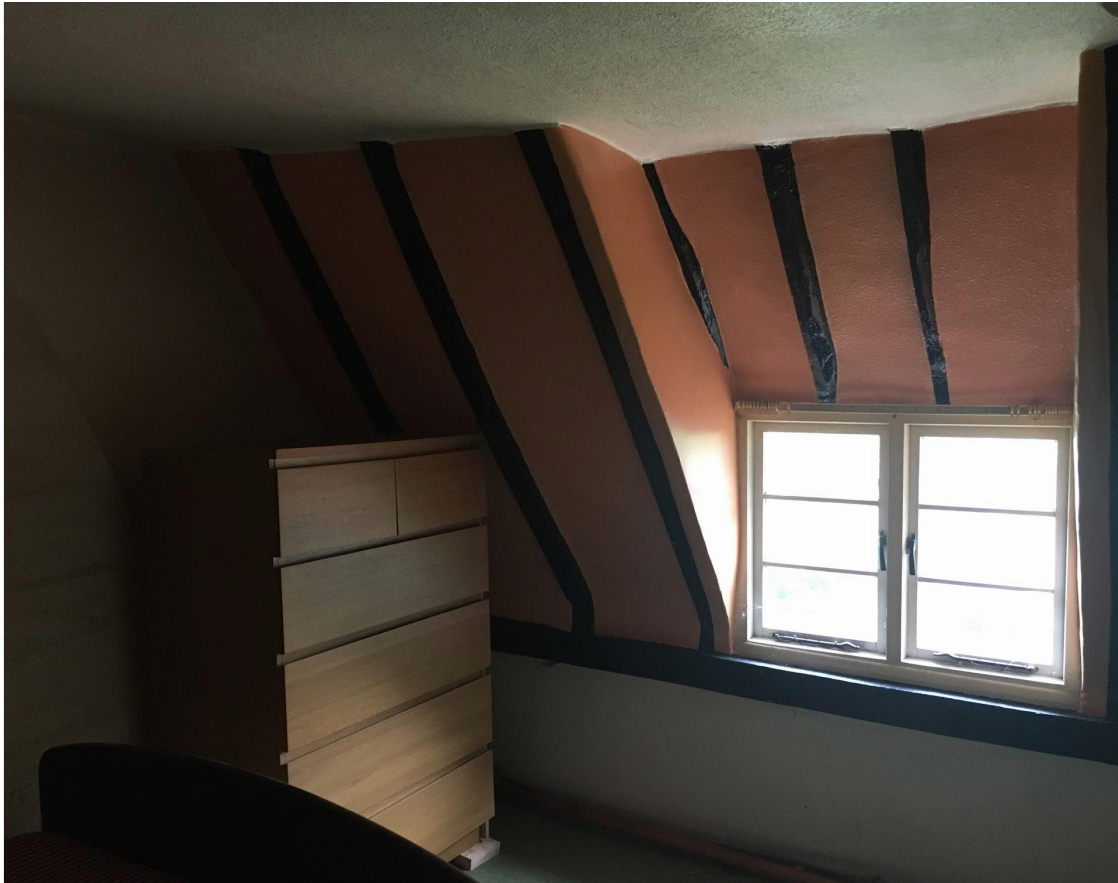
22

Upstairs main room to No.2
