# A428 Black Cat to Caxton Gibbet improvements

## 9.18 Brook Cottages Technical Note

**9.18 Brook Cottages Technical Note**

<b>Regulation Reference:</b>	Rule 8(1)(k)
<b>Planning Inspectorate Scheme Reference</b>	TR010044
<b>Application Document Reference</b>	TR010044/EXAM/9.18
<b>Author</b>	A428 Black Cat to Caxton Gibbet Improvements Project Team, Highways England

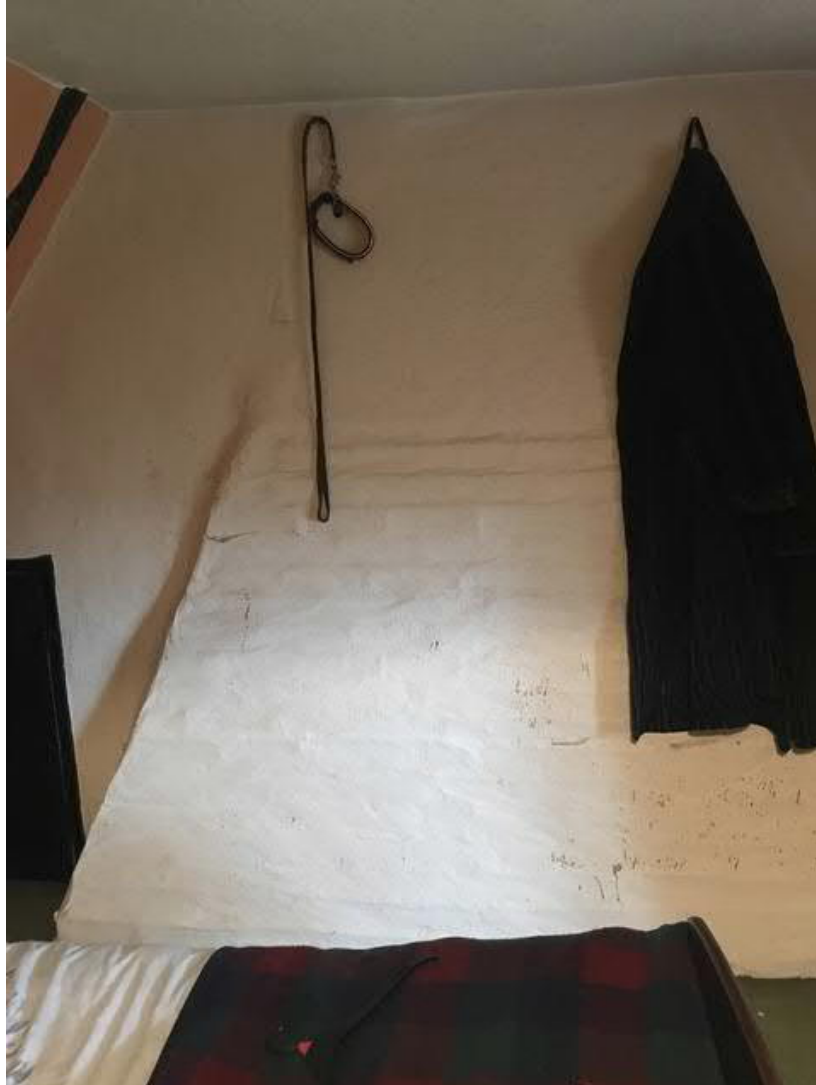
23

Projecting chimney breast to No. 2

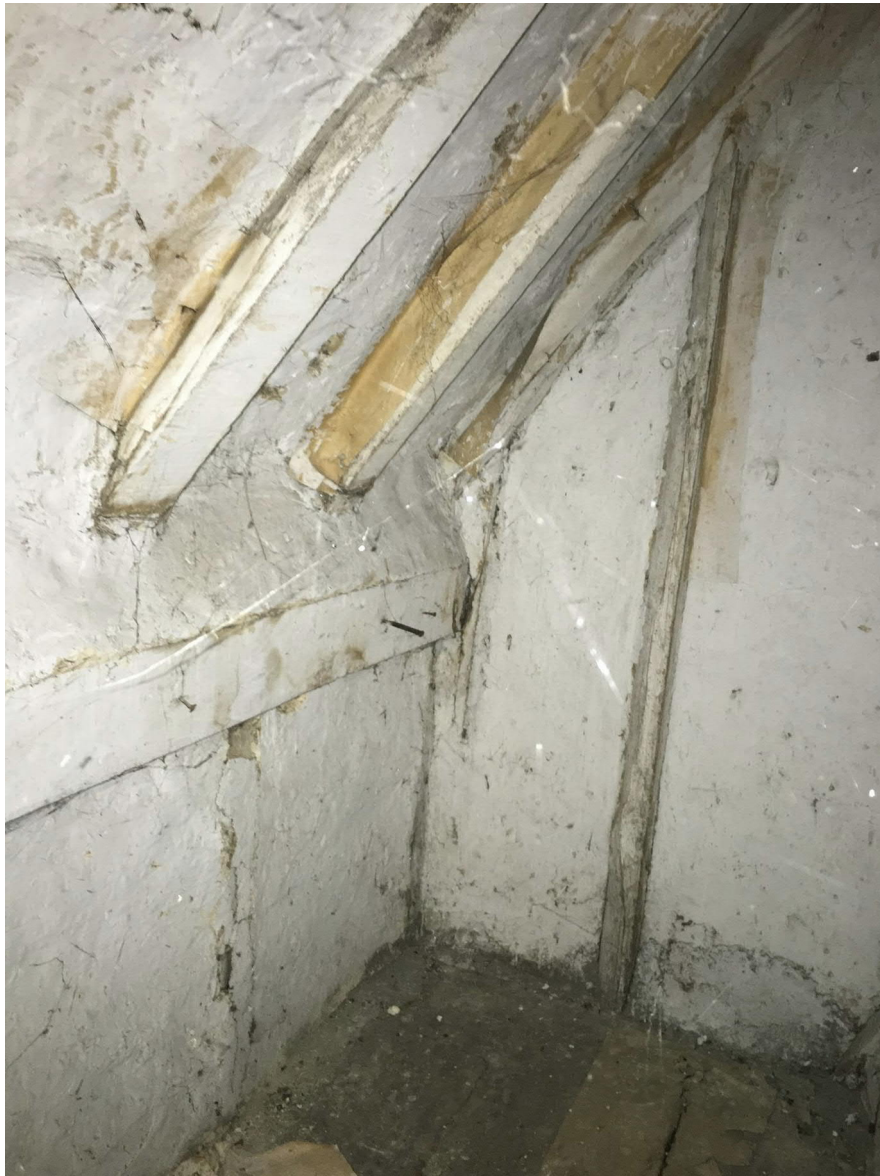
- 3.1.13 The upper floor is divided into two rooms, directly accessed from each other. The main bedroom is to the east (Plate 22). The large chimney breast is evident in the east elevation, although there is no evidence of a fireplace (Plate 23). A small cupboard flanks this to the north. This provides the best evidence of the roof structure with closely spaced common rafters carried over the wall plate (Plate 24). However, the junction between the two is concealed by plaster. The purlins are also not visible.

24 Framing detail visible in cupboard to north of chimney breast in no.2. Shows purlins and wall plate.

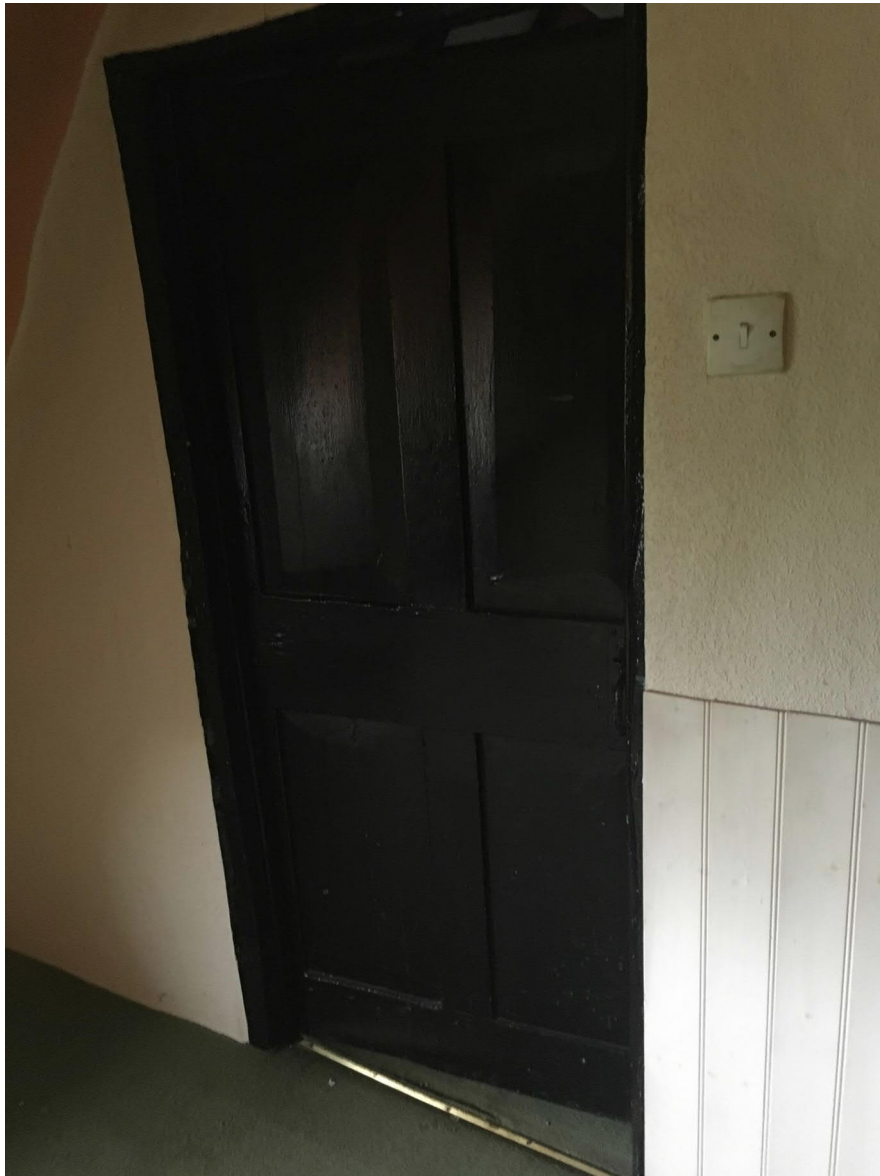
25

- 3.1.14 A four-panel door leads into the second bedroom (Plate 25). The arrangement of this matches the first, but without the chimney breast. Lifting the carpet also revealed a wooden floor (Plate 26).

Panel door to second bedroom in No.2
