M5 Junction 10 Improvements Scheme

Environmental Statement

Appendix 9.4 Arboricultural Impact Assessment

6.15 Environmental Statement: Appendix 9.4 Arboricultural Impact Assessment

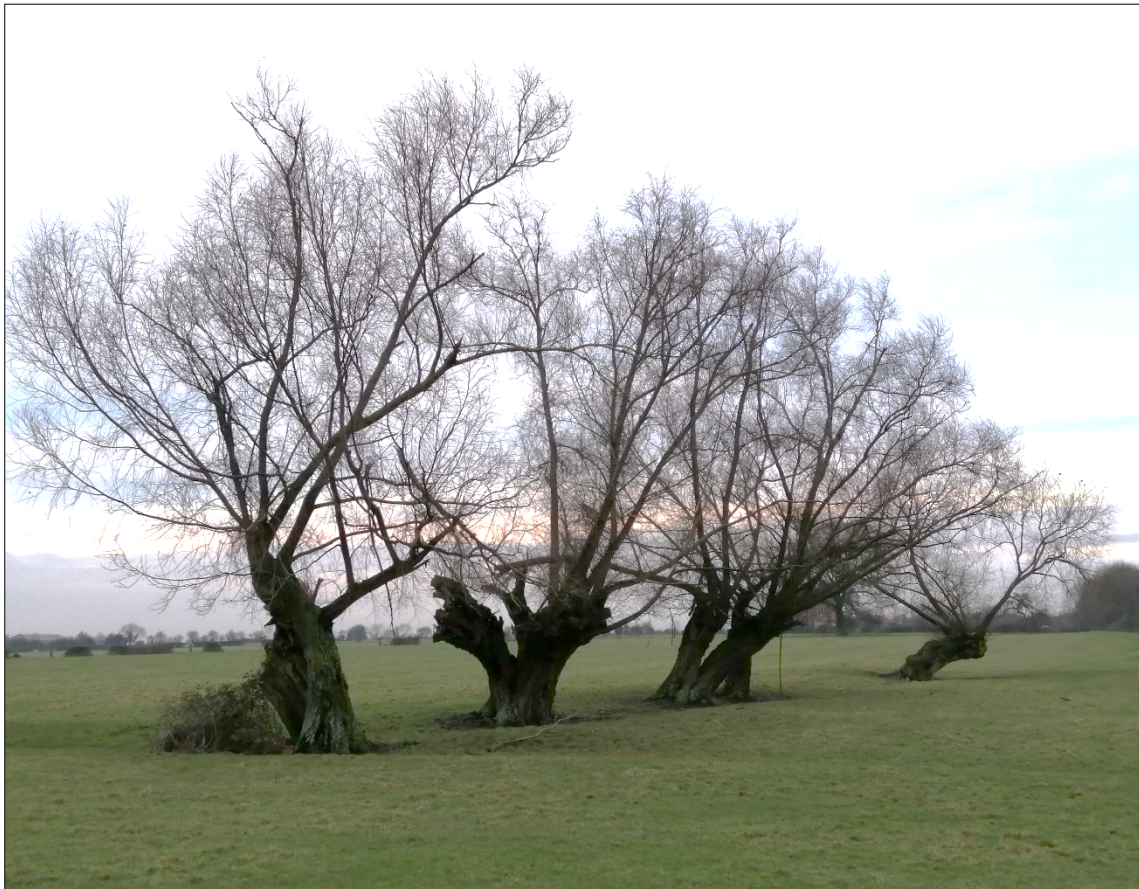
3.1.5. The notable over-mature trees present include a linear group of crack willows (G081) that are growing to the south of the A4019 where the new Link Road is planned. These trees being historically pollarded and now reaching over-maturity with extensive storm damage recorded in their crowns where regenerated branches/stems have failed. These branch/stem failures are synonymous with crack willow specimens in advanced maturity. In the majority of cases the main stems are also hollow, offering some saproxylic habitat value. The stem diameters range between 800-1000mm, meaning they are not large for the species. Those trees that are being retained have been recommended for pollarding to manage the risk of further branch/stem failures, especially given the close proximity of the proposals and increased risk of harm to adjacent people or property. See figure 3-1 showing a few of the trees in G081.

Figure 3-1 – part of group G081, over mature crack willow specimens

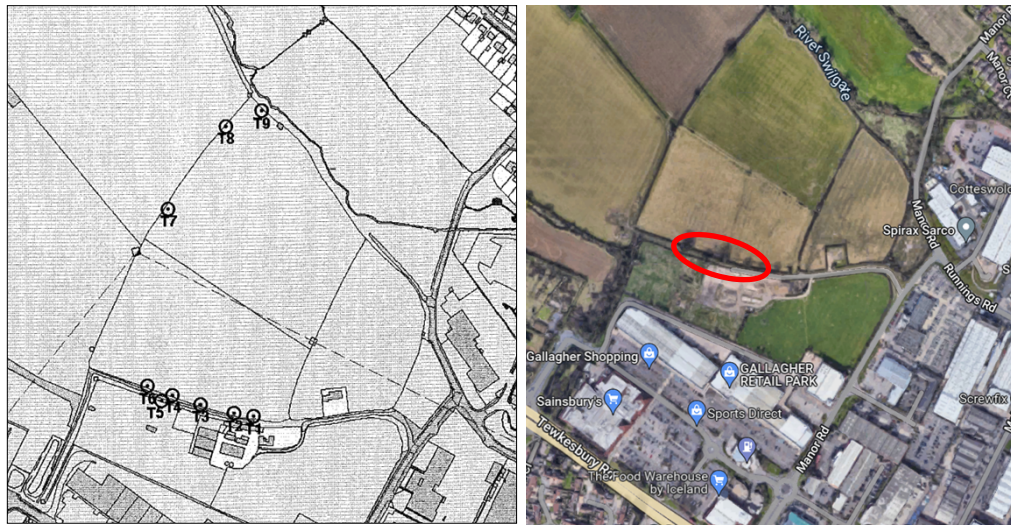
- 3.2.1. There are trees protected by TPOs within the DCO boundary. A TPO makes it an offence to cut down, uproot, lop, top, wilfully damage or wilfully destroy a protected tree without authorisation. However, a DCO may include powers to undertake works to trees which are subject to a TPO.
- 3.2.2. Cheltenham Borough Council (CBC) confirmed that there are no TPOs under their jurisdiction within the DCO boundary. However, they noted TPO reference no. 675 is located to the north of the Gallagher Retail Park that falls outside of the Scheme boundary. See figure 3-2 for location specifically trees T1 to T5.

Figure 3-2 – CBC TPO reference 675. Exert from TPO citation and exert from Google aerial

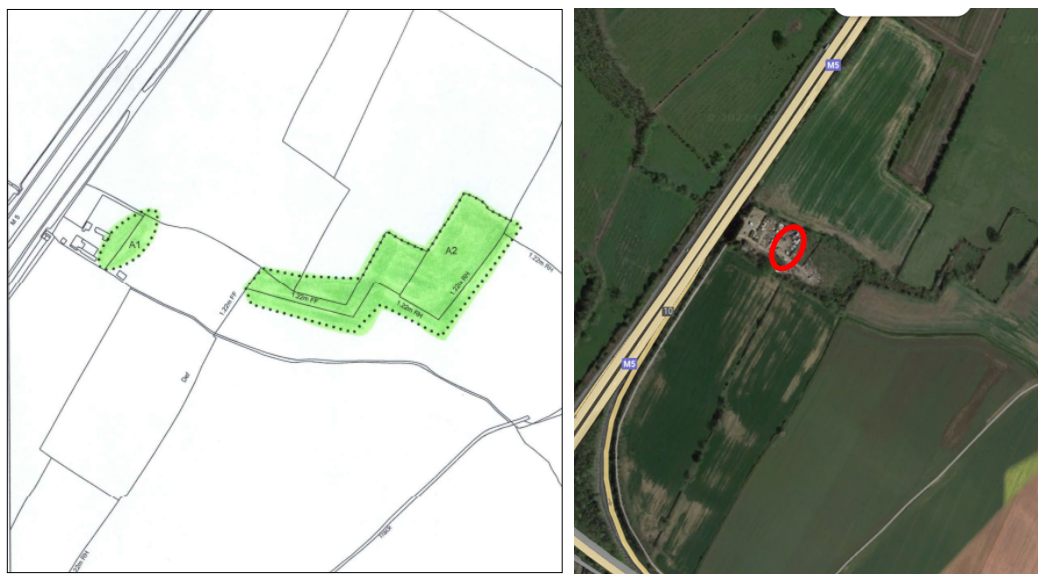
- 3.2.3. Tewksbury Borough Council (TBC) have confirmed that there are TPOs under their jurisdiction within the DCO boundary and those in close proximity to this boundary.
- 3.2.4. TPO reference A1 from TPO294 North West Cheltenham is located to the east of the M5 and falls outside of the DCO boundary. Description Oak & Willow made in November 2008.

Figure 3-3 – TBC TPO reference A1 from TPO294. Exert from TPO citation and exert from Google aerial

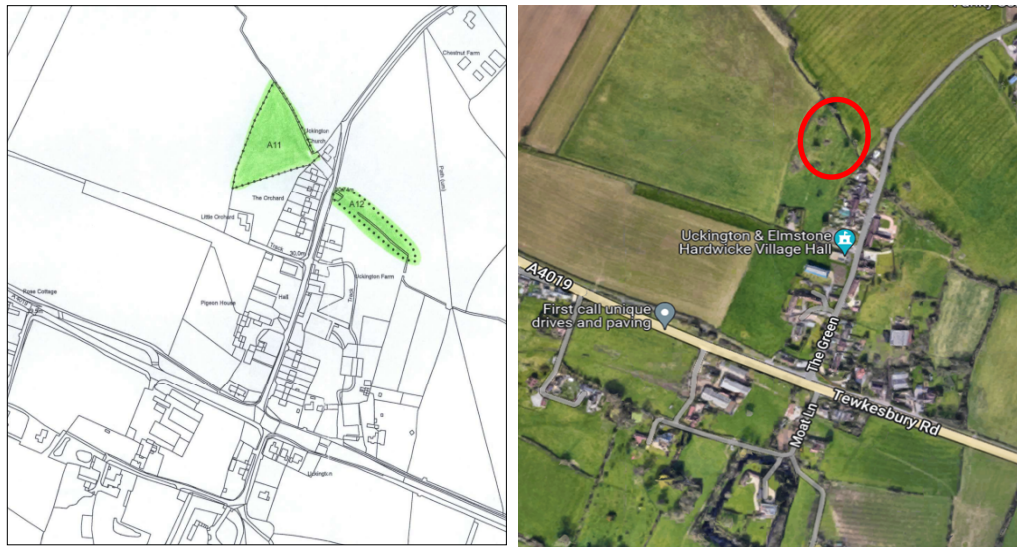
- 3.2.5. TPO reference A11 from TPO294 North West Cheltenham is located to the north of the A4019 and to the west of The Green, and falls outside of the DCO boundary. Description orchard trees and Ash made in November 2008.

Figure 3-4 – TBC TPO reference A11 from TPO294. Exert from TPO citation and exert from Google aerial

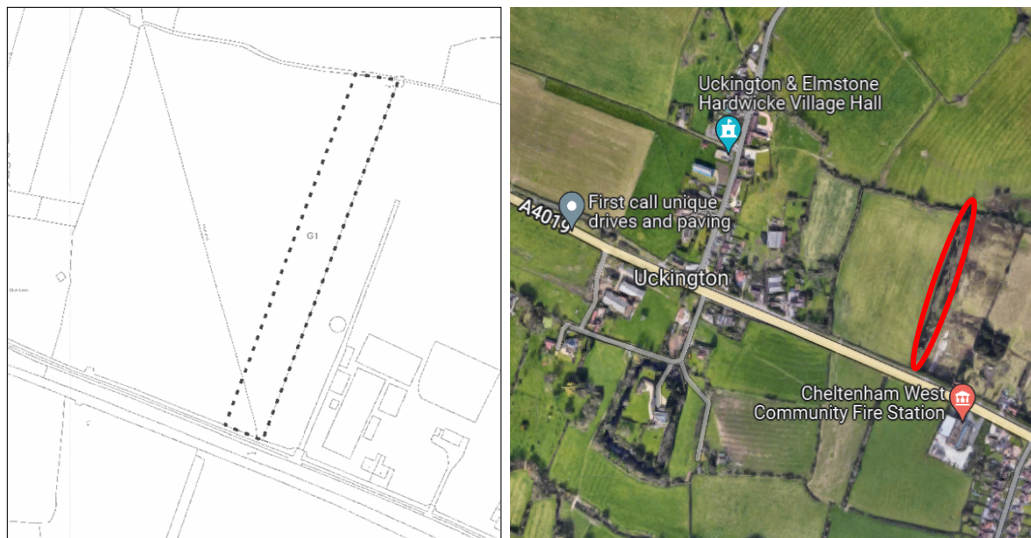
3.2.6. TPO reference G1 from TPO325 North West Cheltenham, Uckington is located to the north of the A4019 falls partially within the DCO boundary. Description Poplar (*Populus nigra 'Italica'*) made in May 2010. The tree group is referenced G003 as part of the tree survey.

Figure 3-5 – TBC TPO reference G1 from TPO325. Exert from TPO citation and exert from Google aerial

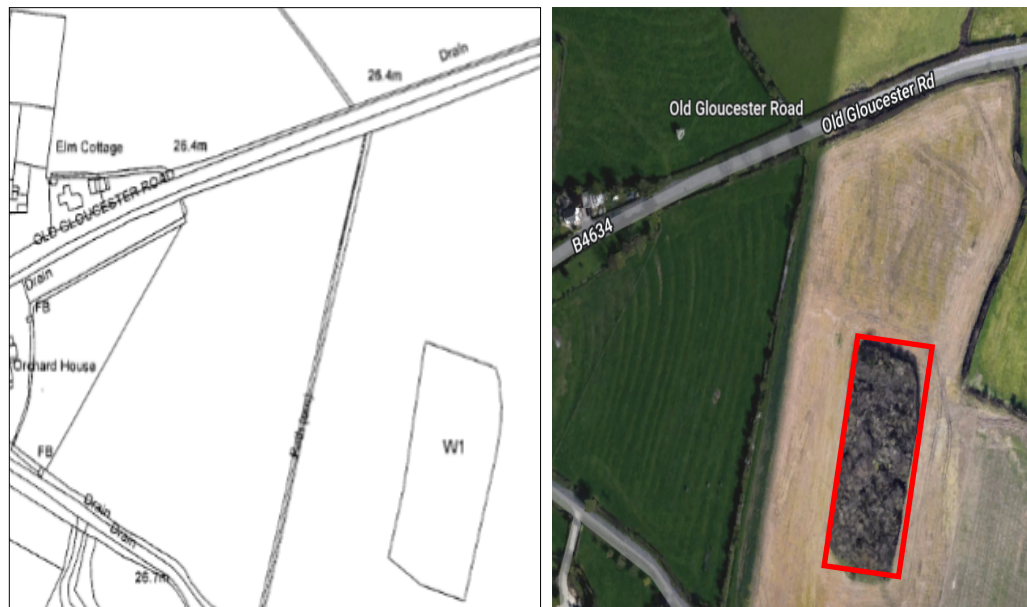
3.2.7. TPO reference W1 from TPO400 Land adjoining The Sewage Works, Hayden Lane and is located to the south of the B4634 and falls outside of the DCO boundary. Description mixed species group (Oak, Ash, Field Maple, Hawthorn, Blackthorn, Hazel, Elder, Spindle, Wayfaring) made in September 2020.

Figure 3-6 – TBC TPO reference W1 from TPO400. Exert from TPO citation and exert from Google aerial

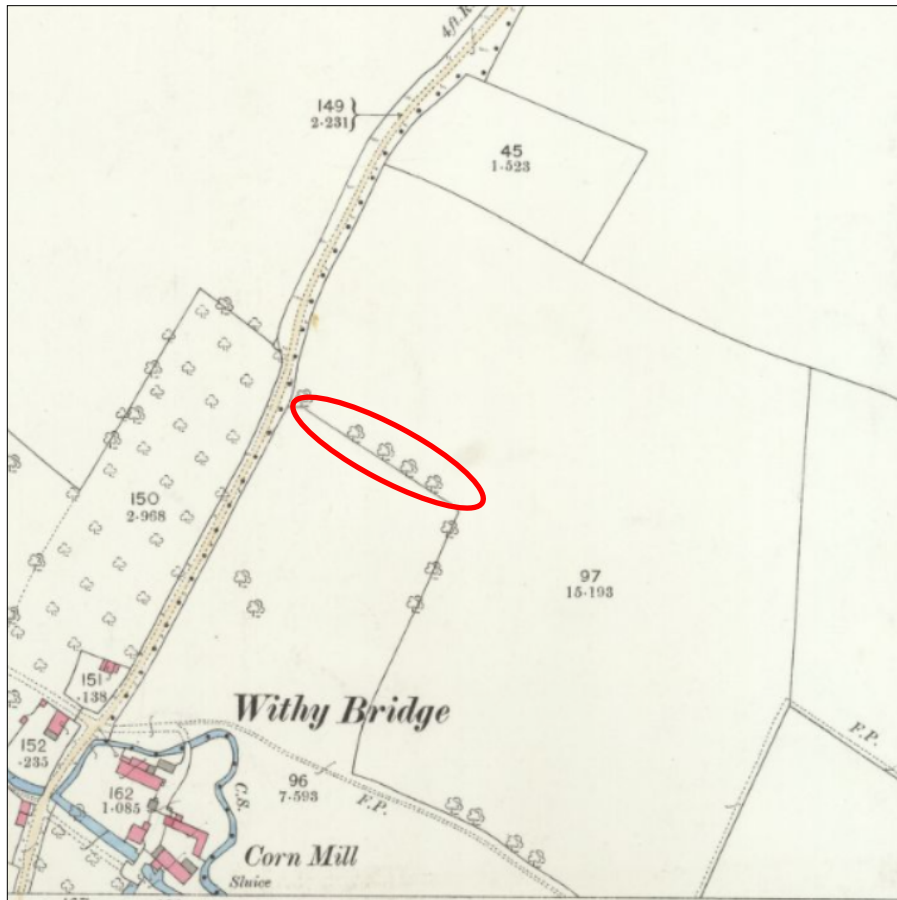
- 3.3.3. A review of available online mapping resources indicate that this tree was potentially present at the time of the 1882 survey along this field boundary, the red outline enclosing the veteran tree and the adjoining specimens believed to be part of G249. The remaining trees within G249 have been classified as locally notable given their stem sizes and saprophytic features.

Figure 3-7 – extract from 1882 ordnance survey mapping (taken from old maps online) potentially showing tree group G249 and the veteran tree G249-C

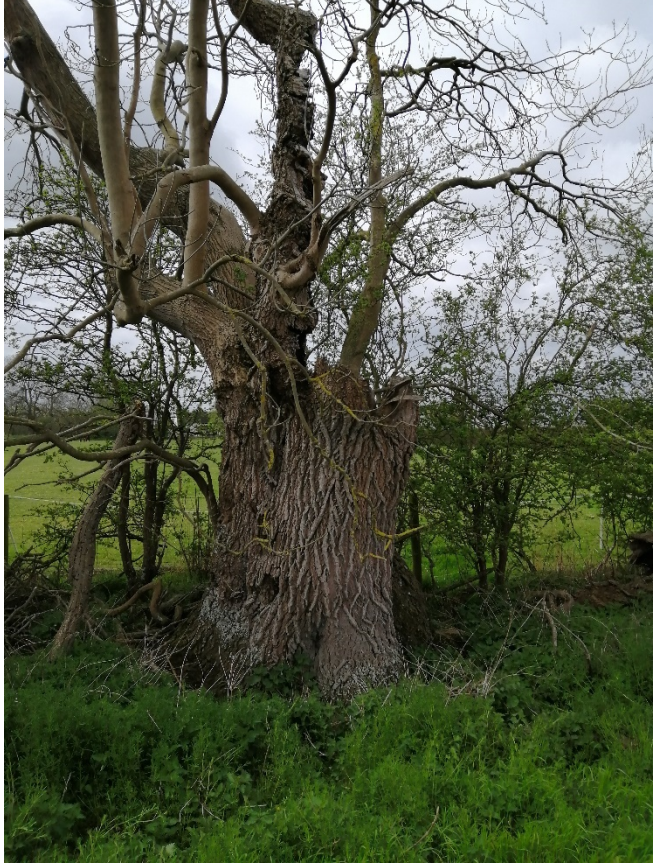
Tree no.	Species	Location	Summary of value	Tree photographs
G249-C	Common Ash	Land to east of Withybridge Lane Easting: 39061901 Northing: 22484973	<p>Size: Large stem girth in comparison to other trees in locality.</p> <p>Condition: Extensive decay features present including hollow main stem with heartwood decay.</p> <p>Dead branches and old storm damage recorded in crown with desiccated white rot present.</p> <p>Crown break at approximately 3m. Live crown mainly regenerated branches from 3m.</p> <p>Biodiversity value: Decayed heartwood rot and white rot providing habitat for saproxylic invertebrates.</p> <p>Cultural and heritage value: Tree forms part of old field boundary.</p> <p>Age: Its diameter of 1530mm means it has a girth of 4.8m and means it is included within the ‘veteran/notable’ criterion of girth in relation to age as shown in Figure 1.3 of ‘Ancient and Other Veteran Trees: Further Guidance on Management’ (Lonsdale, 2013).</p>
