# London Luton Airport Expansion

Volume 5 Environmental Statement and Related Documents  
**5.02 Appendix 17.1 Preliminary Risk Assessment of Land  
Contamination - Part G**

## SITE WALKOVER PROFORMA

**PROJECT:** London Luton Airport Expansion Development Consent Order Project No:261327-05

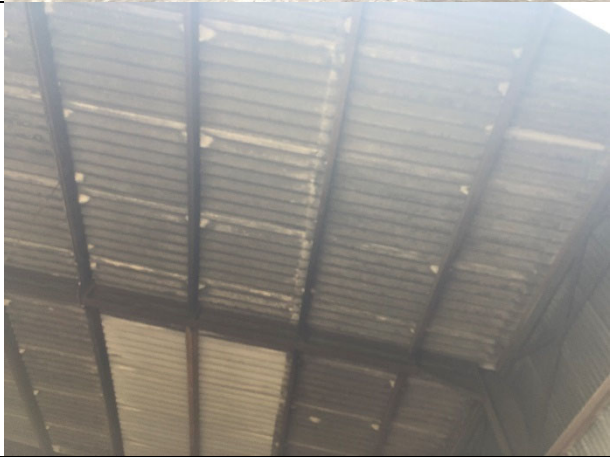
<p>Shed roof, possible asbestos cement.</p>
<p>19</p>

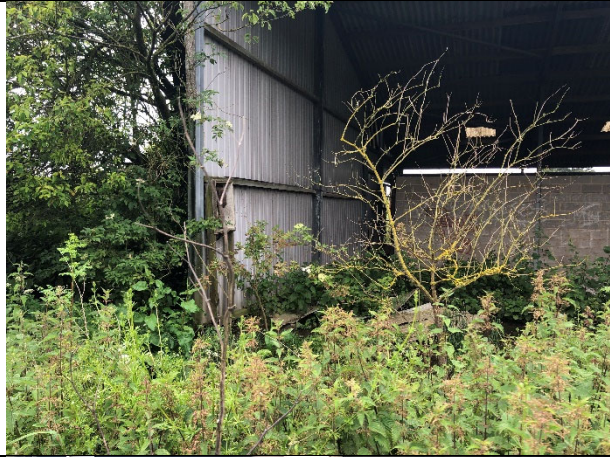
<p>Agricultural shed, broken roofing sheets, looking east.</p>

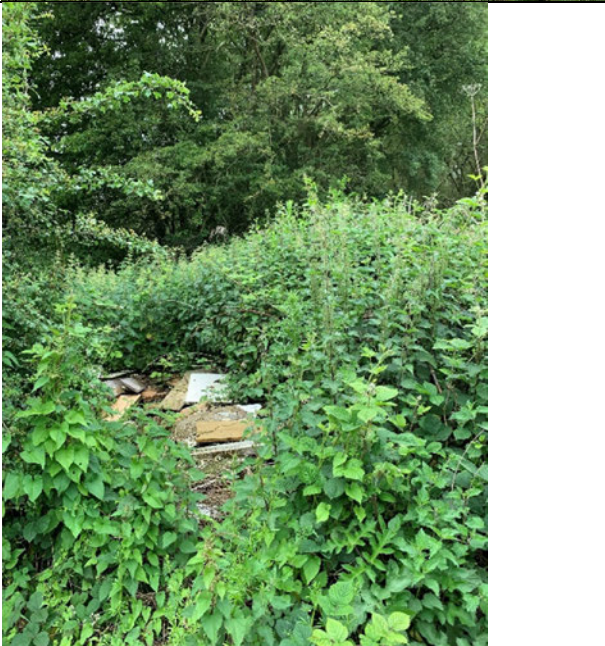
Flytipping in Area B, opposite side of Winch hill Lane.

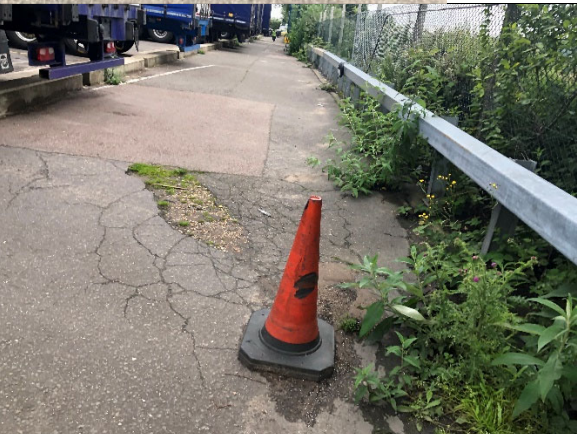
<p><u>Hardstanding</u></p> <p>Location, type and repair</p>	<p>E1. - Trailer Park is entirely comprised of hardstanding- concrete and asphalt, which is in average to poor condition, with cracking/crazing, areas of degraded surfacing, potholes and patched repairs.</p> <p>E2. - Concrete/asphalt hardstanding across the southern area used for car parking, hardstanding in average to poor condition. Asphalt to front of building at the northern end of the site in average condition.</p> <p>E3. - Asphalt in good condition, with landscaping to western and northern boundaries.</p>
<p><u>Site boundary</u></p> <p>fences, walls, open, state of repair. Is boundary shown adequately on site plan?</p>	<p>E1 - Vehicle barriers are located to western boundary to rear of which is a concrete post and chain-link fence (which is in poor condition showing signs of movement), the fence continues around the southern boundary. A vehicle barrier is located to the eastern boundary with heras fencing forming edge protection at the southern end. Post and chain-link fencing continues around the northeastern corner and a short section of damaged metal paling fence. Vehicle barriers are located along the northern site boundary. Evidence of slope instability was noted on the southern and eastern embankments with netting installed. The platform also appears to have been reduced in size with vehicles brought in away from the edges. The embankments to the west and north are heavily vegetated. Vegetation is present to the top of the southern embankment. The toe of the southern embankment has been excavated back to allow extension of the access ramp carriageway due to the constriction of the MPTE south of the site.</p> <p>E2 - Boundary fencing comprises metal paling and concrete post and chain-link fencing in good condition. Stone-filled gabions are located to the rear of the fence at the northeast corner of the area at the toe of the embankment.</p> <p>E3 - Sheet piling has been installed part-way along the eastern and southern boundaries to the car showroom area to retain the earth embankments beyond. A post and chain-link fence is located to the top of the embankment at the eastern boundary and at the north-eastern corner. Further sections of chain-link fencing and metal paling fencing are located at the southern boundary. A low wooden post and rail fence is located to the remaining boundaries to the rear of landscaping. Fencing generally in good condition.</p>

Damage to surfacing at western boundary, looking south.

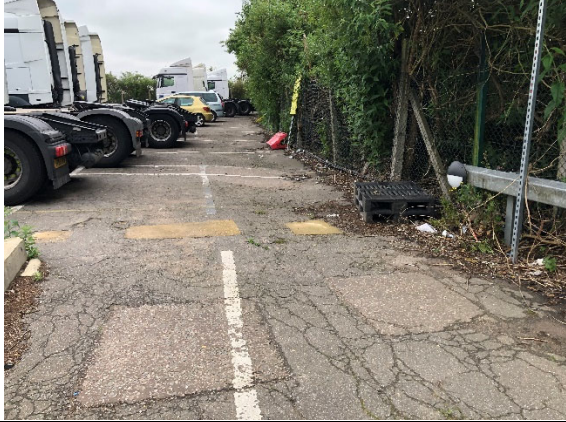
<p>Western boundary, showing movement to fence line, looking south.</p>
6

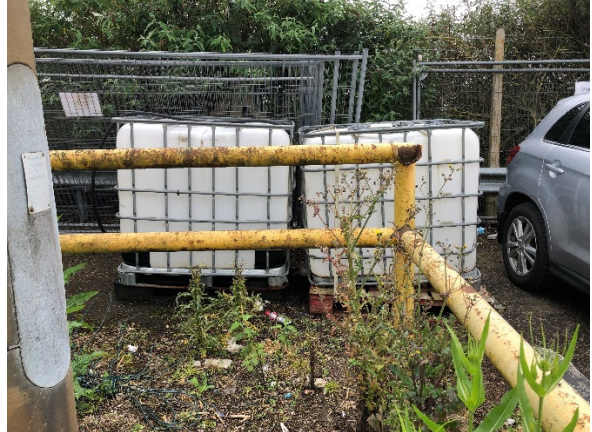
Empty IBC containers at southern boundary.
9

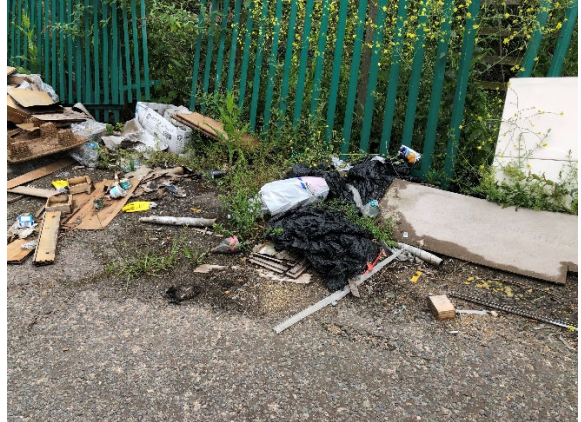
Flytipping and broken fence in northeastern corner.
18

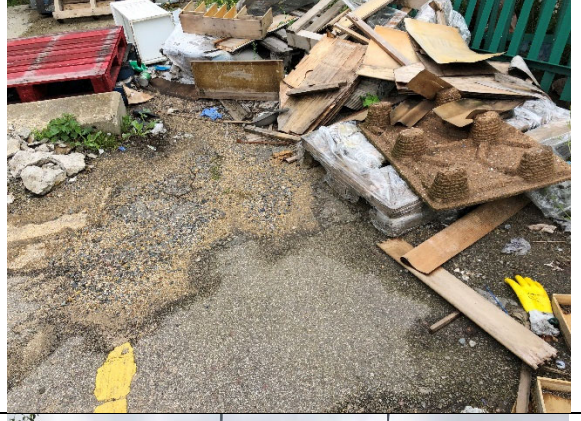
Flytipping, northern boundary.
19

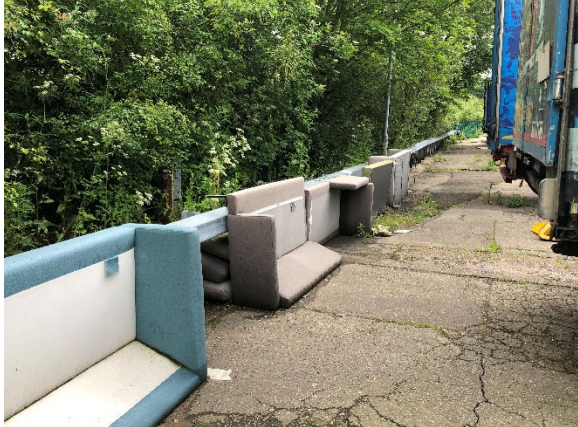
Flytipping of sofas at northern boundary, looking east.
23

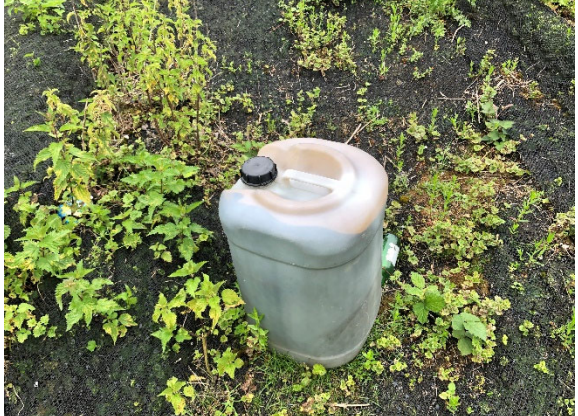
Plastic container, with possible oil inside.

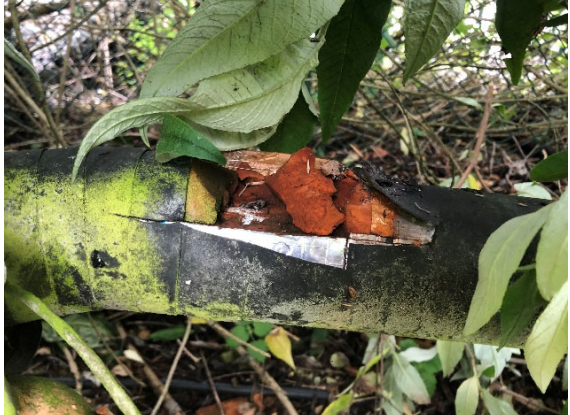
Insulation to cabling on steps upto plateau.
