London Luton Airport Expansion

Volume 5 Environmental Statement and Related Documents
**5.02 Appendix 17.1 Preliminary Risk Assessment of Land
Contamination - Part H**

**5.02 ENVIRONMENTAL STATEMENT APPENDIX 17.1
PRELIMINARY RISK ASSESSMENT OF LAND CONTAMINATION -
PART H**

PROJECT: London Luton Airport Expansion Development Consent Order Project No:261327-05

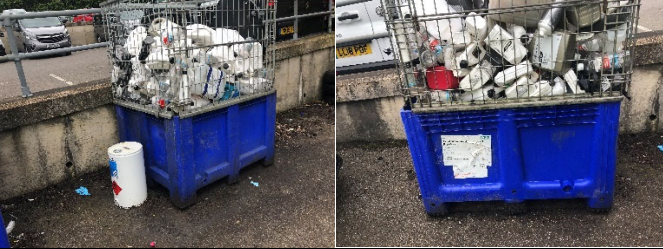
Contaminated plastic storage
62

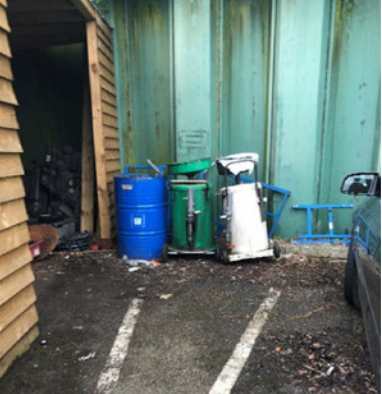
Waste Oil transfer pump at southern boundary

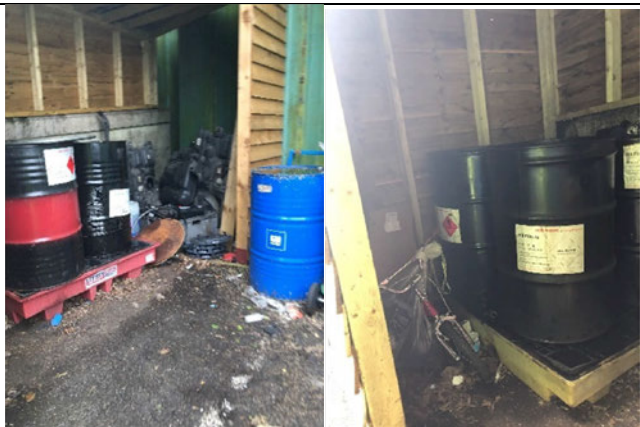
Barrels waste oil filters, fuel tanks, car batteries, hub caps, petroleum distillate barrels.
64

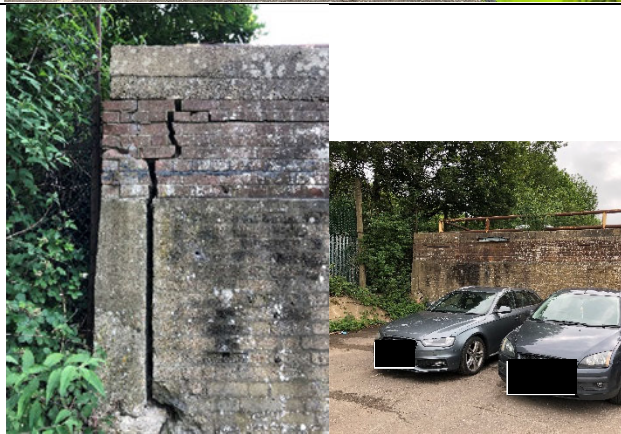
View of retaining wall to platform 1 and damage at northeast corner Looking southeast.
7

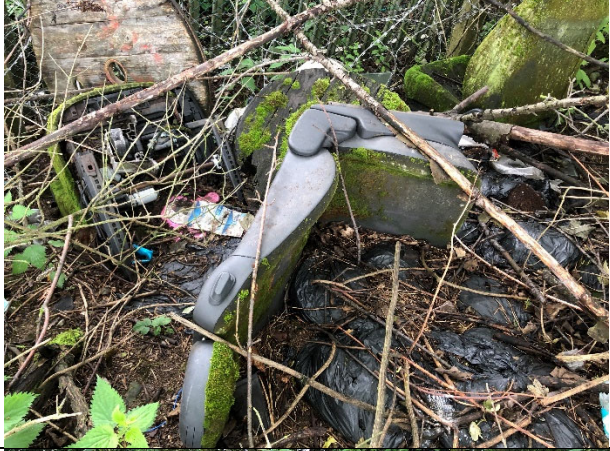
A photograph showing a pile of flytipped waste. The waste includes black plastic bags, sticks, and other debris. A large, dark, curved object, possibly a piece of machinery or a large container, is partially visible in the center of the pile. The area is overgrown with some green plants.	Flytipping at northeastern boundary at side of platform 3.
14

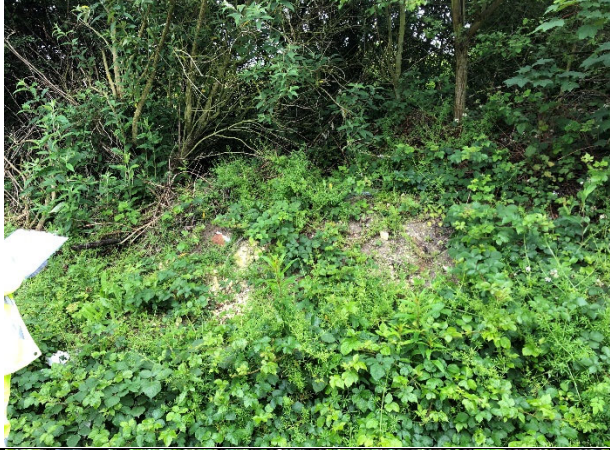
A photograph showing a mound of soil and vegetation. The ground is covered with dense green undergrowth, including various leafy plants and small trees. The mound appears to be a spoil mound, possibly from a construction site, and is located in an undergrowth area.	Spoil mound in undergrowth at southeast corner of platform 3.

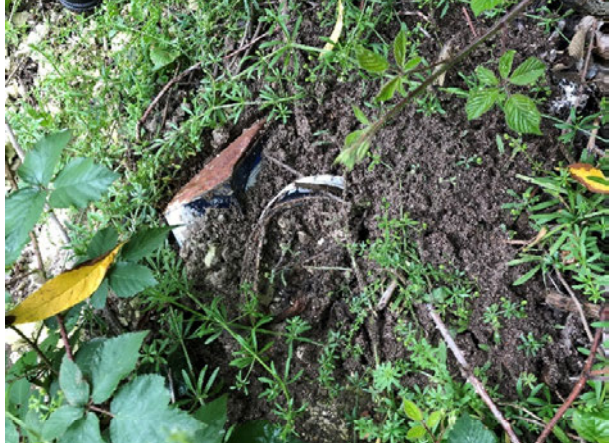
A photograph showing a paint tin buried in the earth. The tin is partially covered by soil and is surrounded by green vegetation, including leaves and stems. The tin appears to be a discarded container, possibly for paint or another liquid, and is located in an undergrowth area.	Paint tin buried in earth, platform 3

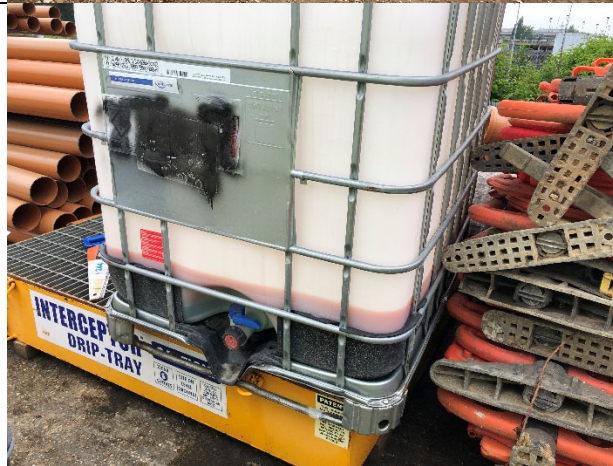
<p>IBC with antifreeze, platform 5.</p>
<p>22</p>

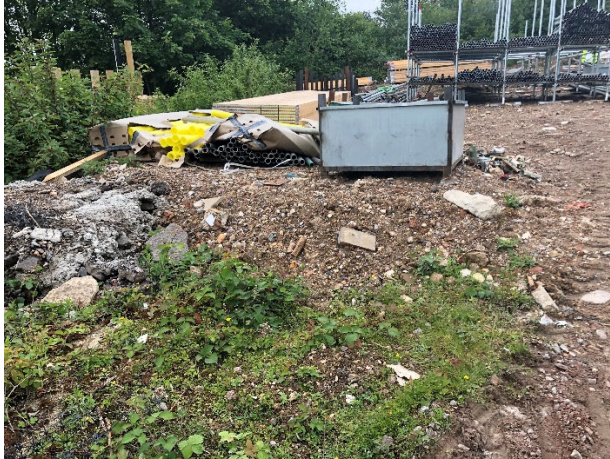
23

Small stockpile of old asphalt/road chippings at edge of Platform 7, looking east.

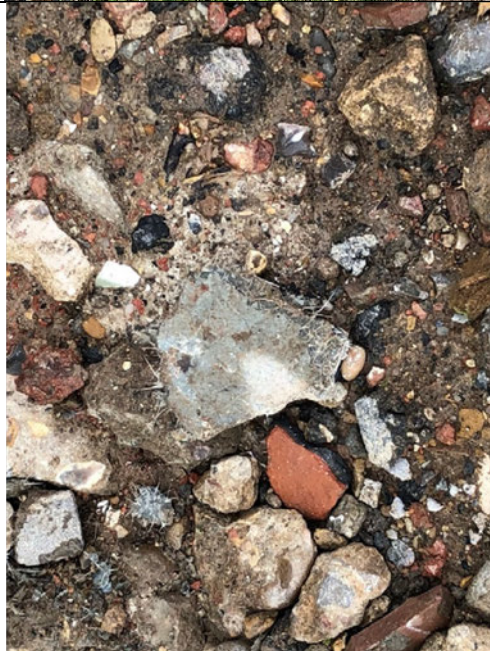
24

Fragment of fibrous material, possible asbestos.

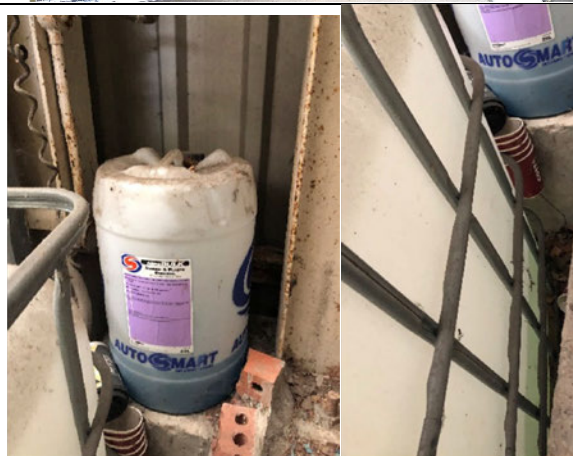
<p>A close-up photograph of a white plastic container (IBC) with a purple label. The container is sitting on a concrete base. The label has the word 'AUTO SMART' on it. The container is in a storage area, with other items visible in the background.</p>	25l plastic container of rubber and plastics dressing and IBC with possible water content inside vehicle inspection shed.
