**IMMINGHAM EASTERN RO-RO TERMINAL DEVELOPMENT CONSENT ORDER APPLICATION**

**PINS REFERENCE TR030007**

**DFDS' ANSWERS TO THE EXAMINING AUTHORITY'S SECOND WRITTEN QUESTIONS**

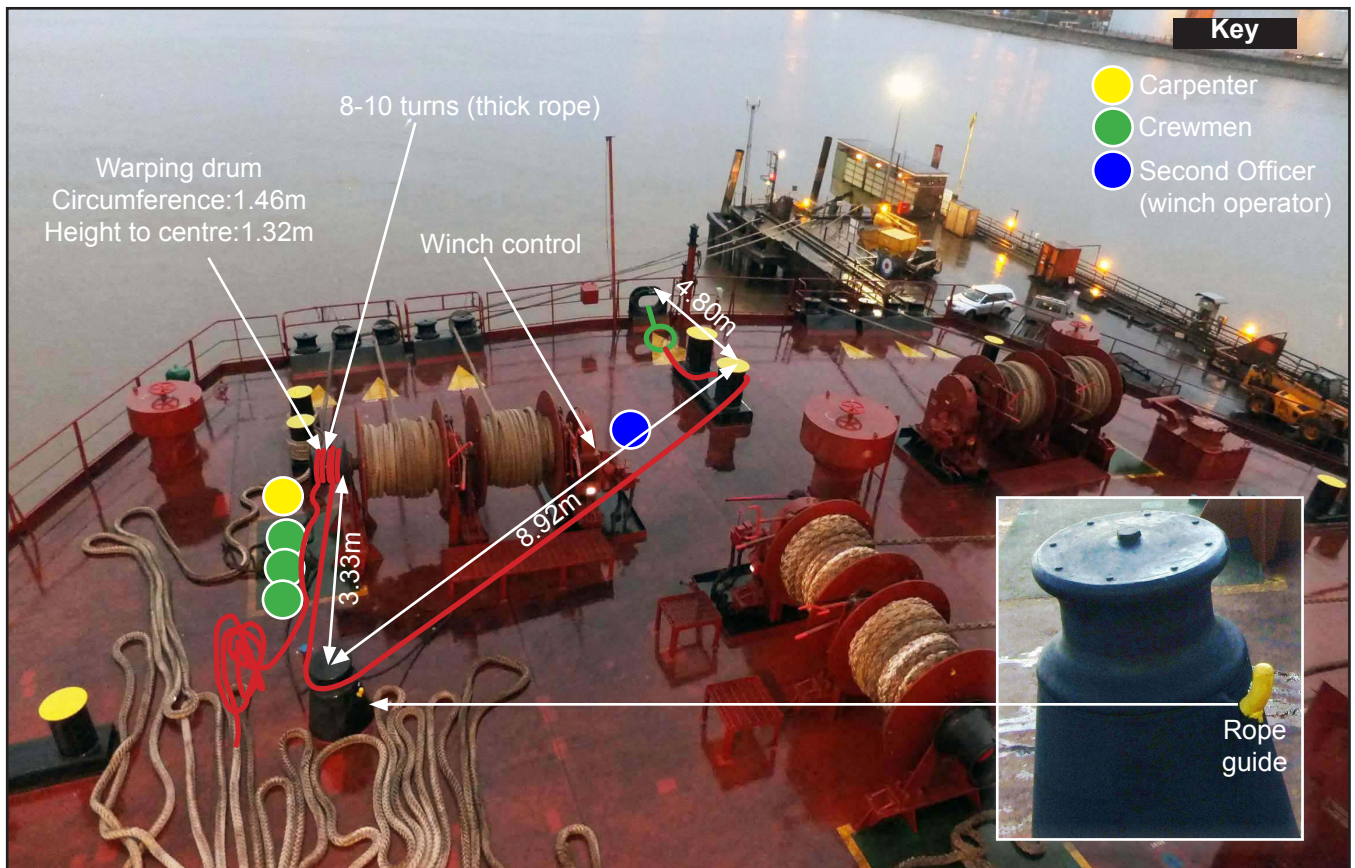
**Figure 2:** Layout of mooring equipment and messenger line routing at the time of the accident

The carpenter passed the messenger lines through the aft centreline bits and then diagonally across the deck, past the inboard side of the starboard winch, to a pedestal fairlead which was forward of the winch. He then passed the messenger line around the pedestal fairlead so it led off the outboard side of the fairlead to the warping drum (**Figure 2**). He then piled the free end of the

messenger line on the deck between the pedestal fairlead and winch and heaved it in by hand until all the slack line was taken up. Finally, the carpenter turned up the messenger line onto the warping drum, winding it on to the drum from the underside and leading it back towards the pedestal fairlead. The welder operated the winch controls, which were located at the opposite end of the winch (on the inboard side) to the warping drum. When standing at the winch controls, the welder could not see the carpenter due to the rope guards on the winch's main drums. The second officer stood at the aft railing to watch the tow wire as it was heaved up, while the two engine room ratings stood by to help secure it.

Once the aft mooring team decided to use the starboard winch to heave up the tow wire, they chose, and then persisted with, an unsuitable lead for the messenger line. The messenger line not only damaged the winch's hydraulic pipes, but also led onto the pedestal fairlead from the wrong direction. The pedestal fairlead was designed to assist in taking a breast or spring mooring line from ashore, with the line exiting from the pedestal on its inboard side. If it was used in this way, the line would lead onto the winch at a suitable fleet angle. There was also a rope guide positioned on the pedestal to support any slack lines when it was being used in this configuration (**Figure 2**). Routeing the messenger line around the pedestal fairlead from the inboard to the outboard side caused it to have a lead angle onto the warping drum of more than  $1.5^\circ$ . This made the messenger line accumulate at the outer end of the warping drum as it rotated. In this state, the messenger line was far more likely to develop riding turns and, or, slip off the outer edge of the warping drum.

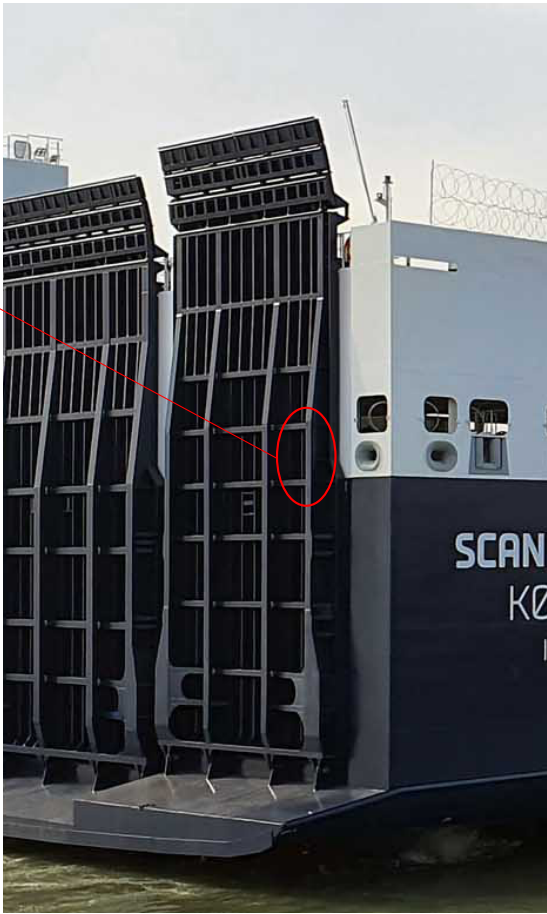
**Danger to tugs line**

The sharp edges of the ramp mean that tugs need to operate at 45° to the vessel at all times

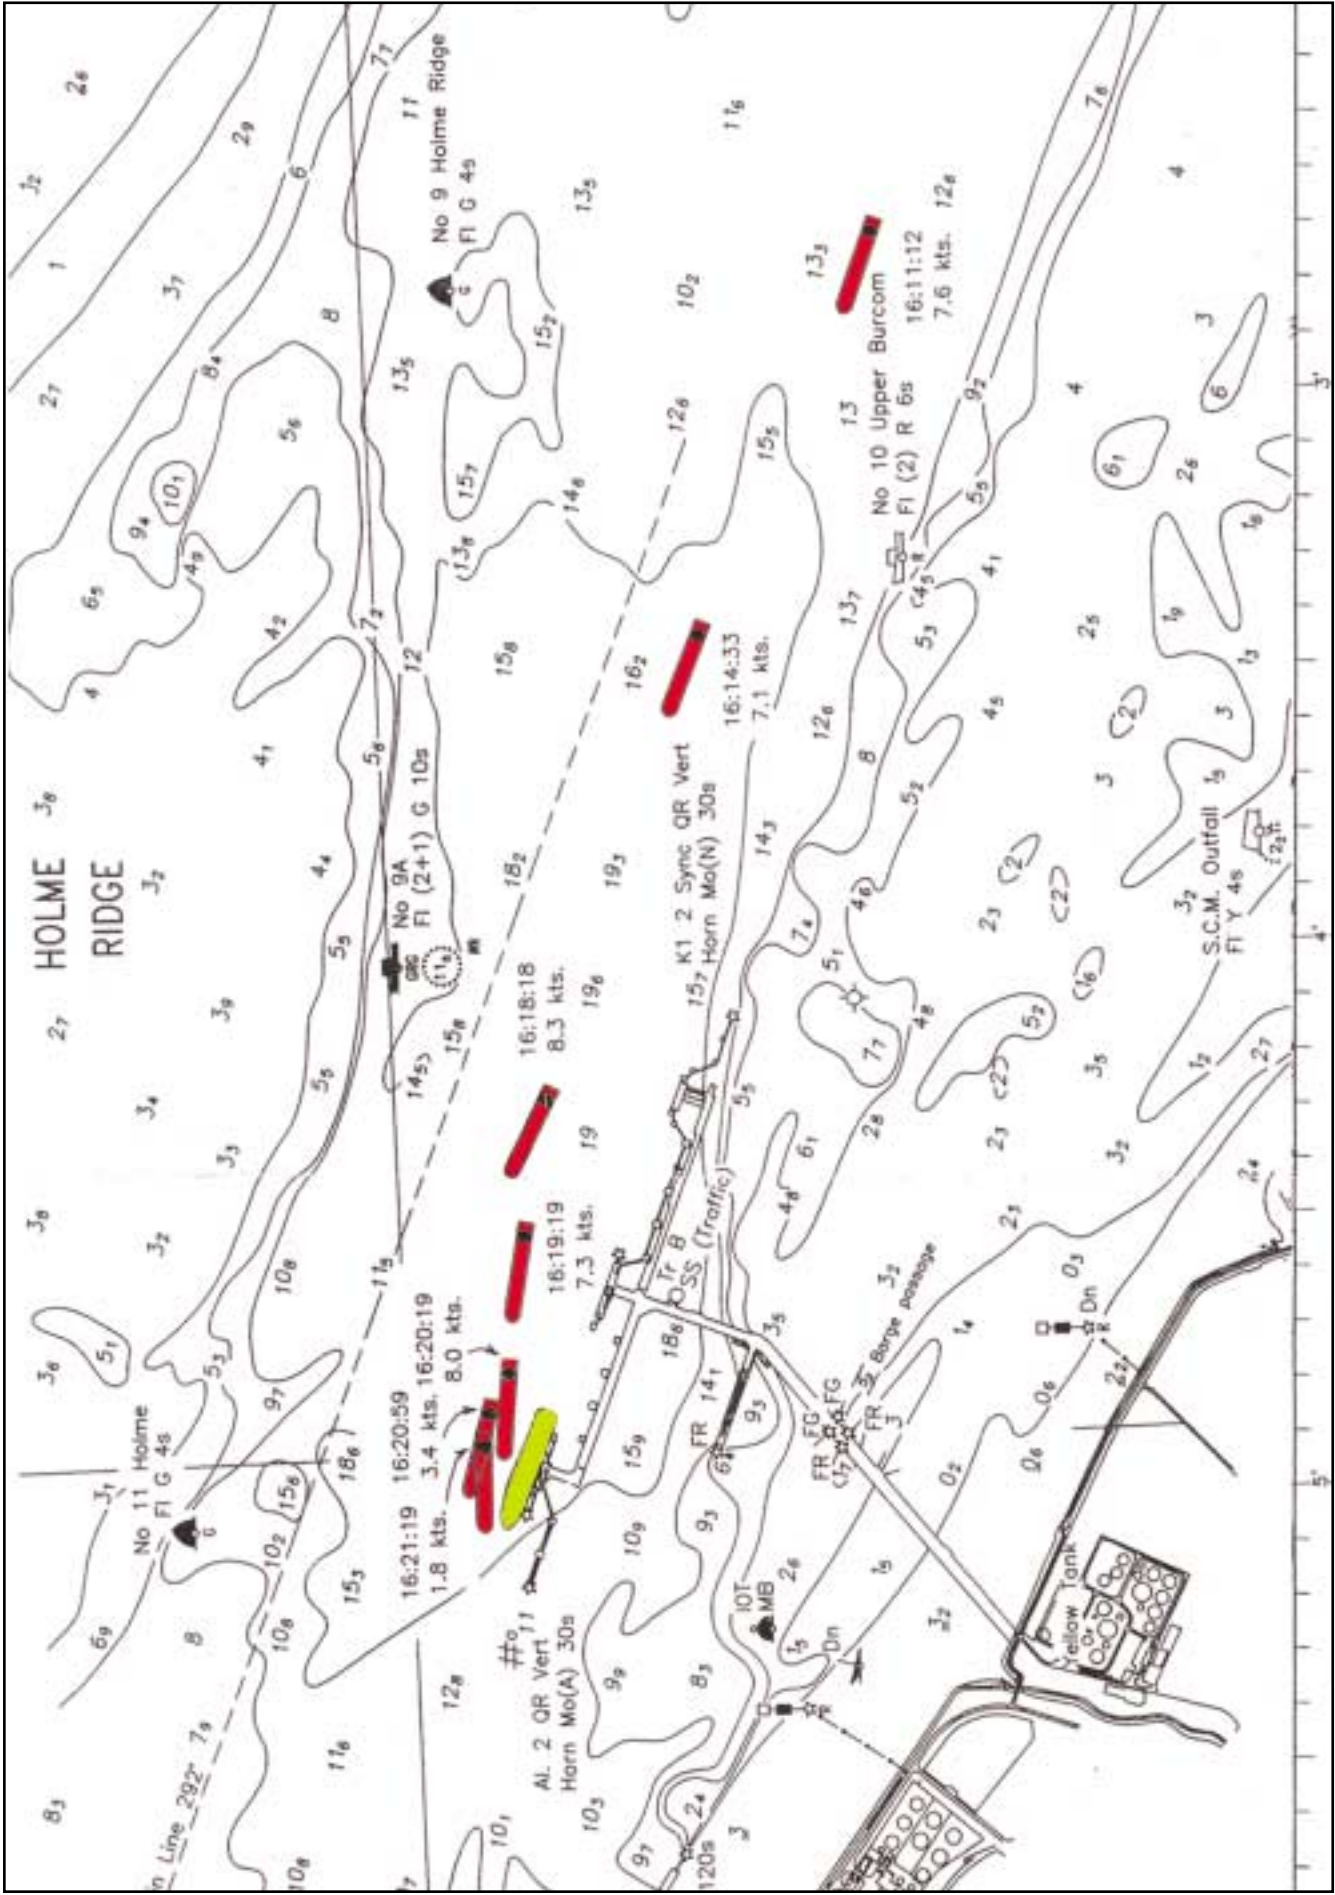
Figure 1

In anticipation of having to turn off the entrance to Immingham Dock, the pilot reduced the vessel's speed as she approached the eastern end of the oil terminal. Making only 3 knots through the water, with a 20-knot wind on her port quarter, and in a strong flood stream, *Xuchanghai* lost steerage and turned towards *Aberdeen*. The pilot took corrective action using helm, engine and the bow tug, but failed to prevent *Xuchanghai* colliding with *Aberdeen*.

Track of Xuchanghai as recorded by Humber VTS

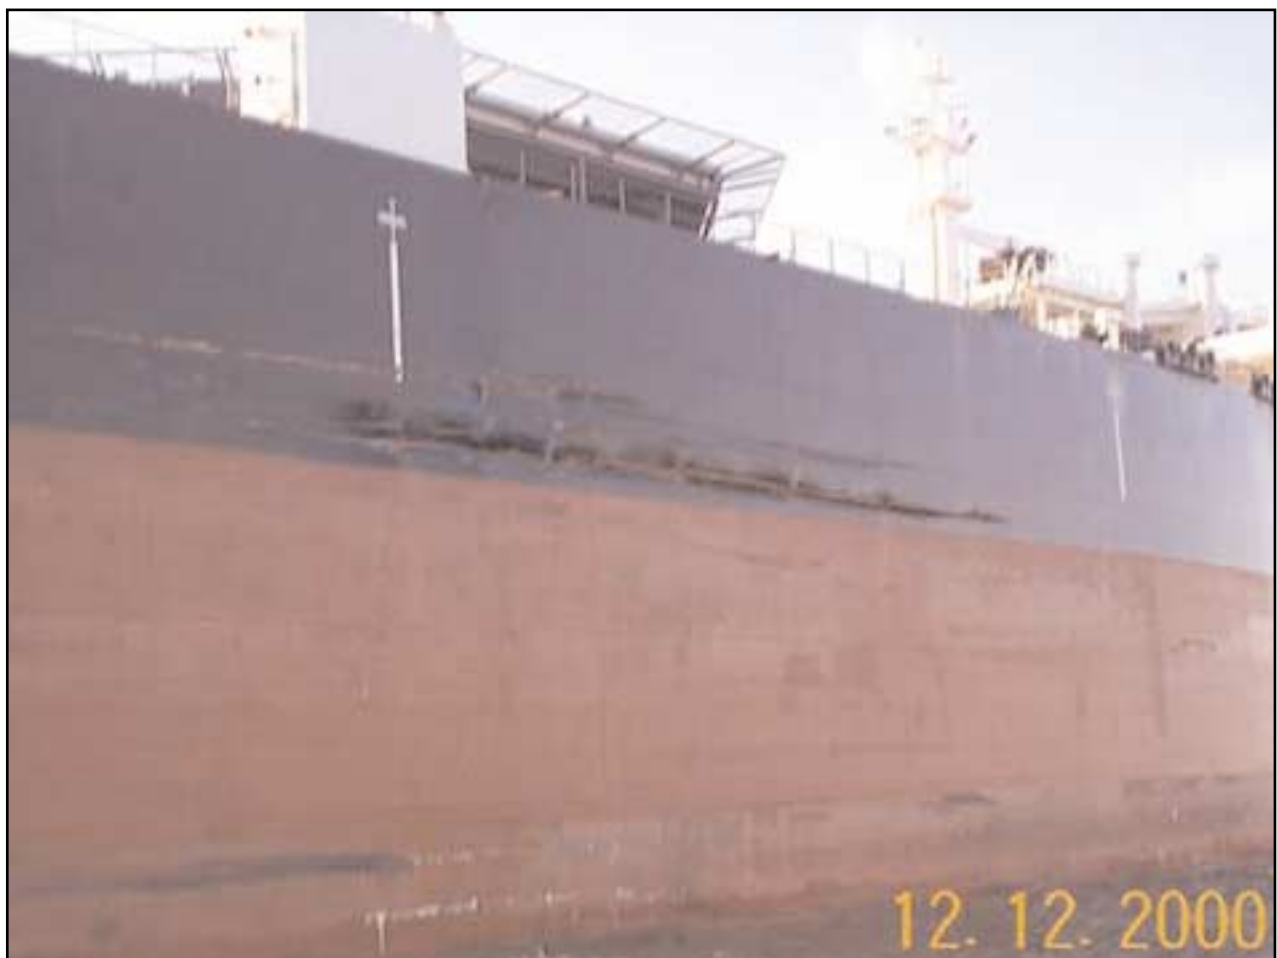
Figure 3

As a result of the collision, *Aberdeen*'s No 2 segregated ballast tank was ruptured, and one of her forward shore mooring lines parted. *Lady Cecilia*'s tow wire also parted immediately after impact. Using VHF radio, *Lady Cecilia*'s master immediately informed Immingham Dock of the collision.

The vessel had a double bottom and was fitted with segregated ballast tanks. She had completed discharging her cargo, and her empty cargo tanks had been crude oil washed and inert gassed. As a result of the collision, she sustained a 20m gash in her No 2 starboard ballast tank and, after sailing from the IOT, proceeded to Rotterdam for repairs. In Rotterdam the vessel was put into dry dock where it was confirmed there had been no damage below the waterline or inner hull, and a 40m long section was cropped and replaced. A photograph showing *Aberdeen* undergoing repair is at **Figure 3**.

Photograph of damage to *Aberdeen*

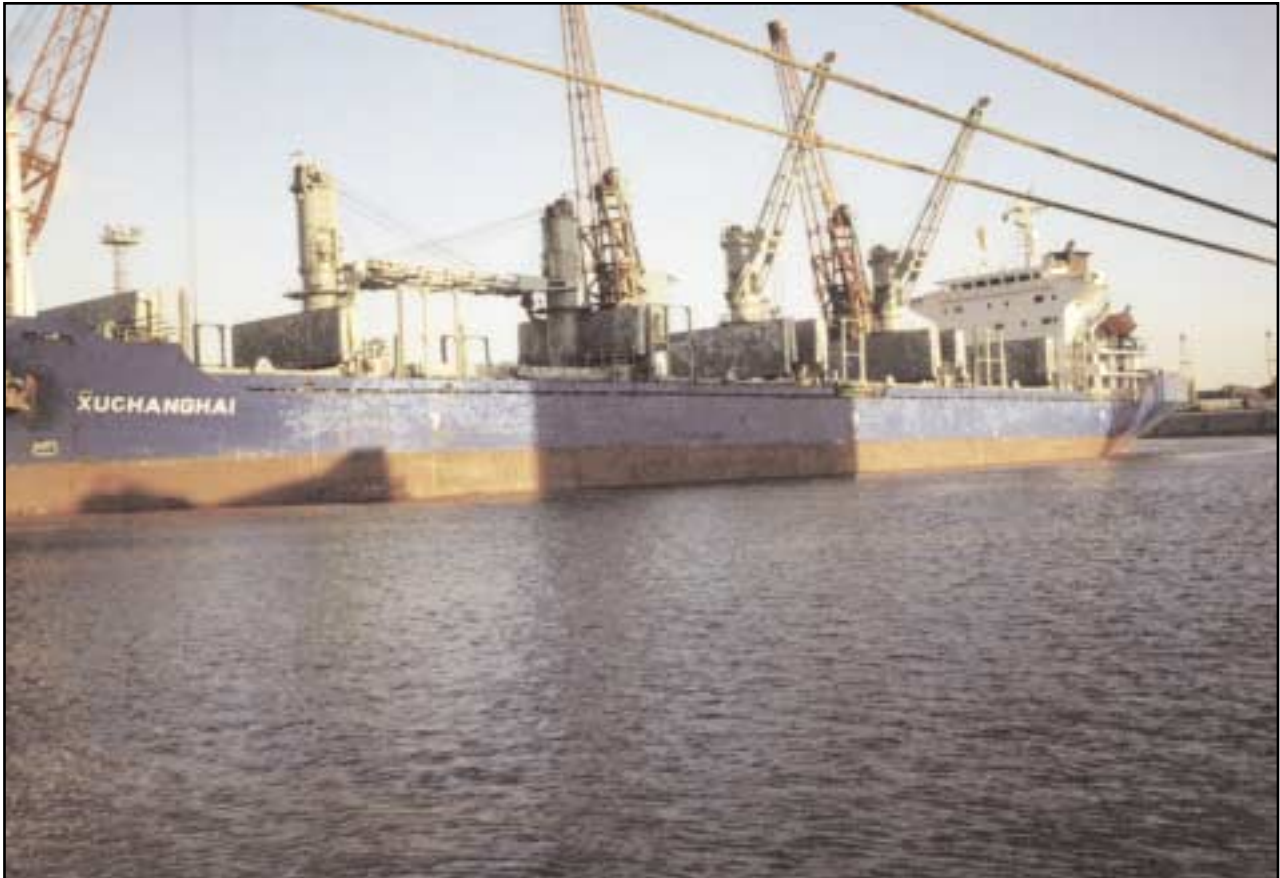
Figure 4

*Xuchanghai* sustained damage to her port side bulwark and stiffening over about 10m from the stem. A ladder and vent in this area were also buckled. There was no damage below the waterline. A photograph of *Xuchanghai* alongside in Immingham following the collision is at **Figure 4**.
