HINCKLEY NATIONAL RAIL FREIGHT INTERCHANGE

Interim Stage 1 Road Safety Audit Response Report

Document reference: 21.1

Report Title:	Hinckley National Rail Freight Interchange – Interim Stage 1 RSA Response Report
Document Number:	HRF-BWB-HGN-RSA-RP-CH-0001
Prepared By:	BWB Consulting Ltd
Overseeing Organisation:	Leicestershire County Council
BWB Reference:	NTT2814

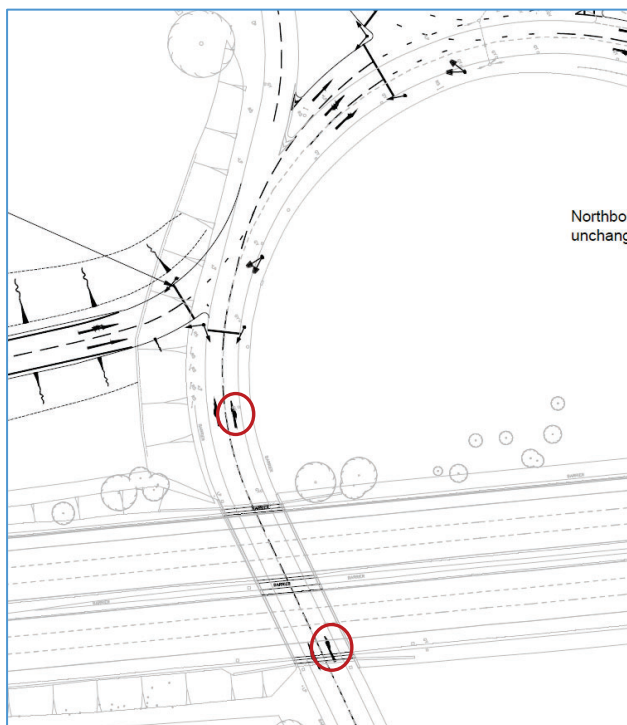
Around the southern carriageway of the circulatory the lane destinations show an “ahead” and a “right turn” arrow. However, approaching the junction and on the approaches before this point, “ahead” and “ahead and right” arrows are shown. This could lead to late lane changes, sudden and unexpected braking and side swipe type collisions due to driver confusion and late decision making as a result of confusing and misleading lane destinations.

It is recommended that the markings are amended so that they are consistent with the available movements around the southern half of the circulatory and on the westbound link road exit.

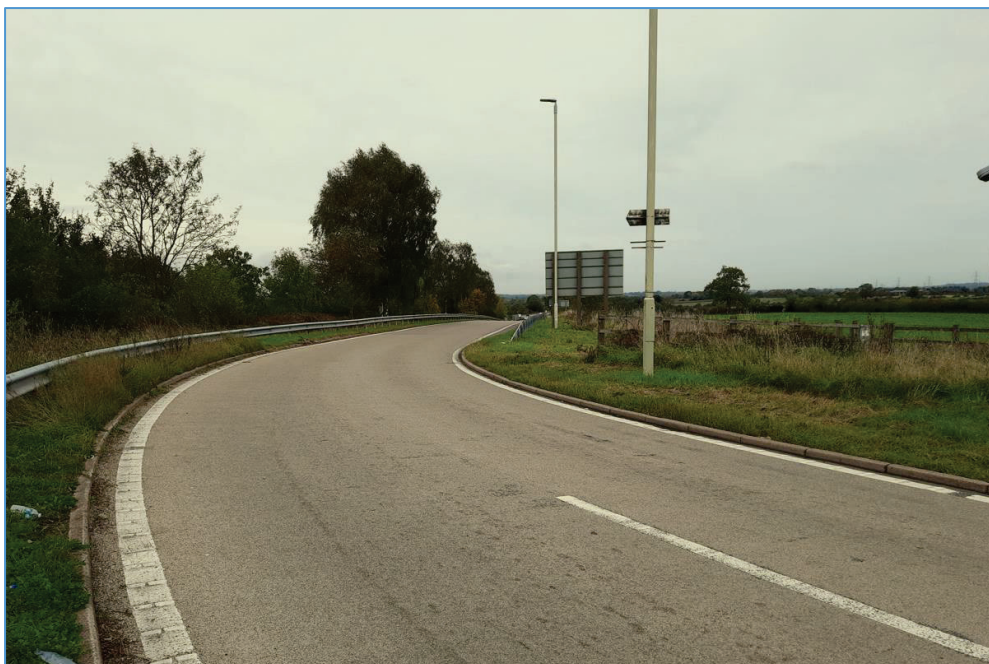
The southbound off-slip approach to the proposed signals at Junction 2 has a significant vertical and horizontal alignment change on the approach to the current Give-Way line. There is a concern that, given these changes and the existing signing infrastructure, that forward visibility towards the signal heads will not be provided for vehicles.

It is recommended that the signals are located and designed, including raised poles and/or gantry signals if needed, so as to provide adequate forward visibility for approaching vehicles. Furthermore, it is recommended that the signing on the approach is amended so as not to pose an obstruction.

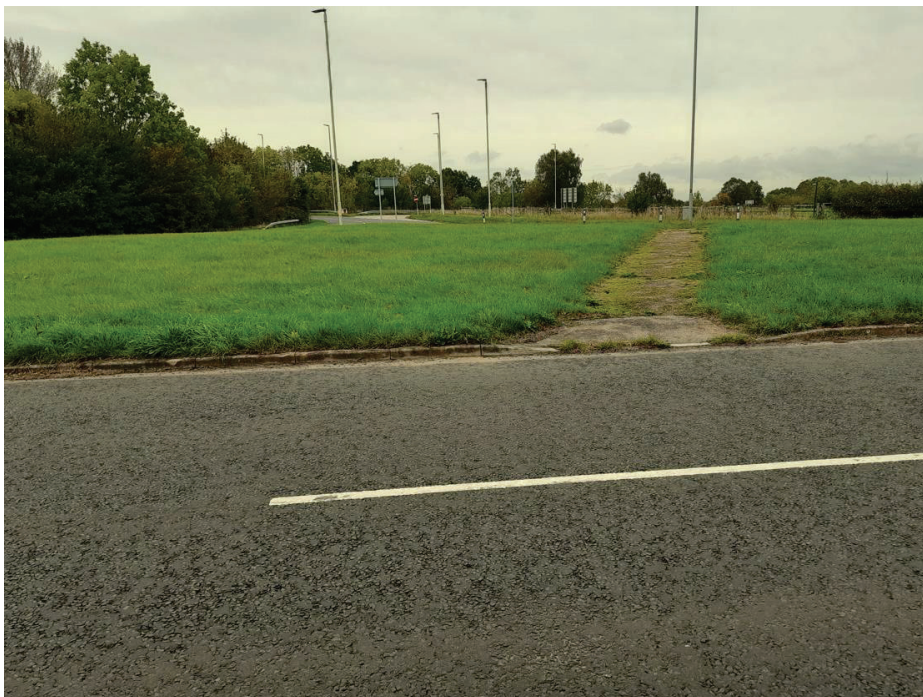
The existing bridleway crossing on the B4669 is set back from the carriageway by approximately 26m. Under the new arrangement equestrians will cross in front of the signal stop line, resulting in a diversion from the desire line and bringing riders towards the circulatory carriageway and traffic signals. There are concerns that the added noise and proximity to circulatory traffic may result in horses being 'spooked' and potentially result in vehicle to horse / equestrian collisions.

It is recommended that consultation is undertaken with local horse-riding groups and that, should the above concerns be realised, that the bridleway crossing is relocated.

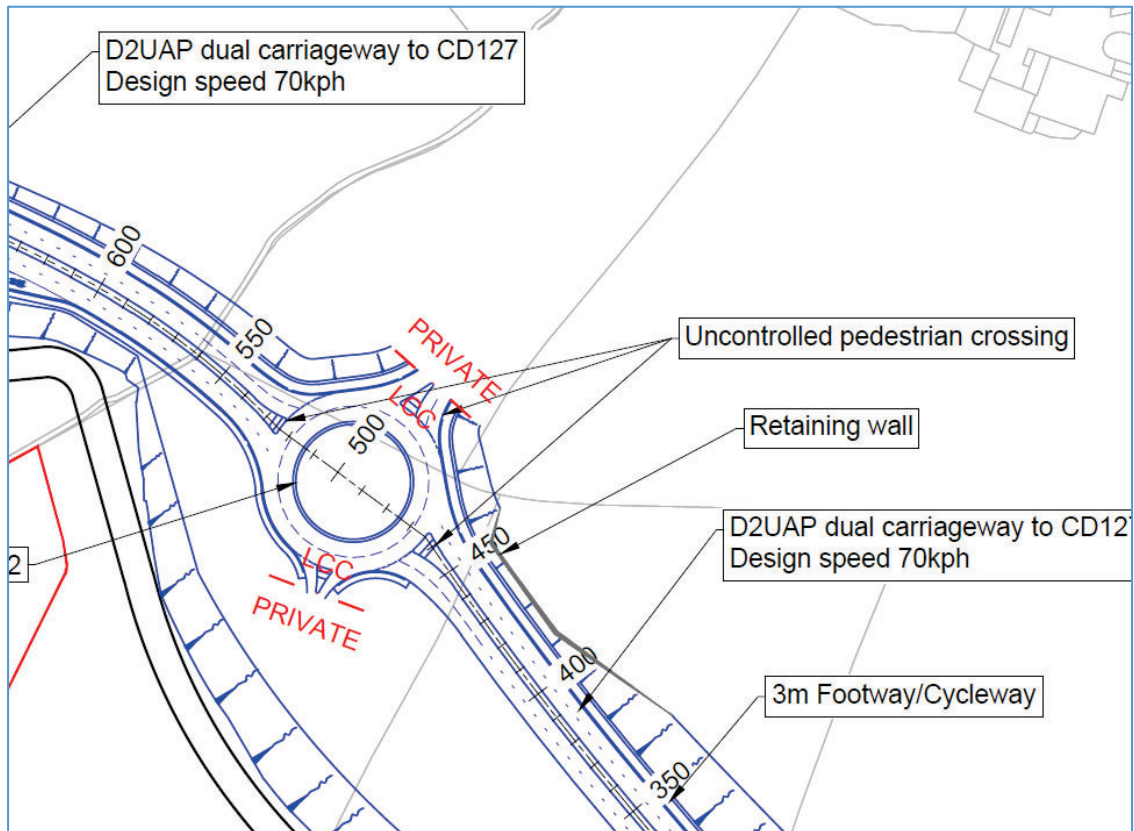
A 3m wide shared footway / cycleway is proposed along the northern side of the link road. However, the crossing point and route across the northern splitter island appear to be narrow and may not be of sufficient width to safely accommodate pedestrian and cycle movements. This risks cycle to pedestrian collisions.

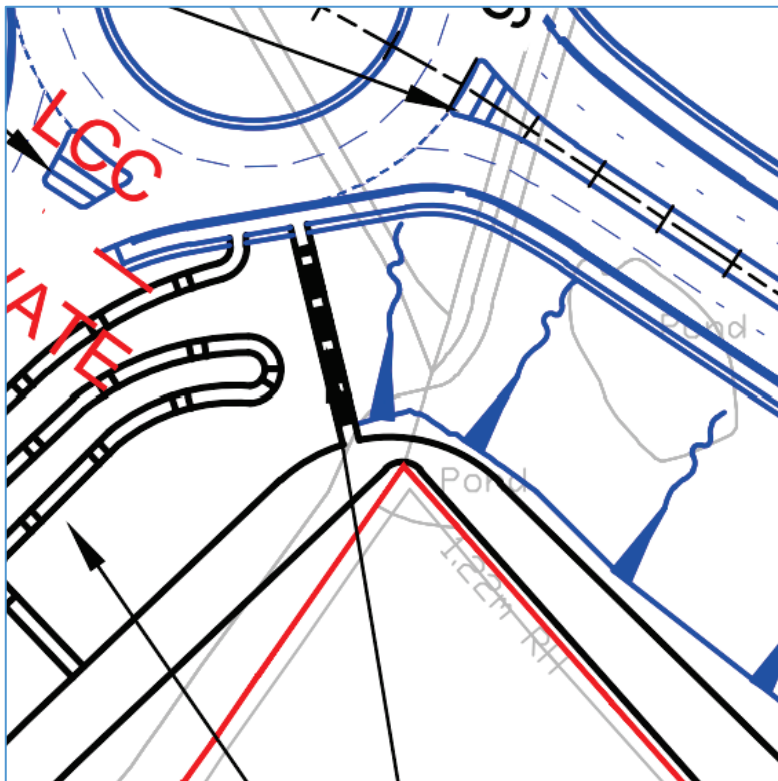
There are several instances on plan where the 10m brideway corridor narrows at bends in the route where forward visibility towards an oncoming user may be limited. It is not possible to ascertain the resulting width at these pinch points and thus likelihood of collisions and conflict between these users.

It is recommended that appropriate widths are maintained along the entirety of the brideway corridor.

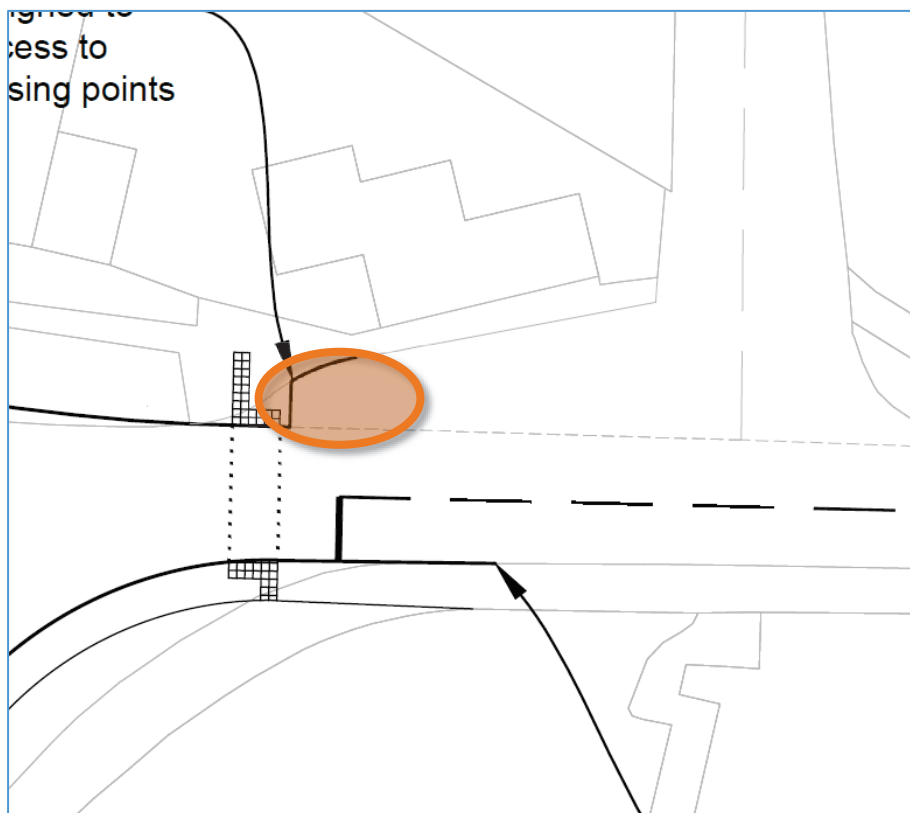
It was observed on site that a number of vehicles frequently park immediately adjacent to the property to the east of the crossing. There is a risk that a parked vehicle will obstruct visibility for and of pedestrians waiting to cross here, and that pedestrians may therefore enter the carriageway when it is unsafe to do so risking vehicle to pedestrian collisions.

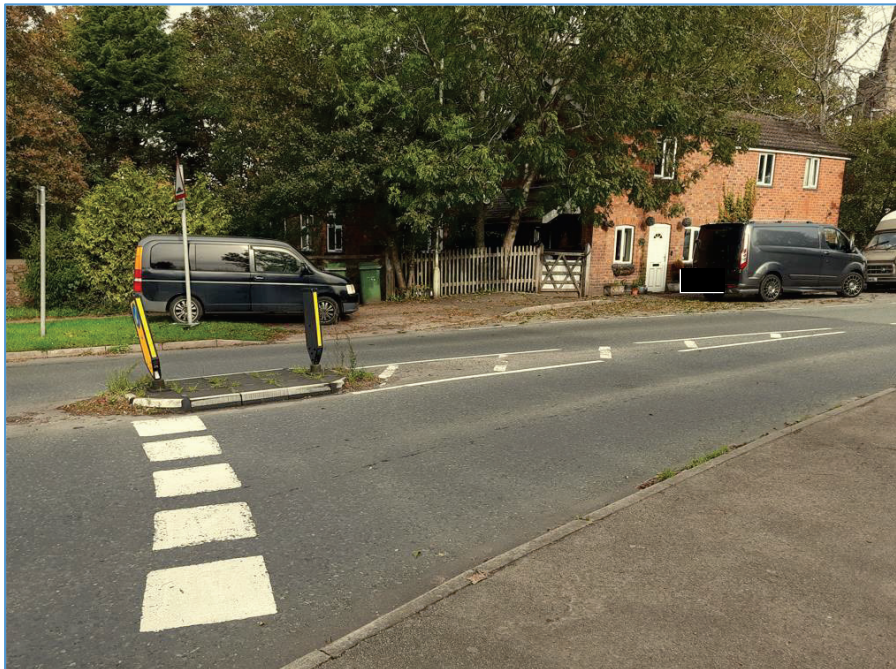
There is a private driveway access located immediately behind the northern side of the proposed pedestrian crossing, on the northern side of New Road. Should vehicles overrun the crossing there is a risk of damage to the tactile paving, creating trip type hazards. Furthermore, vehicles exiting from the driveway will enter the junction at a point where they cannot see a traffic signal, potentially entering in conflict with other movements resulting in collisions within the junction.

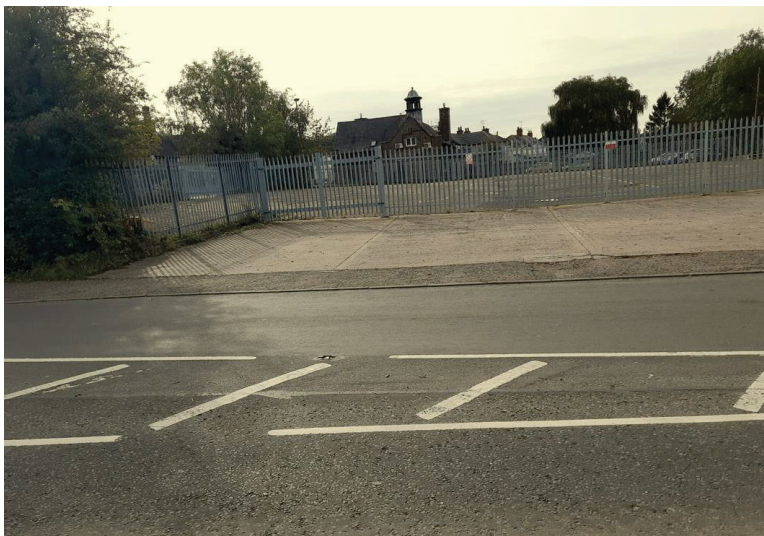
The proposed pedestrian crossing is situated within a long section of dropped kerb that appears to provide access to a depot car park, with the vehicular access directly behind the proposed pedestrian crossing. This could lead to vehicles overrunning the crossing in order to access the car park, posing a risk of collisions with pedestrians, unexpected stopping of vehicles within the junction risking shunts and damage to the tactile paving resulting in pedestrian trips.

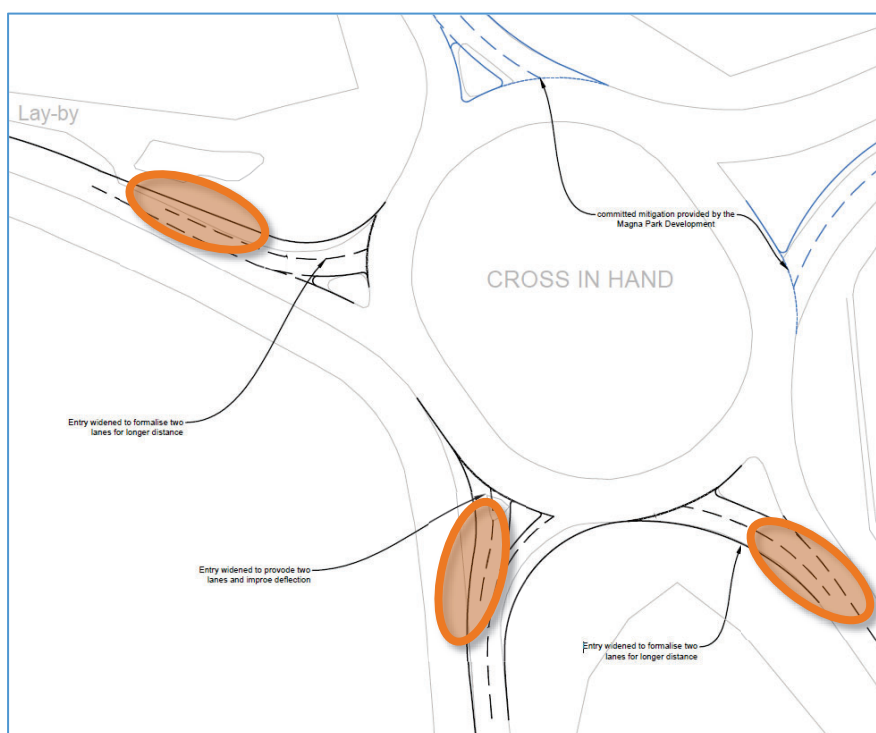
The proposed two-lane approaches appear to show lane widths of under 3.0m. Given the high-speed approaches and high percentage of HGV movements observed and expected through the junction, there is a risk that narrow lanes may result in side-swipe type collisions.

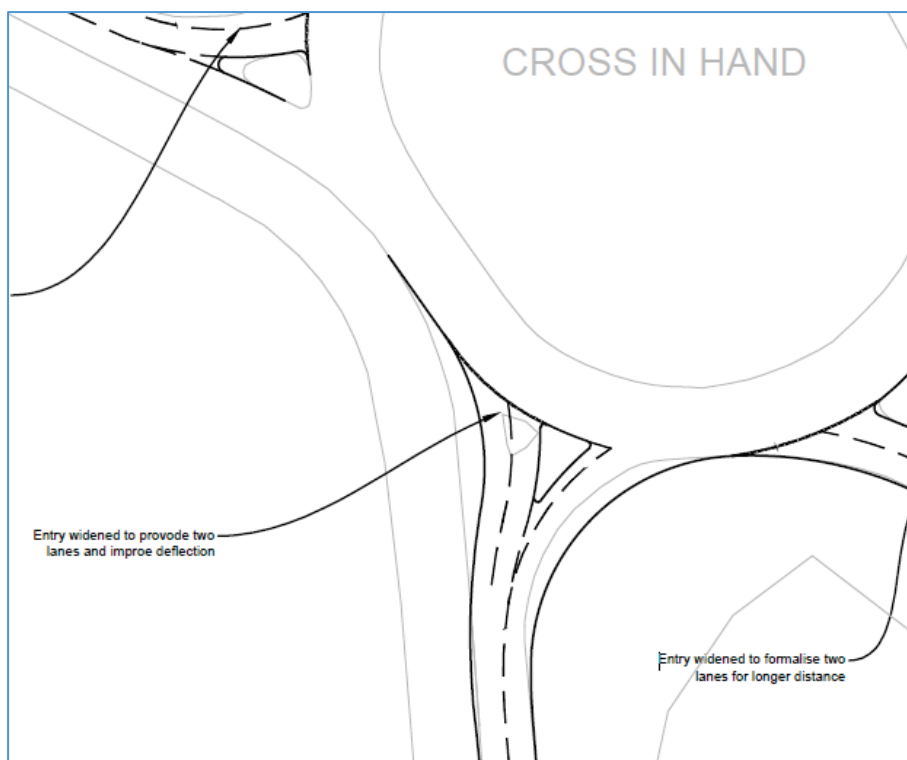
There is a concern that the entry path curvature from the offside lane on the B4027 approach will direct drivers toward the centre of the roundabout, risking kerb strikes. Furthermore, the realignment of the approach also means that vehicles in the nearside lane are likely to “squeeze” drivers in the offside lane, risking side-swipe type collisions.

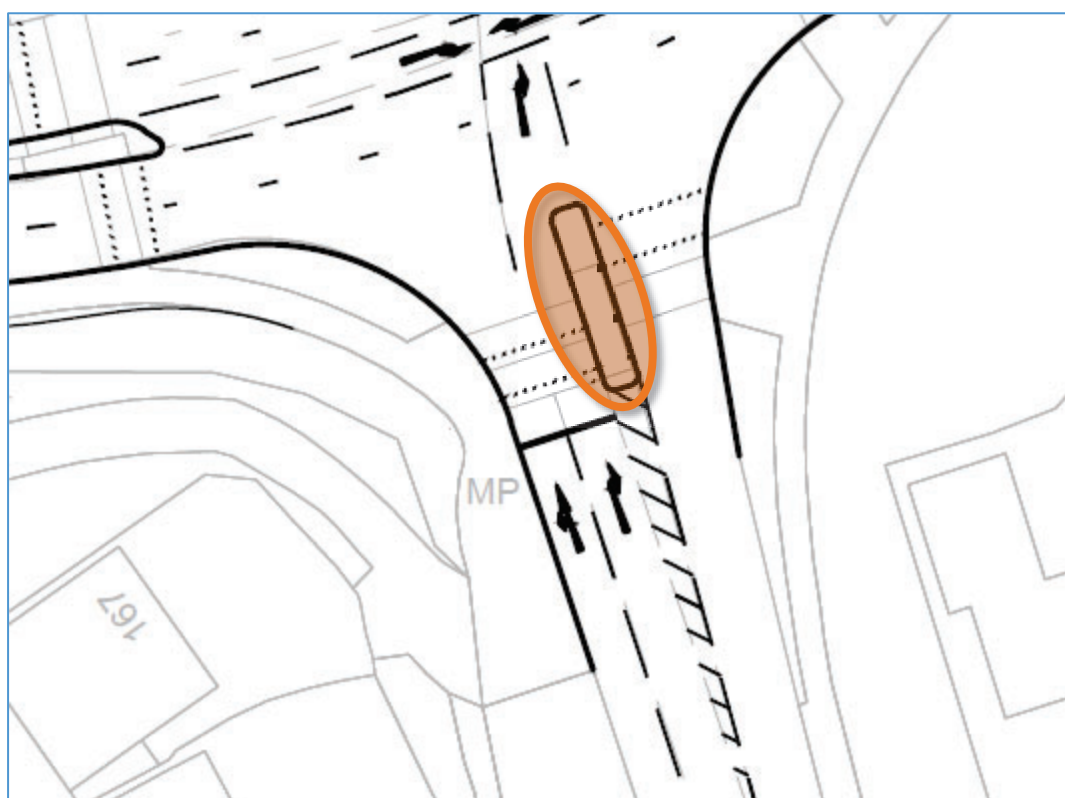
It was observed on site that a shared footway / cycleway is present along the southern side of the A47 through the junction. There is a concern that the proposed central island that segregates the two opposing traffic flows on this arm is not wide enough to safely accommodate shared use and there is therefore a risk of cycle to pedestrian collisions here.

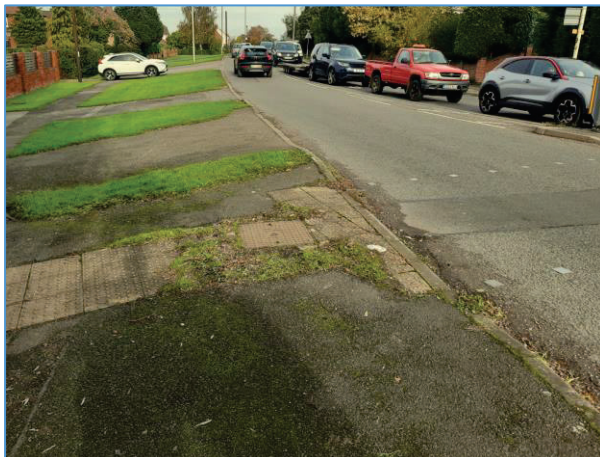
The western side of the existing pedestrian crossing on the northern arm of the Ashby Road approach currently has a significant gradient. As part of the detailed design, it is recommended that the gradient at the realigned side of the crossing is amended so as to mitigate the impact of on mobility impaired pedestrians.

RSA Ref.	RSA Problem and Recommendation	Design organisation response	Overseeing organisation response	Agreed RSA action
4.2	The western side of the existing pedestrian crossing on the northern arm of the Ashby Road approach currently has a significant gradient. As part of the detailed design, it is recommended that the gradient at the realigned side of the crossing is amended so as to mitigate the impact of on mobility impaired pedestrians.	This will be considered as part of the detailed design and improved as far as possible.

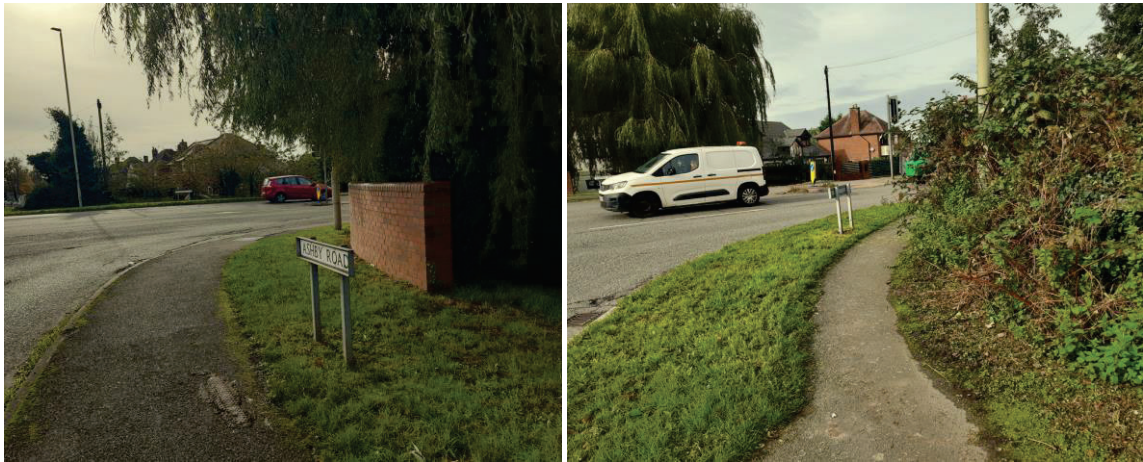
As with AC 1 above, it was observed that at present visibility of approaching vehicles for pedestrians crossing the A47 eastern arm and Ashby Road northern arm is restricted by vegetation as well as the adjacent property boundaries. As part of the detailed design, it is recommended that the site clearance includes maximising inter-visibility for and of pedestrians at the crossing points.

4.3	As with AC 1 above, it was observed that at present visibility of approaching vehicles for pedestrians crossing the A47 eastern arm and Ashby Road northern arm is restricted by vegetation as well as the adjacent property boundaries. As part of the detailed design, it is recommended that the site clearance includes maximising inter-visibility for and of pedestrians at the crossing points.	Site clearance will assess all potential opportunities for vegetation clearance to improve junction intervisibility.

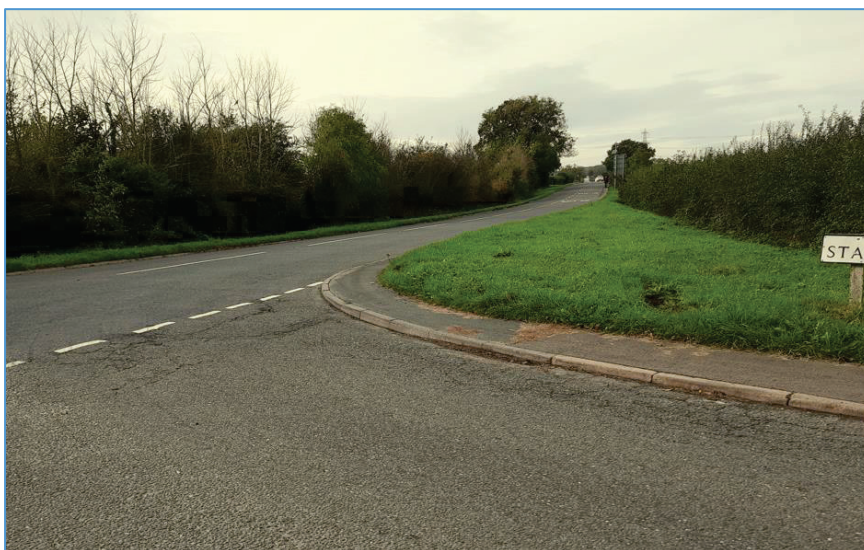
Whilst on site it was observed that a level difference was present between the base of the hedgerow to the west of the Stanton Lane junction and the existing verge and footway. As part of the proposals this approach will be widened to accommodate the central hatched area and traffic signals infrastructure. As part of the detailed design, it is recommended that the finished levels of the footway and embankment here are reviewed and amended so that there is not an immediate drop to the back of the footway that would pose a risk of injury to pedestrians.

RSA Ref.	RSA Problem and Recommendation	Design organisation response	Overseeing organisation response	Agreed RSA action
	Whilst on site it was observed that a level difference was present between the base of the hedgerow to the west of the Stanton Lane junction and the existing verge and footway. As part of the proposals this approach will be widened to accommodate the central hatched area and traffic signals infrastructure. As part of the detailed design, it is recommended that the finished levels of the footway and embankment here are reviewed and amended so that there is not an immediate drop to the back of the footway that would pose a risk of injury to pedestrians.	The levels will be reviewed as part of the detailed design and any retaining or level difference will be provided with appropriate edge restraint to protect pedestrians.

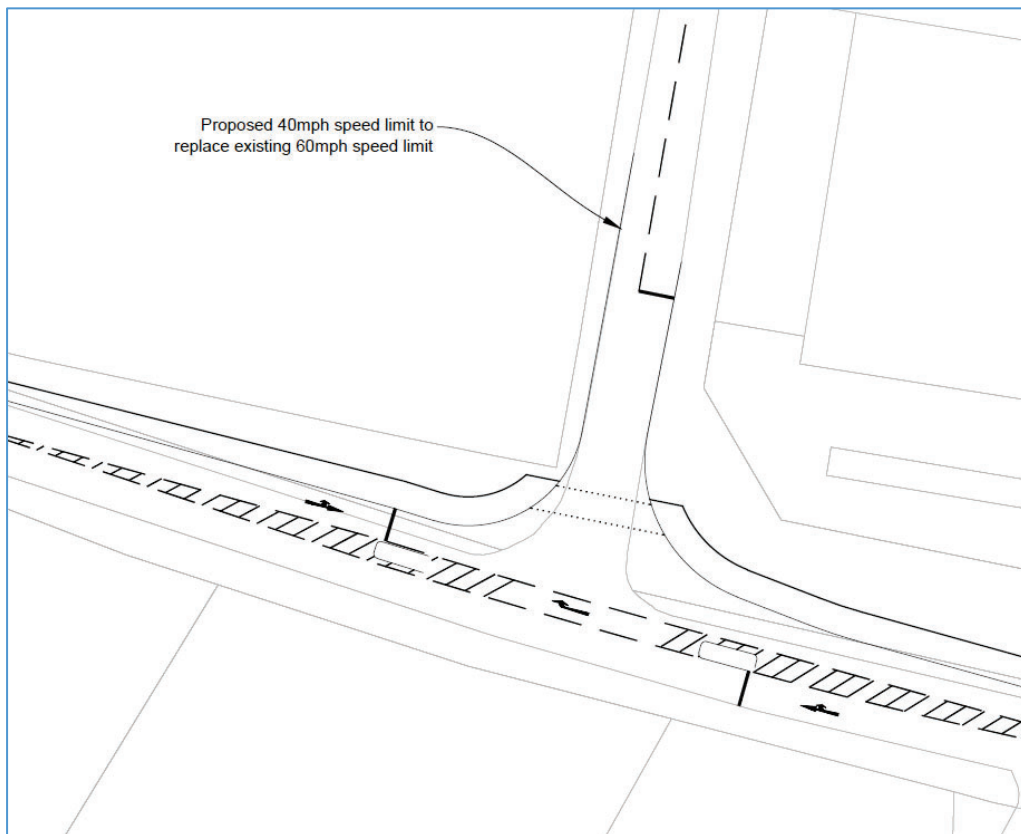
The proposals include a significant set-back for the signals and stop line on the Stanton Lane arm of the junction. As part of the detailed design, it is recommended that suitable inter-greens and vehicle detection are provided so as to ensure that vehicles are able to clear the junction before opposing phases in the signals are ‘released’.

RSA Ref.	RSA Problem and Recommendation	Design organisation response	Overseeing organisation response	Agreed RSA action
4.2	The proposals include a significant set-back for the signals and stop line on the Stanton Lane arm of the junction. As part of the detailed design, it is recommended that suitable inter-greens and vehicle detection are provided so as to ensure that vehicles are able to clear the junction before opposing phases in the signals are 'released'.	The recommendation is noted, however the designer has reduced the set back of the stop line now that the topo survey of the junction has been completed which should eliminate the issue noted.

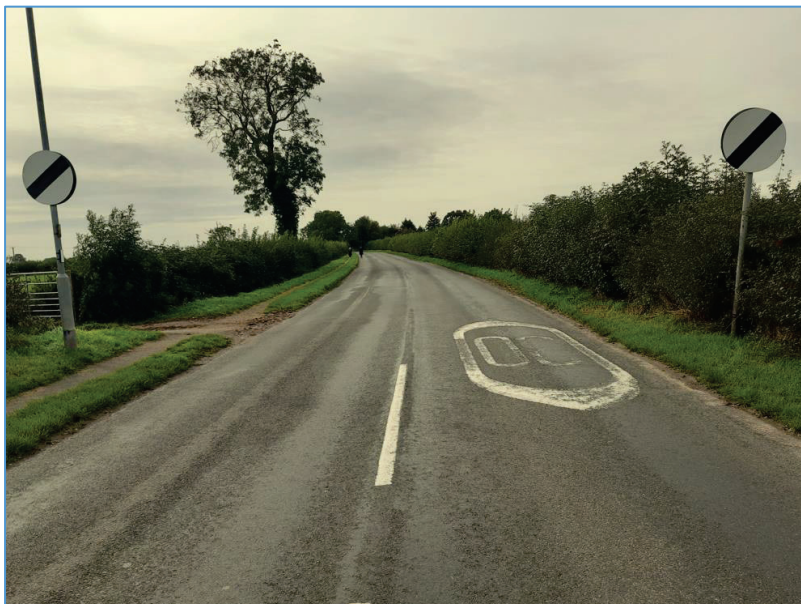
It is proposed to reduce the speed on Stanton Lane and Hinckley Road to 40mph from the existing national speed limit. This represents a significant reduction with no changes to the surrounding environment that would indicate why a 40mph speed would be viewed as ‘appropriate’ by drivers. As such, there is a risk of significant disparities between vehicle speeds should some drivers continue at higher speeds whilst others comply to the proposed lower limit, resulting in shunts and overtaking collisions.

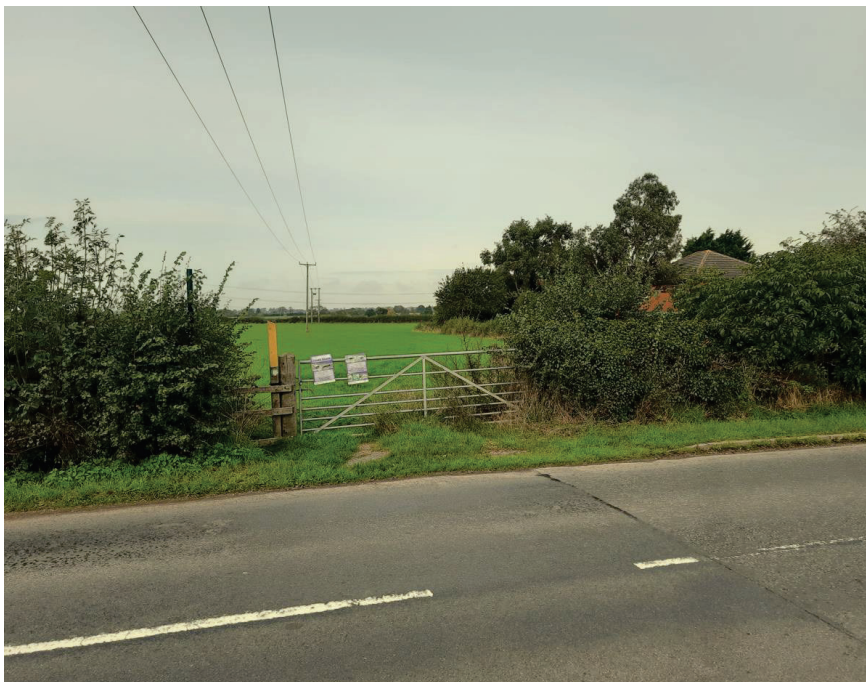
Whilst on site it was observed that there is a field access opposite the proposed feature on the northern side of Hinckley Road. It is unclear whether a farm vehicle (potentially with a trailer) would be able to turn in/out of the access without overrunning the feature, leading to it being damaged and potentially rendering it inconspicuous to other road users, risking kerb strikes and loss of control collisions.

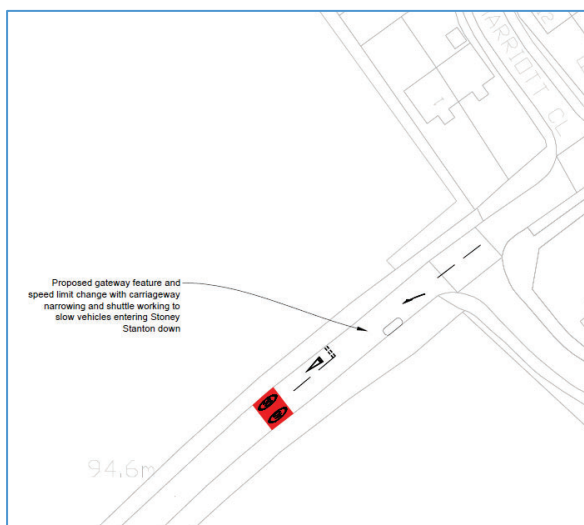
Traffic flows on Stanton Lane were observed to be low, with little two-way traffic observed at the same time. There is a concern that drivers will seldom be required to give way to oncoming vehicles and, as such, will not be prepared to slow or stop when approaching the give way. This is exacerbated by the location of the proposed feature – within the outbound lane on Stanton Lane – meaning that vehicles required to give way will not have a feature to negotiate or be informed of such. This, along with the potential high-speed approach as detailed in Problem 2 above means that there is a risk of vehicles striking the kerbed build out, as well as failures to give way and late braking, resulting in loss of control or head-on collisions. In the experience of the Audit Team, these types of features in this scenario and as a first response to reducing speed on entry to a village can result in collisions when used in isolation.

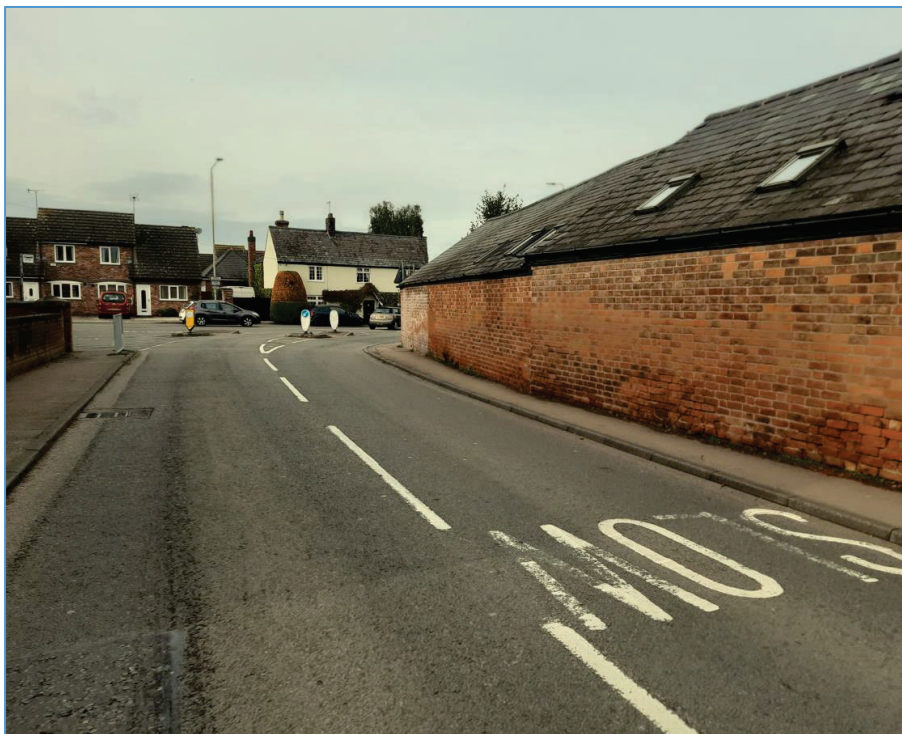
The bus stop is to be relocated from a lay-by arrangement outside of the Co-Op to an on-carriageway location adjacent to the Sapcote Church School. This is close to a right-hand bend in Leicester Road where the building line obstructs forward visibility of eastbound vehicles. Should a driver or rider decide to overtake a stationary bus here there is a risk that they will not see or be seen by an eastbound vehicle, risking a head-on/side swipe type collision.

RSA Ref.	RSA Problem and Recommendation	Design organisation response	Overseeing organisation response	Agreed RSA action
	<p>Location: Proposed bus stop – adjacent to the Sapcote Church School.</p> <p>Summary: Lack of forward visibility risks head on collisions involving overtaking vehicles. The bus stop is to be relocated from a lay-by arrangement outside of the Co-Op to an on-carriageway location adjacent to the Sapcote Church School. This is close to a right-hand bend in Leicester Road where the building line obstructs forward visibility of eastbound vehicles. Should a driver or rider decide to overtake a stationary bus here there is a risk that they will not see or be seen by an eastbound vehicle, risking a head-on/side swipe type collision.</p> <p>Recommendation: It is recommended that the bus stop is relocated such that a westbound overtaking vehicle will be able to complete their manoeuvre safely and with adequate forward visibility based on the speed of approaching, eastbound vehicles.</p>	<p>Agree with RSA recommendation: Yes</p> <p>The on carriageway bus stop adds to the general traffic calming features that are proposed through Sapcote in order to make this route less desirable for re-routeing traffic and therefore vehicles should be discouraged from overtaking stopped buses. The location of the bus stop has been considered to ensure that suitable visibility is available to parked buses. In addition, 47m of forward visibility (in line with LCC Table DG4) is available from behind a parked bus to oncoming vehicles so that should vehicles decide to overtake a parked bus, they are able to see oncoming vehicles. The designer has realigned the northern kerbline of the B4669 to improve forward visibility for eastbound vehicles.</p>

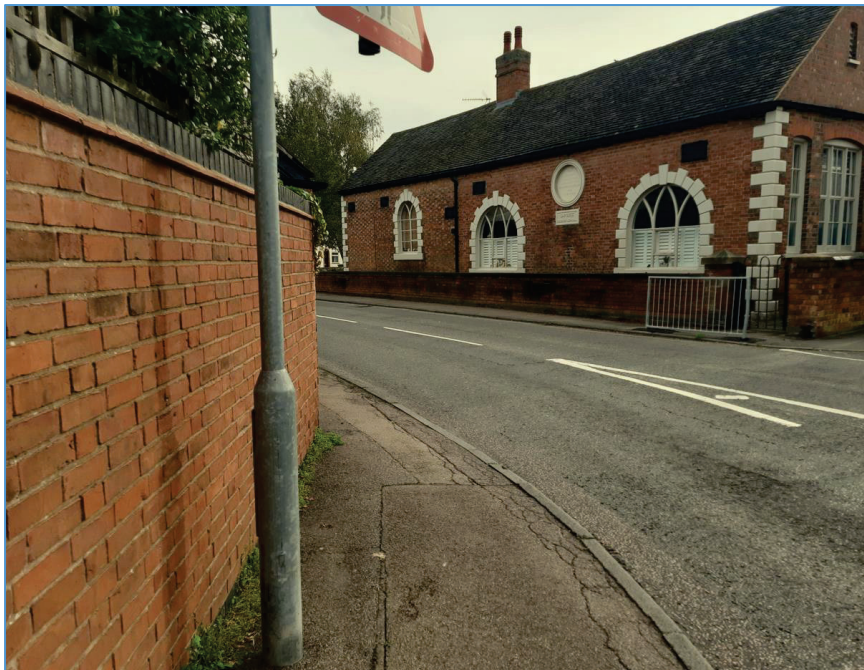
When crossing north to south, visibility for and of pedestrians crossing or waiting to cross is restricted to the east by the building line and boundary wall of the adjacent properties. This would be especially the case for wheelchair and pushchair users. Should they enter the carriageway when unsafe to do so there is a risk of vehicle to pedestrian collisions.

RSA Ref.	RSA Problem and Recommendation	Design organisation response	Overseeing organisation response	Agreed RSA action
3.3	<p>Location: Leicester Road - proposed Zebra crossing</p> <p>Summary: Restricted visibility risks vehicle to pedestrian collisions.</p> <p>When crossing north to south, visibility for and of pedestrians crossing or waiting to cross is restricted to the east by the building line and boundary wall of the adjacent properties. This would be especially the case for wheelchair and pushchair users. Should they enter the carriageway when unsafe to do so there is a risk of vehicle to pedestrian collisions.</p> <p>Recommendation:</p> <p>It is recommended that unobstructed pedestrian visibility commensurate with measured vehicle speeds is provided at the crossing point.</p>	<p>Agree with RSA recommendation: Yes</p> <p>While the zebra crossing replaces an existing uncontrolled crossing and is seen as an improvement in pedestrian safety, the designer has reviewed the location and the northern B4669 kerb line has been amended to provide more footway width and to ensure suitable forward visibility to users waiting to use the crossing. This is illustrated on the revised drawings.</p>

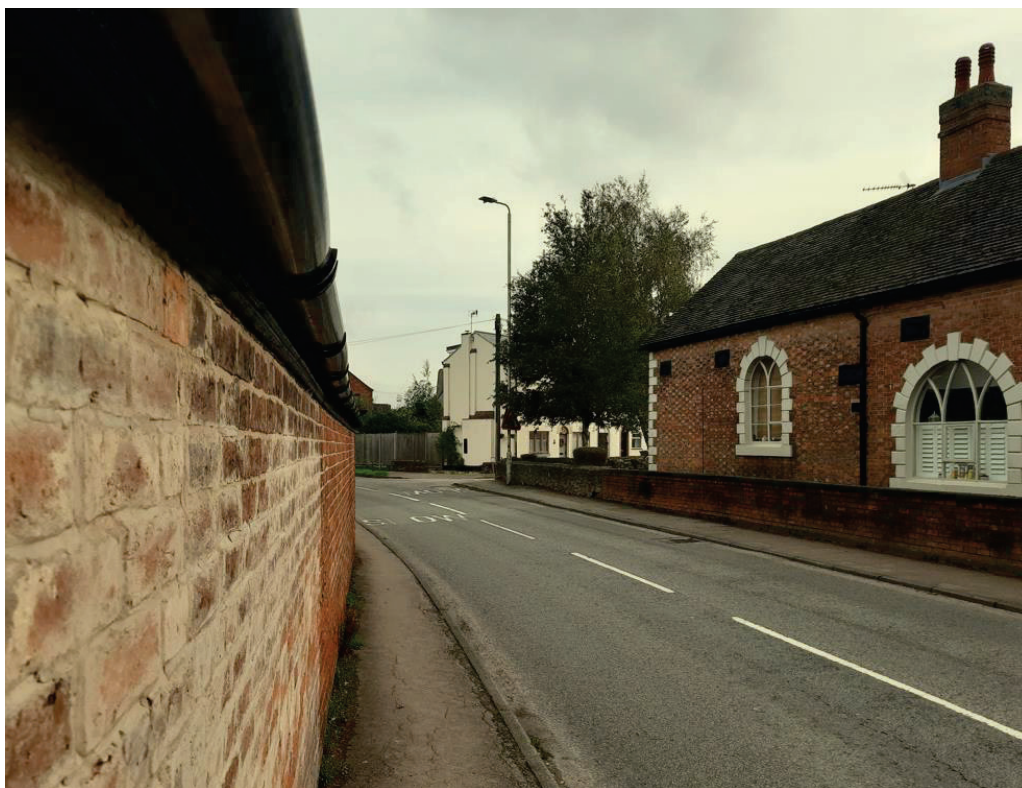
The footway immediately to the east of the proposed Zebra crossing is very narrow (<1m), with insufficient width for two-way pedestrian movements meaning pedestrians have to enter the carriageway in order to pass one another at a point where visibility of eastbound traffic is obscured by the adjacent property (refer to Problem 2). The location of the crossing will encourage an increase pedestrian movements along this narrow footway, risking vehicle to pedestrian collisions.

RSA Ref.	RSA Problem and Recommendation	Design organisation response	Overseeing organisation response	Agreed RSA action
3.4	<p>Location: Leicester Road – footway to the east of the proposed Zebra crossing.</p> <p>Summary: Narrow footway risks vehicle to pedestrian collisions. The footway immediately to the east of the proposed Zebra crossing is very narrow (<1m), with insufficient width for two-way pedestrian movements meaning pedestrians have to enter the carriageway in order to pass one another at a point where visibility of eastbound traffic is obscured by the adjacent property (refer to Problem 2). The location of the crossing will encourage an increase pedestrian movements along this narrow footway, risking vehicle to pedestrian collisions Recommendation:</p> <p>Recommendation:</p> <p>It is recommended that the crossing is relocated to a location where sufficient footway widths on the approaches are available.</p>	<p>Agree with RSA recommendation: In Part</p> <p>The zebra crossing is a replacement for an existing uncontrolled crossing point and as a result additional pedestrians are unlikely to utilise the narrow section of footway. It is the opinion of the designer that a controlled crossing point makes it more likely that pedestrians will choose to cross the road to avoid using the narrow section of footway and as a result, the proposals reduce the safety risk posed by this existing section of footway. This said, the designer has revised the northern kerbline of the B4669 to provide a wider footway where possible and to enhance visibility to pedestrians crossing. Furthermore, the removal of the central islands on the B4669 means that large vehicles are less likely to mount the kerbs as they have the full width of the carriageway in which to manoeuvre rather than being restricted in width by refuge islands.</p>

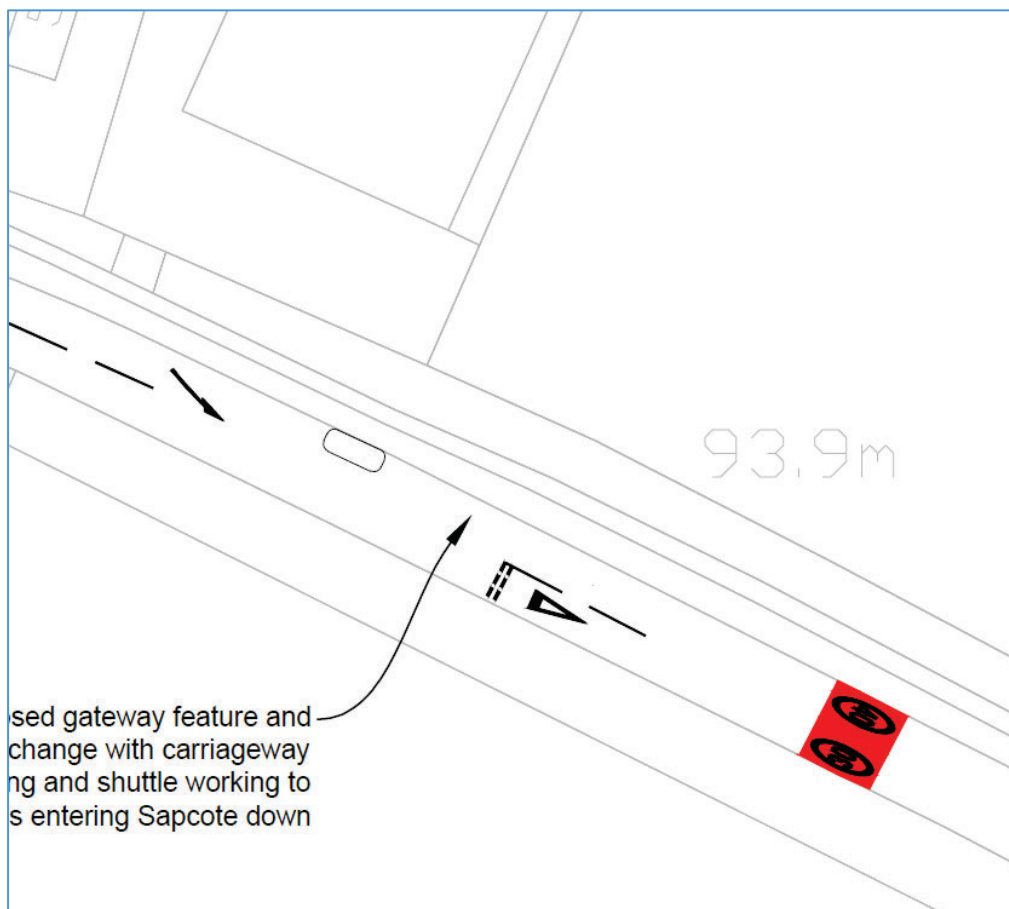
There are no street lights close to the proposed traffic calming feature location and there are several mature trees in close proximity. This means that the feature may be inconspicuous during the hours of darkness, risking it being struck by eastbound vehicles resulting in loss of control incidents.

3.5	<p>Location: Leicester Road - proposed traffic calming build-out.</p> <p>Summary: Lack of illumination risks collisions with the feature during the hours of darkness.</p> <p>There are no street lights close to the proposed traffic calming feature location and there are several mature trees in close proximity. This means that the feature may be inconspicuous during the hours of darkness, risking it being struck by eastbound vehicles resulting in loss of control incidents.</p> <p>Recommendation:</p> <p>It is recommended that the feature is sufficiently illuminated during the hours of darkness.</p>	<p>Agree with the RSA recommendation: Yes</p> <p>Further to discussions with the overseeing organisation, the gateway feature has been removed from the design.</p>

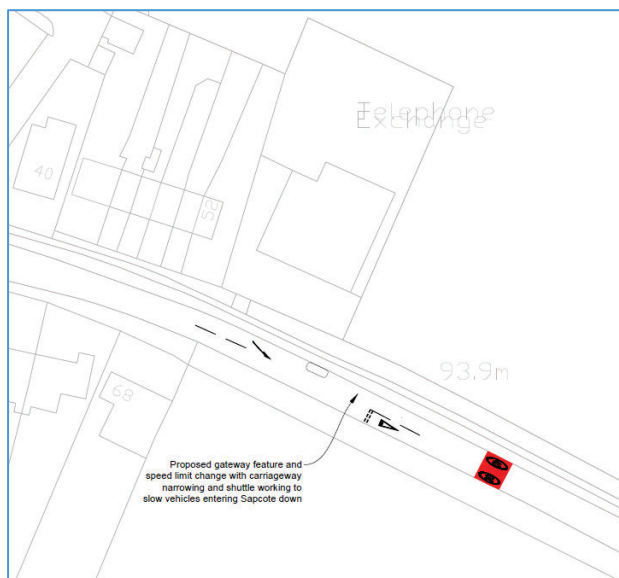
Traffic flows on Leicester Road were observed to be low, with little opposing two-way traffic observed. There is a concern that drivers will seldom be required to give way to oncoming vehicles and, as such, will not be prepared to slow or stop when approaching the give way. This is exacerbated by the location of the proposed feature – within the outbound lane on Leicester Road – meaning that vehicles required to give way will not have a feature to negotiate and therefore slow down in anticipation. This means that there is a risk of vehicles striking the kerbed build out, as well as failures to give way and late braking, resulting in loss of control or head-on collisions. In the experience of the Audit Team, these types of features in this scenario and as a first response to reducing speed on entry to a village, can result in collisions when used in isolation.

RSA Ref.	RSA Problem and Recommendation	Design organisation response	Overseeing organisation response	Agreed RSA action
3.6	<p>Location: Proposed traffic calming feature – Leicester Road.</p> <p>Summary: Low opposing flow risks late breaking and kerb strikes / loss of control / head on collisions.</p> <p>Traffic flows on Leicester Road were observed to be low, with little opposing two-way traffic observed. There is a concern that drivers will seldom be required to give way to oncoming vehicles and, as such, will not be prepared to slow or stop when approaching the give way. This is exacerbated by the location of the proposed feature – within the outbound lane on Leicester Road – meaning that vehicles required to give way will not have a feature to negotiate and therefore slow down in anticipation. This means that there is a risk of vehicles striking the kerbed build out, as well as failures to give way and late braking, resulting in loss of control or head-on collisions. In the experience of the Audit Team, these types of features in this scenario and as a first response to reducing speed on entry to a village, can result in collisions when used in isolation.</p> <p>Recommendation:</p> <p>It is recommended that the gateway feature type is amended and / or that additional supportive measures are provided to ensure slow approach speeds at the feature. It is also recommended that should this feature type be provided, that the build-out is located within the in-bound lane, on the side that drivers will be required to give way.</p>	<p>Agree with RSA recommendation: Yes</p> <p>Further to discussions with the overseeing organisation, the gateway feature has been removed from the design.</p>

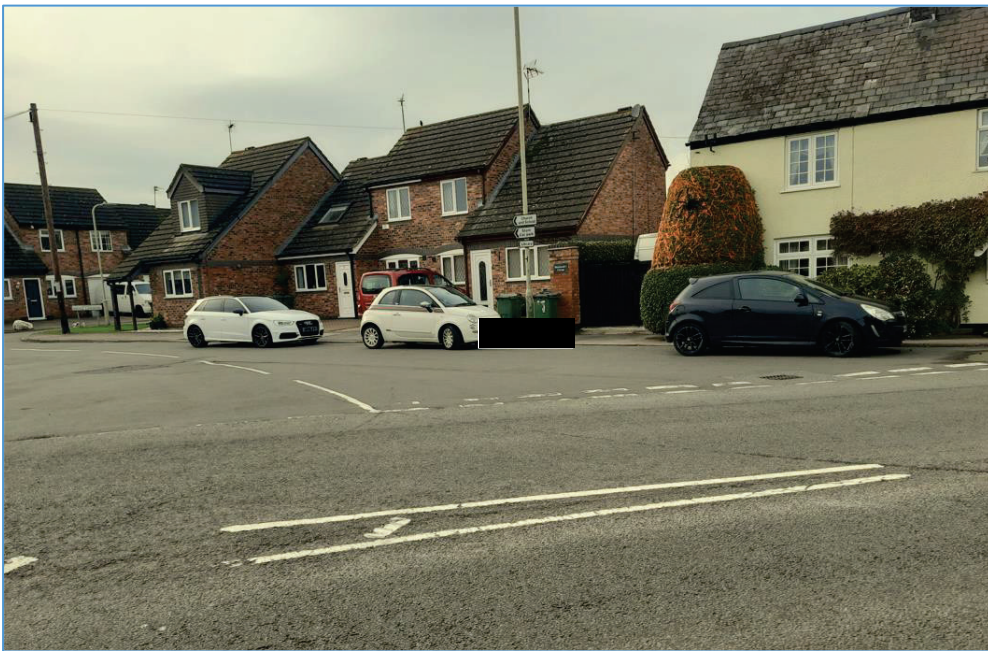
Whilst on site it was observed that several vehicles were parked along the western side of Church Street. With the proposed amendments to the kerblines here, vehicles parking here will potentially cause an obstruction to turning large vehicles and to visibility for and of emerging vehicles. It is therefore recommended that, as part of the detailed design, waiting restrictions are provided at the junction.

RSA Ref.	RSA Problem and Recommendation	Design organisation response	Overseeing organisation response	Agreed RSA action
4.1	Whilst on site it was observed that several vehicles were parked along the western side of Church Street. With the proposed amendments to the kerbline here, vehicles parking here will potentially cause an obstruction to turning large vehicles and to visibility for and of emerging vehicles. It is therefore recommended that, as part of the detailed design, waiting restrictions are provided at the junction.	The designer has considered this point and revised the design to leave this section of Church Street unchanged, meaning that vehicles that currently park along this stretch of carriageway (noting the presence of several driveways) will continue to be able to do so.

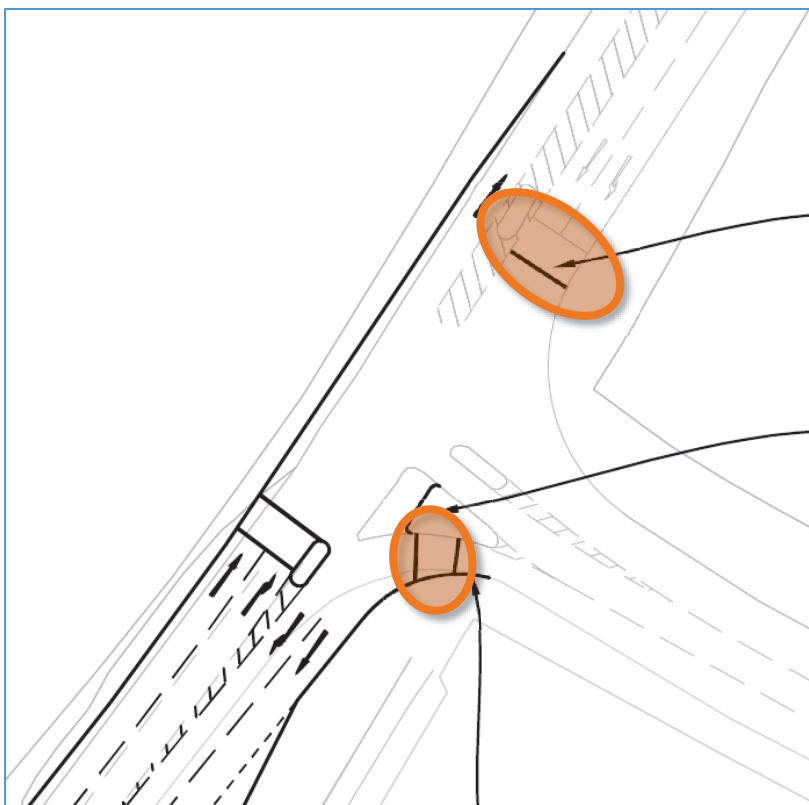
The proposed advanced stop line waiting areas on the northern and eastern arms of the junction are in advance of the majority of the traffic signals within the junction. Should signal visibility be restricted there is a risk that following motorists will move off prior to cyclists getting underway, risking collisions between the two .

RSA Ref.	RSA Problem and Recommendation	Design organisation response	Overseeing organisation response	Agreed RSA action
	<p>Location: Existing signalised junction of the B4114 and B581 Coventry Road.</p> <p>Summary: Location of new advanced stop lines limits traffic signal visibility and risks vehicle to cycle shunts / collisions. The proposed advanced stop line waiting areas on the northern and eastern arms of the junction are in advance of the majority of the traffic signals within the junction. Should signal visibility be restricted there is a risk that following motorists will move off prior to cyclists getting underway, risking collisions between the two .</p> <p>Recommendation:</p> <p>It is recommended that the signal and stop line arrangements are such that cyclists have a clear view of the traffic signals when waiting within the advanced stop line area.</p>	<p>Agree with RSA recommendation: Yes</p> <p>Locations of advanced stop lines will be reviewed and amended where required.</p>
