HINCKLEY NATIONAL RAIL FREIGHT INTERCHANGE

Interim Stage 1 Road Safety Audit Response Report

Document reference: 21.1

Report Title:	Hinckley National Rail Freight Interchange – Interim Stage 1 RSA Response Report
Document Number:	HRF-BWB-HGN-RSA-RP-CH-0001
Prepared By:	BWB Consulting Ltd
Overseeing Organisation:	Leicestershire County Council
BWB Reference:	NTT2814

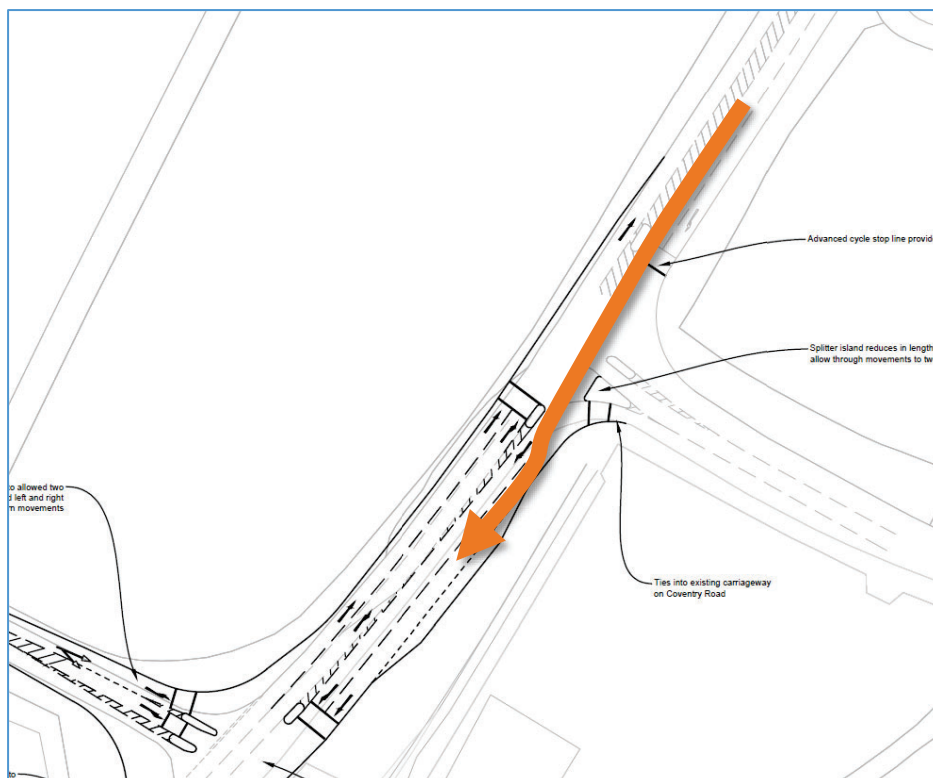
The alignment of the ahead movement, when travelling southbound, means that drivers are naturally directed to continue into the right turn lane inadvertently, risking late lane changes and potential side-swipe or shunt type collisions.

RSA Ref.	RSA Problem and Recommendation	Design organisation response	Overseeing organisation response	Agreed RSA action
3.3	<p>Location: B4114 Coventry Road – on the exit from the junction with the B581 Coventry Road.</p> <p>Summary: Alignment for straight ahead southbound vehicle movements risks late lane changes and side-swipe type collisions.</p> <p>The alignment of the ahead movement, when travelling southbound, means that drivers are naturally directed to continue into the right turn lane inadvertently, risking late lane changes and potential side-swipe or shunt type collisions.</p> <p>Recommendation:</p> <p>It is recommended that the two-lane arrangement on the exit from the junction is started further south and the road markings amended so as to encourage drivers to make a conscious decision to enter the right turn lane.</p>	<p>Agree with RSA recommendation: Yes</p> <p>The alignment and lane markings will be reviewed and amendment made to address the problem.</p>

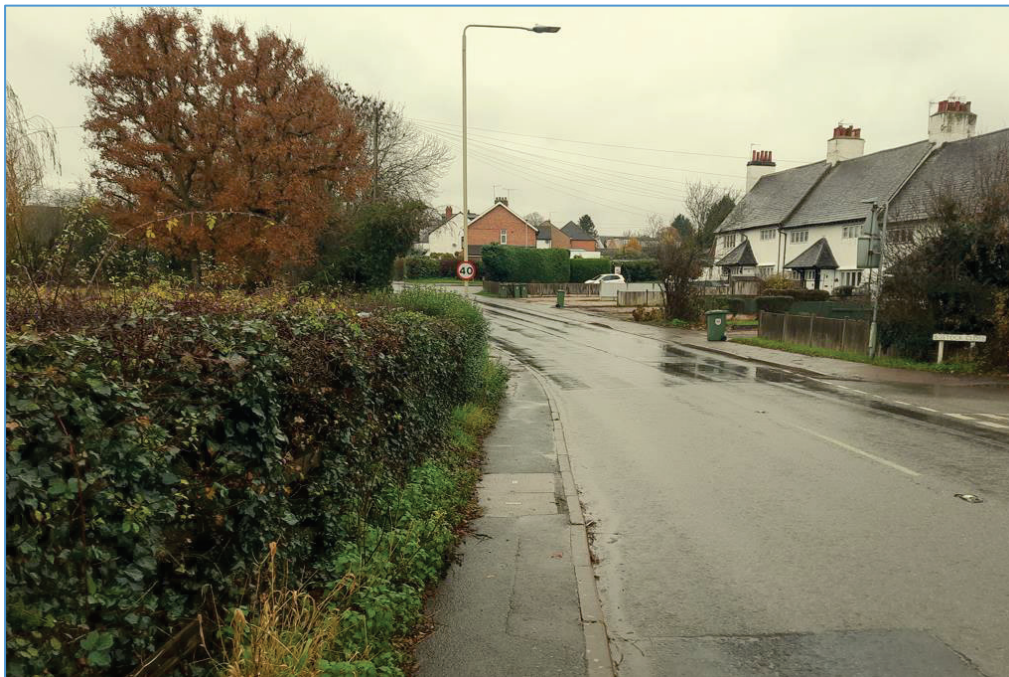
When crossing west to east, visibility of approaching vehicles is restricted by the horizontal alignment of the carriageway and by the adjacent vegetation. This restricts visibility for and of pedestrians crossing at the proposed located and may result in them entering the carriageway when it is unsafe to do so, risking vehicle to pedestrian collisions.

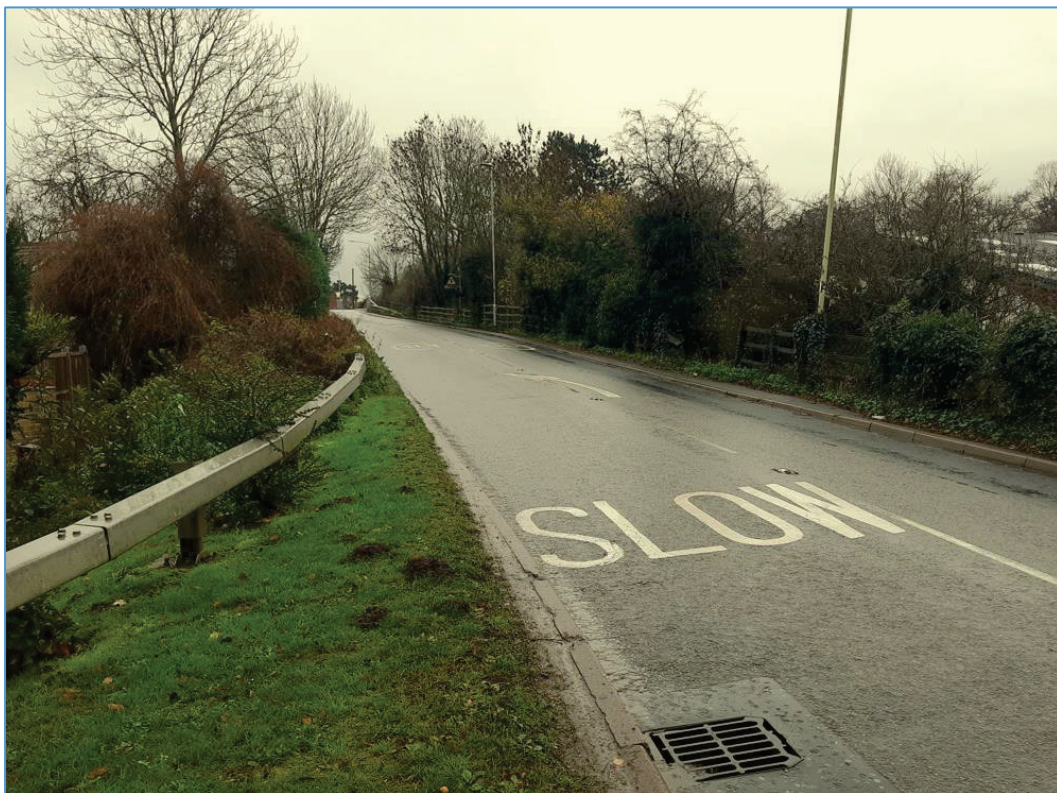
When crossing east to west, visibility of approaching northbound vehicles is restricted by the vertical alignment of the carriageway and by the adjacent vegetation. This restricts visibility for and of pedestrians crossing at the proposed located and may result in them entering the carriageway when it is unsafe to do so, risking vehicle to pedestrian collisions.
