Appendix 5.1

Preliminary Ecological Appraisal

NORTH KILLINGHOLME POWER PROJECT Project No.: 70055743 | Our Ref No.: PEA C.GEN Killingholme Limited

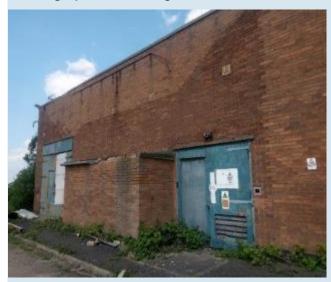
Photograph 1 – Building 1

Bat Target Note Number	Bat Target Note Description	Bat Roost Suitability
Building 1	Rectangular redbrick flat roof structure. PRF 1 – Timber framed window shutter with gaps between. PRF 2 – Some gaps in masonry between brick work on southern elevation – shallow cavities PRF 3 – Missing brick 7 cm x 4 cm gap in south east corner at approx. 6 m height	Low
Building 4	Small red brick single storey substation with flat roof. PRF 1- slight gap in missing masonry between brickwork – 1 cm wide extending in horizontally	Low
Building 5	Redbrick rectangular single storey structure with flat roof. PRF 1 - Concrete plinths separate internal rooms with concrete lintel – gap between each lintel (Photograph 7). PRF 2 – gap in brickwork above blue door PRF 3 – Large gap in central section where roofs join together on lintel and plinth – extends back into structure PRF 4 – Several gaps where concrete is missing – tight crevices 1cm x 4/5cm	Moderate

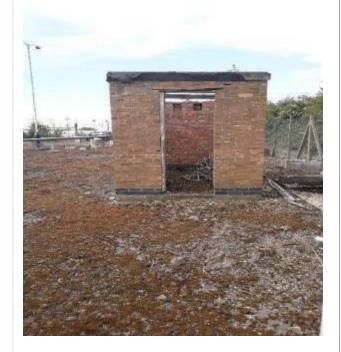
Photograph 7 – Building 9

Building 9	Derelict single storey red brick structure in fenced off area. Small building – approx. 3 m x 5 m. No roof present so completely open. PRF 1 - gap between brickwork above doorway – approx. 5 cm x	Low

1.5 cm which likely extends in 5 cm

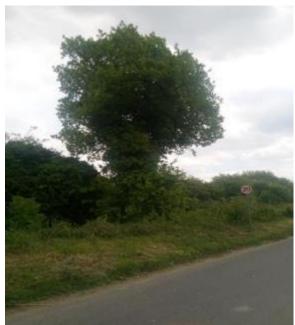
Photograph 8 – Tree 1

Bat Target Note Number	Tree Species	Tree Description	PRF No. and Type	PRF Height (m)	PRF Aspect	PRF Description	PRF Suitability Category
T1 (TN10)	Oak	Mature tree on bank by ditch and road with loose ivy coverage	1: lvy	N/A	N/A	Ivy coverage is not likely to provide features itself but may obscure features (However, healthy condition of tree suggests this is not likely), see Photograph 8.	Low

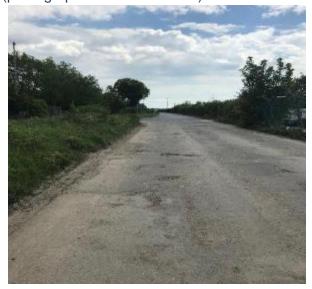
Photograph 13 – Hardstanding, tall ruderal, dense scrub and scattered broadleaved trees along Clough Lane/Entrance D to south of site (photograph orientation: south)

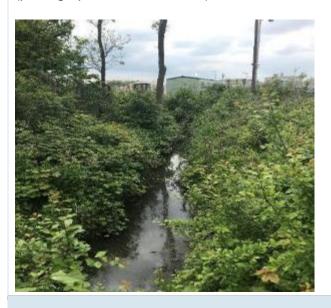
Photograph 21 – standing water drain perpendicular to Clough Lane to the south of the Site with dense scrub on each side and scattered broadleaved trees in the background (photograph orientation: west)

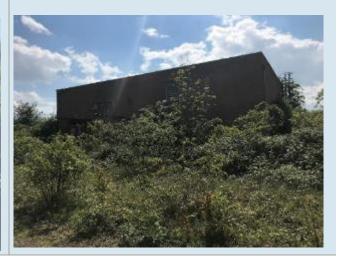
Photograph 24 – Dense scrub habitat to the north of B1 (photograph orientation: south)
