Regarding the Applicants assessment of Hydrogeology and Flood Risk

Bomb Store at Glyn Rhonwy, Llanberis

Structural Report

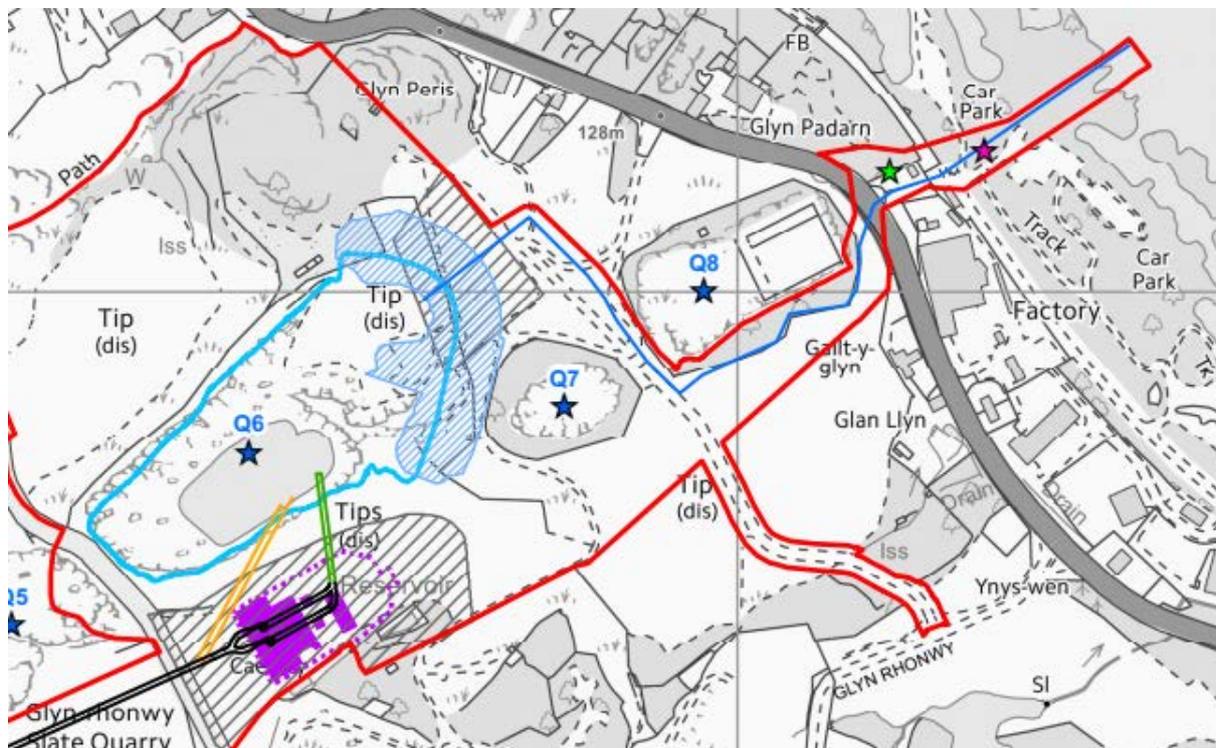
This map shows the Applicants site boundary in red just (by a matter of a meter or two) skirting the ground above the back end of the void which constitutes the remaining part of the bomb store – at the south east edge of the pit labelled Q8. The footprint of the tailpond dam shown shaded in blue shows that the foot of the dam is approx 110m from the back end (SE extent) of this void.

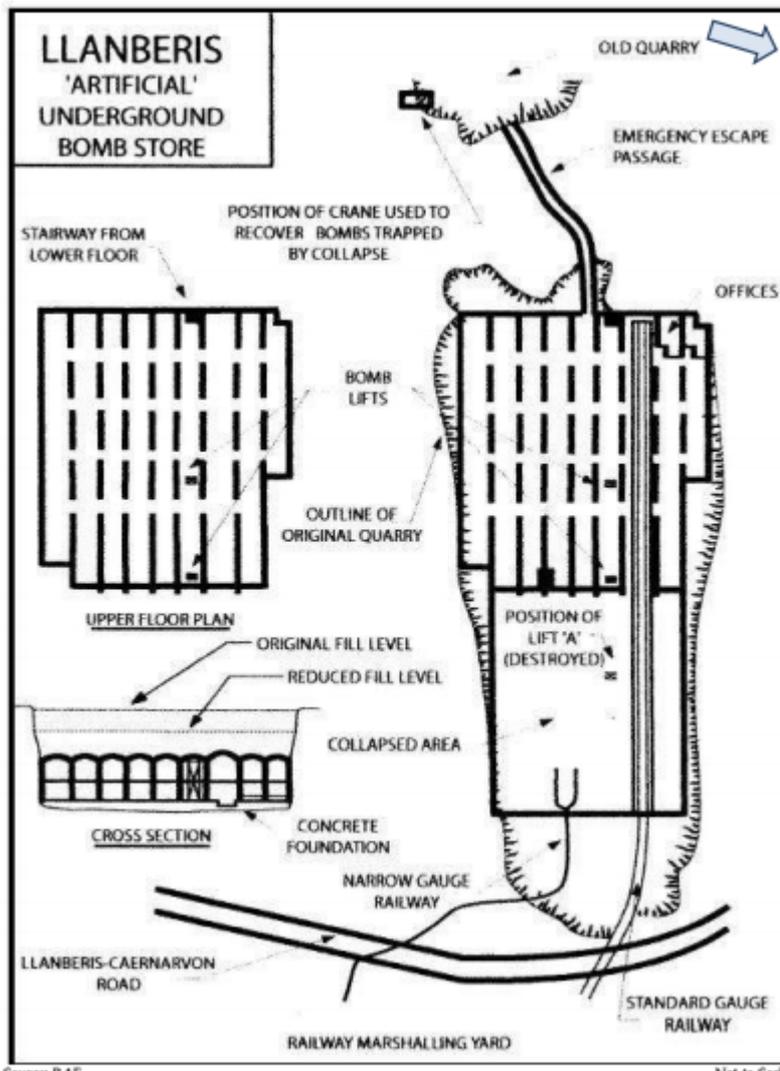
The picture above shows on the right the plan of the bomb store .. the “collapsed area” is now the clear open area which shows on aerial images and Applicant’s maps. The upper half of the plan is the still existing void hidden under slate overburden which extends almost to the Applicants site boundary.

Its condition has not been recently assessed for nearly 20 years, it is subject to degradation and it is not as far as I know being monitored. Whoever owns the structure and wherever it is, if its collapse could threaten the integrity of a dam and the safety of the public then it needs to be considered.
