# SPR EA1N and EA2 PROJECTS

## ACCOMPANIED SITE INSPECTION

Interested Party: SASES PINS Refs: 20024106 & 20024110

Date: 22 January 2021

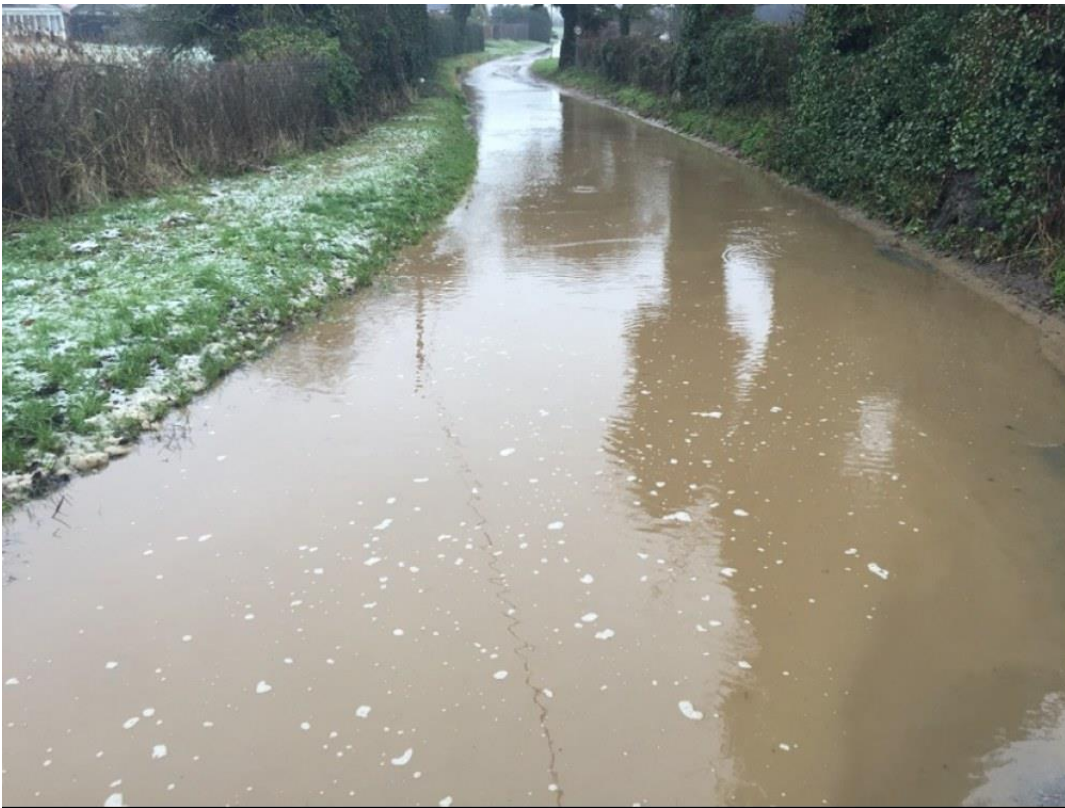
*Grove Road – 16<sup>th</sup> January 2021*

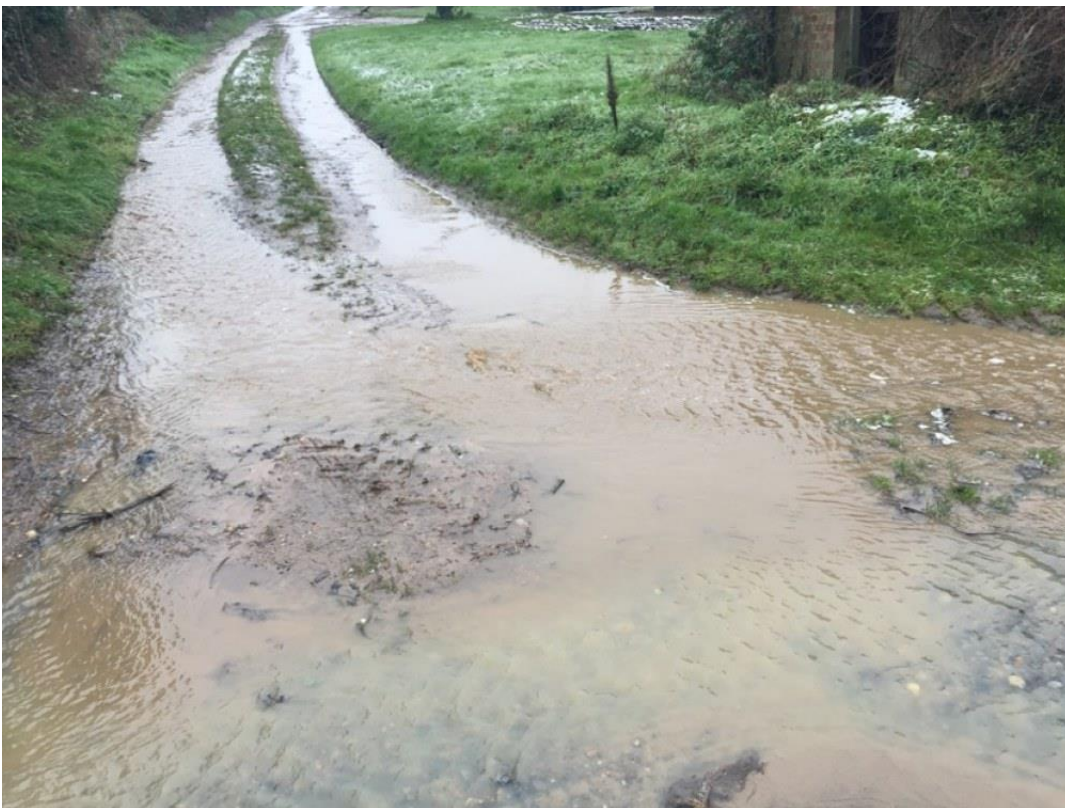
*Discharge from FP2 to Grove Road – 16<sup>th</sup> January 2021*

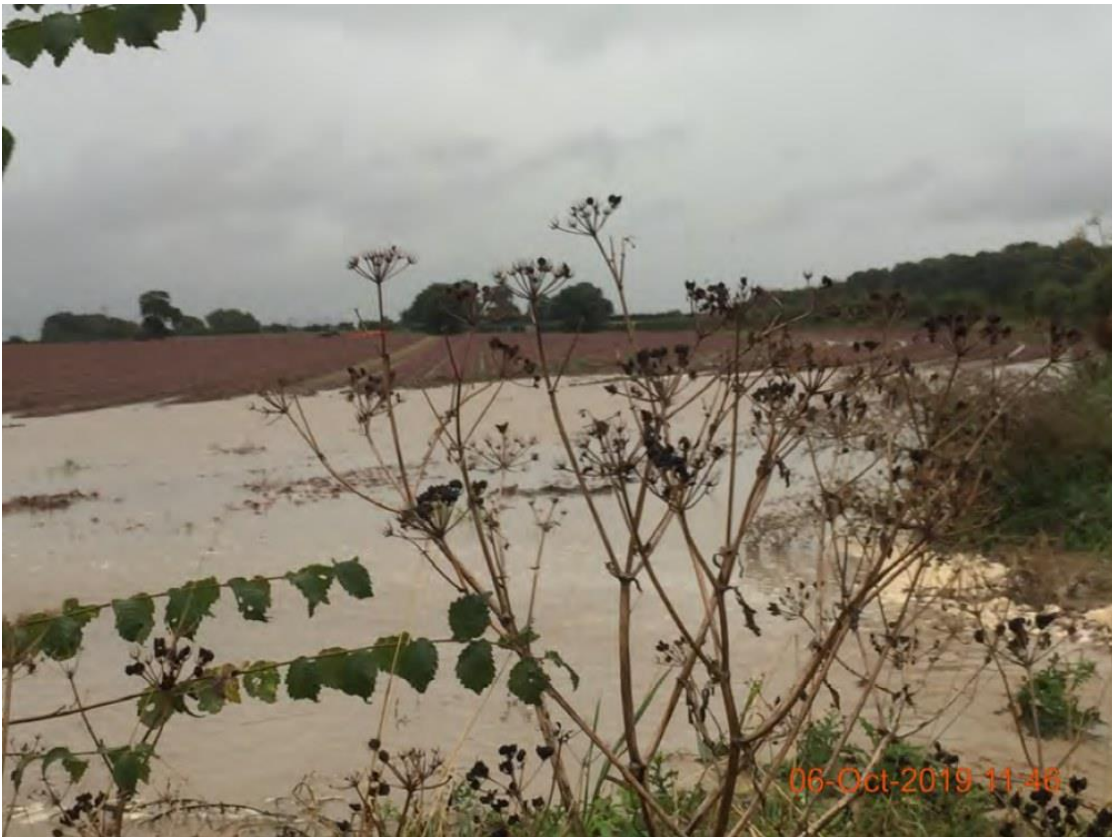
*Flooded field where haul road crosses 6 October 2019*

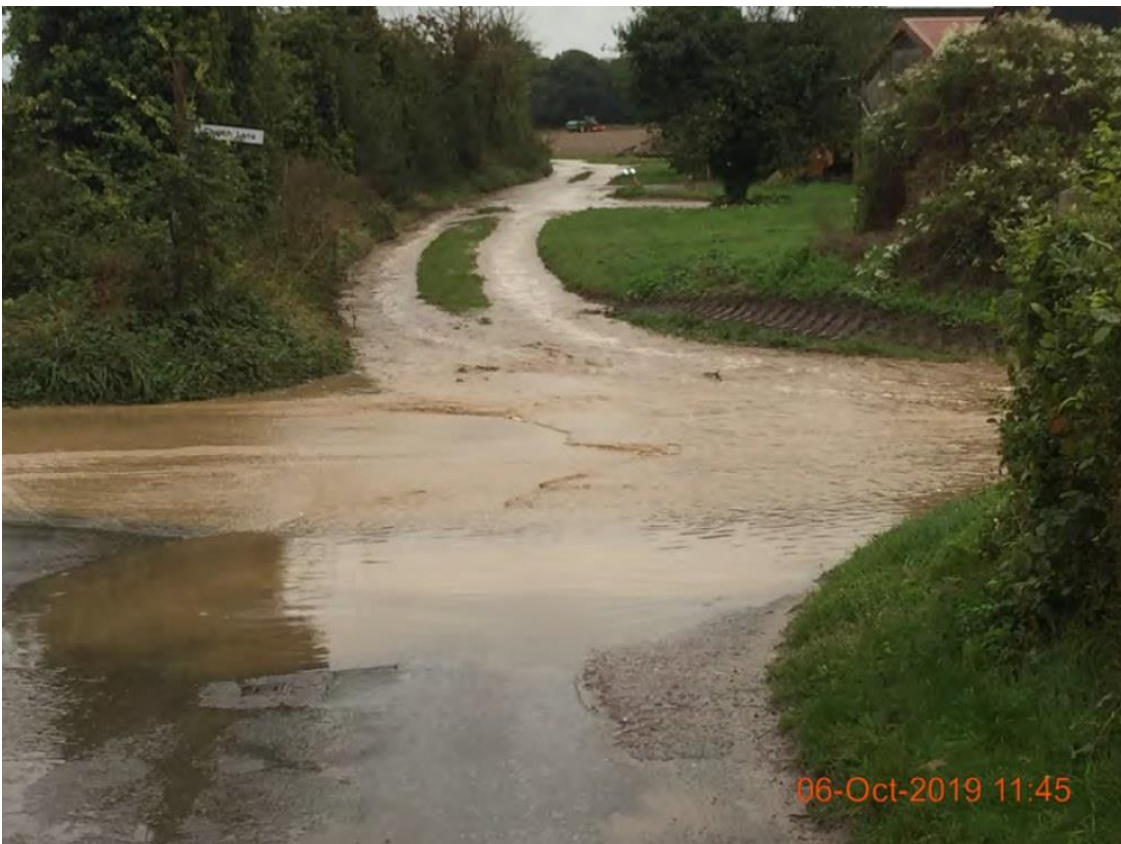
*FP2 (pre-construction access) 6<sup>th</sup> October 2019*

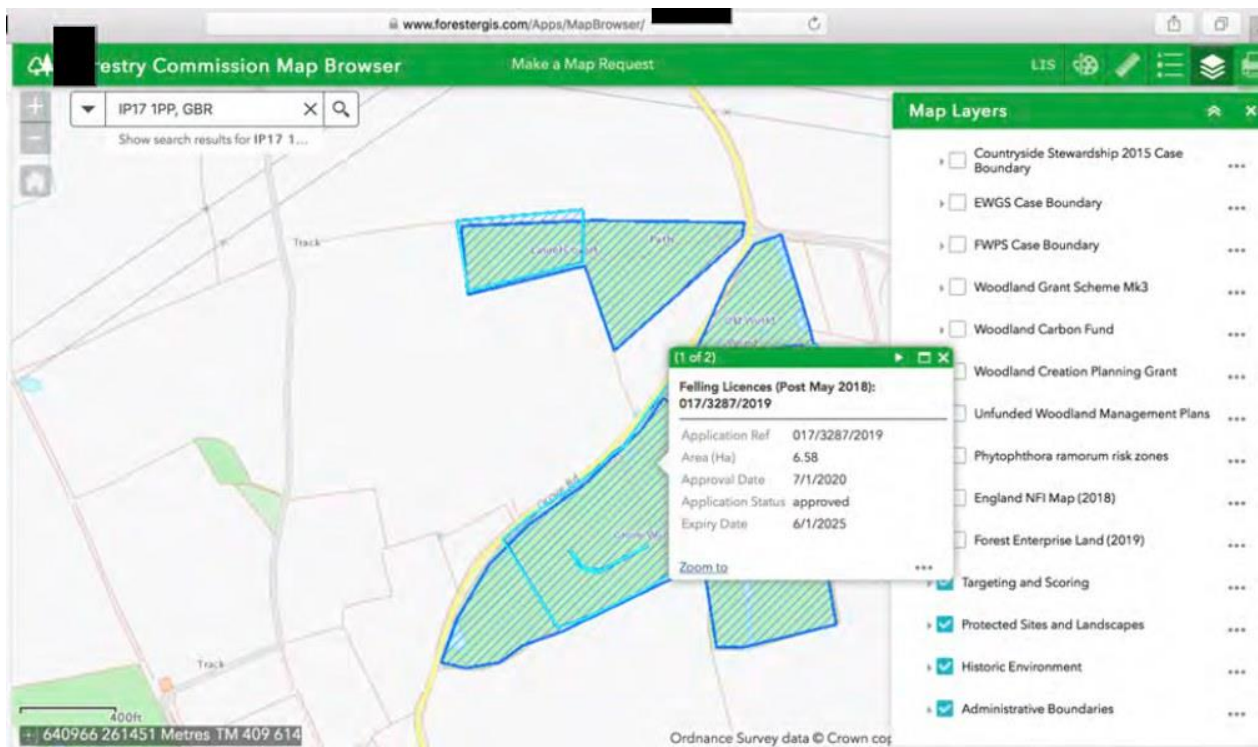
*Location of felling licences at Grove Wood and Laurel Covert*

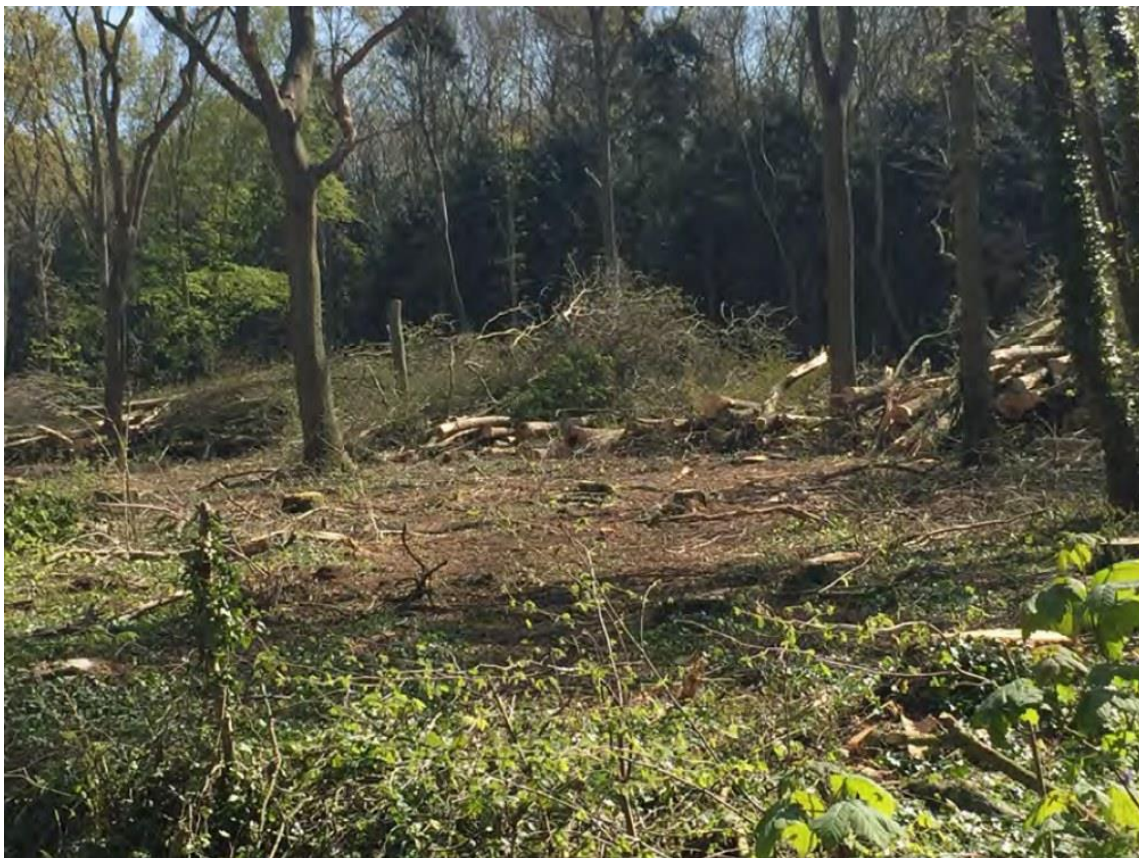
*Grove Wood felling May 2020*

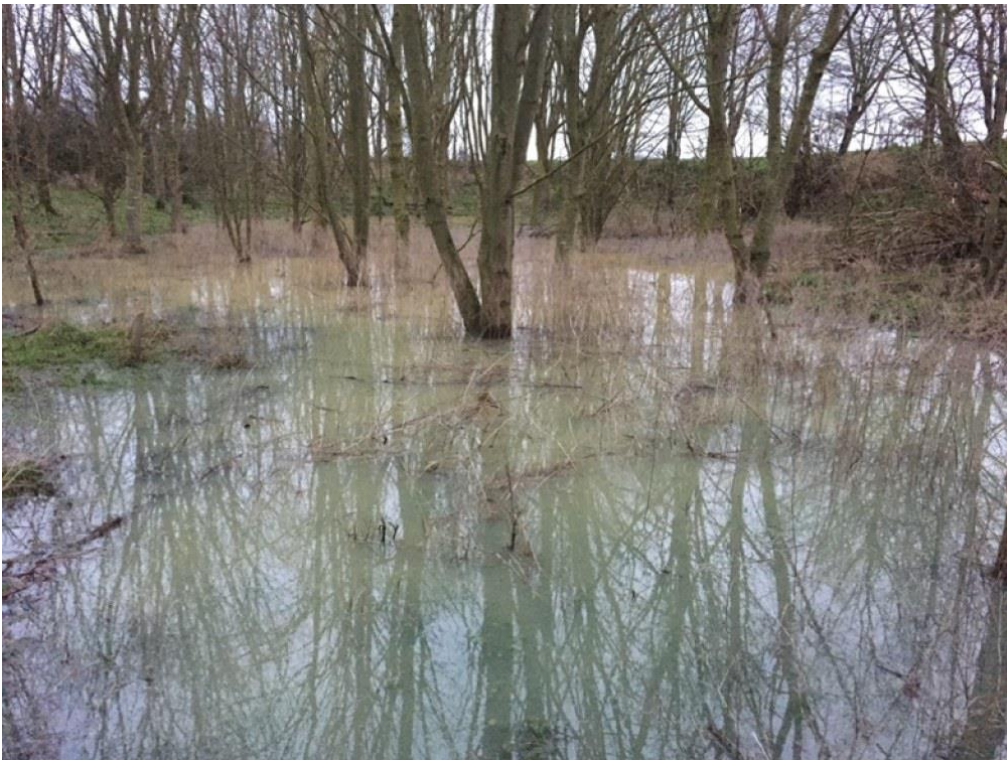
- This pit is of a considerable size.
- Two land drains discharge into this pit, which floods in winter months or heavy rain.
- [REDACTED]
- It is a haven for other wildlife – deer, bats, birds etc who are completely undisturbed.
- The westernmost substation will be in close proximity to the pit.
- How is the stability of the pit to be maintained?
- What are the effects of noise and light on the wildlife?
- There is a further pit on the north-western side of the site near the pylons/FP17 (Pit 2)
- There is a drainage ditch flowing east to west across the site
- Land drains are marked by a white post and discharge into the above ditch, which in turn feeds the Pit 2.

*Wooded pit -flooded on 15<sup>th</sup> January 2020*

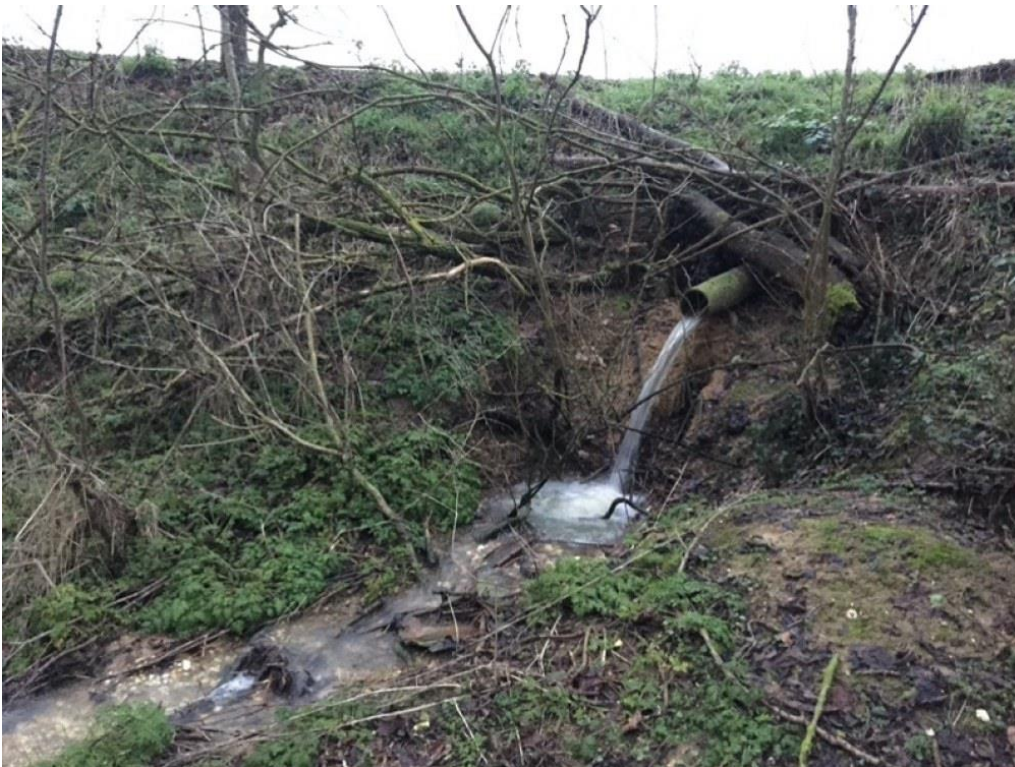
*Land drain discharging into pit from substation site*

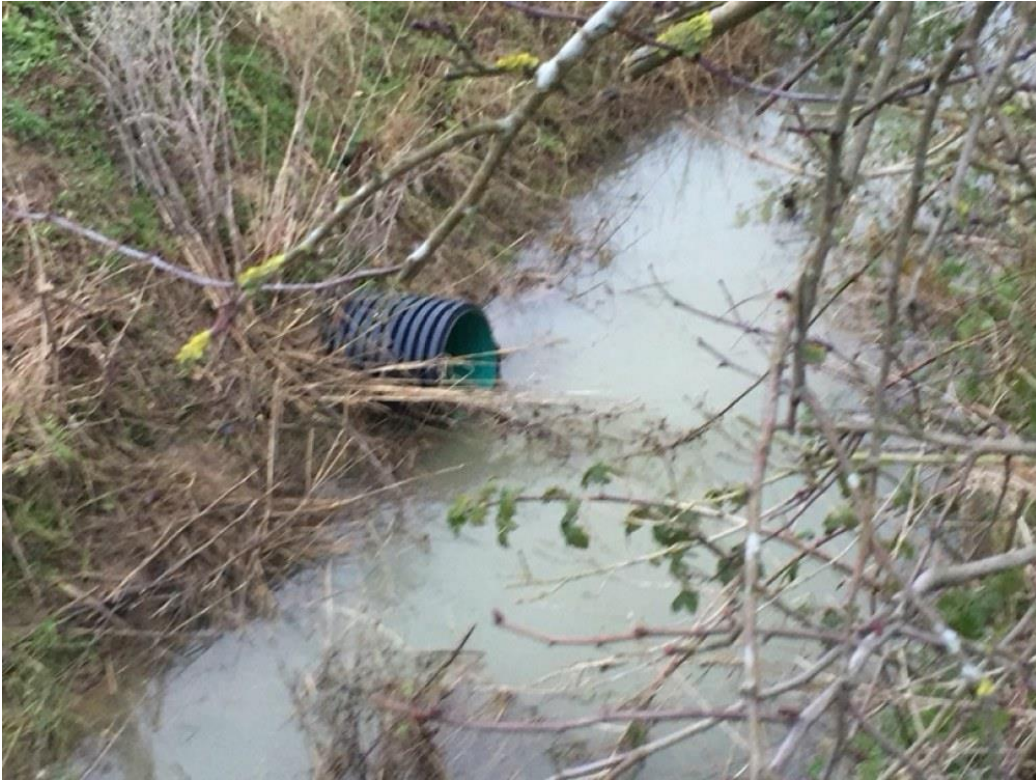
*Land drain discharging into ditch near overhead cables, which feeds into Pit 2 near pylon adjacent to FP17 – 15<sup>th</sup> January 2021*

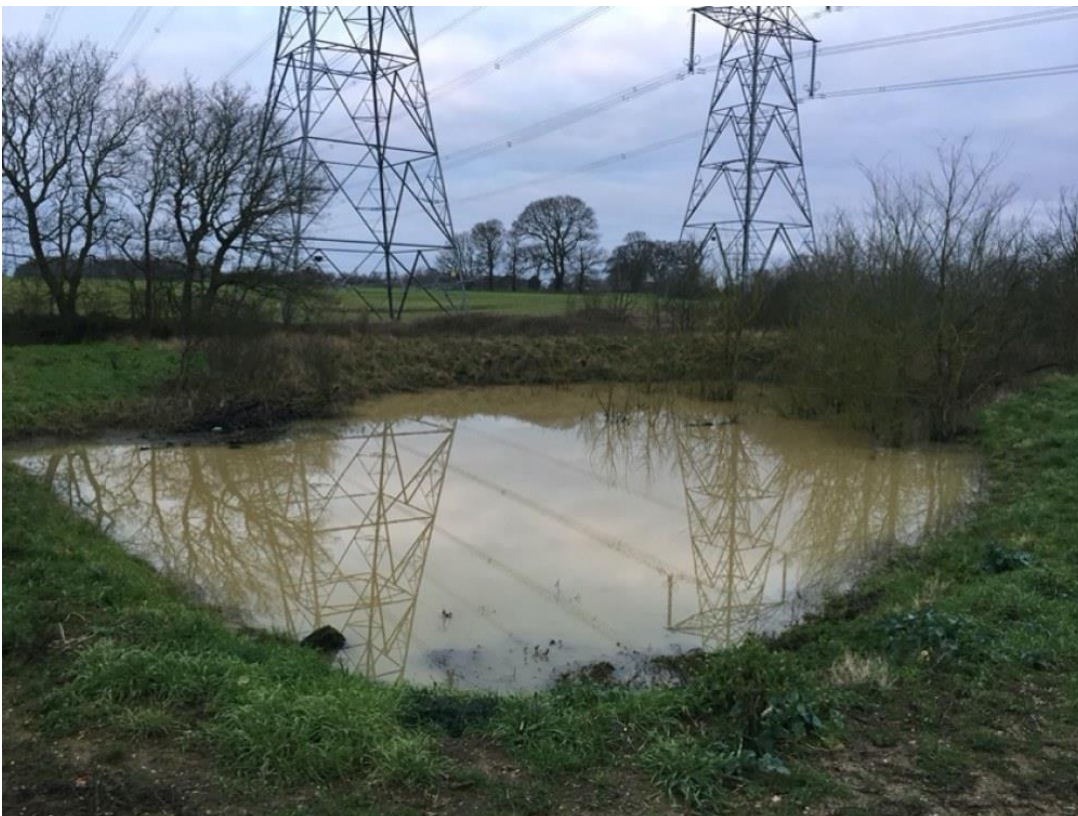
*Pit 2 below – 15<sup>th</sup> January 2021*

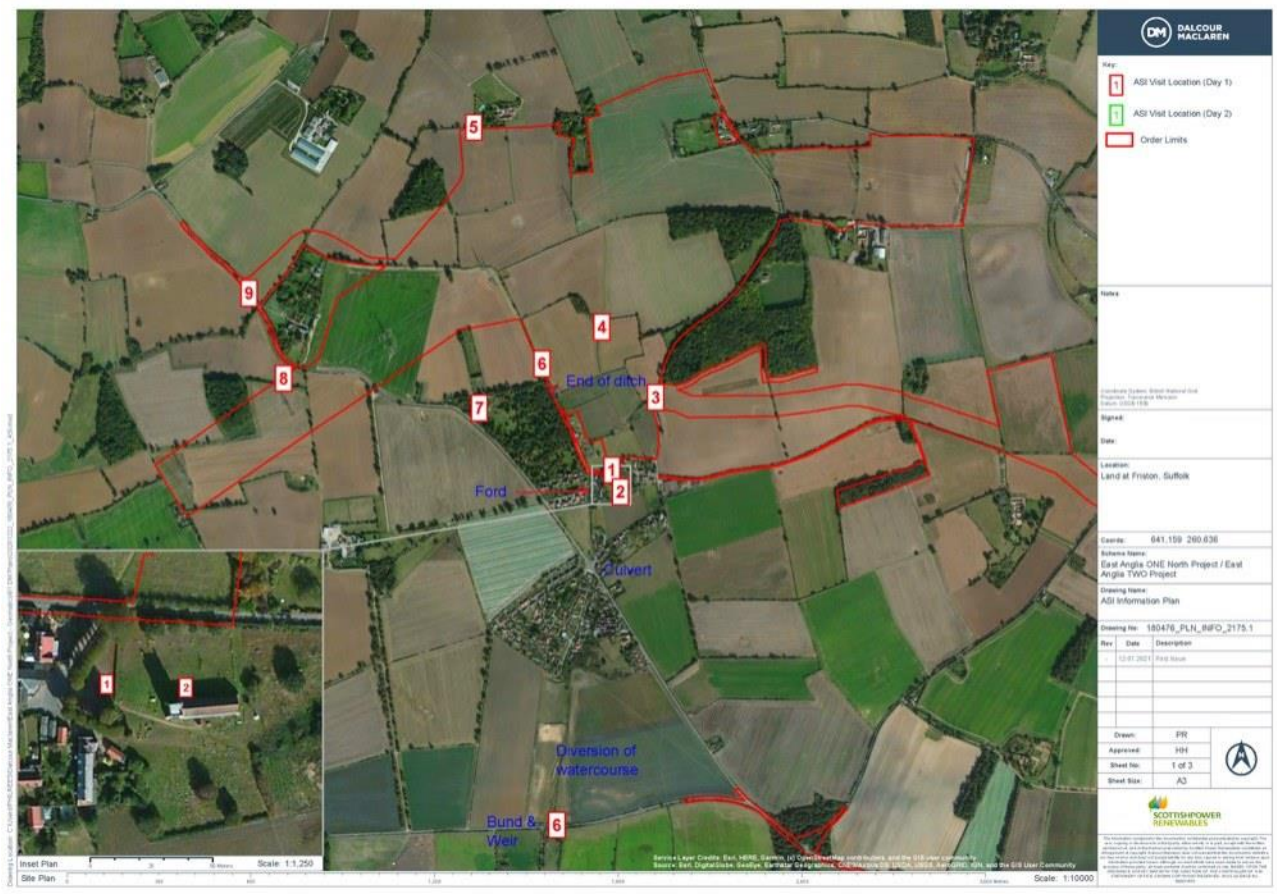
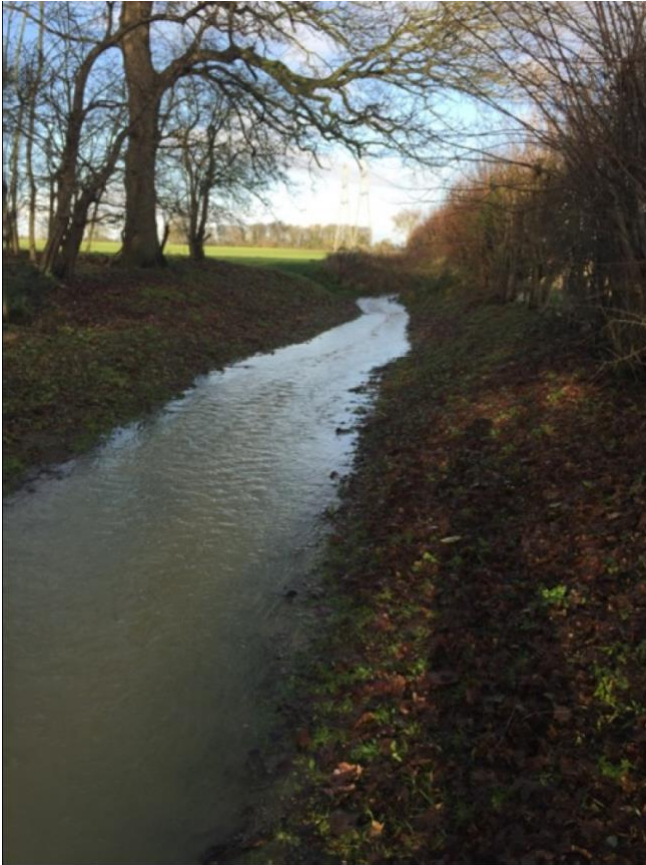
- Ditch adjacent to FP17 is not continuous. It ends north of Woodside Farm, adjacent to northern end of woodland belonging to Friston House
- After rainfall this ditch overtops and flows down the track (FP17) past Woodside Farm and over a ford in Church Road to enter the 'Main River'.

*Ditch overtopping on FP17 adjacent to northern end of Friston House Wood – 24<sup>th</sup> December 2020*  
*Below: South of Woodside Farm – 24<sup>th</sup> December 2020*

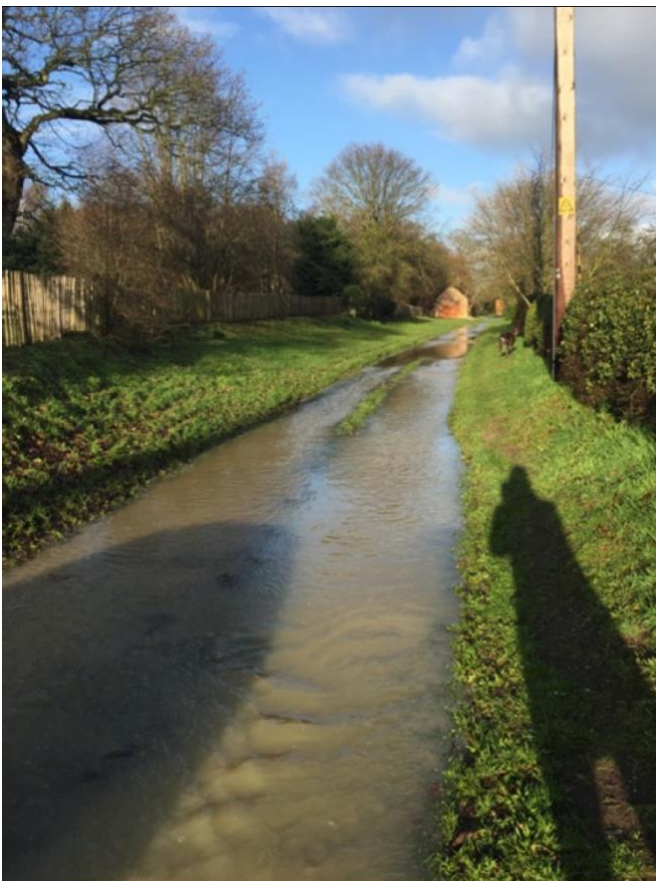
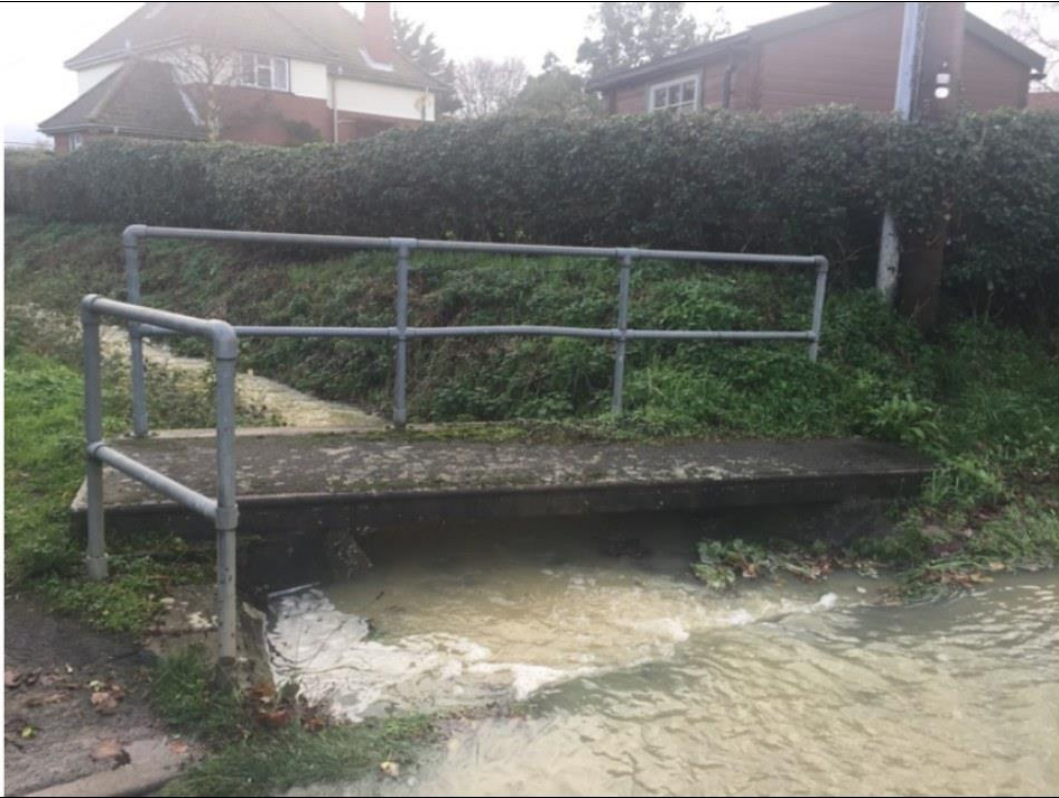
*Ford in Church Road and below Church Path – 24<sup>th</sup> December 2020*

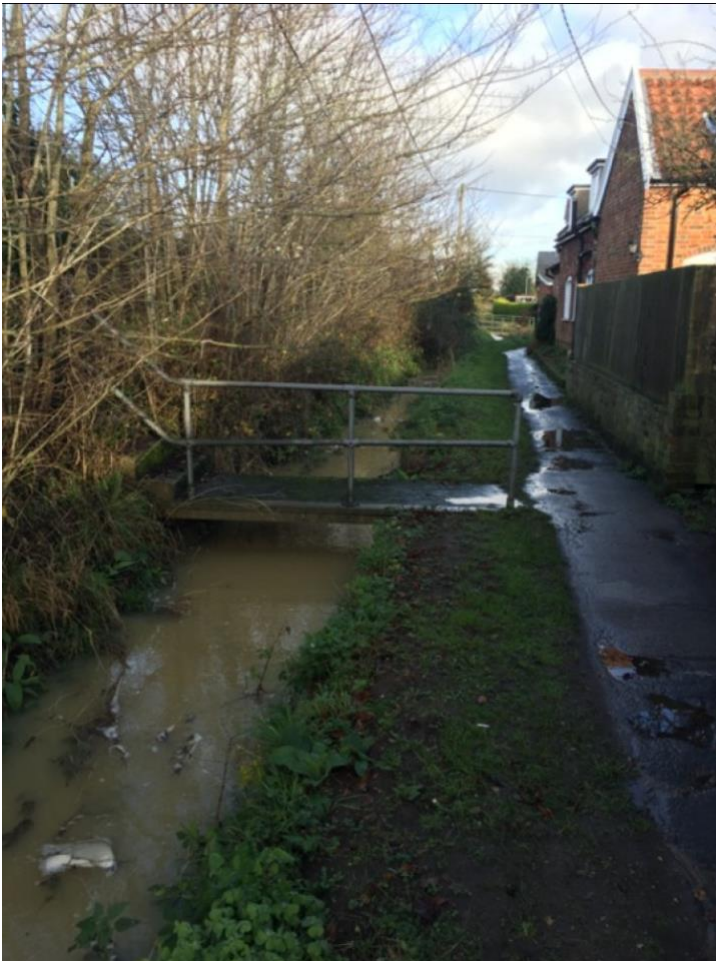
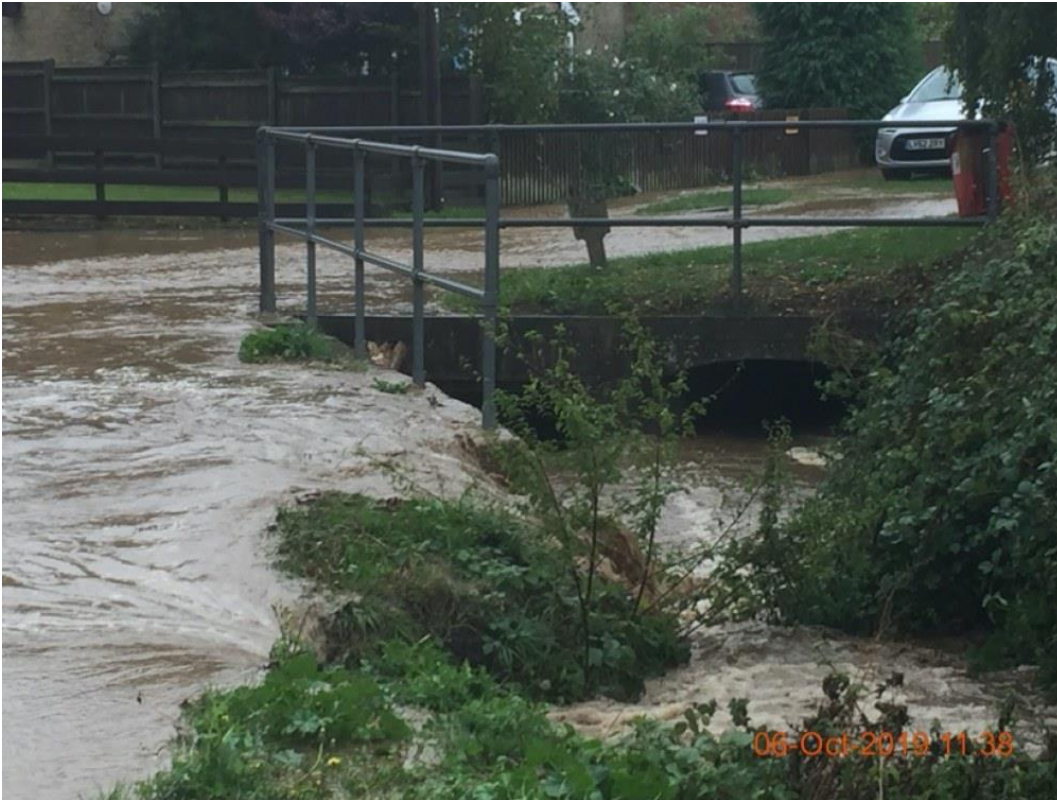
- Watercourse follows Church Path and enters culvert at junction with Grove Road.
- At this junction with any flood water from Grove Road, or from either direction along Aldeburgh Road, combines with floodwater from the substation area to be carried southwards.

*Culvert at Grove Road – 6<sup>th</sup> October 2019*

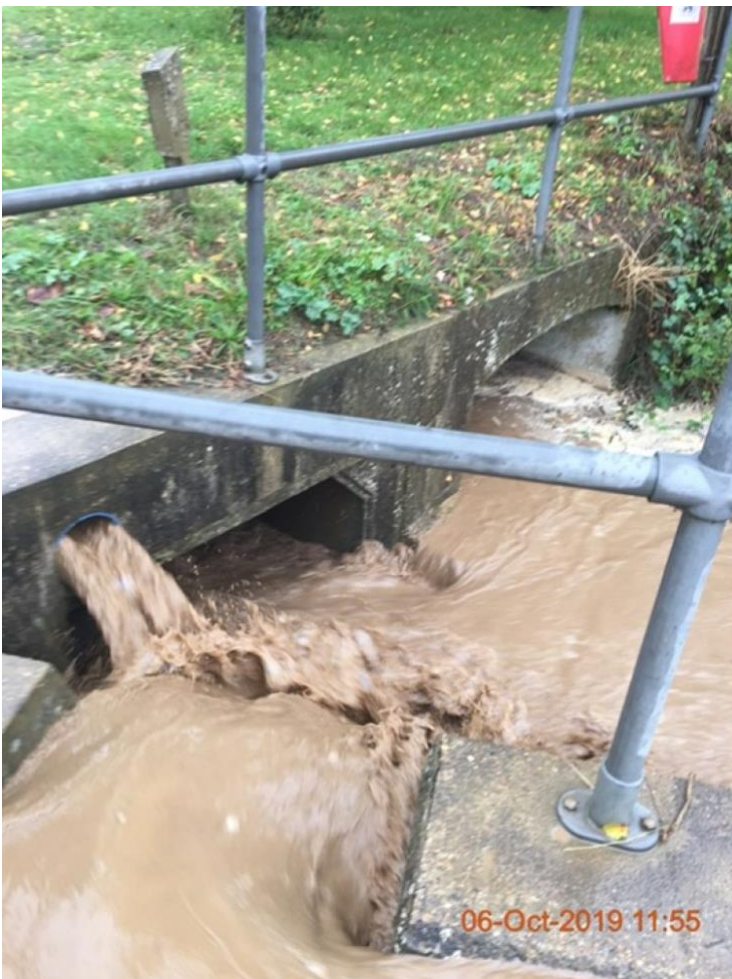
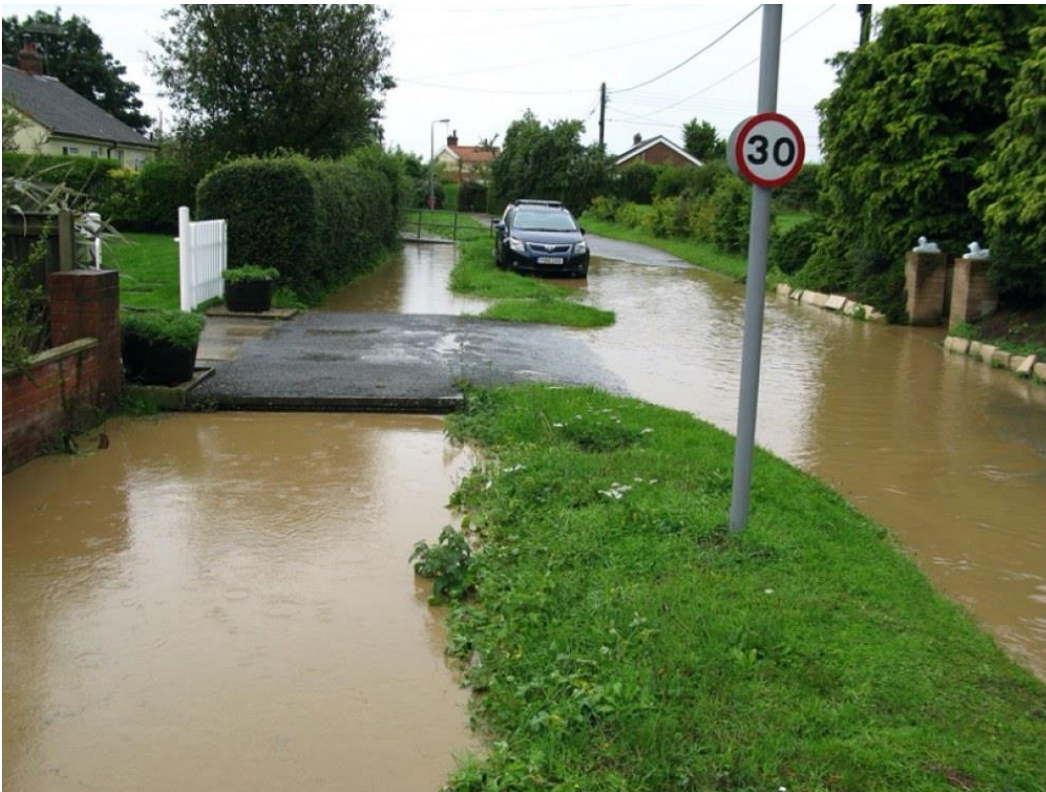
- There is a long culverted section from Grove Road to some distance down Low Road. Gulleys taking surface water from Low Road also enter the culvert.
- Where the watercourse emerges from the culvert, note the height/width restriction and therefore volume of water which can be conveyed.

*Low Road, Friston – 6<sup>th</sup> October 2019*

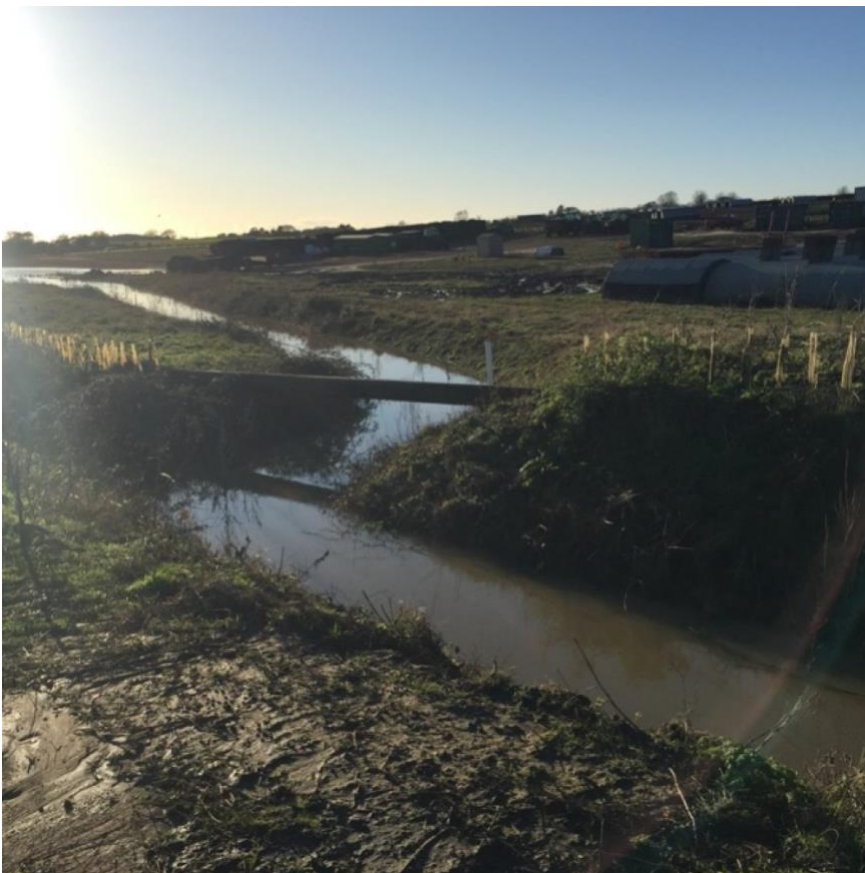
- The watercourse continues adjacent to Footpath 26 through pig fields.
- The watercourse has been diverted south-west and the ditch comes to an end in a flood storage area adjacent to the A1094.

*Diversion of watercourse in pig fields – 27<sup>th</sup> December 2020*

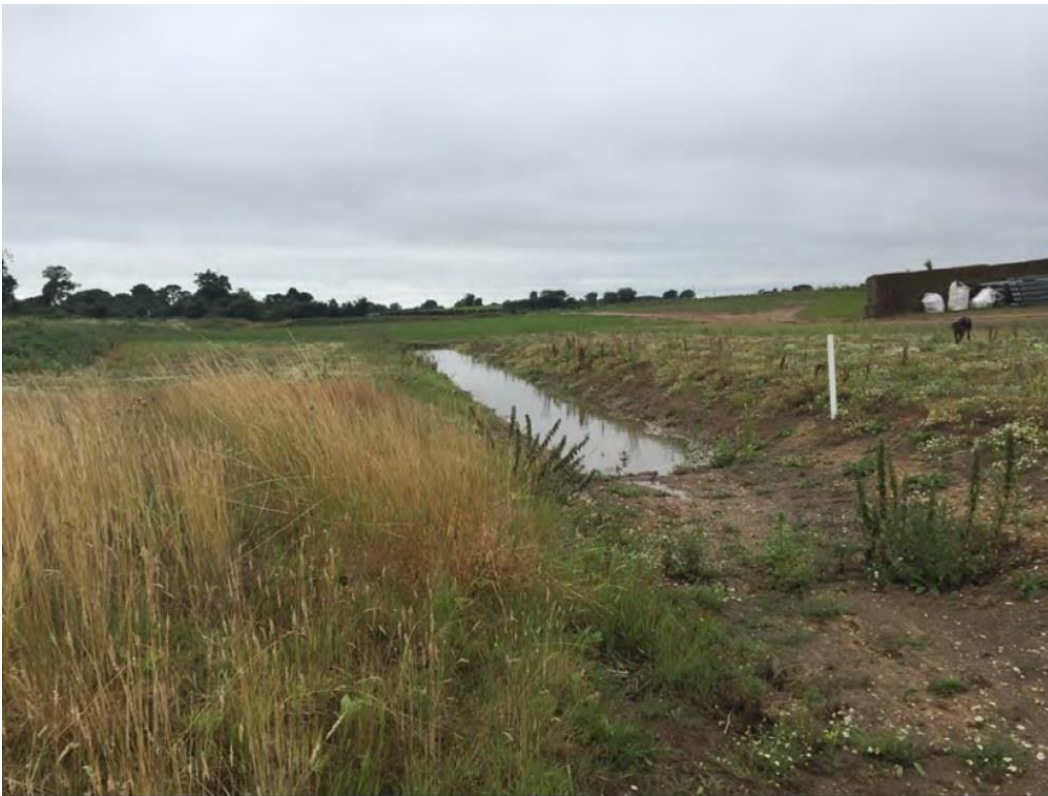
*End of watercourse at attenuation area – 28<sup>th</sup> July 2019*

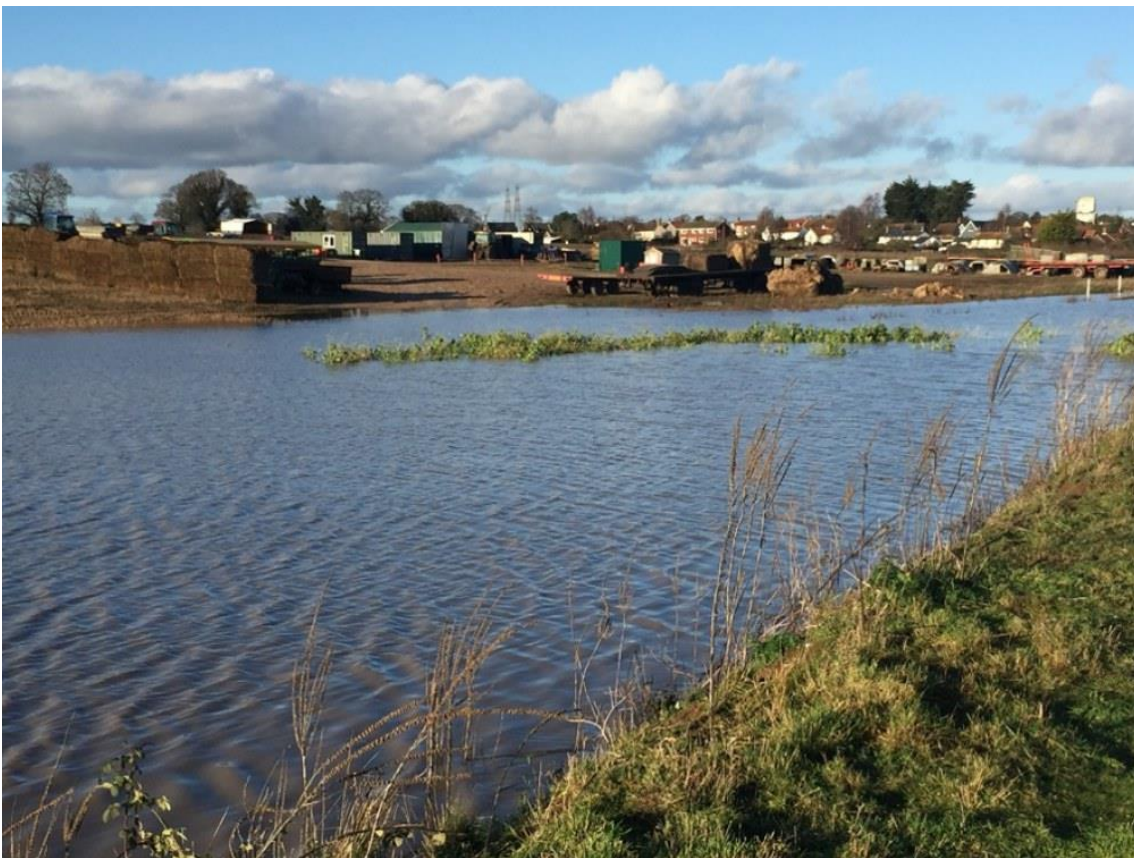
*Attenuation area – 27<sup>th</sup> December 2020*

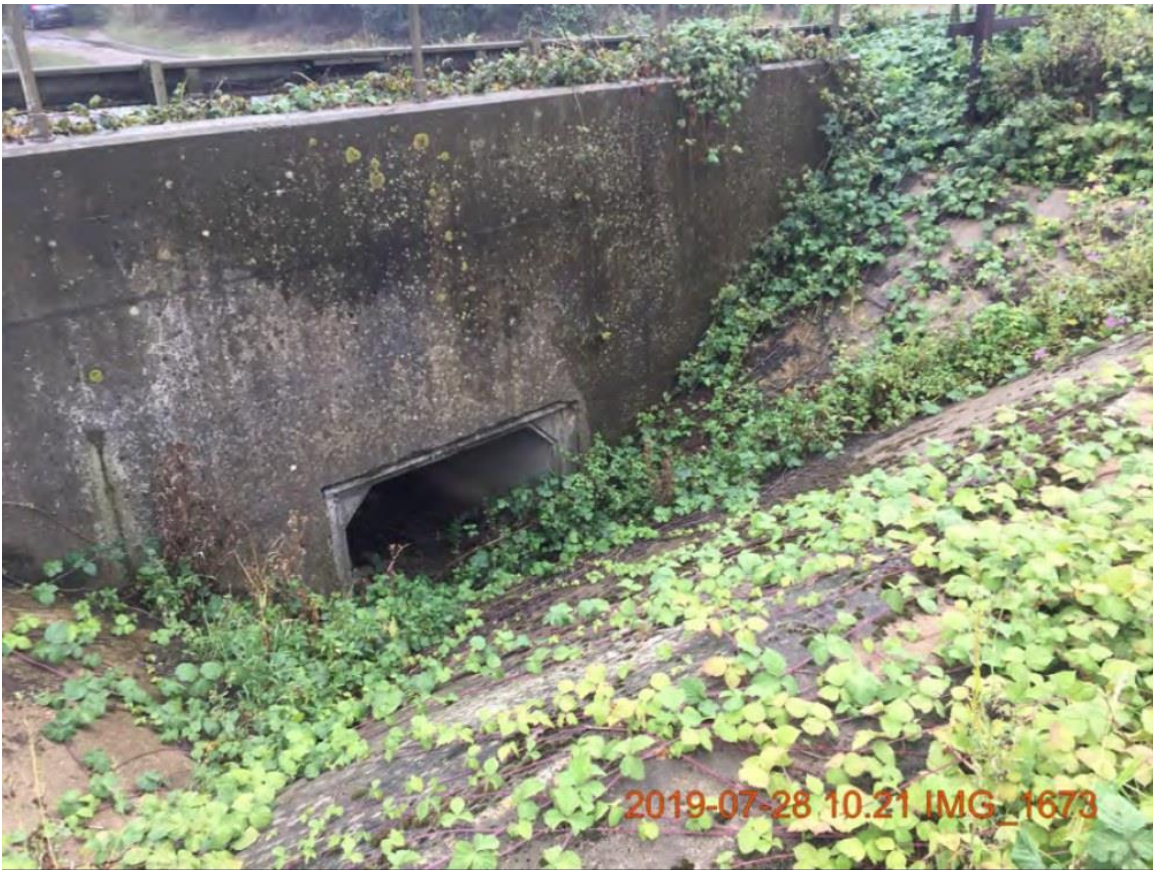
- There is a bund some 950mm high and then a weir, where any overtop is culverted under the A1094 southwards down the access to Firs Farm. This is designed to prevent serious flooding downstream.

*Weir and culvert at A1094 – 28th July 2019*

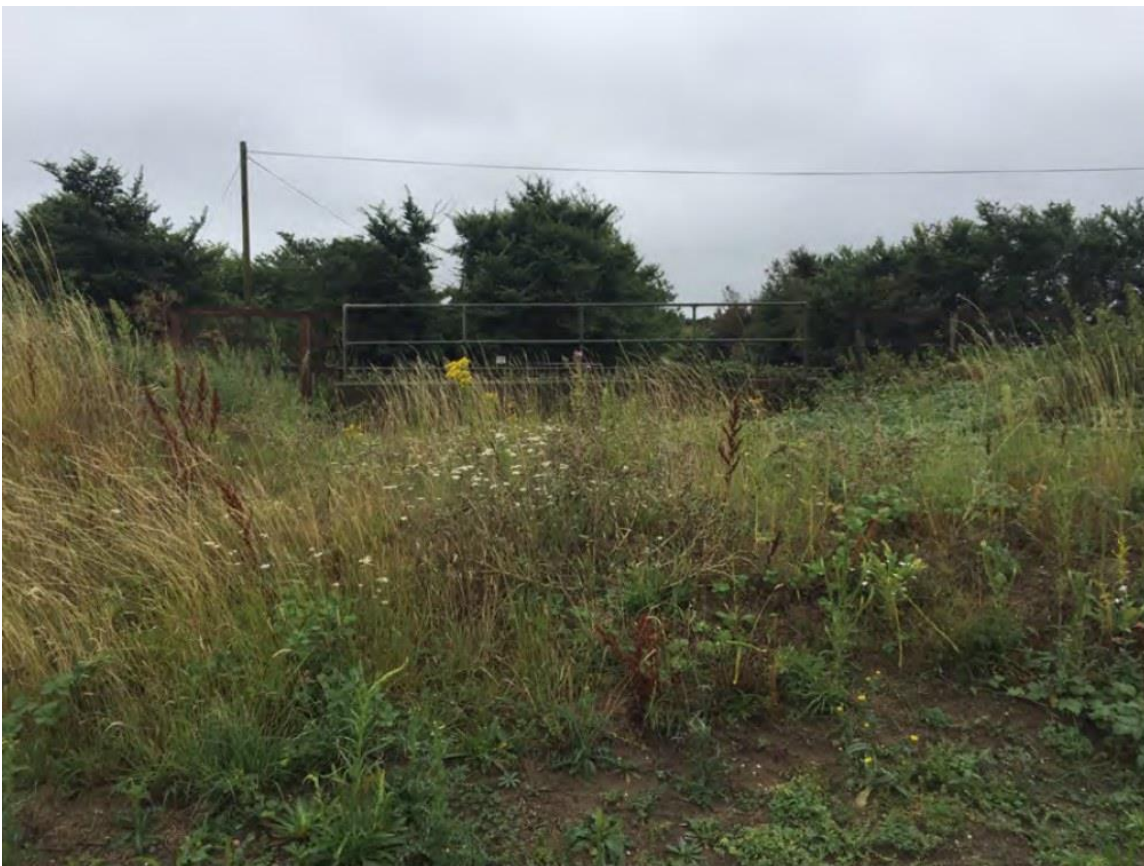
*Bund before weir – approximately 950mm high*

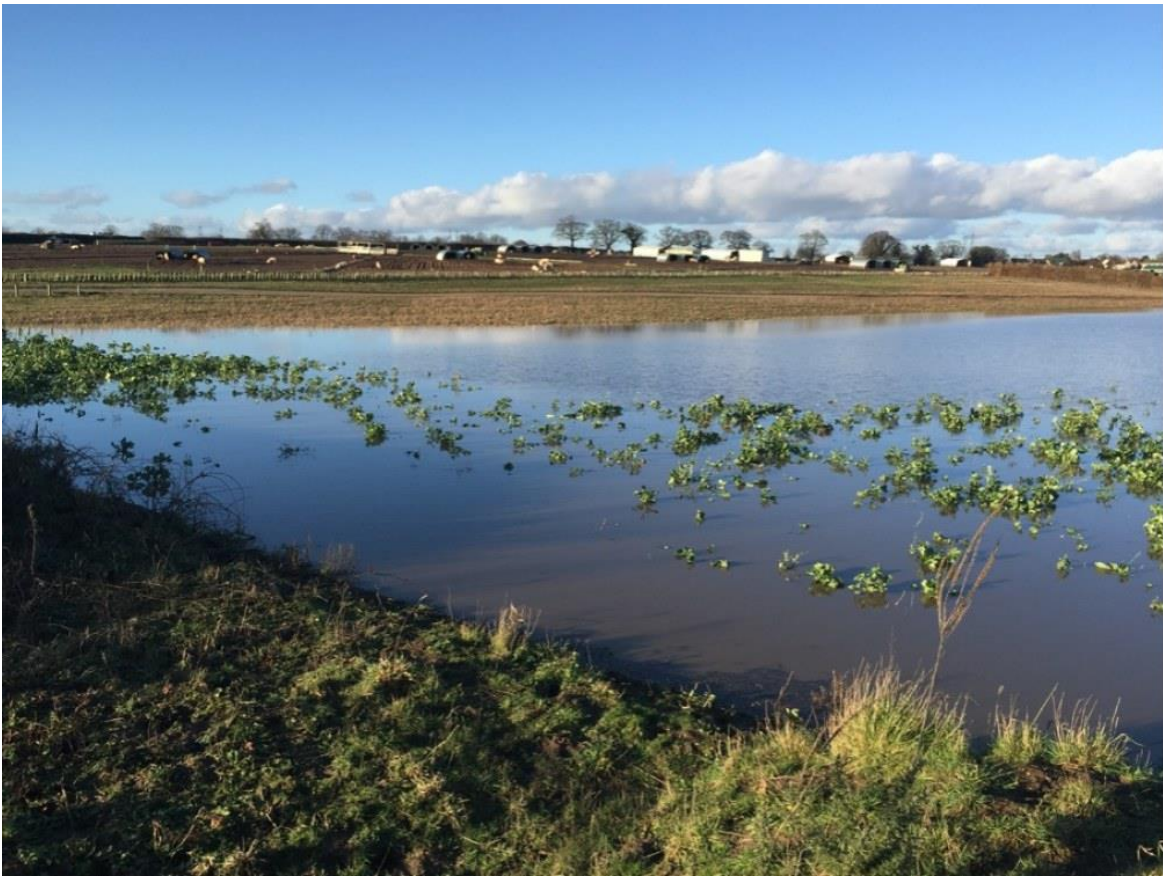
*Photograph taken from top of bund – 27<sup>th</sup> December 2020*
