**Thanet Extension Offshore Wind Farm**

**Annex 6-1: Phase 1 Geo-environmental Desk  
Study**

June, 2018, Revision A

Document Reference: 6.5.6.1

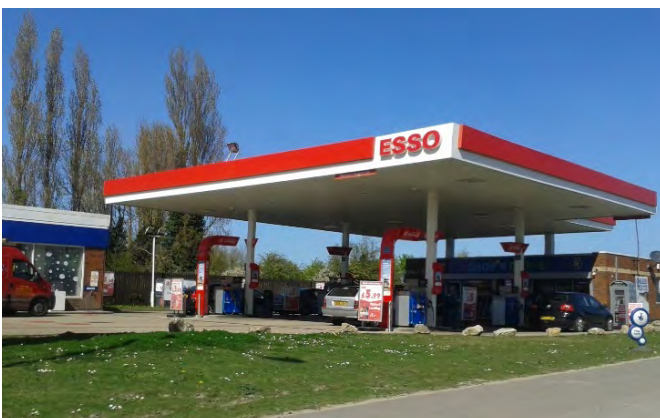
During the April 2017 site walkover, the PFSs above ground infrastructure appeared to be maintained adequately, with some staining around the pumps from spills when vehicles are filled.

Picture 1 Esso active fuel station located adjacent off-site

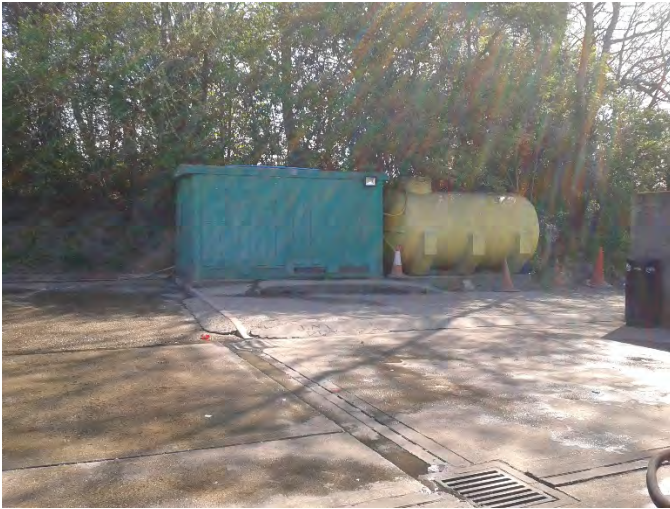
There was an above ground storage tank located at the Gulf fuel station (Picture 2), located off-site north-west of the proposed location of the substation, which appeared to be used as part of the car wash facility, but the contents were not known.

Picture 2 Above ground tank used as part of the car wash facility

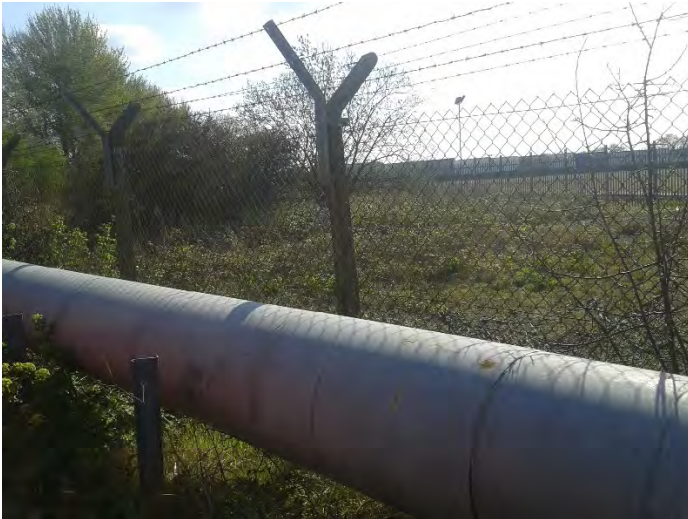
Picture 3 Pipeline running parallel to the road south of the car auction site

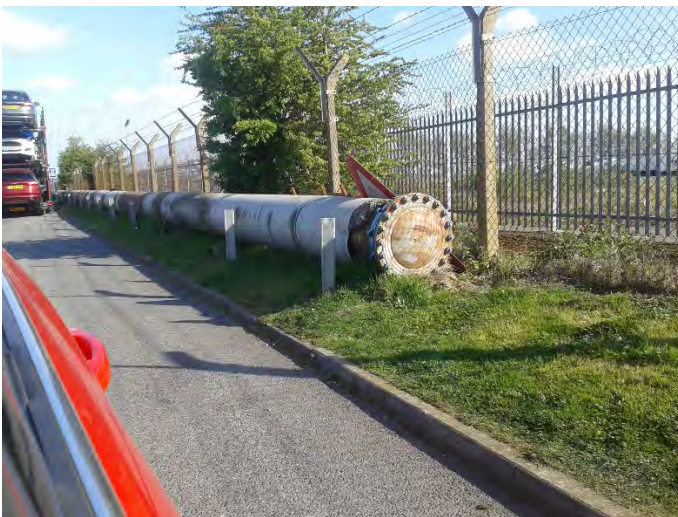
Picture 4 Western end of the pipeline

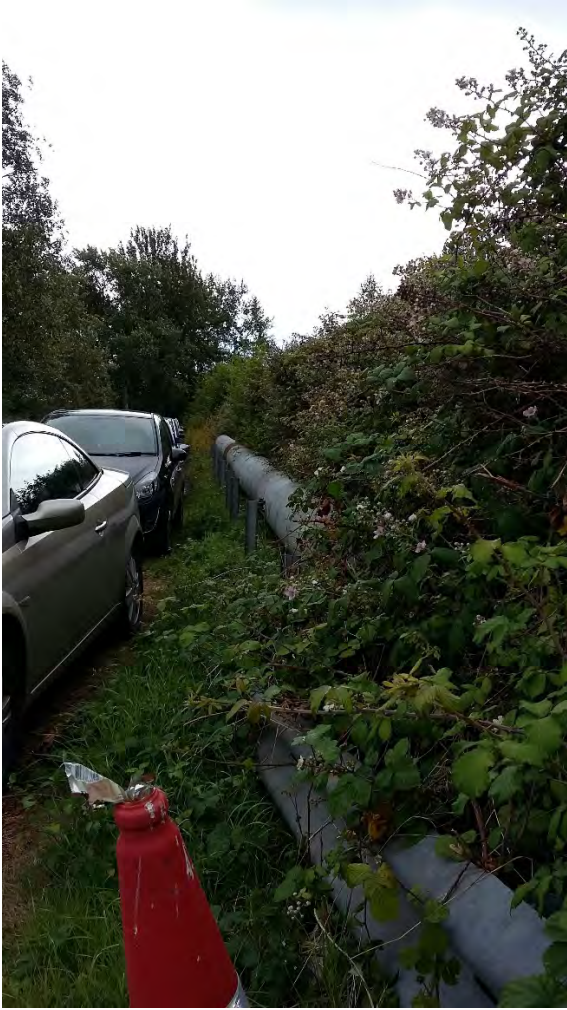
Picture 5 Pipeline towards the River Stour

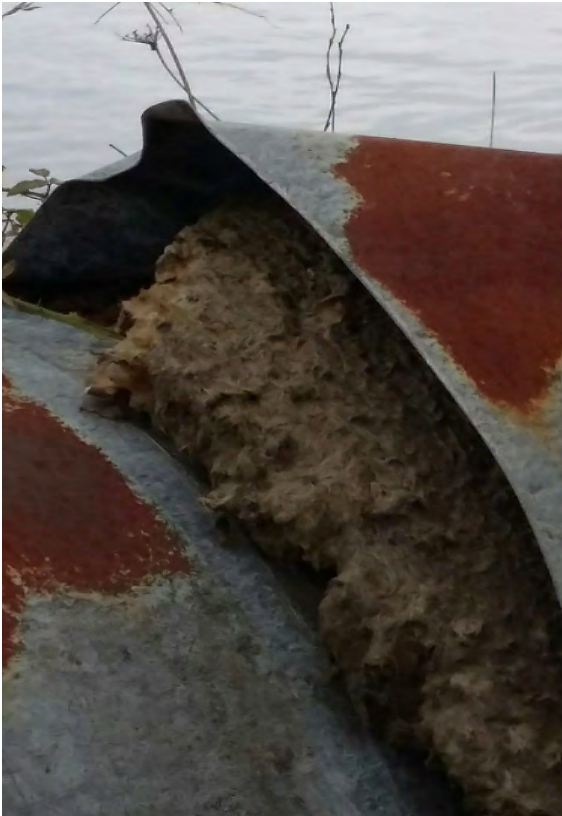
Picture 6 Pipeline lagging

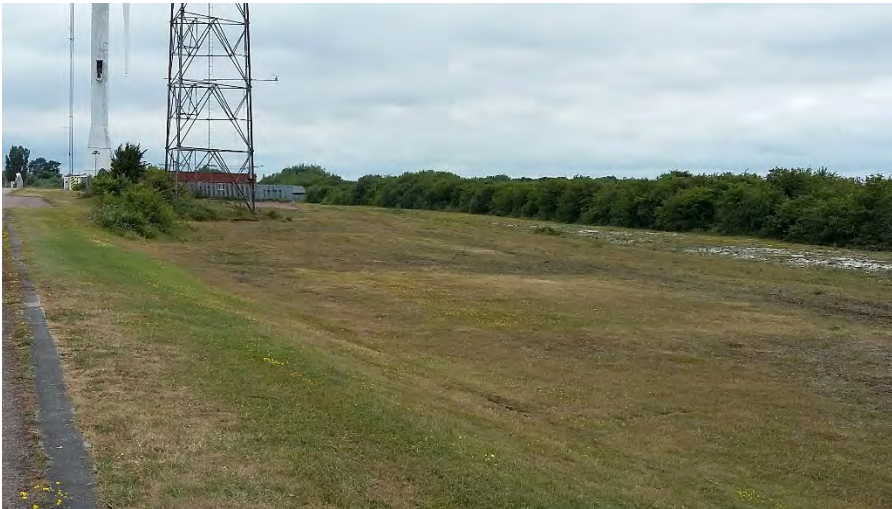
The area could only partially be inspected during the June 2017 site walkover, as most of the site is a construction site. Made Ground was observed at the site, notably across the area where the cable would connect to the National Grid substation (Picture 7). According to the Envirocheck historical mapping, there used to be a railway in this area.

Picture 7 Area where the cable would connect to the National Grid substation

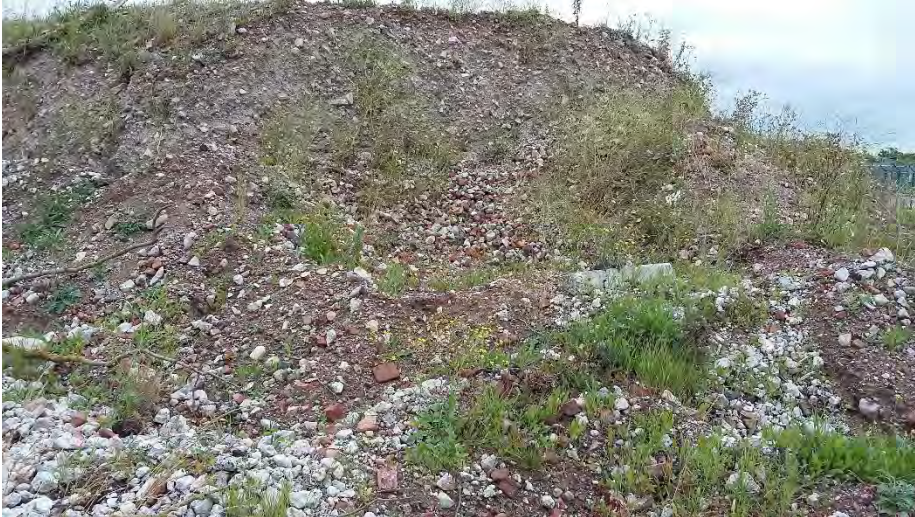
Arisings from the demolition of the former towers and other infrastructure were observed to be stockpiled on the ground along the road to the south of the site (Picture 8).

Picture 8 Stockpiled material

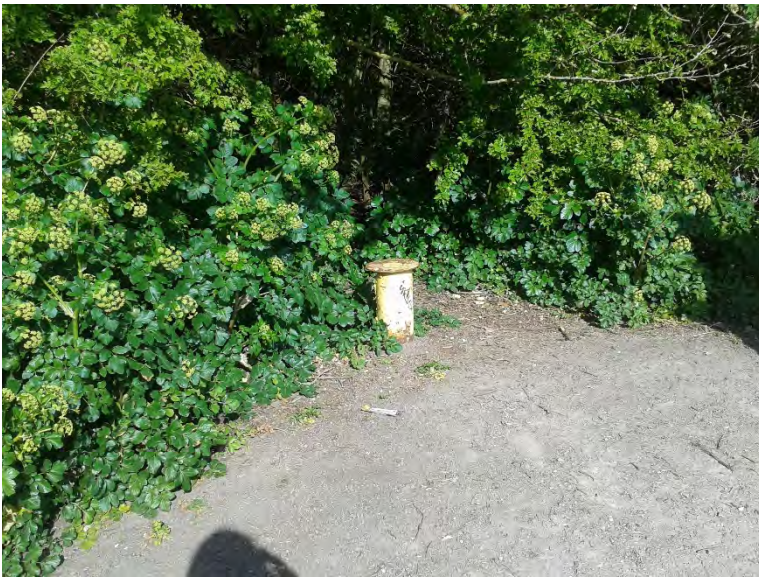
During the April and June 2017 site walkovers, some boreholes were observed on the perimeter of the Pegwell Country Park (Picture 9), indicating that ongoing monitoring may take place. There was some possible fill material noted where footpath erosion had removed the grass and topsoil and exposed areas of anthropogenic material; glass, brick and ceramic (Picture 10). It was also noted that site clearance works had started for the Nemo (electricity connection between UK and Belgium) project by Balfour Beatty in the western area of the country park. The drainage ditches/ watercourses around the sites varied in turbidity and flow rates.

Picture 9 Borehole observed on the perimeter of the Pegwell Country Park

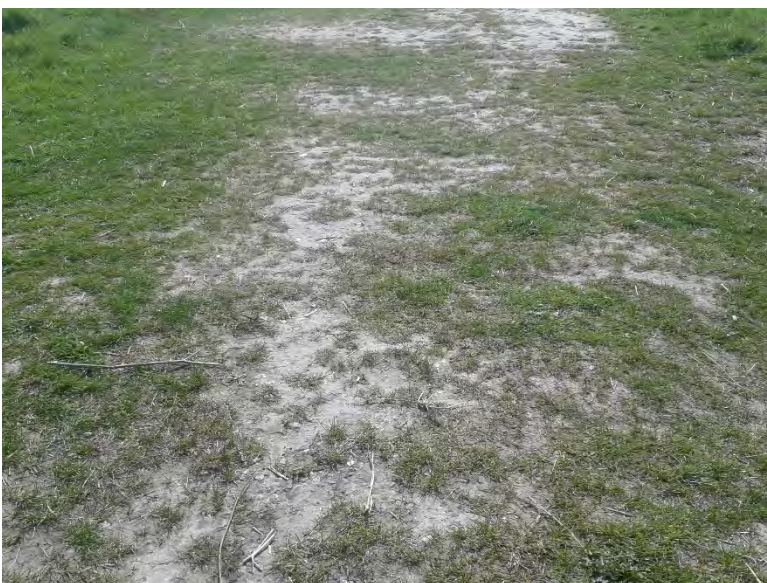
Picture 10 Possible fill material at the Pegwell Bay Country Park

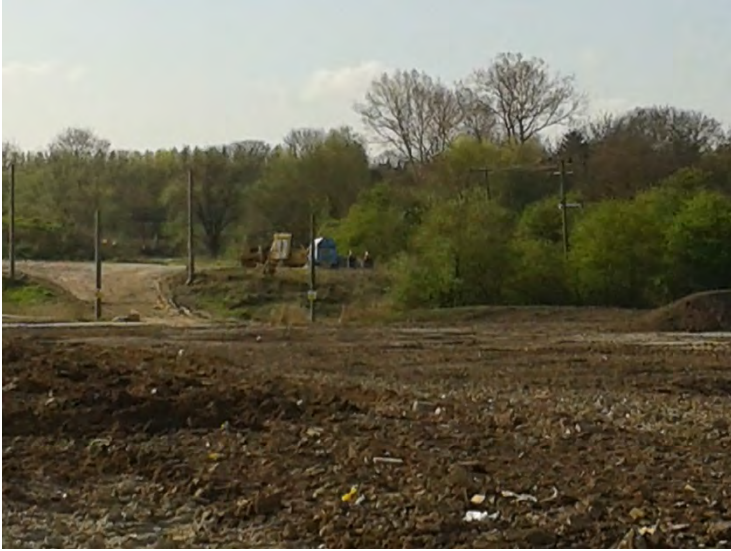
Picture 11 Plant equipment and soil stockpiles south-east of Stonelees Golf Centre

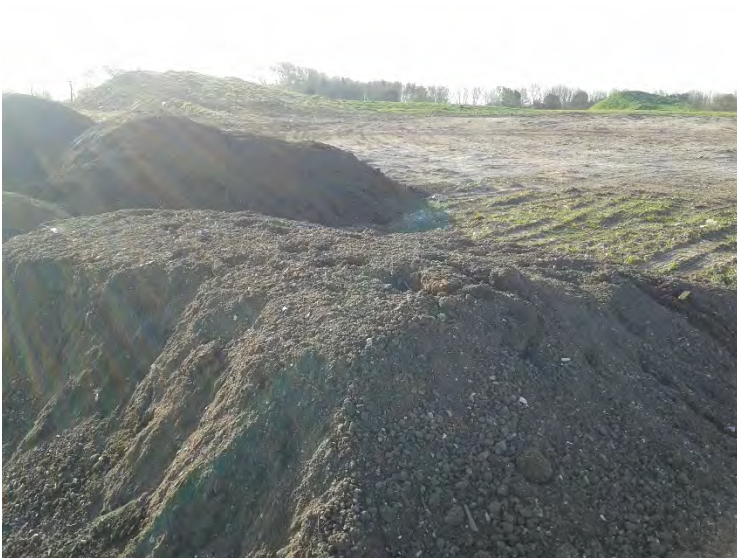
Picture 12 South-eastern part of Stonelees Golf Centre

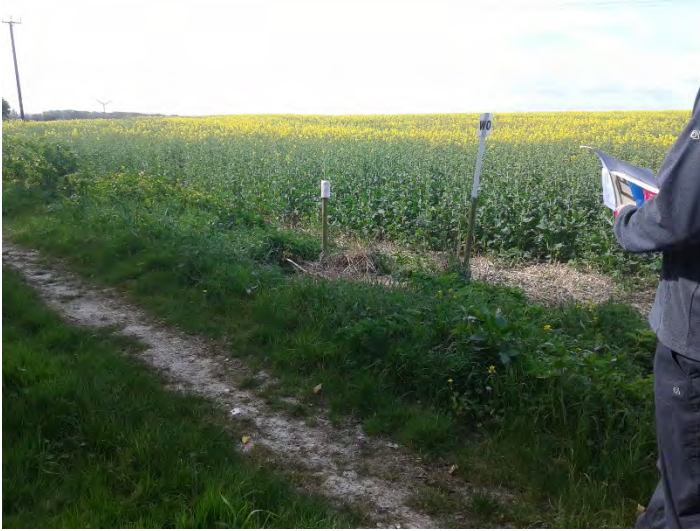
In the field to the west of St Augustine's Golf Course and west of Cottingham Lane (off-site), two field markers were identified with the text 'WO' marked upon them. They appeared to be extraction points for water irrigation for the fields (Picture 13).

Picture 13 WO points noted off Cottington lane, west of St. Augustine's Golf Course

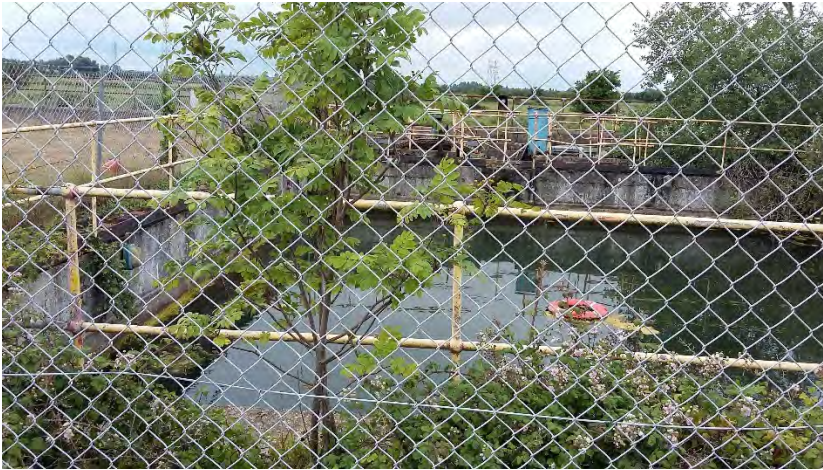
A historical WWTW on-site associated with the former Richborough power station was observed during the June 2017 walkover (Picture 14).

Picture 14 WWTW on-site at the former Richborough Power Station

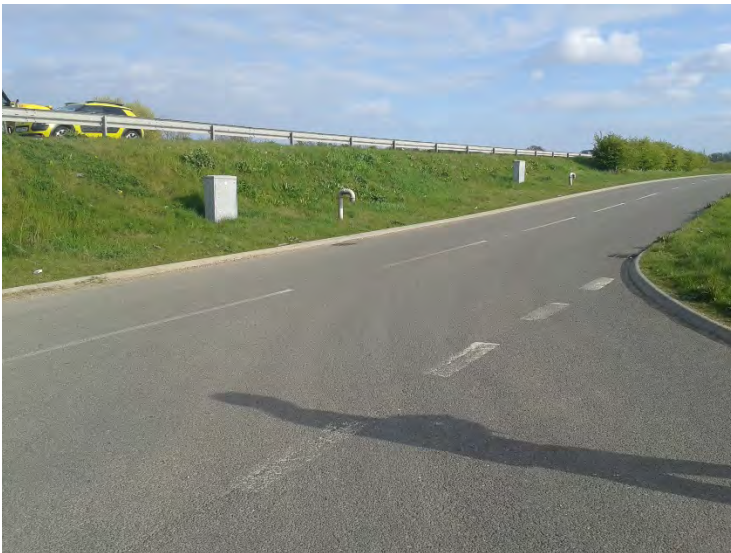
The Weatherlees WWTW could not be accessed during the April and June 2017 walkovers. Observations made from the surrounding areas were that there seemed to be breather pipes to the entrance of the sewage treatment works, to the east, possibly indicating an underground tank (Picture 15).

Picture 15 Breather pipes at the entrance of Weatherlees WWTW

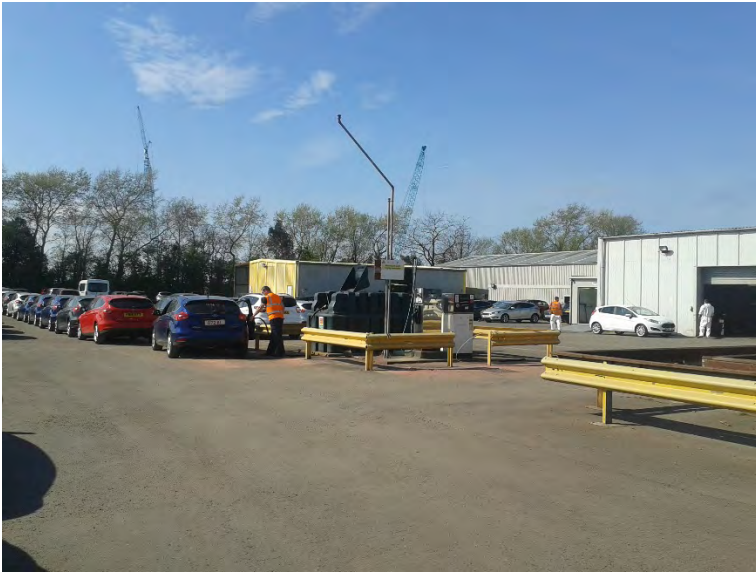
Picture 16 Car auction site

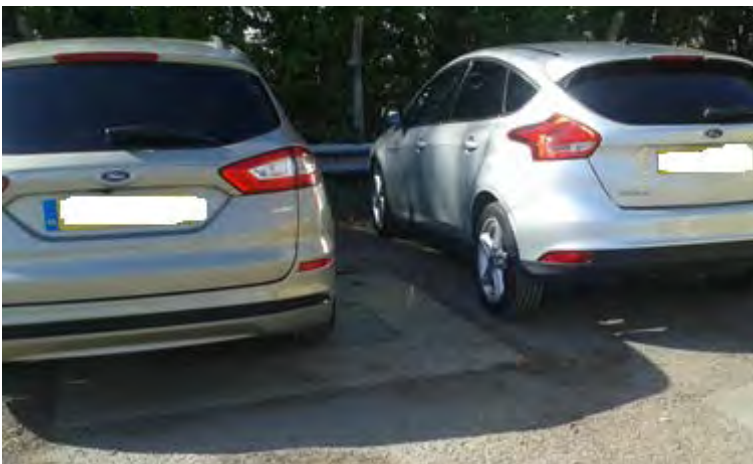
The motor vehicle depot is currently used to repair cars prior to auction (Picture 16). The April 2017 site walkover identified a disused oil/ water interceptor located on the western area of the main buildings. This was previously emptied via tanker, but had not been used

Picture 17 Disused underground oil water interceptor (cover beneath car on left).

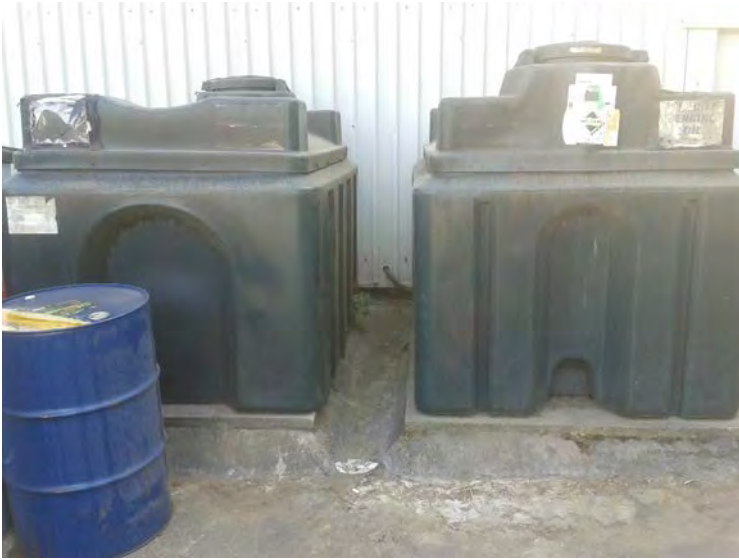
Picture 18 New oil and fuel storage tanks

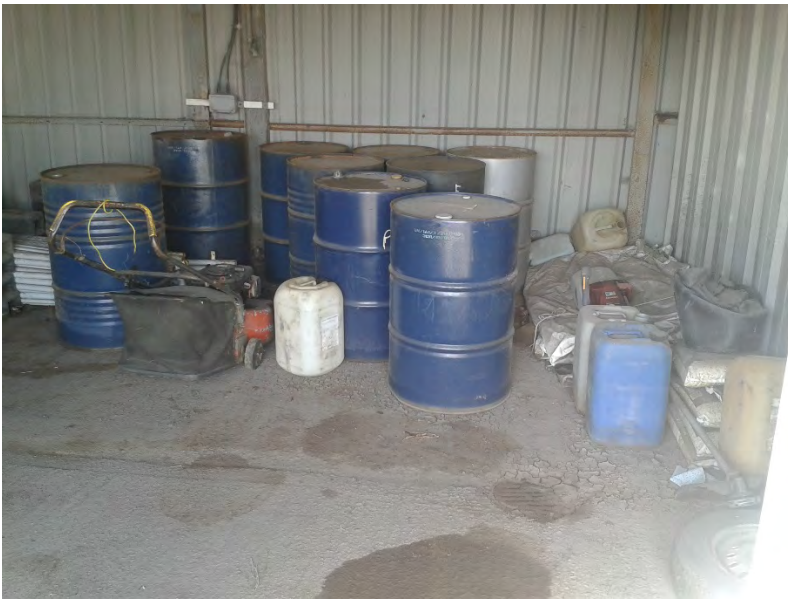
Picture 19 Storage with signs of spillages

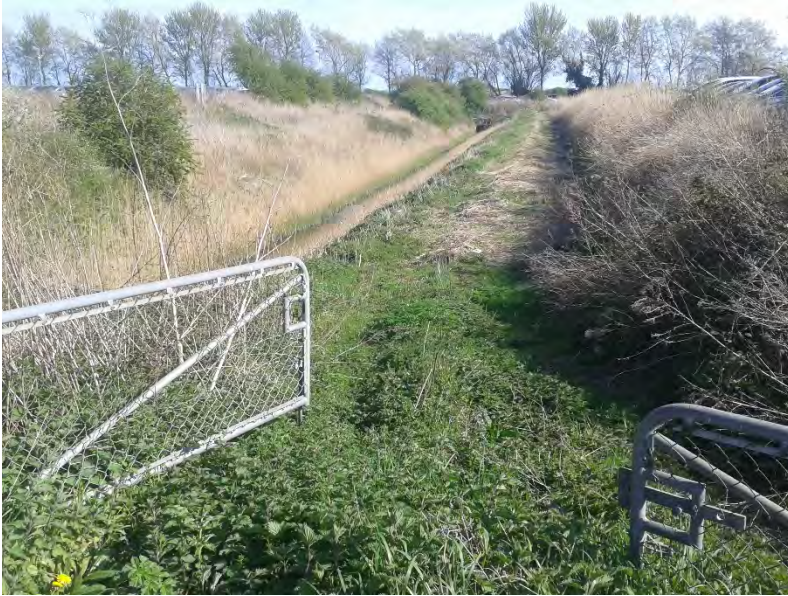
Picture 20 Tributary to River Stour on Maintenance Facility site

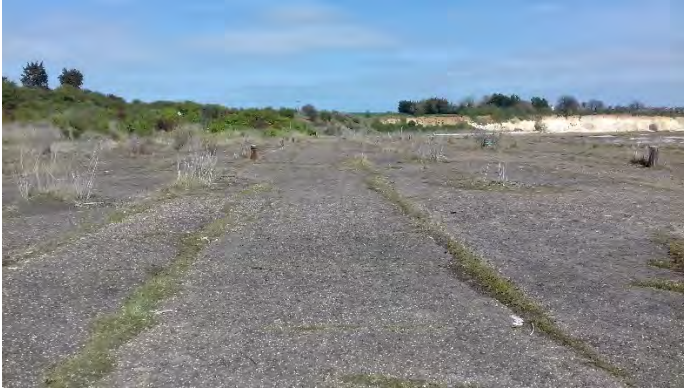
Picture 21 Disused hoverport

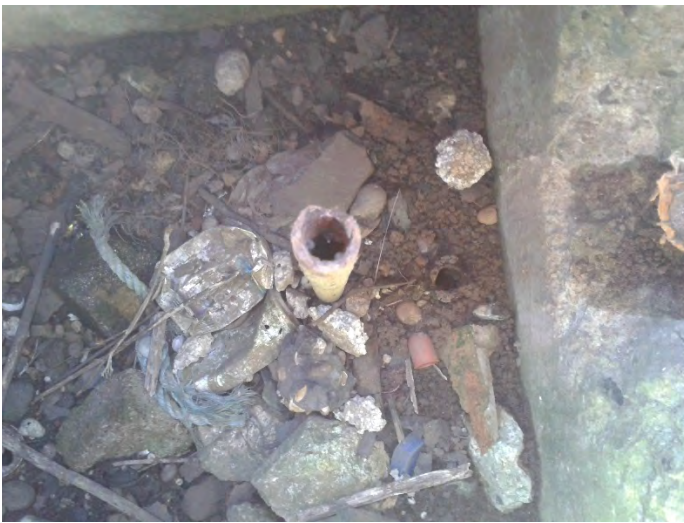
During the April 2017 site walkover, a narrow diameter, apparently disused piezometer installation was noted on the hoverport tarmac pad area, indicating that SI and monitoring may have taken place in the past (Picture 22).

Picture 22 Borehole installation observed on the hoverport tarmac

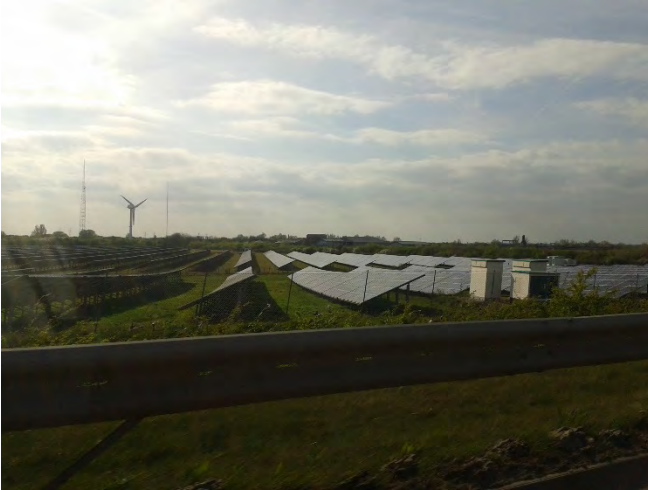
Picture 23 Solar panels to east of Richborough Energy Park

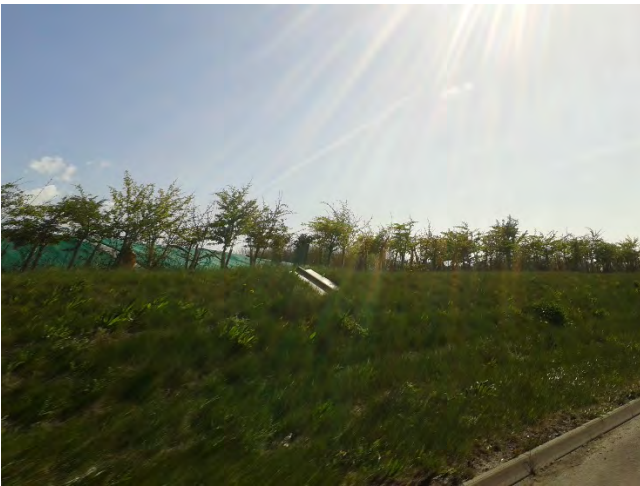
Picture 24 Covered stockpiles – possible low level fertilizer storage derived from Richborough Energy Park

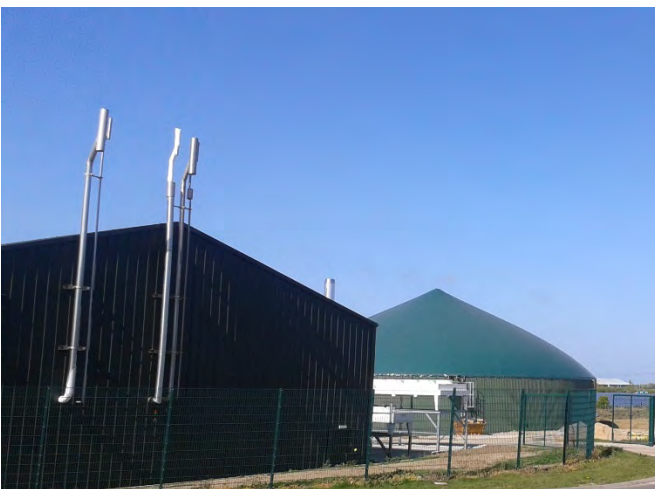
Part of the energy park is understood to be a waste treatment facility which operates as an A23 activity under Environmental Permit (Ref. 103686), and is indicated as an anaerobic digestion facility (Picture 25).

Picture 25 Anaerobic Digester facility within Richborough Energy Park

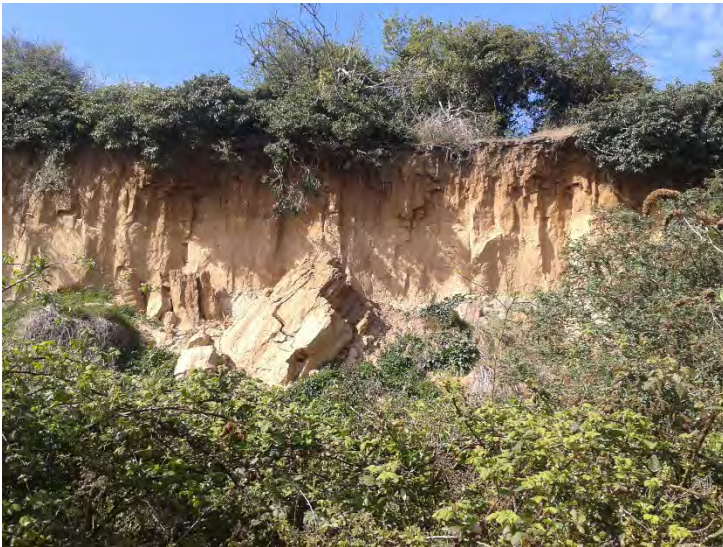
Picture 26 View of cliffs behind Pegwell Bay Hoverport, note apparent instability of cliff
