Norfolk Boreas Offshore Wind Farm

Initial HDD Feasibility Report

HDD FEASIBILITY REPORT

Cable Landfalls for East Anglia North Tranche 1 (EAN) U.K.

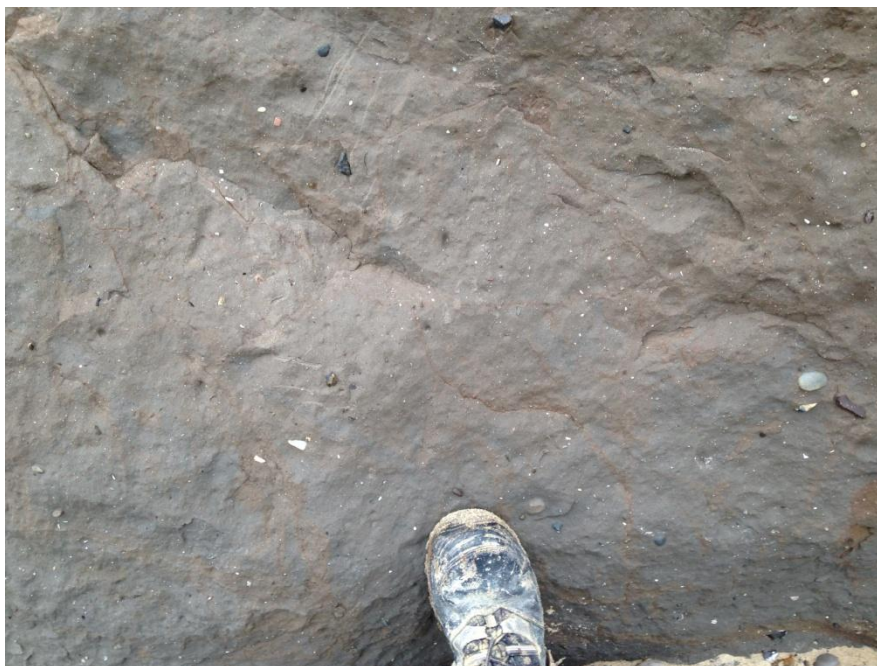
The various till members within the formations in the study areas are expected to form a stable borehole when drilled with HDD. No large boulders or beds of cobbles were seen in any of the tills during the site visit, however locally they might occur. If boulders or cobbles within a till were encountered during a HDD they would cause inconvenience (additional time required to clean the borehole) and a relatively small cost increase for the contractor. They would be unlikely to require re-drilling or re-routing of the HDD.

Figure 5. Happisburgh Till member exposed in cliffs at Happisburgh.

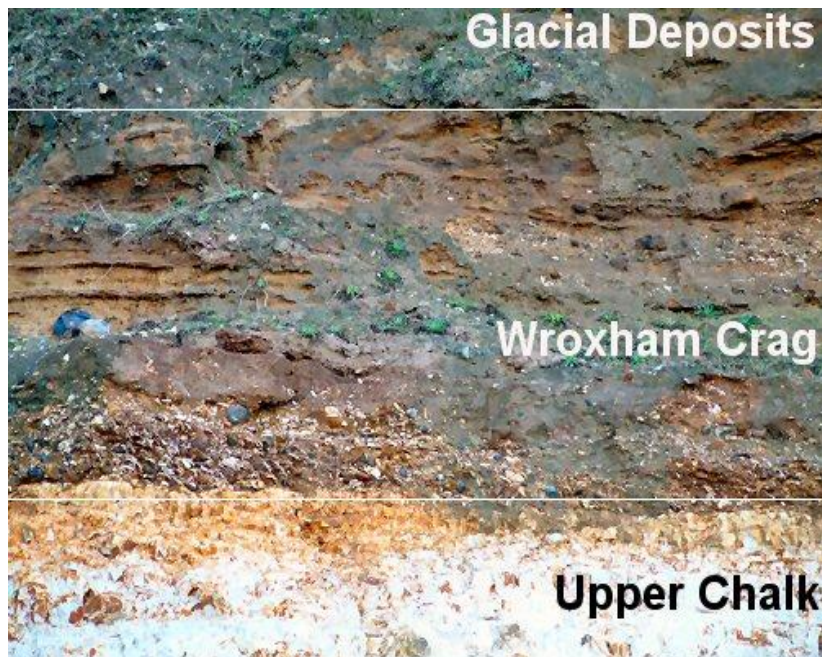
Any flint within the Crag will lead to greater than normal wear on downhole equipment and possibly the drilling fluid recycling equipment. It might also require additional time to physically remove from the borehole but both wear and hole cleaning can be factored into schedule (perhaps an additional 1 to 2 days per HDD) and price by the HDD contractor.

Figure 7. Cliff exposure from Weybourne, Norfolk showing Crag deposits. Photograph from <http://www.weybourne.ukfossils.co.uk/Weybourne-Fossils-Geology/geology-guide.htm>.

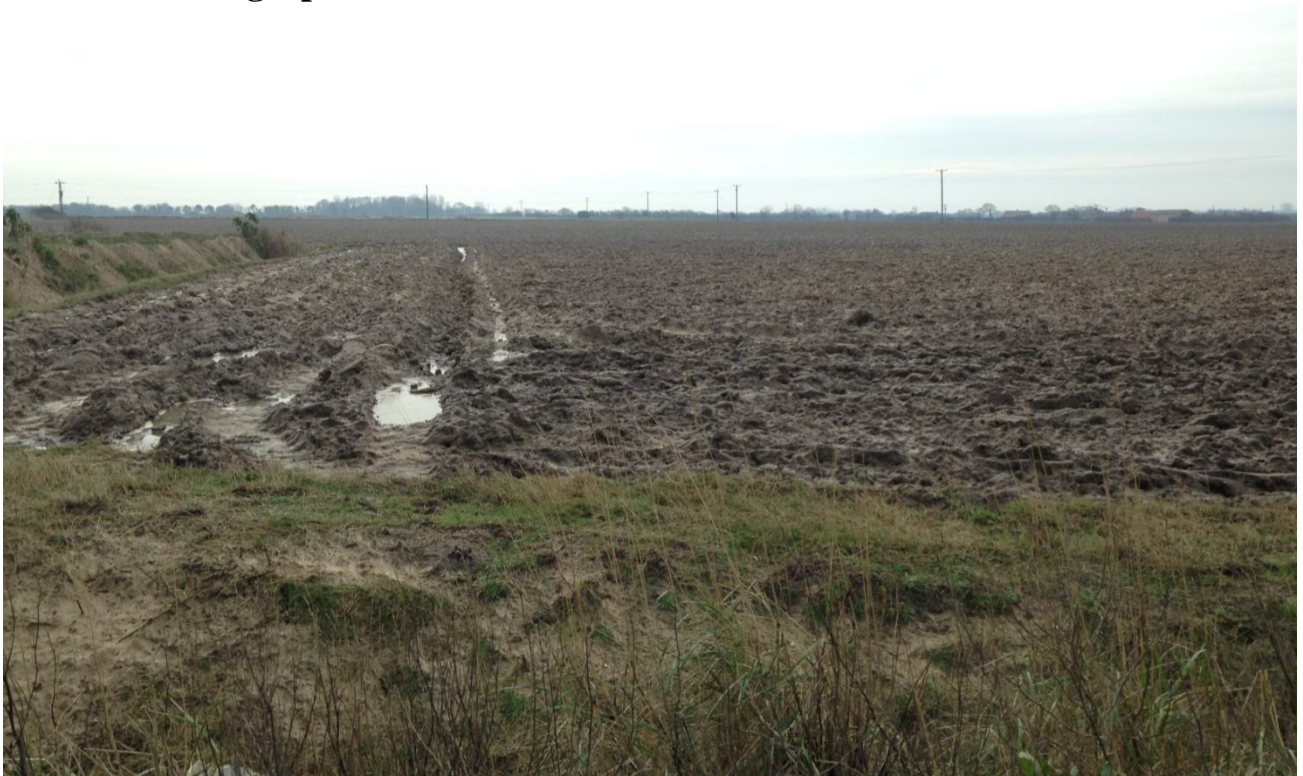
Figure 28. Site 1. View of field from B1159 southward with likely entry point mid photograph.

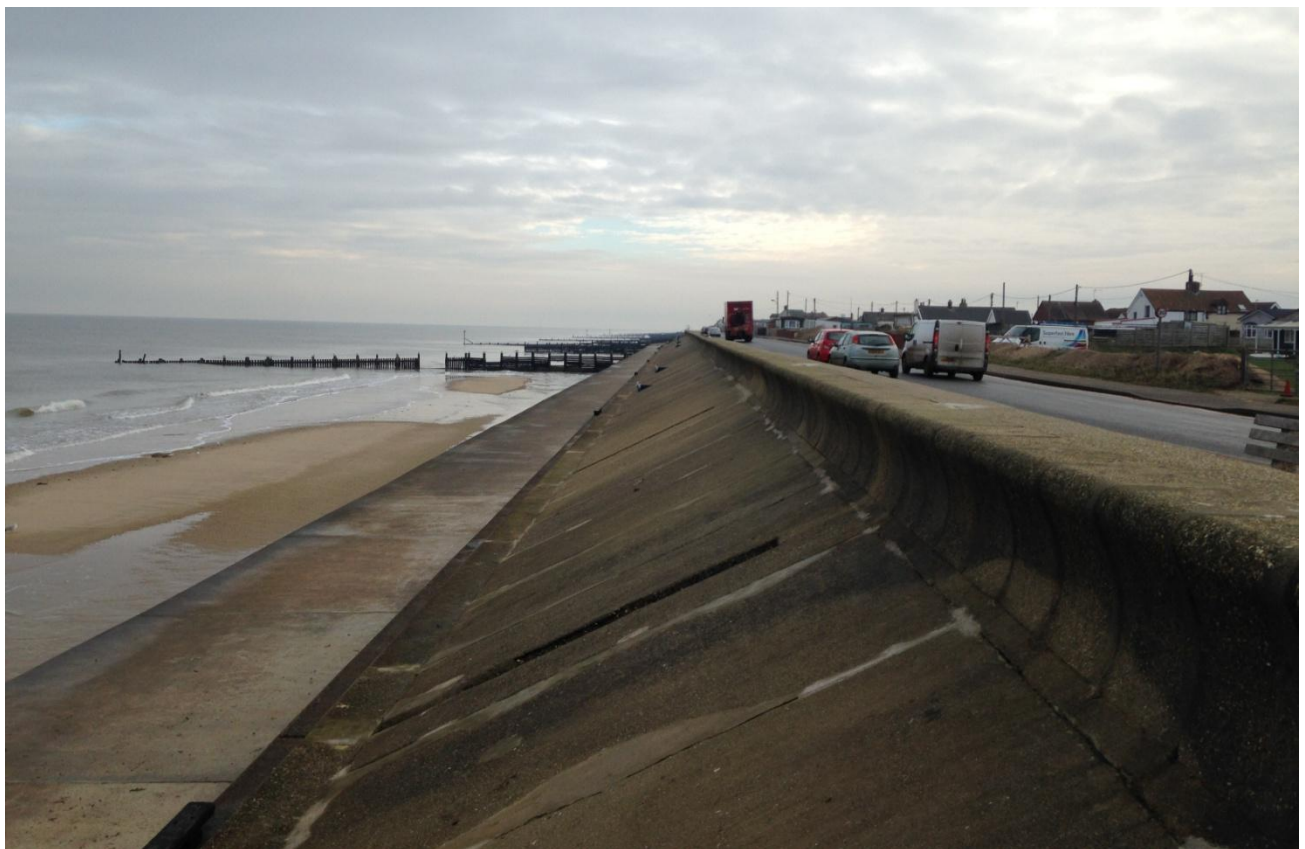
Figure 29. Site 1. View to Southeast from above the potential HDD alignment showing coastal defences and B1159.

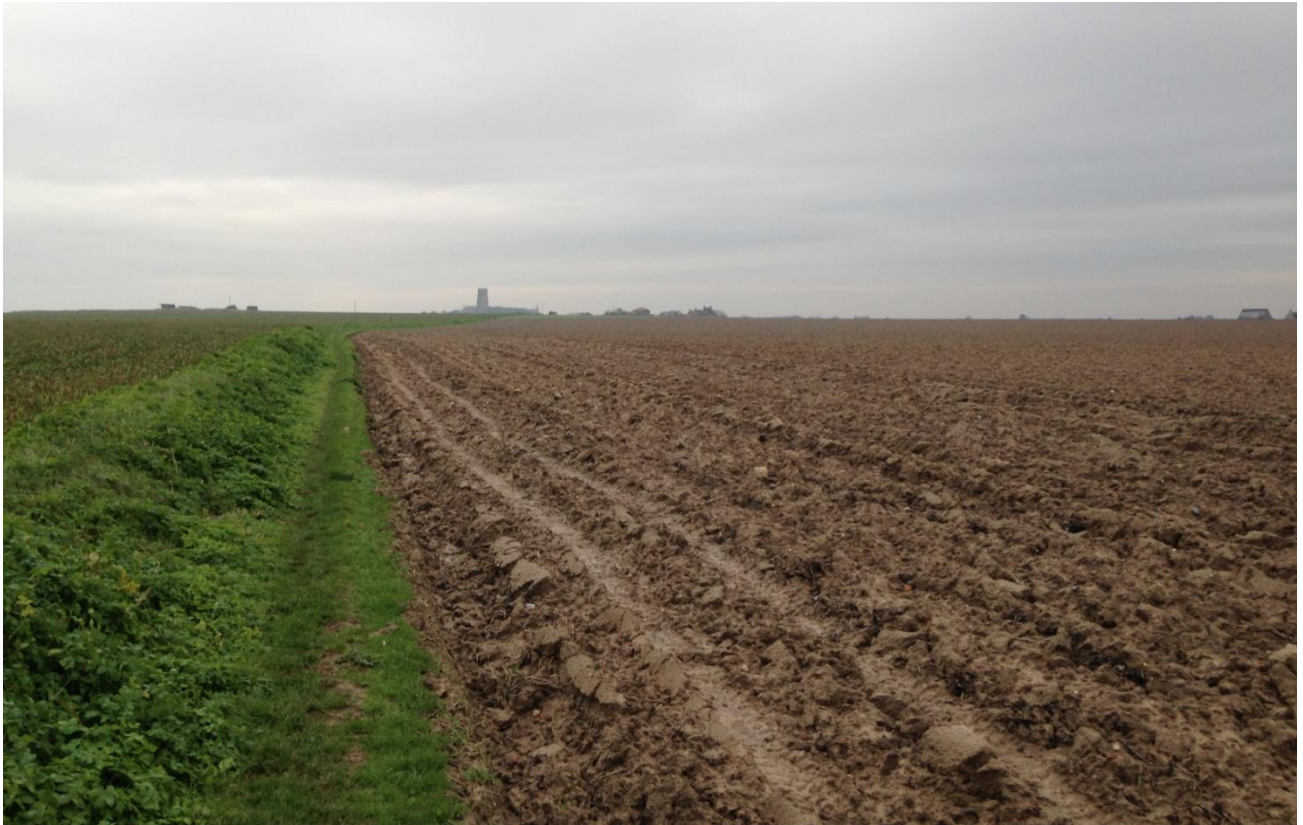
Figure 30. Site 2. View from likely entry point (right of picture) southwards to Happisburgh.

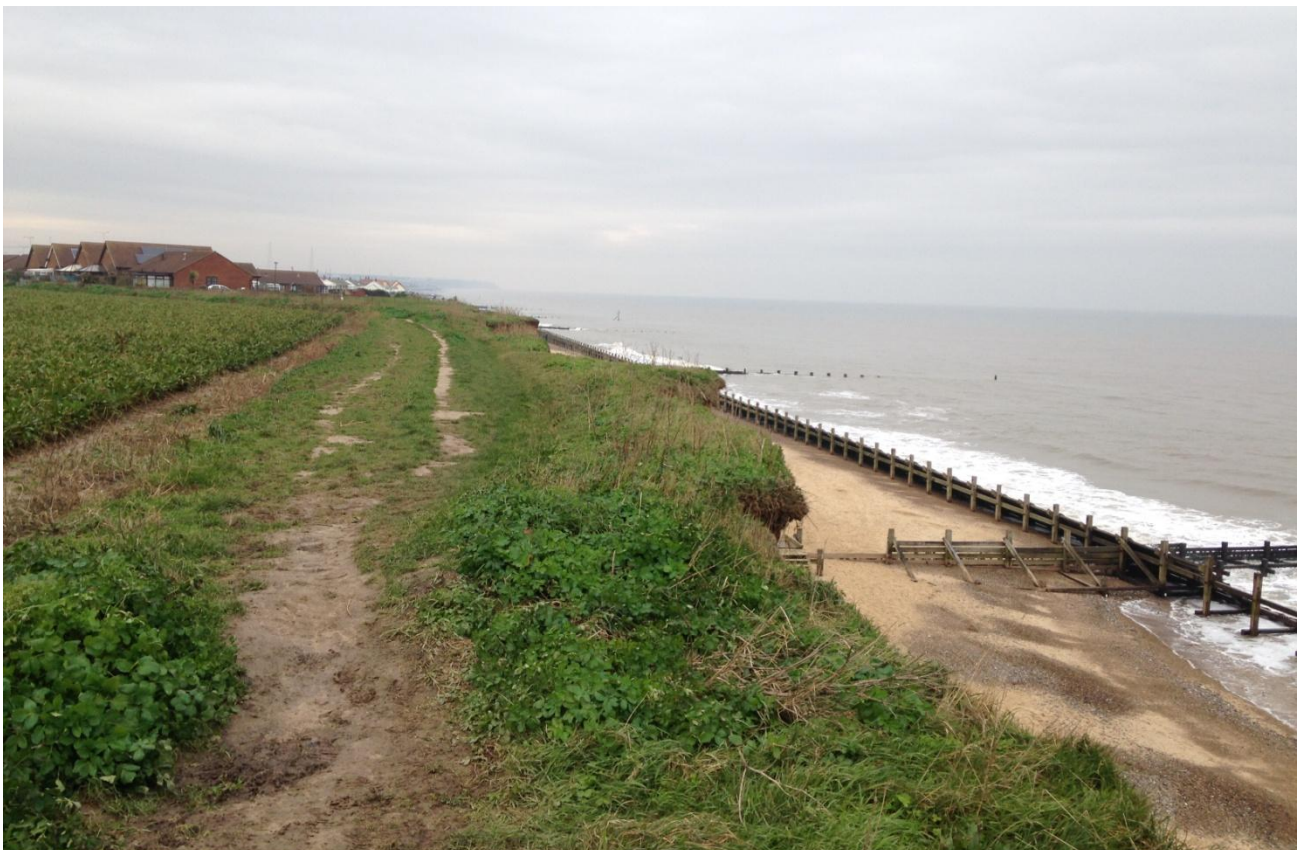
Figure 31. Site 2. View Northward towards Ostend. HDD route is through mid distance with likely entry point to left of photograph, exit point on right between the groins but beyond their seaward end. Note cliff height and coastal erosion.

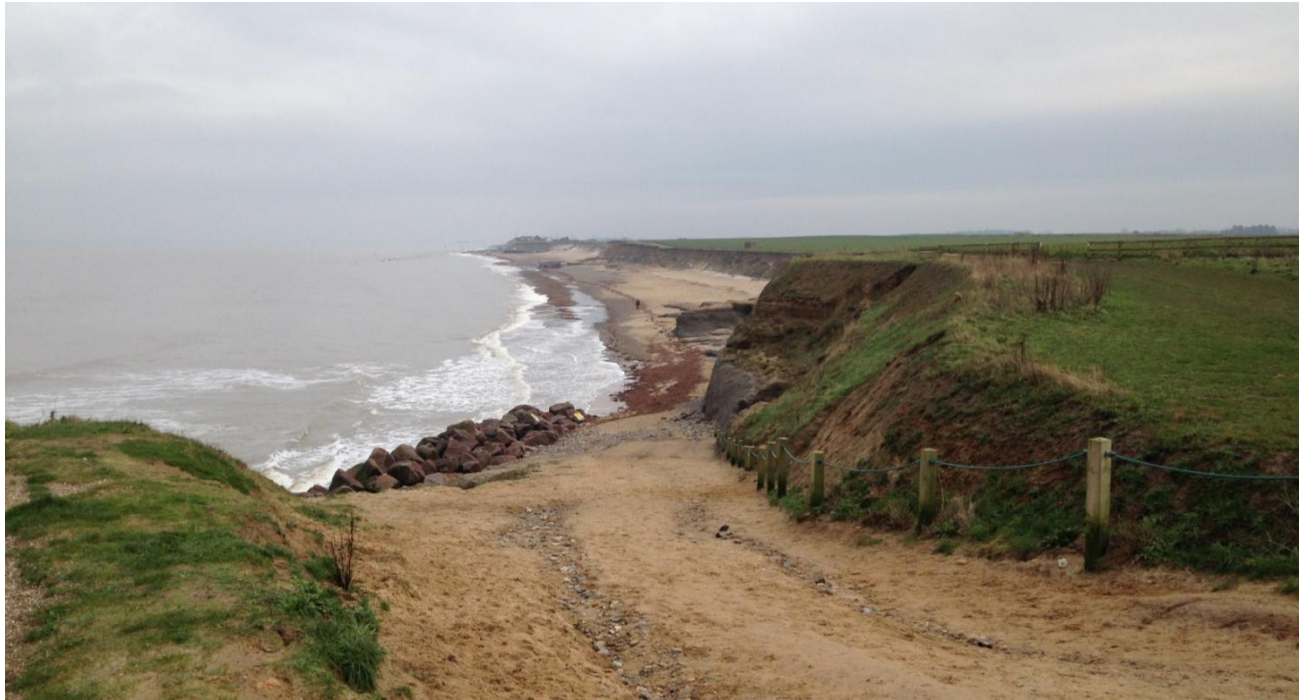
Figure 32. Site 3a. View to southwest from beach access. Beach access will periodically require reinstatement as coastal erosion advances. Site 3a entry point is in far distance before the small headland.

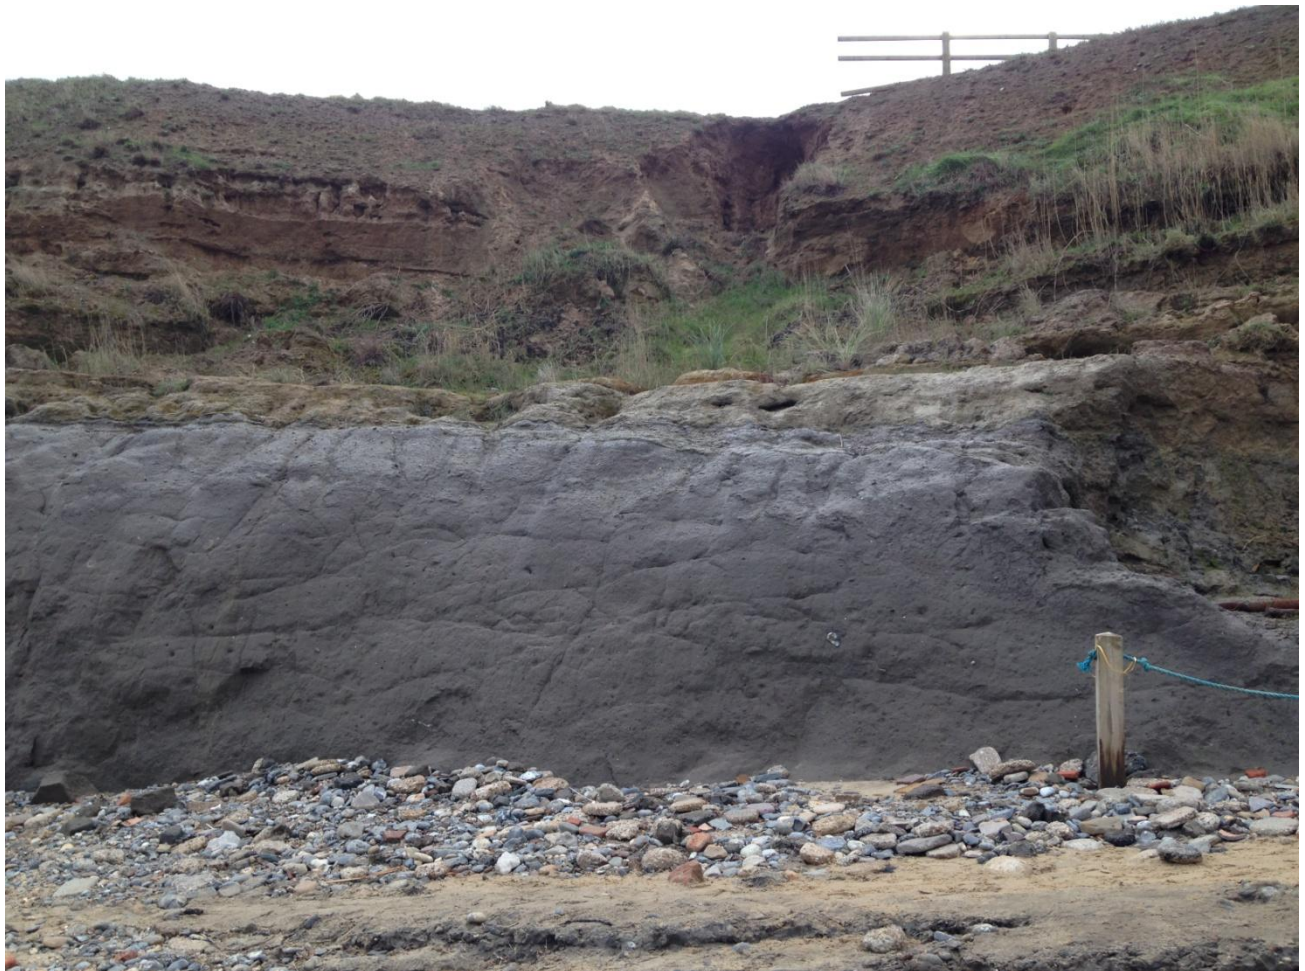
Figure 33. Site 3a. Cliffs at base of access ramp. Cliffs at the site of 3a are half the height (approximately 6m) and consists of the clayey fine sand seen in the upper half of the cliff here. The lower half of this photograph shows glacial till that will form the ground at sea level at Site 3a.

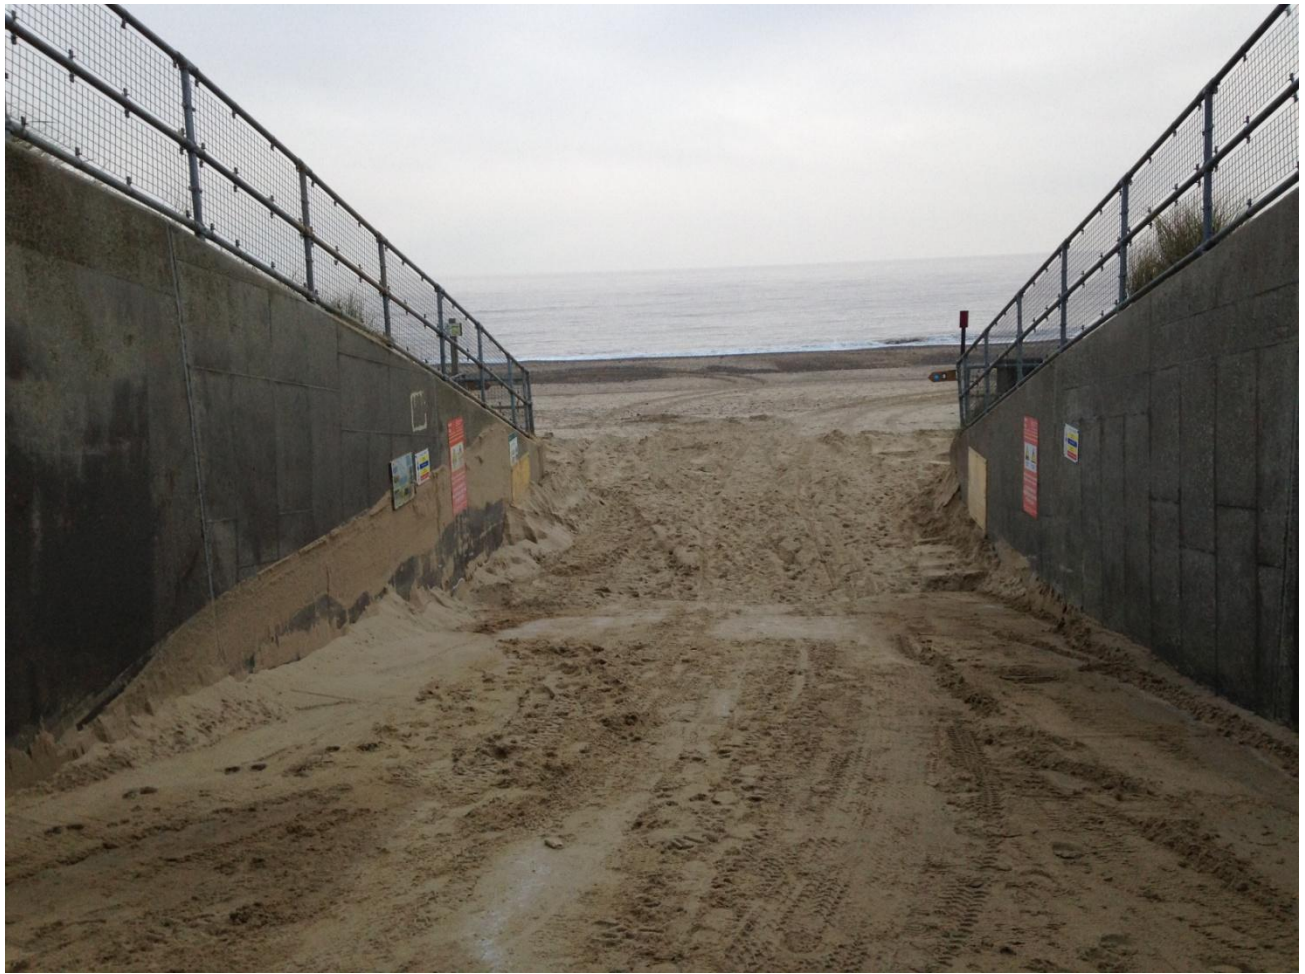
Figure 38. Site 4a. Beach access at North Gap. HDD alignment is 70m to the right of the photograph.

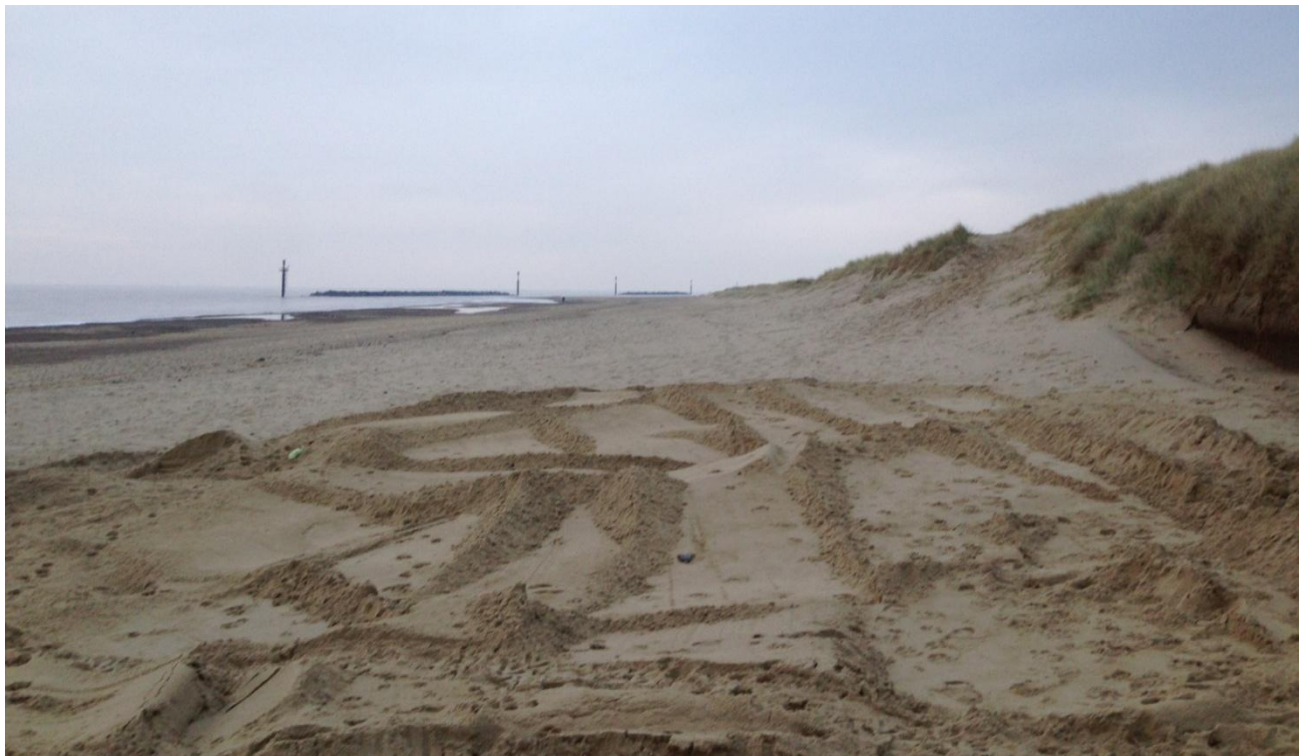
Figure 39. Site 4a. Looking southeast from beach access at North Gap. HDD alignment 4a is 70m along the beach in the mid distance. The alignment for 4b passes between the first and second rock walls in the far distance.

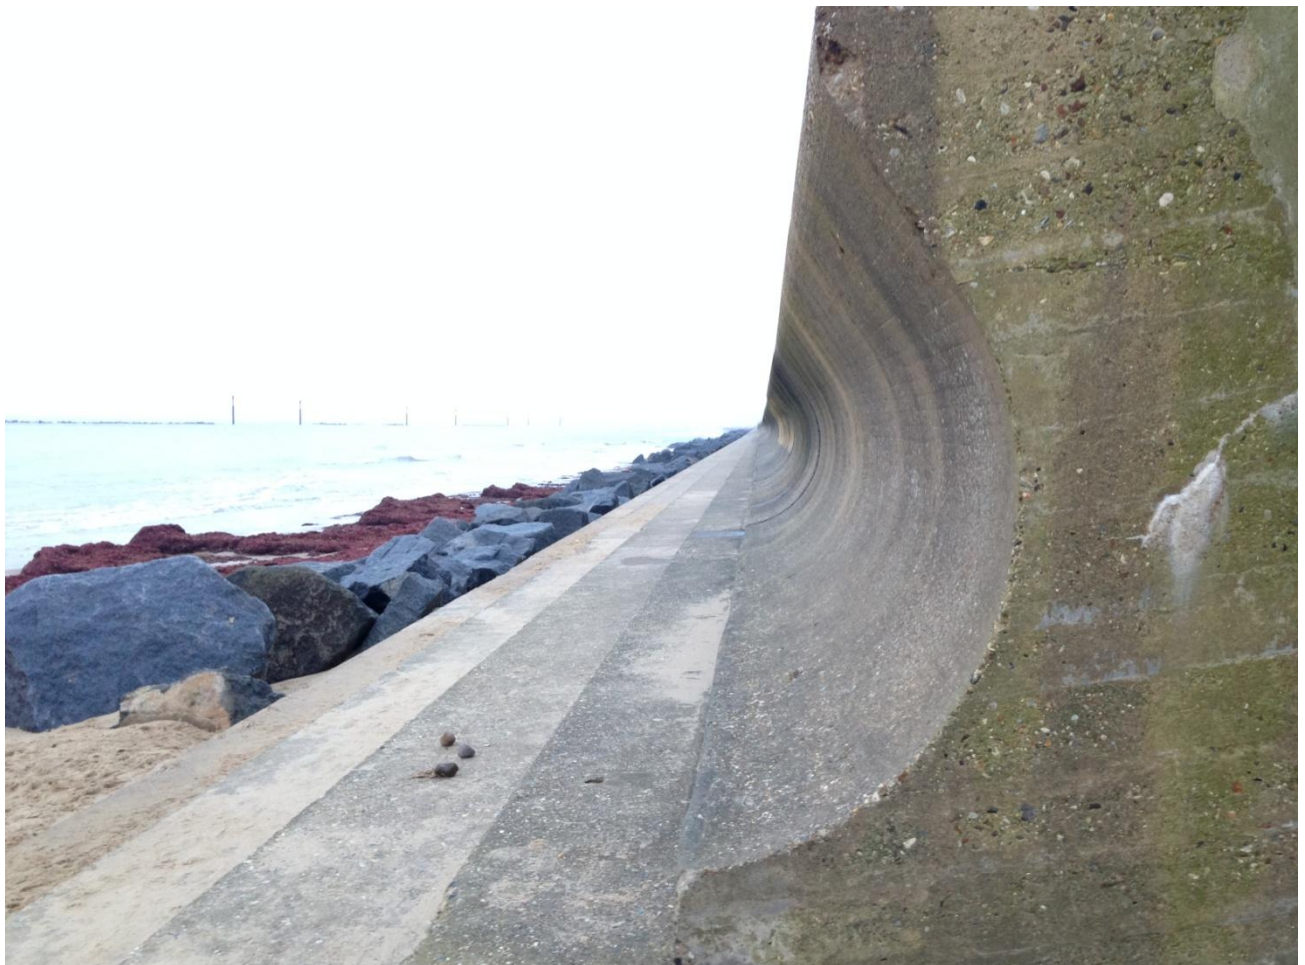
Figure 41. Site 5. Beach defences looking south east from Sea Palling beach access. Offshore rock walls are 250m from the shore. The concrete shoreline defences continue beyond the HDD alignment, 300m from the viewpoint. Alignment 5 passes to the left of the offshore rock wall on the left of the photograph.

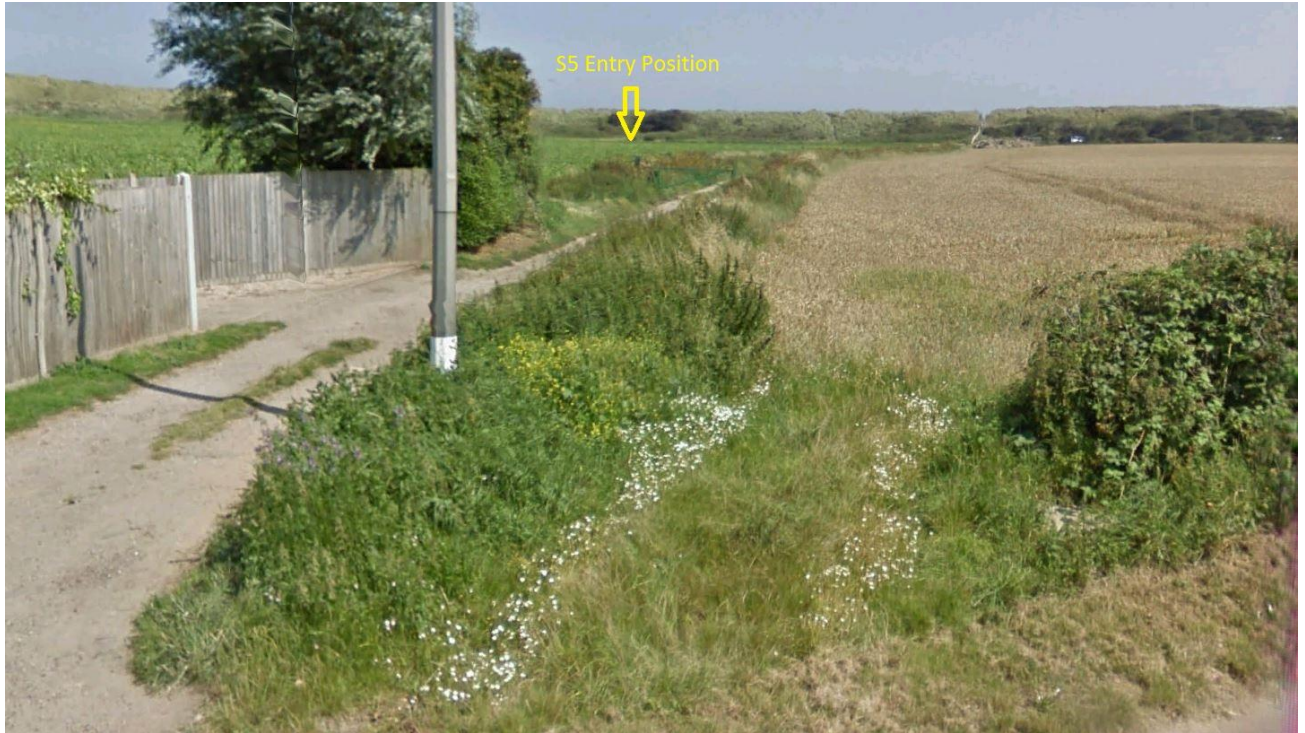
Figure 42. Site 5. Google Street View from Waxham Road looking north-northeast. Potential HDD entry point at end of the field before the dunes. Access track in foreground and junction with Waxham Road might require upgrading for HDD equipment.

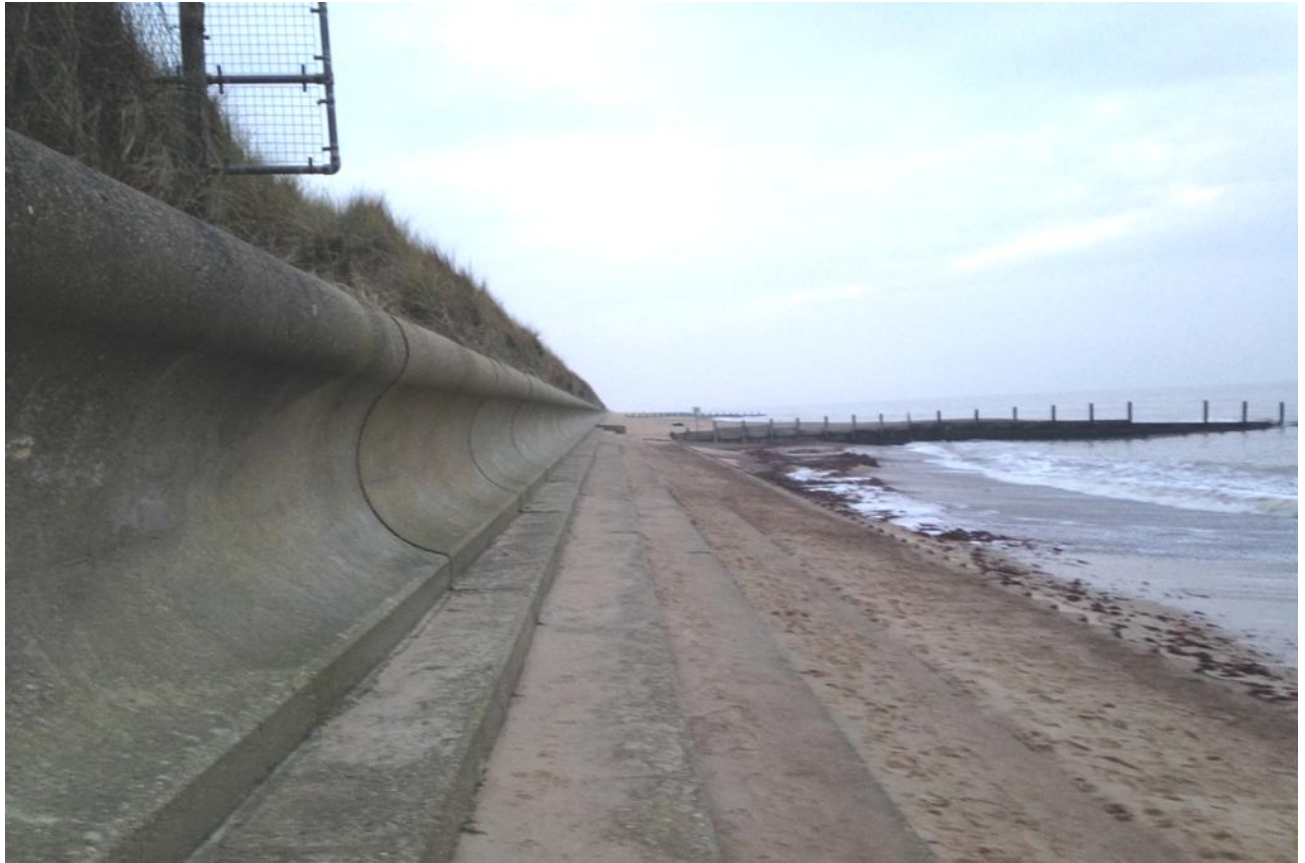
Figure 44. Site 7. Sea defences at Site 7 looking to the northwest.

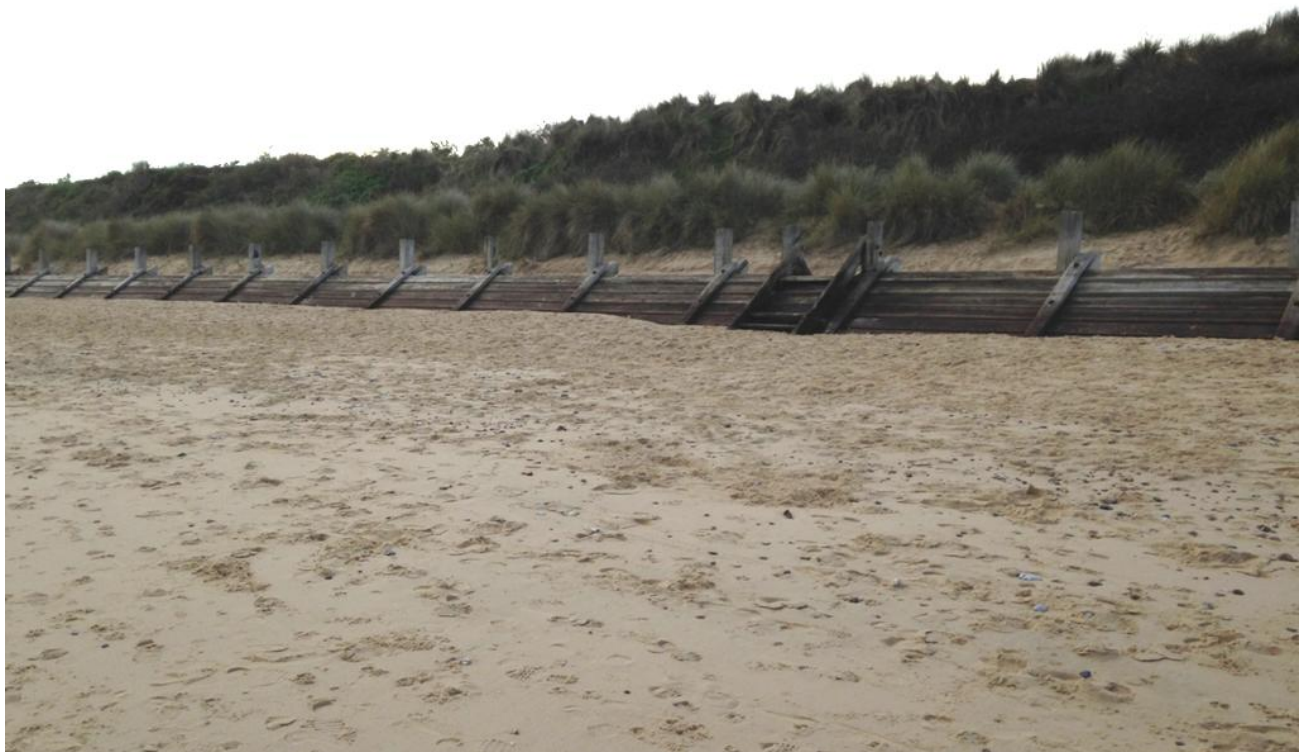
Figure 47. Site 8. Coastal defences and dune / cliffs near Site 8.

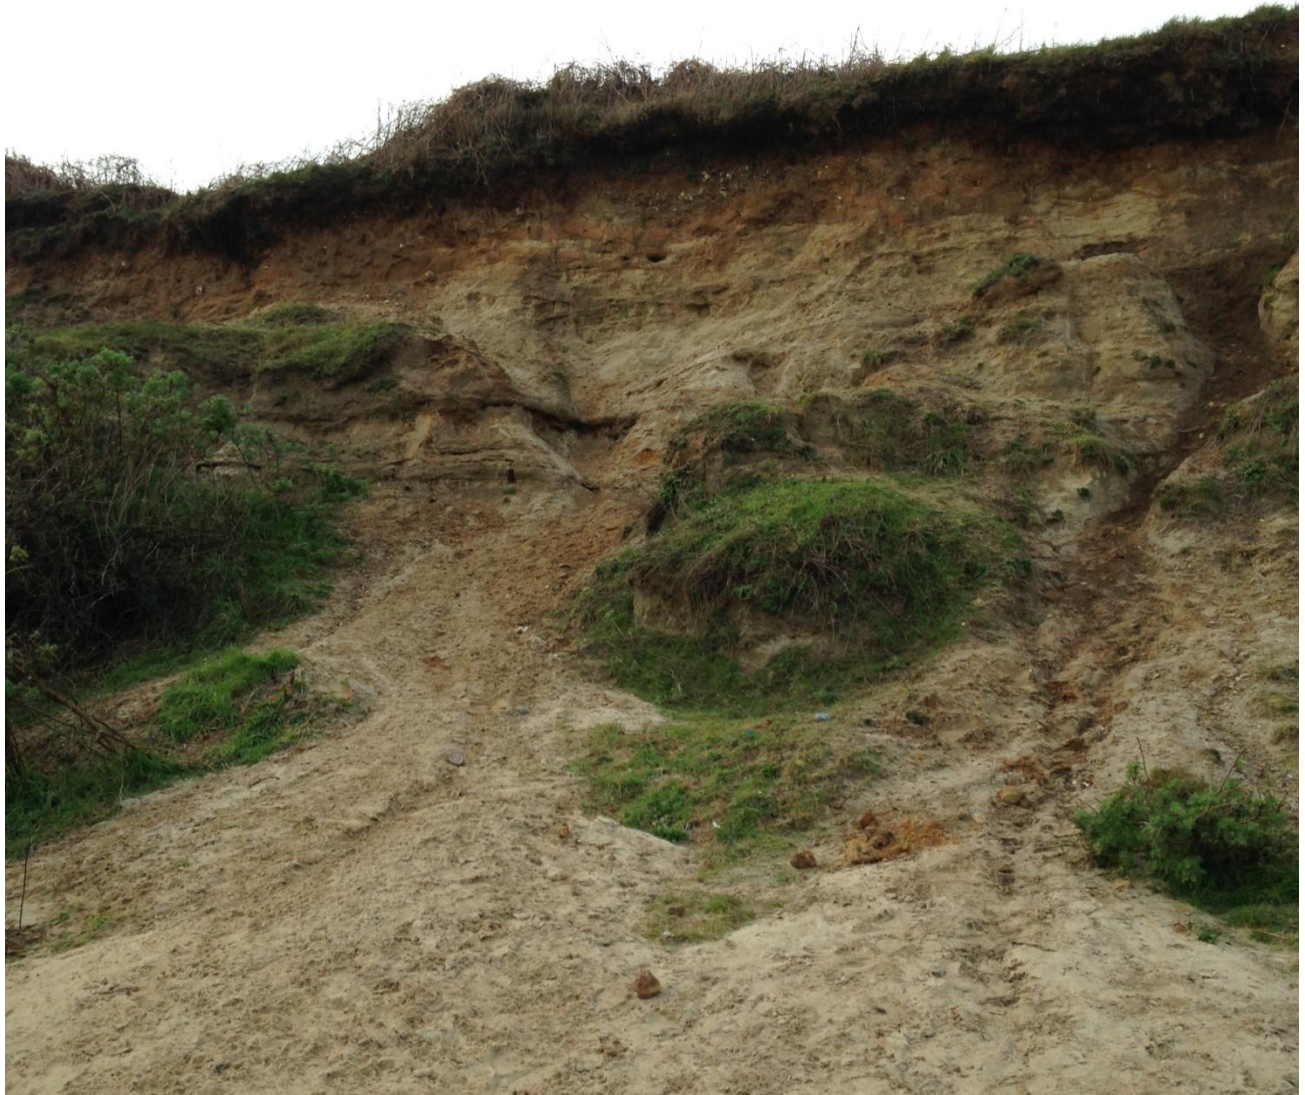
Figure 48. Site 8. Cliff near Site 8 showing eroding sand with some gravel and clay layers.

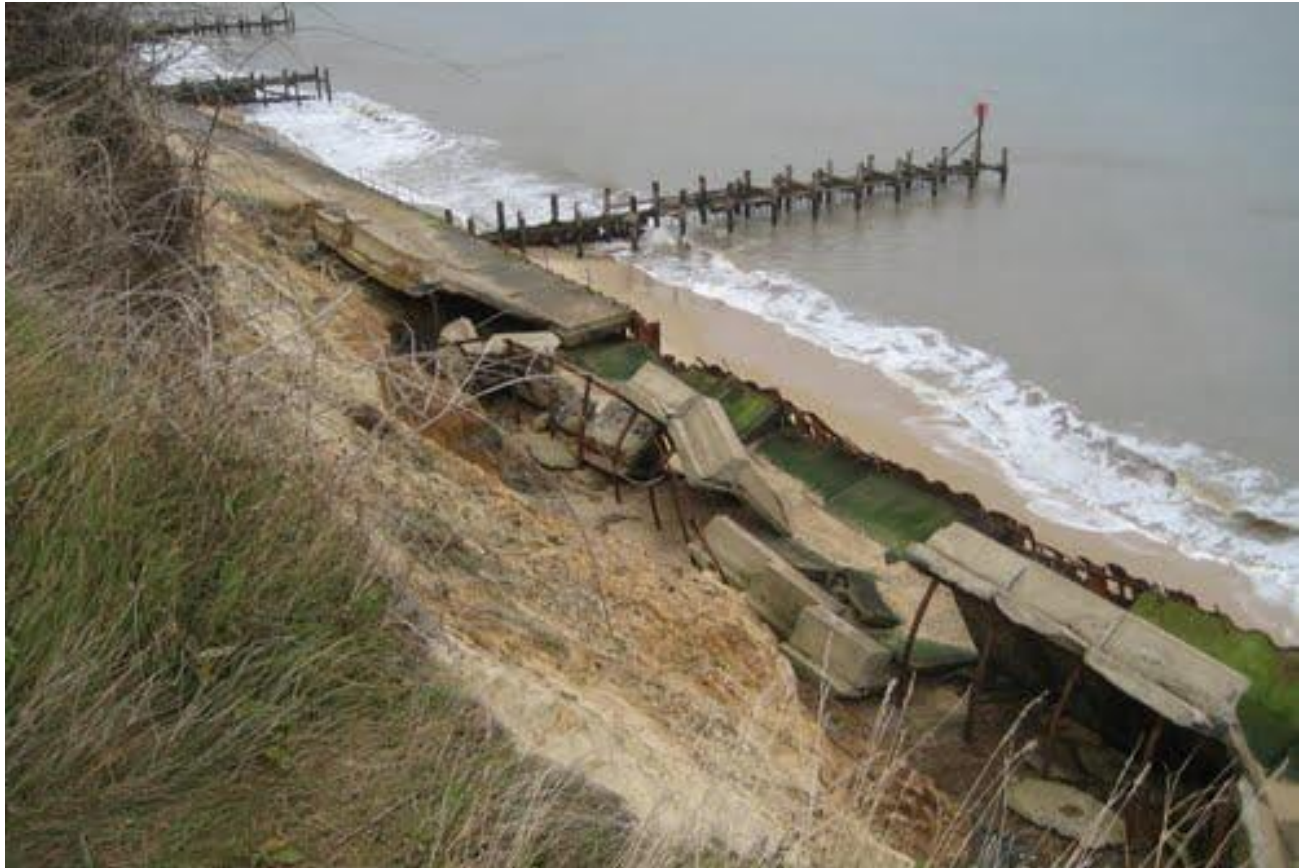
Figure 50. Site 9. Google Earth Panoramio photograph showing damaged sea wall near Site 9. There is now no pedestrian access either along the cliff top or down on the beach except at very low tides with difficulty.

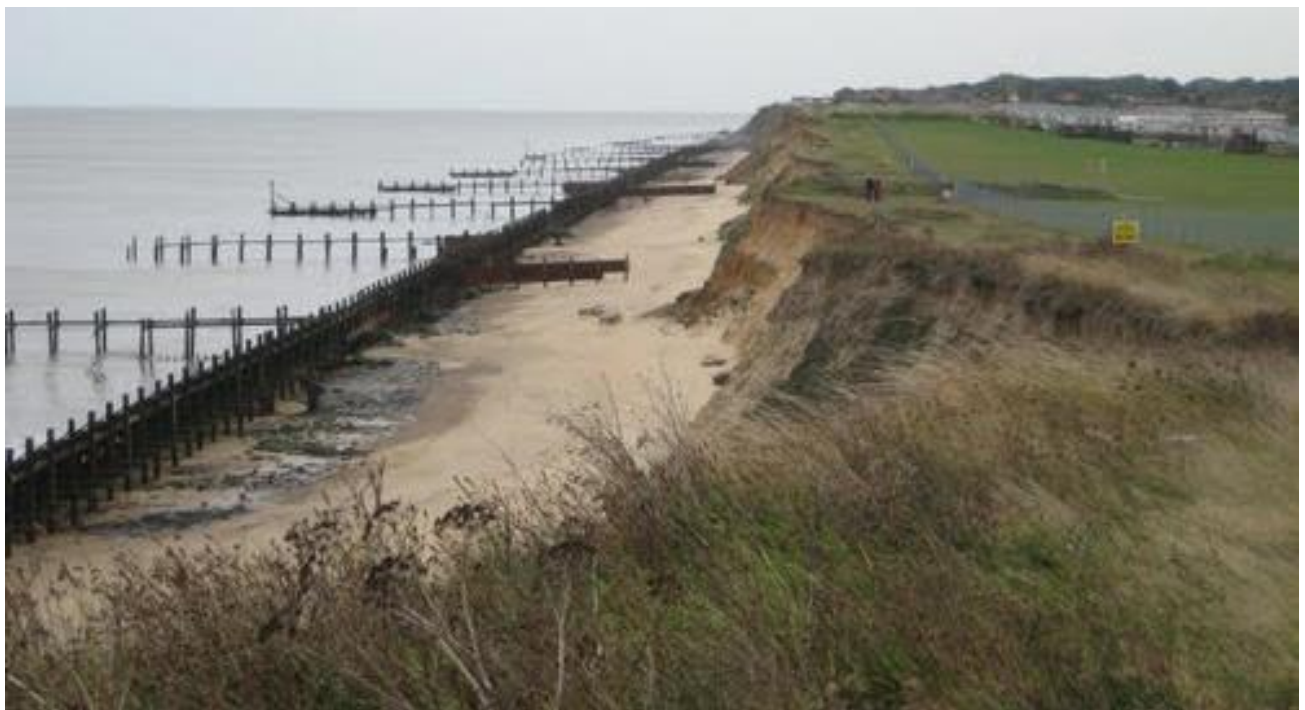
Figure 51. Site 9. Google Earth Panoramio photograph viewed southwards towards Broadlands Sands Holiday Park. Site 9 HDD route crosses the cliffs 50m beyond the people in mid distance. Erosion has since reached the boundary fence, taking the coastal footpath and preventing access. Vehicle access to a short HDD exit position would be very difficult due to sea defences.

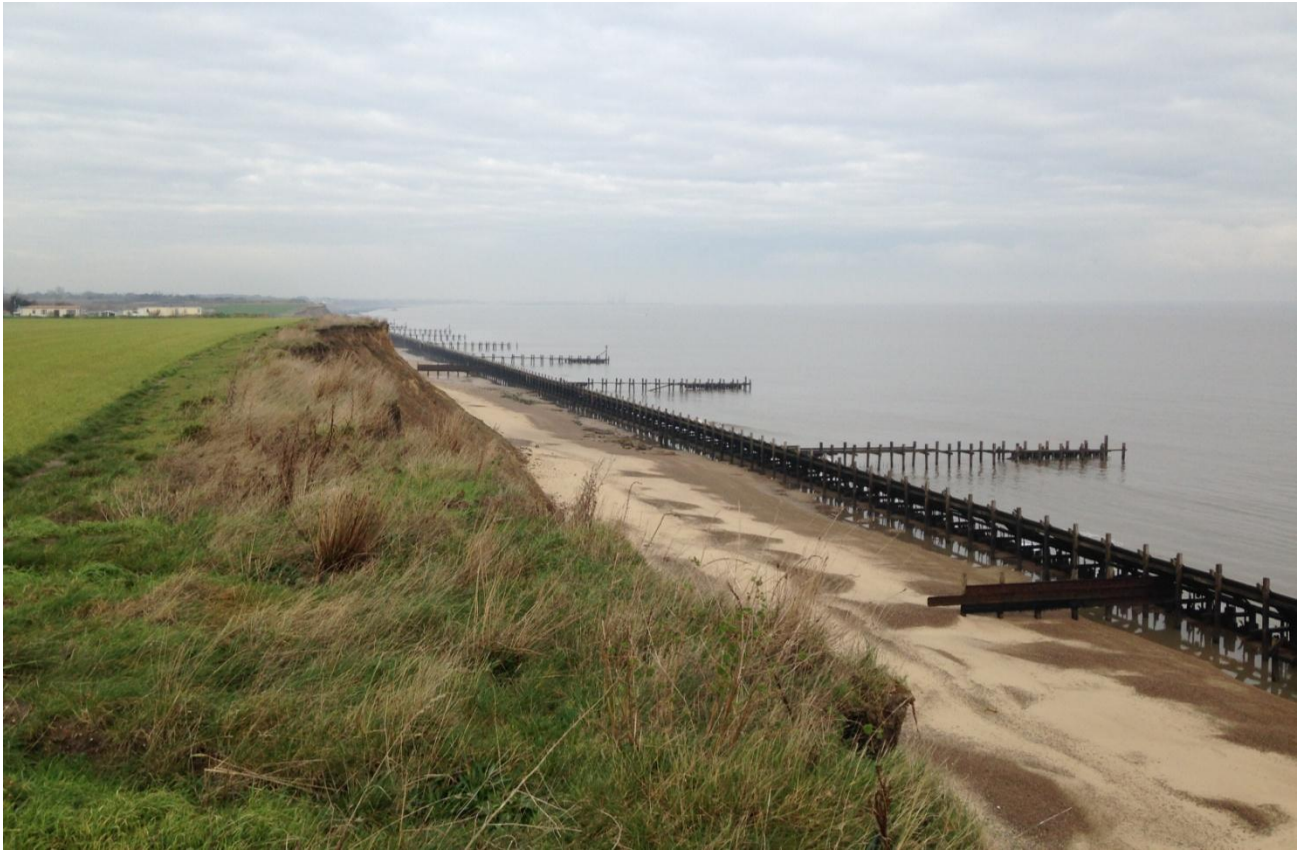
Figure 54. Site 10. View northwards from Site 10 illustrating the coastal topography and sea defence structures.

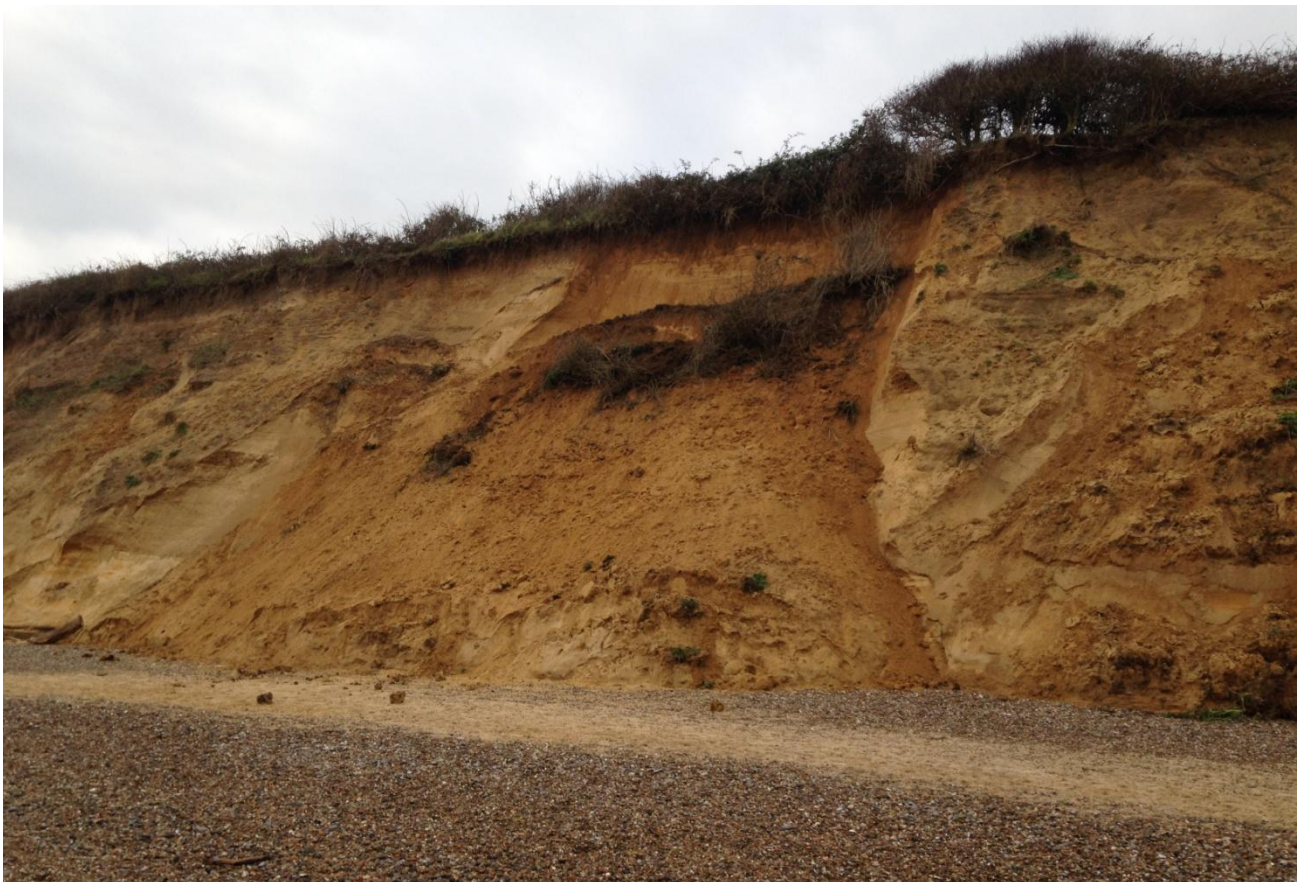
Figure 55. Site 11. Coastal cliffs at Site 11 showing erosion of fine sands.

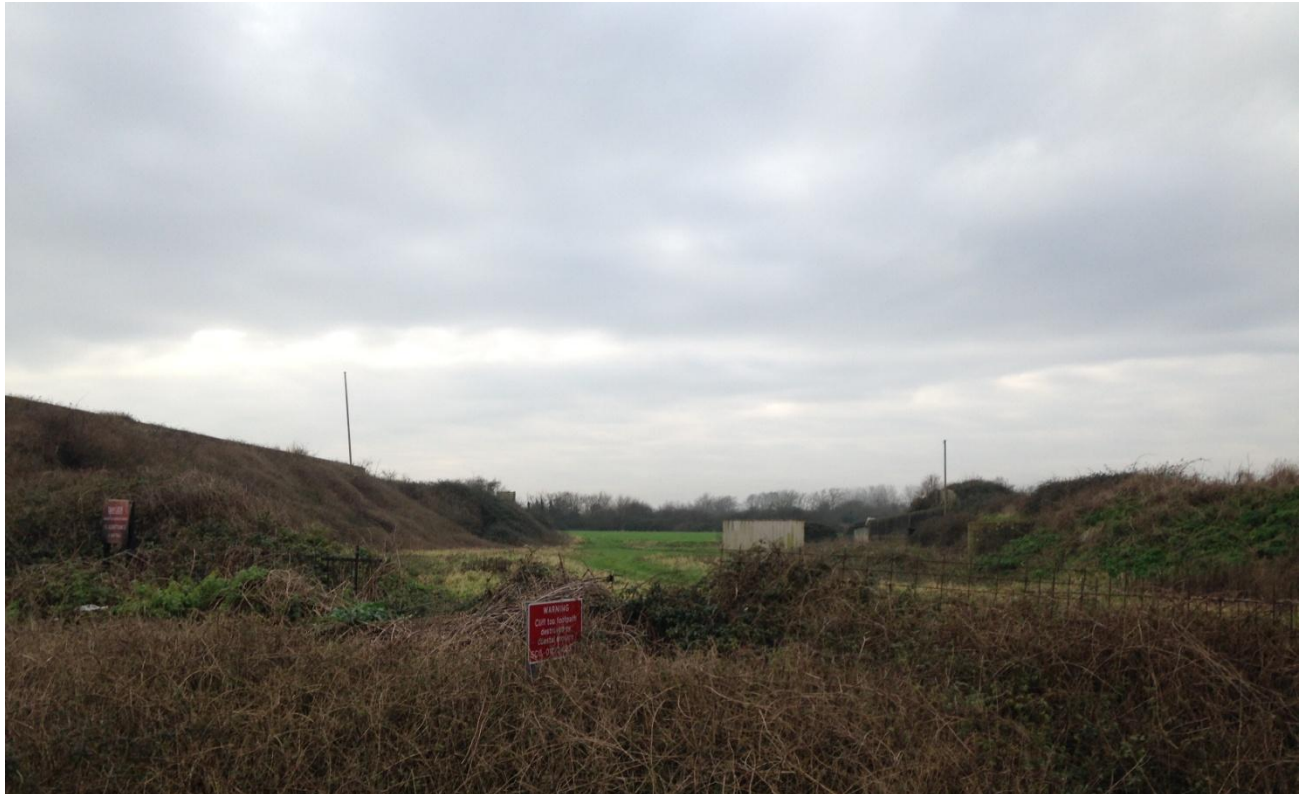
Figure 56. Site 11. Former Artillery Range and Military structures 80m south of Site 11 HDD alignment .

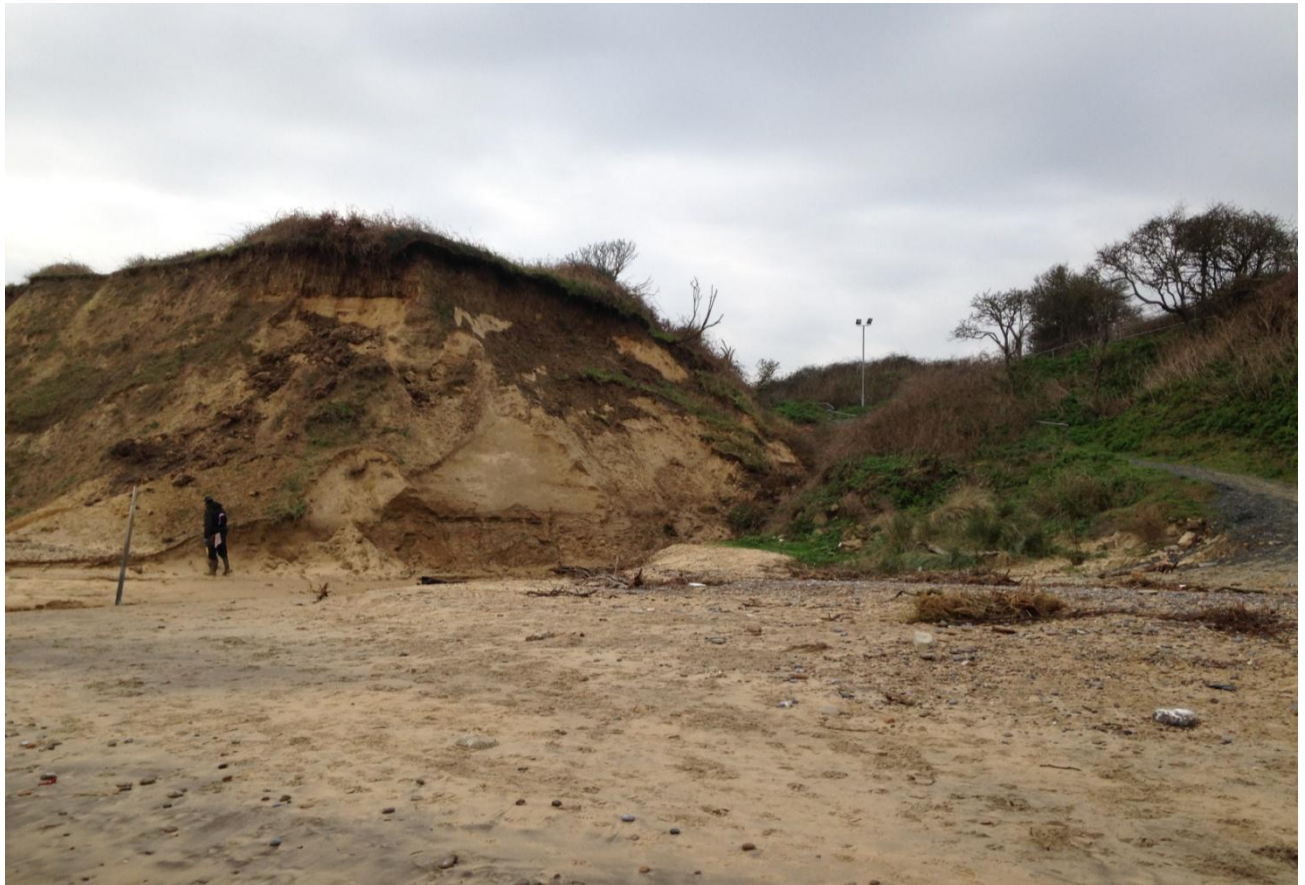
Figure 59. Site 12. Footpath to Pakefield Coastwatch Tower showing eroding cliffs of fine sand.
