Norfolk Boreas Offshore Wind Farm

Initial HDD Feasibility Report

HDD FEASIBILITY REPORT

Cable Landfalls for East Anglia North Tranche 1 (EAN) U.K.

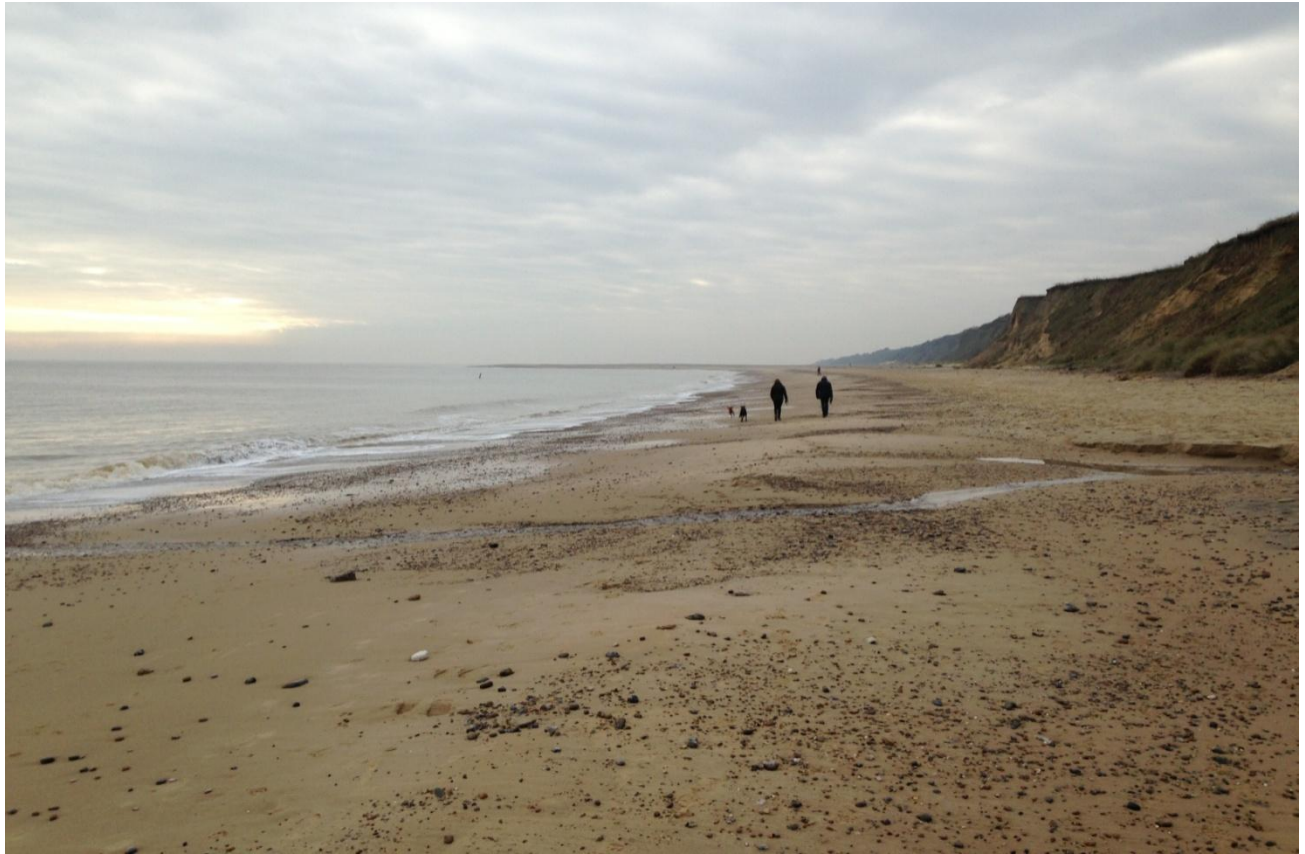
Figure 60. Site 12. View south from below Pakefield Coastwatch Tower. The HDD for Site 12 would pass approximately beneath the closest pedestrians.

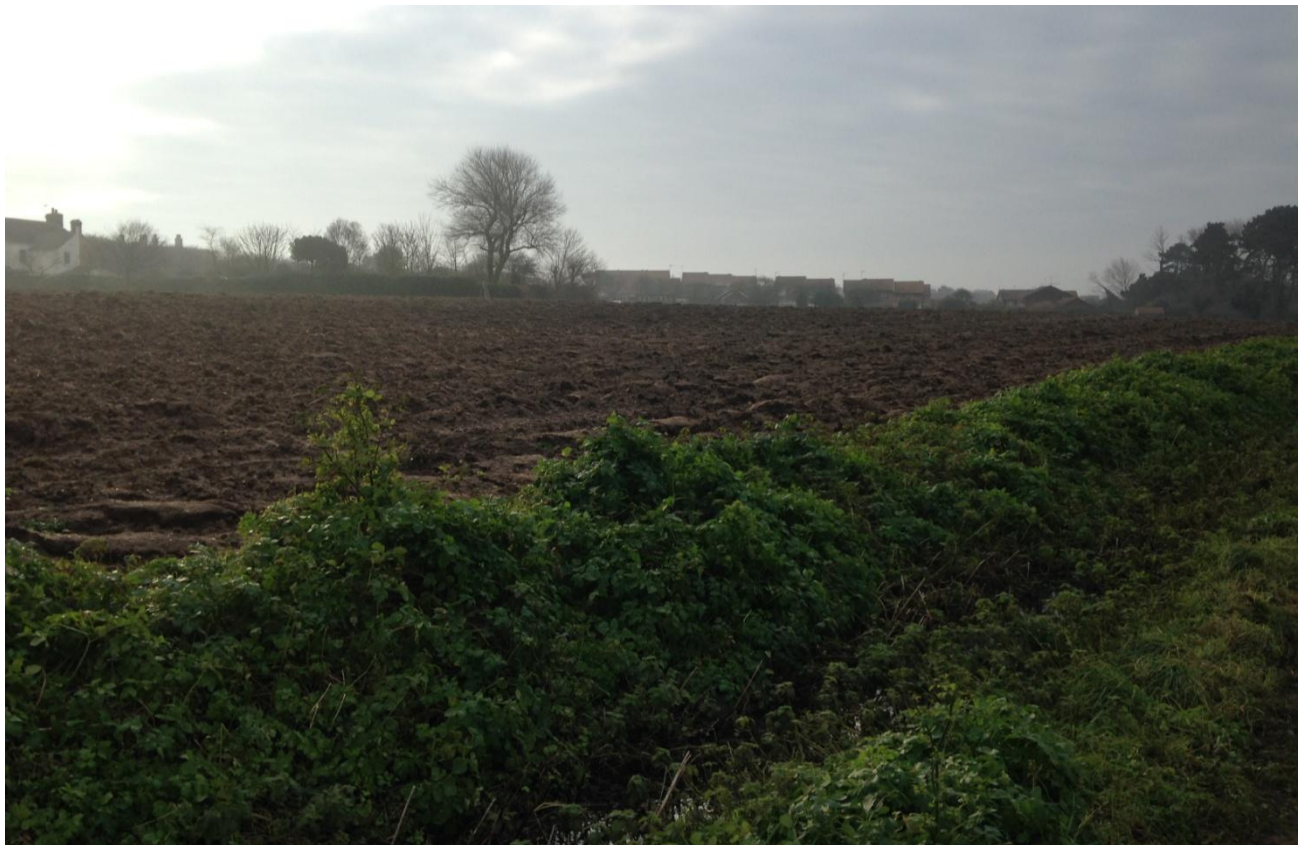
Figure 61. Site 13. Potential HDD entry point in field 30m from viewpoint. Residential properties overlooking the field in the distance.

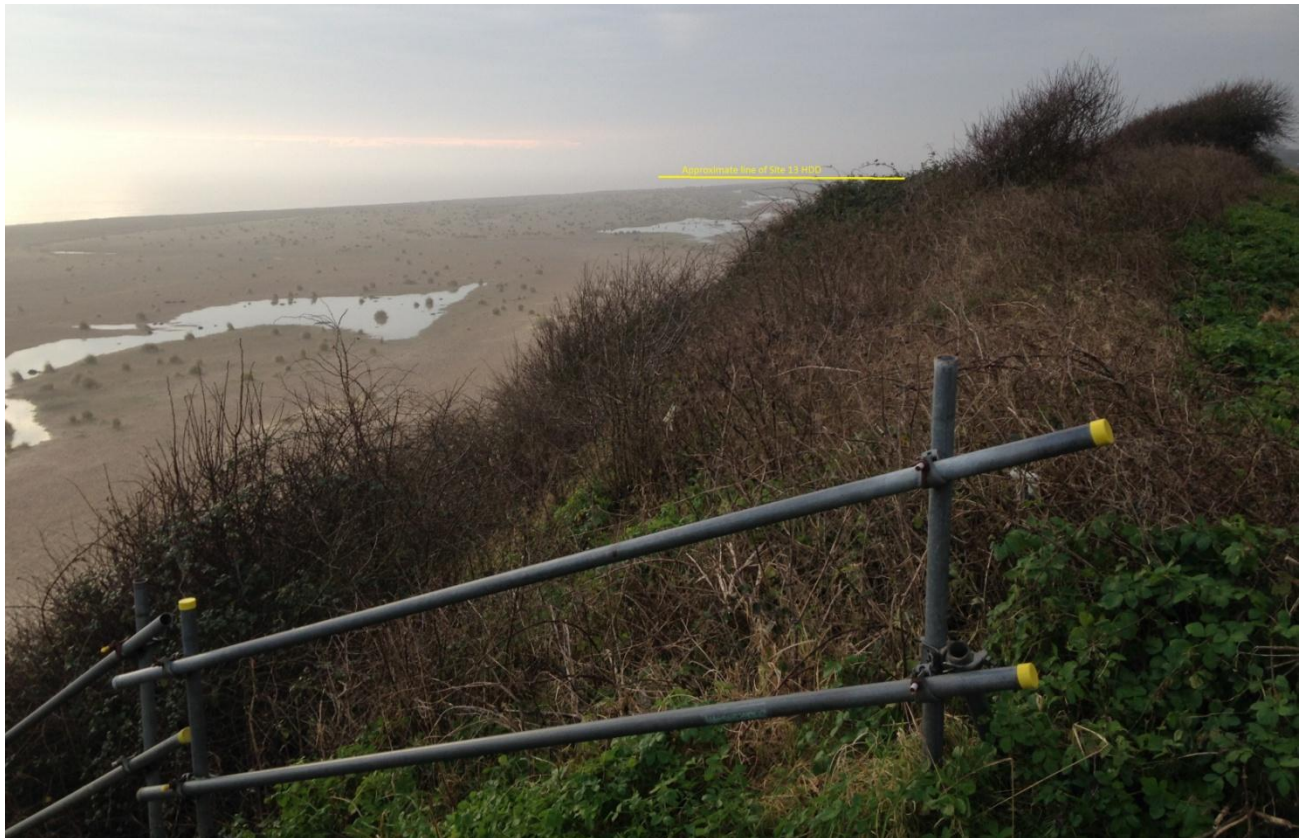
Figure 62. Site 13. View south from Cliff Farm Lane footpath, 600m north of Site 13. Approximate HDD route indicated in yellow across the Ness. The photograph gives an indication of cliff heights and the width of the Ness.
