Norfolk Boreas Offshore Wind Farm

Appendix 20.3

Geomorphological Walkover Survey

Applicant: Norfolk Boreas Limited
Document Reference: 6.3.20.3
RHDHV Reference: PB5640-006-2003
Pursuant to APFP Regulation: 5(2)(a)

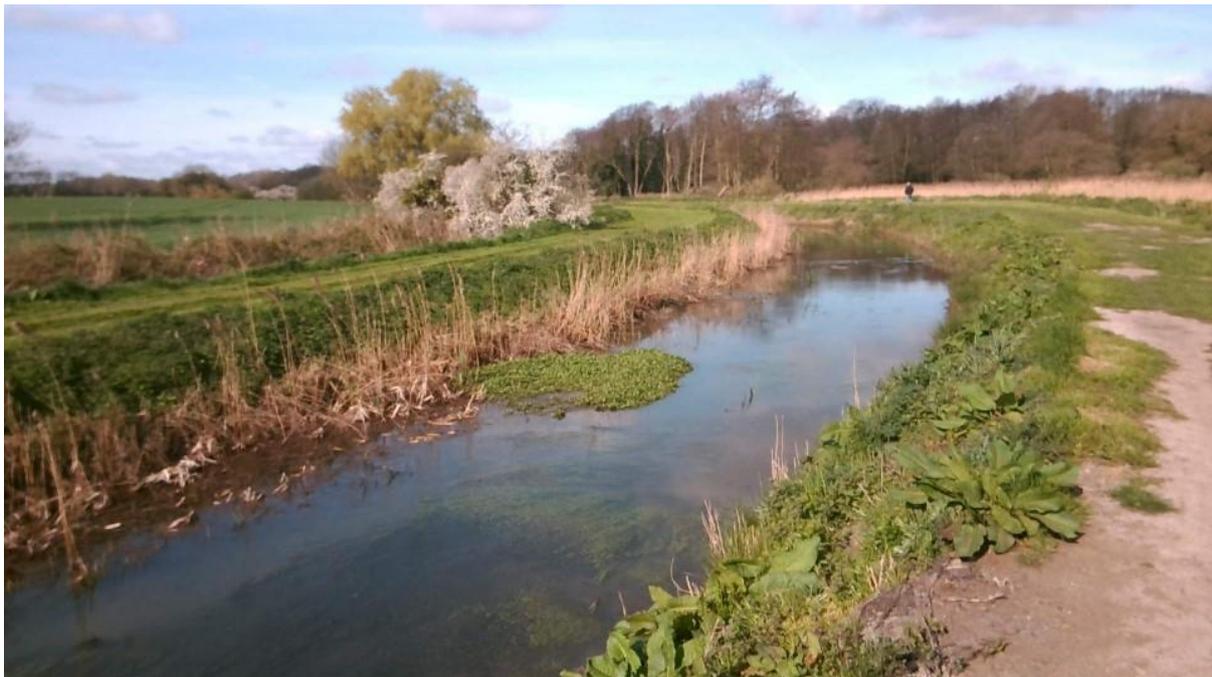
Plate 3.1 North Walsham and Dilham Canal

7. The North Walsham and Dilham Canal is an extensively modified watercourse with a straight planform and uniformly graded banks. The channel is dominated by low energy glide flows and appears to support very little geomorphological diversity (Plate 3.1). The canal was formerly known as the River Ant.

8. The channel has a straight, uniform planform. The banks are steeply graded, approximately 1.5 to 2m high, stable and well vegetated throughout the reach. The channel is approximately 5m wide at the bank base and 7m wide at the bank top.

9. The substrate is dominated by sands and silts. There were no visible bedforms or signs of erosion in the main canal, although siltation was evident in the channel margins and in the lee of emergent vegetation.

10. The main channel is punctuated by an earth dam at the downstream end of the reach (although the channel continues as a reed-filled remnant channel). Flow from the main canal is diverted via a pipe into the drain located immediately to the left, which markedly increases flows in this drain. The discharge from the main channel enters the side drain perpendicular to the flow, which has resulted in a localised area of scour immediately opposite the outfall.

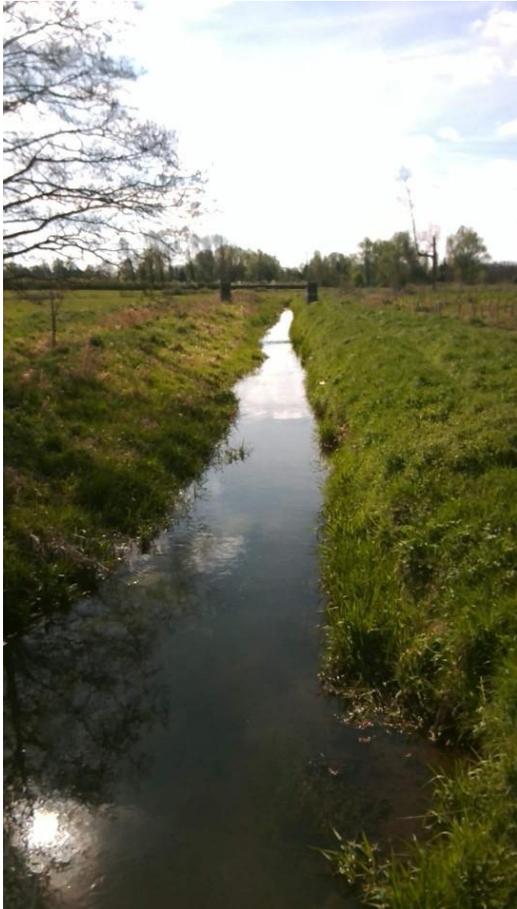
Plate 3.2 King's Beck (main channel)

15. King's Beck is a uniform, incised channel that has been artificially straightened and resectioned (Plate 3.2). The channel is dominated by glide flows and there is extensive in-channel vegetation growth. In addition to the main channel, there are several connected channels that have similar characteristics (Plate 3.3). These are largely artificial, although some reaches may represent a resectioned historical course of the watercourse.

16. King's Beck follows a narrow, incised channel with a straight planform. The banks are approximately 1.5 to 2m high, steeply graded, stable and well vegetated, with a vertical or near-vertical toe in places. The channel is approximately 2m wide at the bank base and 5m wide at the bank top.

17. The substrate was largely obscured by in-channel vegetation growth, although where visible appear to be dominated by silts and fine sands. There are extensive deposits of fine sediment at the toe of each bank, supporting thick vegetation growth. The channel has cut through the marginal deposits, maintaining a narrow meandering path free of encroaching sediment and vegetation along the thalweg¹.

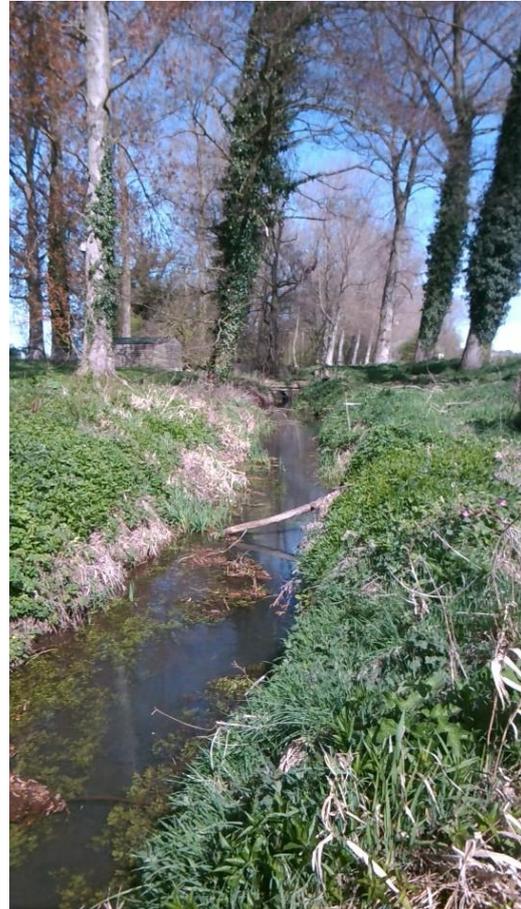
Plate 3.3 Channel adjacent to King's Beck

18. In addition to the main channel, there are several other watercourses that run parallel and are connected with the King's Beck. These channels have similar characteristics to King's Beck, with uniform banks, glide flows and a pronounced thalweg visible within the bank line. The bed of the channel on the right (eastern) side of the beck appears to be slightly lower than the main river and other adjacent channels in this reach (Plate 3.3). This watercourse diverges from King's Beck downstream of Beck Farm, flowing further east along a more sinuous course before re-joining the main river upstream of Aylsham Road. This may represent a historical course of the main King's Beck.

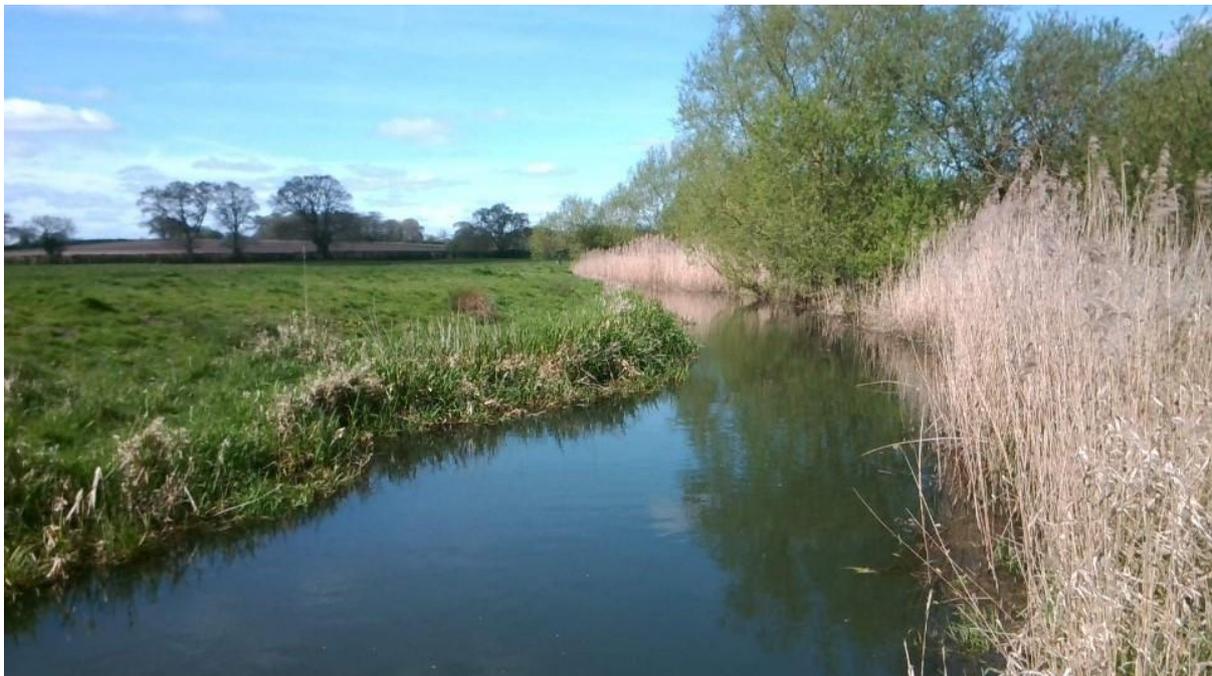
Plate 3.4 River Bure

22. The River Bure is a moderately sinuous watercourse that has been historically resectioned and enlarged (Plate 3.4). The channel has largely uniform banks and flow conditions are dominated by uniform glides. Evidence of lateral accretion (in the form of low berms within the resectioned bank line) suggests that the channel is naturally recovering from historical modifications.

25. Low level floodplain units (berms or inset benches) were apparent throughout the reach, most notably (but not exclusively) on the right bank. These features have formed inside the wider bank line, and are likely to be representative of channel narrowing by lateral accretion. This suggests that channel has been historically enlarged but is now readjusting naturally. This is supported by the uniformly graded banks and localised straightening within the larger-scale meandering planform.

26. Although there was no evidence of erosion at the time of the survey, evidence of cattle poaching was observed in parts of the left bank that lacked the low-level berms.

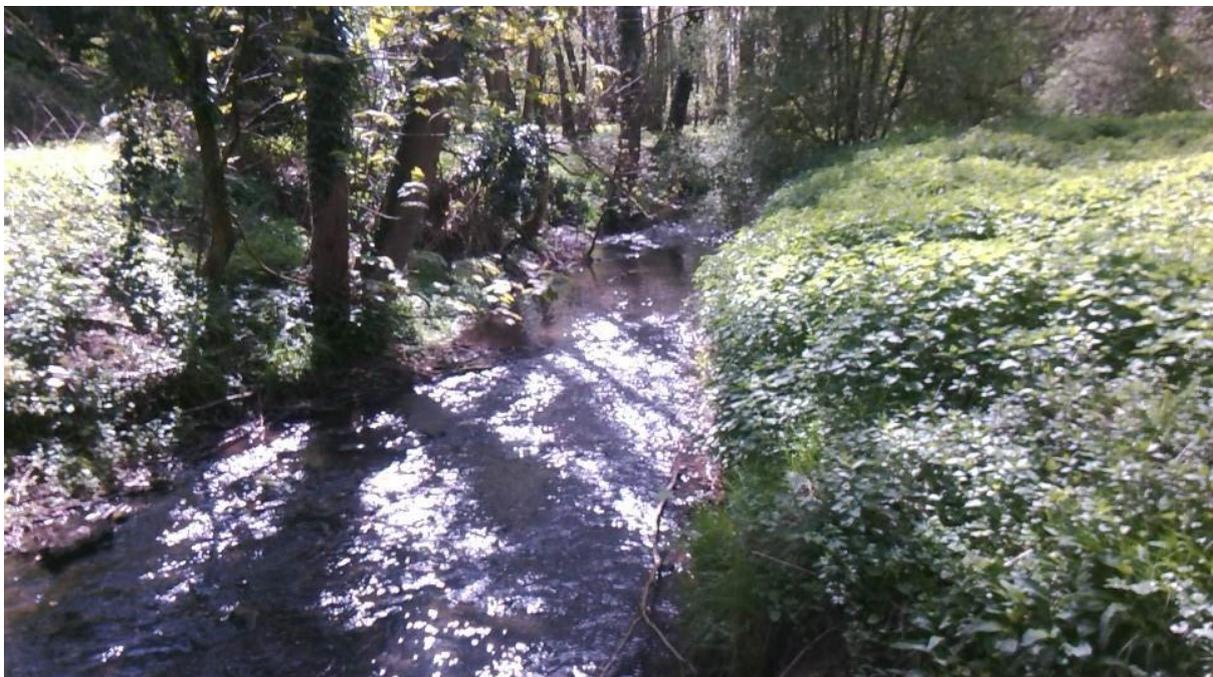
Plate 3.5 Blackwater Drain

30. The Blackwater Drain (also known as the Booton Watercourse at this point) is a narrow, meandering channel that supports a range of different flow types and geomorphological habitat niches (Plate 3.5). Exposed tree roots in the bed indicate that the channel has recently incised.

31. The channel is approximately 3m wide and follows a gently meandering course. The banks are steep, stable and well vegetated. The channel supports a range of habitat niches, including exposed gravel bars, shallow riffles and deeper pools. The substrate is dominated by gravels with occasional cobbles, with silt deposition occurring in the margins and slower flowing areas.
32. Exposed tree roots in the survey reach, particularly downstream of the proposed cable crossing, suggest that the watercourse is currently incising or has done so recently.

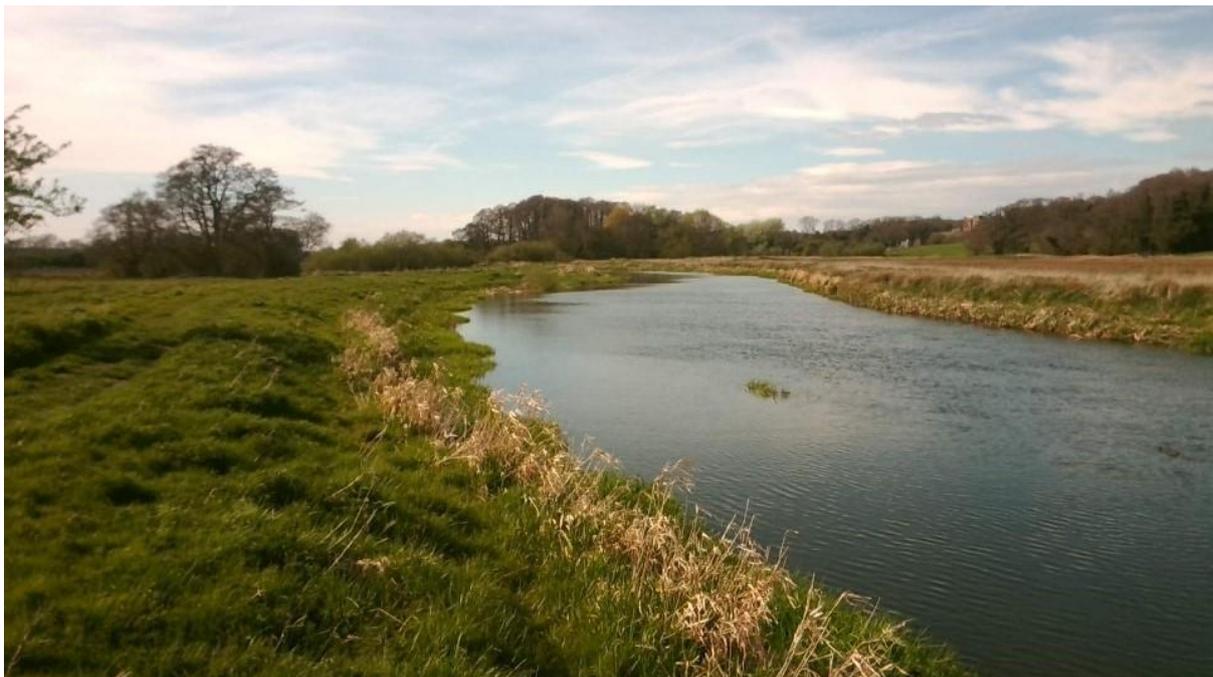
Plate 3.6 River Wensum (upstream end of cable route)

36. The River Wensum is a gently meandering chalk river, with a wide, deep channel and very shallow banks (Plate 3.6 and Plate 3.7). Flows are dominated by uniform, low energy glides, and siltation appears to be the dominant geomorphological process. The channel is fringed by low embankments which may reduce floodplain connectivity but are likely to be frequently overtopped.

40. Although deposition is the dominant process in this reach, an area of bank scour and collapse was observed on the right bank at the upstream limit of the proposed onshore cable route. This is likely to be a response to the growth of trees and reeds on the opposite side of the channel, which pushes flows towards the right bank.

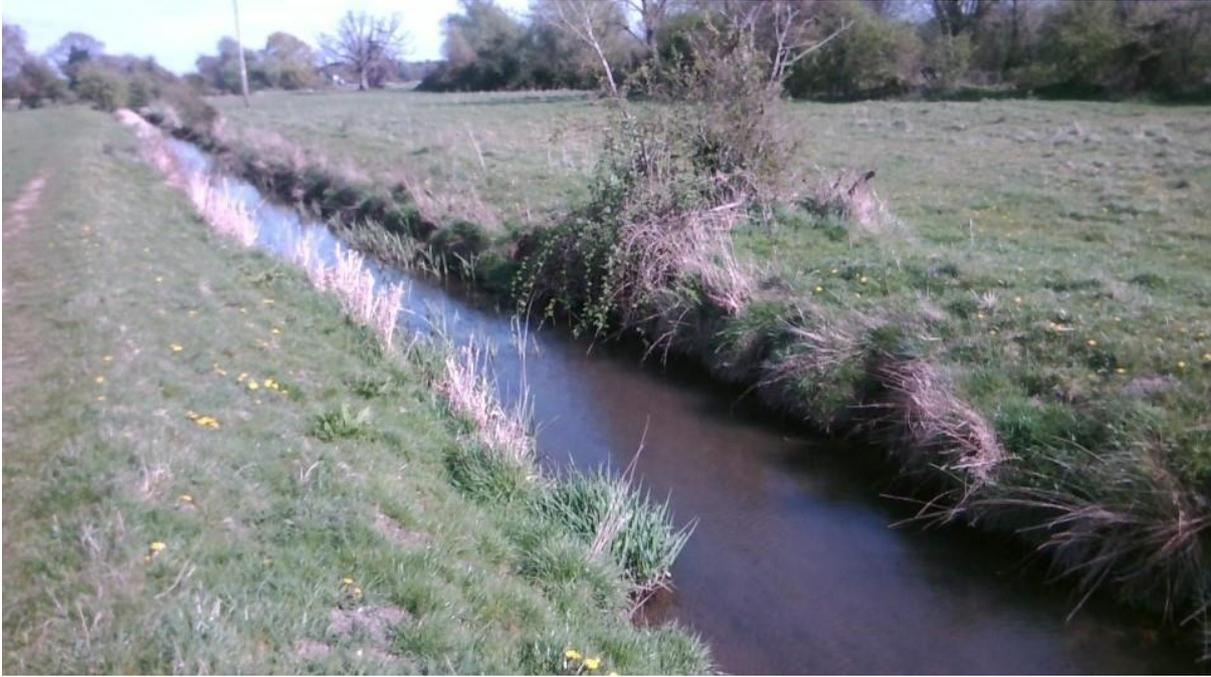
Plate 3.8 Penny Spot Beck

47. The onshore cable route also crosses Penny Spot Beck, a tributary of the River Wensum that joins the main river approximately 30m downstream of the outer limit of the onshore cable route (Plate 3.8).

48. The narrow, straight channel is characterised by steep, uniform banks and shallow, low energy glide flows. There is significant impoundment along parts of the reach, as a result of fallen trees or culverts beneath earth bank crossings.
49. Siltation is the dominant geomorphological process along much of the channel, with the natural coarse gravel bed largely obscured by thick deposits of silt. However, flow is sufficiently swift in several isolated steeper reaches that are also free from impoundment to maintain a clean gravel substrate.
50. A large proportion of the channel within the proposed onshore cable route is affected by cattle poaching, resulting in localised bank collapse and an extensive supply of fine sediment. The water is highly turbid along the entire reach.

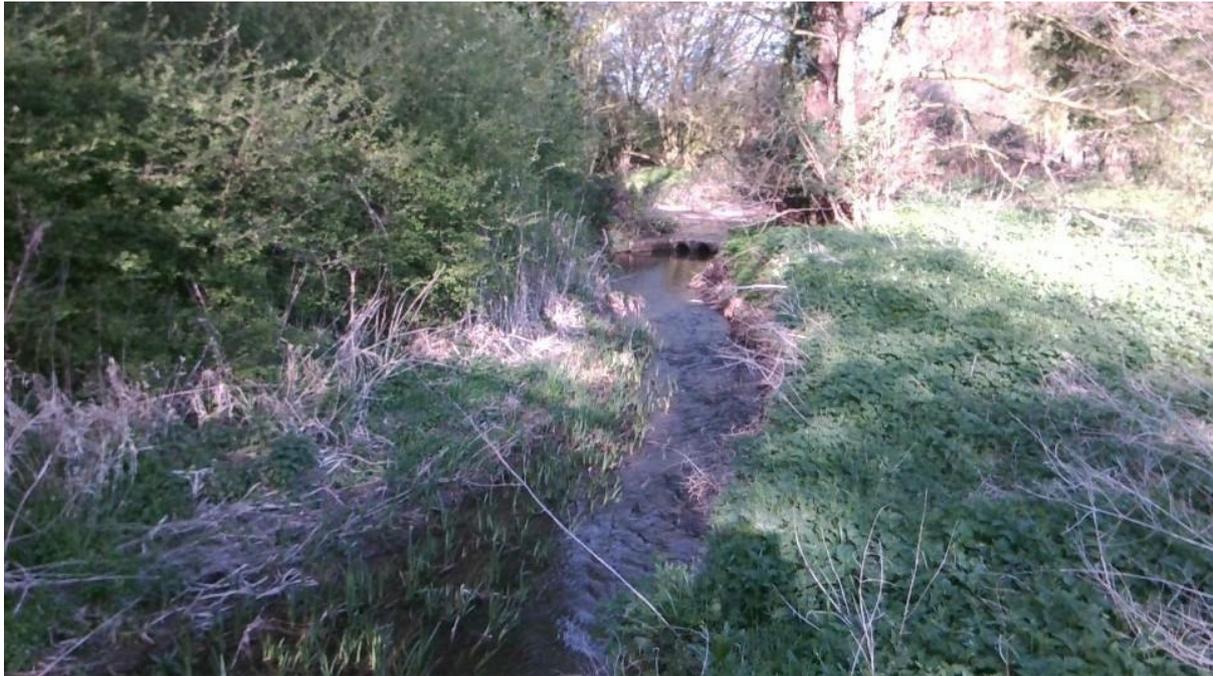
Plate 3.9 Wendling Beck (Bushy Common reach)

51. Wending Beck is a gently meandering chalk river that has been historically straightened (Plate 3.9). The channel is shallow, with steep, low banks and swift flows. These maintain the natural coarse substrate along the majority of the reach, although there is evidence of fine sedimentation along the channel margins and upstream of a twin pipe culvert.

52. The channel is approximately 2m wide, follows a low sinuosity, gently meandering planform through the proposed onshore cable route, and is likely to have been historically straightened. The planform is highly sinuous in the unmodified reach immediately downstream.
53. The banks are steep and very low (<0.5m high). Although they are largely well vegetated, there is some evidence of localised toe scour, and exposed tree roots on the right bank indicate that the channel has migrated by at least 0.3m.
54. The channel flows through twin pipe culverts beneath the road at the downstream end of the onshore cable route.
55. The substrate is dominated by coarse gravels, although there is evidence of fine sedimentation in the channel margins. The proportion of silts increases upstream of the culverts, which reduce energy sufficiently to promote enhanced deposition.

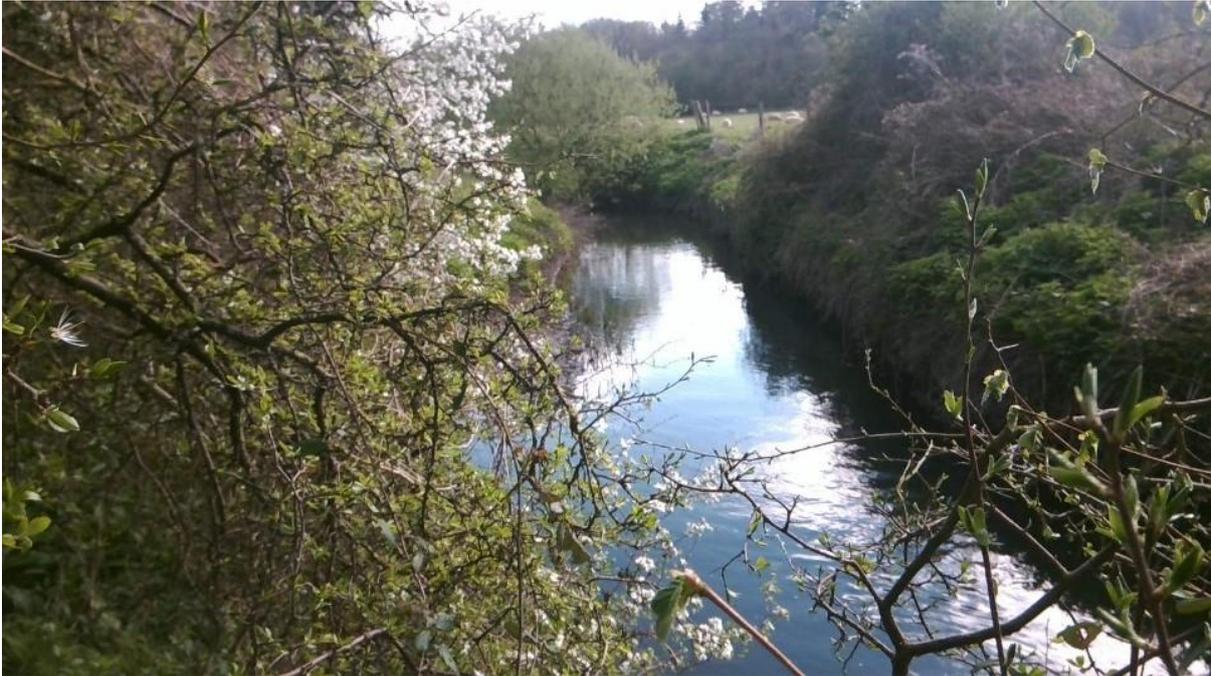
Plate 3.10 Wendling Beck (Old Brigg reach)

59. Wendling Beck is a gently meandering channel with low energy glide flows and extensive siltation which obscures the coarse substrate that would typically be associated with chalk rivers (section 3.6). The deep, narrow channel has steep banks, and much of the watercourse is likely to have been historically resectioned (Plate 3.10).

61. The channel is narrow (approximately 4m wide) and incised. The banks are vertical or steeply graded, and frequently obscured by extensive vegetation growth. The substrate is dominated by silts, which overlie the natural coarse bed observed further upstream (see section 3.6). The steep banks and straightened nature of the channel at sub-reach scale suggest that the beck has been historically resectioned and potentially dredged.
