Speaking notes Sunnica – Memorial Hall Newmarket 6th December 2022 – 1800hrs

Unique reference No - 20030246

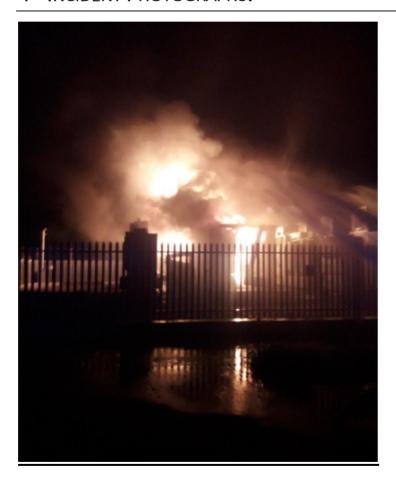
Fire development from the unit at approximately 01:30 hours.

Note the intensity of fire and therefore heat from the centre of the unit and extension of flame into the plume.

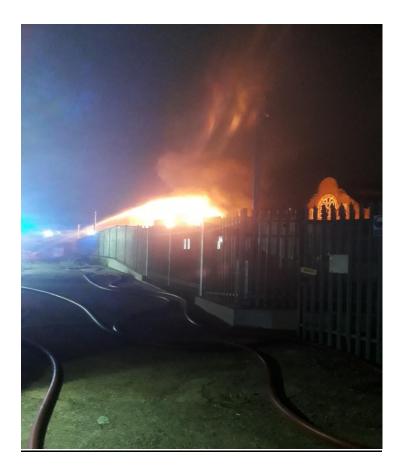
Ground monitors in use and personnel upwind of plume approximately 03:00 hours.

Information on plume toxicity gained at this point.

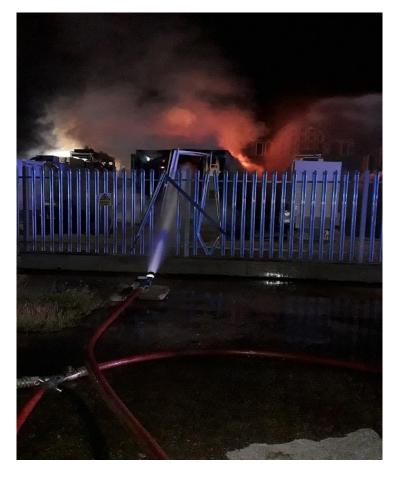
Ground monitor in use at approximately 05:15hrs.

Note sections of railings opened by MFRS to allow straight play of monitor jet.

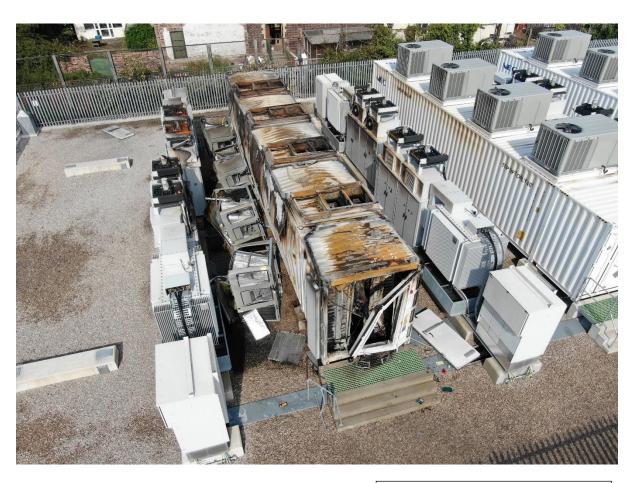
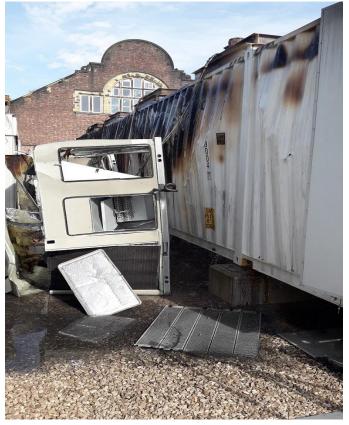
Image above: Taken from

AIR Unit. Full extent of damage
visible. Roof mounted cooling units
ejected to side of unit. Pressure
damage visible along length of unit.
Note scorching of top edge of
second unit to mid-right of image.
Firefighting tactics mitigated
further spread and damaged
beyond original unit and blast.

Image left: FI Photography, note pressure damage and expansion of unit above burn line pattern.
Remains of cooling unit pictured to left hand side.

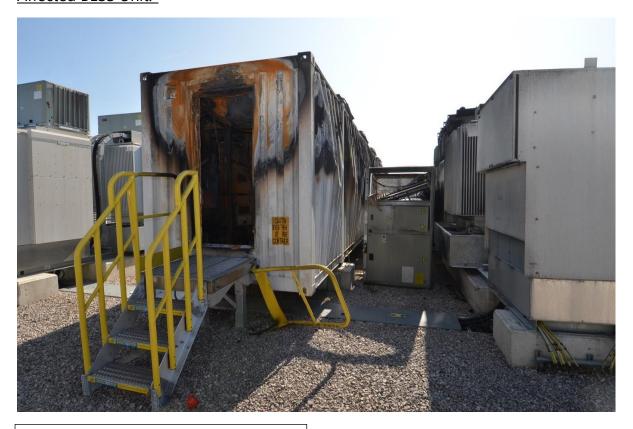
Affected BESS Unit:3

'Accidental ignition caused by a lithium battery failure transitioning into thermal runaway'.

Image above: Exterior of unit with pressure damage to side.

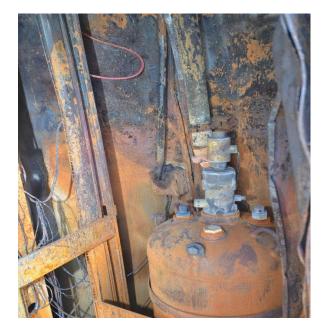
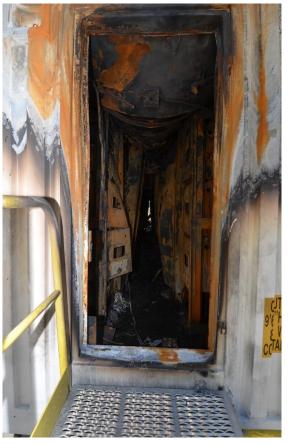
Image below right: Internal view of modules.

Image below left: Fire damaged NOVEC 1230

unit.
