NORTH FALLS

Offshore Wind Farm

Appendix 23.1 Extended Phase 1 Habitat
Survey Report (Part 3 of 3)

Document Reference:	3.3.30
Volume:	3.3
APFP Regulation:	5(2)(a)
Date:	July 2024
Revision:	0

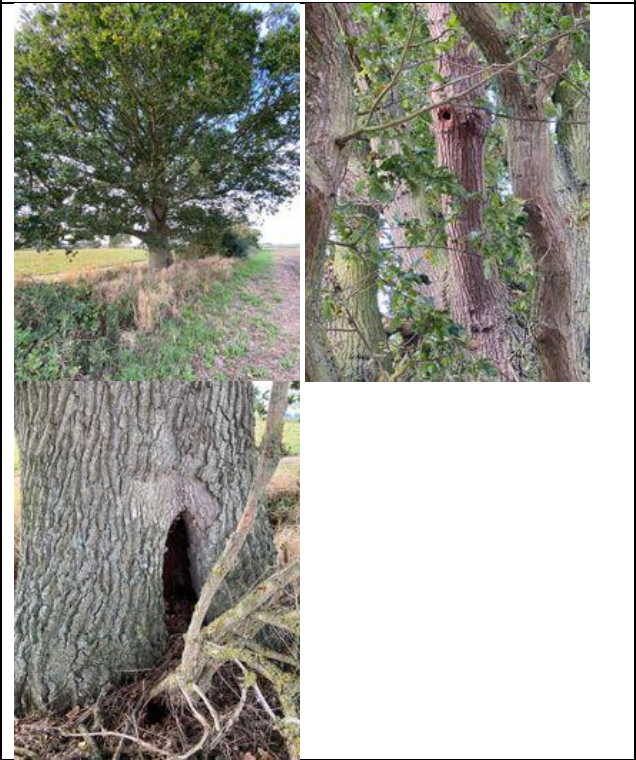
Bat roost feature reference	Notes	Habitat suitability	Photographs
BR183	Large, potentially veteran oak with split trunk and woodpecker holes	Moderate

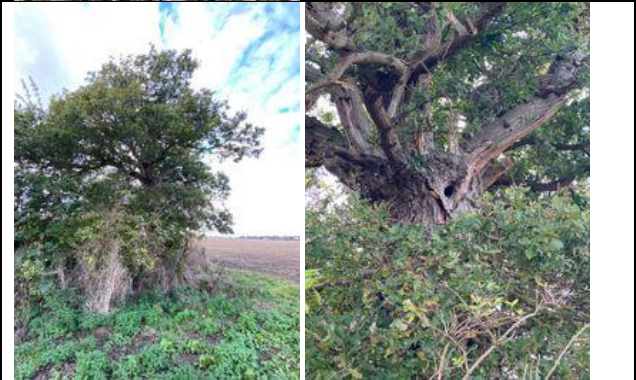
BR184	Mature oak with large hole and cracked limbs	Moderate

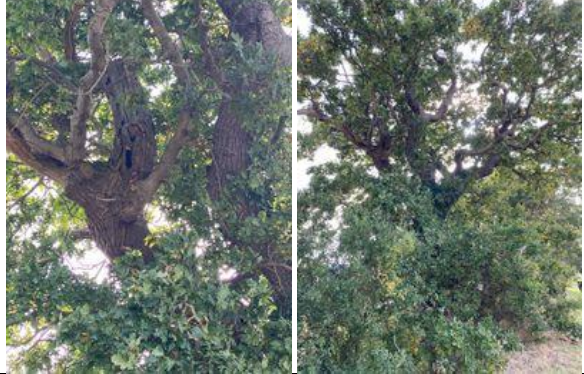
BR187	Mature ivy clad oak with cracks and holes	Moderate

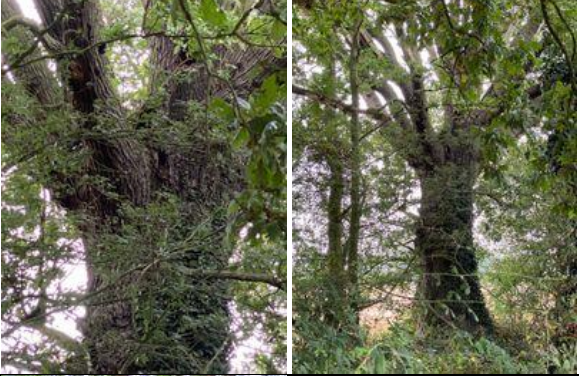
BR213	Potentially veteran oak with visible holes and cracks	Moderate

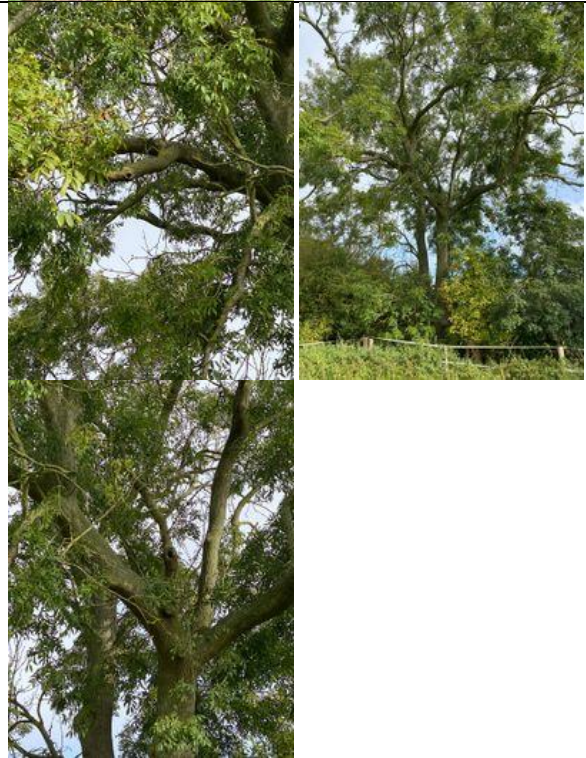
BR222	Mature walnut tree with two visible holes	Moderate

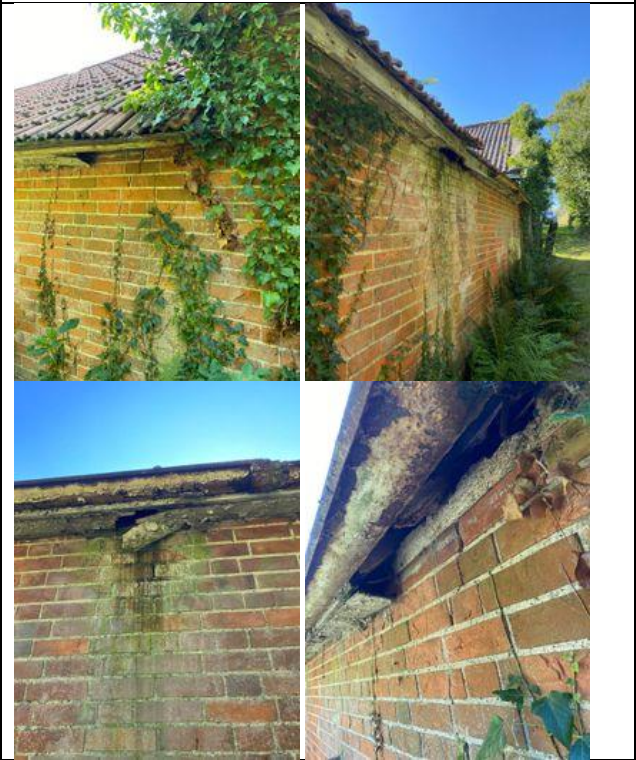
Bat roost feature reference	Notes	Habitat suitability	Photographs
BR265	Barn with holes and cracked tiles. Adjacent to good commuting and foraging habitat.	Moderate

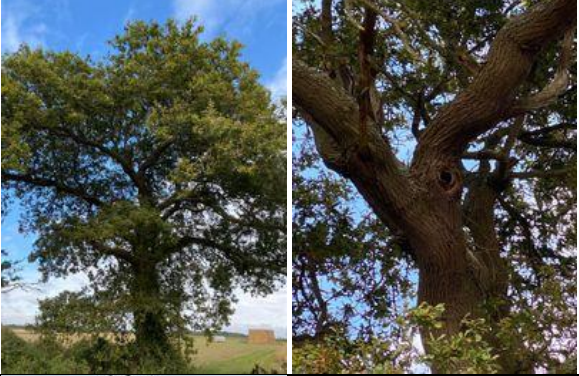
BR268	One Oak tree mature. Some PRFs visible, part of intact hedge.	Moderate

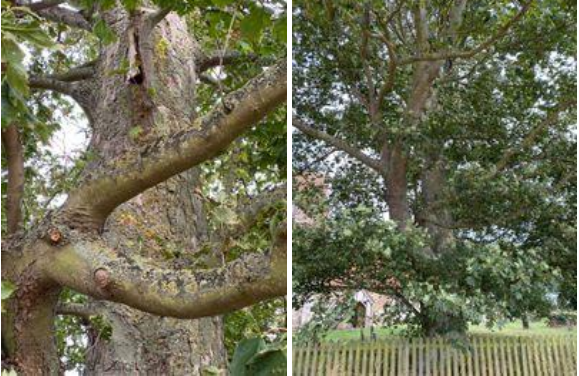
Bat roost feature reference	Notes	Habitat suitability	Photographs
BR282	Mature, potentially veteran sycamore with cracks and broken limbs.	Moderate

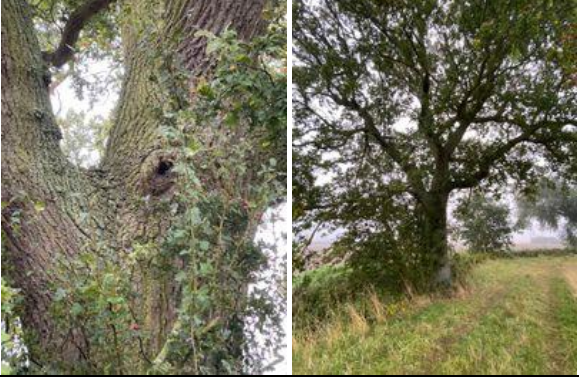
BR310	Mature oak with one visible hole, potential staining present on outside.	Moderate

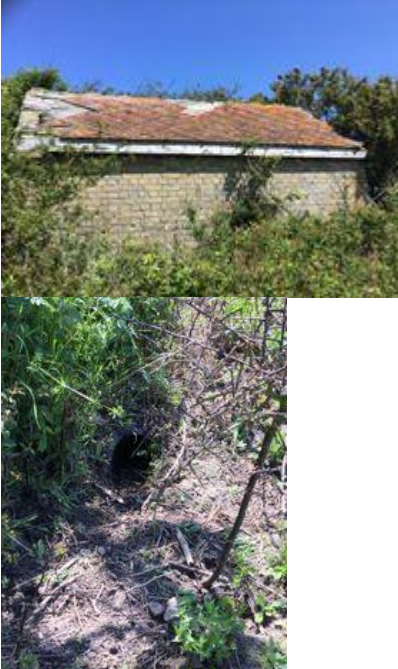
BR323	Rabbit holes present. Single structure (brick) with a tiled roof. Exposed eaves and assessed as providing low to moderate bat potential.	Low/moderate

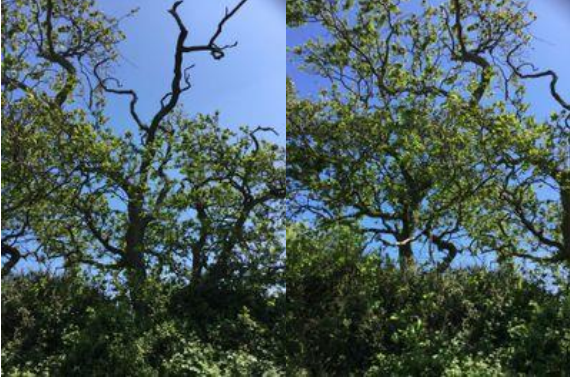
Bat roost feature reference	Notes	Habitat suitability	Photographs
BR324	Two oak trees with broken limbs, rot holes and areas of loose bark present. Assessed as providing low bat potential.	Low

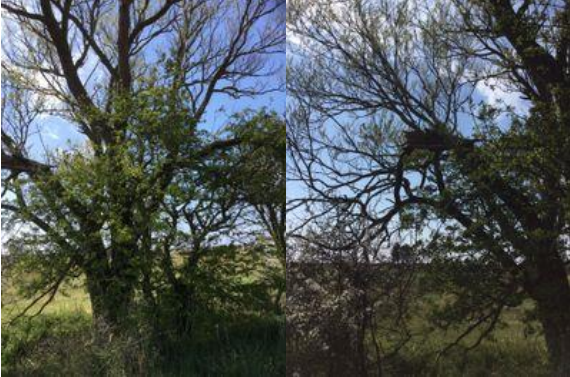
Bat roost feature reference	Notes	Habitat suitability	Photographs
BR327	Willow tree with broken limb and exposed bark - assessed as providing moderate bat potential	Moderate

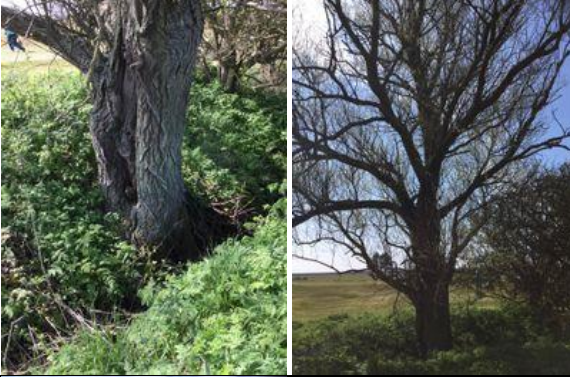
BR328	Willow tree with exposed holes and loose bark - assessed as providing low bat potential	Low

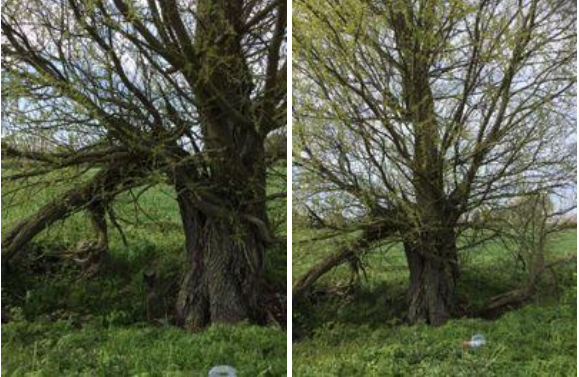
Bat roost feature reference	Notes	Habitat suitability	Photographs
BR330	Single willow tree with broken limb assessed to provide moderate bat potential.	Moderate

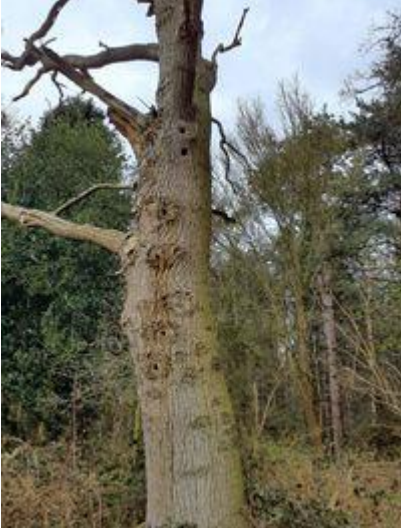
Bat roost feature reference	Notes	Habitat suitability	Photographs
BR343	Dead oak, 3 woodpecker holes in trunk. Could support larger roost, also in well connected woodland.	Moderate

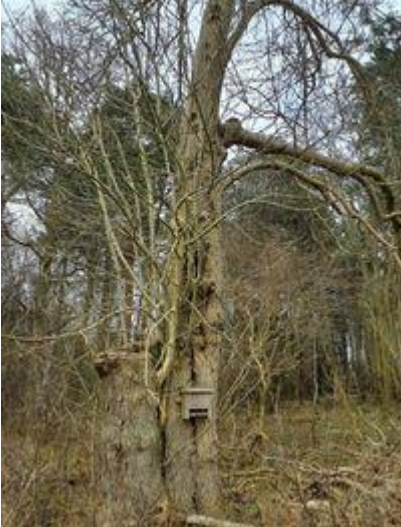
BR344	Veteran ash tree with broken limb and crevices, within woodland providing potential roosting habitat.	Moderate

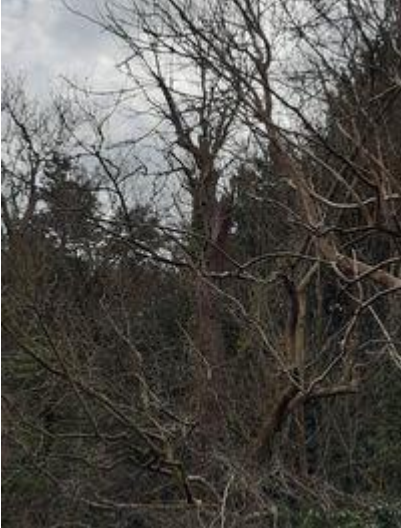
Bat roost feature reference	Notes	Habitat suitability	Photographs
BR345	Mature ash tree with 3 large woodpecker holes in upper trunk. Located in mature woodland.	Moderate

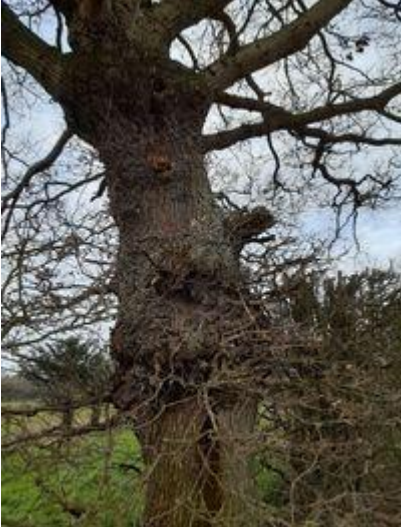
BR346	Mature oak with cracks, located in species-poor hedgerow but near woodland to south.	Low

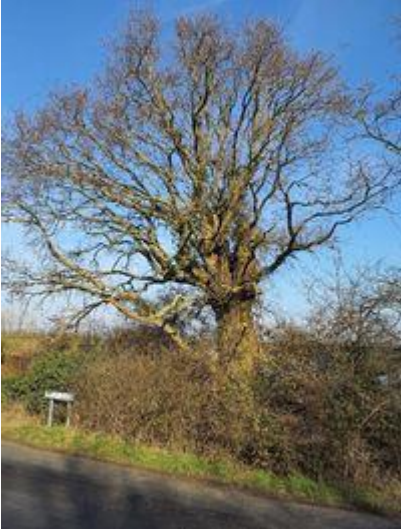
Bat roost feature reference	Notes	Habitat suitability	Photographs
BR347	<p>Veteran oak tree with some small crevices which may provide roosting habitat. Part of hedgerow network connected to wider landscape including woodland. Adjacent to road.</p>	Low

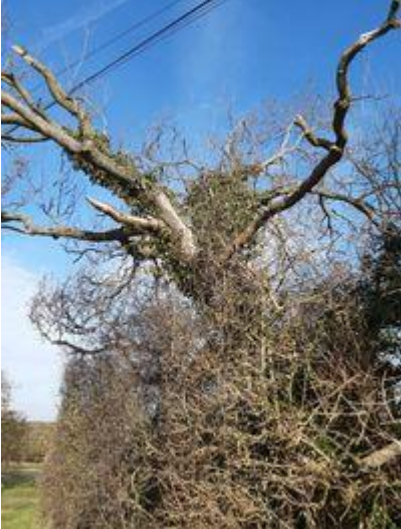
Bat roost feature reference	Notes	Habitat suitability	Photographs
BR349	Mature oak, large crack in open trunk, but isolated in landscape.	Low

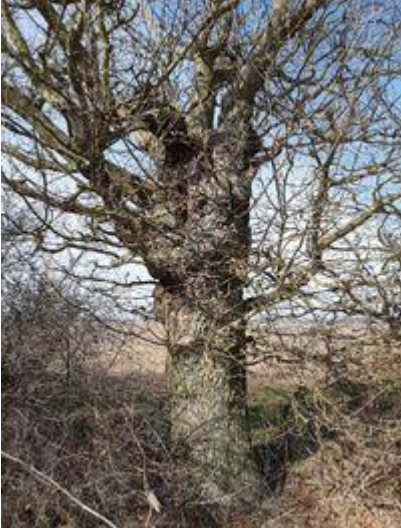
Bat roost feature reference	Notes	Habitat suitability	Photographs
BR358	Mature oak with small cracks in dead limbs. Isolated in landscape.	Low

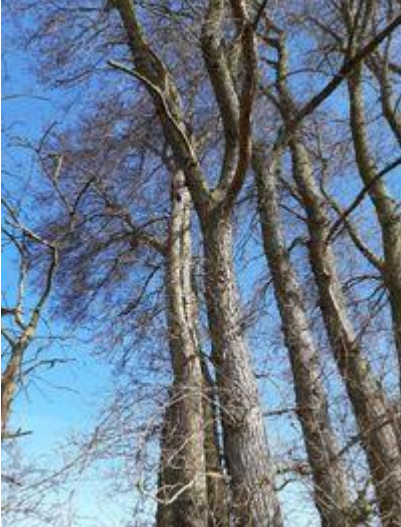
BR361	Elm tree with woodpecker hole in upper trunk. Located in hedgerow, but isolated from wider landscape.	Low

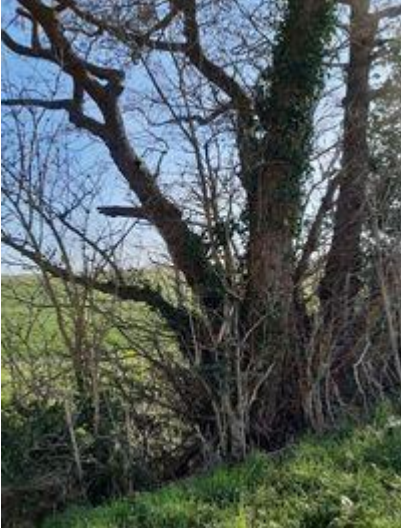
Bat roost feature reference	Notes	Habitat suitability	Photographs
BR362	Mature alder, small cracks around knot holes, but located adjacent to excellent foraging habitats around Tendring Brook.	Moderate

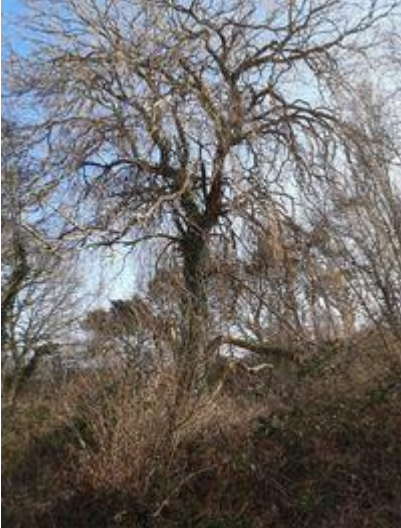
Bat roost feature reference	Notes	Habitat suitability	Photographs
BR364	Mature willow, small crevices in trunk and covered in loose ivy, but located in excellent foraging habitat, by pond and Tendring Brook.	Moderate

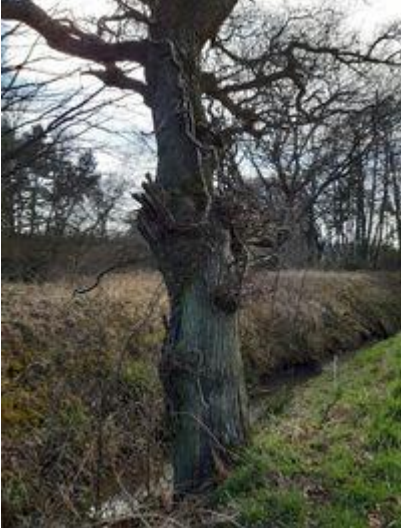
Bat roost feature reference	Notes	Habitat suitability	Photographs
BR366	Mature oak, small cracks and crevices but located adjacent to excellent foraging habitats around pond and Tendring Brook.	Moderate

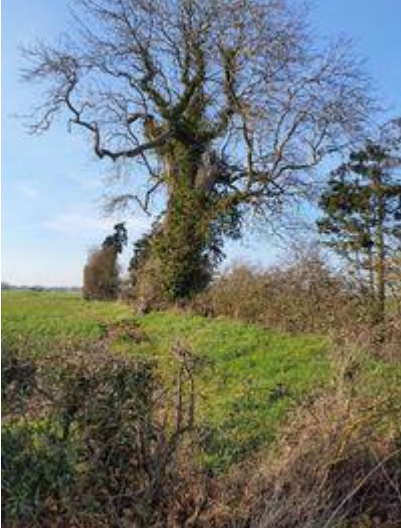
Bat roost feature reference	Notes	Habitat suitability	Photographs
BR380	Veteran ash, ivy clad, large crack present. Isolated in landscape.	Moderate

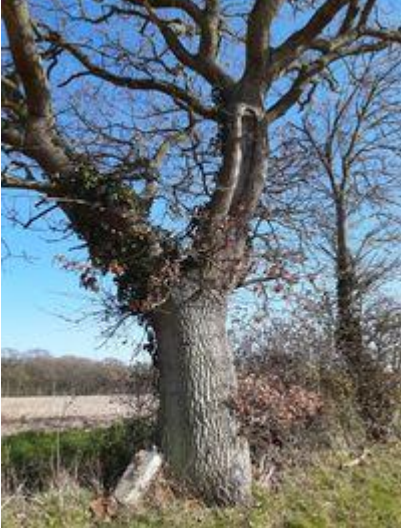
Bat roost feature reference	Notes	Habitat suitability	Photographs
BR384	Mature oak with small cracks in limb. On edge if tree line, but connected to Tendring Brook to south.	Low

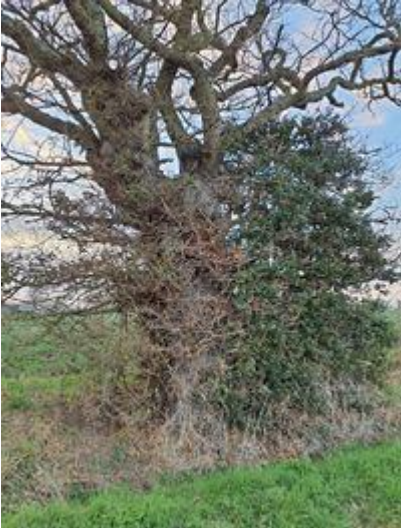
Bat roost feature reference	Notes	Habitat suitability	Photographs
BR399	Veteran oak, with no obvious crack or crevices but of sufficient age to have some present. Isolated in landscape.	Negligible

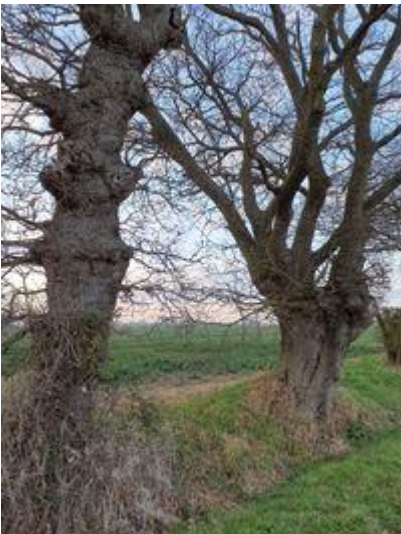
BR400	2x veteran oaks with multiples small cracks in old knot holes. Isolated in landscape.	Low

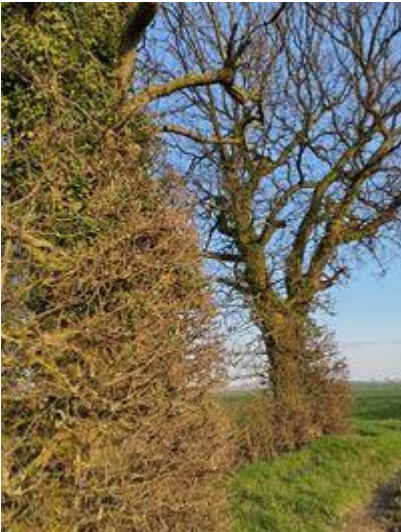
BR402	2x mature oaks, large crack near top and immature ivy present.	Low

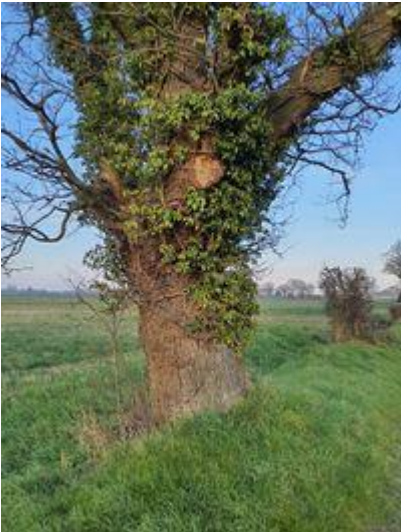
BR404	Mature oak with crack in dead limbs and immature ivy. Isolated in landscape.	Low

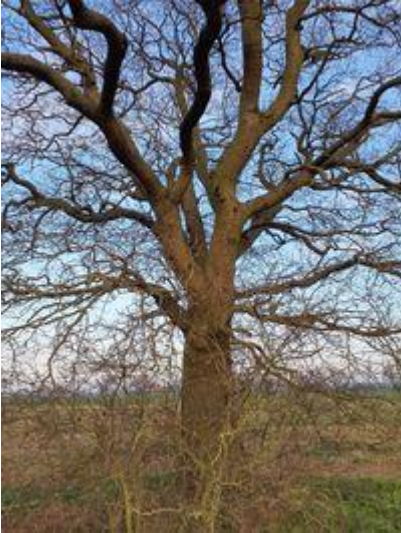
Bat roost feature reference	Notes	Habitat suitability	Photographs
BR407	<p>Veteran oak tree with some cracks and crevices, connected to pond habitat and reasonable connection to wider landscape.</p>	<p>Low</p>

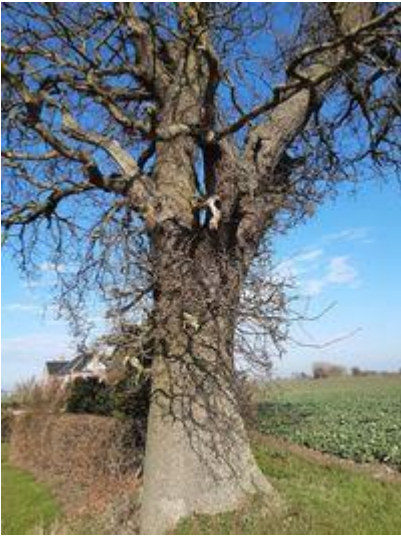
BR408	<p>Veteran oak, small crevices in dead limbs. Isolated in wider landscape.</p>	<p>Low</p>

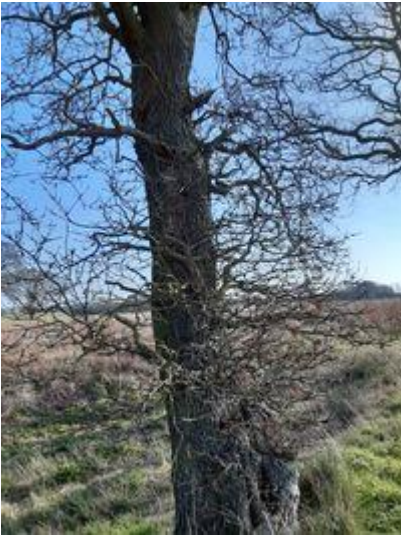
BR412	<p>Mature oak with small cracks in trunk. Isolated in landscape</p>	Low

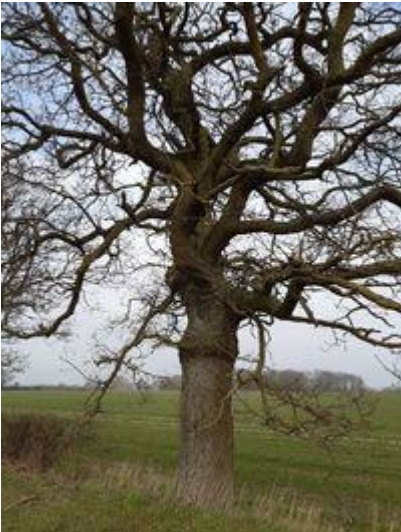
BR420	Mature oak, medium crack in bark near crown. In good linear habitat connecting to nearby woodland.	Moderate

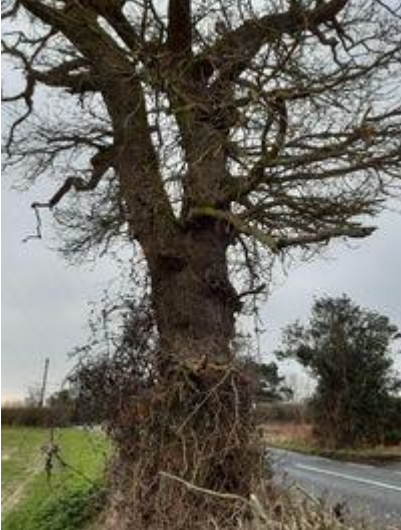
Bat roost feature reference	Notes	Habitat suitability	Photographs
BR421	Mature oak, no obvious cracks or features, although noted that canopy cannot be viewed in full.	Negligible

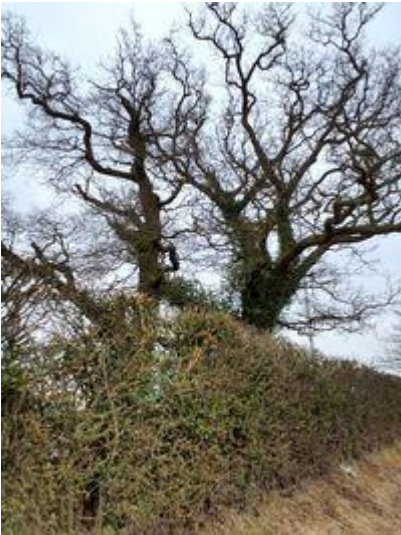
BR422	Large oak tree with ivy cover providing limited roosting opportunities. Adjacent to road and part of hedgerow with good connectivity to wider landscape and woodland.	Low

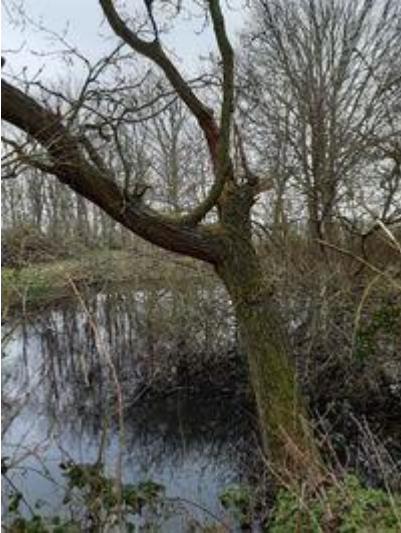
Bat roost feature reference	Notes	Habitat suitability	Photographs
BR423	Mature oak with crevices under loose bark, in woodland by pond, with drains nearby providing good connecting habitat.	Moderate

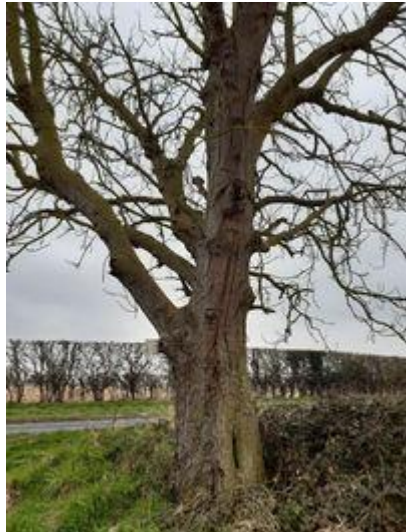
BR430	Mature sycamore, no obvious holes or cracks although cannot see canopy in full.	Negligible

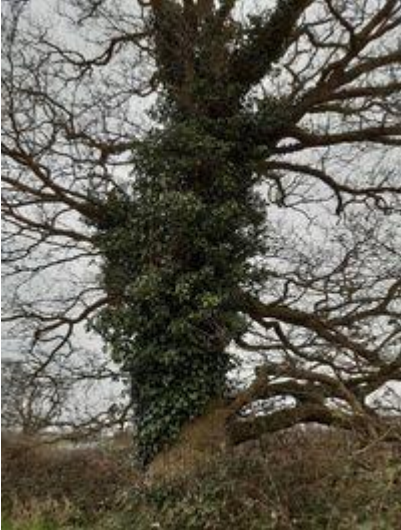
Bat roost feature reference	Notes	Habitat suitability	Photographs
BR431	Mature ivy clad oak no obvious PRFs but ivy may provide some. Good connecting habitat to woodland to east.	Low

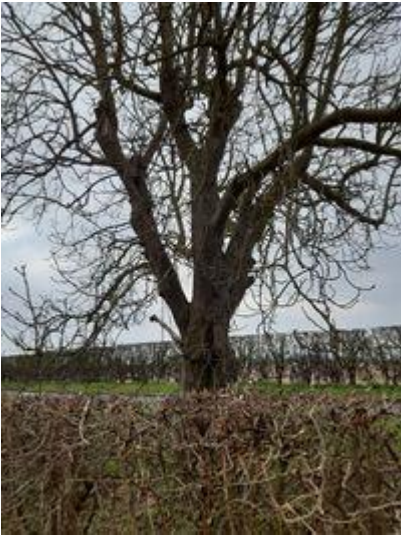
BR432	Mature sycamore, minor holes or cracks, good connecting habitat to woodland to east.	Low

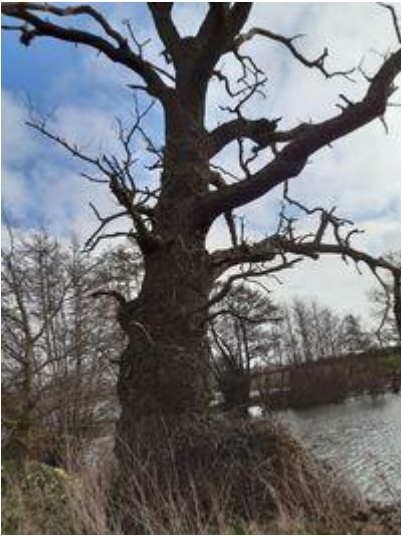
BR456	Veteran dead oak, small crack and crevices visible, adjacent to ponds and a small woodland.	Moderate

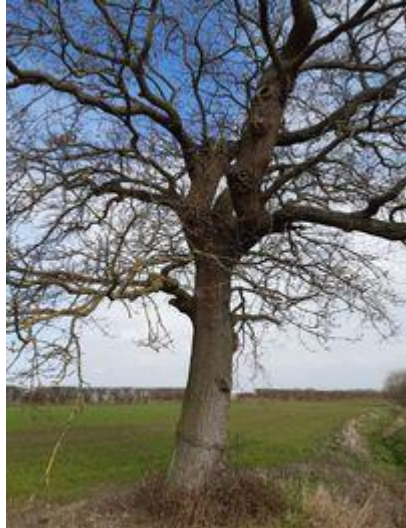
Bat roost feature reference	Notes	Habitat suitability	Photographs
BR465	Veteran oak, with moderate cavities in decaying limbs. Connected via stream to foraging ponds near farmhouse.	Moderate

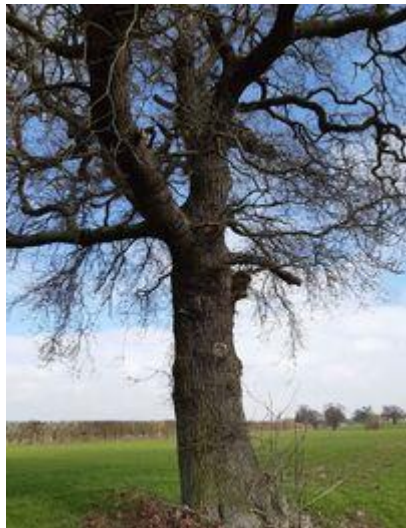
BR466	Veteran oak, with small cavities in limbs. Connected via stream to foraging ponds near farmhouse.	Low

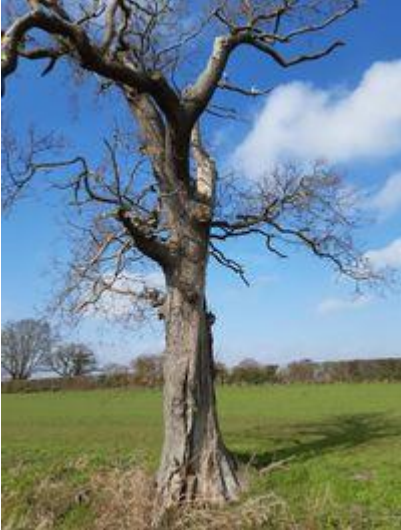
Bat roost feature reference	Notes	Habitat suitability	Photographs
BR467	<p>Veteran oak, with moderate cavities in decaying trunk. Connected via stream to foraging ponds near farmhouse.</p>	Moderate

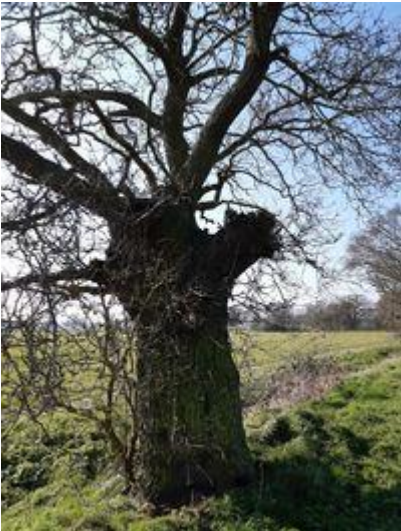
BR490	Veteran oak, decaying bark around limbs provides crevices, suitable for small roosts. Isolated.	Low

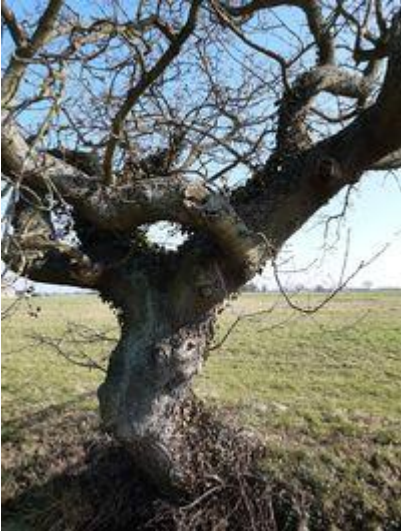
Bat roost feature reference	Notes	Habitat suitability	Photographs
BR493	Veteran isolated oak, small crack for opportunistic roosting.	Low

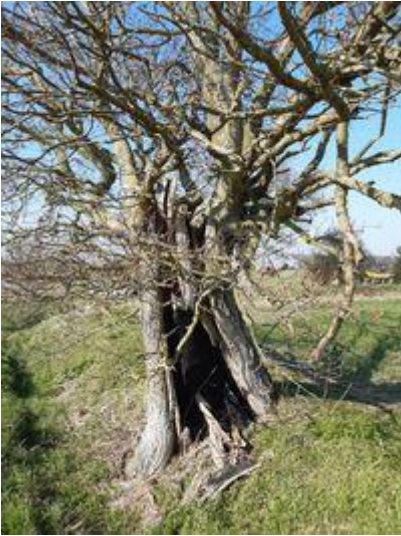
BR505	Veteran oak, with large decay cavity in centre, but open to elements and vulnerable to ground predators. Isolated in landscape.	Low

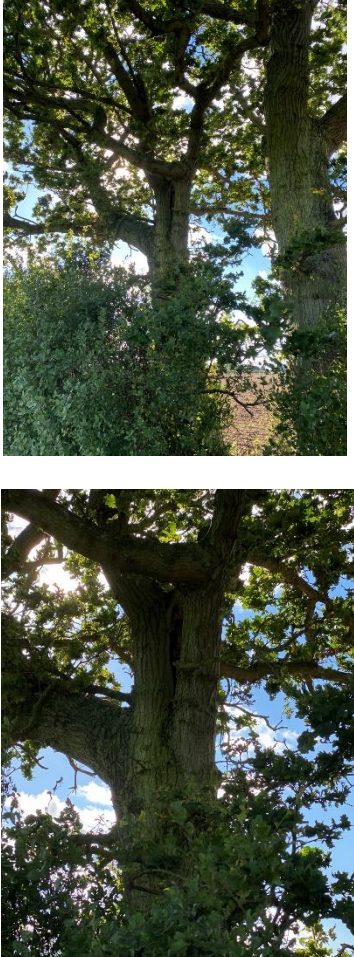
Bat roost feature reference	Notes	Habitat suitability	Photographs
BR515	Mature oak with crack with potential holes inside, however tree doesn't look to be substantial enough to support a bat roost. Potential opportunistic roosting only, if enough cover from the elements	Low

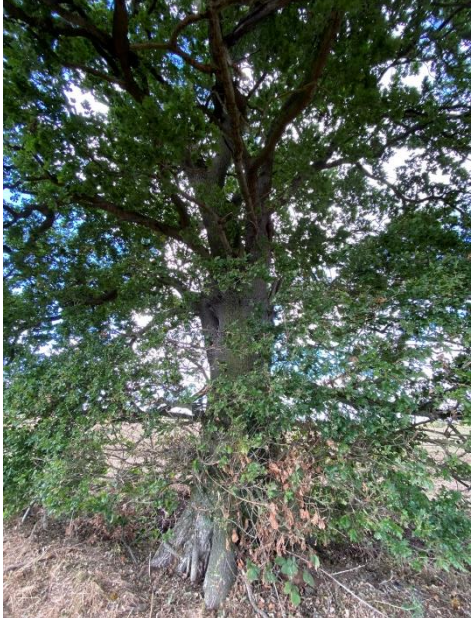
Bat roost feature reference	Notes	Habitat suitability	Photographs
BR516	Mature oak in hedge with a few visible cracks and holes, though doesn't appear to be substantial enough for protection against elements	Low

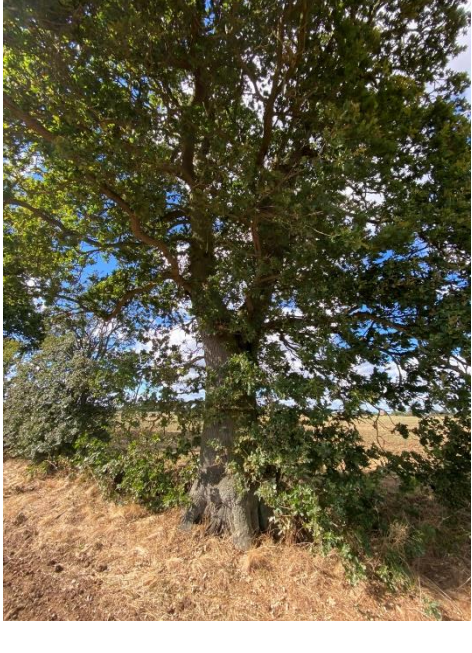
BR517	Mature oak in hedge with a few visible cracks and holes, though doesn't appear to be substantial enough for protection against elements	Low

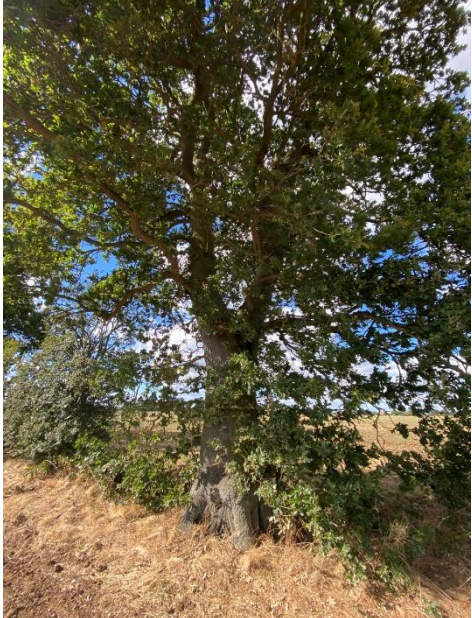
Bat roost feature reference	Notes	Habitat suitability	Photographs
BR518	Mature oak with a few visible holes but nothing substantial	Low

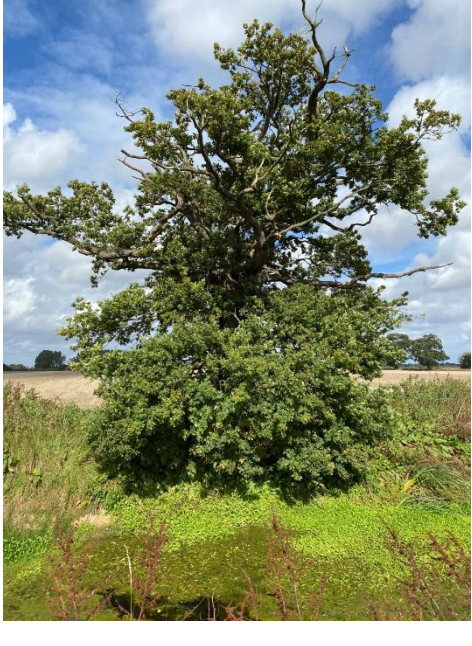
BR519	Mature potentially veteran oak with lots of holes and cracks, however potentially quite isolated from commuting and foraging habitat.	Low
