**NORTH FALLS**

*Offshore Wind Farm*

## **ENVIRONMENTAL STATEMENT**

### Appendix 21.1 Geomorphology Baseline Survey

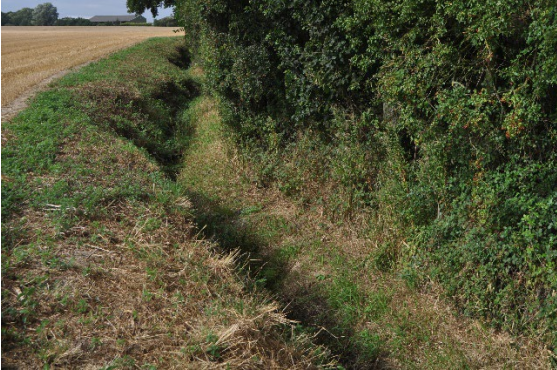
12. The upstream end of the reach has an asymmetrical cross-section. The right bank has a near vertical scarp of ~1.50 to 1.75m due to bank erosion, and the left hand bank transitions to a gentler slope of ~1.0m height. (Plate 1). Channel width is ~1.0m and bankfull depth is ~0.30 to 0.50m. Channel planform is typically straight with evidence of a gently meandering thalweg.
13. Towards the bottom of the reach the channel appears to be heavily managed with a symmetrical trapezoidal cross-section (Plate 2), typical of desilting / dredging, and there was evidence of recent vegetation clearance. The channel has a gently meandering planform and channel width is ~1.0m and bankfull depth ~0.3m.

<p><b>Plate 1 Incised channel and localised bank erosion at the upstream end of the reach</b></p>

16. The channel is typically incised 1.5 to 1.75m below the adjacent floodplain and there is limited opportunity for channel-floodplain connection. At the upstream end of the reach the left-hand bank is bordered by a mature hedgerow (Plate 1).

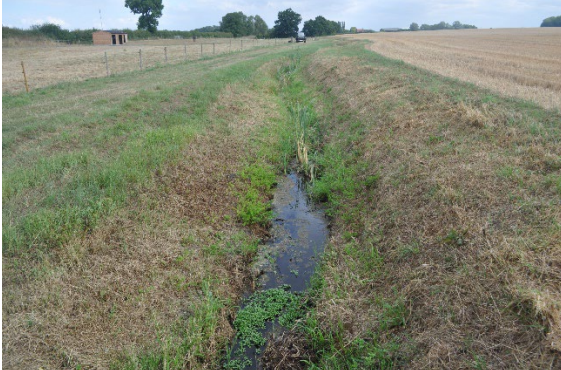
<p><b>Plate 2 Trapezoidal cross-section and evidence of vegetation clearance</b></p>

17. At the lower end of the reach the channel appears to be regularly cleared of vegetation (Plate 2) and grass / riparian vegetation cut back. Towards the upstream end of the reach there are patches of duckweed and other aquatic vegetation (Plate 6, Plate 7).

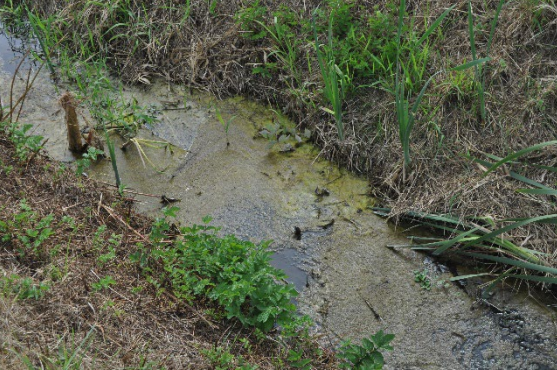
<p><b>Plate 3 Frothy scum in stagnant areas of flow</b></p>

14. Flows are typically low velocity / sluggish to stagnant with evidence of unidentified frothy scum on the surface in places (Plate 3). Locally, at the upstream end of the reach, in-channel woody material has led to the formation of a gently meandering thalweg and gentle riffles (Plate 4).

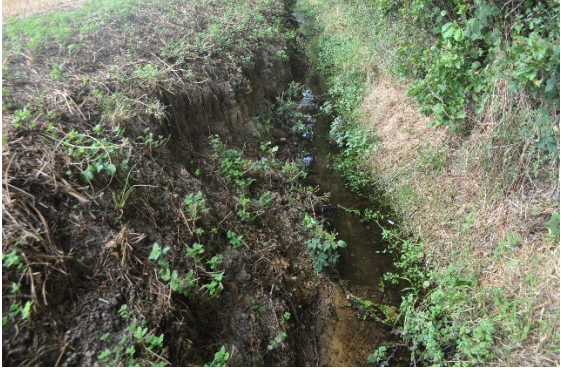
<p><b>Plate 4 In-channel vegetation and woody material</b></p>

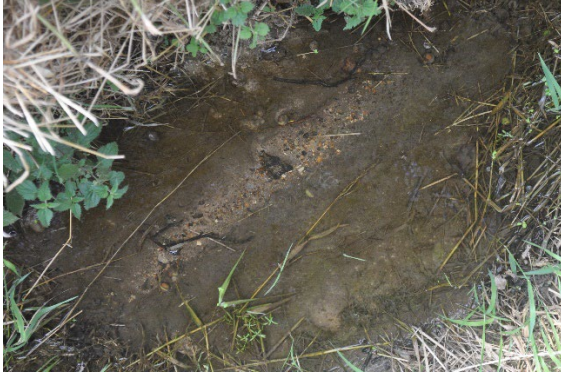
**Plate 5 Channel substrates**

15. In sluggish to stagnant areas of flow the channel bed is covered in fine sediments (silt and clay), and the dominant processes appear to be depositional. At the upstream end of the reach where there are locally faster flows, there are patches of cleaner coarse substrates (coarse sand and gravel (Plate 5)). Floodplain sediments are massive, structureless silts and clays. Fines covering the bed are sourced from localised eroding scarp slopes (Plate 1), and soil erosion from arable land beside the channel and in the wider catchment.

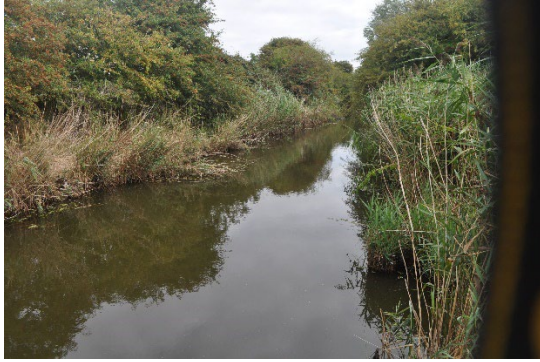
20. Over its lower course, Holland Brook is typical of a low energy, lowland river. The channel is ~6m wide and bankfull depth is ~1.5m (Plate 10, Plate 11). On the right bank the land rises steeply to the ridge (the 5m AOD contour) that separates the channel from the coast, and on the left, there appears to be a low embankment that limits inundation of the wider agricultural floodplain. The final section of the reach is impounded by a large sluice and the channel then flows to the sea via an outfall.

**Plate 10 Lower course of Holland Brook**

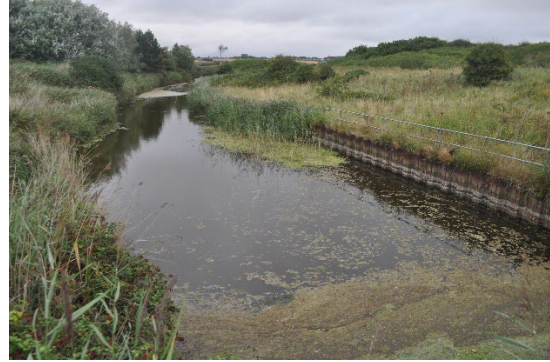
**Plate 11 Lower course of Holland Brook upstream of the sluice**

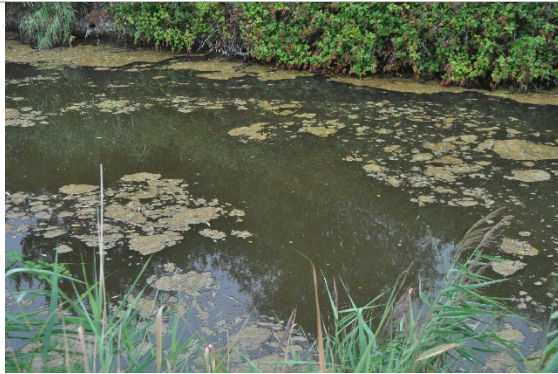
**Plate 12 Surficial frothy scum**

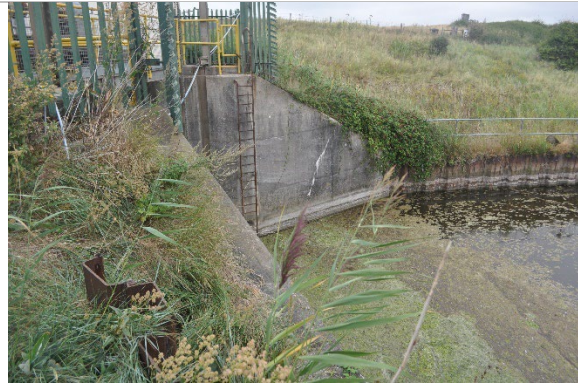
**Plate 13 The sluice that impounds the lower course of Holland Brook**

25. At its lower limit the channel is impounded by a large sluice (Plate 13) and the left hand bank immediately upstream of the sluice is made of corrugated steel sheeting (Plate 11). Holland Brook's confluence with the shoreline is artificial and formed by a concrete outfall (Plate 14 (Holland Haven outfall)).

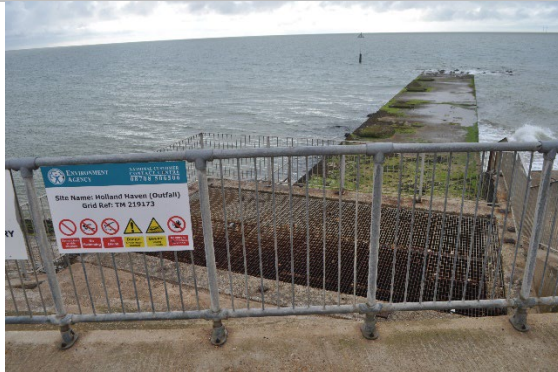
**Plate 14 Holland Brook's confluence with the sea (Holland Haven Outfall)**

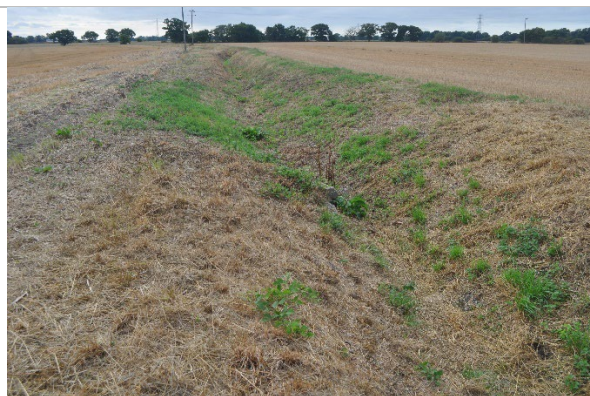
56. At the upstream end of the reach the channel is ~1m wide and has a distinct trapezoidal cross-section indicative of regular maintenance (Plate 31). At the time of survey there had been recent vegetation clearance of the channel at this location. Bankfull is ~0.5 - 0.75m and the planform is straight. The channel had clearly been dry for some time prior to the survey as there was no water or exposed sediment on the channel bed. In the middle and downstream sections of the reach (Plate 32), channel form is similar although the channel is more deeply incised (~1m) and lined with scrubby vegetation.

**Plate 31 Trapezoidal nature of the channel at the upstream end of the reach**

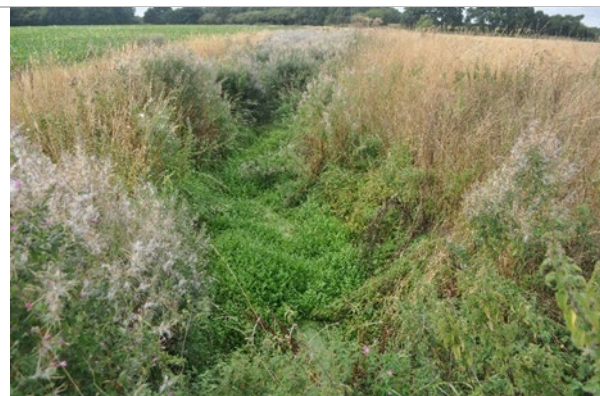
**Plate 32 Incised nature of the channel at the downstream end of the reach**

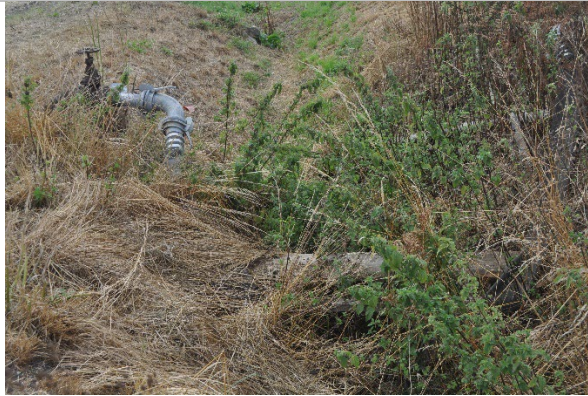
**Plate 33 Permanent pipework on the channel bank**

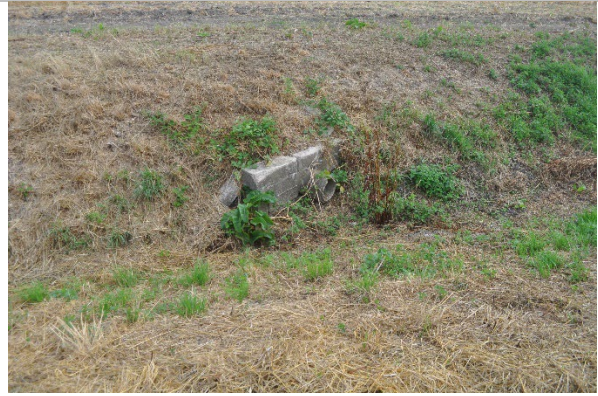
**Plate 34 Field drain outfall**
