**HELIOS** RENEWABLE  
ENERGY  
PROJECT

**PINS Document Number:**  
EN010140/APP/6.3.8.3

**Environmental Statement  
Appendix 8.3:  
Otter and Water Vole Report**

## Technical Appendix 8.3: Otter and Water Vole Survey

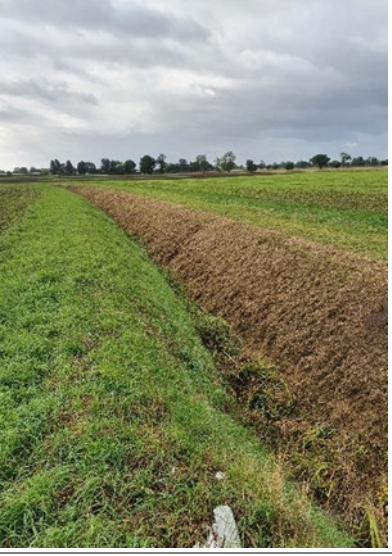
Photo 8: D3.J-K

(j) Non-native invasive plant species absent (HB, JK, GH etc)							
HABITAT ASSESSMENT SCORE AND SUITABILITY CATEGORY:				3			
Comment(s):		Small mammal burrows observed, attributed to field vole.					
Photograph(s): Appendix 2; Photo 8.

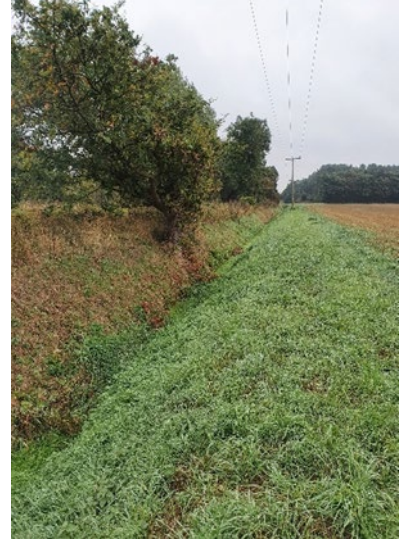
**Photo 21: D8.A-E**

(a) Well developed (>60%) bankside <u>and</u> emergent vegetation providing food & cover (b) A good variety of food plants including favoured plants and winter food sources (c) Suitable refuge areas above extremes in water levels (d) Soft, earth banks suitable for burrowing (30 to 60 degree slope) (e) Water permanently present (does not dry up) (f) Open water for swimming (g) Ledge or berm present at or close to water level (h) Lack of damage or erosion to the banks (i) Slow flowing current or static water (j) Non-native invasive plant species absent (HB, JK, GH etc)			x x x x x x x x x	*DAFORN Dominant 81-100% Abundant 61-80% Frequent 41-60% Occasional 21-40% Rare 1-20% None 0%		
<b>HABITAT ASSESSMENT SCORE AND SUITABILITY CATEGORY:</b>			<b>3</b>			
<b>Comment(s):</b>	Depth/Current – damp, but no standing water. Small mammal burrows present.					
<b>Photograph(s): Appendix 2; Photo 21.</b>

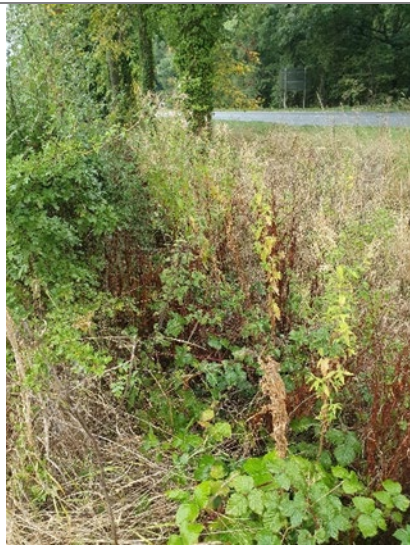
**Photo 22: D9.A**

(a) Well developed (>60%) bankside <u>and</u> emergent vegetation providing food & cover (b) A good variety of food plants including favoured plants and winter food sources (c) Suitable refuge areas above extremes in water levels (d) Soft, earth banks suitable for burrowing (30 to 60 degree slope) (e) Water permanently present (does not dry up) (f) Open water for swimming (g) Ledge or berm present at or close to water level (h) Lack of damage or erosion to the banks (i) Slow flowing current or static water (j) Non-native invasive plant species absent (HB, JK, GH etc)			x x x x x x x x x	*DAFORN Dominant 81-100% Abundant 61-80% Frequent 41-60% Occasional 21-40% Rare 1-20% None 0%		
<b>HABITAT ASSESSMENT SCORE AND SUITABILITY CATEGORY:</b>			<b>5</b>			
<b>Comment(s):</b>	Depth/Current – Dry.					
<b>Photograph(s): Appendix 2; Photo 22.</b>

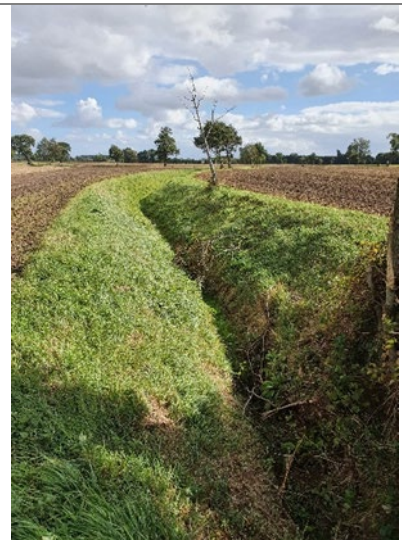
**Photo 27: D11.A-F**

(a) Well developed (>60%) bankside <u>and</u> emergent vegetation providing food & cover (b) A good variety of food plants including favoured plants and winter food sources (c) Suitable refuge areas above extremes in water levels (d) Soft, earth banks suitable for burrowing (30 to 60 degree slope) (e) Water permanently present (does not dry up) (f) Open water for swimming (g) Ledge or berm present at or close to water level (h) Lack of damage or erosion to the banks (i) Slow flowing current or static water (j) Non-native invasive plant species absent (HB, JK, GH etc)			x x x x x x x x	*DAFORN Dominant 81-100% Abundant 61-80% Frequent 41-60% Occasional 21-40% Rare 1-20% None 0%		
<b>HABITAT ASSESSMENT SCORE AND SUITABILITY CATEGORY:</b>			<b>3</b>			
<b>Comment(s):</b>	Depth/Current – Dry.					
<b>Photograph(s): Appendix 2; Photo 27.</b>

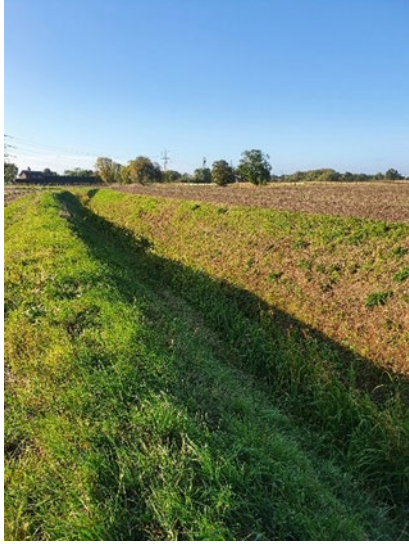
Photo 28: D12.A-B

(a) Well developed (>60%) bankside <u>and</u> emergent vegetation providing food & cover (b) A good variety of food plants including favoured plants and winter food sources (c) Suitable refuge areas above extremes in water levels (d) Soft, earth banks suitable for burrowing (30 to 60 degree slope) (e) Water permanently present (does not dry up) (f) Open water for swimming (g) Ledge or berm present at or close to water level (h) Lack of damage or erosion to the banks (i) Slow flowing current or static water (j) Non-native invasive plant species absent (HB, JK, GH etc)			x x x x x x x x	*DAFORN Dominant 81-100% Abundant 61-80% Frequent 41-60% Occasional 21-40% Rare 1-20% None 0%		
<b>HABITAT ASSESSMENT SCORE AND SUITABILITY CATEGORY:</b>			<b>5</b>			
<b>Comment(s):</b>	D12.A featured rat droppings.					
<b>Photograph(s): Appendix 2; Photo 28.</b>

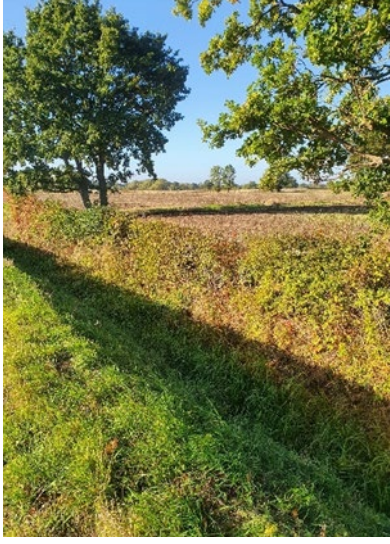
Photo 29: D12.C-F

(h) Lack of damage or erosion to the banks					None 0%	
(i) Slow flowing current or static water	x					
(j) Non-native invasive plant species absent (HB, JK, GH etc)	x					
<b>HABITAT ASSESSMENT SCORE AND SUITABILITY CATEGORY:</b>			<b>6</b>			
<b>Comment(s):</b>						
<b>Photograph(s): Appendix 2; Photo 29.</b>

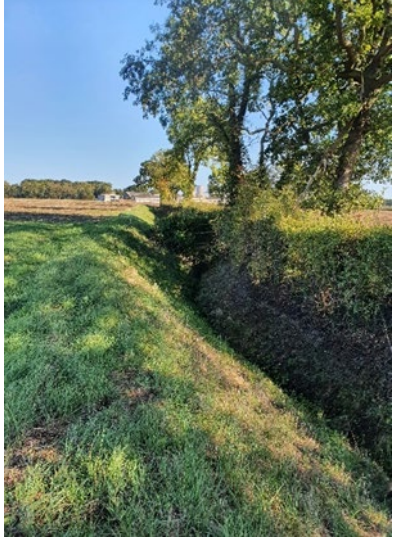
Photo 30: D12.G-H

(h) Lack of damage or erosion to the banks					None 0%	
(i) Slow flowing current or static water						
(j) Non-native invasive plant species absent (HB, JK, GH etc)						
<b>HABITAT ASSESSMENT SCORE AND SUITABILITY CATEGORY:</b>			<b>5</b>			
<b>Comment(s):</b>						
<b>Photograph(s): Appendix 2; Photo 30.</b>
