**Tillbridge Solar Project
EN010142**

**Volume 6
Environmental Statement**
Appendix 9-10: Baseline Report for Riparian mammals
Document Reference: EN010142/APP/6.2

**April 2024
Revision Number: 00**

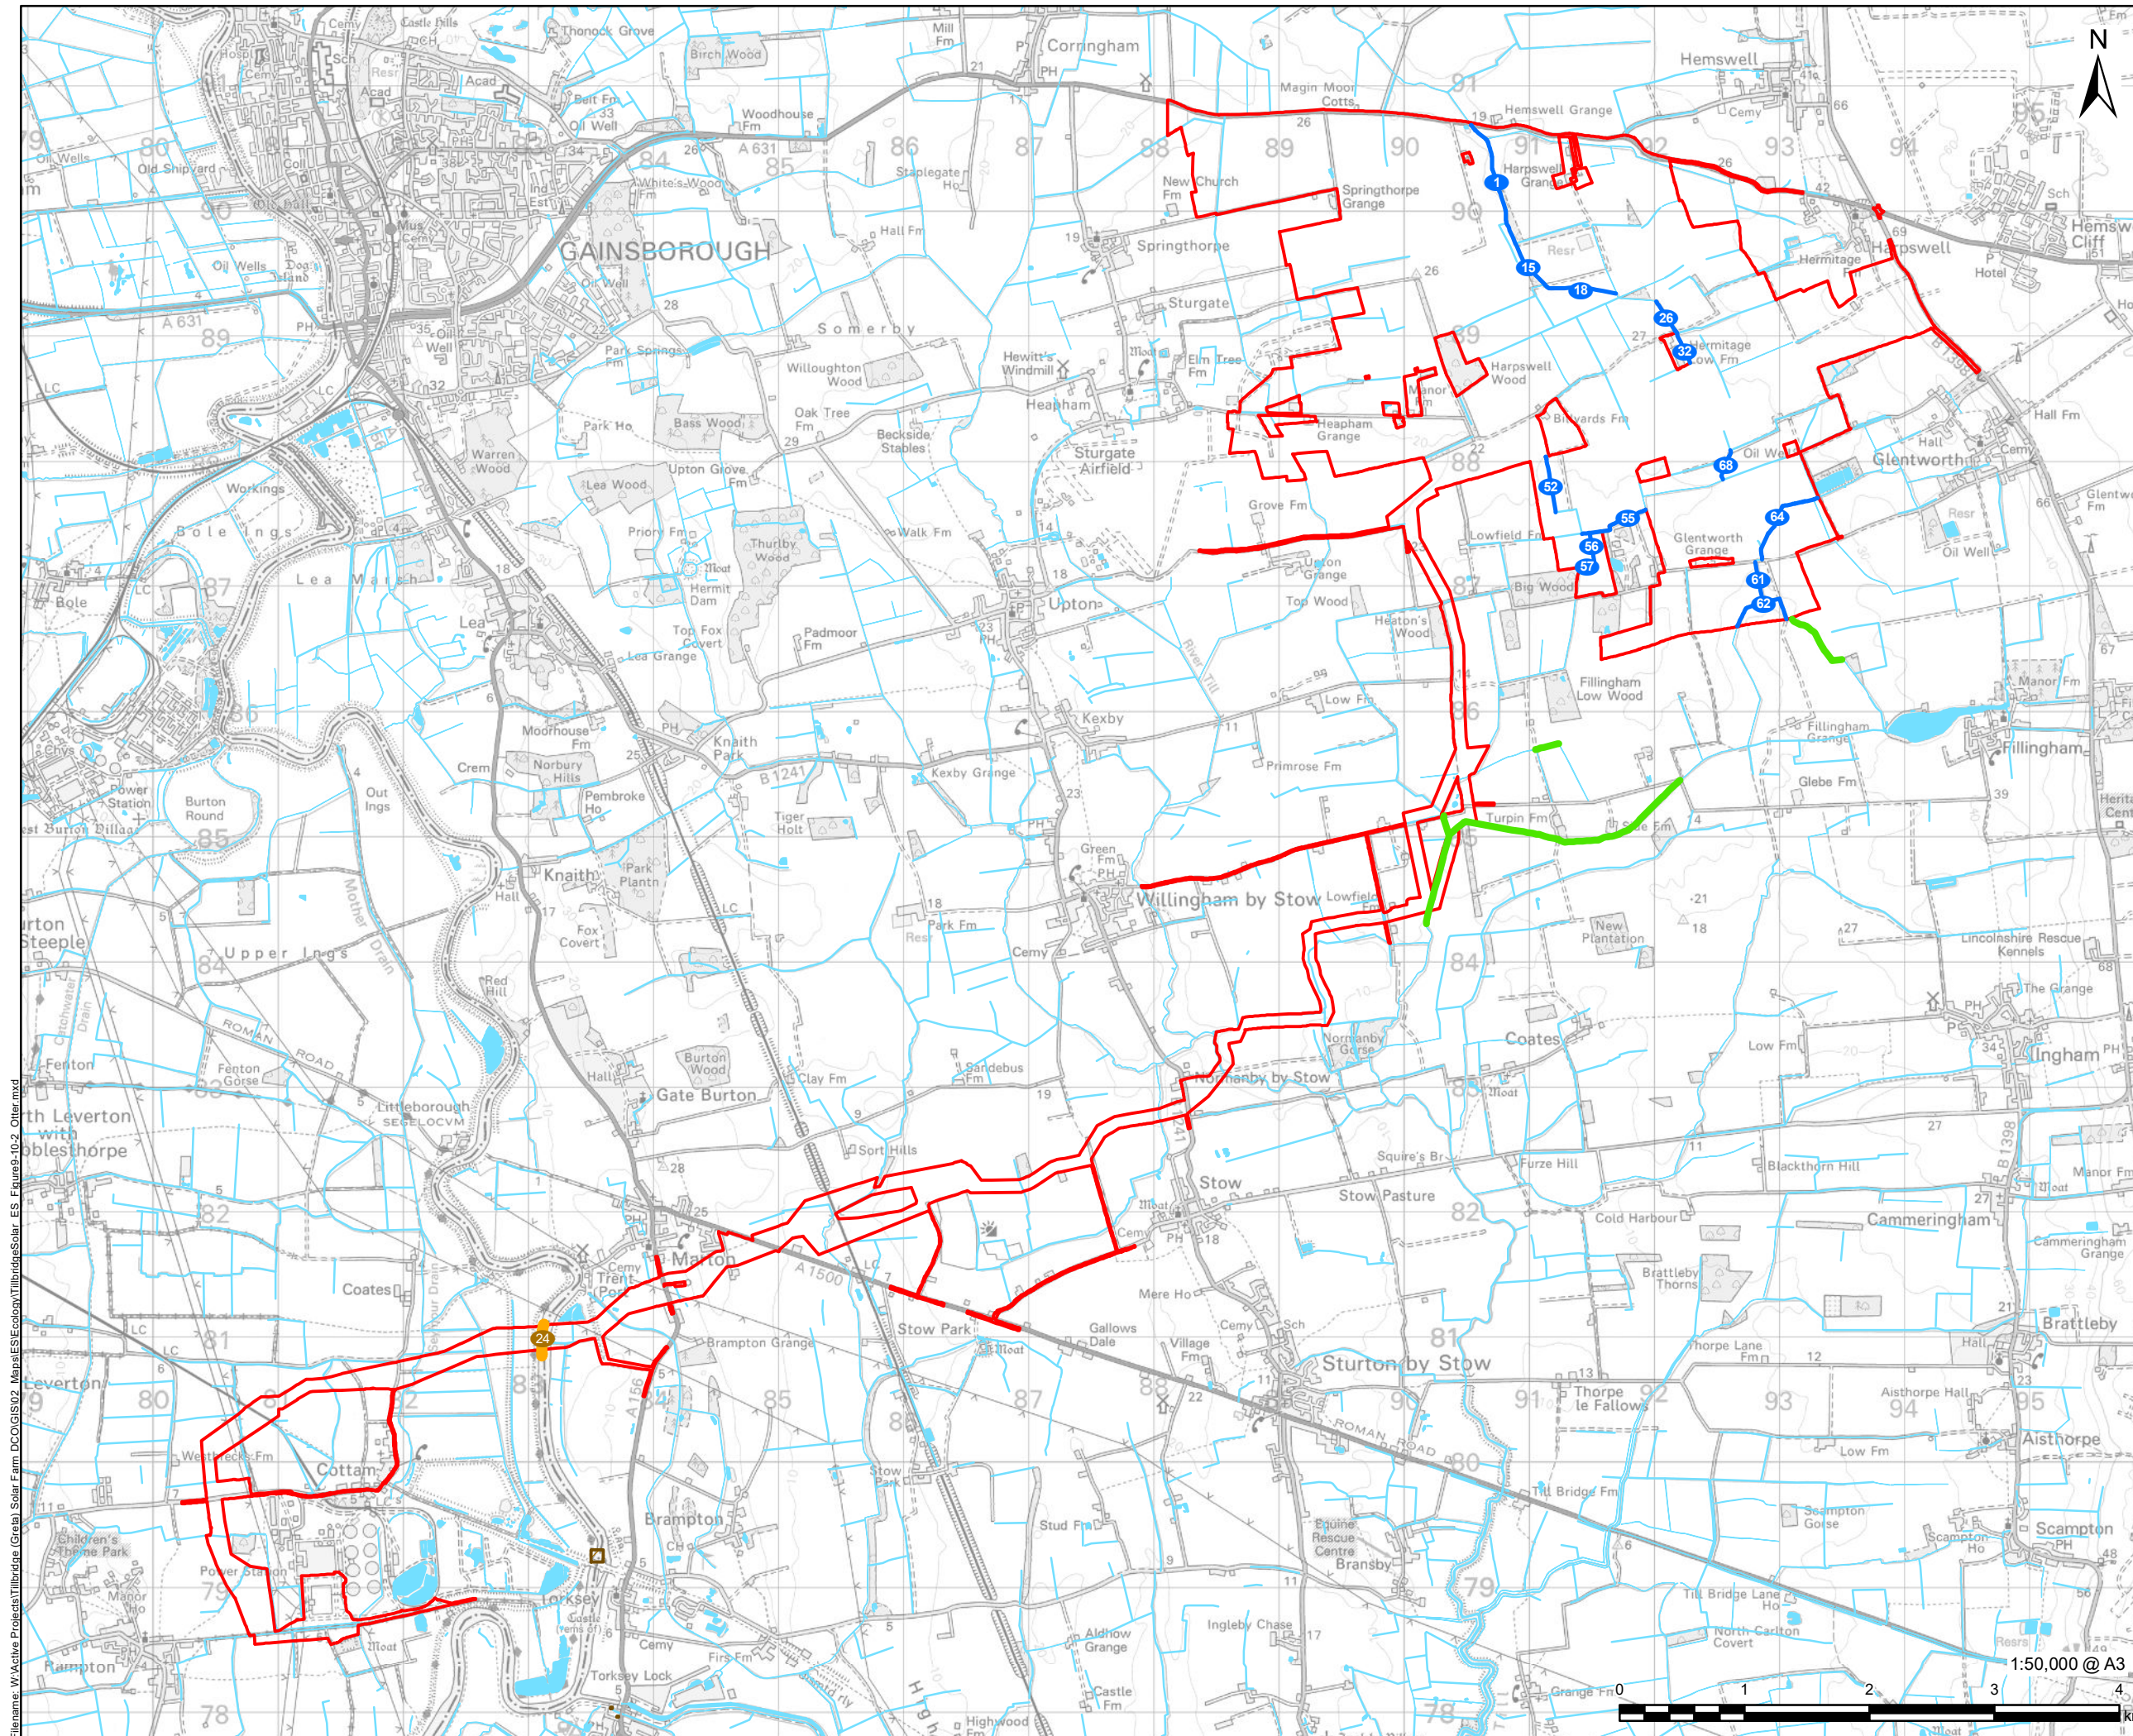
Figure 9-10-2 Location of records of Otter from desk study data and field survey

4.3.5 No evidence of Otter (including holts) or Water Vole was found anywhere within the Order limits during surveys for riparian mammals, including within watercourses where there were desk study records of Otter or Water Vole presence (such as watercourse 62).

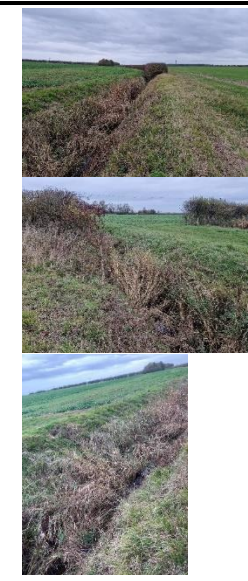
Watercourse reference (see Figure 9-10-1)	Summary description	Habitat Suitability	Photograph
1	<ul style="list-style-type: none"> ▪ Connected to three on-site watercourses (2, 14 and 15) ▪ Bankside vegetation is predominately grass, some herbaceous vegetation, occasional shrub ▪ Mainly herbaceous vegetation and occasional shrub in half of channel, the rest is open ▪ No year-round food source ▪ Wet in November 2022 (<15cm) ▪ Shaded in patches by occasional shrub on bankside, heavily shaded by vegetation in channel ▪ Steep banks suitable for burrowing ▪ Heavy disturbance - adjacent to arable, regularly managed by mowing and regularly reprofiled ▪ Water quality moderate – no litter debris but a few signs of agriculture run-off / pollution e.g., green algae, oil on surface of water etc. ▪ Condition assessment: poor 	Suitable but poor

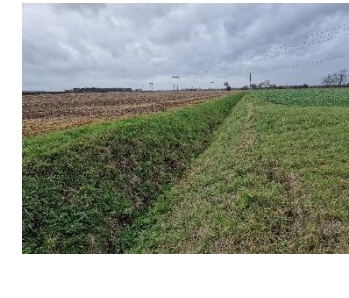
2	<ul style="list-style-type: none"> ▪ Connected to two on-site watercourses (1 and 3) ▪ Bankside vegetation is predominately grass, limited herbaceous vegetation, no woody vegetation ▪ Open channel ▪ No year-round food source ▪ Dry in November 2022 ▪ No shading ▪ Steep banks suitable for burrowing 	Unsuitable

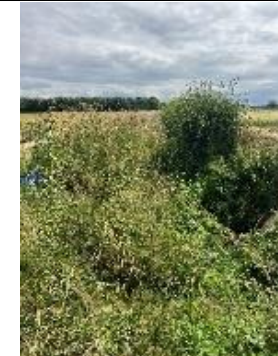
12 ■ Defunct hedgerow in dry, shallow ditch

N/A

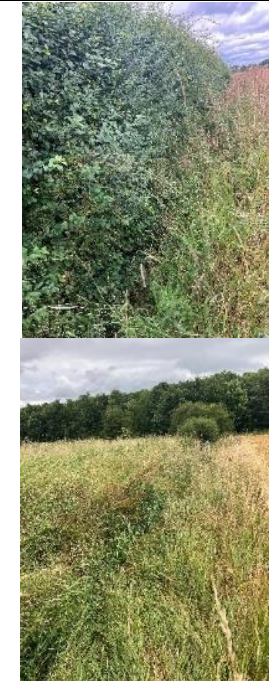
| <p>14</p> <ul style="list-style-type: none"> ▪ Connected to one on-site watercourse (1) ▪ Hedgerow encroaching ditch from the west side ▪ Mixture of grass and woody vegetation on banksides, some herbaceous vegetation ▪ Mainly grass and woody vegetation in channel, limited herbaceous vegetation ▪ No year-round food source ▪ Dry in July 2023 ▪ Heavily shaded by encroaching hedgerow from the western side ▪ Steep banks suitable for burrowing ▪ Some disturbance - adjacent to arable ▪ No obvious signs of pollution e.g., agricultural run-off or litter debris ▪ Condition assessment: N/A - Dry | <p>Unsuitable</p> | |

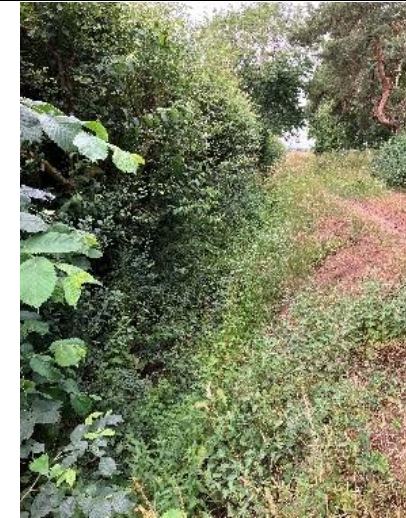
| <p>16</p> <ul style="list-style-type: none"> ▪ Connected to three on-site watercourses (15, 17 and 18) ▪ Hedgerow encroaching ditch from the south side ▪ Mixture of grass and woody vegetation on banksides, limited herbaceous vegetation ▪ Mixture of grass, herbaceous and woody vegetation in channel ▪ No year-round food source ▪ Dry in June 2023 ▪ Heavily shaded by encroaching hedgerow from the south side and bankside vegetation ▪ Steep banks suitable for burrowing ▪ Limited disturbance - adjacent to woodland on the north side and arable on the south side ▪ No obvious signs of pollution e.g., agricultural run-off or litter debris ▪ Condition assessment: N/A - Dry | <p>Unsuitable</p> | |

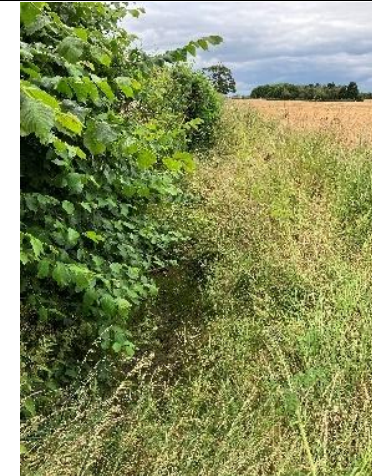
-
- 17
- Connected to one on-site watercourse (16)
 - Hedgerow in wet ditch
 - Mixture of grass and woody vegetation on banksides, limited herbaceous
 - Mainly woody vegetation in channel, some herbaceous vegetation, limited grass vegetation
 - No year-round food source
 - Wet in June 2023 (<10cm)
 - Heavily shaded by hedgerow in channel
 - Steep banks suitable for burrowing
 - Some disturbance - adjacent to arable on both sides
 - Water quality is moderate - no litter debris but a few signs of agriculture run-off / pollution from field drains e.g., green algae, oil on surface of water etc.
 - Condition assessment: poor

Unsuitable

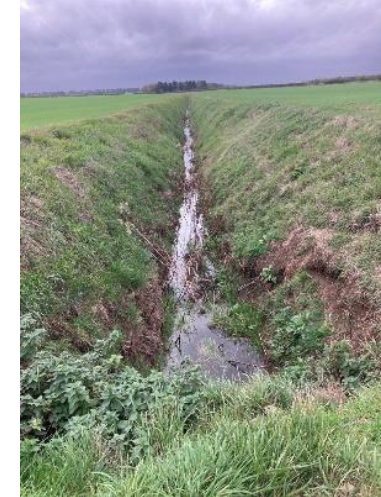
| 18 | <ul style="list-style-type: none">▪ Connected to two on-site watercourse (15 and 16)▪ Bankside vegetation is predominantly grass, limited herbaceous vegetation, no woody vegetation▪ Open channel▪ Limited year-round food source▪ Wet in November 2022 (<30cm), slight flow▪ No shading▪ Steep banks suitable for burrowing▪ Some disturbance - adjacent to arable on both sides▪ Water quality is moderate - no litter debris but some signs of agriculture run-off / pollution e.g., green algae, oil on surface of water etc.▪ Condition assessment: poor |

Suitable but
poor

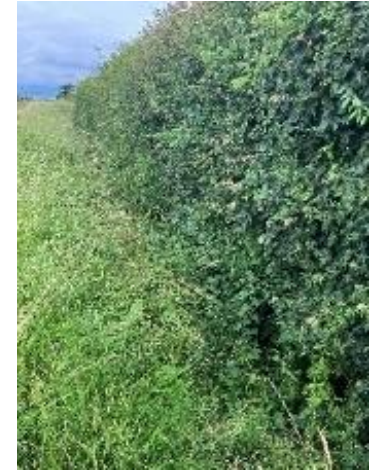
19 ■ Hedgerow in dry ditch

N/A

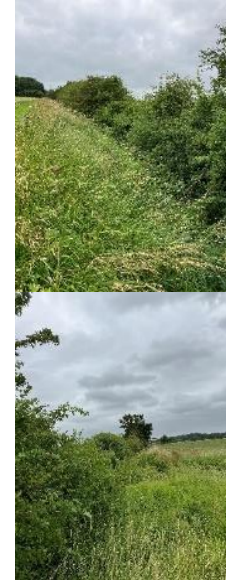
20 ■ Hedgerow in dry, shallow ditch

N/A

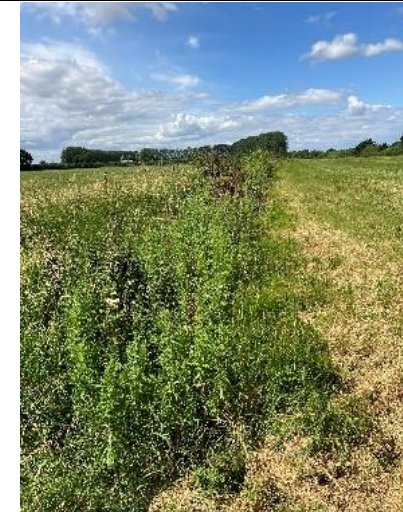
| 21 | <ul style="list-style-type: none">▪ Not connected▪ Bankside vegetation is predominately herbaceous, some grass vegetation, no woody vegetation▪ Mainly herbaceous vegetation in channel, limited grass vegetation, no woody vegetation▪ No year-round food source▪ Dry with wet patches in June 2023 (<10cm)▪ Heavily shaded by vegetation in channel▪ Steep banks suitable for burrowing▪ Some disturbance - adjacent to arable on both sides▪ No obvious signs of pollution e.g., agricultural run-off or litter debris▪ Condition assessment: N/A - Dry |

Unsuitable

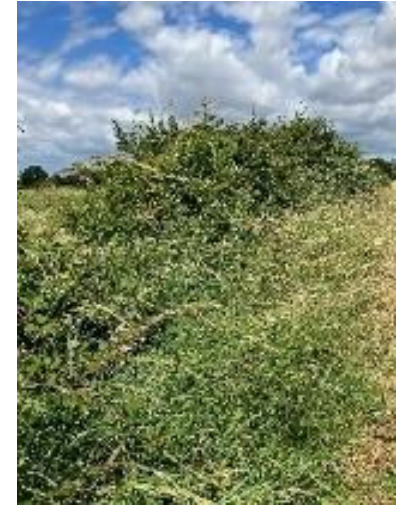
22 ■ Defunct hedgerow in dry ditch

N/A

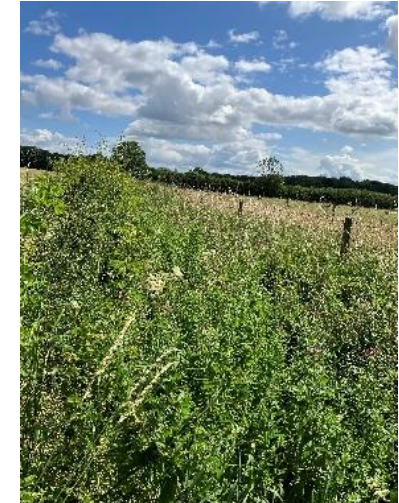
- 23
- Not connected
 - Small hedge on the north side of ditch
 - Mixture of herbaceous and woody vegetation on bankside, limited grass vegetation
 - Mainly herbaceous vegetation in channel, some woody vegetation, limited grass vegetation
 - No year-round food source
 - Dry in June 2023
 - Shaded in patches by hedge on the north side and heavily shaded by vegetation in channel
 - Steep banks suitable for burrowing
 - Some disturbance - adjacent to arable on both sides
 - No obvious signs of pollution e.g., agricultural run-off or litter debris
 - Condition assessment: N/A - Dry

Unsuitable

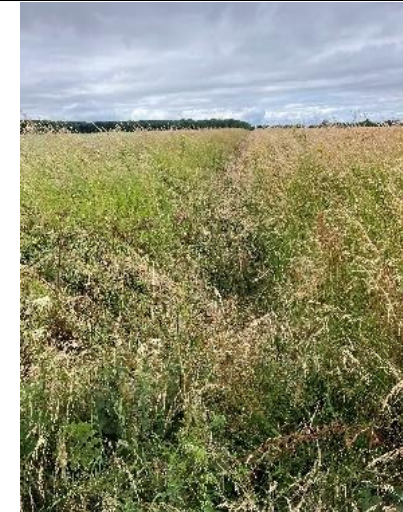
-
- 24
- Not connected
 - Bankside vegetation is predominately grass, some herbaceous vegetation, no woody vegetation
 - Mainly grass vegetation in channel, limited herbaceous vegetation, no woody vegetation
 - Limited year-round food source
 - Dry in June 2023
 - Heavily shaded by vegetation in channel
 - Steep banks suitable for burrowing
 - Some disturbance - adjacent to arable on both sides
 - No obvious signs of pollution e.g., agricultural run-off or litter debris
 - Condition assessment: N/A - Dry

Unsuitable

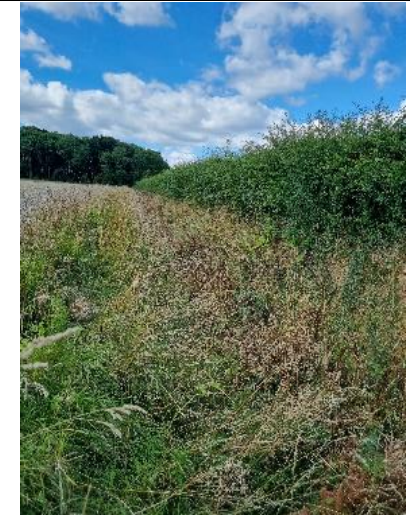
-
- 24a
- Connected to one on-site watercourse (24)
 - Hedgerow encroaching ditch from the north-east side
 - Mixture of grass and woody vegetation on banksides, limited herbaceous vegetation
 - Mainly grass vegetation in channel, some herbaceous vegetation, no woody vegetation
 - Limited year-round food source
 - Dry in June 2023
 - Heavily shaded by encroaching hedgerow from the north-east side
 - Steep banks suitable for burrowing
 - Some disturbance - adjacent to arable on both sides
 - No obvious signs of pollution e.g., agricultural run-off or litter debris
 - Condition assessment: N/A - Dry

Unsuitable

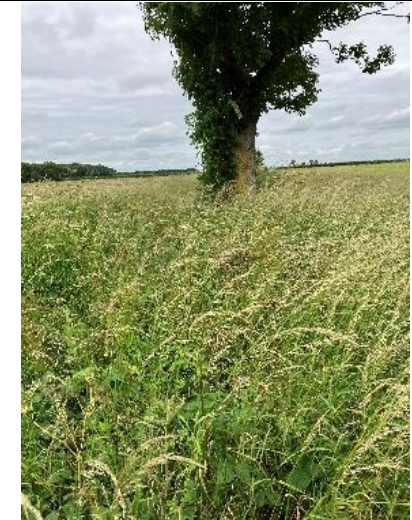
- 25a
- Connected to three on-site watercourses (25b, 40 and 39)
 - Bankside vegetation is predominately grass, some herbaceous vegetation, occasional tree
 - Mainly grass vegetation in channel, limited herbaceous vegetation, occasional tree
 - Limited year-round food source
 - Dry in June 2023
 - Heavily shaded by vegetation in channel and by occasional tree
 - Steep banks suitable for burrowing
 - Some disturbance - adjacent to arable on both sides
 - No obvious signs of pollution e.g., agricultural run-off or litter debris
 - Condition assessment: N/A - Dry

Unsuitable

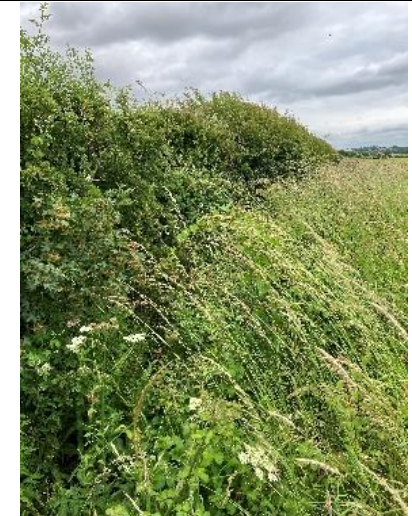
- Connected to three on-site watercourses (25a and 38)
- Hedgerow encroaching ditch from the north-west side
- Mixture of grass and woody vegetation on banksides, limited herbaceous vegetation
- Mixture of grass, herbaceous and woody vegetation in channel
- No year-round food source
- Dry in June 2023
- Heavily shaded by encroaching hedgerow from the north-west side and vegetation in channel
- Steep banks suitable for burrowing
- Some disturbance - adjacent to arable on both sides
- No obvious signs of pollution e.g., agricultural run-off or litter debris
- Condition assessment: N/A - Dry

Unsuitable

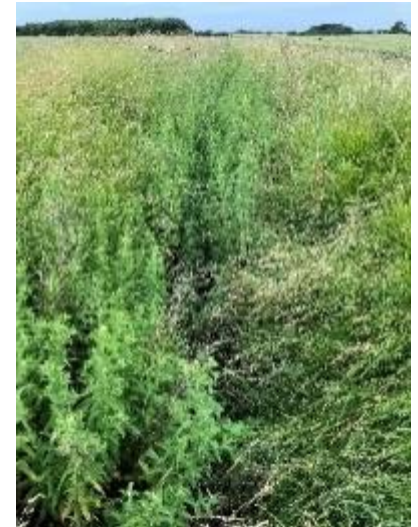
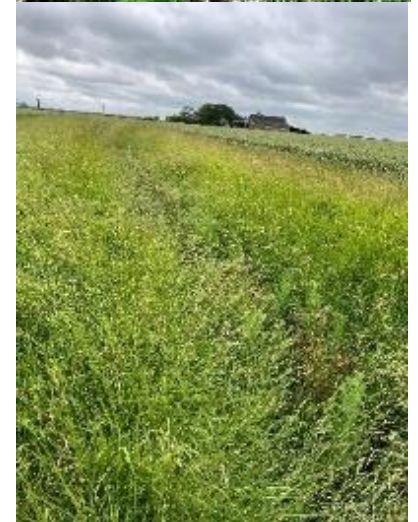
26

- Connected to one on-site watercourse (26a)
- Bankside vegetation is predominately herbaceous, some grass vegetation, no woody vegetation
- Mainly herbaceous vegetation in channel, limited grass vegetation, no woody vegetation
- Limited year-round food source
- Wet in June 2023 (<10cm)
- Heavily shaded by vegetation in channel
- Steep banks suitable for burrowing
- Some disturbance - adjacent to arable on both sides
- Water quality is good – no obvious signs of pollution e.g., agricultural run-off or litter debris
- Condition assessment: poor

Suitable but
poor

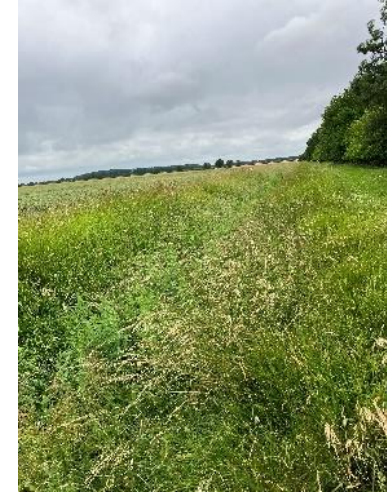
- 26a
- Connected to one on-site watercourse (26)
 - Bankside vegetation is predominately grass, some herbaceous vegetation, no woody vegetation
 - Patches of herbaceous vegetation in channel, no grass or woody vegetation
 - Limited year-round food source
 - Dry in June 2023
 - Heavily shaded in patches by vegetation in channel
 - Steep banks suitable for burrowing
 - Limited disturbance - adjacent to woodland on the north side and arable on the south side
 - No obvious signs of pollution e.g., agricultural run-off or litter debris
 - Condition assessment: N/A - Dry

Unsuitable

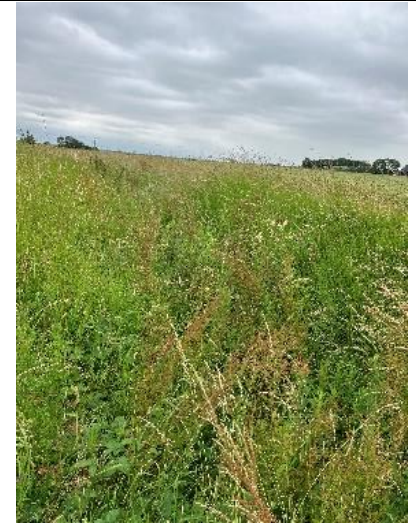
-
- 27
- Connected to one on-site watercourse (28)
 - Bankside vegetation is predominately grass, some woody vegetation, limited herbaceous vegetation
 - Mainly herbaceous vegetation in channel, limited grass vegetation, no woody vegetation
 - Limited year-round food source
 - Dry in June 2023
 - Heavily shaded by vegetation in channel
 - Steep banks suitable for burrowing
 - Some disturbance - adjacent to arable on both sides
 - No obvious signs of pollution e.g., agricultural run-off or litter debris
 - Condition assessment: N/A - Dry

Unsuitable

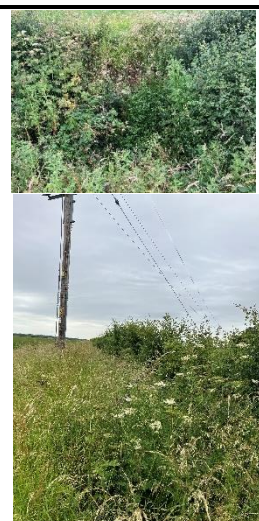
32	<ul style="list-style-type: none"> ▪ Connected to one on-site watercourse (34) ▪ Hedgerow on the south-west side ▪ Mixture of grass, woody and herbaceous vegetation on banksides ▪ Mainly herbaceous vegetation in channel, limited grass vegetation, limited woody vegetation ▪ No year-round food source ▪ Wet in north end (<20cm), dry for the rest in June 2023 ▪ Heavily shaded by hedgerow on the south-west side, bankside vegetation and vegetation in channel ▪ Steep banks suitable for burrowing ▪ Some disturbance - adjacent to arable on both sides ▪ Water quality is moderate – no litter debris but a few signs of agriculture run-off / pollution e.g., green algae, oil on surface of water etc. ▪ Condition assessment: poor 	Suitable but poor

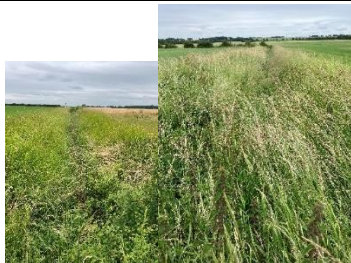
<ul style="list-style-type: none"> Condition assessment: N/A - Dry 		
34	<ul style="list-style-type: none"> Connected to one on-site watercourse (32) Mixture of grass and herbaceous vegetation on banksides, no woody vegetation Mainly herbaceous in channel, limited grass vegetation, no woody vegetation Limited year-round food sources Dry in June 2023 Heavily shaded by vegetation in channel Steep banks suitable for burrowing Some disturbance - adjacent to arable on both sides No obvious signs of pollution e.g., agricultural run-off or litter debris Condition assessment: N/A - Dry 	Unsuitable

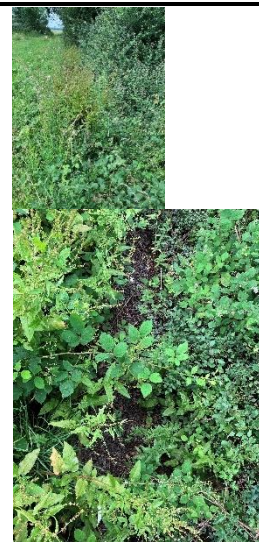
Habitat Suitability	Photograph
44	<ul style="list-style-type: none"> ▪ No connected ▪ Scrubland edge encroaching ditch from the west side ▪ Bankside vegetation is predominantly herbaceous and woody vegetation, some grass vegetation ▪ Mainly herbaceous vegetation in channel, limited grass vegetation, no woody vegetation ▪ No year-round food source ▪ Dry in June 2023 ▪ Heavily shaded by encroaching scrubland edge from the west side, some shading by vegetation in channel ▪ Steep banks suitable for burrowing ▪ Some disturbance - adjacent to scrubland on west side and arable on east side ▪ No obvious signs of pollution e.g., agricultural run-off or litter debris ▪ Condition assessment: N/A - Dry 	Unsuitable

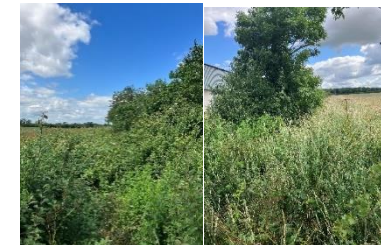
- No connected
- Hedgerow / line of trees at the west end of ditch on the north side
- Mixture of grass, woody and herbaceous vegetation on banksides
- Mainly herbaceous vegetation in channel, some woody vegetation, limited grass vegetation
- No year-round food source
- Dry in June 2023
- Heavily shaded by hedgerow / line of trees at the west end on the north side and by vegetation in channel
- Steep banks suitable for burrowing
- Some disturbance - adjacent to arable on both sides
- No obvious signs of pollution e.g., agricultural run-off or litter debris
- Condition assessment: N/A - Dry

Unsuitable

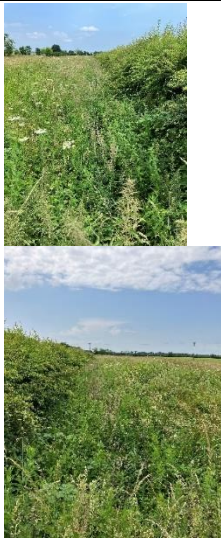
55	<ul style="list-style-type: none"> ▪ Connected to one on-site watercourse (54) ▪ Hedgerow on the south side of ditch ▪ Mixture of grass, woody and herbaceous vegetation on banksides ▪ Mixture of grass and herbaceous vegetation in channel, some woody vegetation ▪ Limited year-round food source ▪ Wet in June 2023 (<20cm) ▪ Heavily shaded by hedgerow from the south side, by bankside vegetation and by vegetation in channel ▪ Very steep banks suitable for burrowing ▪ Some disturbance - large field margin (>50m) between arable and ditch, livestock on south side. ▪ Water quality moderate - no litter debris but a few signs of agriculture run-off / pollution e.g., green algae, oil on surface of water etc. ▪ Condition assessment: poor 	Suitable but poor

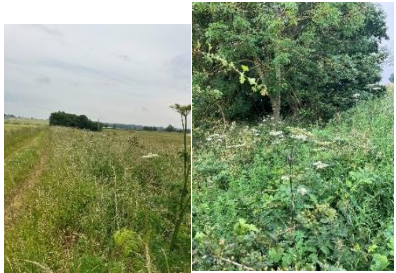
71	<ul style="list-style-type: none"> ▪ Connected to one on-site watercourse (70) ▪ Woodland edge at the east end of ditch ▪ Bankside vegetation is predominately grass, some herbaceous vegetation, limited woody vegetation ▪ Mainly herbaceous vegetation in channel, some grass vegetation, no woody vegetation ▪ Limited year-round food source ▪ Dry in June 2023 ▪ Heavily shaded by edge of woodland at east end, shaded by bankside vegetation and by vegetation in channel ▪ Steep banks suitable for burrowing ▪ Some disturbance - adjacent to arable on both sides ▪ No obvious signs of pollution e.g., agricultural run-off or litter debris ▪ Condition assessment: N/A - Dry 	Unsuitable

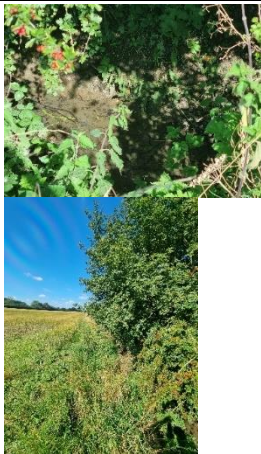
<ul style="list-style-type: none"> Condition assessment: could not complete condition assessment due to vegetation in channel 		
74	<ul style="list-style-type: none"> Not connected Hedgerow in wet ditch Bankside vegetation is predominately woody, some grass and herbaceous vegetation Mainly woody vegetation in channel, limited grass and herbaceous vegetation No year-round food source Wet in August 2023 (<10cm) Heavily shaded by hedgerow in channel Steep banks suitable for burrowing Some disturbance - adjacent to arable on both sides Water quality is moderate - no litter debris but a few signs of agriculture run-off / pollution e.g., green algae, oil on surface of water etc. Condition assessment: poor 	Unsuitable
