Botley West Solar Farm

Environmental Statement

Appendix 9.15: Veteran Tree Survey Report

November 2024

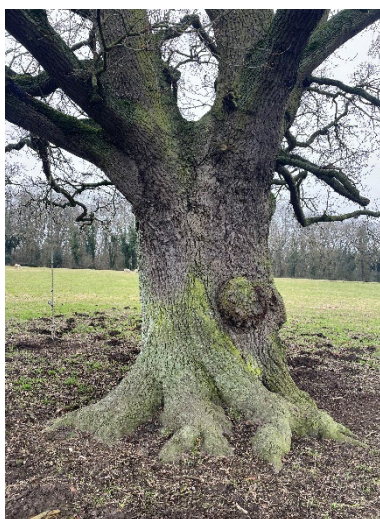
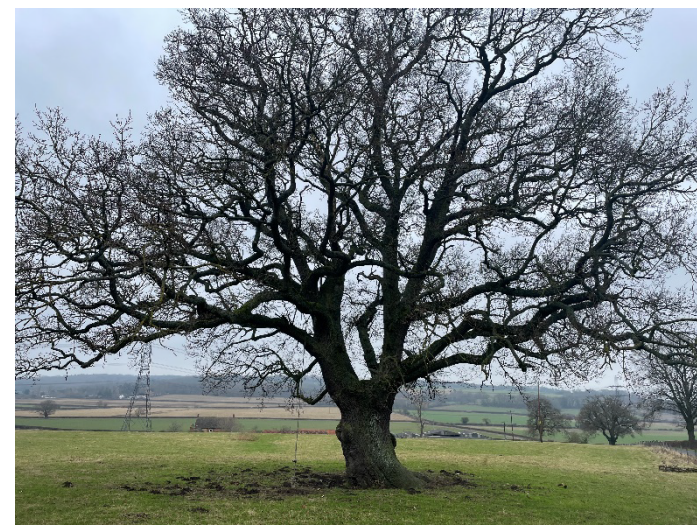
Species	Height (m)	Crown spread (m)				Stem dia. (mm) including irregularities information	Stem no. at 1.5m	Height of crown clearance (m)	Dir/height	Age class	Condition	Type	General observations Management recommendations	Estimated remaining contribution (years)	Tree Quality Category (BS5837)	Tree Typology	
		N	E	S	W												
T2	<i>Quercus robur</i> - Pedunculate Oak	14.0	9.0	10.0	12.0	12.0	1600	1	2.00	-	V	Good	Field	Fine, Open grown former pollard, curved stem to west. Bulged unions, minor pruning stubs rope swing.	60+	A2/3	Field

Primary Tree Qualities						
Extensive Decay			Previous aged management	Senescence / Aged decline	Retrenchment / Canopy Reduction	
Brown rot	Exposed heartwood	Hollowing (by %)				
None	None	X	Former Pollard	X		X

Secondary Tree Qualities											
Attached deadwood >150mm dia	Storm Damage	Roosts, nests, crevices	Aerial Roots	Bark flux / Sap	Wet pockets	Bark loss/decay	Fungi		Other epiphytic plants		
							Major	Minor	Lichens	Ferns	Other
0.2m	X	Dry nest in hollow, dry hollow at pollard union at 2.5m	Root flare at buttress	None	None	Bulged	None visible	Ganoderma root flare	None	None	-

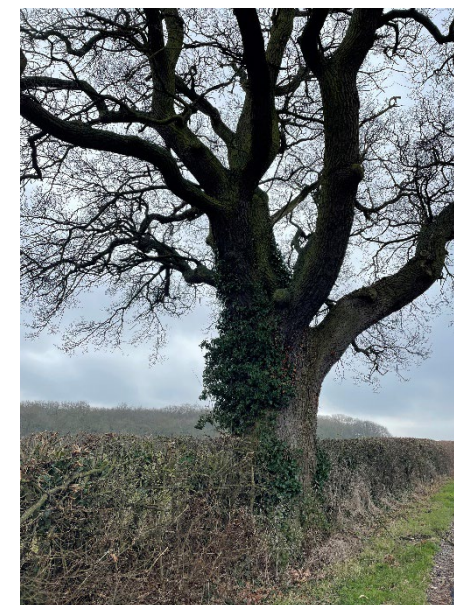
Species	Height (m)	Crown spread (m)				Stem dia. (mm) including irregularities information	Stem no. at 1.5m	Height of crown clearance (m)	Dir/height	Age class	Condition	Type	General observations Management recommendations	Estimated remaining contribution (years)	Tree Quality Category (BS5837)	Tree Typology
		N	E	S	W											
T3 <i>Quercus robur</i> - Pedunculata Oak	16.0	12.0	12.0	10.0	10.0	1500	1	3.00	-	V	Good	Hedgerow	Fine hedgerow oak, former pollard, huge bole, ivy in places, attached deadwood – up to 20cm diameter. Various decay stubs.	40+	A2/3	Hedgerow

Primary Tree Qualities												
Extensive Decay			Previous aged management			Senescence / Aged decline			Retrenchment / Canopy Reduction			
Brown rot	Exposed heartwood	Hollowing (by %)										
None visible	On major bough, over road	None visible	Pollard			X			X

Secondary Tree Qualities												
Attached deadwood >150mm dia	Storm Damage	Roosts, nests, crevices	Aerial Roots	Bark flux / Sap	Wet pockets	Bark loss/decay	Fungi		Other epiphytic plants			
							Major	Minor	Lichens	Ferns	Other	
0.2m	-	Dry hollow at pollard	None	None	None	Yes	None visible	None visible	None	None	-

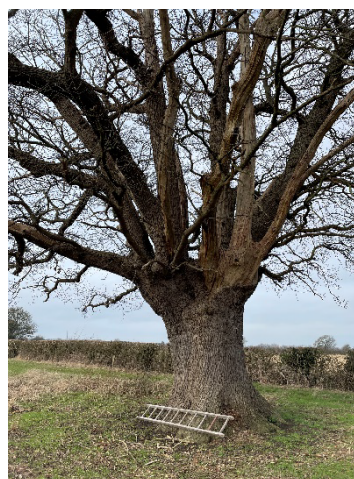
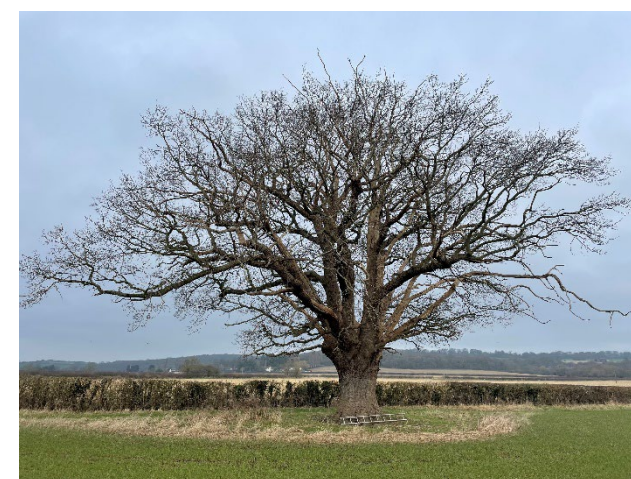
T4	Species	Crown spread (m)					Stem dia. (mm) including irregularities information	Stem no. at 1.5m	Height of crown clearance (m)	Dir/ height	Age class	Condition	Type	General observations Management recommendations	Estimated remaining contribution (years)	Tree Quality Category (BS5837)	Tree Typology
		Height (m)	N	E	S	W											
	<i>Quercus robur</i> - Pedunculata Oak	12.0	13.0	11.0	12.0	12.0	1700	1	2.00	-	V	Fair	Field	Superb, former pollard, major decline/decay. Decayed hollow pocket at roof flare. Attached and hung deadwood greater than 30cm diameter. Pollard head circa 3m diameter	30+	A2/3	Field

Primary Tree Qualities						
Extensive Decay			Previous aged management		Senescence / Aged decline	Retrenchment / Canopy Reduction
Brown rot	Exposed heartwood	Hollowing (by %)				
Yes	-	70% buttress cavity	Pollard		40-50% dead pollard head	40% major decline

Secondary Tree Qualities											
Attached deadwood >150mm dia	Storm Damage	Roosts, nests, crevices	Aerial Roots	Bark flux / Sap	Wet pockets	Bark loss/decay	Fungi		Other epiphytic plants		
							Major	Minor	Lichens	Ferns	Other
+10 30cm diameter	-	Major saddle at pollard head	Fluted buttress	x	Major saddle	Yes	None visible	None visible	None	None	-

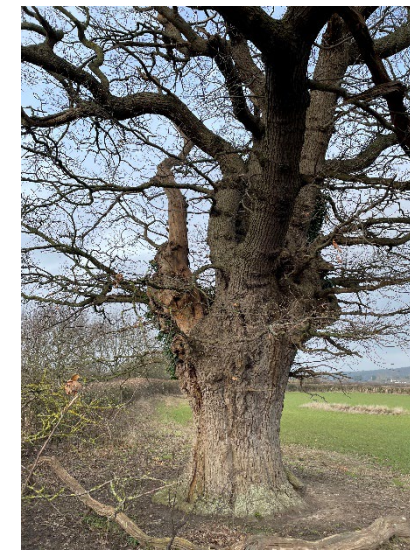
Species	Height (m)	Crown spread (m)				Stem dia. (mm) Including irregularities information	Stem no. at 1.5m	Height of crown clearance (m)	Dir/ height	Age class	Condition	Type	General observations Management recommendations	Estimated remaining contribution (years)	Tree Quality Category (BS5837)	Tree Typology	
		N	E	S	W												
T5	<i>Quercus robur</i> - Pedunculate Oak	13.0	8.0	10.0	9.0	9.0	1400	1	2.00	-	V	Fair/good	Field	Superb, former pollard. Pollard head circa 2.5m diameter. Major decay to west, evident to root flare. Dry saddle at pollard head, ivy and fluted buttress.	40+	A3	Field

Primary Tree Qualities					
Extensive Decay			Previous aged management	Senescence / Aged decline	Retrenchment / Canopy Reduction
Brown rot	Exposed heartwood	Hollowing (by %)			
Yes	Yes, saddle	Estimated 30-50%	Yes	Yes	25%

Secondary Tree Qualities											
Attached deadwood >150mm dia	Storm Damage	Roosts, nests, crevices	Aerial Roots	Bark flux / Sap	Wet pockets	Bark loss/decay	Fungi		Other epiphytic plants		
							Major	Minor	Lichens	Ferns	Other
0.4m	-	Insects and potentially bats	Fluted	-	-	Yes	None visible	None visible	None	None	-

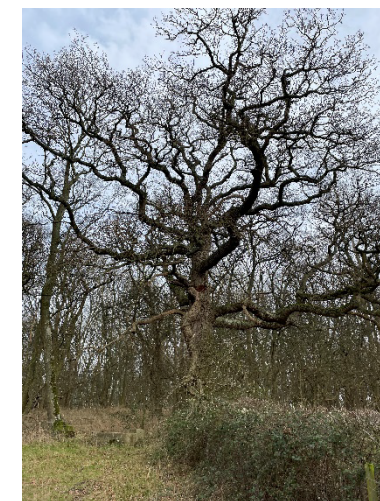
Species	Height (m)	Crown spread (m)				Stem dia. (mm) Including irregularities information	Stem no. at 1.5m	Height of crown clearance (m)	Dir/ height	Age class	Condition	Type	General observations Management recommendations	Estimated remaining contribution (years)	Tree Quality Category (BS5837)	Tree Typology	
		N	E	S	W												
T6	<i>Quercus robur</i> - Pedunculata Oak	-	12.0	12.0	14.0	10.0	1300	1	3.00	NW	V	Good	Woodland	Fine, maiden oak on edge of sloping copse. Huge main bole to 8m. Major snags and storm damage attached/ Various stubs and deadwood.	40+	A2/3	Woodland

Primary Tree Qualities						
Extensive Decay			Previous aged management	Senescence / Aged decline	Retrenchment / Canopy Reduction	
Brown rot	Exposed heartwood	Hollowing (by %)				
None	None	None	Maiden	None	25	None

Secondary Tree Qualities											
Attached deadwood >150mm dia	Storm Damage	Roosts, nests, crevices	Aerial Roots	Bark flux / Sap	Wet pockets	Bark loss/decay	Fungi		Other epiphytic plants		
							Major	Minor	Lichens	Ferns	Other
0.4m	Yes	Bat roost potential, Woodpecker holes	Fluted buttress	-	-	Yes	None visible	None visible	Minor	None	-

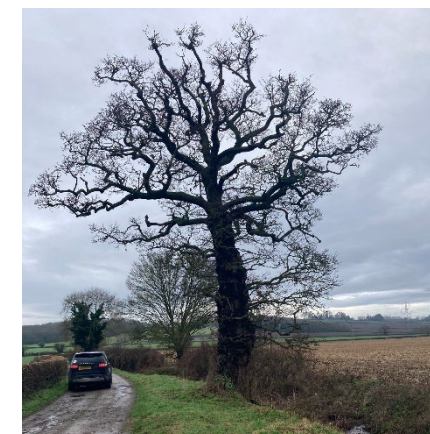
Species	Height (m)	Crown spread (m)				Stem dia. (mm) including irregularities information	Stem no. at 1.5m	Height of crown clearance (m)	Dir/height	Age class	Condition	Type	General observations Management recommendations	Estimated remaining contribution (years)	Tree Quality Category (BS5837)	Tree Typology	
		N	E	S	W												
T8	<i>Quercus robur</i> - Pedunculate Oak	10.0	5.0	7.0	5.0	5.0	1170	1	6.00	S/4m	V	Fair/Poor	Notable	Locally notable oak on the west side of Denman's Lane. Close to the junction with Eynsham Rd. Thinning by aprox. 50%	40+	B2	Field Boundary

Primary Tree Qualities						
Extensive Decay			Previous aged management	Senescence / Aged decline	Retrenchment / Canopy Reduction	
Brown rot	Exposed heartwood	Hollowing (by %)				
X	X	X	Maiden	Yes	Yes

Secondary Tree Qualities											
Attached deadwood >150mm dia	Storm Damage	Roosts, nests, crevices	Aerial Roots	Bark flux / Sap	Wet pockets	Bark loss/decay	Fungi		Other epiphytic plants		
							Major	Minor	Lichens	Ferns	Other
X	X	X	X	X	X	X	X	Yes	Yes	X	-
