# **XLINKS' MOROCCO-UK POWER PROJECT**

**Volume 2, Appendix 1.5: Preliminary Ground Level Bat Tree Roost Assessment**

**Xlinks – Cable Route  
Bideford  
Devon**

**Preliminary Ground Level Bat Tree Roost Assessment**

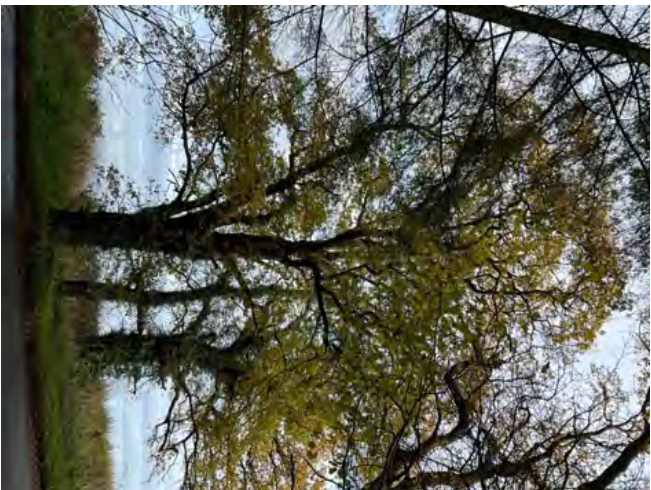
3.8 All four trees considered to have '*High*' potential to support roosting bats were oak trees. The first (T3) had knotholes, stags with collars and ivy throughout, as well as a flush-cut that had fissures, a woodpecker hole, and a tear-out with a likely extending cavity. The second (T5), had stags and ivy throughout, the latter of which formed plates in places. In addition, T5 had a number of tear-out and knotholes that may extend. The third oak (T11) had a tear-

T3 – Oak (High)

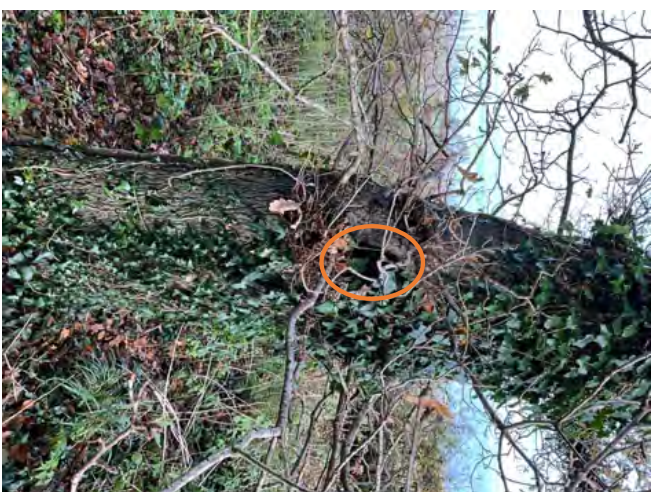
T4 – Knothole

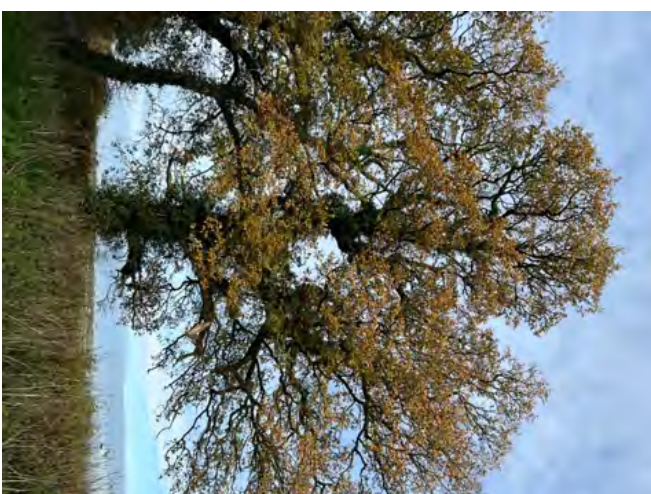
T5 – Oak (High)

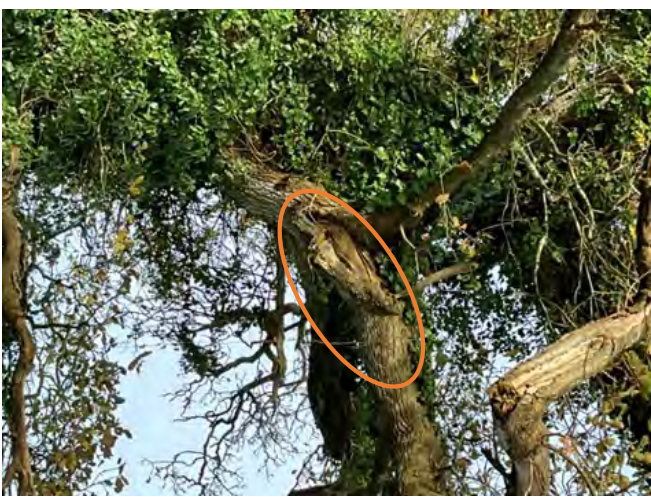
T5 – Tear-out and ivy, > 50 mm in places with plaiting

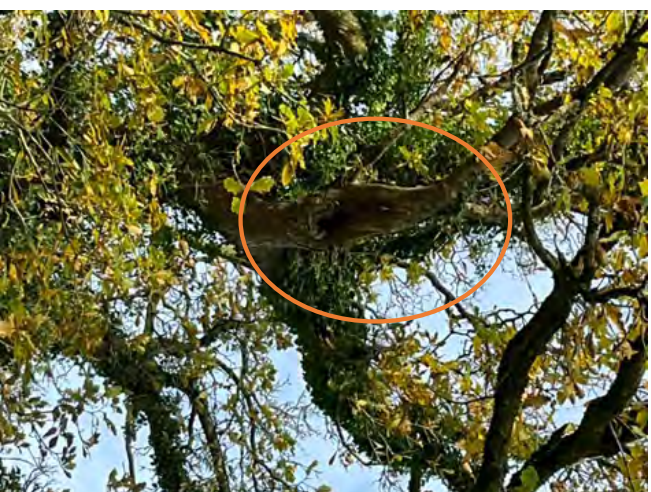
T5 – Tear-out/knothole

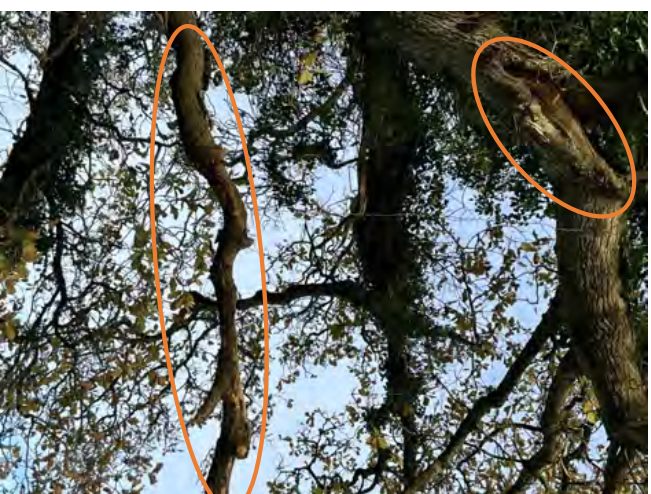
T5 – Tear-out and stag

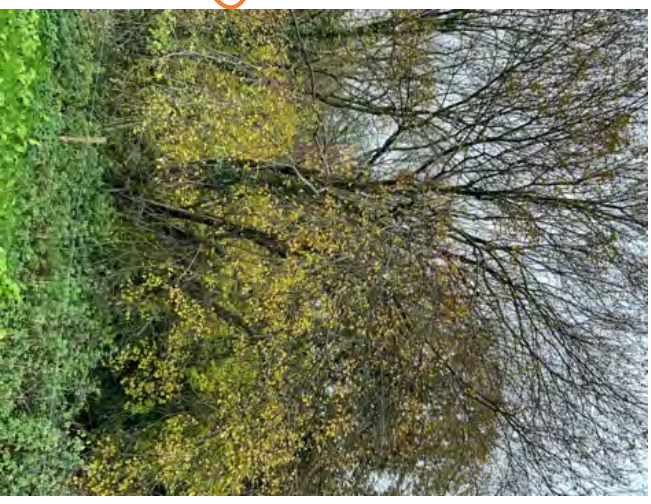
T6 – Willow (Moderate)

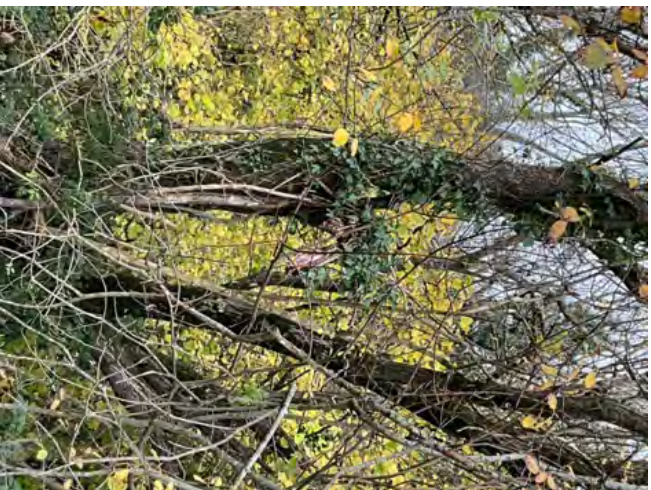
T6 – Snap-limbs throughout

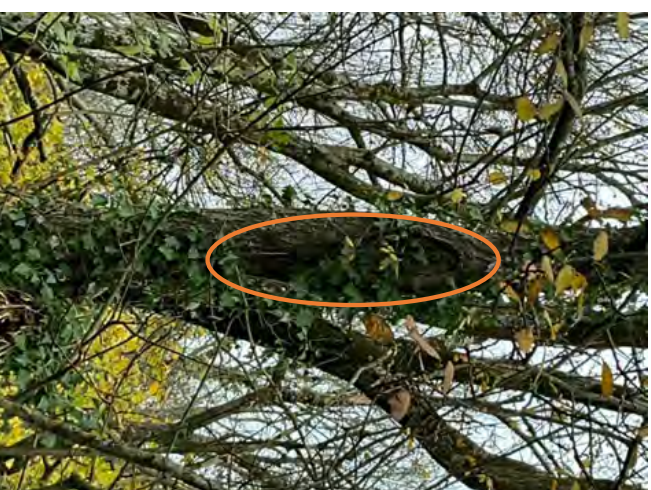
T6 – Wound

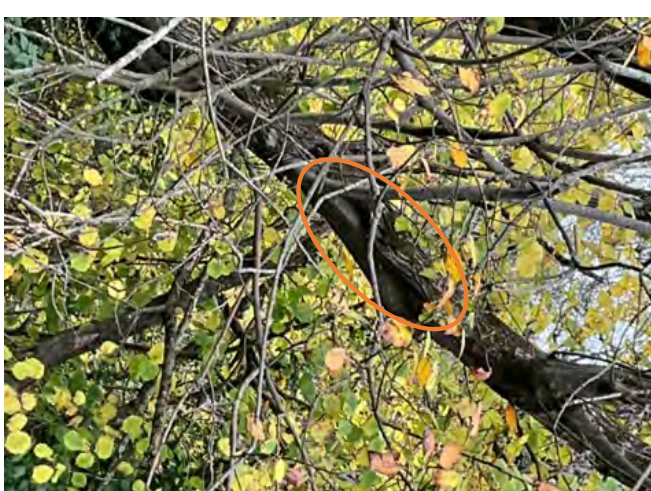
T6 – Wound, healed over

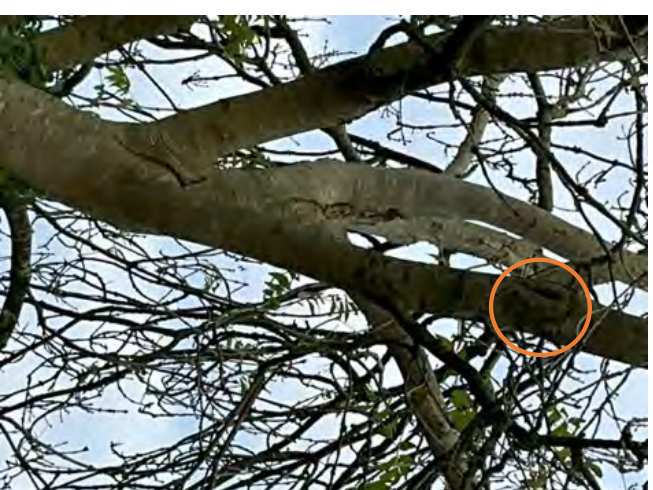
T7 – Canker wound

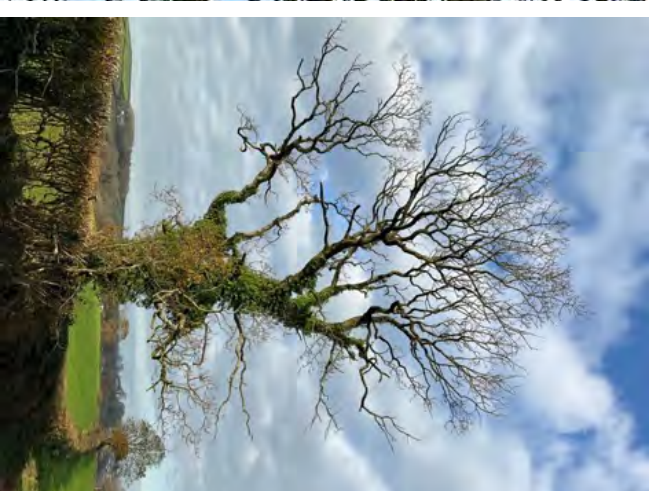
T8 – Oak (Moderate)

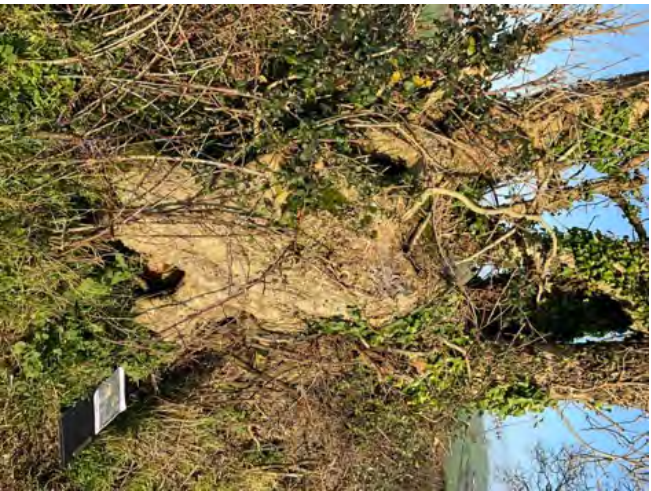
T10 – Butt-rot, multi-access, may extend into limbs

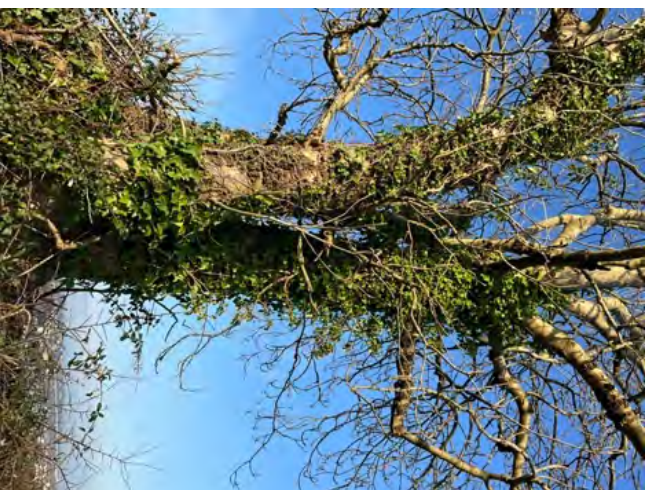
T10 – Ivy throughout, < 50 mm and no plating

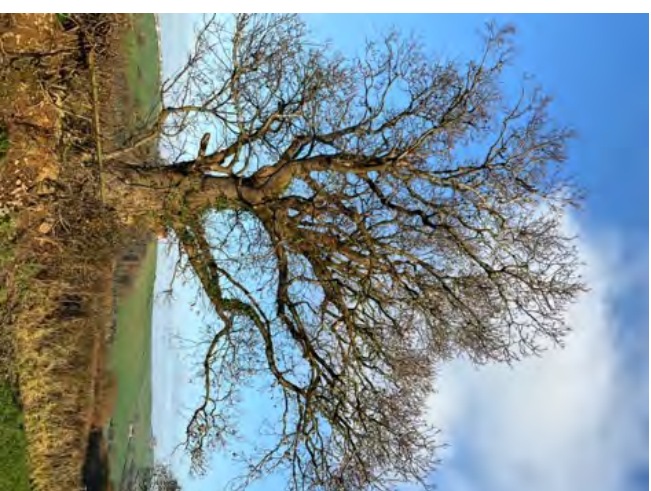
out, butt-rot, wounds, stag and a flush-cut. The fourth (T14) had two knotholes, stags with a knothole or a fissure, lifting bark, three snag-limbs and a tear-out., some extending and providing suitable roosting features for bats.

T11 – Oak (High)

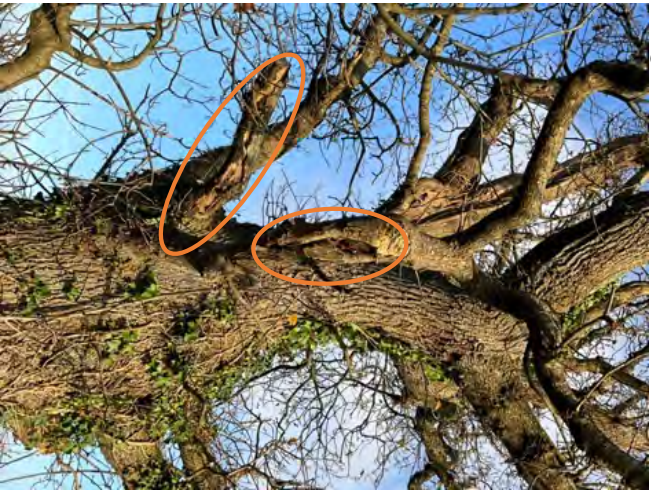
T11 – Wound that may extend and stags

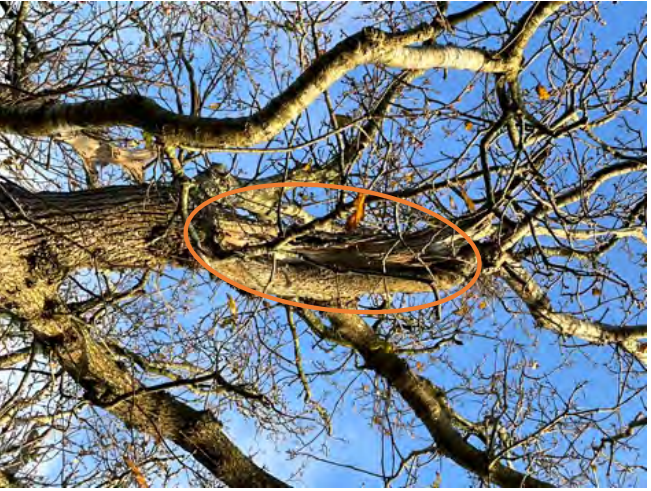
T11 – Tear-out, not extending

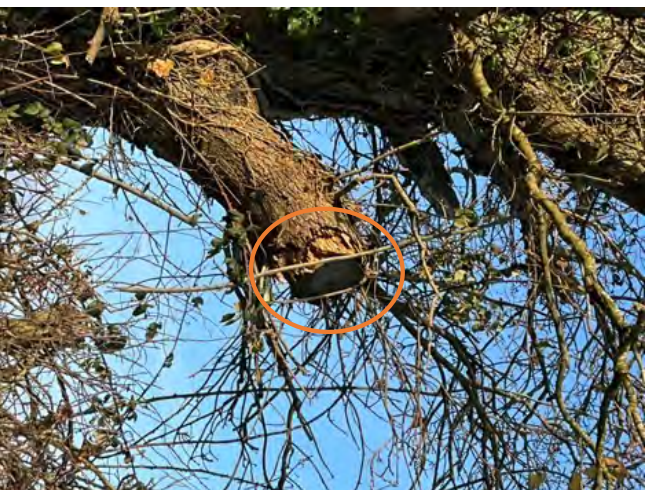
T11 – Flush-cut with no visible cavities

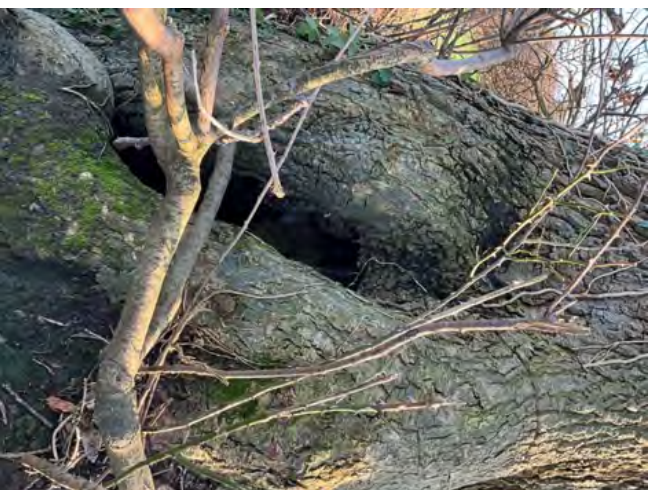
T11 – Butt-rot, may extend

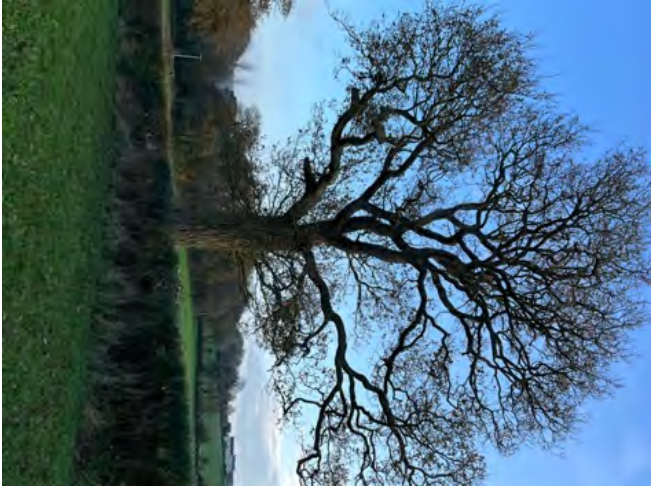
T12 – Oak (Moderate)

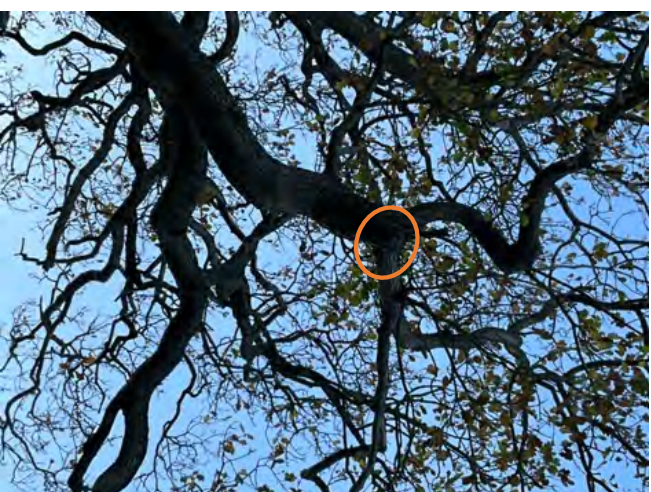
T12 – Flush-cut

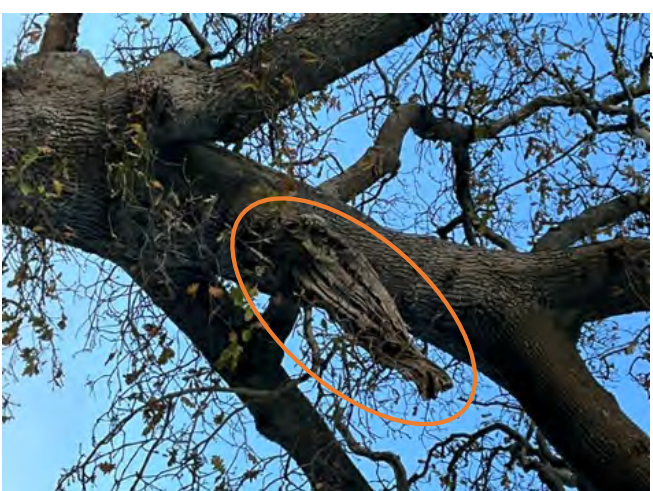
T12 – Snap-limb with a cavity that may extend

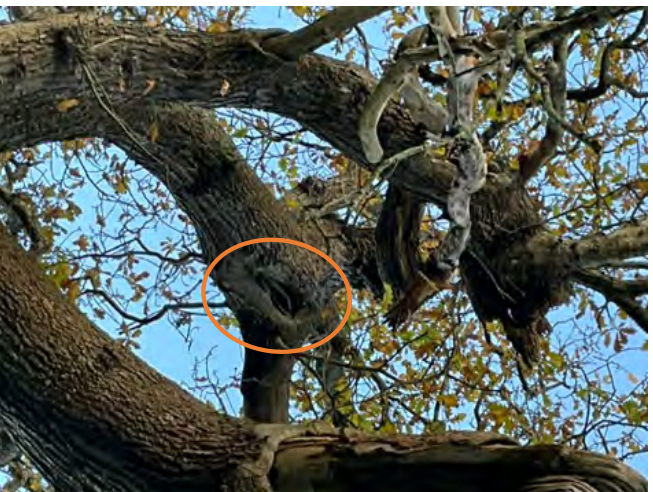
T14 – Tear-out with a likely extending cavity

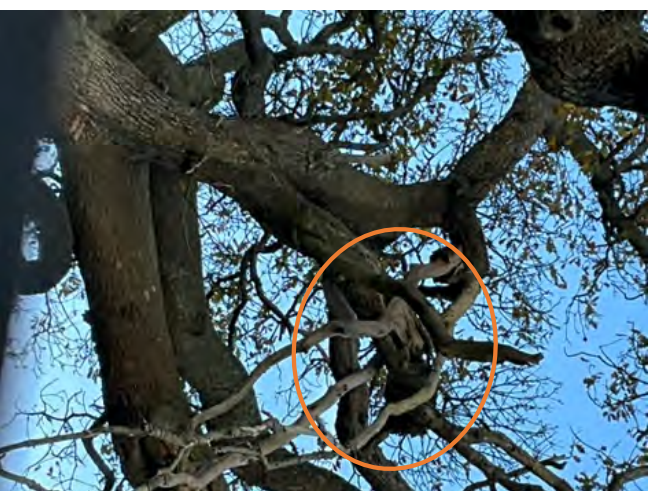
T14 – Snap-limb with upward cavity

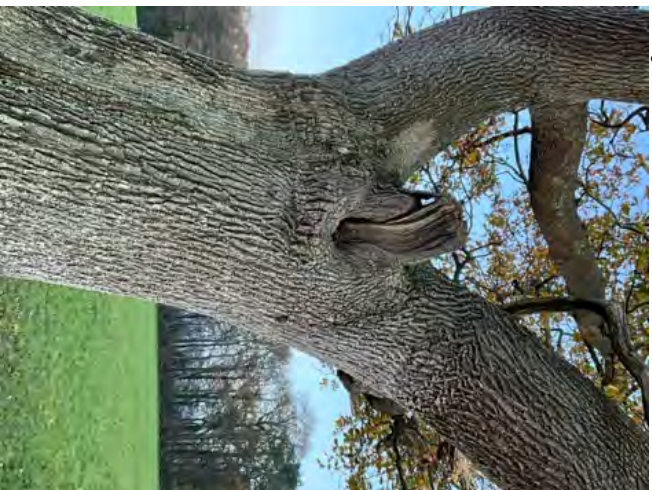
T15 – Knothole with part of stag that may extend

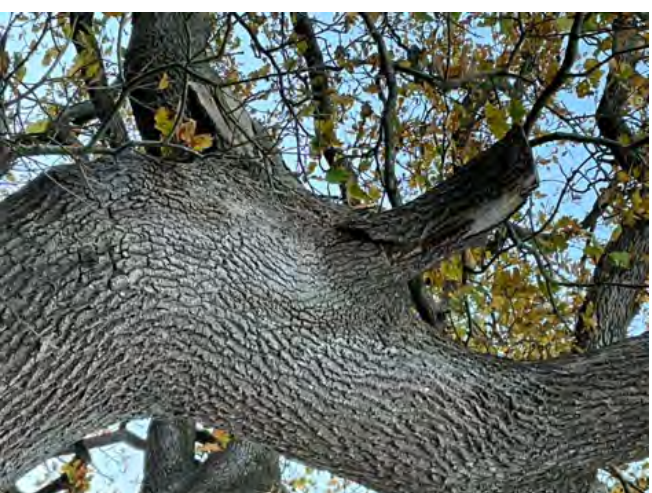
T15 – Flush-cut with lifting bark that may have extending cavity

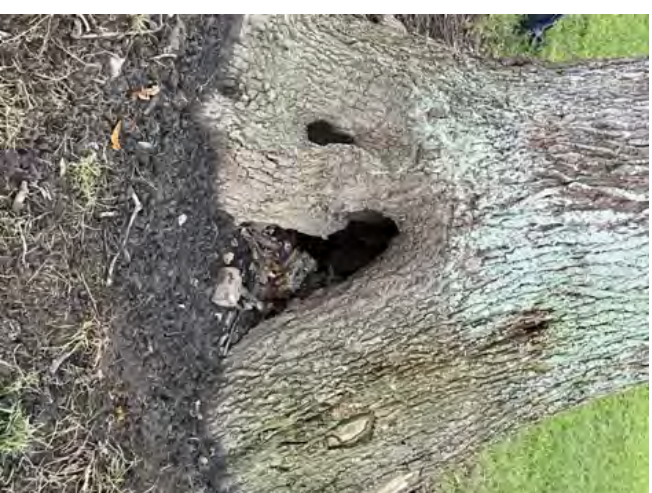
T15 – Butt-rot with extending cavity

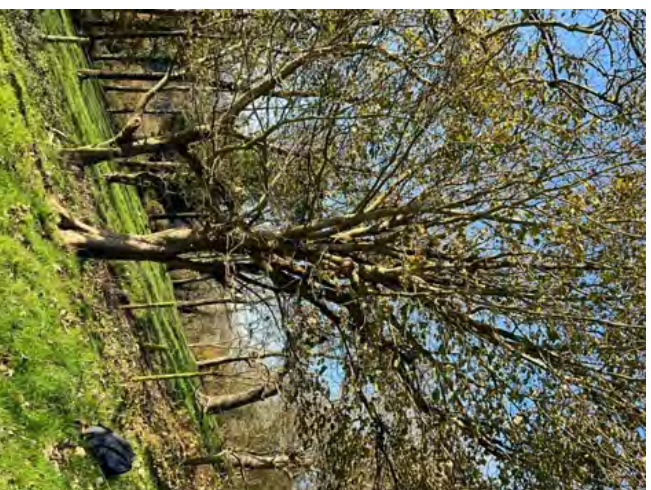
T16 – Sycamore (Moderate)

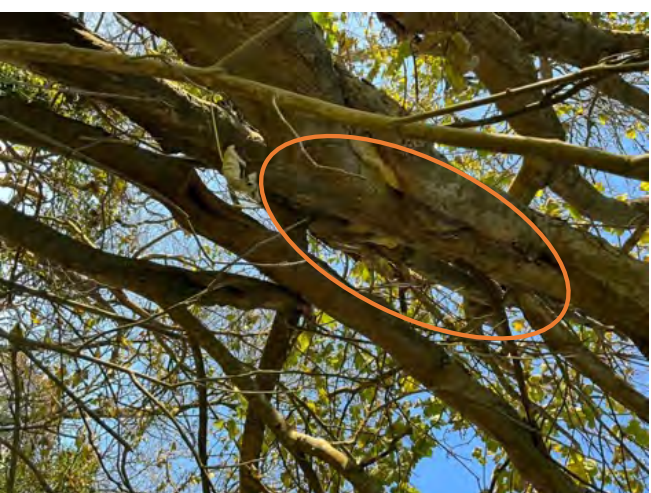
T16 – Union without extending cavity

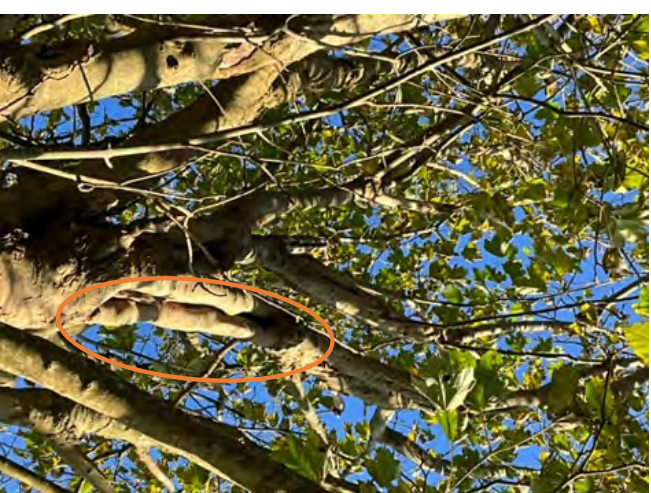
T16 – Wound that may extend

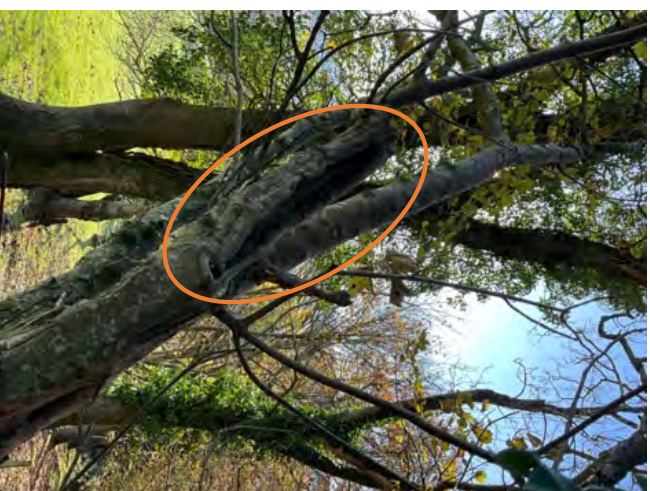
T19 – Wound that does not extend

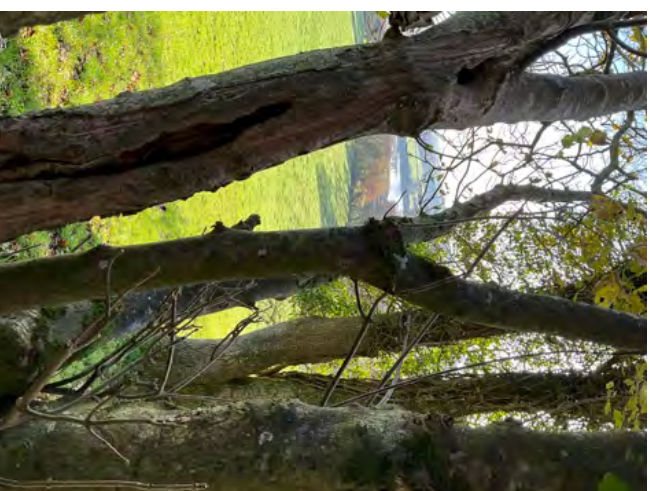
T19 – Wound extending to cavity

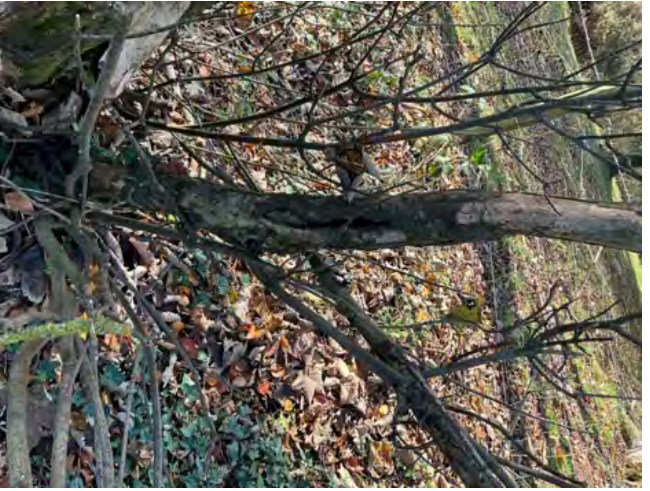
T19 – Wound, likely extending

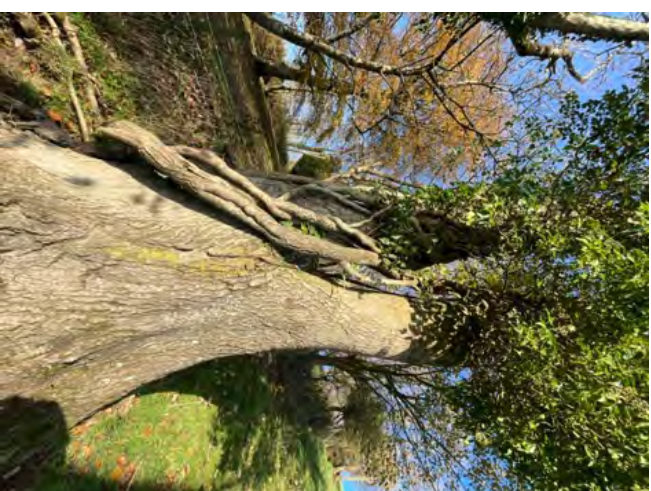
T20 – Ivy, >50 mm with some plaiting

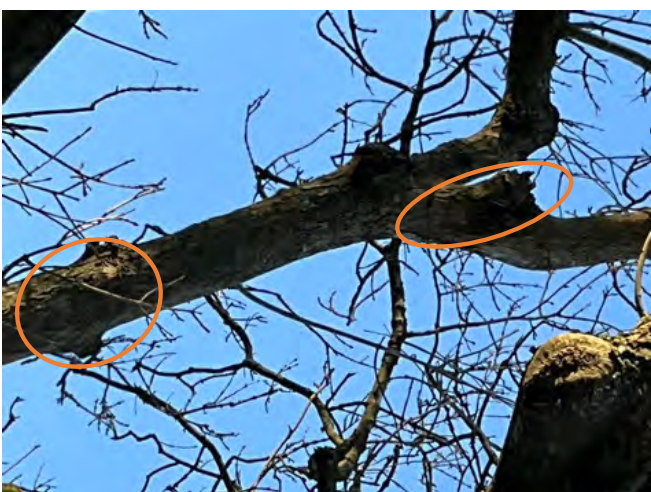
T23 – Cankers throughout some with extending cavities

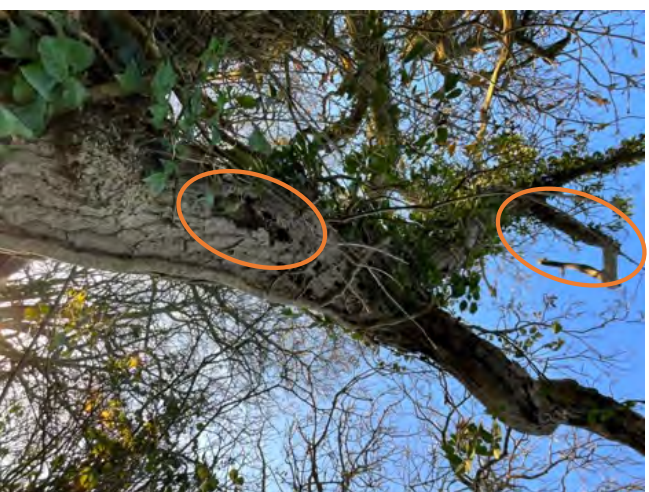
T28 – Lifting bark and stag with cavity at base

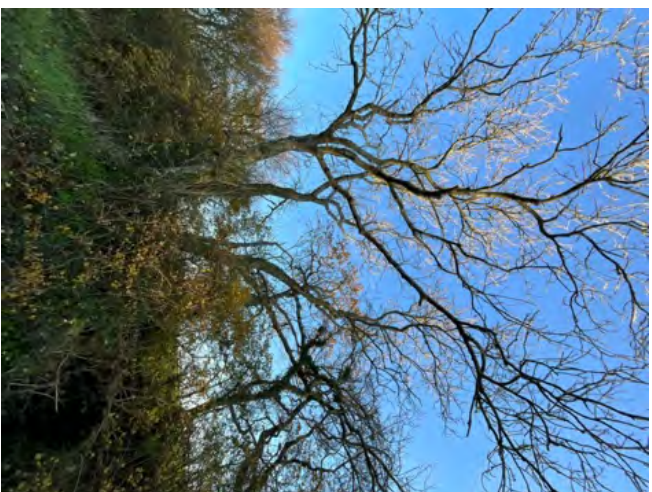
T30 – Ash (Moderate)
