# **AQUIND INTERCONNECTOR**

## **Environmental Statement Addendum 3 – Appendix 3.4 Technical Note – Stockton drilling report**

100-694-TIN-006

Site Survey Findings – Landfalls on Aquind Interconnector to Mannington Sub-Station Q1 2023

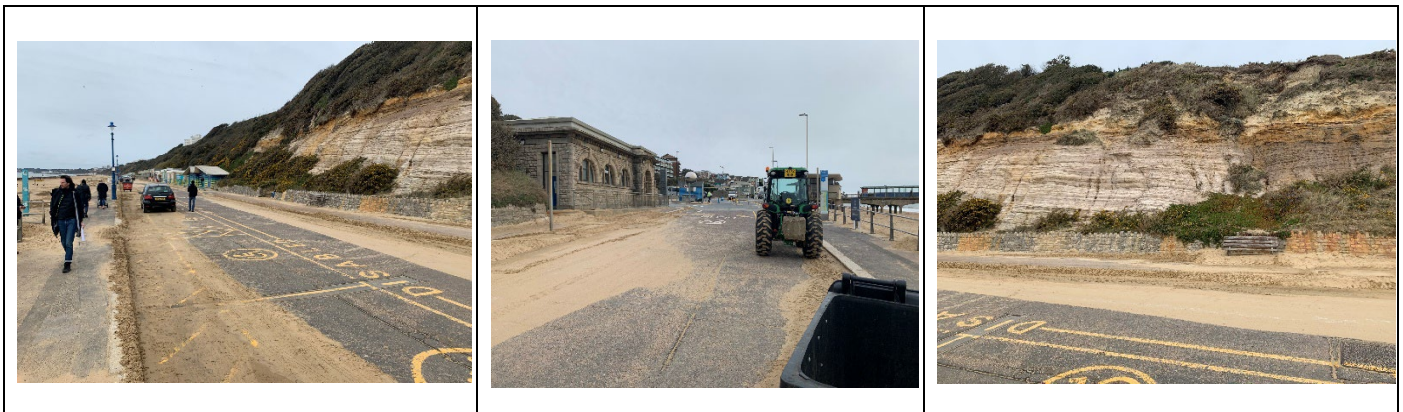
Photos 1-3 Looking west and east and at the cliff face 100m west of Boscombe pier.

The area is clearly tidal given the amount of sand deposited on the road therefore siting an HDD rig and ancillary equipment (2500m<sup>2</sup> area) would not be possible in this location because the area of the HDD compound would be likely to get flooded. The area above the cliff face is built up and has no possible location for set-up at all making this location unfeasible as a landfall site.

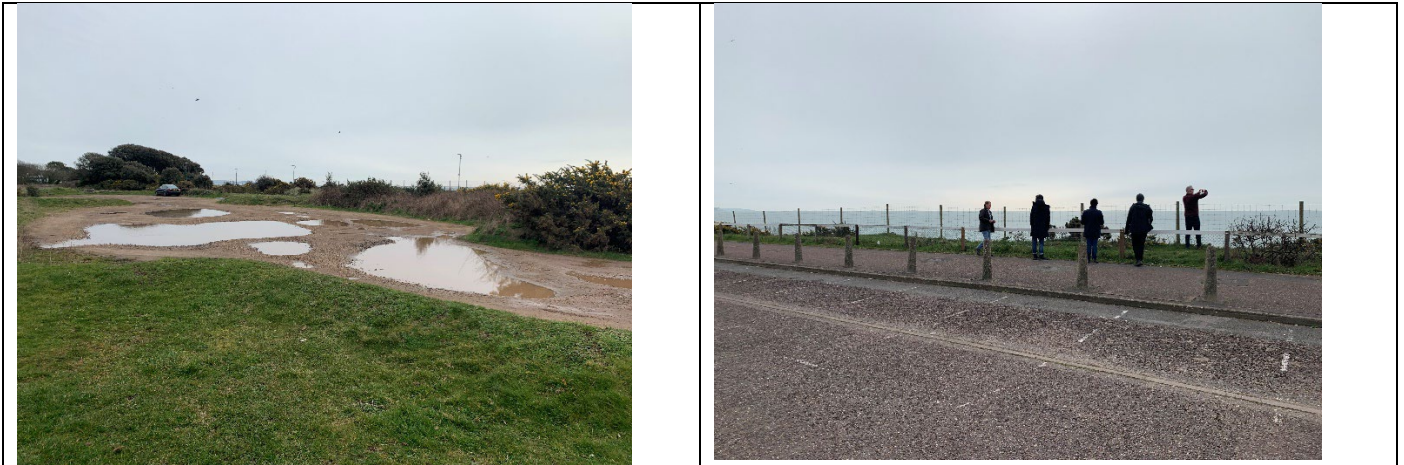
Photos 4 & 5

Given the height of the cliff face and the fact that around 10m cover will be required at the cliff bottom (to avoid the risk of fluid break-out into the sea) there is not enough room on the car park to position the HDD rig back far enough to get the required depth, pipe stringing which involves the laying out and welding of the duct pipe for insertion into the HDD hole will also be a problem in terms of space in this location. The above findings make this location unfeasible as a landfall site.

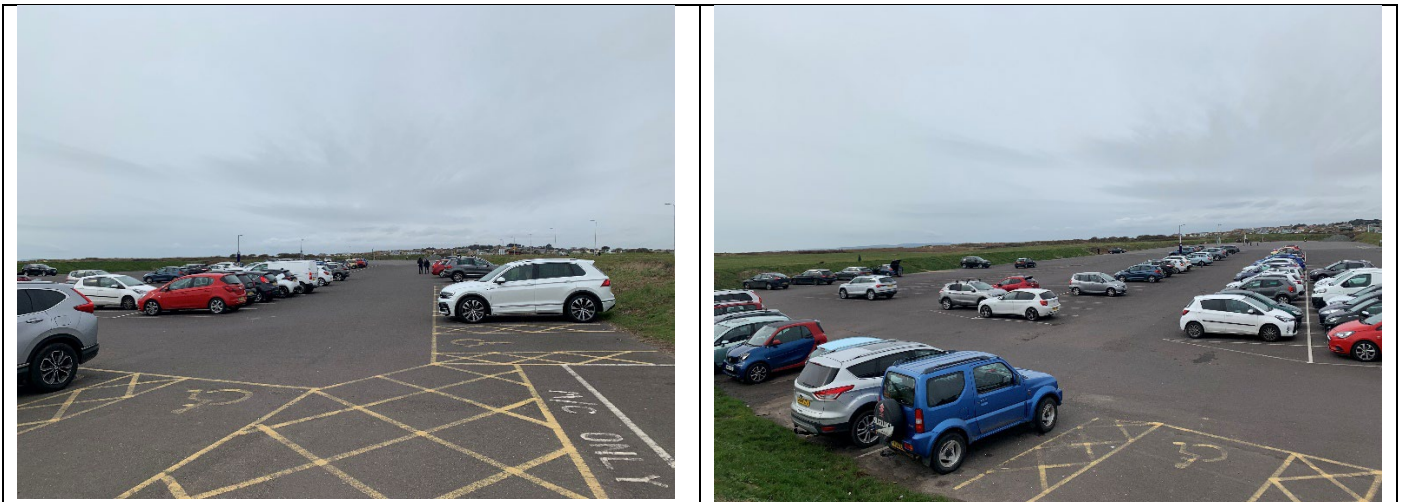
Photos 6 & 7

Given the room potentially available on the car park area shown in the photos, the flatness of the land and the distance back from cliff face, this location in Southbourne is potentially feasible for HDD landfalls subject to further desktop and intrusive investigation and then of course the necessary permissions.

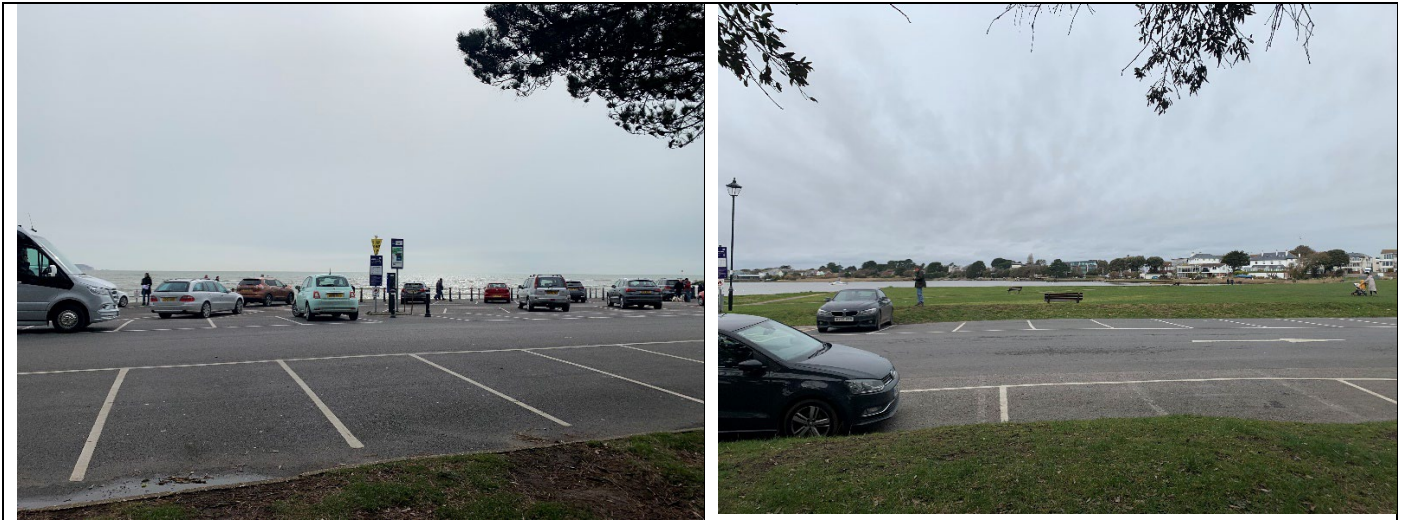
Photos 8 & 9

This site has a number of issues when considering the landfalls that would be required, those being the depth required for the HDD (to avoid fluid break-out into the sea) and the lack of distance available to the sea wall from any likely HDD set-up at this location, the grassland to the north is a possibility but then the trees as you look south from a potential entry point become a problem in terms of their potential removal, it would also not be possible to string out and weld the duct pipe out for installation into the HDD hole, making this location unfeasible as a landfall site.

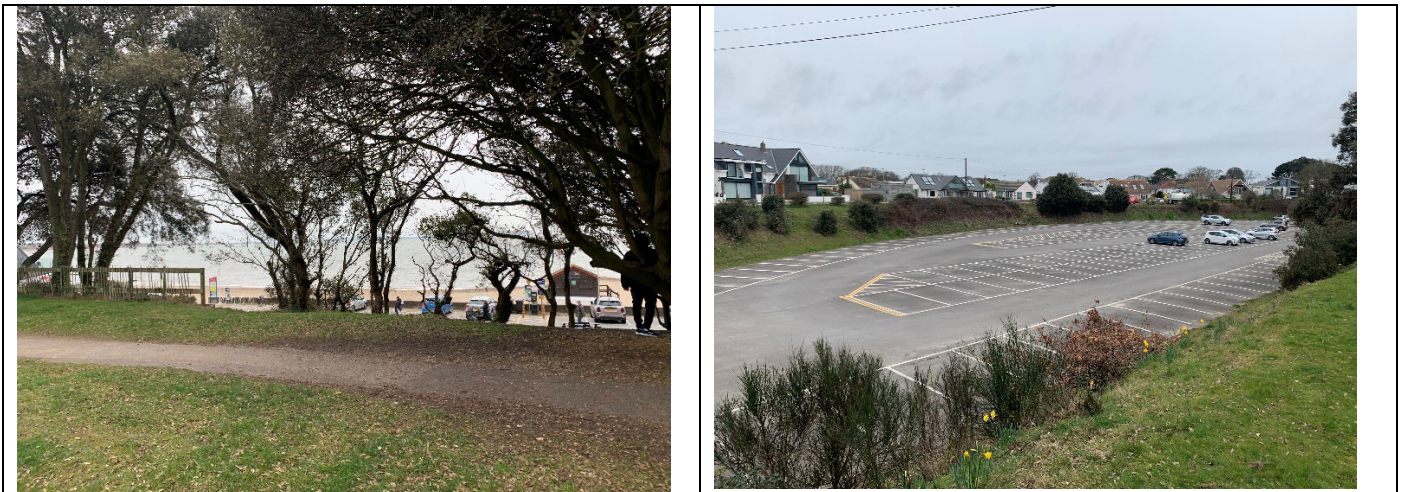
Photos 10 & 11

The car park shown in photo 11 is a possible location for the HDD drill set-up in terms of distance from the sea which would help to get the required depth under the sea (and avoid fluid break-out), however even though the car-park is a reasonable size the shape of the car park is such that there is not enough space to string out and weld the length of duct pipe onshore behind the rig setup which would be required for installation into the HDD hole. Consequently, the stringing of the pipe effectively has to be done at sea with the pipe floated out, and whilst this is in theory able to be done, it is extremely difficult from an engineering perspective and adds significant risk and cost. It is therefore to be avoided unless there is no other alternative. Moreover, and of further risk, it would be necessary to forward ream the HDD holes in this location because of the set-up required at sea, and which in a geology of sands and clays carries significant risk of the HDD holes collapsing and the installation ultimately proving unsuccessful. Taking these constraints and significant risks into account, it has been determined that this location is not feasible as a landfall site.

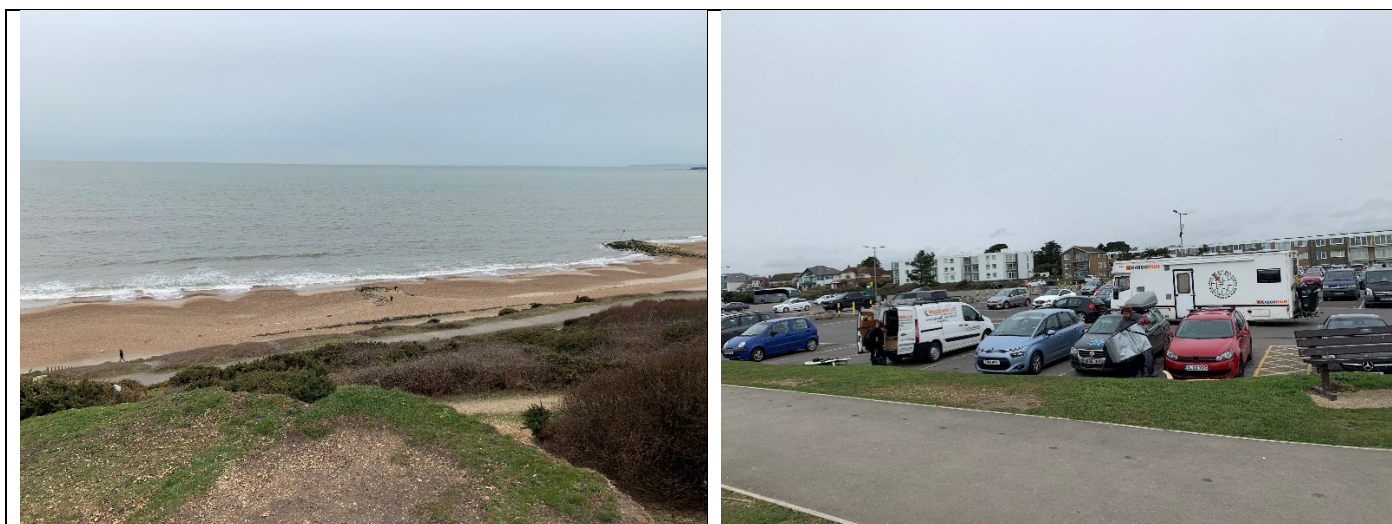
**Photos 12 & 13**

Given the height of the sea cliff and the space available on photo 13 there would not be enough space to set-up the HDD rig far enough back horizontally to achieve the vertical requirements of the drive (need to be 10m cover at the cliff face to avoid fluid break-out), there is also not enough space to string out and weld the duct pipe in this location given the depth requirements detailed above. Also, on the depth required to get far enough under the cliff bottom there could potentially be thermal issues with the electric cables for installation, this will also need to be checked with the cable manufacturer. The issues summarised above make this location unfeasible as a landfall site.

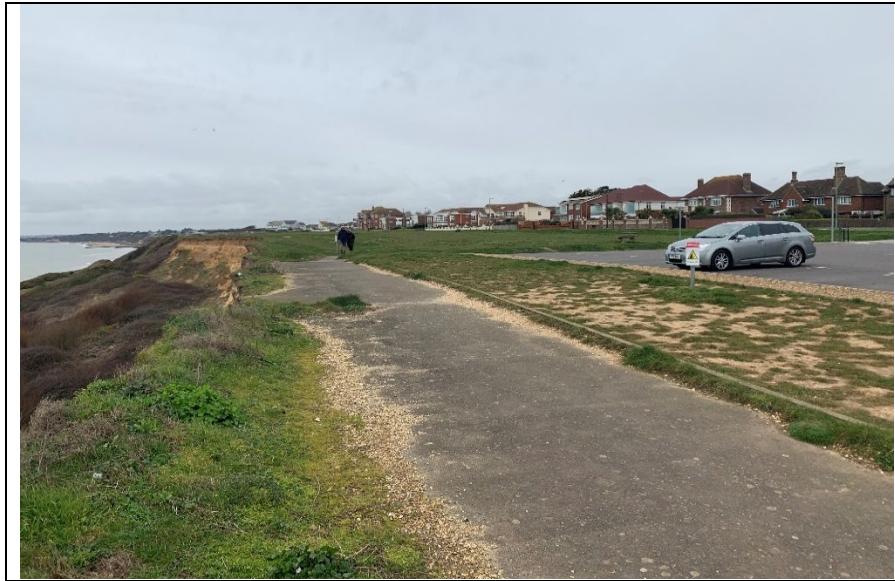
Photo 14

Given the height of the sea cliff and the space available there would not be enough available space to set-up the HDD rig far enough back horizontally to achieve the vertical requirements of the drive (need to be 10m cover at the cliff face to avoid fluid break-out), there is also not enough space to string out and weld the duct pipe in this location given the depth requirements detailed above, making this location unfeasible as a landfall site.

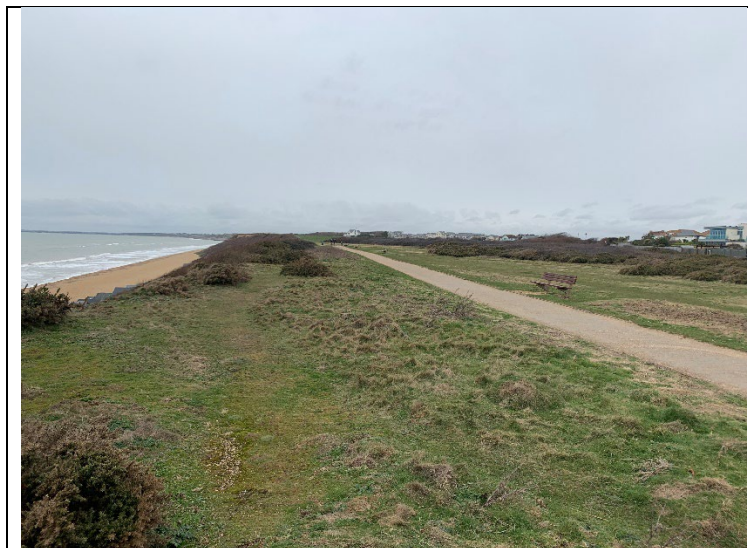
Photos 15

A location at or near the car park located south of the junction of Whitby Road and Cliff Road was considered. Given the height of the sea cliff and the space available there would not be enough available space to set-up the HDD rig far enough back horizontally to achieve the vertical requirements of the drive (need to be 10m cover at the cliff face to avoid fluid break-out), there is also not enough space to string out and weld the duct pipe in this location given the depth requirements detailed above, making this location unfeasible as a landfall site.

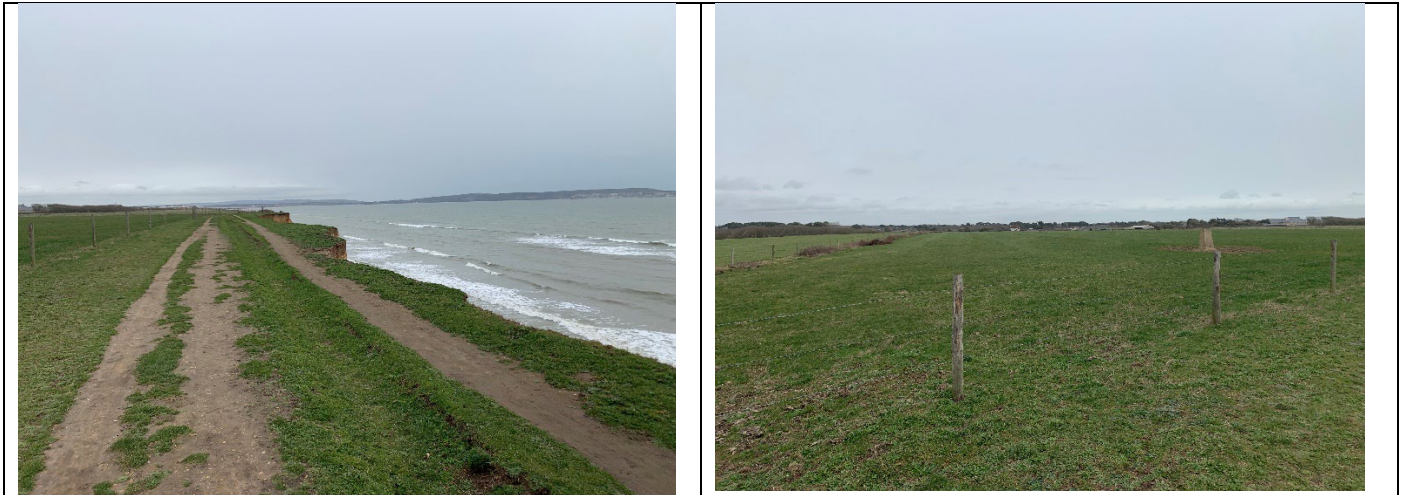
Photos 16 & 17

This location in a farmers field south of B3058 (Milton Rd – Cliff Rd) and south west of the Cliff Rd – Downton Ln junction has enough space available to drill the landfalls and string out and weld the duct pipe for insertion into the HDD hole, however access to the site would have to be through the farm entrance and hard standing will need to be constructed across the site and retained for the life of the project to provide future access. This location is potentially feasible for the HDD landfalls subject to further desktop and intrusive investigation and then of course the necessary permissions. The location of the farm is shown on the image below.

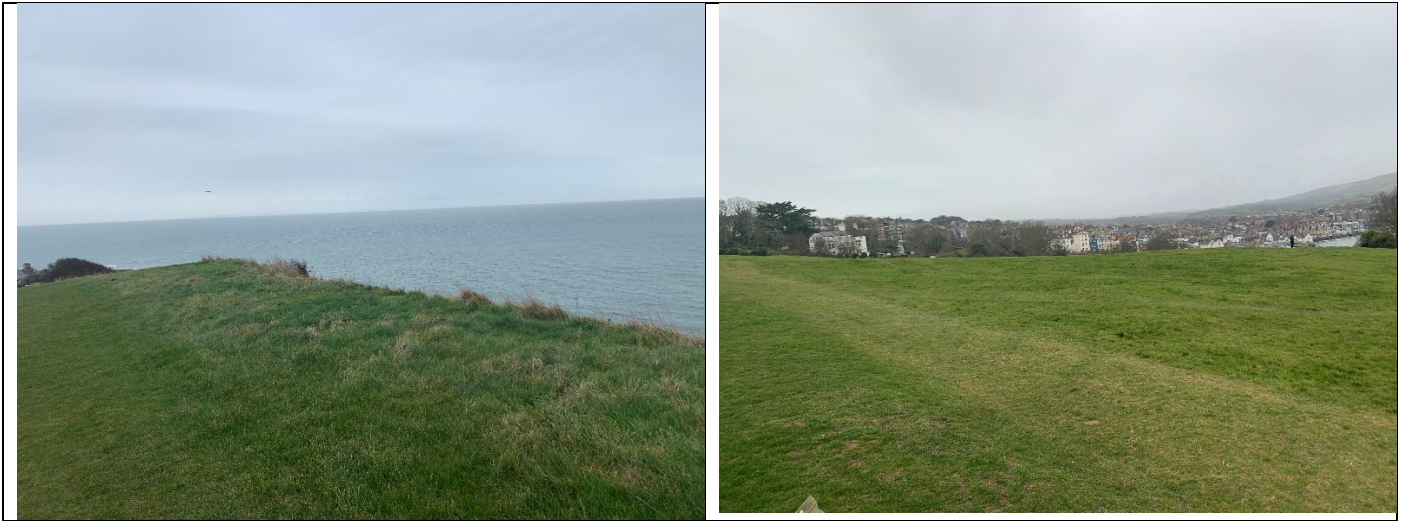
Photos 18 & 19

Access to the land at Swanage was poor, particularly when considering articulated vehicle access will be required, the land up to any potential HDD site set-up is too steep to get the equipment to it, pipe stringing and welding will also not be possible in the very limited space that will be left behind the HDD rig, making this location unfeasible as a potential landfall site.
